### **Roof Inspection Report**

**Property Address:**  
7329 Reserve Creek Dr  
Port St. Lucie FL 34986

8/26/2025

Sample Report

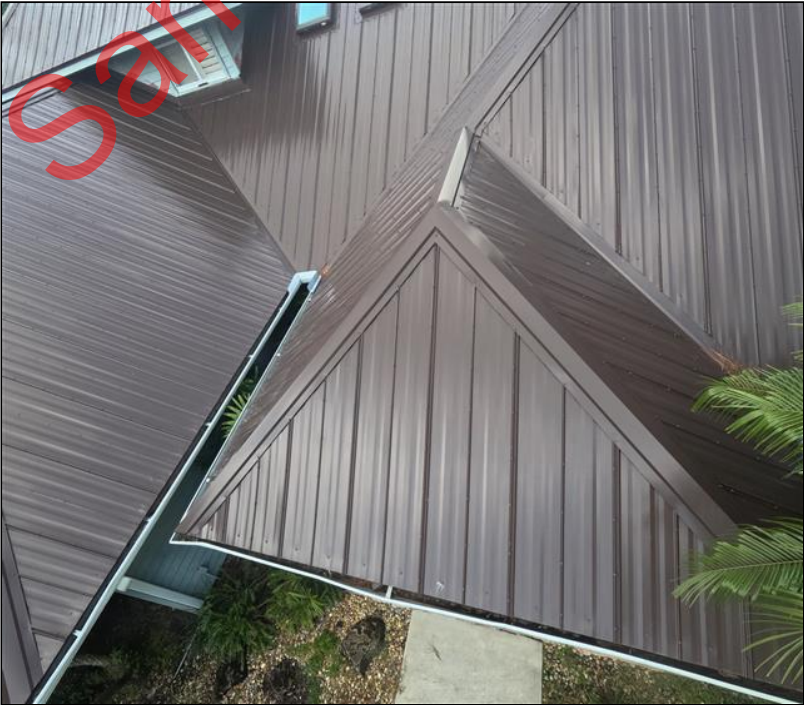
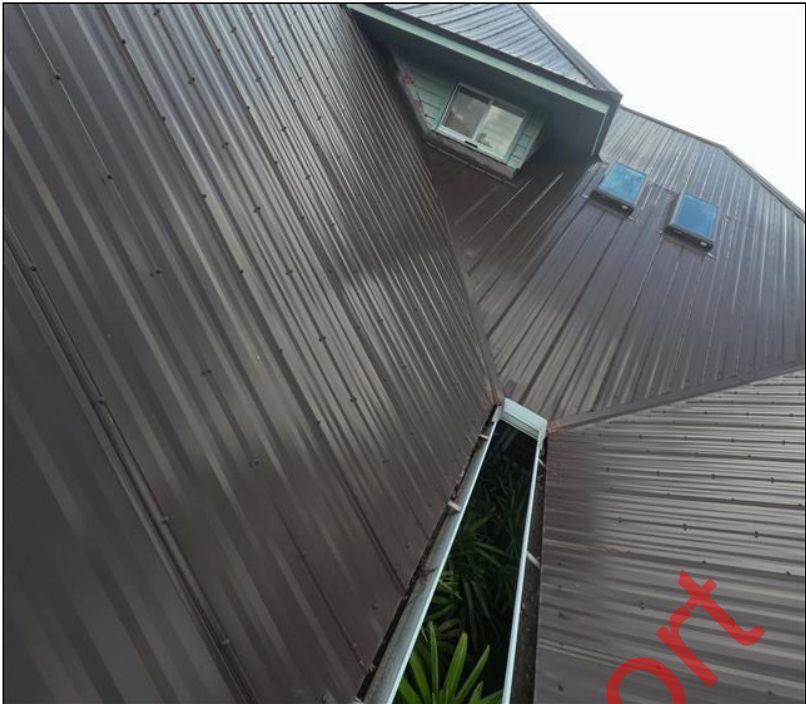
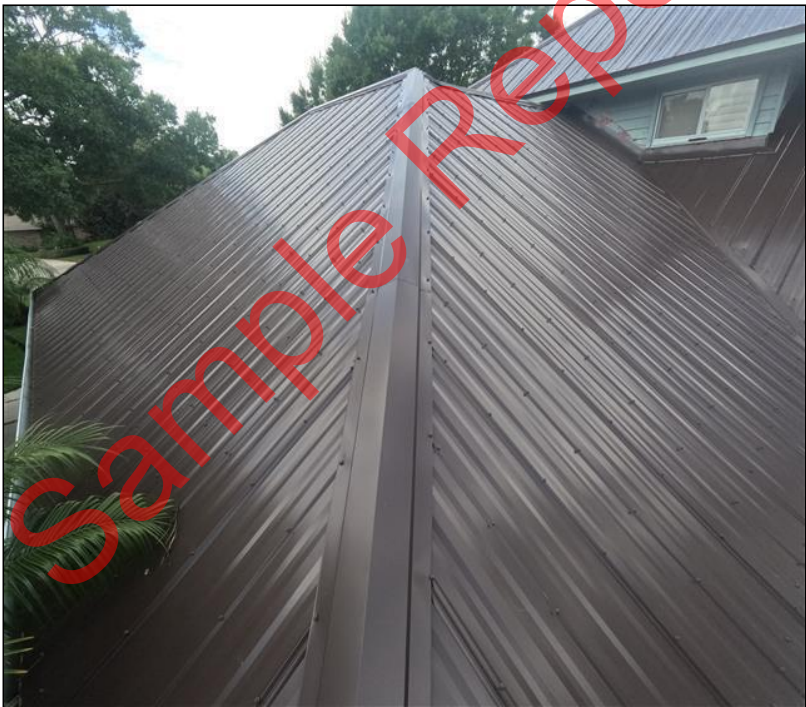
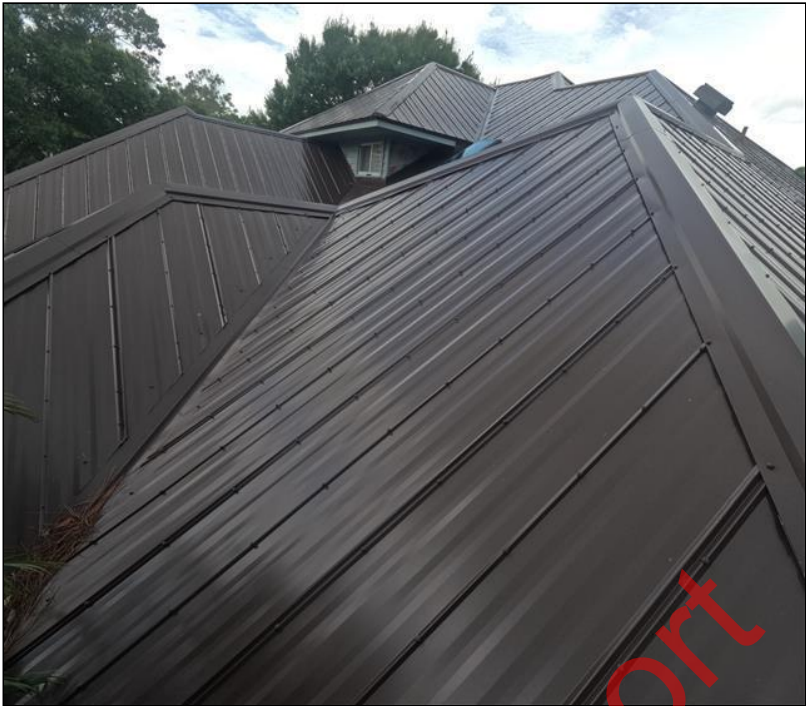
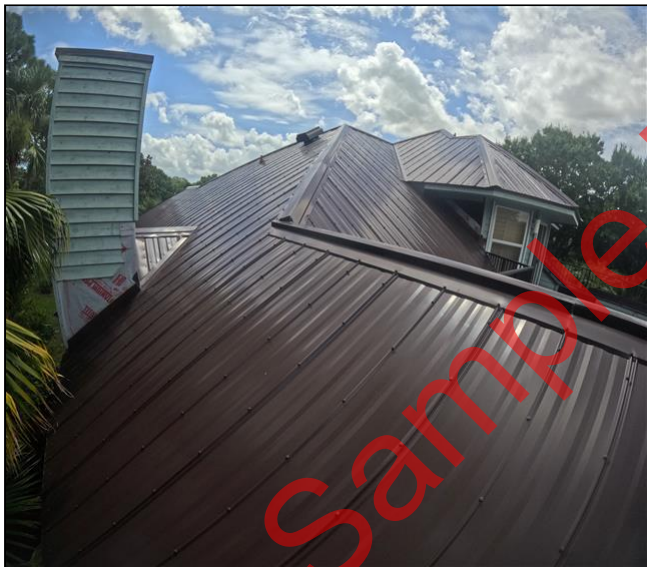
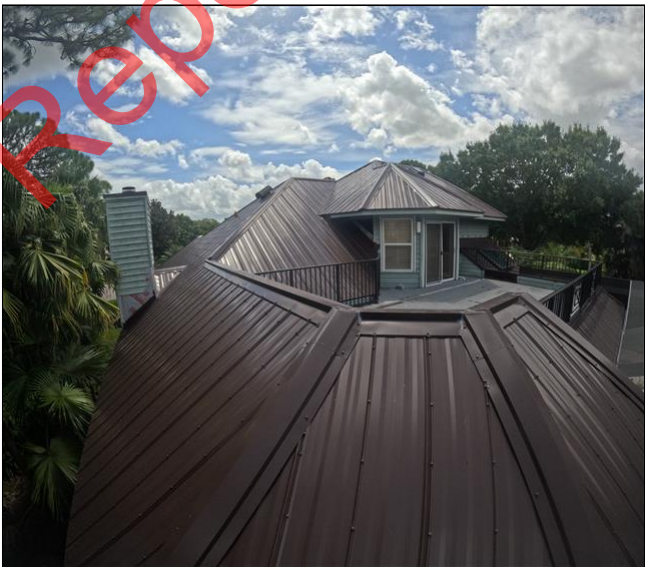
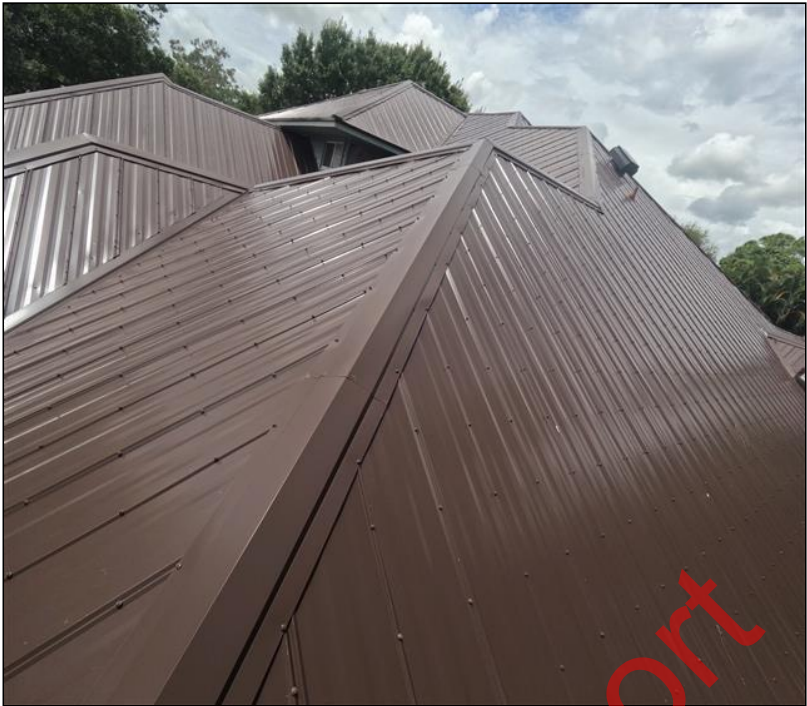
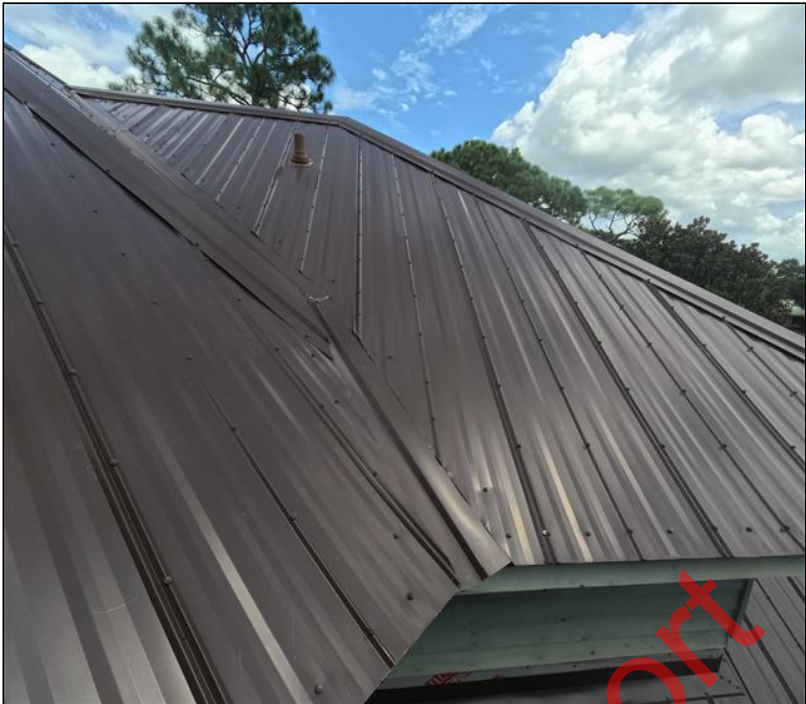
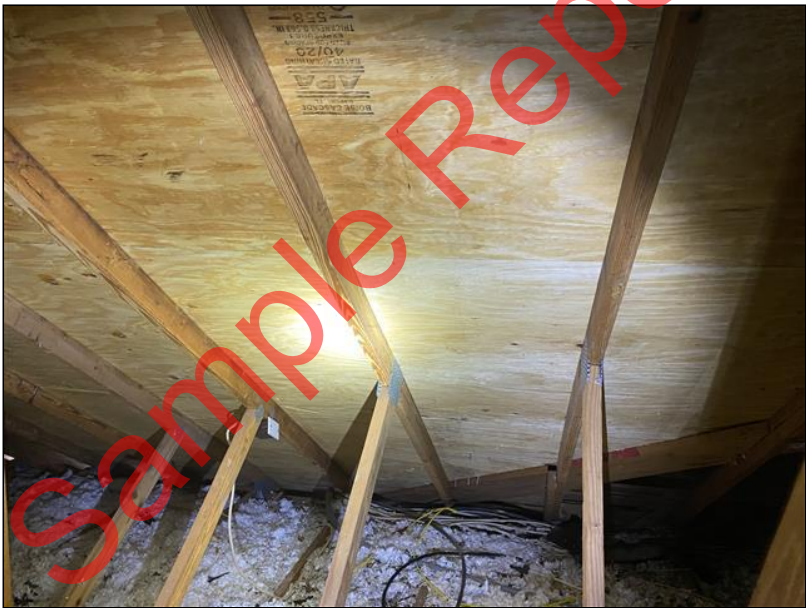
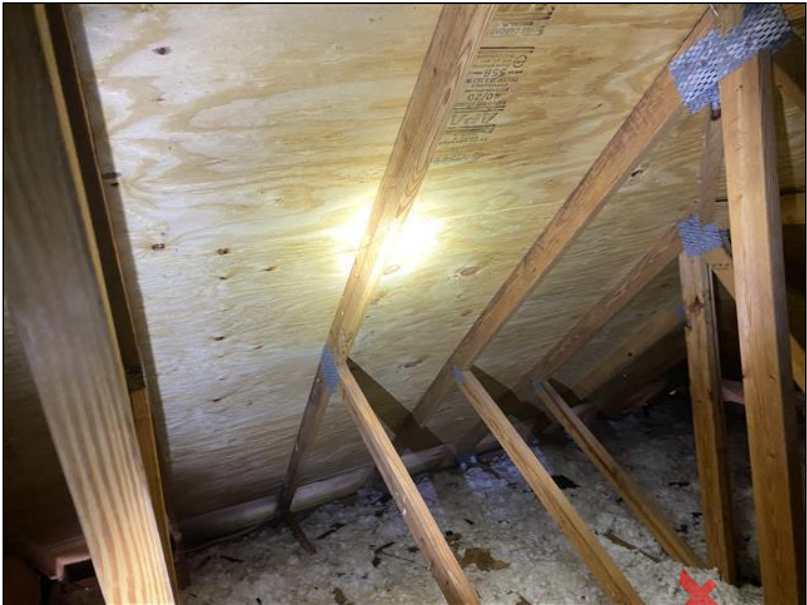
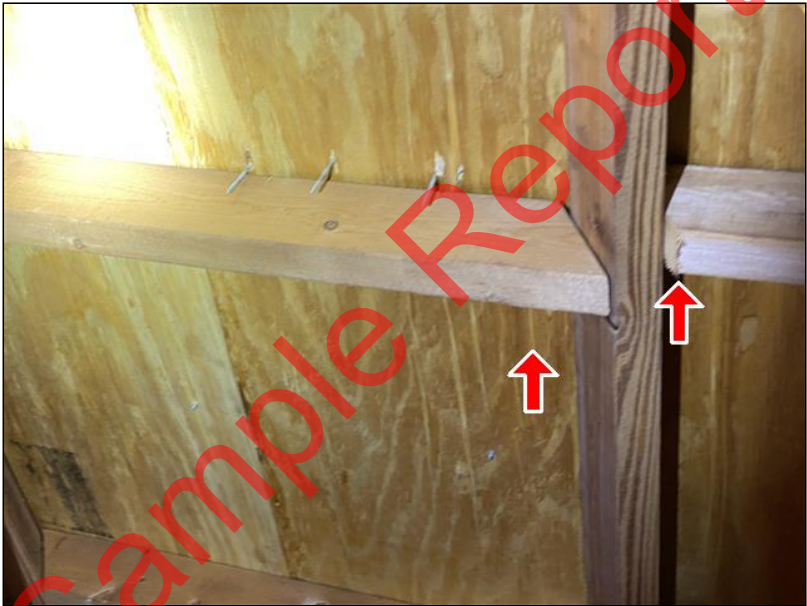
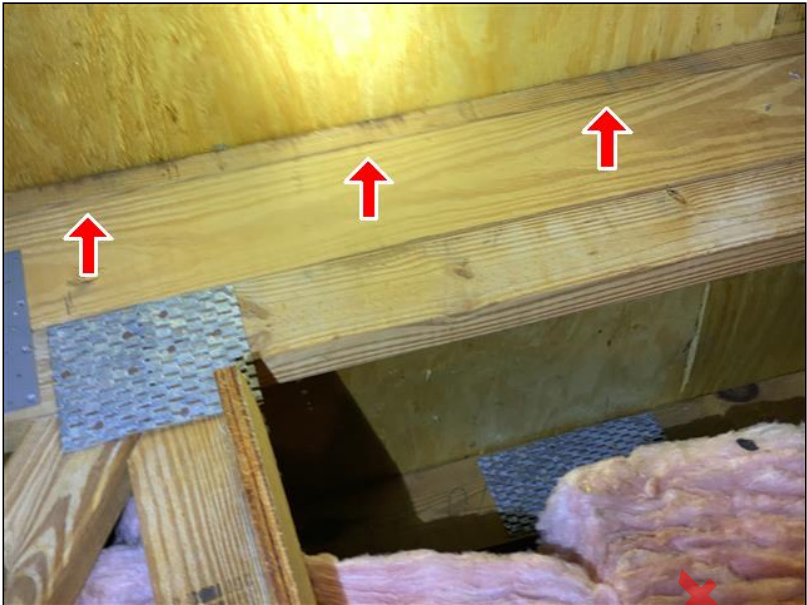
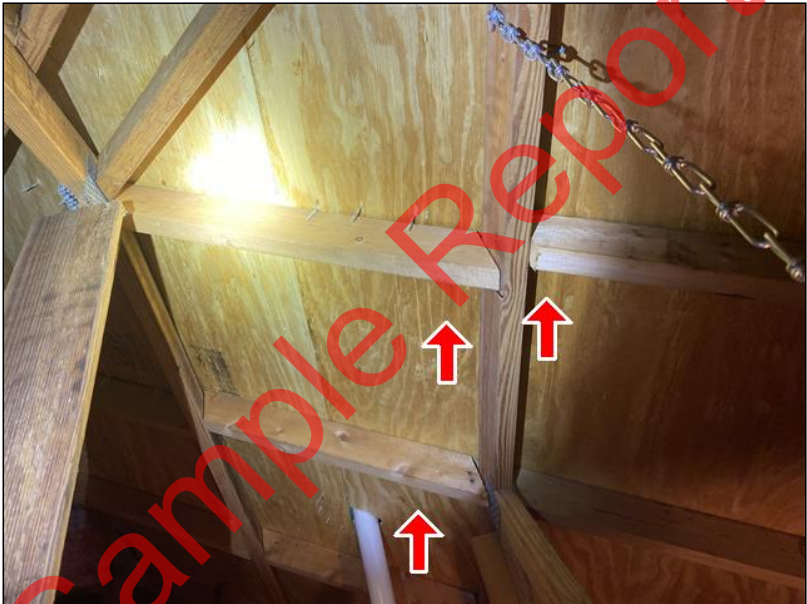
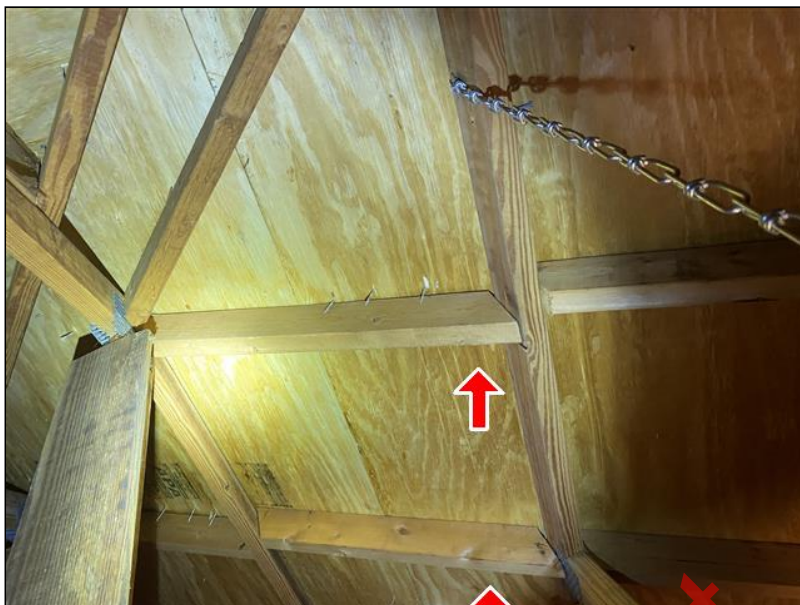
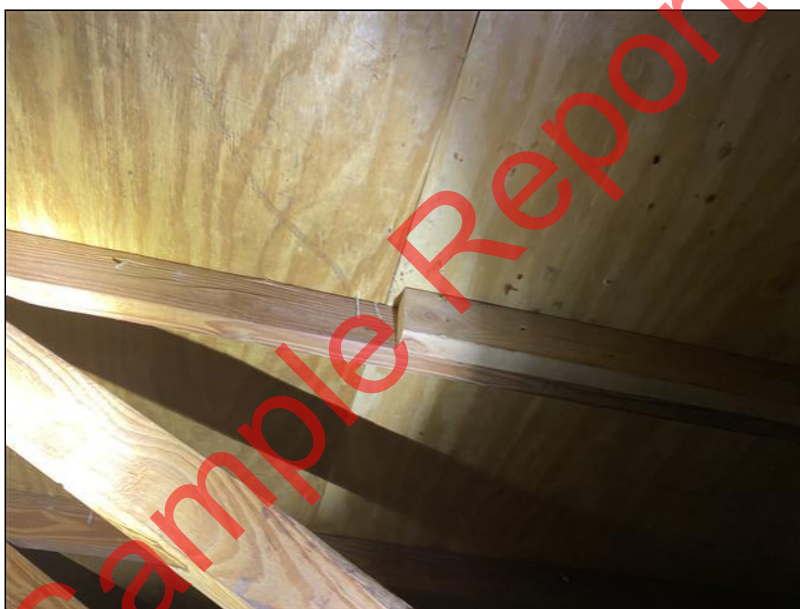
1.2 Roof Structure

**Comments:** Inspected  
The roof was a hip roof. Roof area was 5,442 SQF with a 8x12 roof slope. Inspector observed poor framing design while inspecting the attic. Such defects include several poorly installed or missing rafters spacers, which may impact the condition of the metal roof installation.

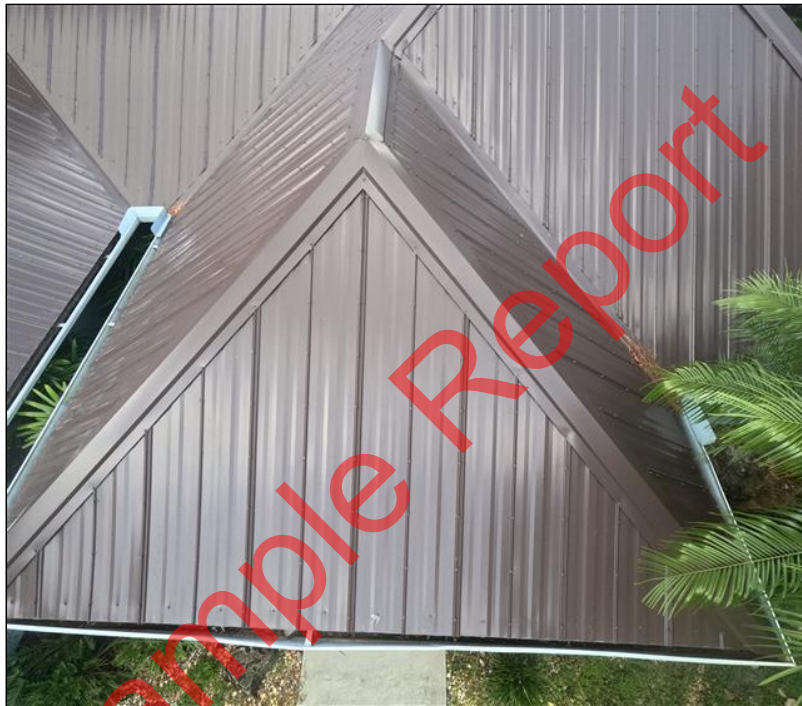
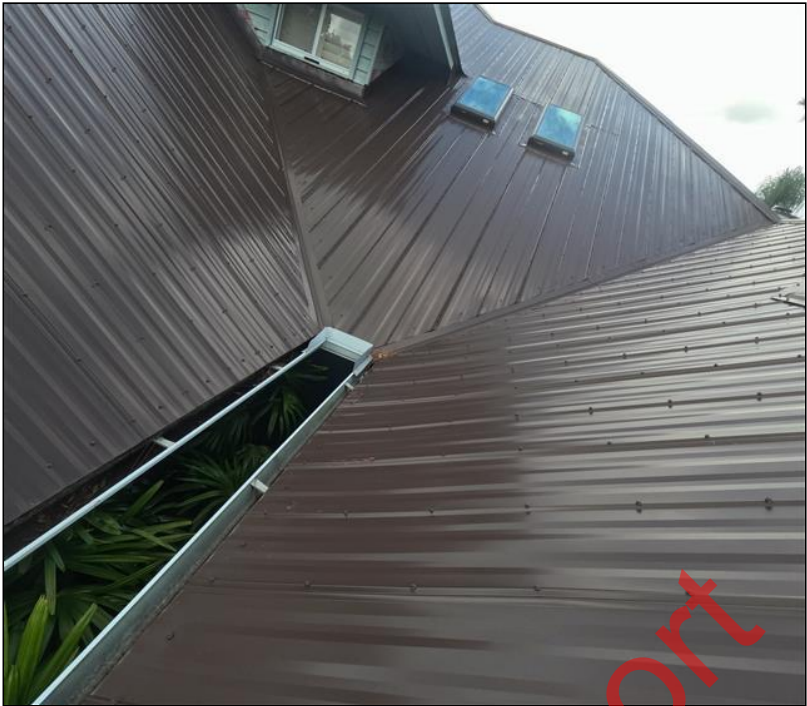
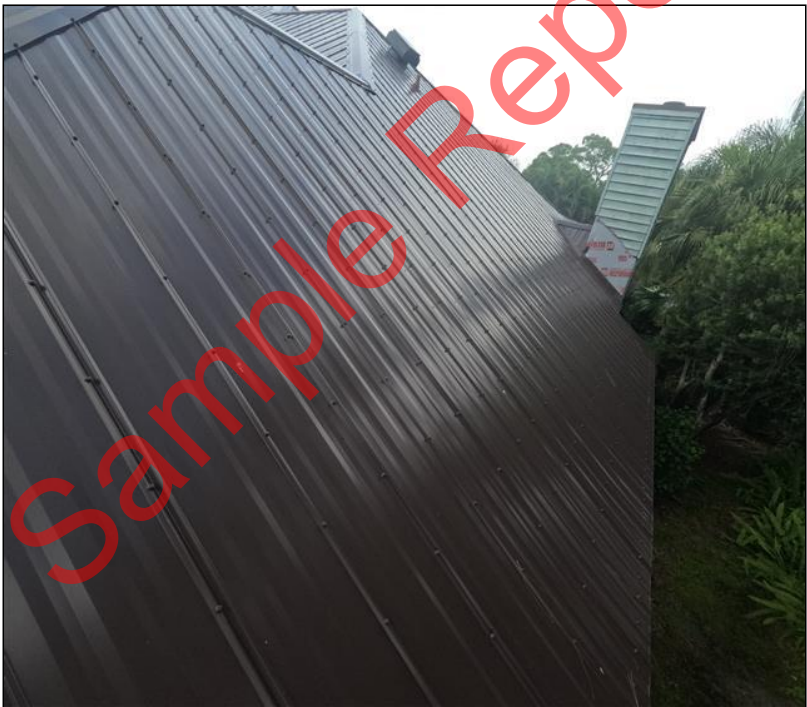
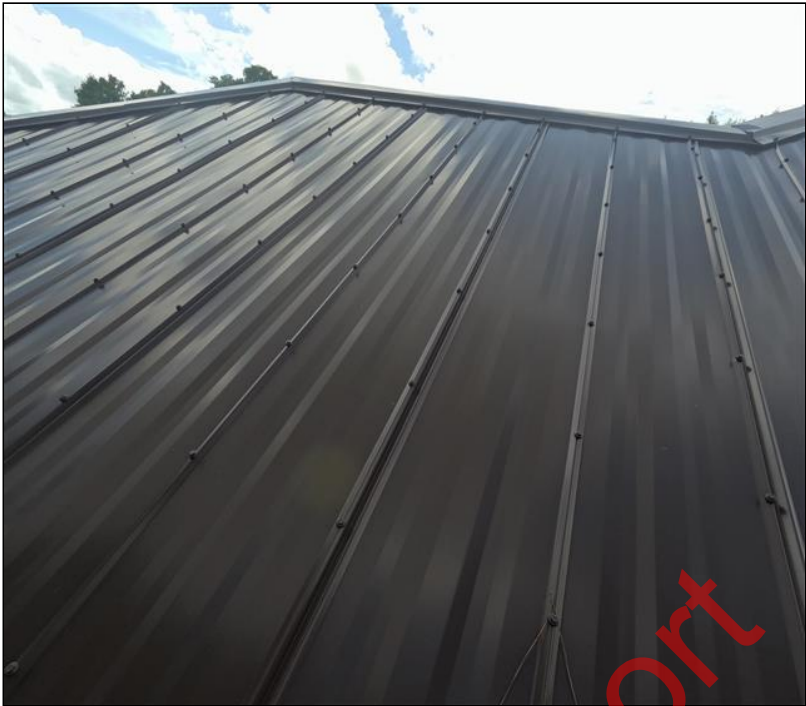
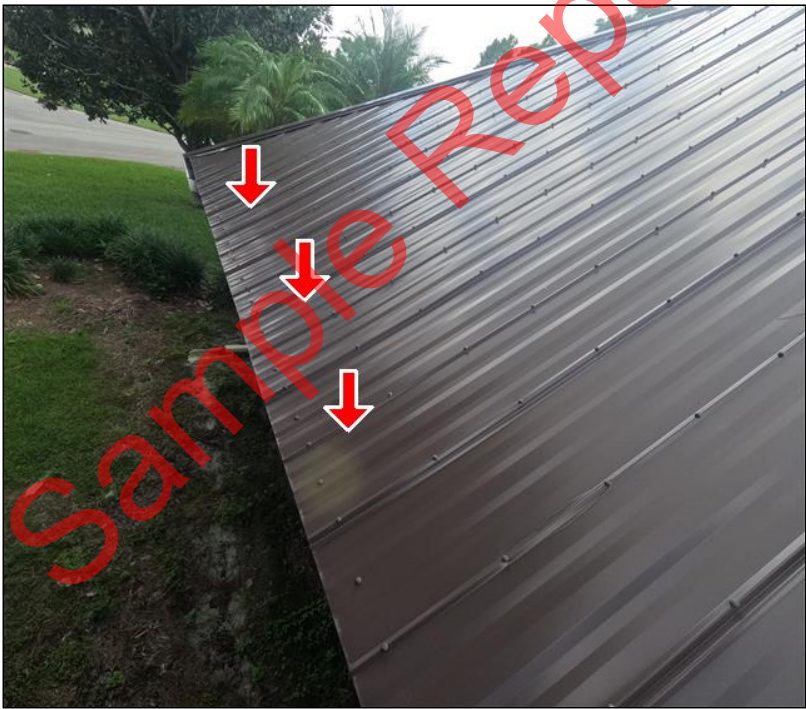
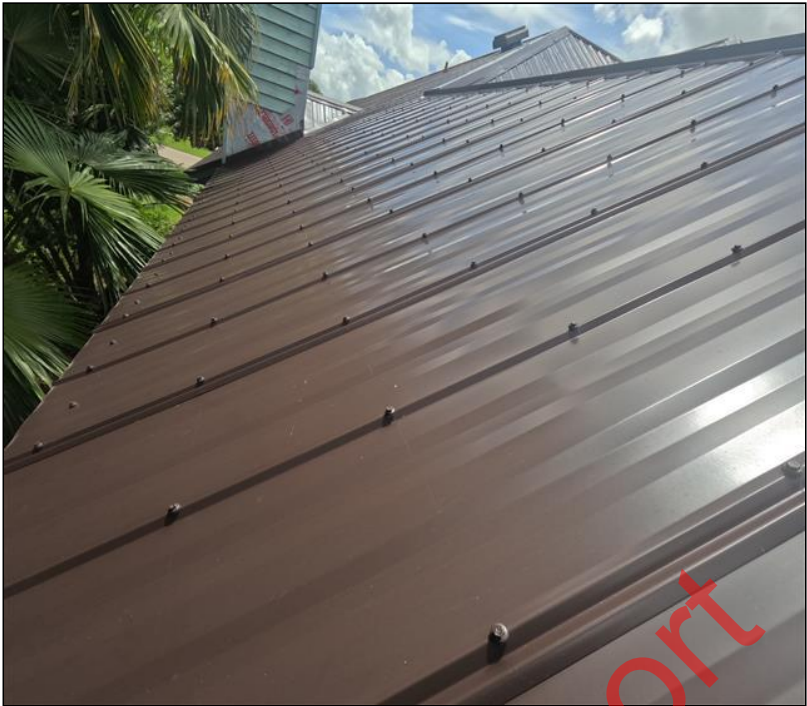
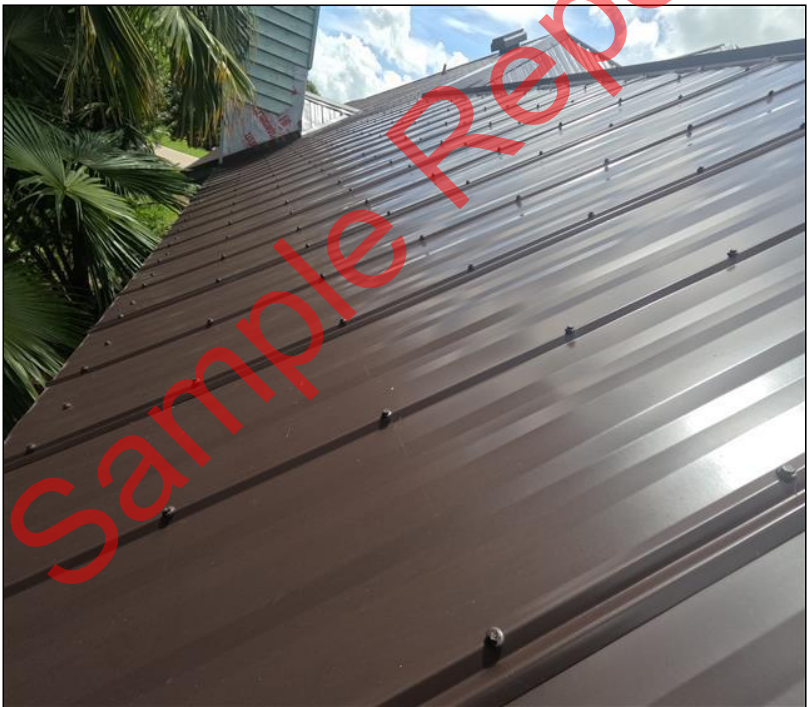
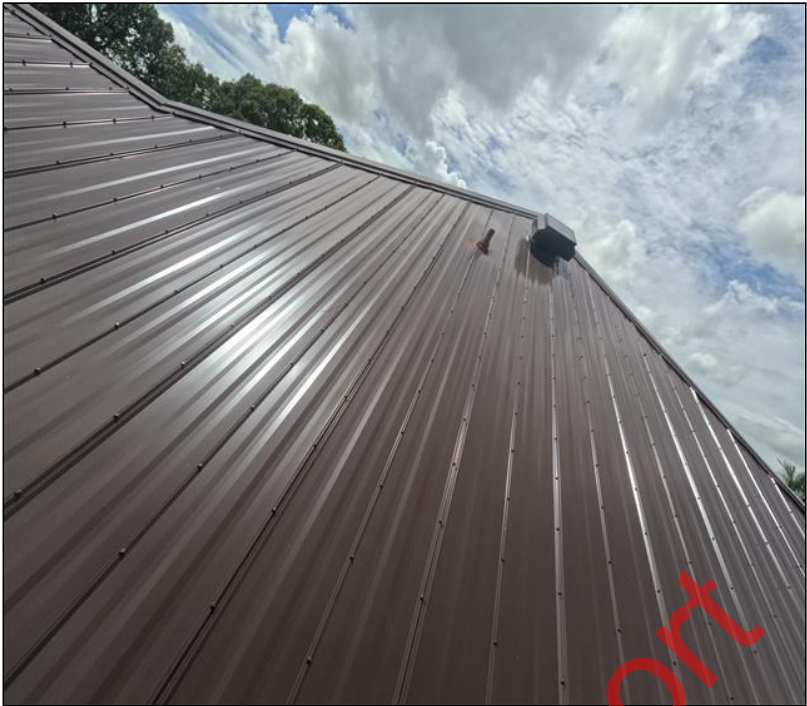
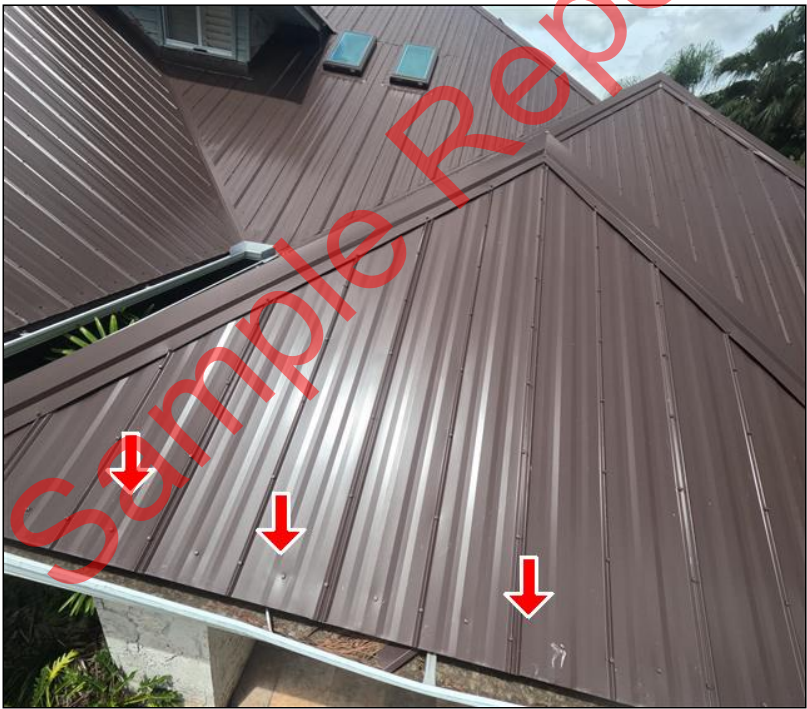
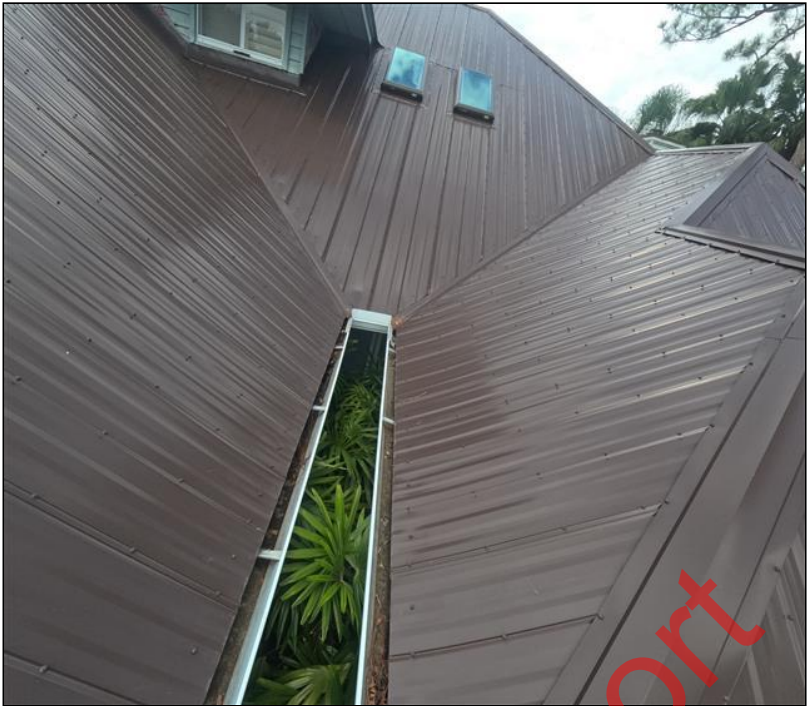
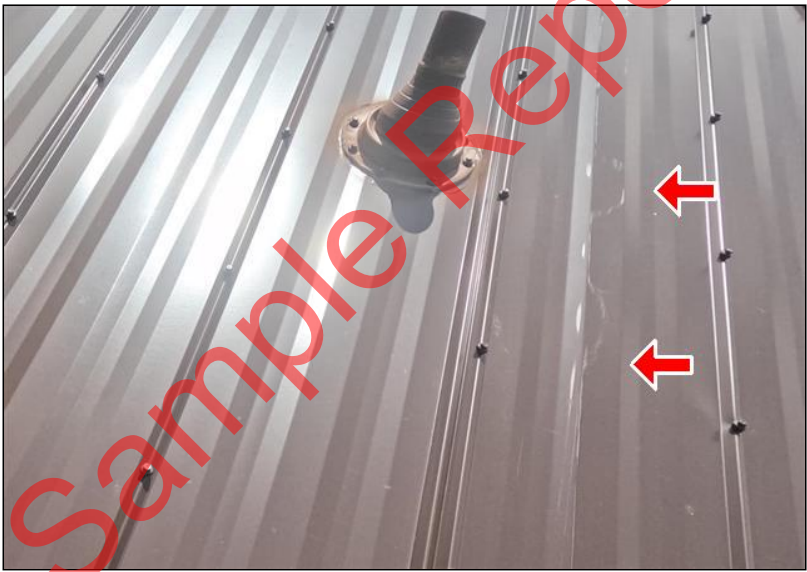
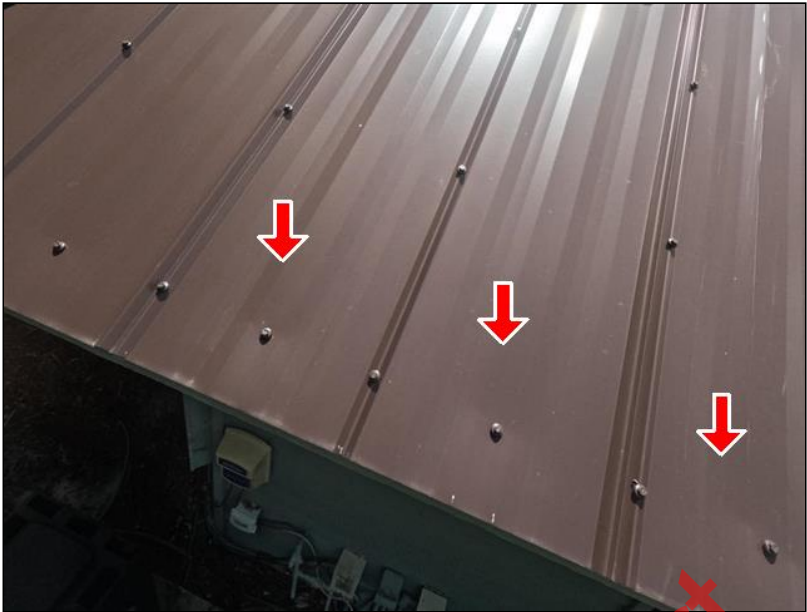
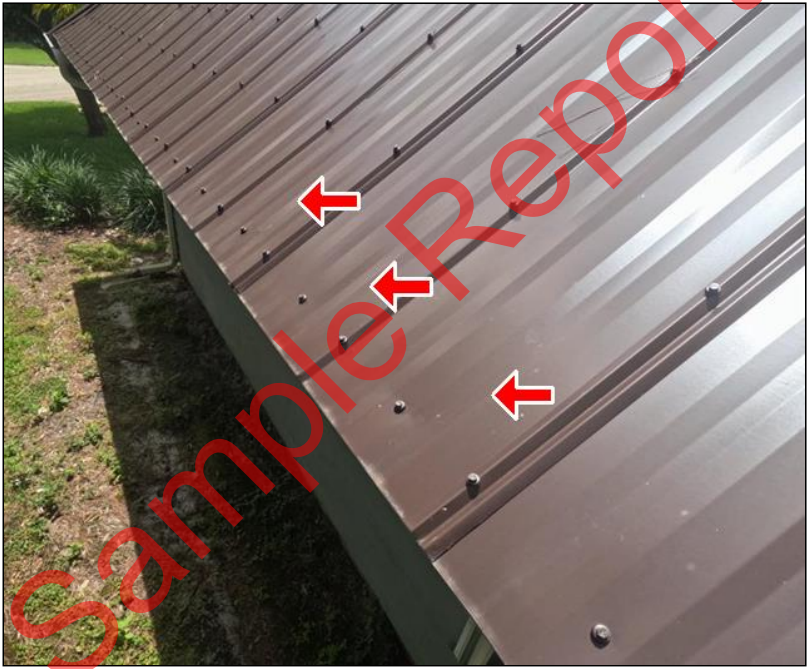
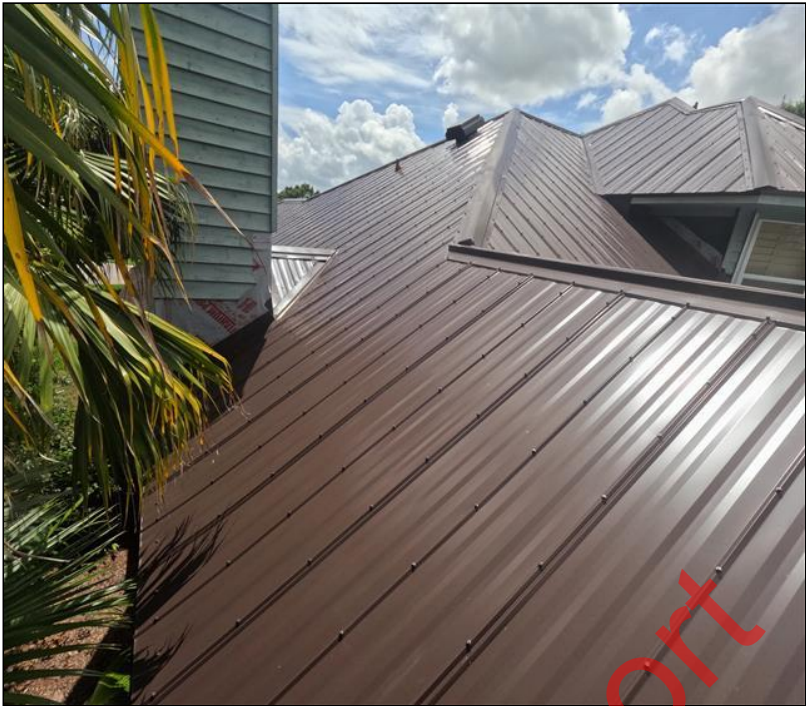
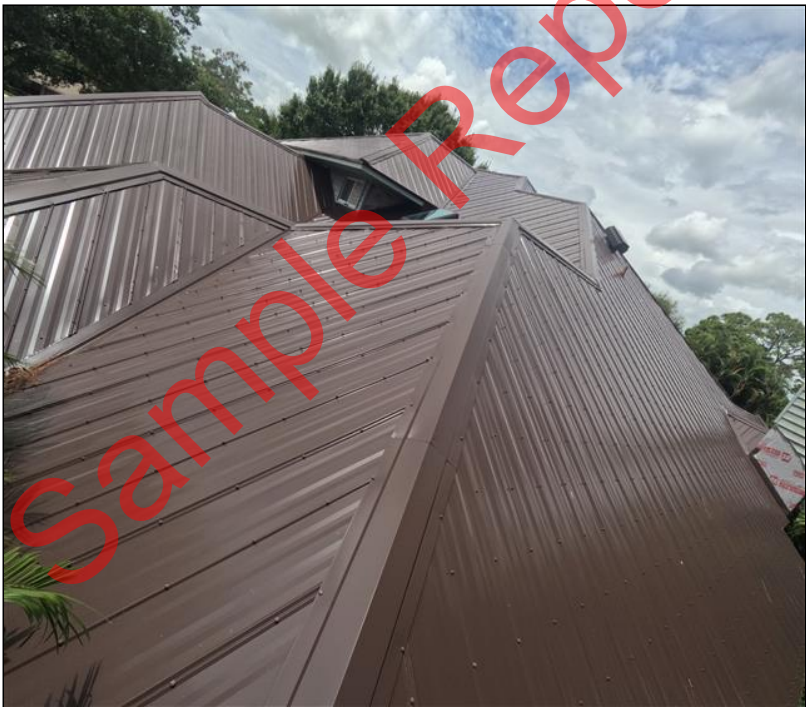
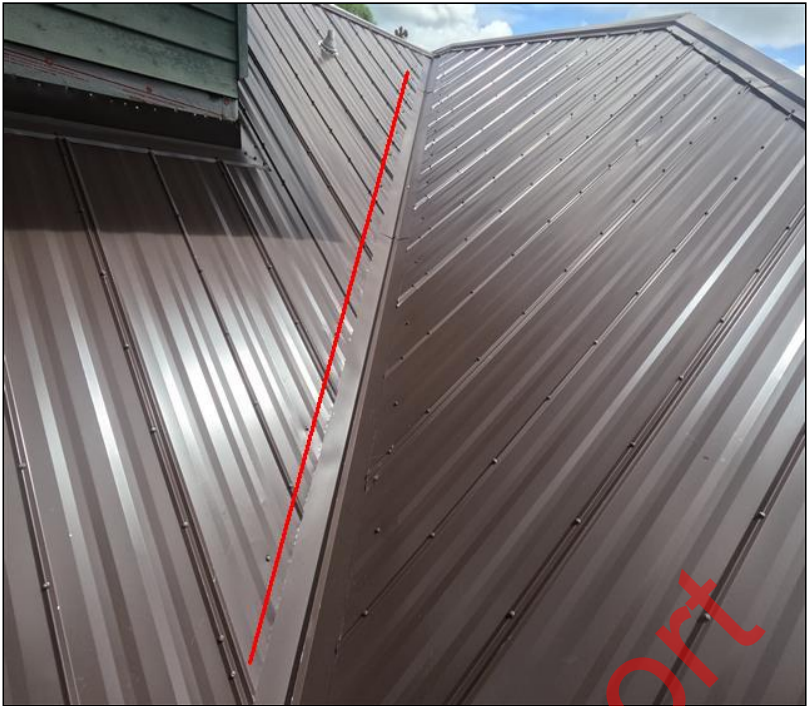
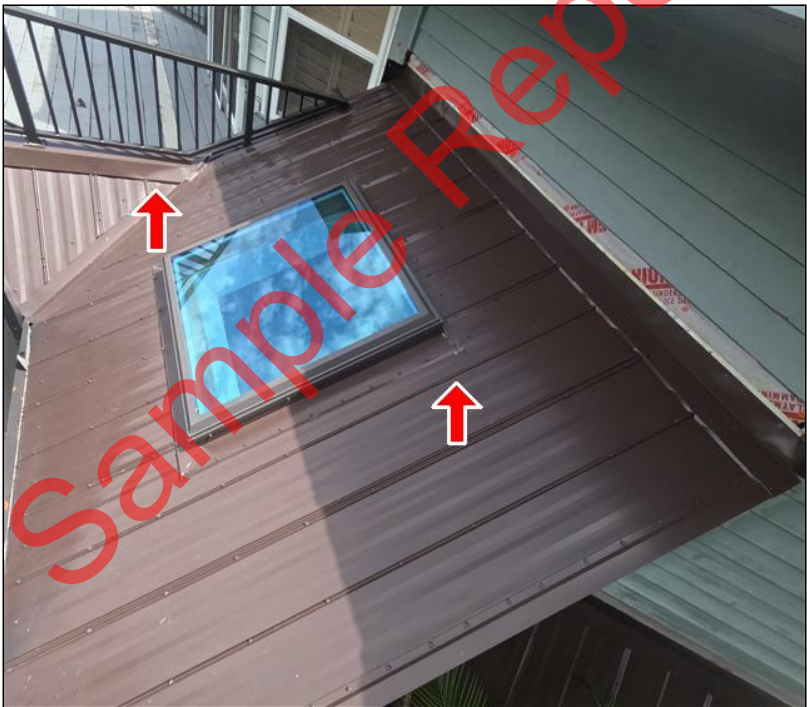
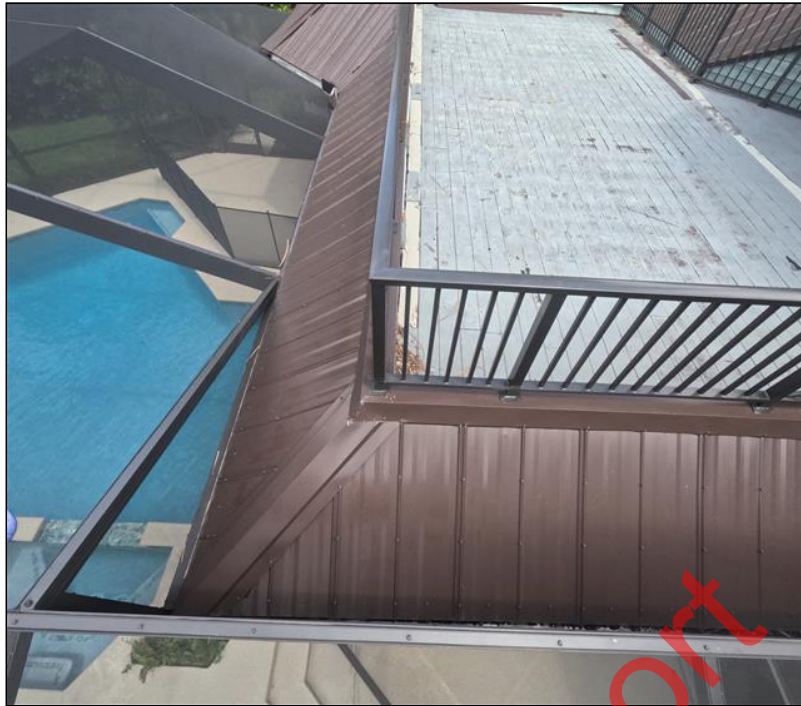
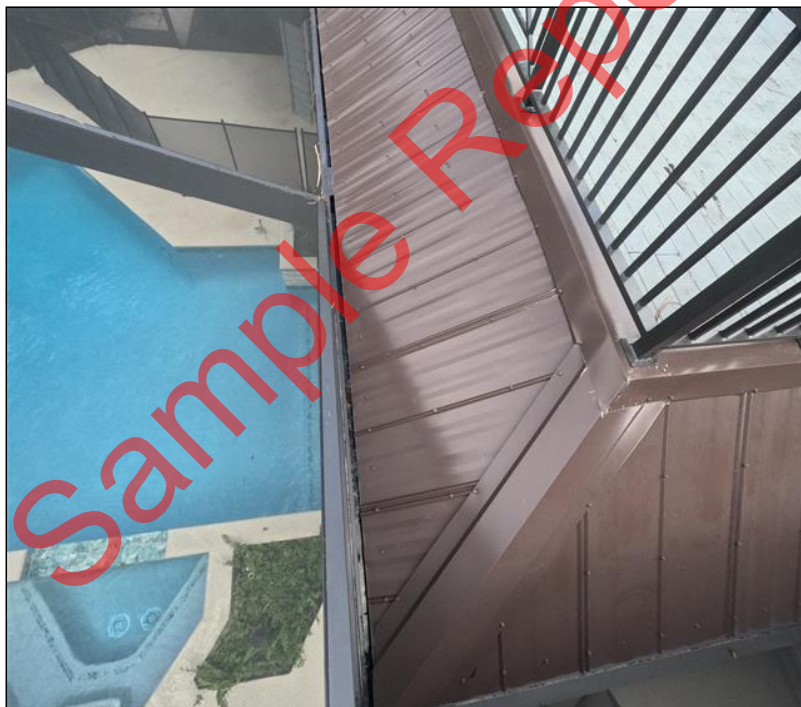
### 1.3 Metal Roof Panels

The roof was built with Extreme Metal Fabricators VMax 5V Crimp Panel with exposed fasteners. Inspector observed evidence of poorly square panels, deck deflection, poorly cut metals, scratched panels, oil canning, wrinkled and cool cut panel edges.

Poorly squared panels happens when the first panel is not installed square with the inside closure on eave flashing. Ensuring the inside closure is square with the roof, the panel is placed over the inside closure and attached to the roof deck using fasteners and spacing per product approvals. It is critical that the first panel is set square to the eave and ridge since it will be used as a baseline and reference for remaining panels. If the first panel is not set square, subsequently installed panels will also not be square impacting appearance and long-term performance of the metal roof.

Roof deck deflection is the bending or downward movement of a roof's structural deck under load, which can be caused by dead and live loads. Excessive deflection is undesirable because it can prevent proper roof drainage, damage roofing membranes, or compromise the overall structural integrity of the building. Allowable deflection is typically expressed as a ratio of the span length, such as  $L/240$ , and is limited by building codes and manufacturer specifications.

Some deflection is allowable. However, if the deck was designed with insufficient strength or inappropriate support deck deflection can occur.

Oil canning is the aesthetic phenomenon of waviness or distortion in the flat areas of a metal roof panel, caused by internal stress from manufacturing, installation, and thermal expansion. It does not affect the panel's structural integrity or water-tightness but is often minimized by using striated panels, ensuring a flat and even substrate, or employing certain installation techniques.

Cold cut metal panels refers to the process of cutting metal roofing panels without generating excessive heat, which can damage their protective coatings and cause rust. Proper tool must be used, avoid metal debris and always cut the panels on a work bench instead of up on the roof. Tin snips or a "nibbler" type electric tool should be used for field cutting. Properly using these tools will deliver the cleanest cuts, cause the least damage, and leave minimal rough edges. Circular saws, torches, and plasma cutters should not be used.

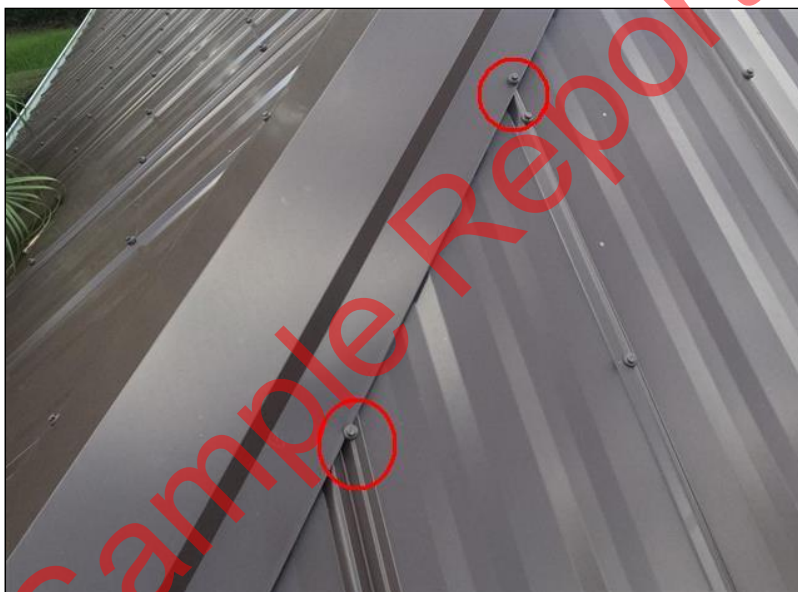
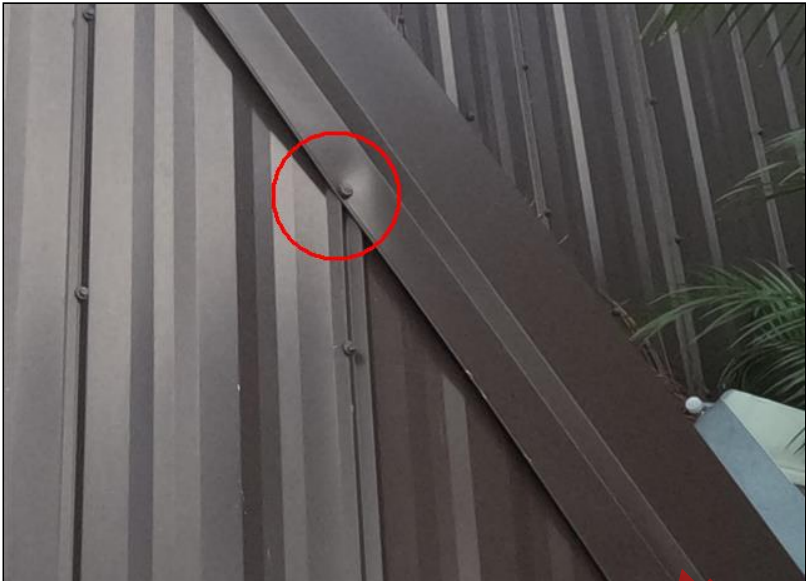
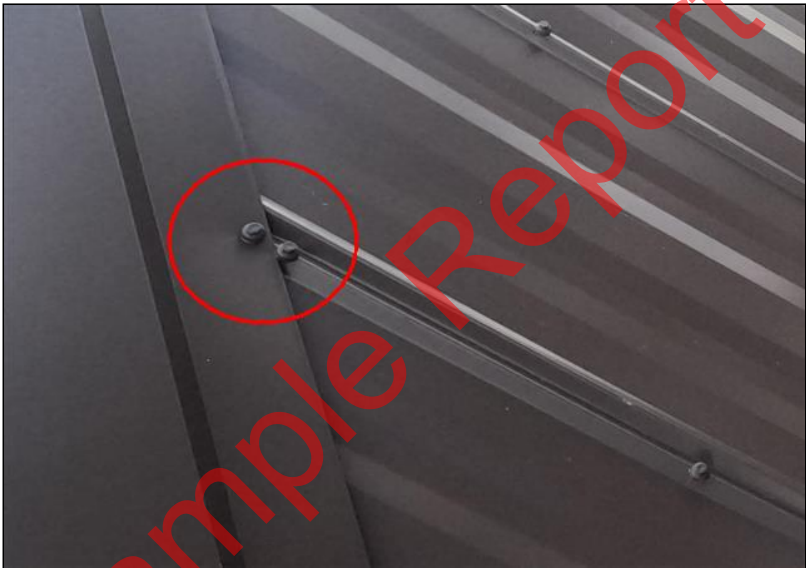
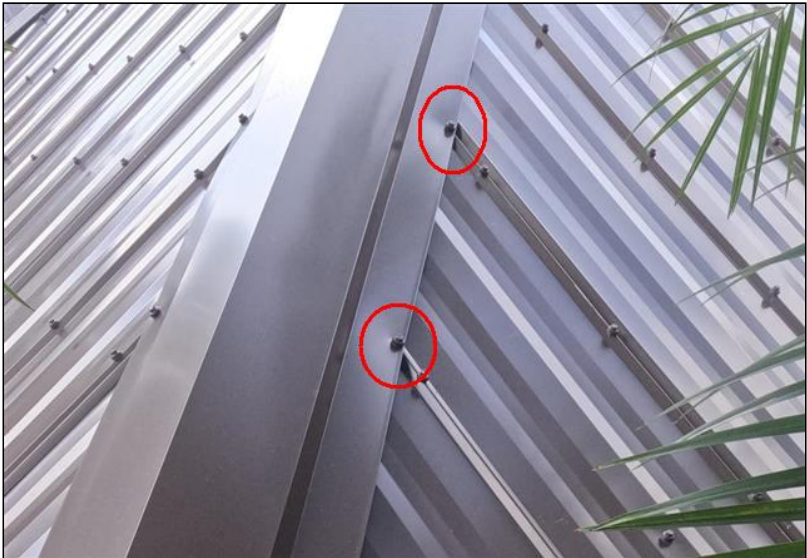
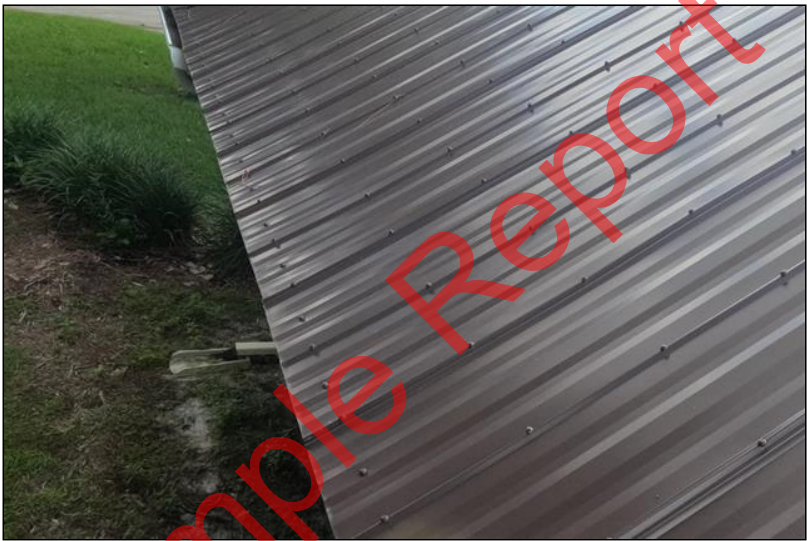
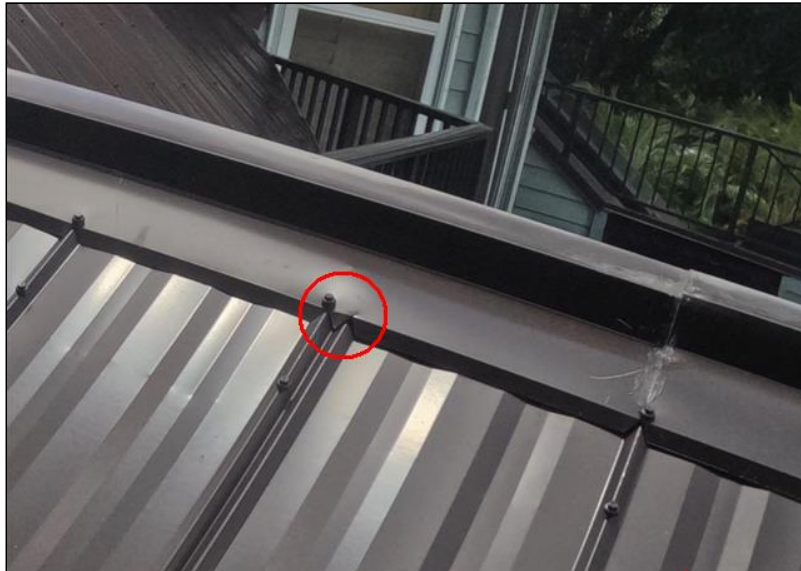
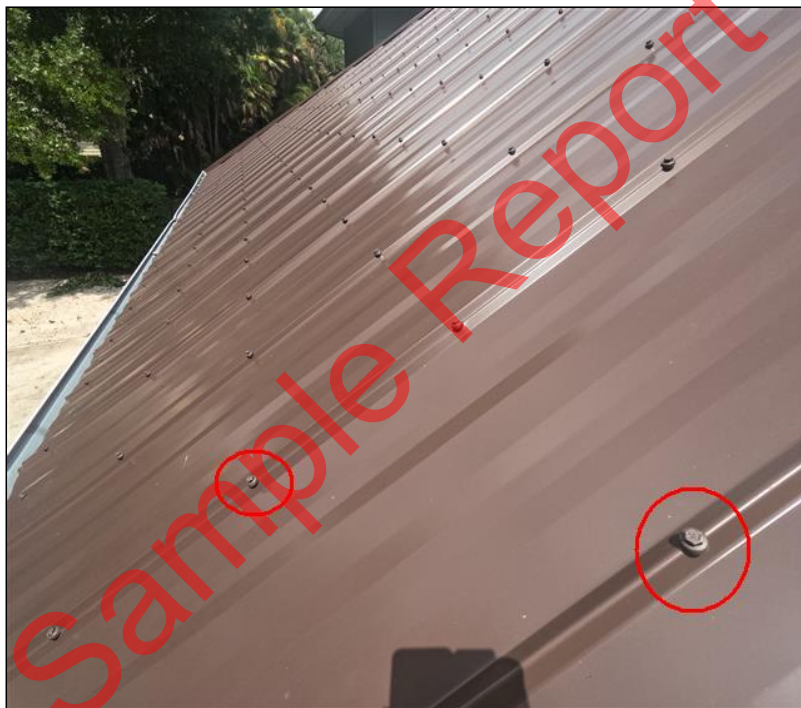
**1.4 Fasteners**

The 26 ga metal panels 5V Crimped exposed seam were installed using #10 x 1.5" fasteners with sealing washers secured to 15/32 CDX plywood. The fastening process in this roof is inconsistent showing visible workmanship problems. Fasteners are either under-driven or over-driven with not many of them in the correct position. There is widespread off-centered fasteners as well.

Overdriving metal roof panels occurs when a fastener is screwed in too deep, damaging the panel's seal, causing leaks, and accelerating deterioration of the rubber washer. This creates a divot that can hold water, breaks the washer, or causes pressure damage to the panel itself. Correct installation requires a screw gun with torque control and a depth-sensing nose piece to prevent overdriving, stopping when the washer begins to plump up but does not squish out.

Under driven screws on a metal roof are fasteners that have not been tightened enough during installation, which prevents the rubber washer from forming a watertight seal. This common installation mistake leaves the roof vulnerable to leaks and other issues. Without the proper compression, the washer cannot seal the screw hole, allowing water to seep beneath the panels and into the building. Under driven screws may not provide adequate holding strength, leaving panels vulnerable to high winds. This can cause the panels to shift, become loose, or even detach from the roof. As screws loosen and panels shift, the overall stability of the roof is compromised.

Off-centered fasteners occur when screws or nails are driven at an angle instead of straight into the roof decking. This is a common installation error that can lead to water leaks and compromise the structural integrity of the roof.
