### **Roof Inspection Report**

**Property Address:**  
7329 Reserve Creek Dr  
Port St. Lucie FL 34986

8/26/2025

Sample Report

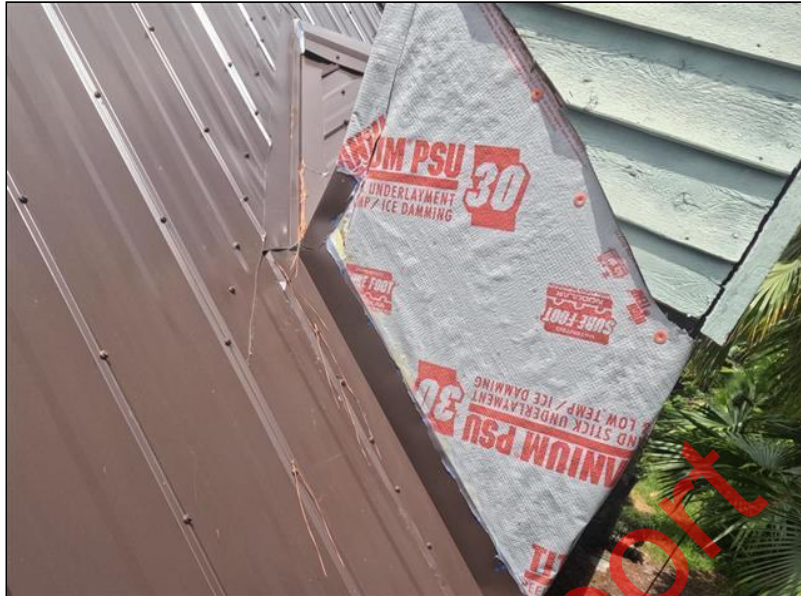
**1.5 Underlayment**

**Comments:** Inspected  
Inspector reviewed relevant permit documents which are referenced herein as an attachment. Inspector was not provided a copy of the contract for review. Permit docs suggest Roofnado Underlayment to be installed. However, Sure-Foot Titanium PSU 30 Peel and Stick was observed.

Inspector observed that roof underlayment was Sure-Foot Titanium PSU 30 Peel and Stick for low temp/ice damming. However, the underlayment prescribed was Roofnado Anchor Deck. Most of the underlayment was hidden from view underneath the metal panels. Underlayment installation can also create issues for metal panel installation if the underlayment was exposed to the weather for long periods of time.

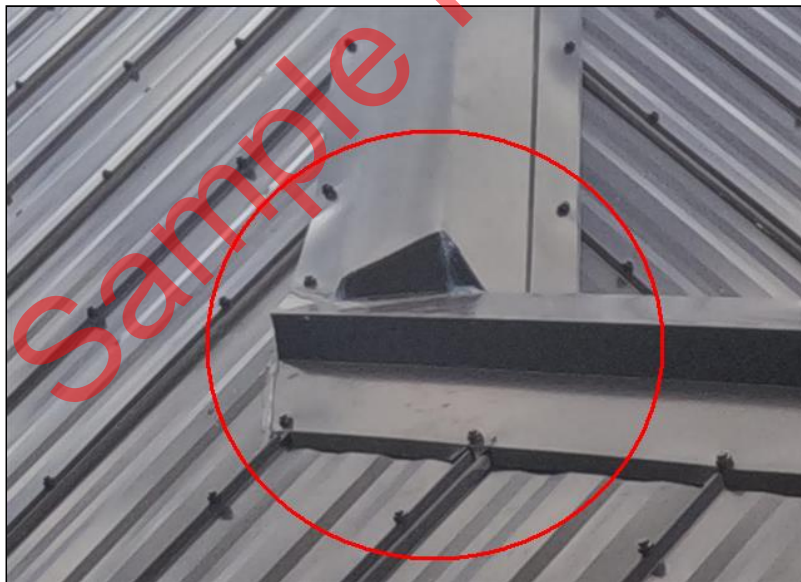
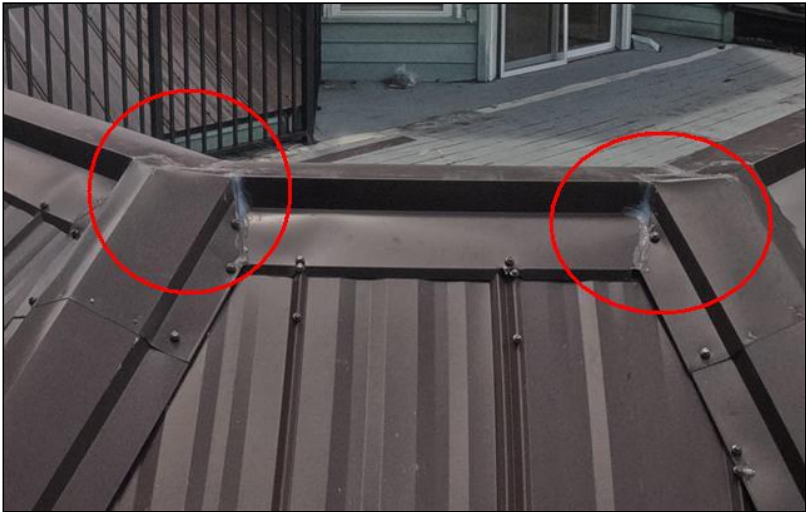
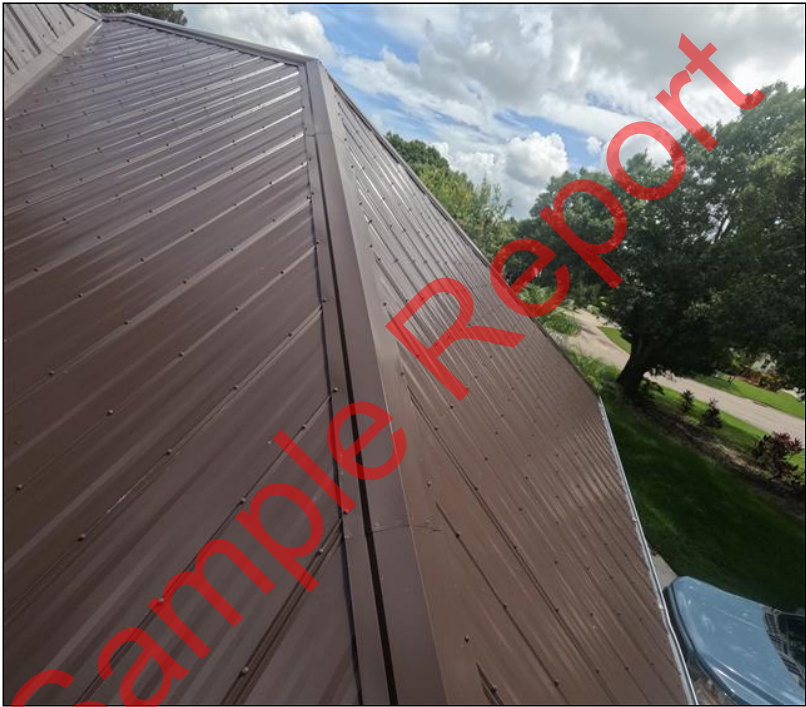
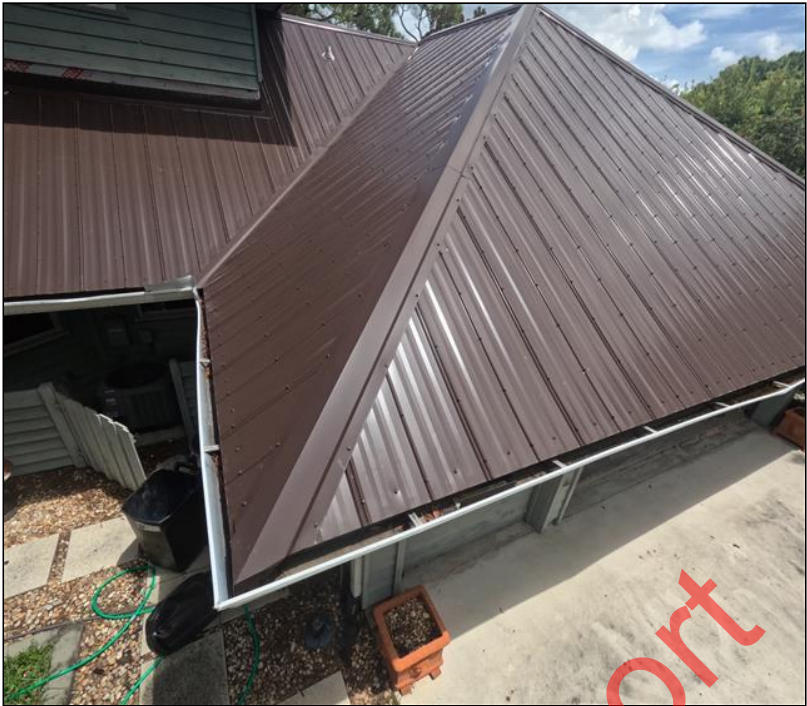
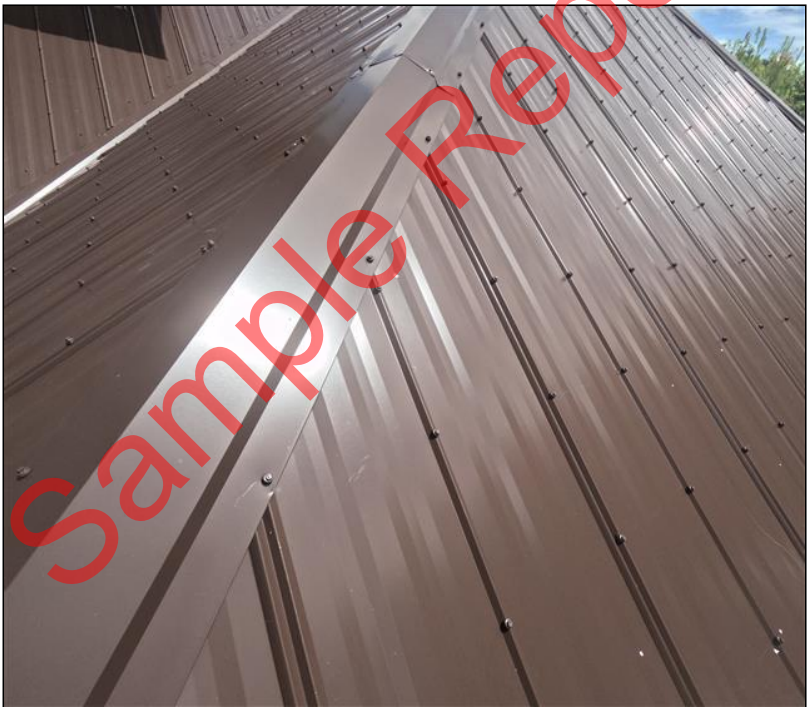
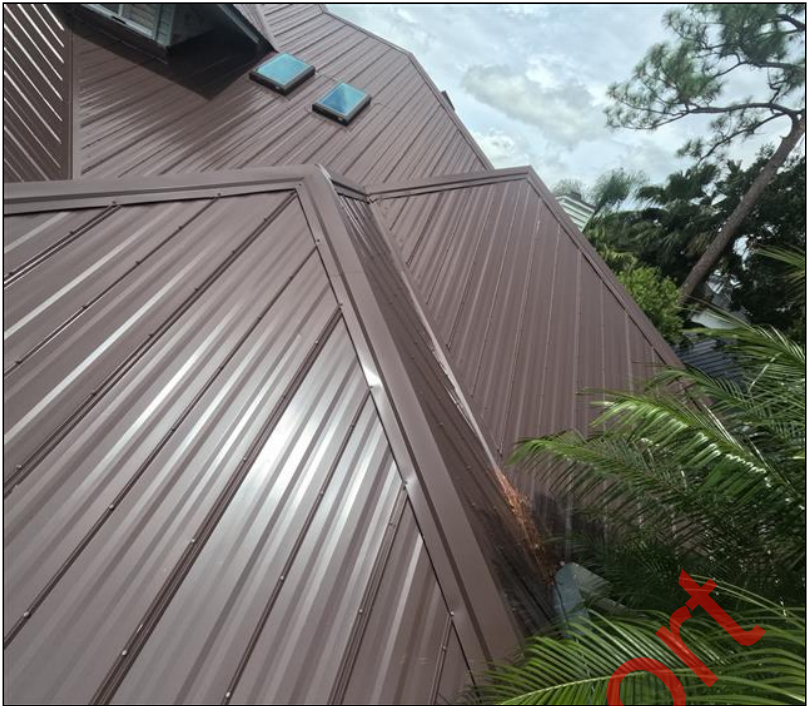
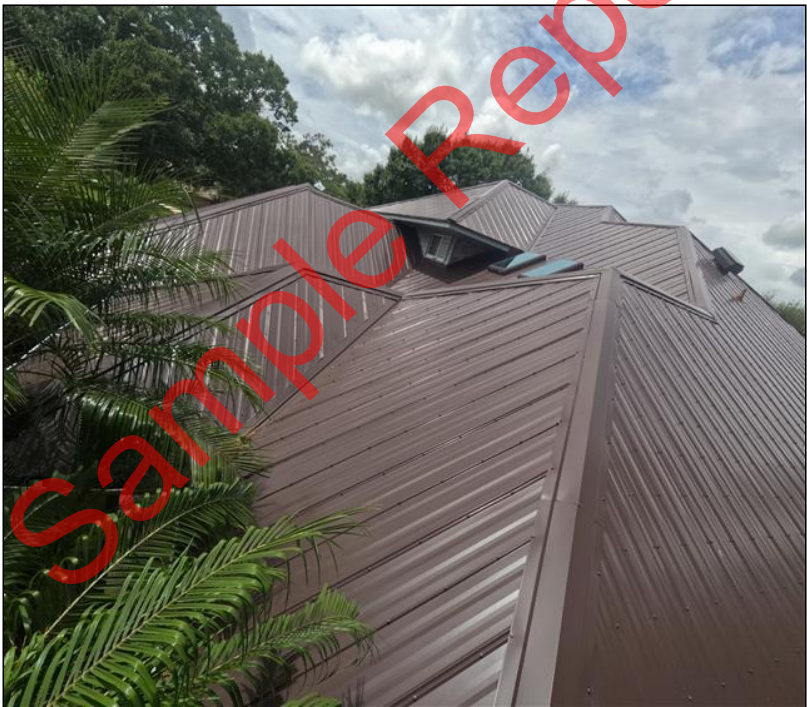
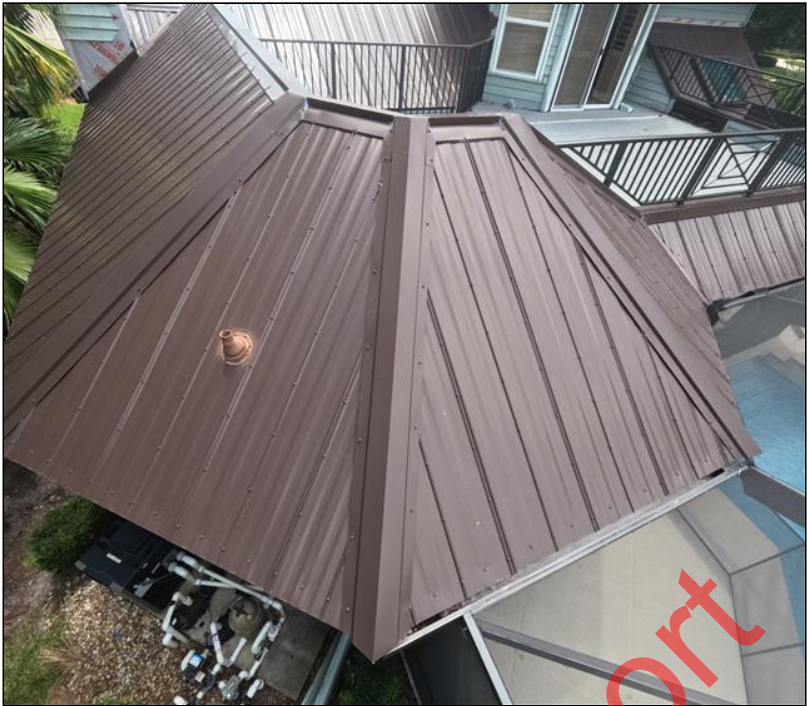
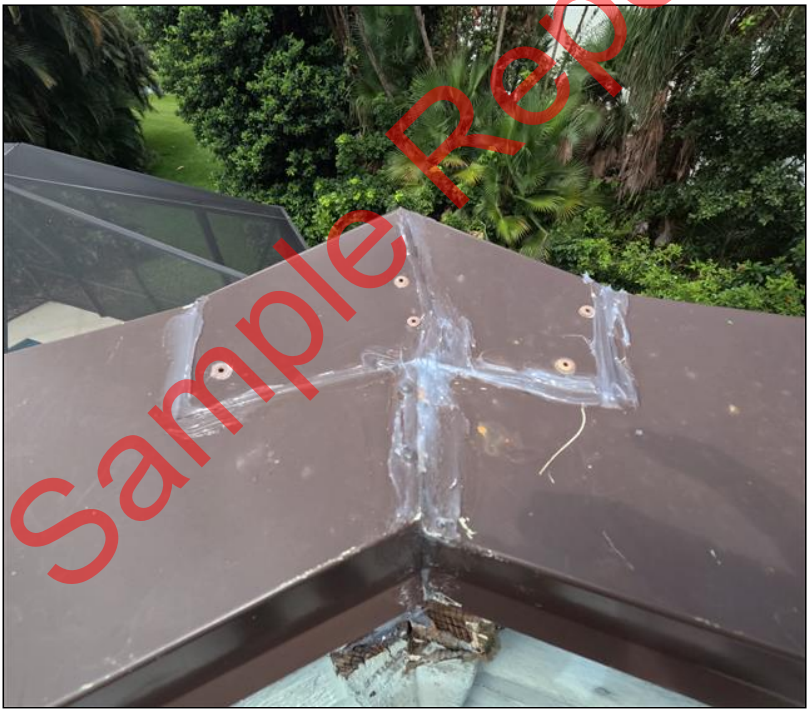
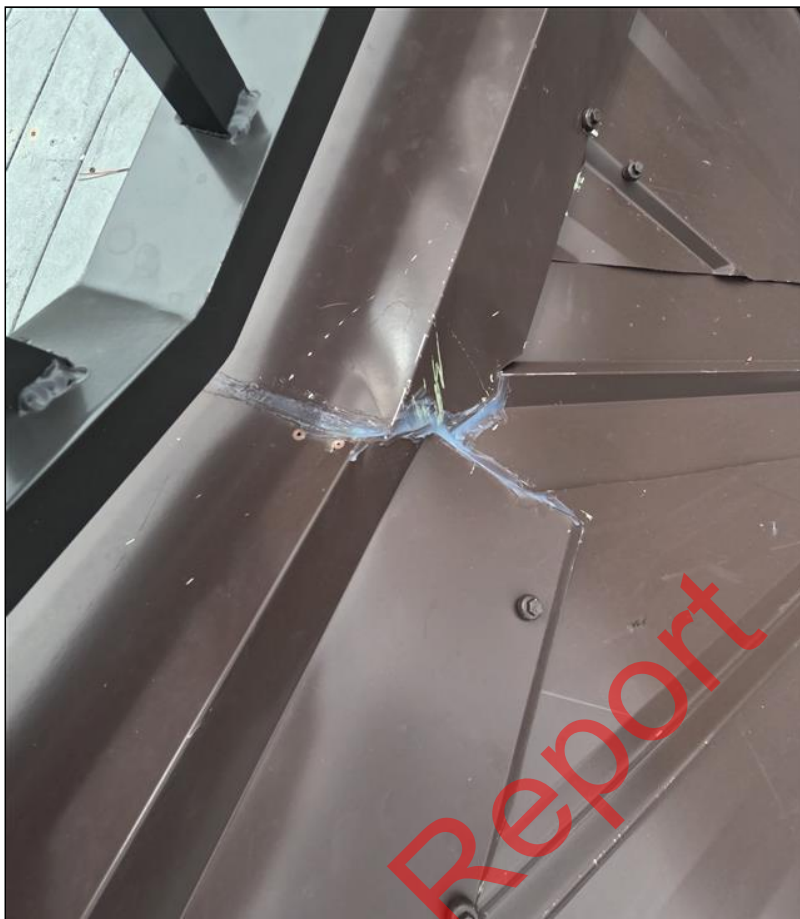
#### 1.6 Top Ridge, Hip, or Ridge Caps

**Comments:** Inspected, Repair/Replace

Inspector observed several ridge cap that exhibited oil canning. Some hip caps were also poorly field cut and they don't fit right with the metal panels below.

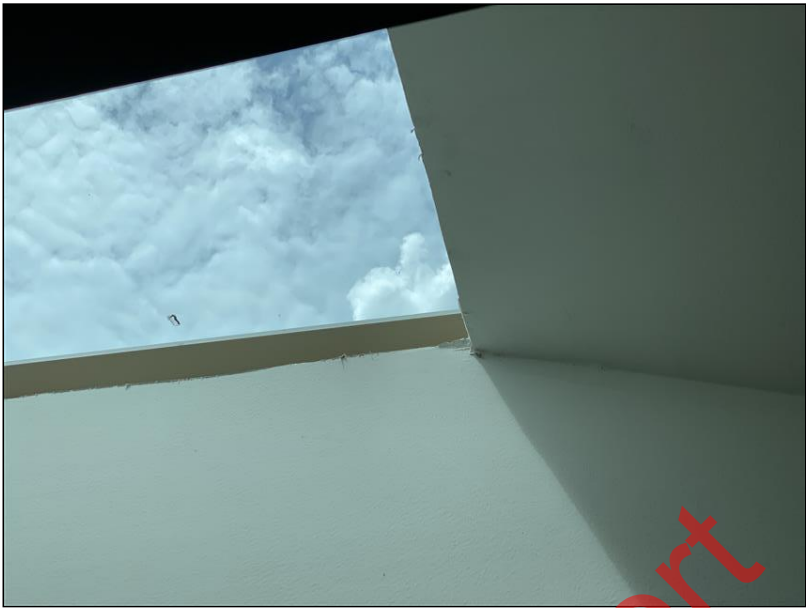
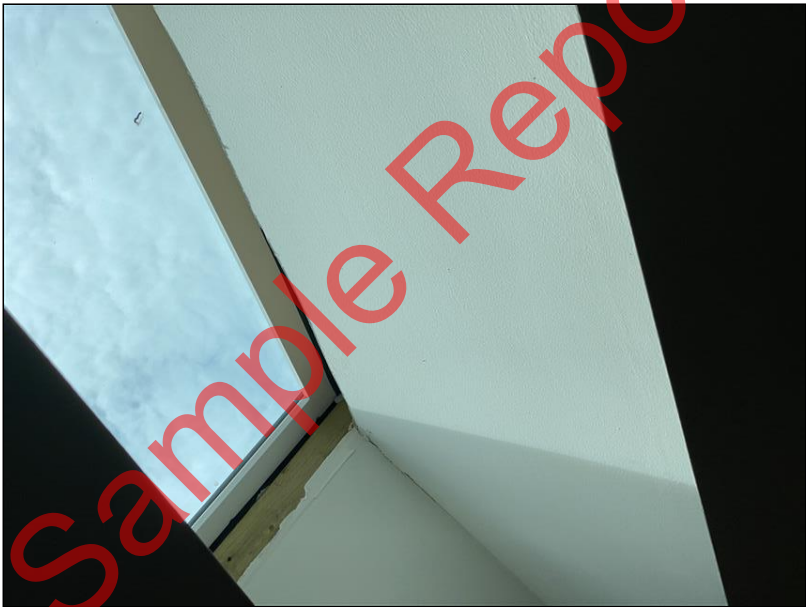
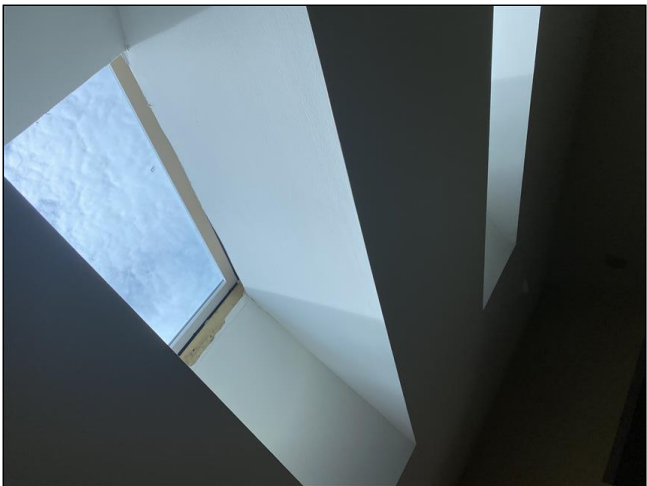
**1.9 Skylight**

**Comments:** Inspected, Repair/Replace

Inspector observed the skylights were poorly installed. The skylights are not sized properly and the frame was adjusted to fit the skylight instead of the opening. This will need to be replaced.
