### **Property Condition Report**

#### **Palomino Farms, LLC**

8087 Palomino Dr  
Wellington FL 33467

4/10/2026

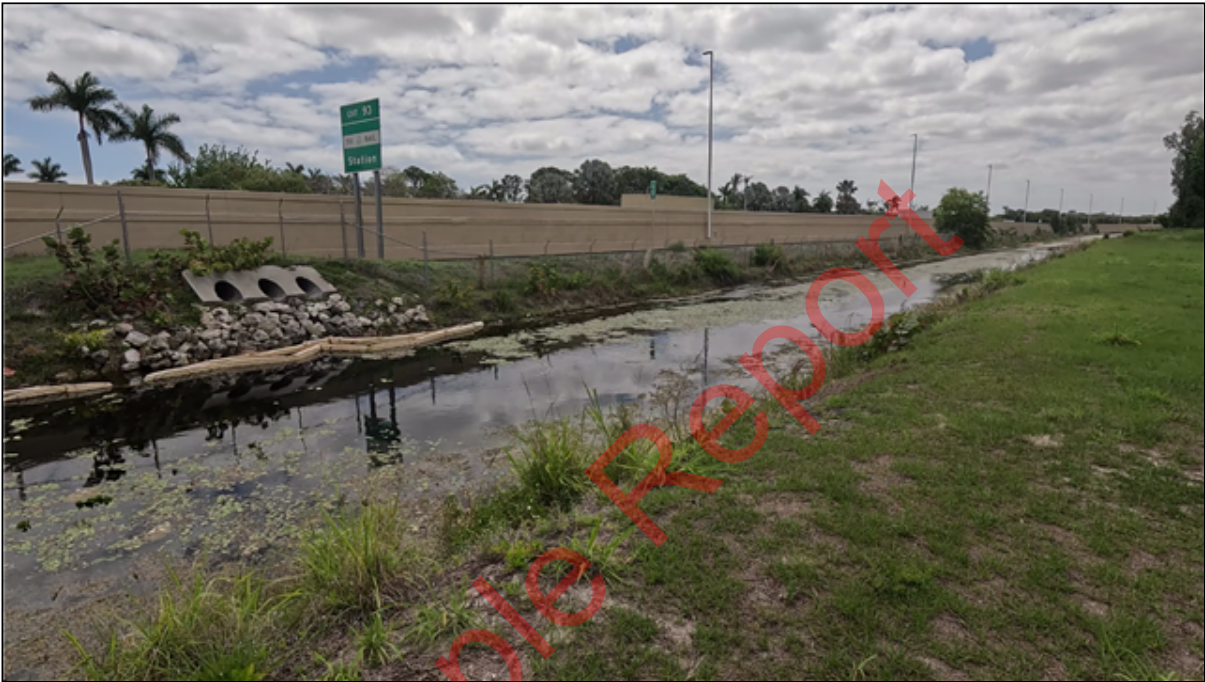
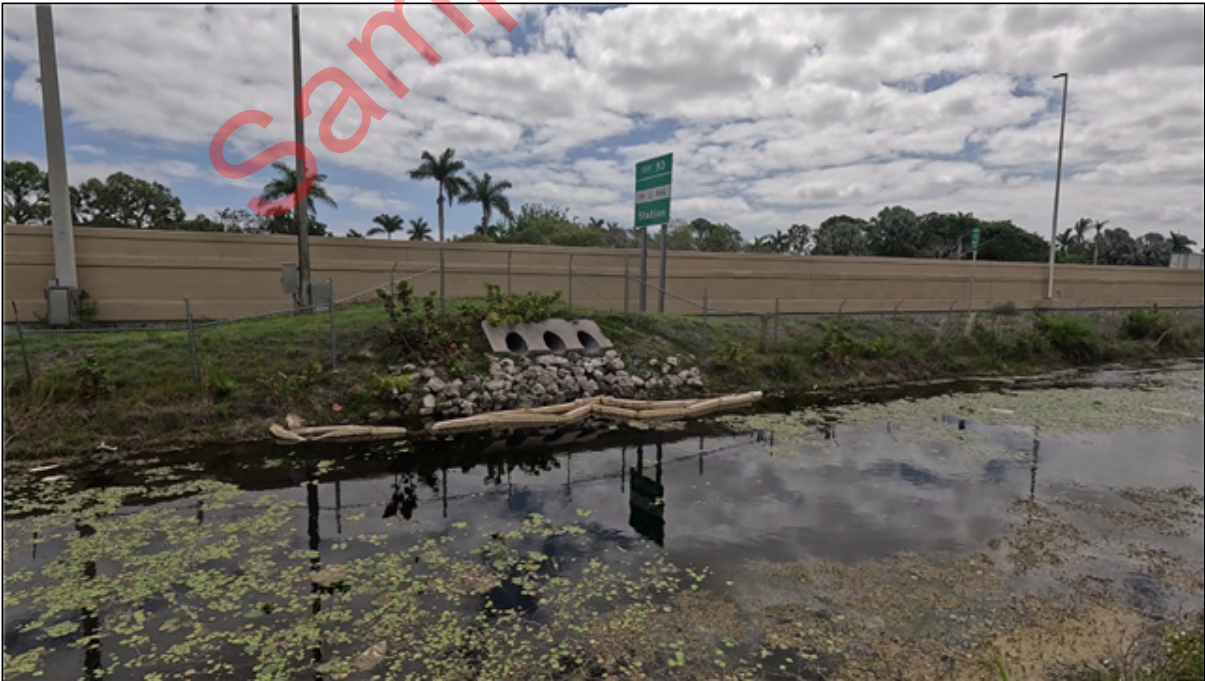
Overall, the drainage system is serviceable but exhibits signs of age and limited infrastructure. Proactive maintenance and phased improvements are recommended to enhance performance and reduce the risk of water-related operational impacts.

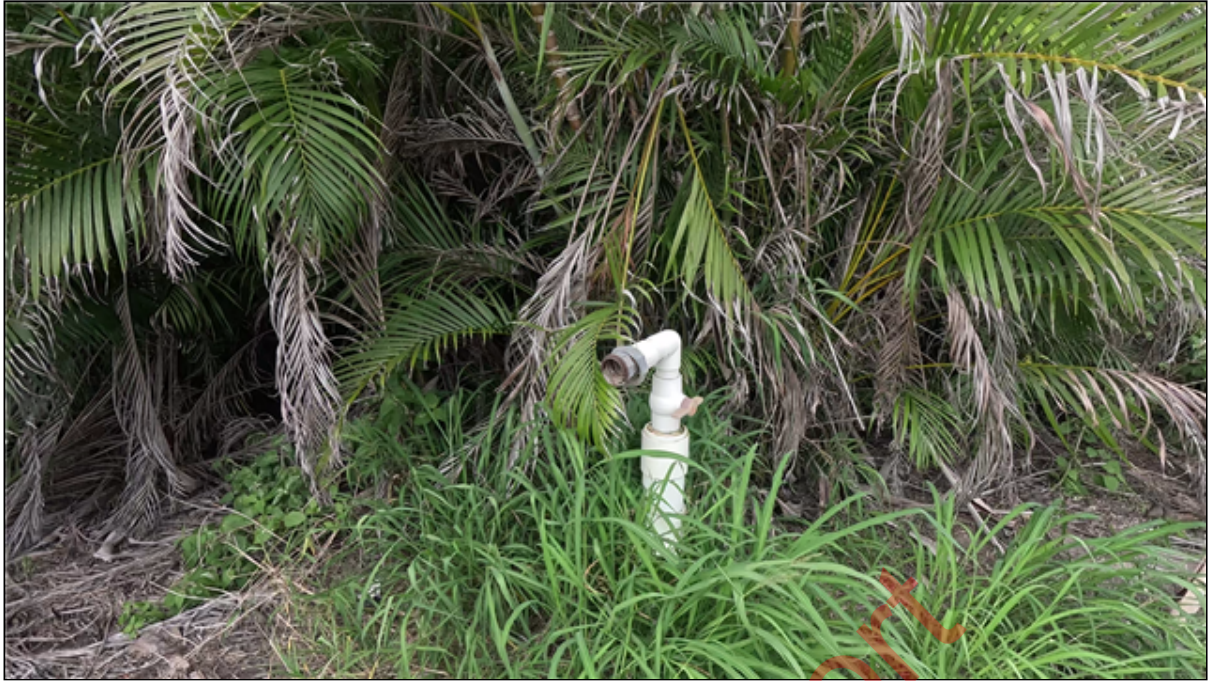
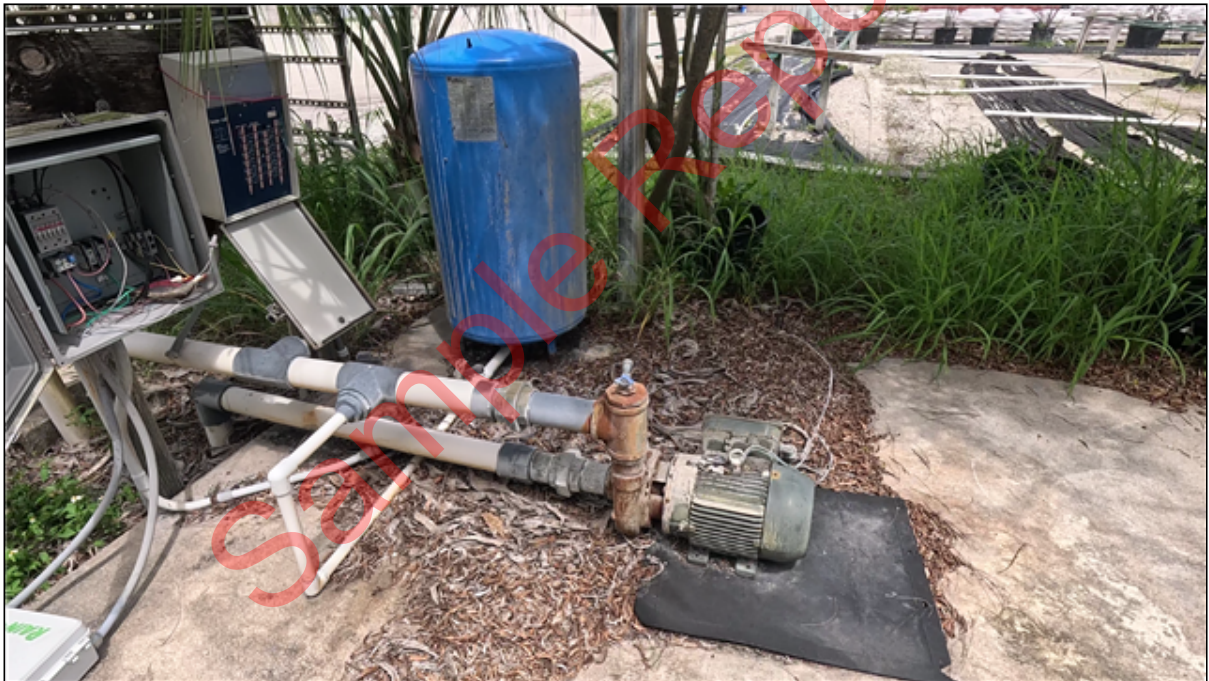
In summary, the irrigation system is not operational and appears abandoned, with visible deterioration and safety concerns. Proper decommissioning or replacement is recommended depending on future site use and landscaping needs.

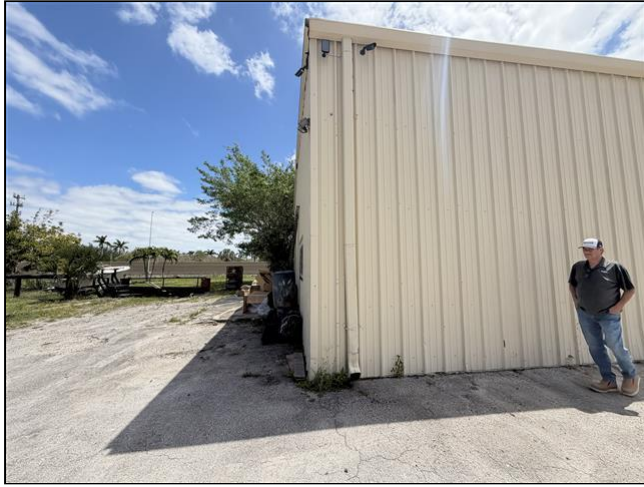
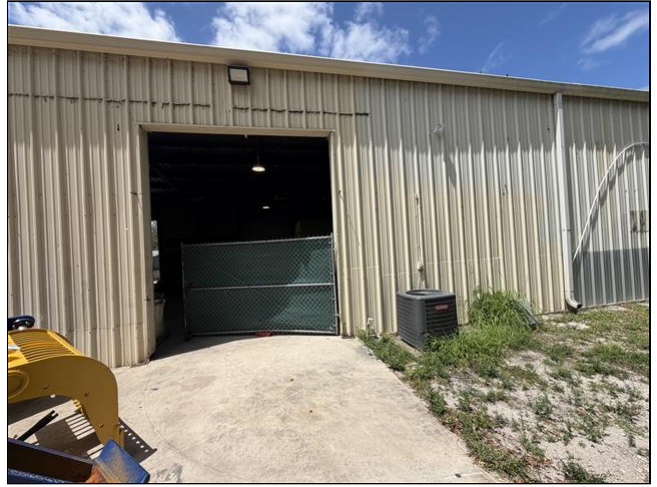
In summary, the exterior lighting system provides minimal illumination and is limited in both coverage and performance. Upgrades to modern LED fixtures and expanded site lighting are recommended to improve safety, security, and operational efficiency.

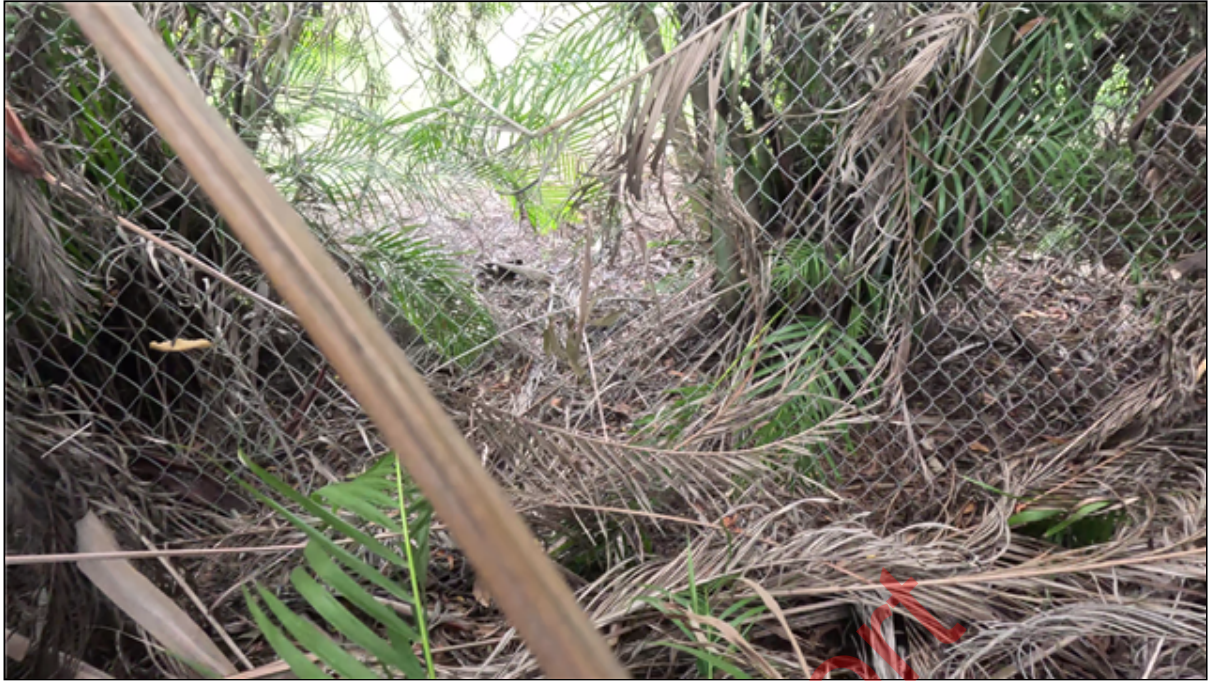
In summary, the fencing and gate system provides partial enclosure but is inconsistent and affected by deferred maintenance. Repairs, vegetation control, and potential upgrades are recommended to improve site security and functionality.

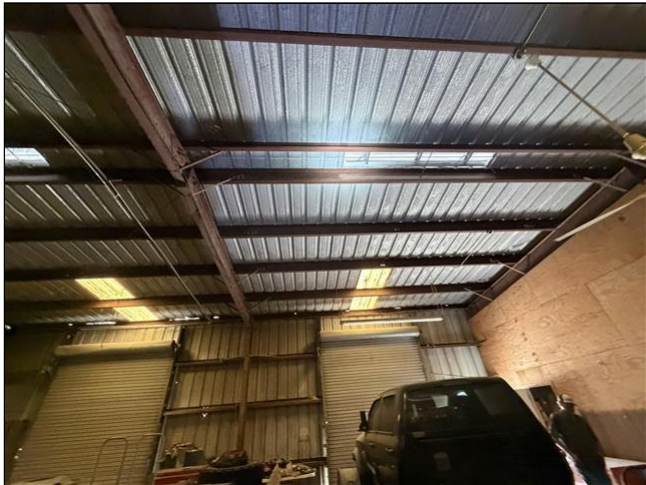
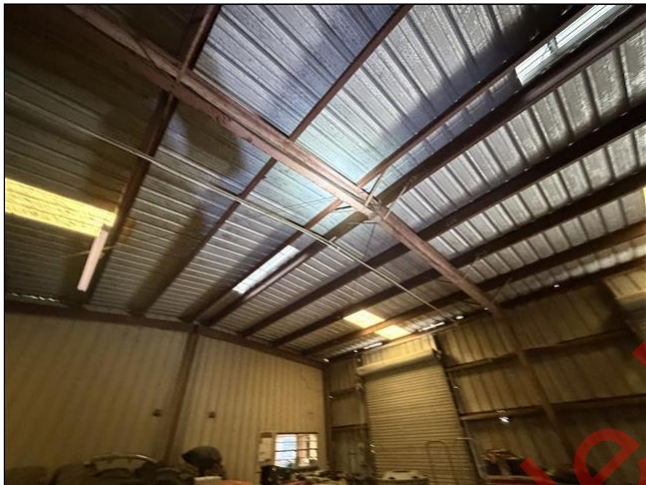
In summary, the roof framing and decking are typical for the building type and remain structurally functional, but exhibit age-related corrosion and exposure to moisture. Timely roof repairs and corrosion mitigation are essential to extend the service life of the system.

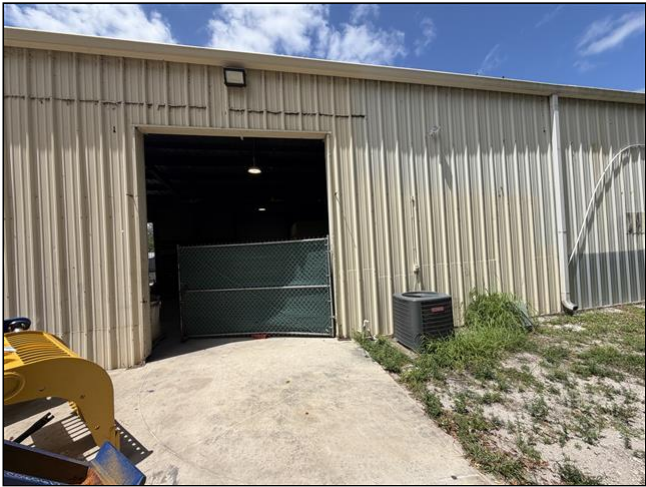
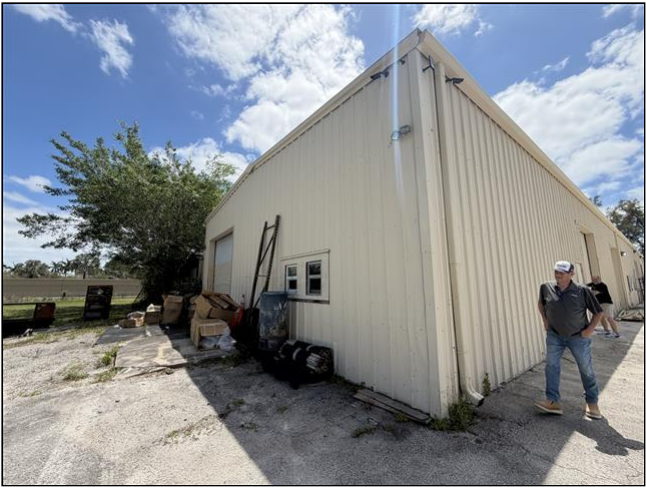
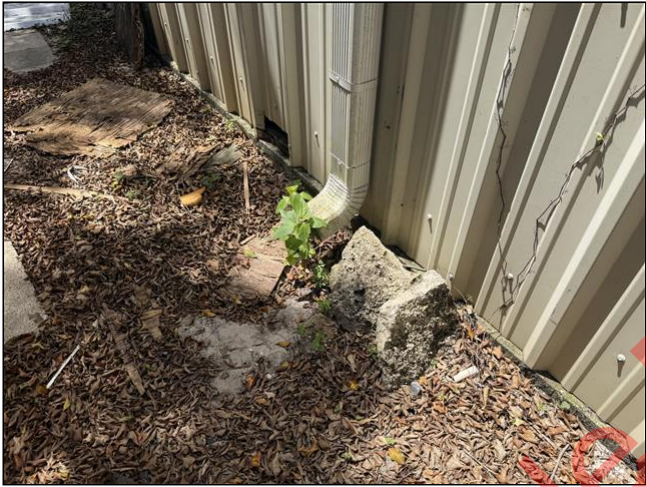
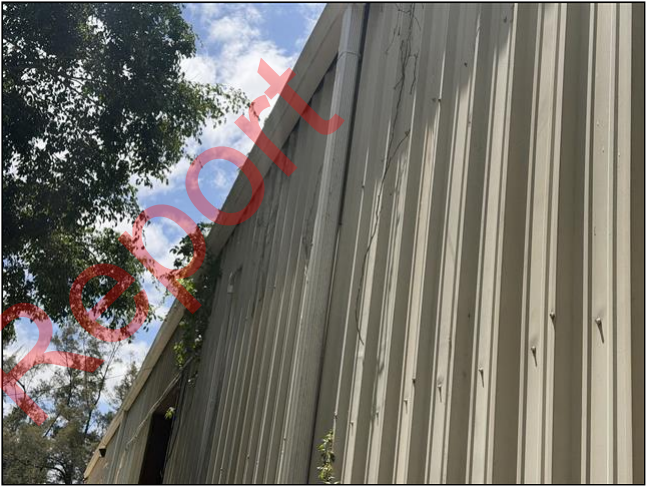
Overall, the existing roof drainage approach is minimal and typical for older industrial buildings but results in limited control of stormwater runoff. Strategic upgrades would significantly improve water management, reduce localized deterioration, and extend the service life of both the roof system and adjacent building components.

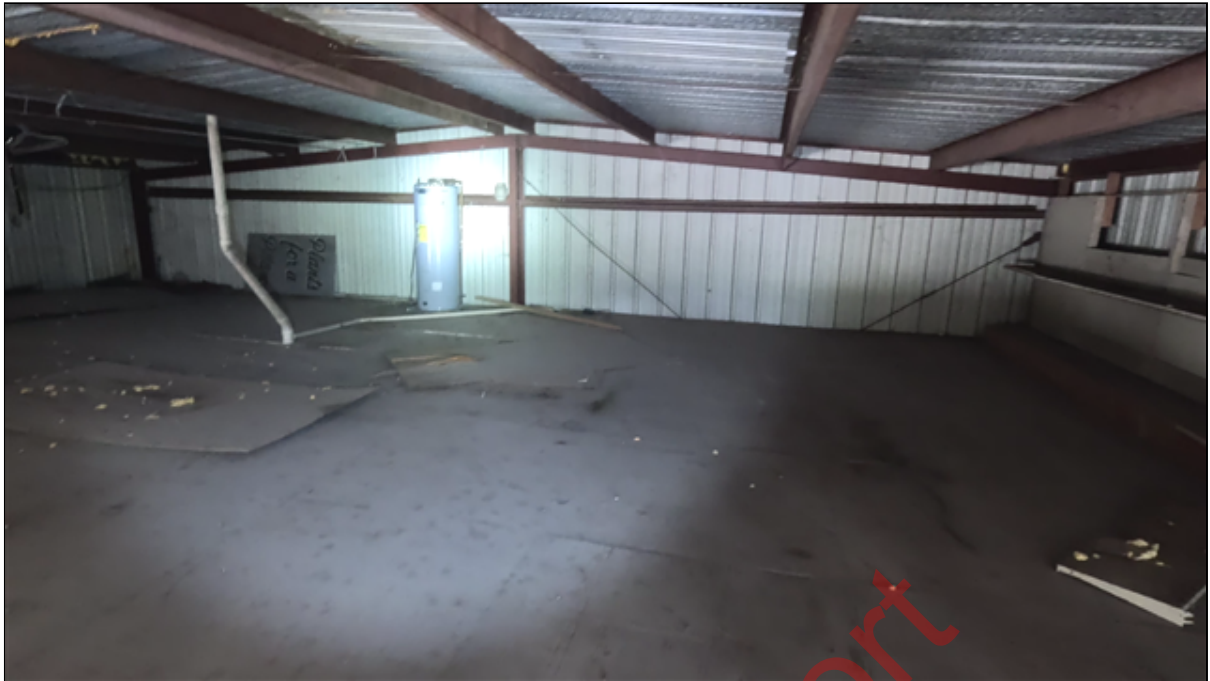
Overall, the domestic hot water system is present and appears operational; however, it is aging and lacks key protective features appropriate for its installation location. Proactive upgrades and safety improvements are recommended to reduce the risk of failure and associated water damage.

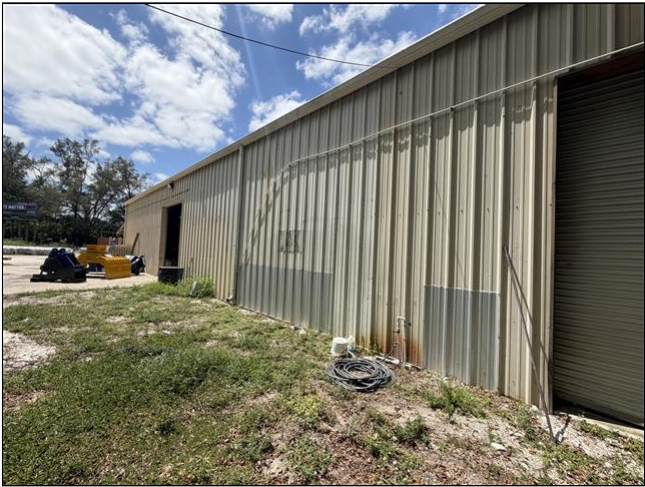
Overall, the septic system condition is unknown and represents a material risk due to the absence of maintenance and documentation. Immediate professional evaluation is strongly recommended to determine functionality, regulatory compliance, and potential need for repair or replacement.

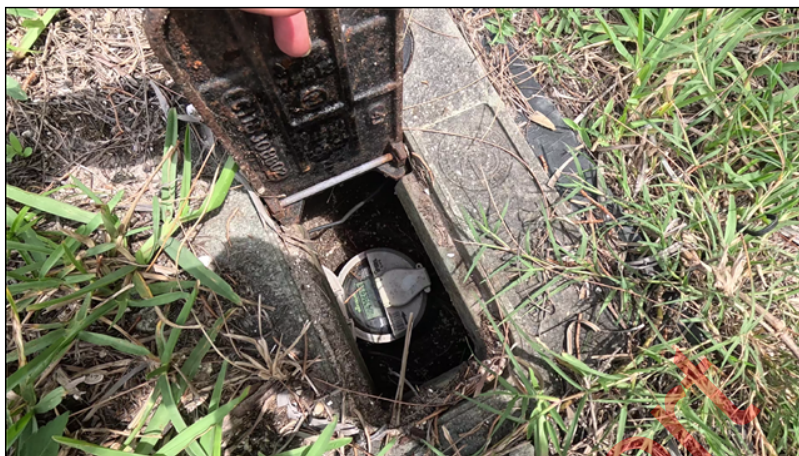
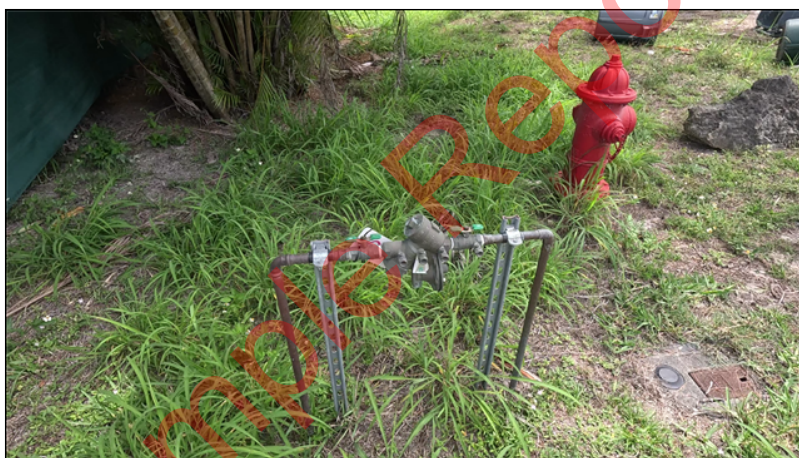
Overall, the water service system, including the meter and backflow prevention assembly, is typical and appears functional but exhibits minor deferred maintenance and lacks verification of backflow compliance. Routine maintenance, testing, and improved site conditions would enhance reliability and regulatory compliance.

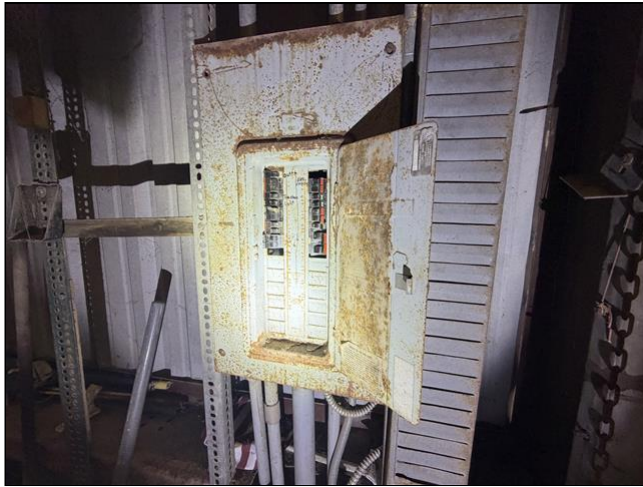
In summary, the electrical distribution panel is in poor, heavily deteriorated condition with significant corrosion and functional concerns. Replacement is recommended in the near term to restore safety, reliability, and compliance with modern electrical standards.

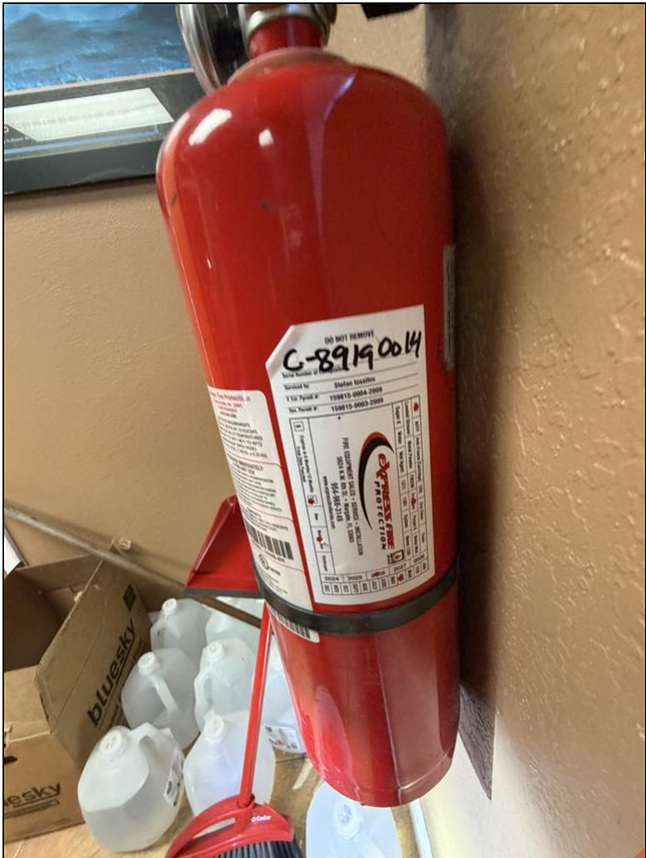
In summary, fire extinguishers are installed and appear generally serviceable; however, verification of inspection compliance, accessibility, and overall coverage is recommended to ensure adequate fire protection throughout the facility.

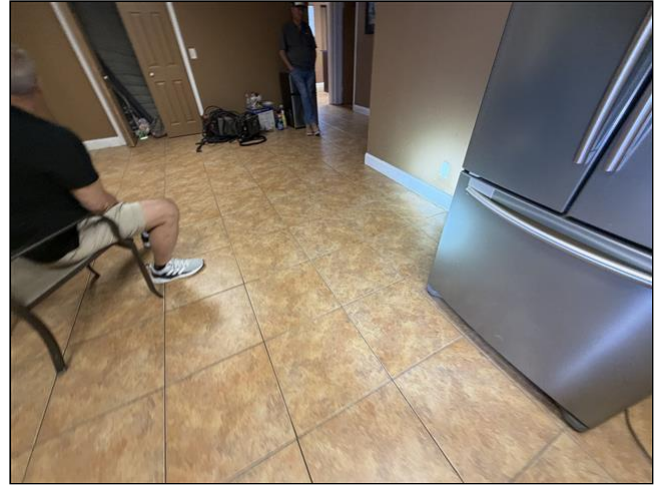
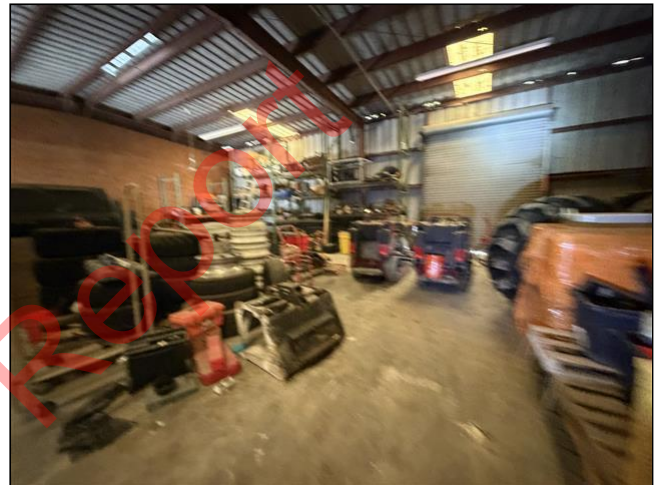
In summary, the flooring systems are serviceable and appropriate for their respective uses. The warehouse slab exhibits expected wear and would benefit from cleaning and recoating, while the office tile flooring remains in generally good, functional condition with routine maintenance recommended.
