### **Property Condition Report**

Undisclosed Address  
Palm Beach Gardens FL 33403

9/13/2023

Subject: Property Condition Report 3168 Northlake Blvd, Palm Beach Gardens, FL

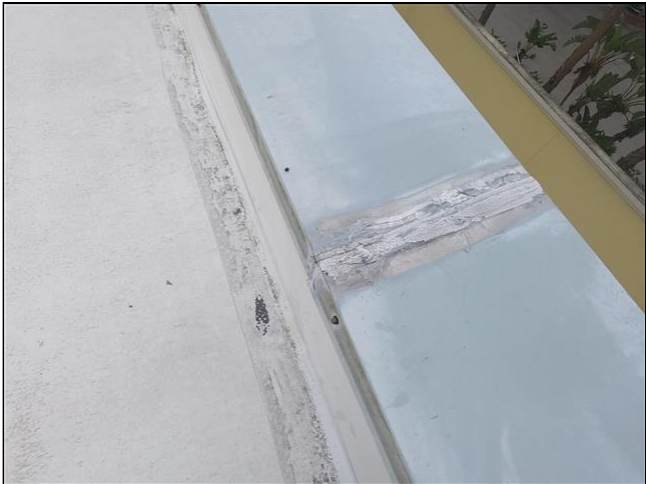
10.2 Item 1 (Picture)

Exterior walls go far above the roof plane as large parapets. The parapets are capped with the same TPO roof material to protect against water. Exterior joints of the parapets exhibited severe deterioration. Several caulk lines are damaged and in need of maintenance.

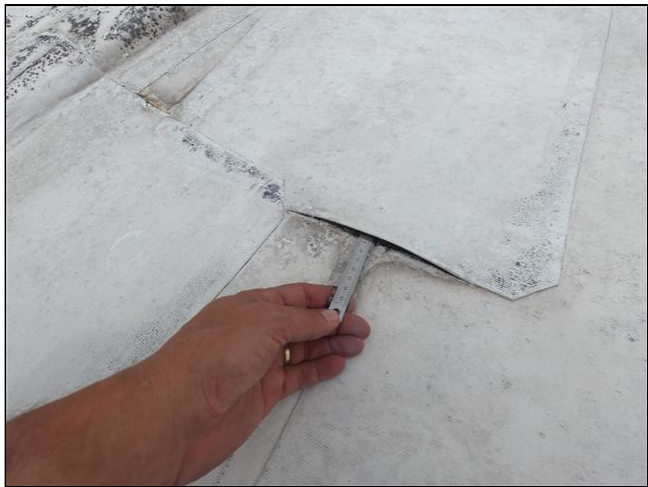
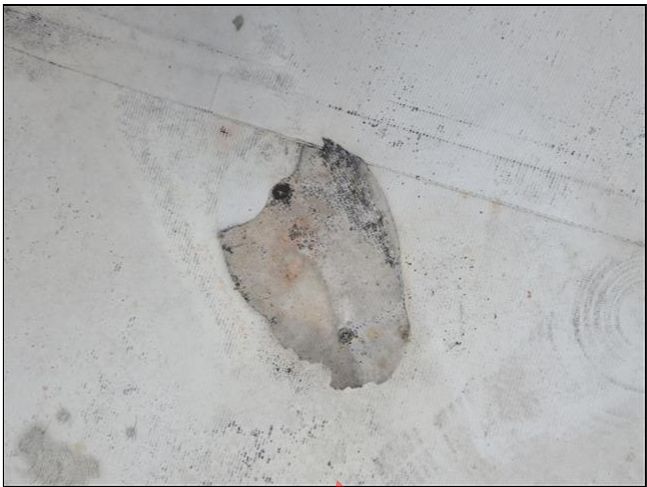
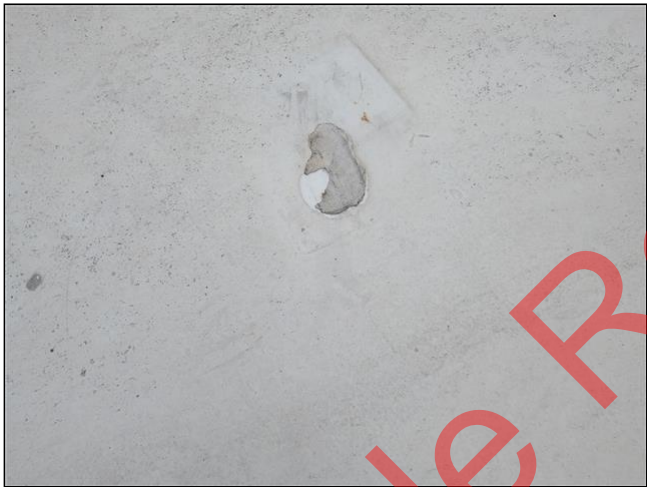
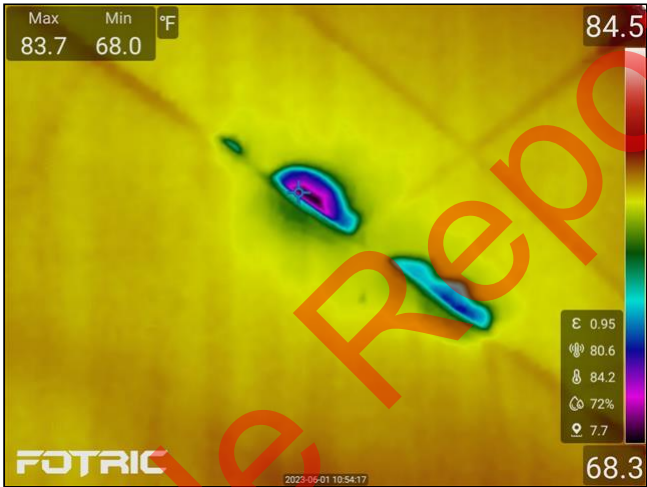
- The roof appears well designed leveraging the aspects of good roof drainage via tapered insulation, internal downspouts, and emergency scuppers.
- Inspector observed several areas where the membrane has been punctured and repairs have been made.
- Inspector observed several pieces of debris including cement blocks that were left on the roof. There were also, several loose HVAC condensate lines found.

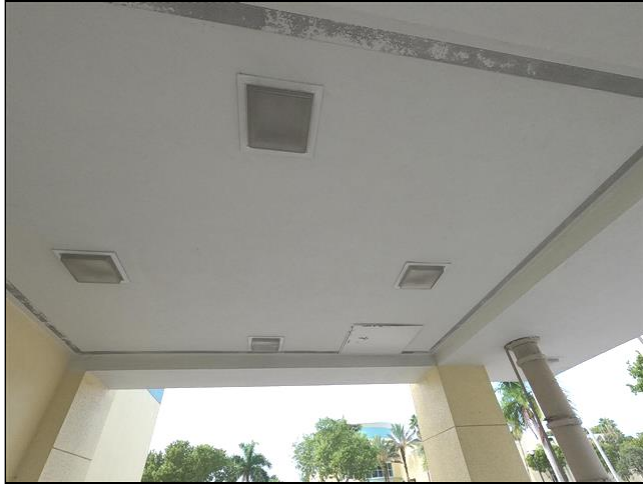
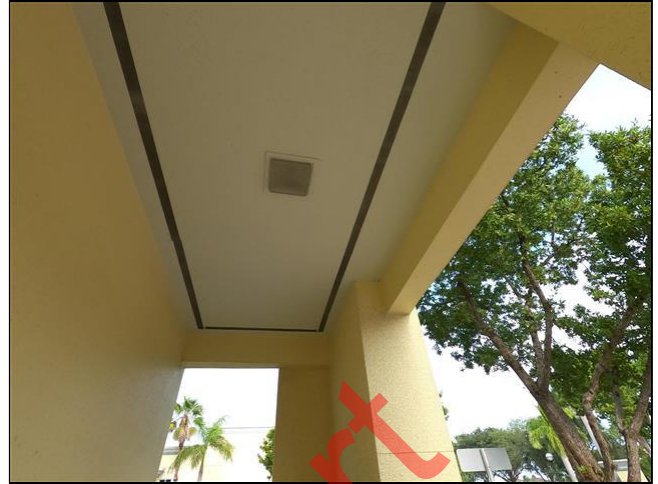
The soffits appears to consist of exterior rated gypsum board. The architectural trim consist of foam inserts. Some areas of the architectural foam in the back of the building exhibited moderate levels of deterioration.

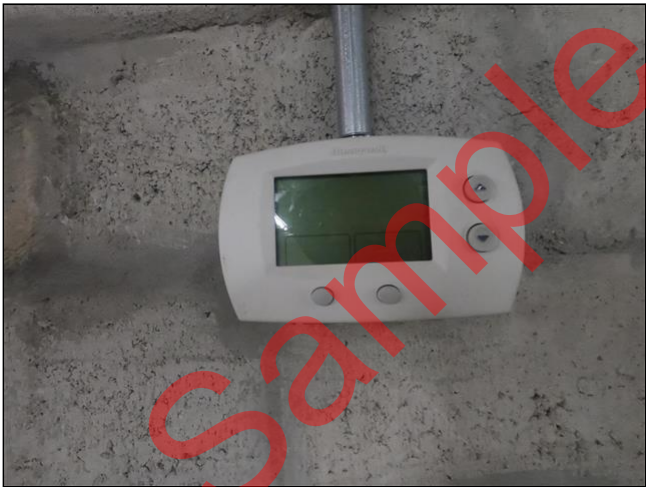
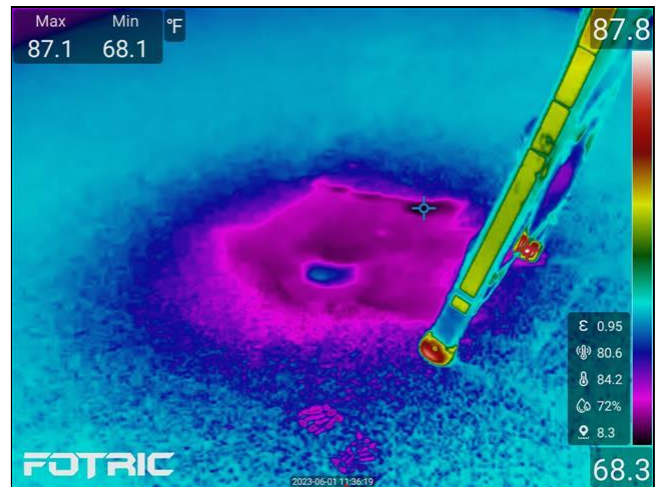
Inspector observed that two of the RTUs were not functional at the time of the inspection (one for the warehouse and one for the office area). Inspector observed that the thermostats associated with the malfunctioning equipment were without battery.

Inspector observed some duct leak that was generating a large amount of condensation. Cold air that escapes the duct and mixes with the hot ceiling cavity air creates condensation. Recommend repair of the damaged duct line.

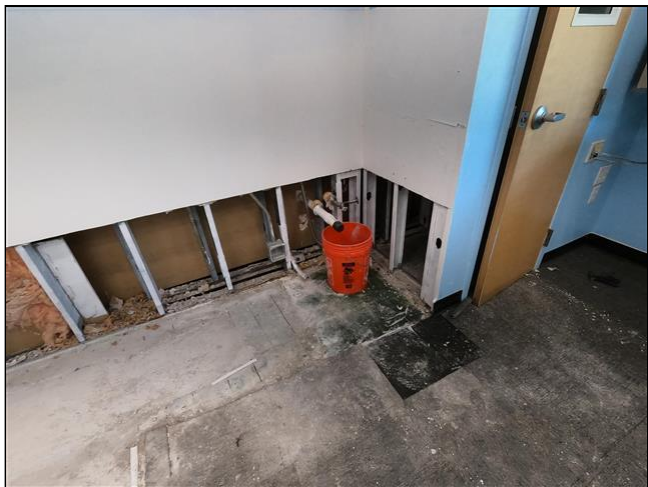
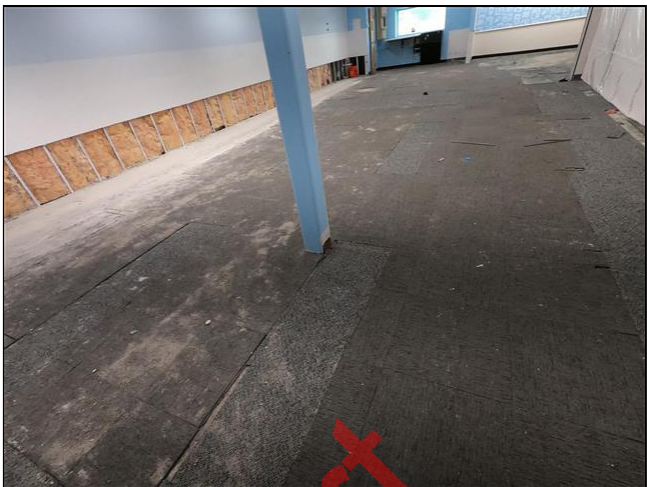
The building appeared to have suffered water damage and possible mold damage as evidenced by the plastic containment and the drywall cuts made along the walls on the west side of the building. There

was also several sections of carpet tile that had been removed. However, this is not a formal mold assessment as mold tests would be required to verify the extent of the contamination.

Based on the observations listed on this report, the level of maintenance of the property, and the signs of observed water damage, a mold assessment which would include several Indoor Air Quality and surface tests is recommended to understand the level of contamination.

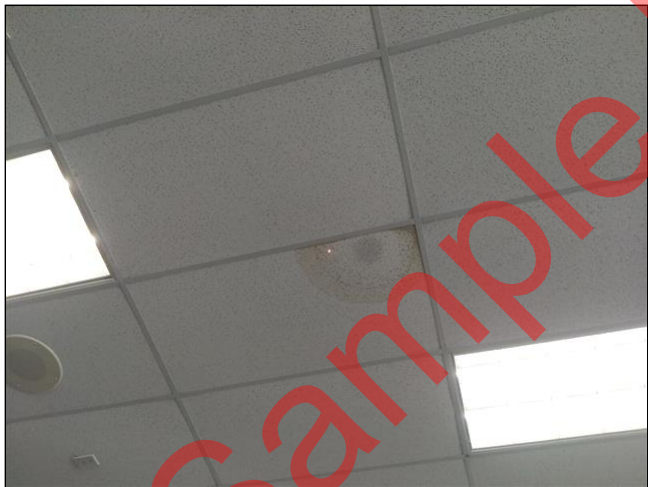
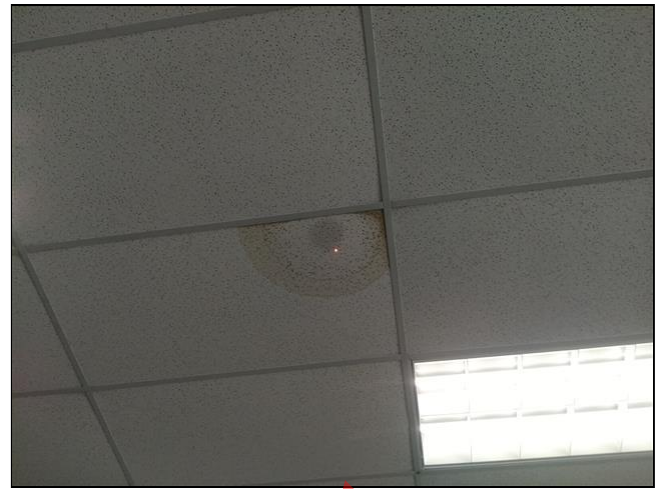
Moderate wall, ceiling, flooring and surface finish damage was observed. Ceiling damaged ceiling tiles were caused by several roof leaks and HVAC duct leaks. Furnishings were old and exhibited moderate levels of deterioration. Some light fixtures were not functional r had damaged light bulbs.

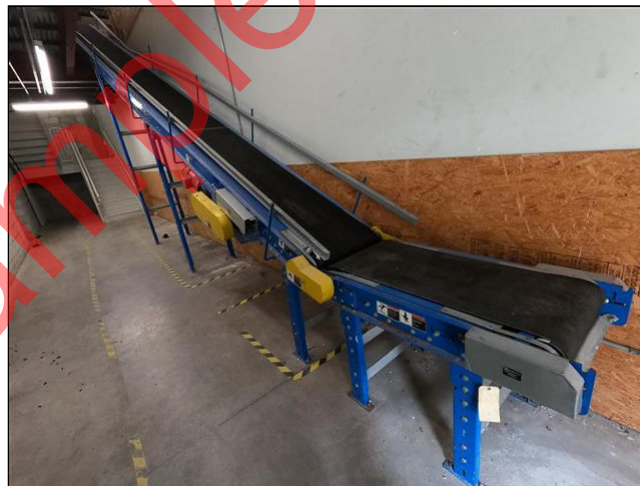
16.11 Item 1 (Picture)

- Water damage: There may be more damage than it appears to walls and ceilings.
- Holes or other damage: Sections of walls were damaged and sections were cut out.
- Soiled or worn flooring: Some areas of soiled or worn flooring were noted. Some sections of carpet tiles were removed or missing.
- Damaged/deteriorating furnishings: The furnishings exhibited moderate levels of deterioration.
- Damaged/Obsolete fixtures: Some inoperable light fixtures were noted.
- Other: There was a conveyor belt system connecting the first floor warehouse with the mezzanine. The system was functional at the time of the survey.
