# Dock Inspection Report

**Mrs. Bonnie Guenther**  
**Conquistador Homeowner's Association**

**Property Address:**  
1800 SE St Lucie Blvd  
Stuart FL 34996

July 17th, 2021

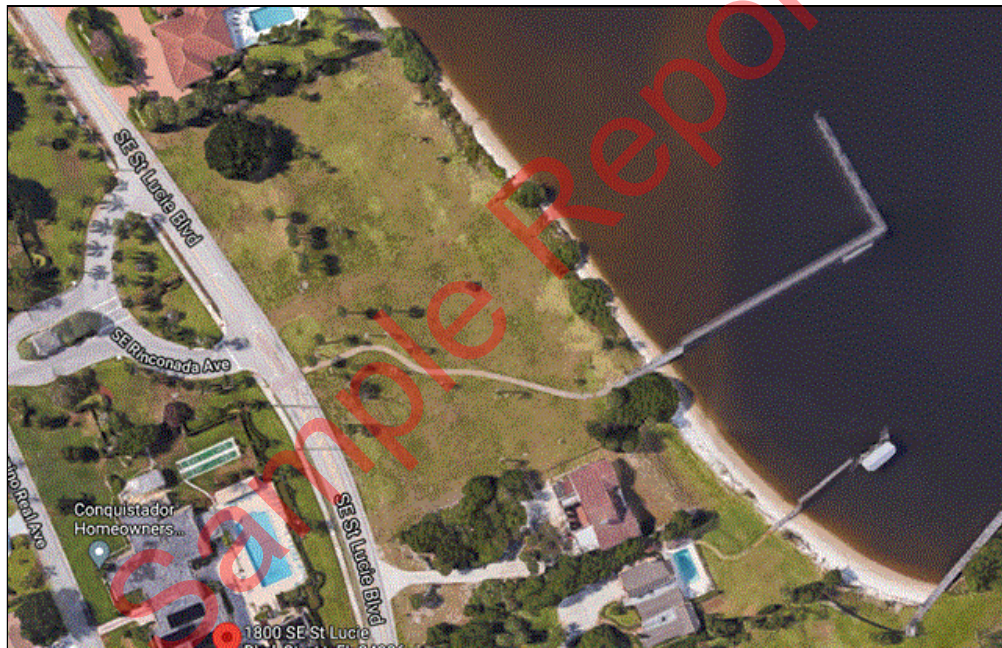
1.0 Item 1 (Picture)

The property is located directly on the St. Lucie River in Stuart, FL. The grounds are characterized as an open lot, as in a park, with a sloped elevation dropping towards the shores off of the St. Lucie River.

The lot where the park is located appears to be professionally maintained and well kept. Inspector found no evidence of erosion or soil de-stabilization that could have an adverse effect on the dock.

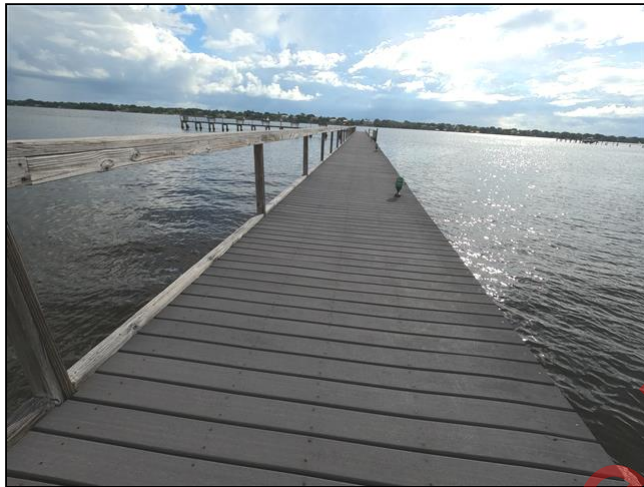
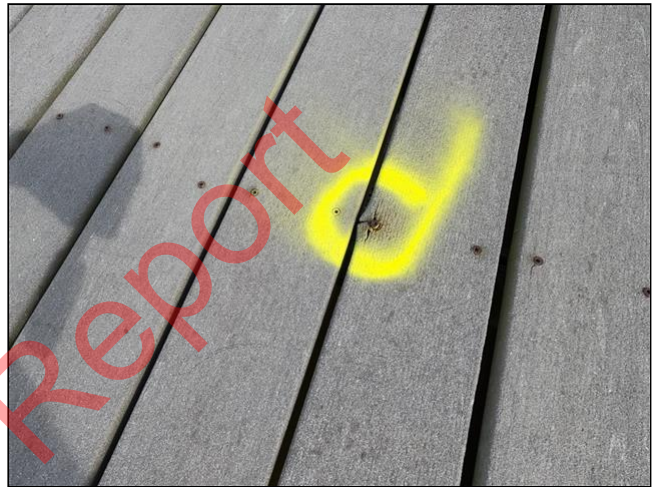
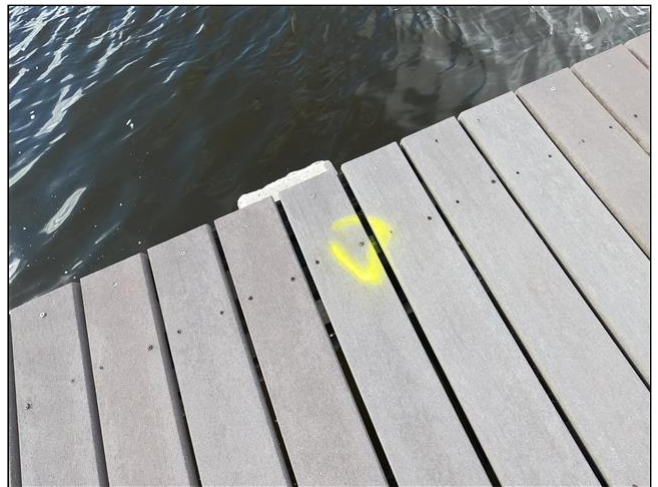
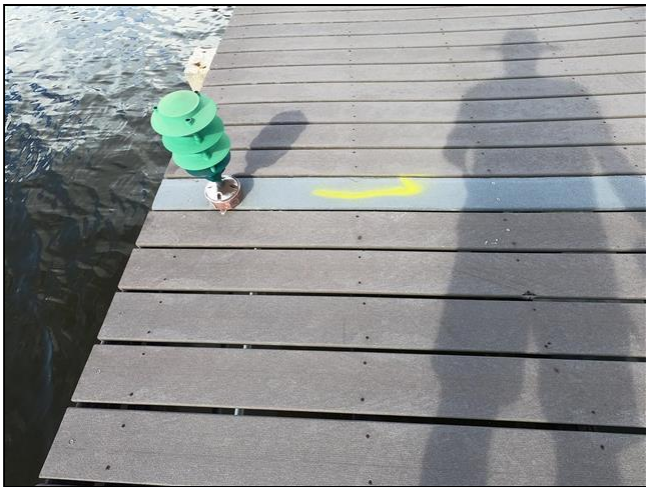
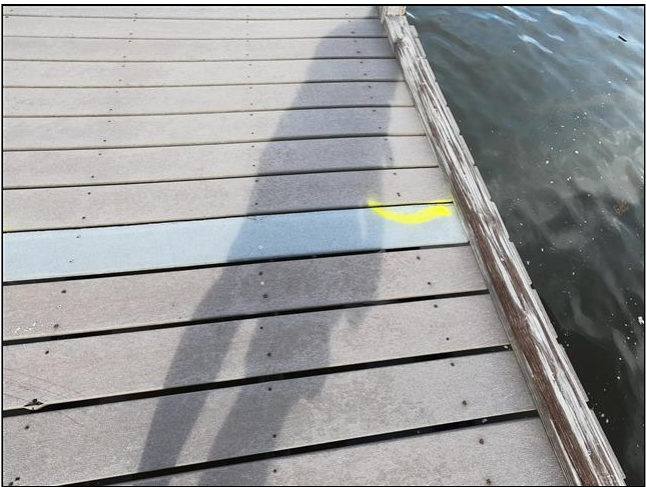
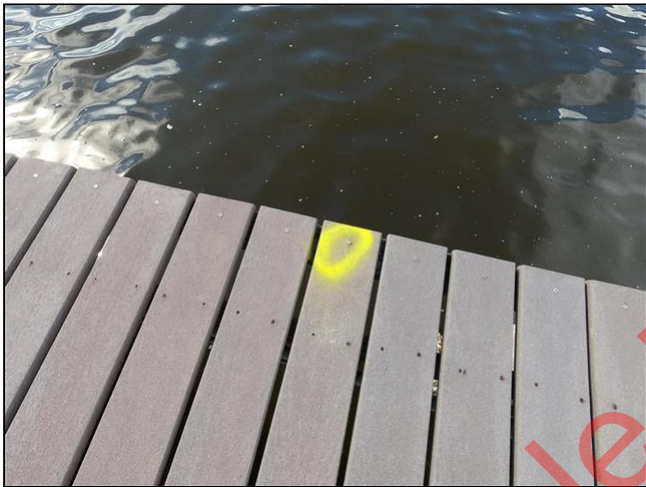
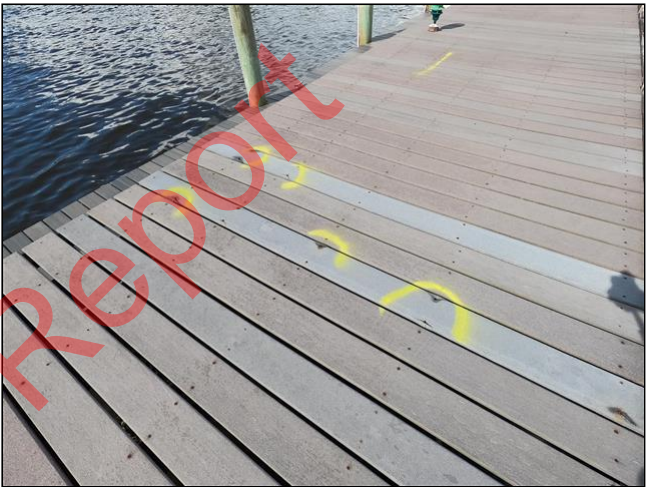
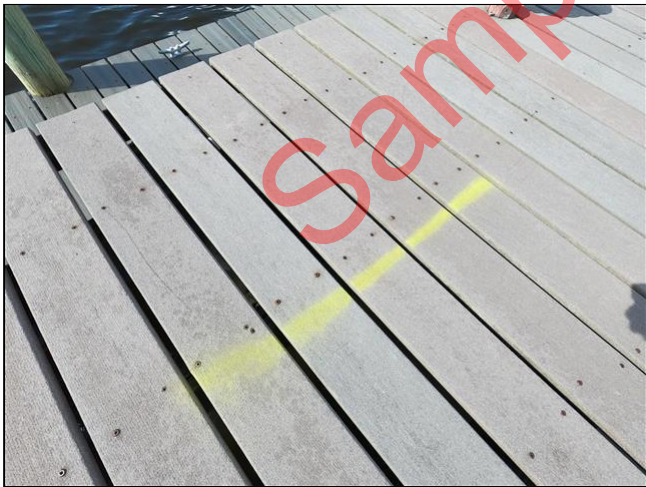
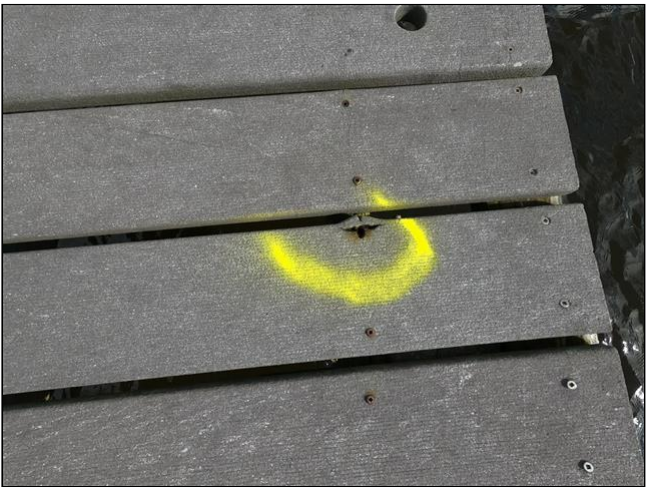
The dock measures +/- 400 lineal feet in length and is +/- 7 lineal feet wide. The deck is built with composite material and screwed in over marine lumber.

The deck exhibited minor signs of deterioration with some boards beginning to crack around some of the screws.

Some boards are not properly installed and not leveled with the rest of the deck. This is a trip hazard which should be corrected to prevent trip and fall accidents.

Also, there are several screw heads sticking out of the deck boards. Several screws are corroded as they stick out of the boards. This also represents a risk of injury and possible trip hazard.

Recommend repair or replacement of all damaged deck boards, re-placement of corroded screws, and re-tightening of all deck boards.

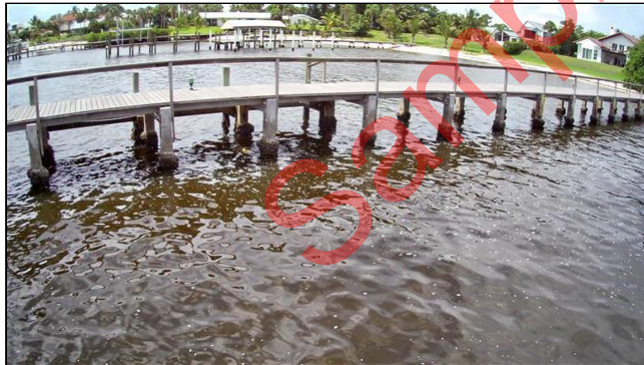
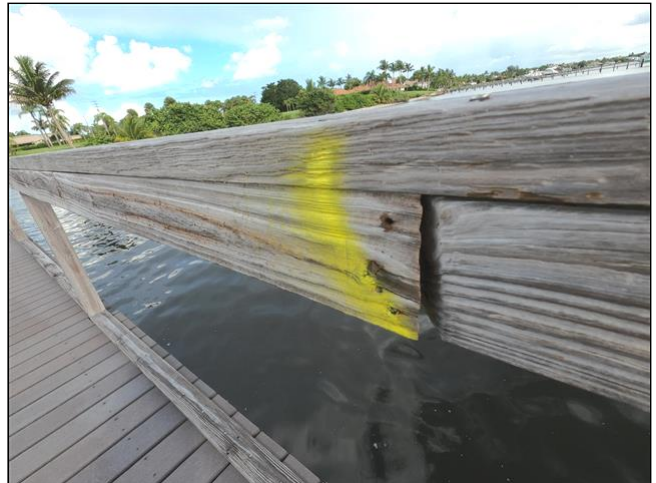
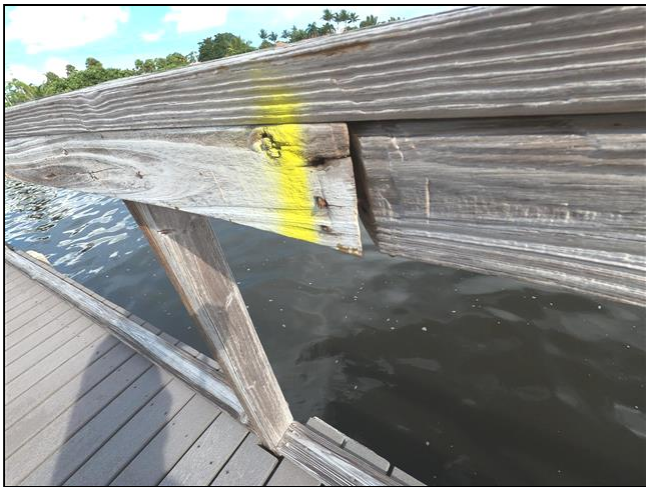
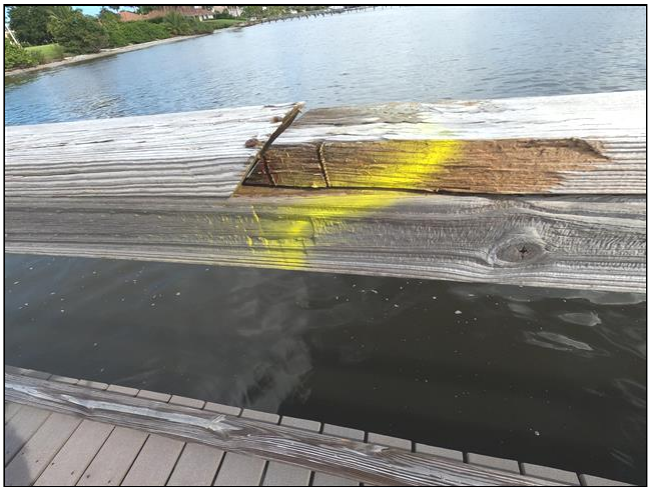
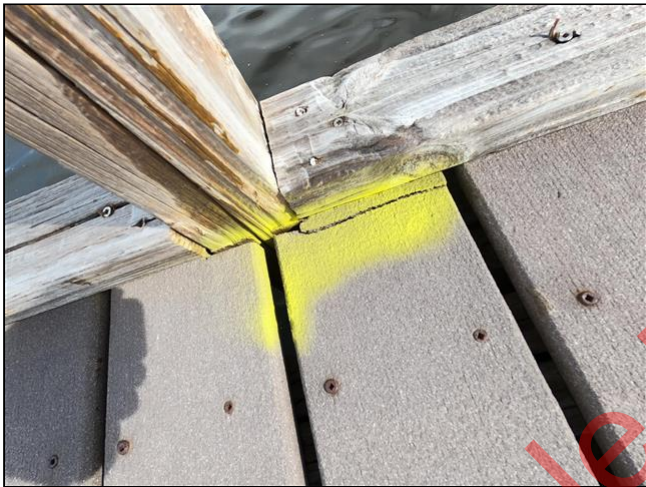
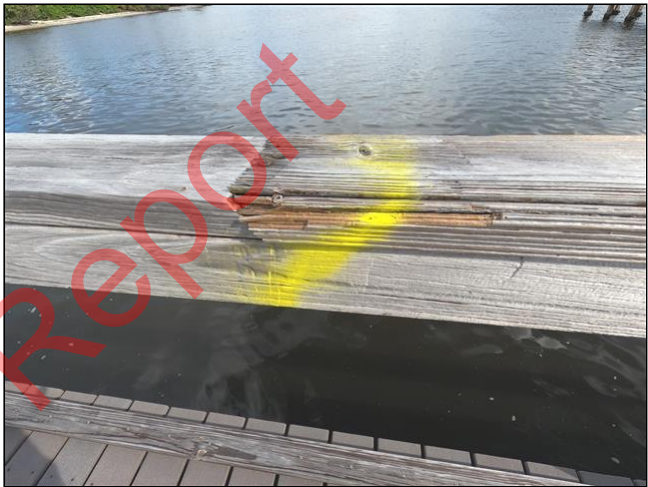
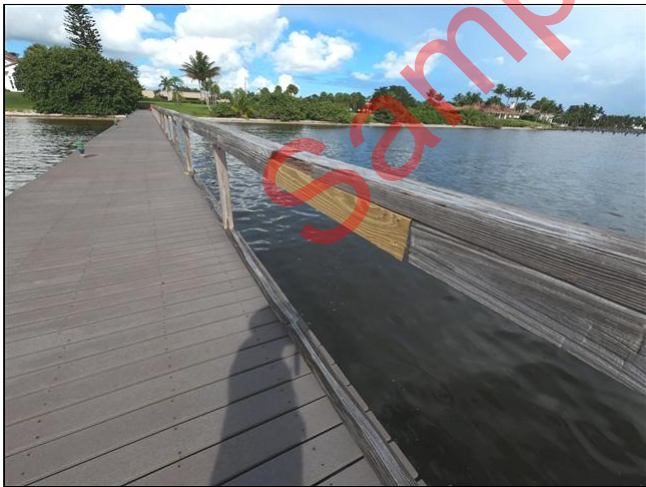
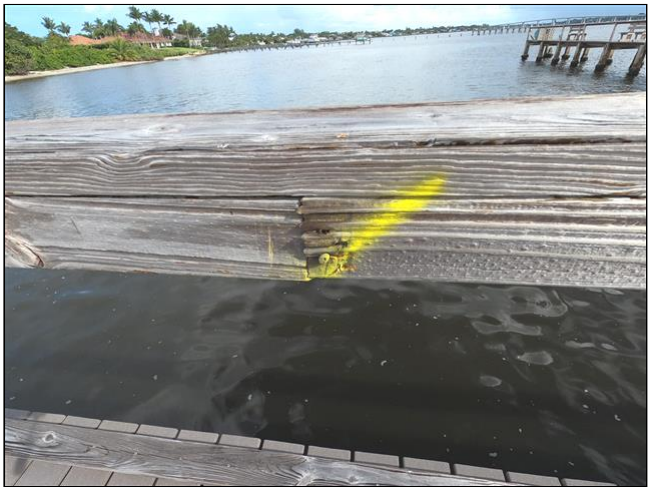
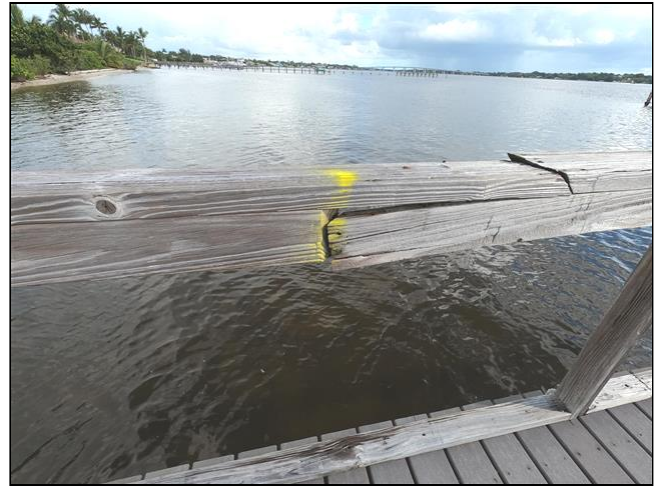
There is a wood deck rail on the entire left extension of the dock. The wood is very old and exhibited moderate levels of deterioration due to exposure to weather and sun.

Inspector found that several deck railing joints were separating or splitting. This represents a risk as people can get insured by corroded screws and splinters.

Inspector also found that a large portion of the railing was loose. The area is represented by the first 160 lineal feet of deck railing.

Recommend repair or replacement of all deck railings where the joints are separating, torn, or has corroded screws. Recommend repair or replacement of the section of railing that is loose. Recommend application of deck painting once every couple of years to extend the life of the wood railings.

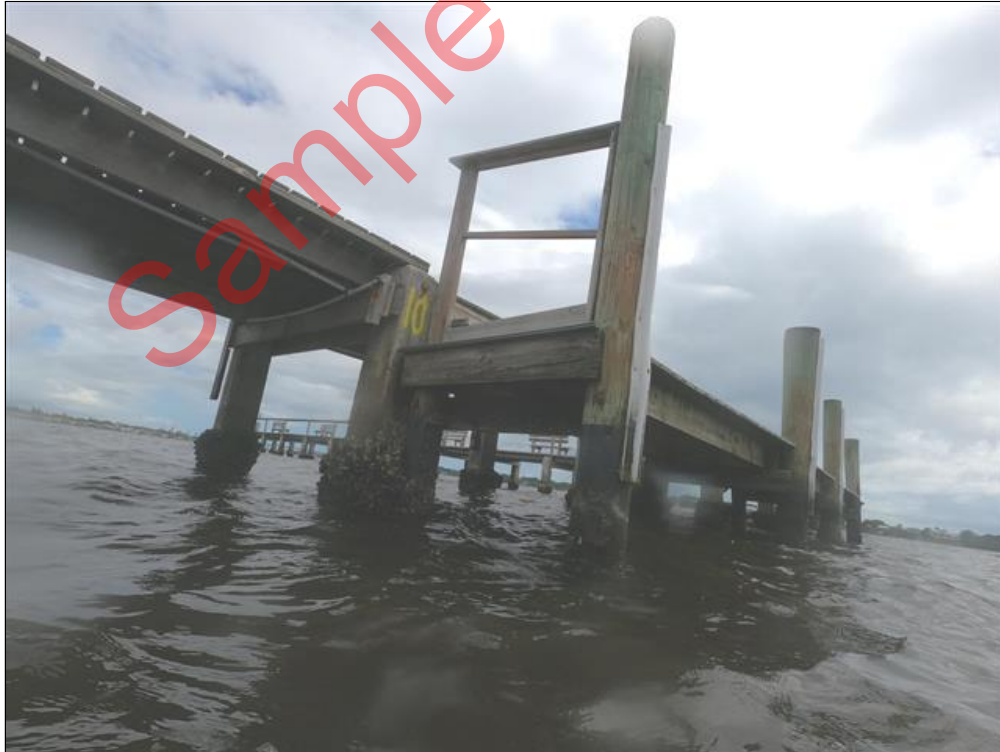
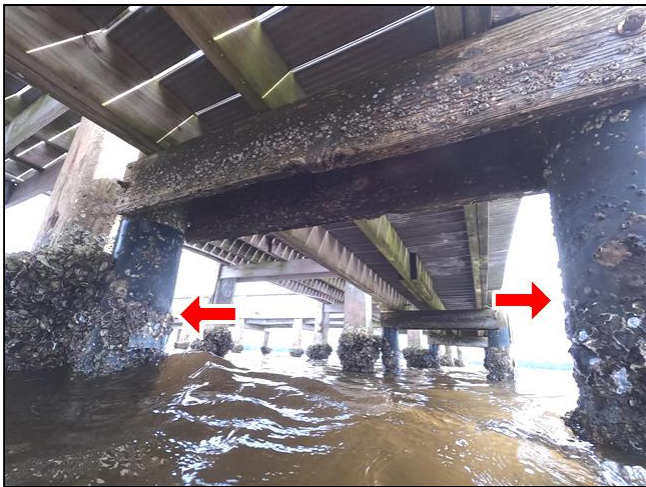
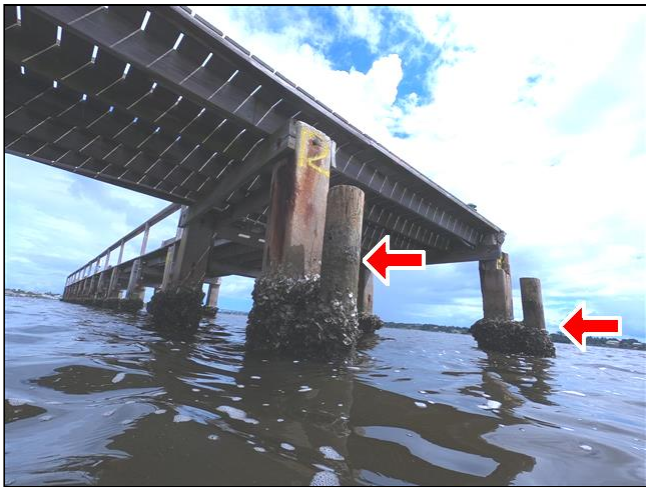
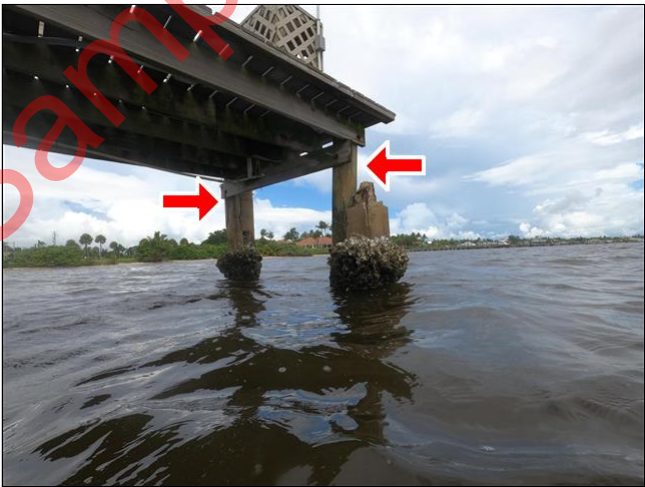
Vertical wood piling are the vertical supports for wood docks. There are some wood piles installed on this dock. The vertical piling can be damaged due to marine borers infestation. To extend the life of the wood piling, marine contractors uses a high-density polyethylene piling wrap. The wood piles on this section of dock are protected and are still in serviceable condition.

There are also some wood piles installed at the end of the dock to serve as temporary support for old concrete piles that collapsed. Those wood piles are intended to be temporary and should not be considered as permanent solution. Recommend those wood piles be removed and replaced by qualified marine contractor.

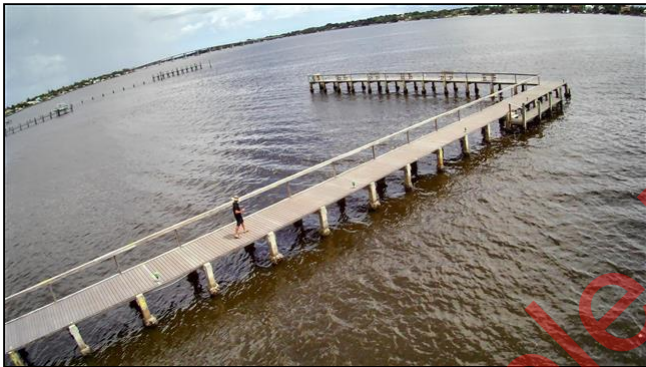
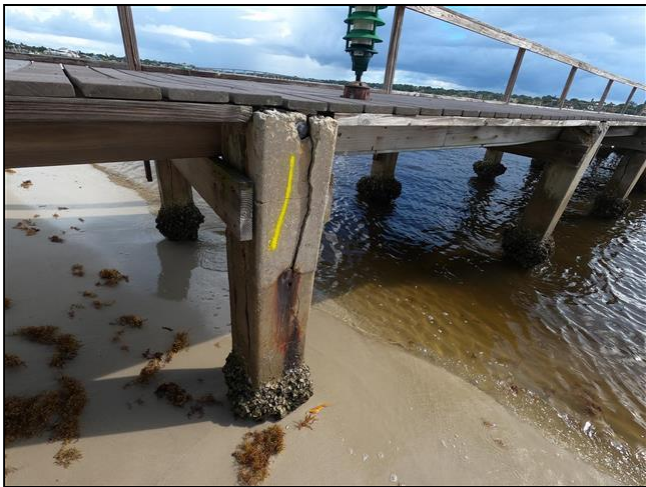
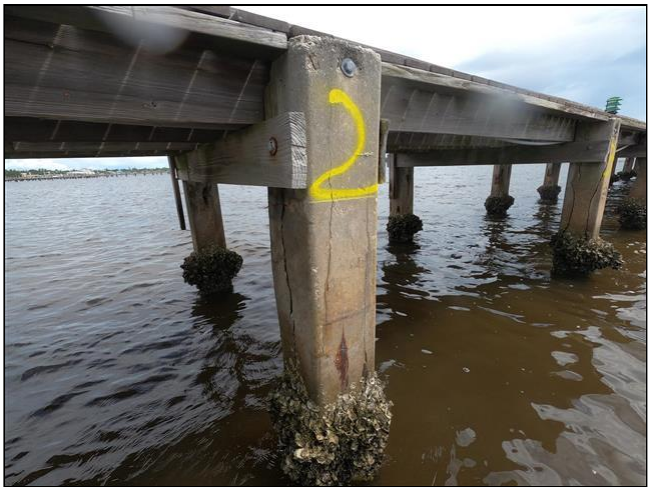
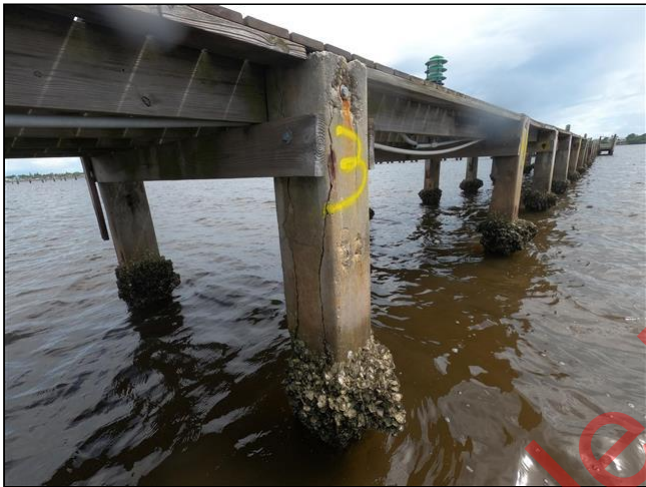
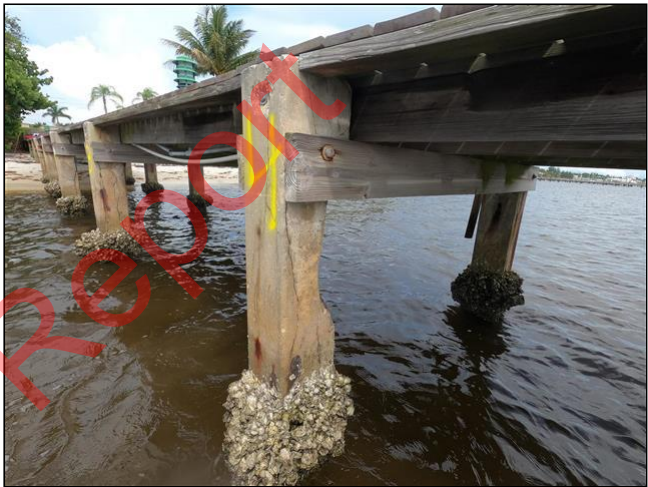
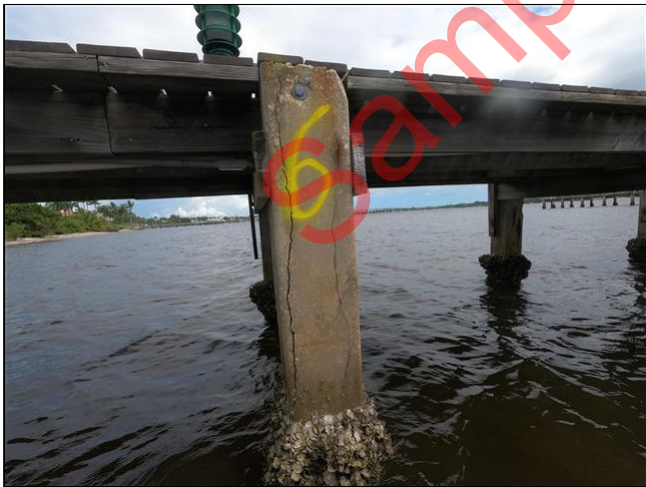
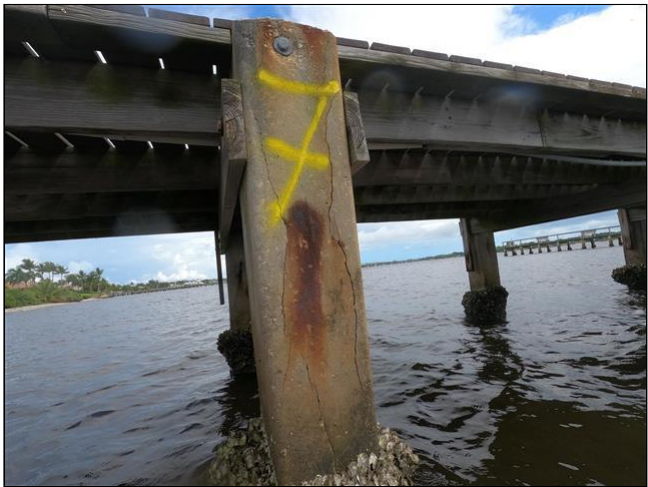
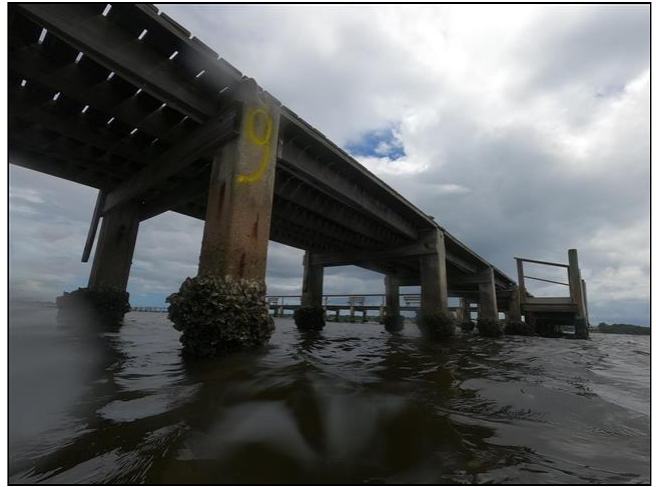
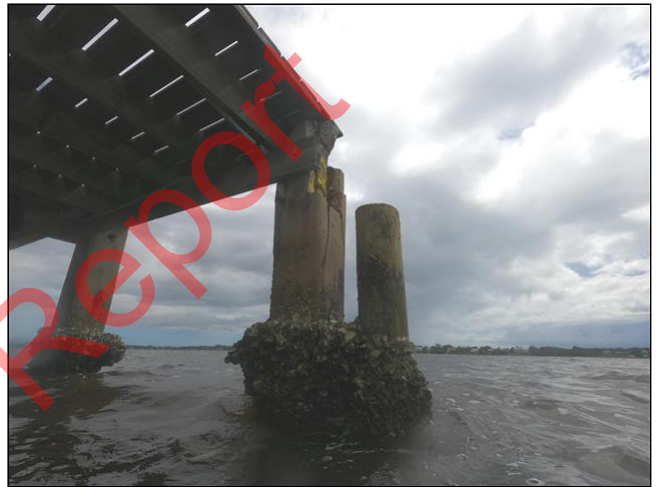
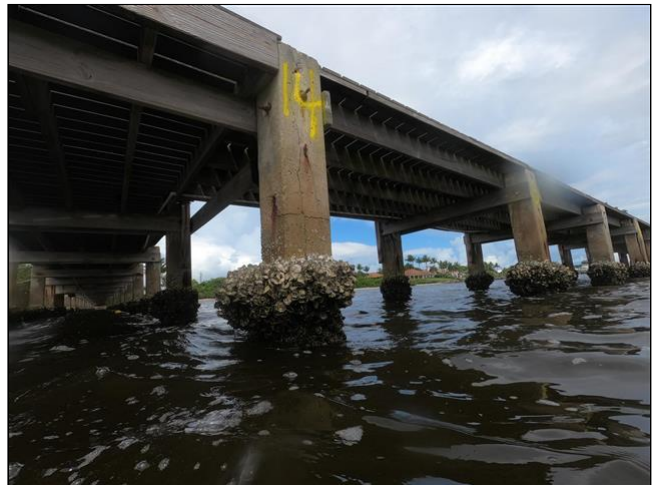
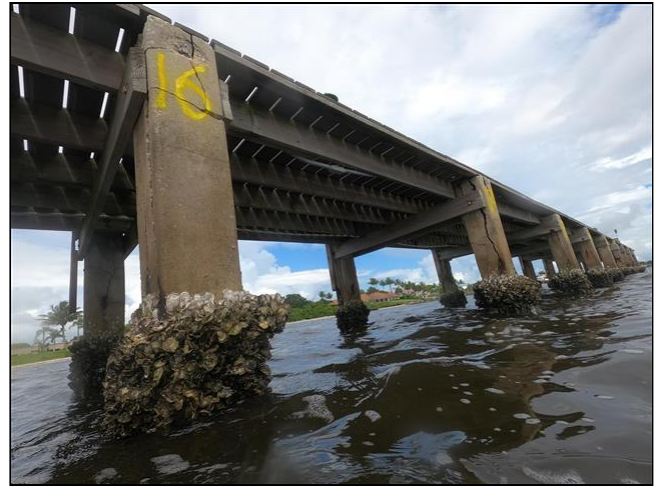
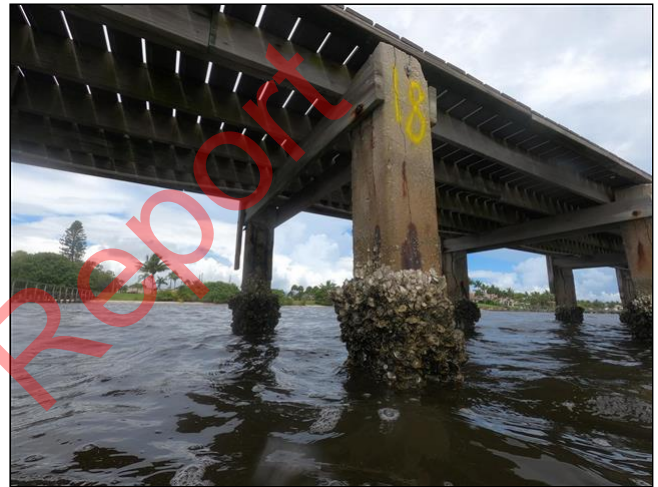
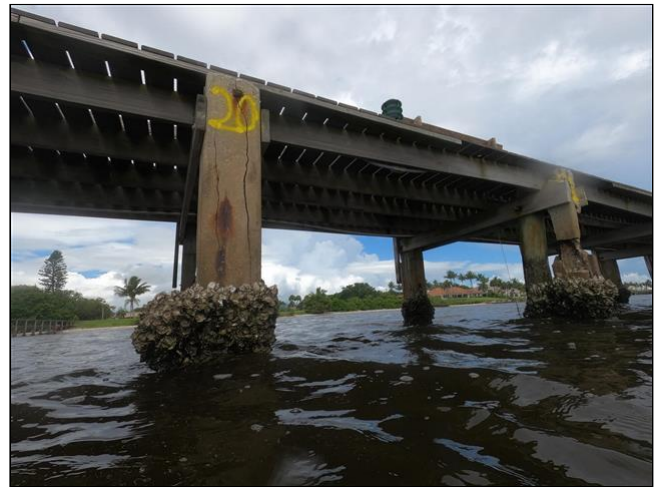
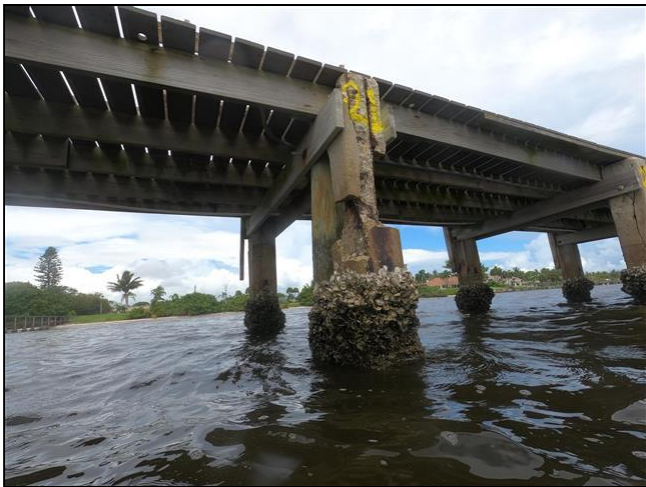
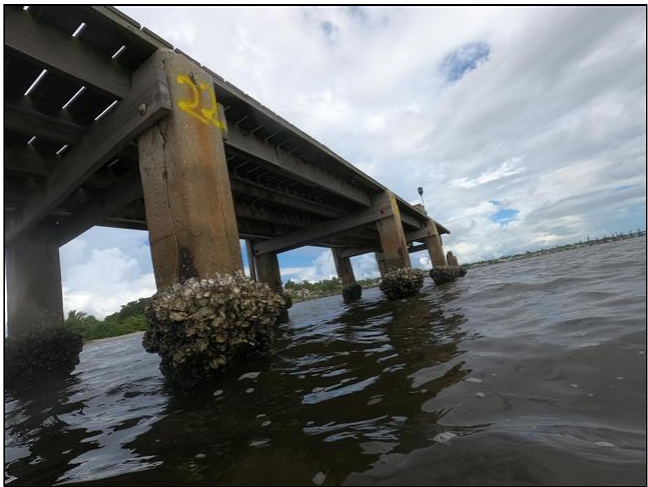
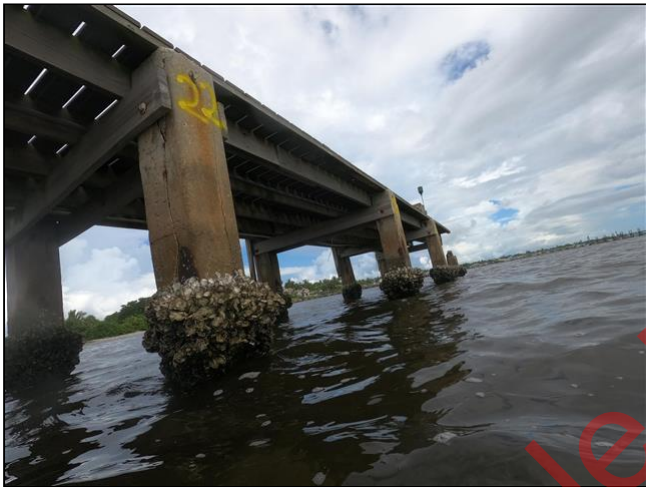
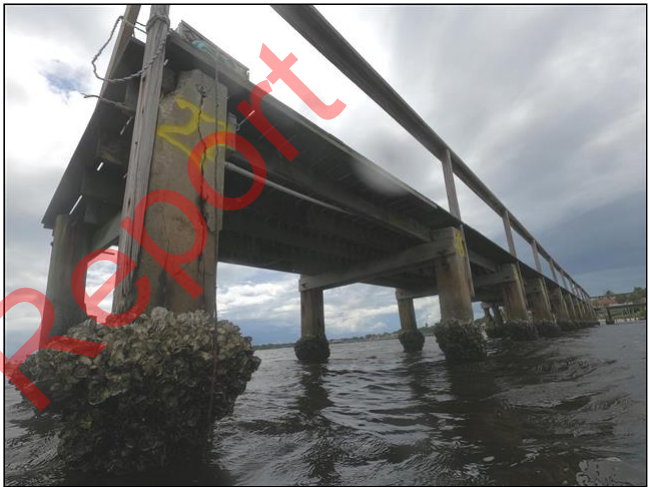
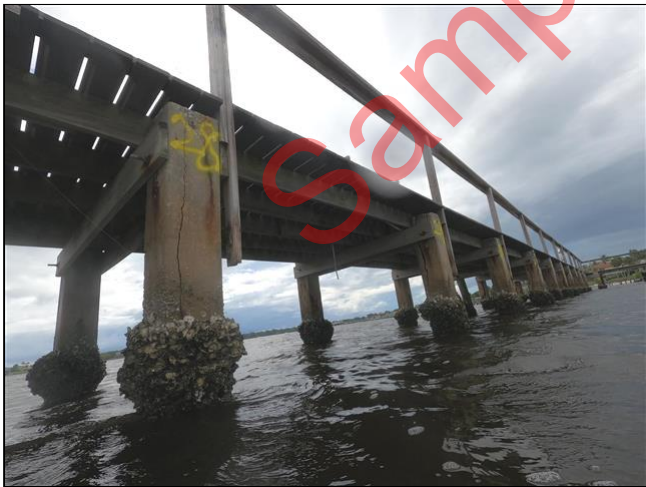
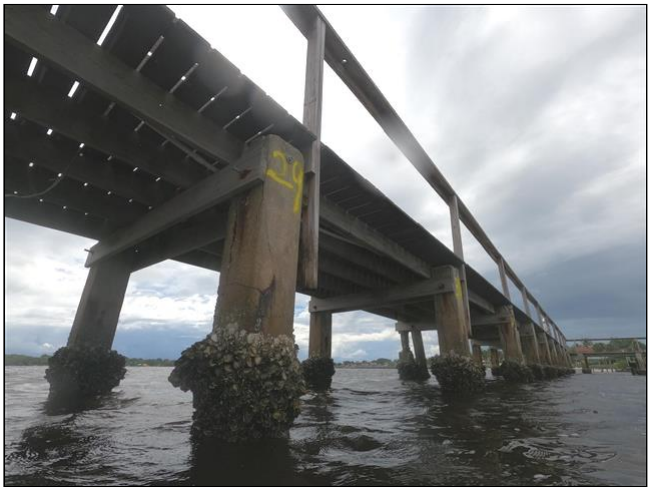
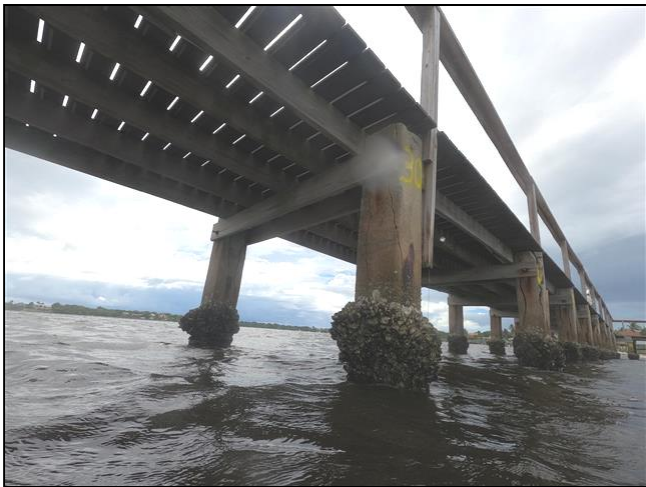
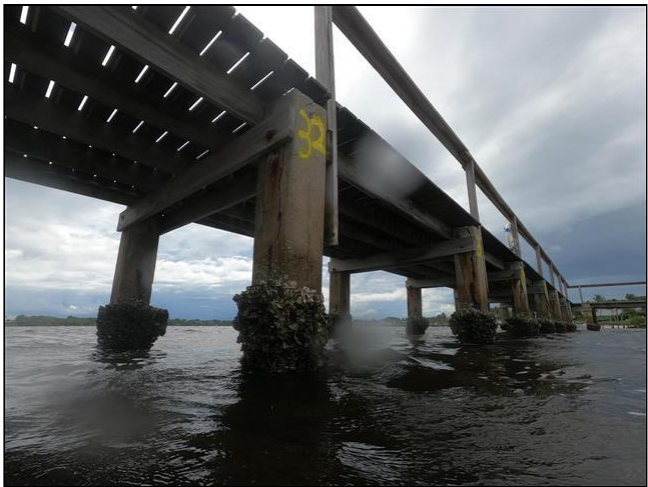
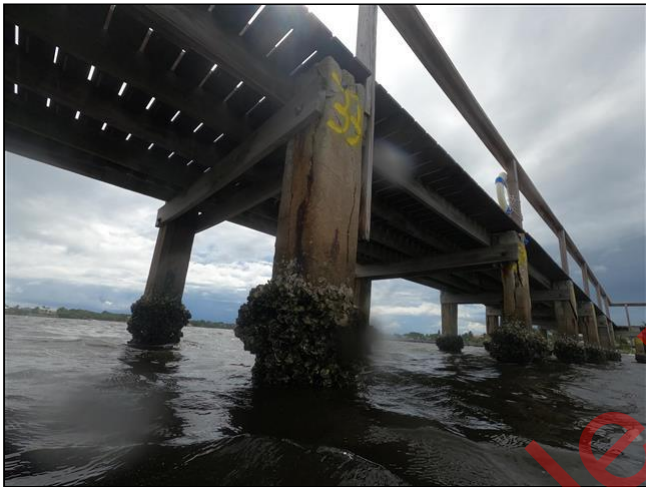
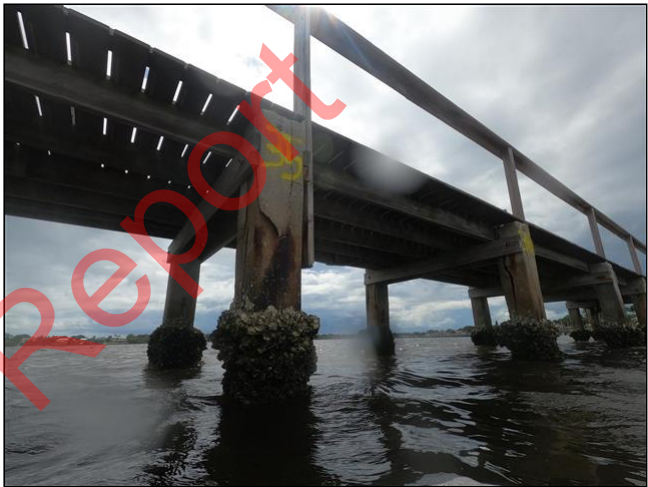
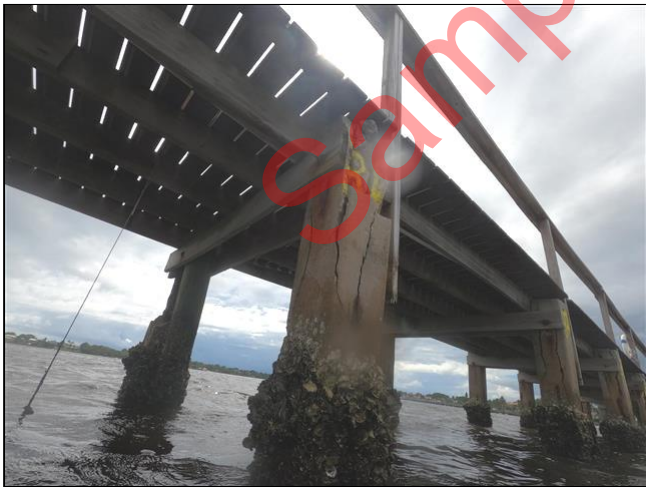
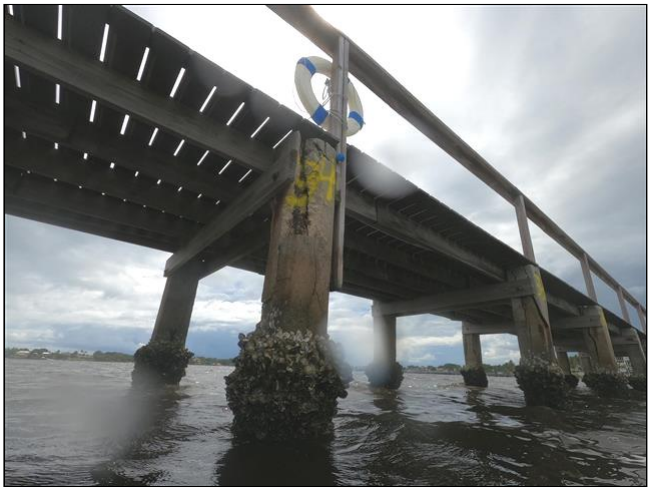
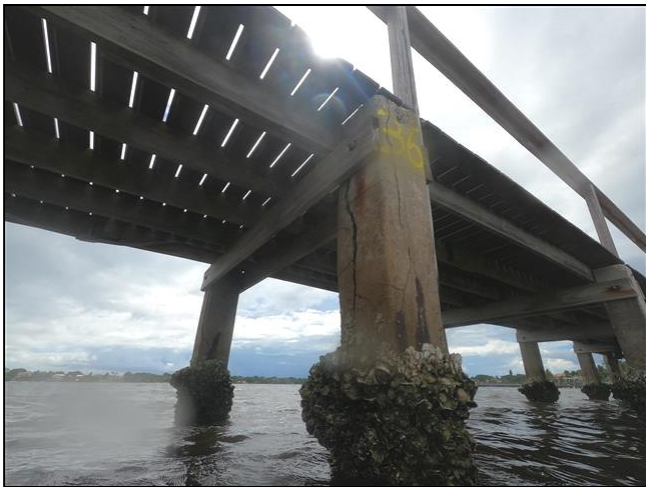
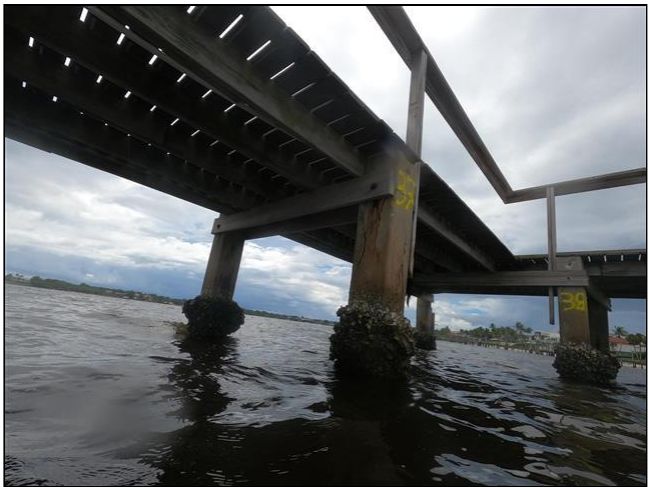
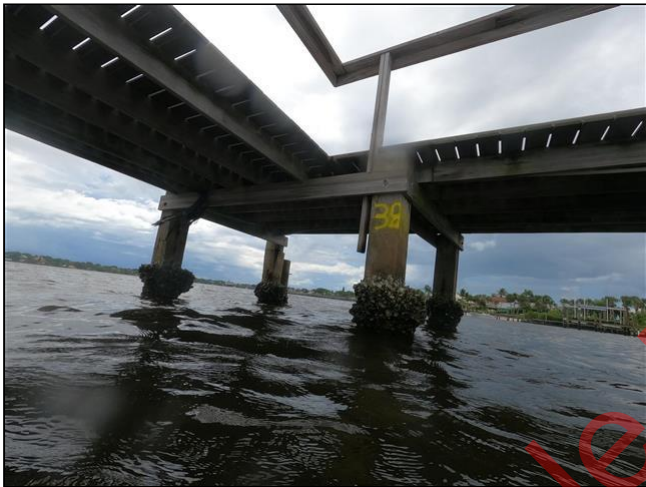
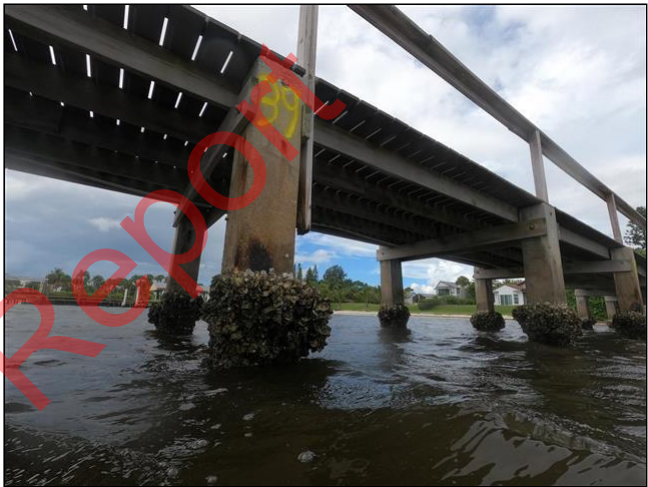
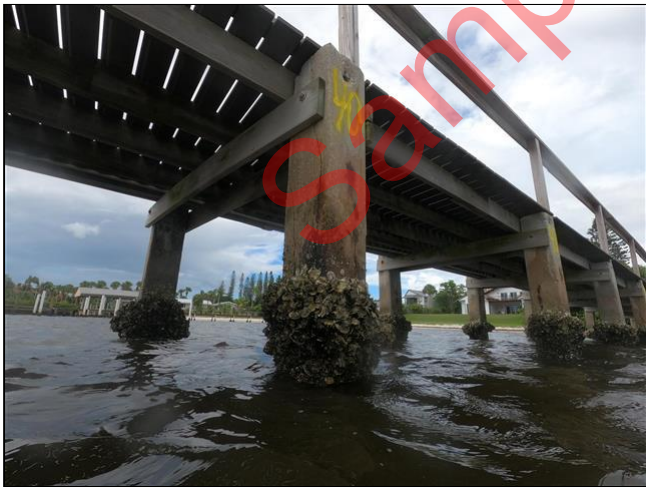
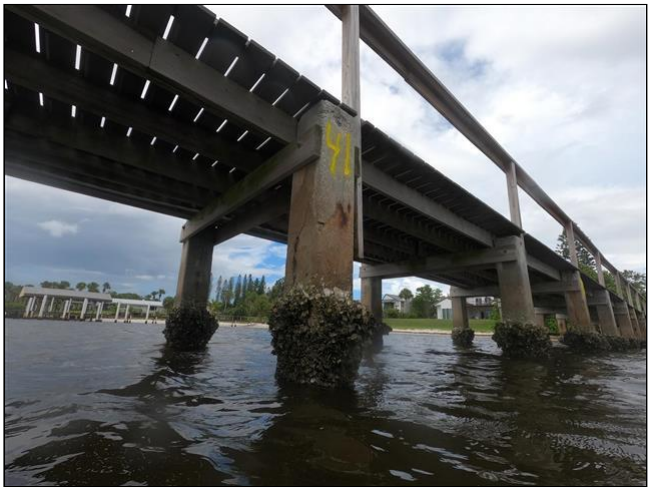
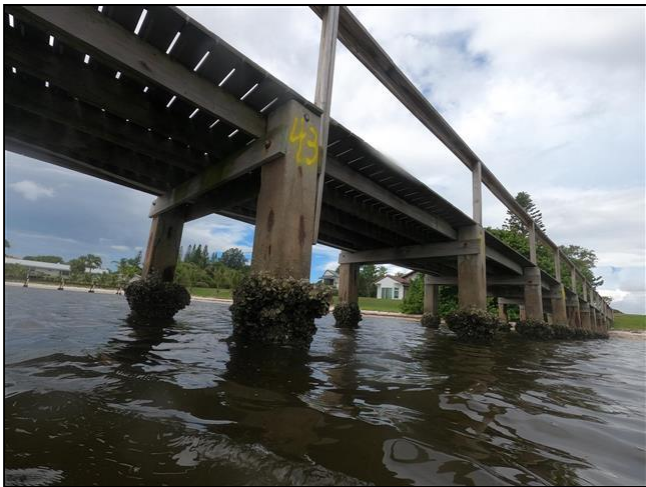
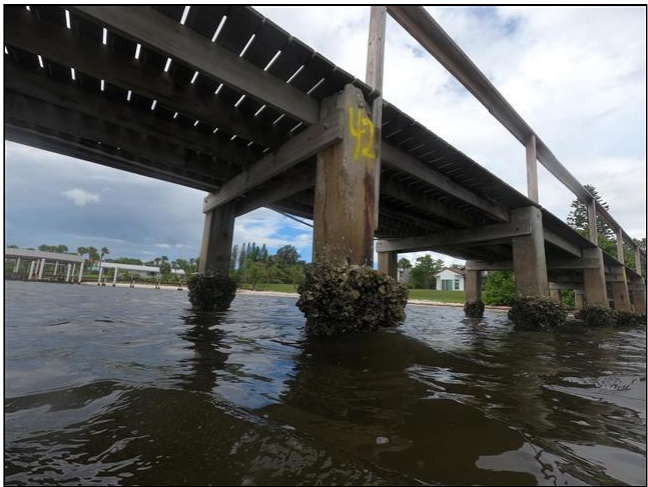
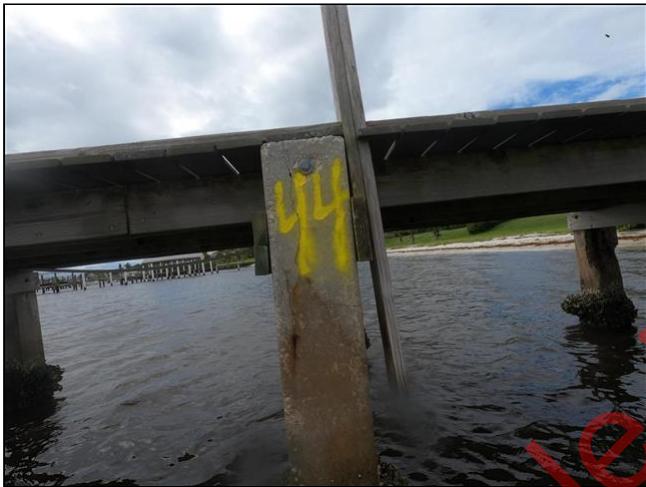
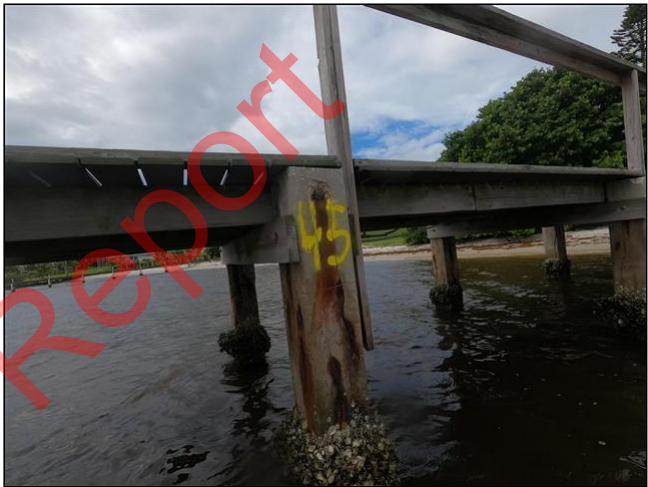
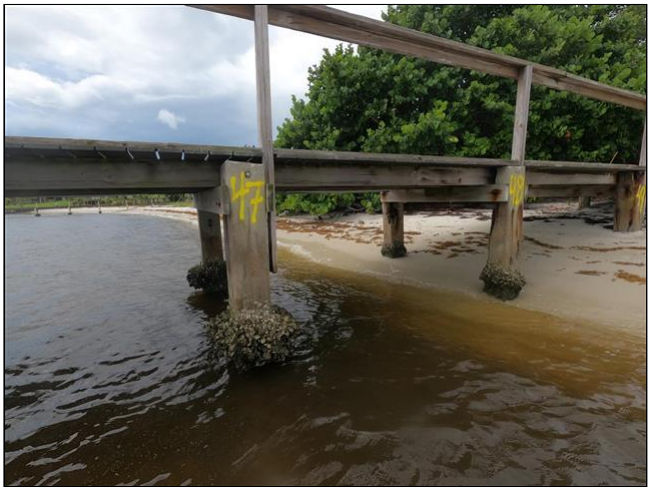
This dock was built with concrete piles that measures 12" x 12" and varies in length. What concrete piles gain in strength, when compared to wood piles, they loose in flexibility. The concrete piles are buried deep into the bottom of the river.

The top of the concrete piles are exposed to the greatest amount of movement (pressure) caused by wave and wind action. Therefore, when the dock moves (or is shaken), due to effects of wave and wind action, the concrete crack and expose the steel rebars inside. When left unattended for long periods of time, the steel rebar corrodes and expands causing further deterioration and weakening of the structure.

There are approximately 76 concrete piles supporting this 400 lineal feet dock. Inspector counted 49 of them in severe stage of deterioration. Most of the damaged concrete piles are beyond repair and should be replaced in its entirety. All work should be performed by a qualified marine contractor.

The portion of the concrete piles that is underground and underwater can resist better to corrosion of the reinforced steel rods due to poor oxygen content. Visibility underwater was very limited and the concrete piles were covered by mussels.

The area around the water line, also known as the splash zone, was covered with mussels. Mussels should be periodically removed to prevent de-calcification of the concrete, safeguard health of residents in the event of a fall, and allow for better and regular visual assessments.

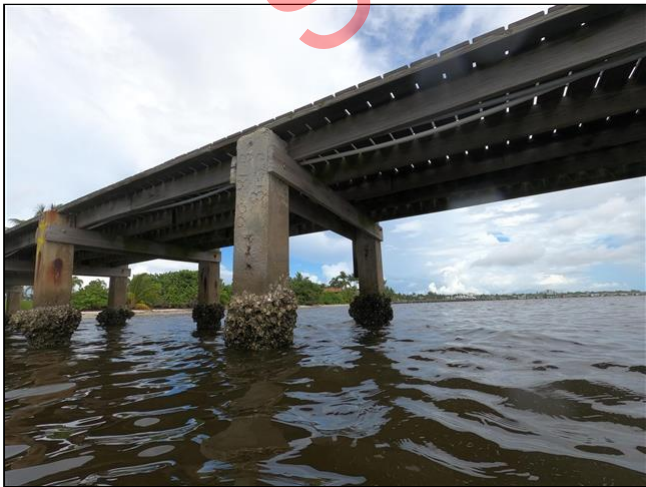
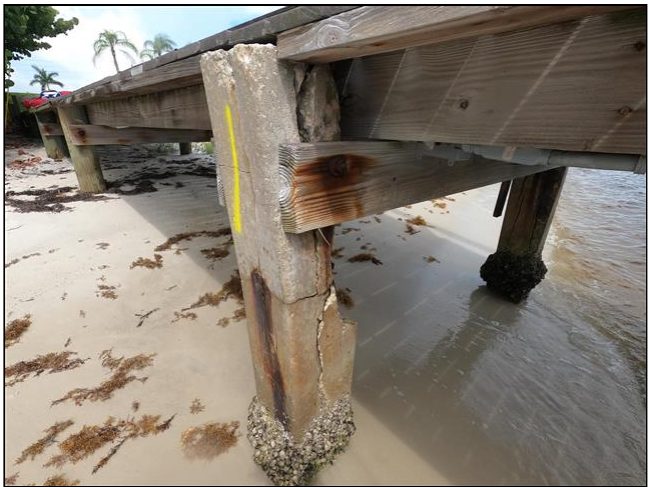
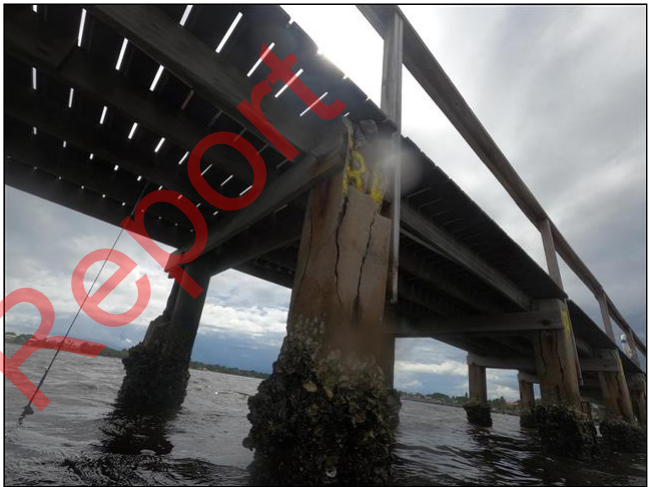
The beams are the underlying support to the deck planks. This composite deck boards are attached to three beams which are made of pressure treated marine lumber. Inspector found no deficiencies with the condition of the beams at the time of the inspection.

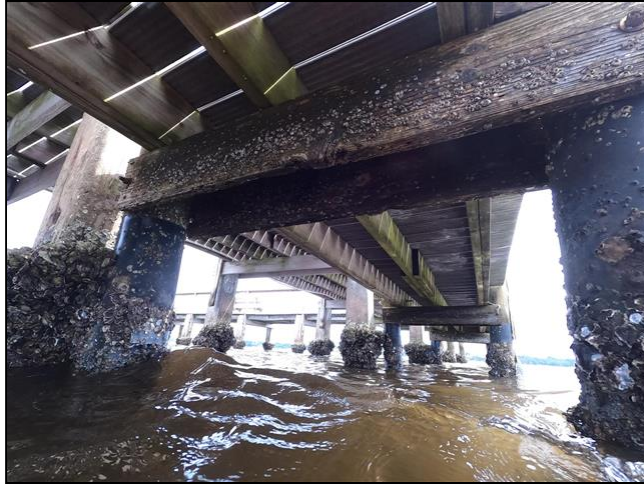
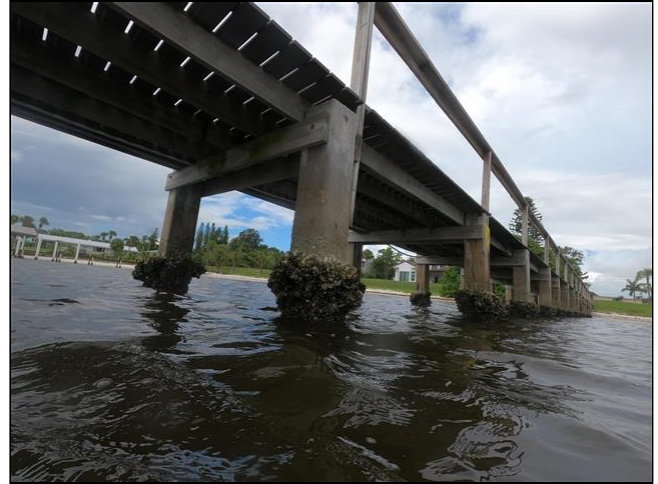
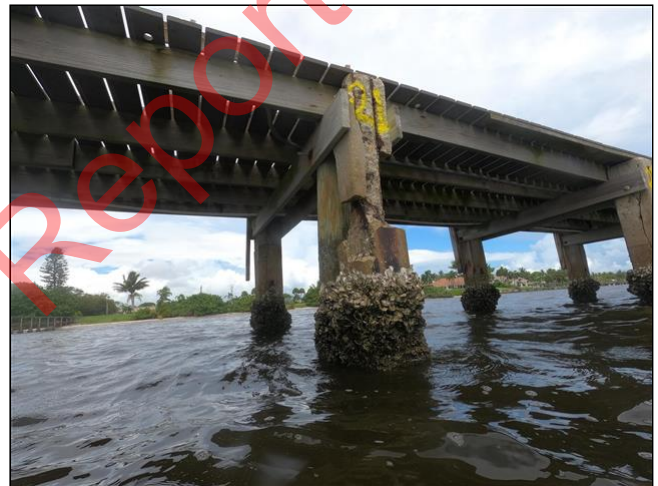
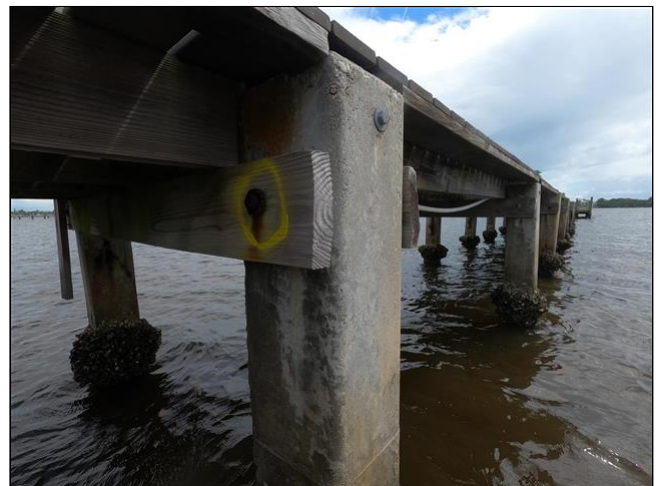
The beams are further supported by wood joists keeping the deck high from the water. Inspector found minor levels of deterioration of the wood joists caused mainly by corroded fasteners. The wood joists are in serviceable condition at this time.

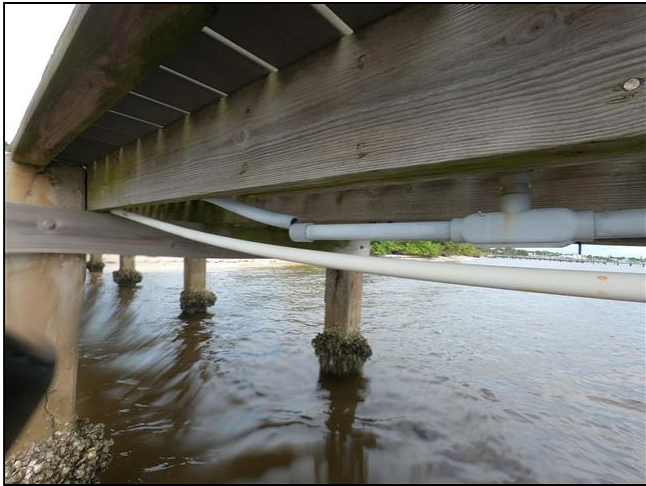
1.7 Item 1 (Picture)

The plumbing supply at the dock was poorly secured and it can break at any time. If it breaks you could loose a lot of water. Recommend securing the plumbing as soon as possible to prevent unexpected water loss.
