# Dock Inspection Report

**Mrs. Bonnie Guenther**  
**Conquistador Homeowner's Association**

**Property Address:**  
1800 SE St Lucie Blvd  
Stuart FL 34996

July 17th, 2021

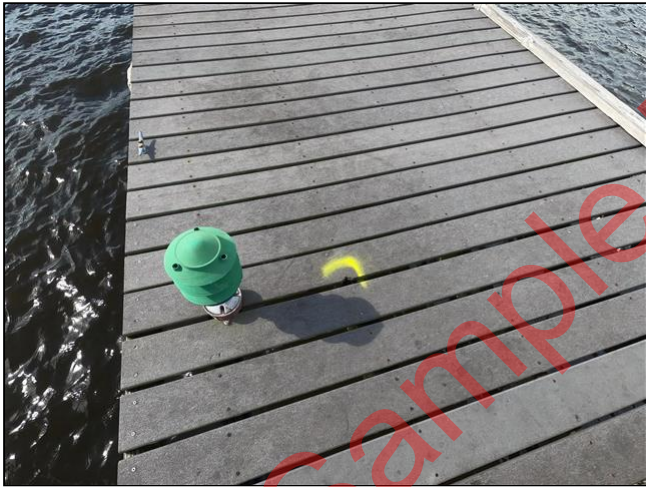
1.8 Item 1 (Picture)

Some dock lighting was not functional at the time of the inspection. Recommend repairs.

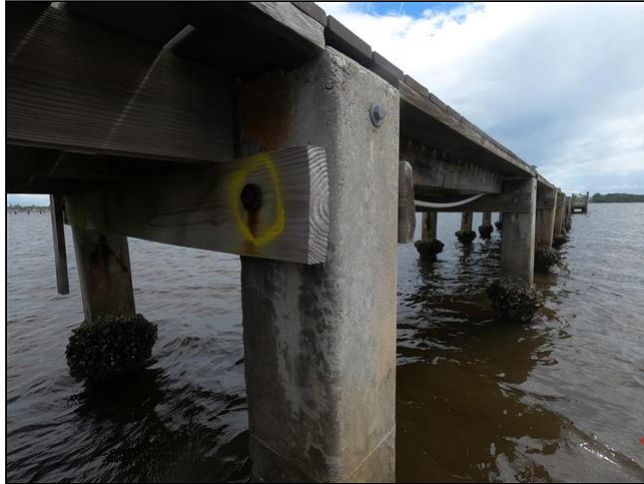
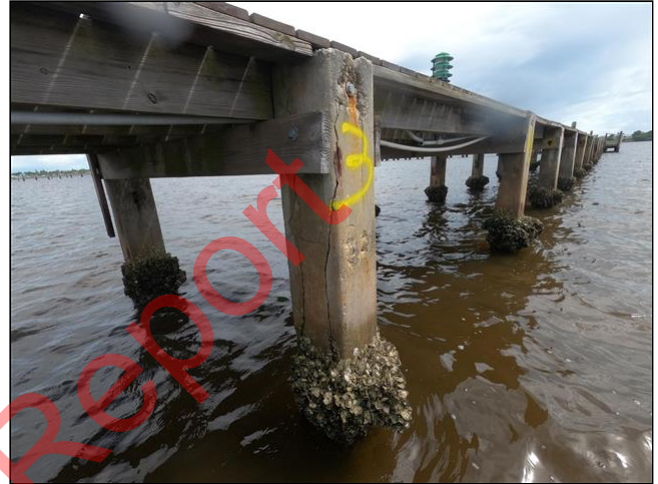
The joists are tied to the concrete piles with galvanized steel hardware such as nuts and bolts. Despite being galvanized, they don't last forever and will corrode. Several nuts and bolts were in advanced stage of deterioration and will need to be replaced.

Also, the beams were never strapped to the wood joists. When the beams are secured with straps or clips, you can maximize the ability of the dock to withstand the effects of strong force winds and wave action. Recommend that all beams be secured or re-enforced with stainless steel straps after you replace the damaged concrete piles.
