# General Home Inspection Report

**Property Address:**

2280 W Silver Palm Rd  
Boca Raton FL 33432

**Certified Inspectors, LLC**

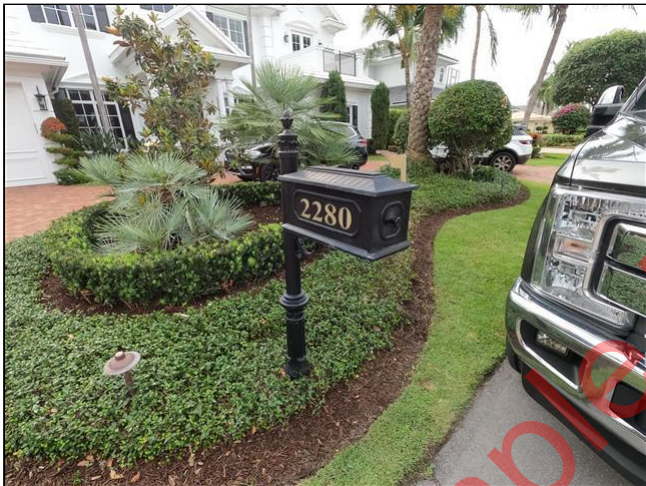
3.0 Item 1 (Picture)

The building site was relatively level and flat. Inspector found some poor ground cover or dying grass in some areas of the home. Recommend evaluation by professional landscaper.

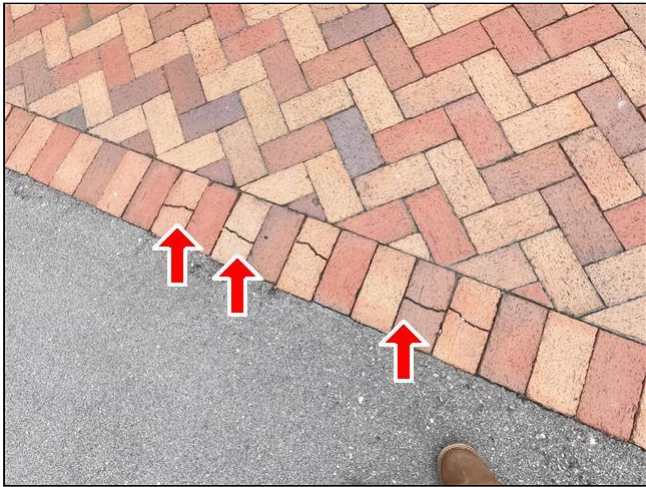
3.2 Item 1 (Picture)

Some pavers were cracked in the driveway.

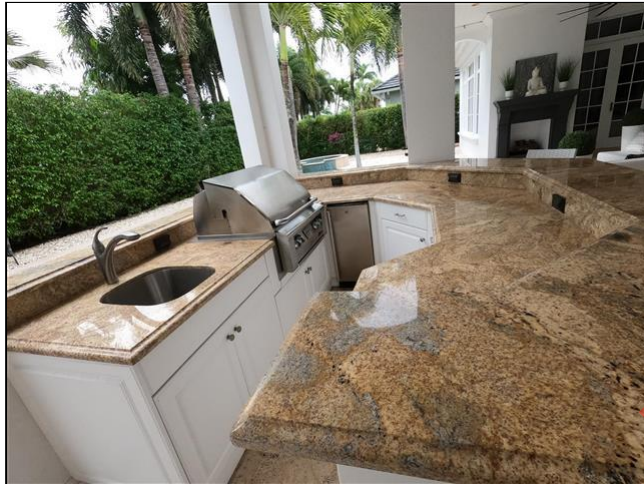
3.9 Item 1 (Picture)

Inspector found several deficiencies with the condition of the outdoor kitchen:

1. The grill lighter was not functional. You have to light up the grill manually.
2. The cabinetry exhibited minor deterioration in several areas.
3. The counter had missing ground along the edges of the backsplash.
4. The small refrigerator and the grill had minor signs of corrosion.

Recommend repairs.

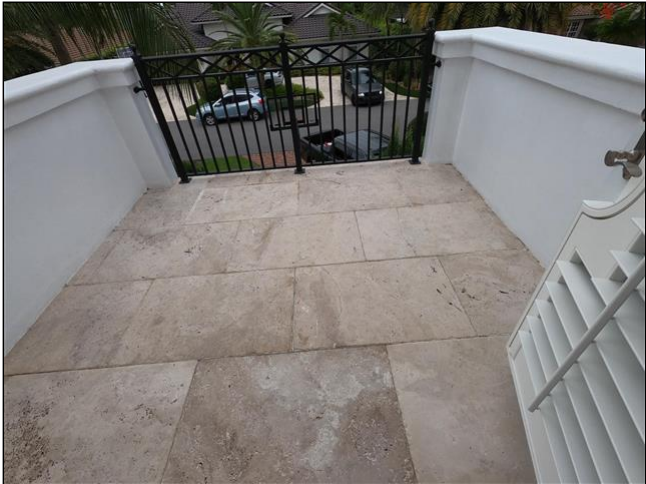
3.11 Item 1 (Picture)

The railings of the balconies in the rear of the home were loose. This is a major safety hazard that needs to be corrected immediately.

Another section of railing was held by corroded screws. The corrosion is staining the walls below. Recommend repairs.

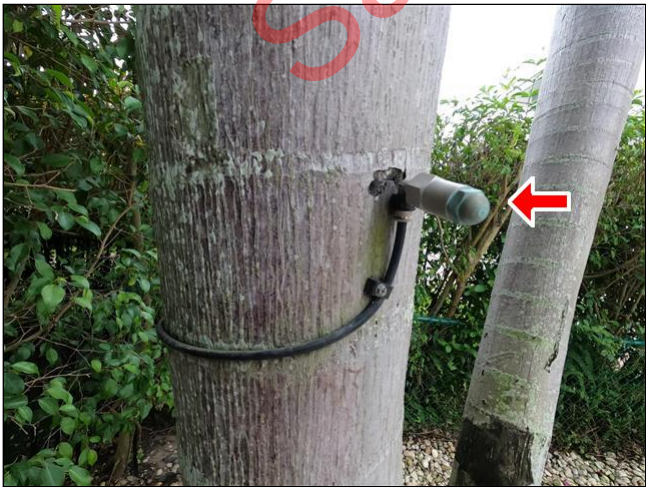
3.12 Item 1 (Picture)

The MosquitoNix Misting System was not functional. Inspector attempted to run the system but it did not respond. Recommend repairs.

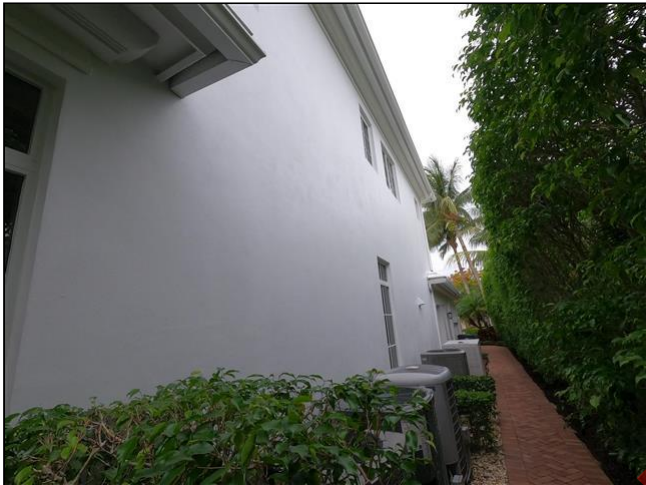
4.0 Item 1 (Picture)

The Inspector observed no deficiencies in the condition of Stucco covering exterior walls. However, there is a rust stain coming from the corrosion of the screws used to hold the railings upstairs. Recommend repair.

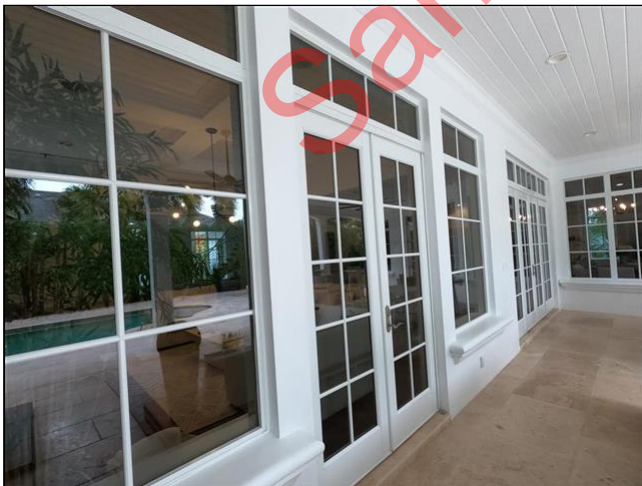
4.2 Item 1 (Picture)

Some windows has started to deteriorate the caulking. Recommend repairs.

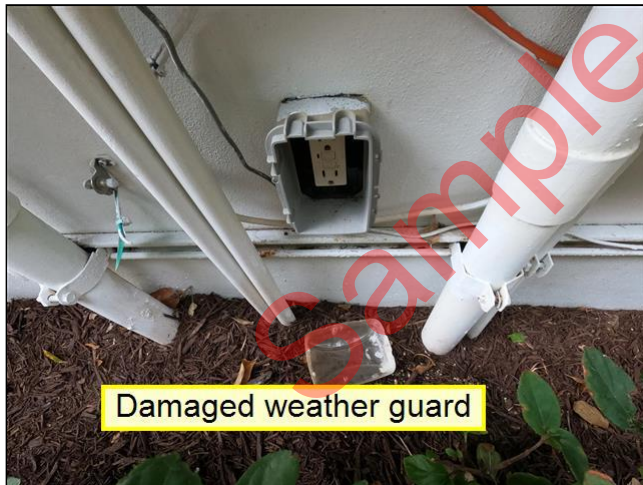
6.12 Item 1 (Picture)

Some exterior conventional electrical receptacles were inoperable at the time of the inspection and should be replaced by a qualified electrical contractor. One receptacle had a broken weather guard. The Inspector recommends that all exterior electrical receptacles be provided with ground fault circuit interruptor (GFCI) protection for safety reasons.

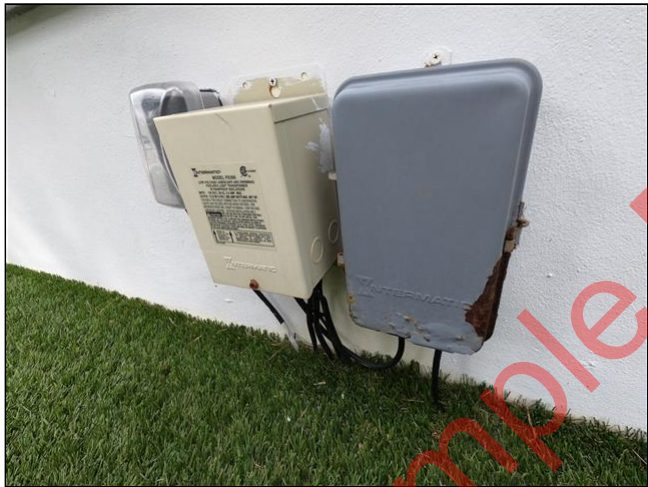
6.17 Item 1 (Picture)

Several landscape lighting was not functional. Recommend repairs by qualified contractor.

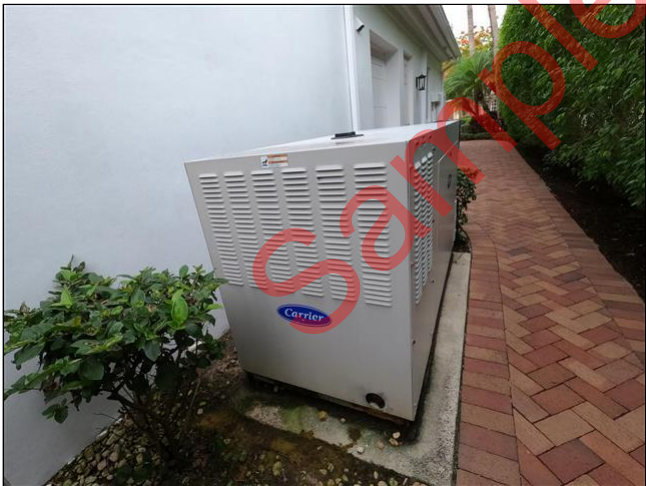
6.21 Item 1 (Picture)

The home was equipped with a Carrier Whole House Generator. It appears that the generator is a 48 Kw unit capable of powering the entire home. The Generator was tested at the time of the inspection and it was functional. However, the generator exhibited a slow start at the time of the inspection. The battery appears to be bad. According to the homeowner, the generator is not being professionally maintained. Recommend you contract with a generator company that can service the unit regularly. Watch the video on Youtube.

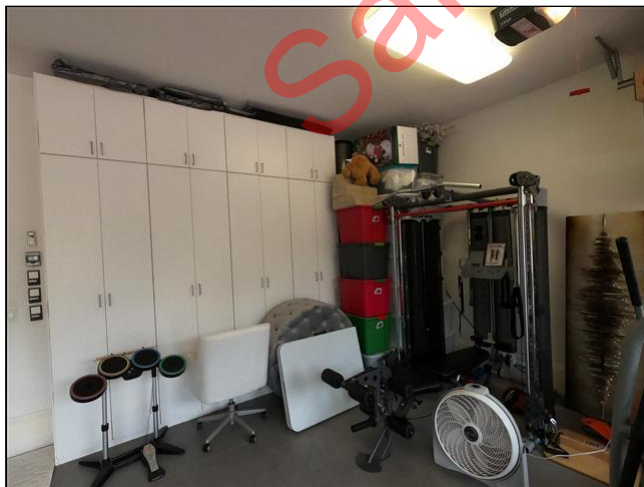
7.9 Item 1 (Picture)

The cabinets in the garage exhibited moderate levels of deterioration typical of a garage.

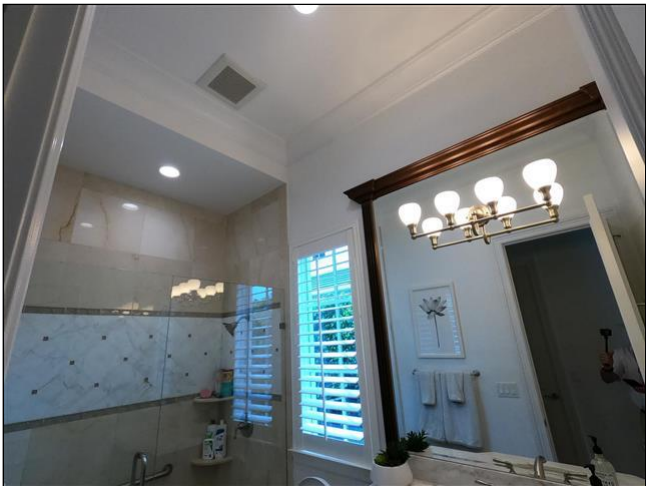
12.5 Item 1 (Picture)

A light fixture in the two guest bathroom did not respond to the switch. The bulb may need to be replaced or there may be a problem with the switch, wiring or light fixture. If after the bulb is replaced this light still fails to respond to the switch, this condition may represent a potential fire hazard and the Inspector recommends that an evaluation and any necessary repairs be performed by a qualified electrical contractor.

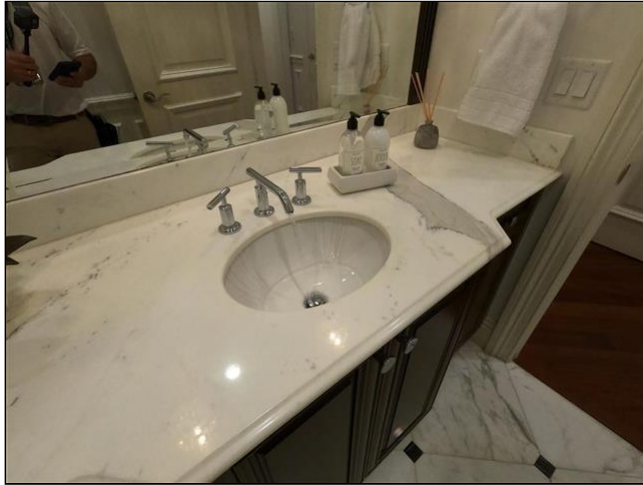
12.7 Item 1 (Picture)

Cabinets in the bathrooms exhibited minor general deterioration commensurate with the age of the home.

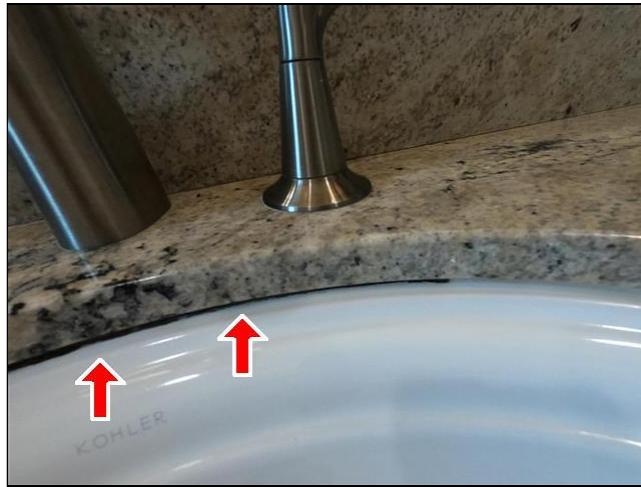
12.11 Item 1 (Picture)

The plumbing fixtures on the bathrooms had functional flow and functional drainage at the time of the inspection. However, the grout line of the sink was missing. recommend re-grout the area.

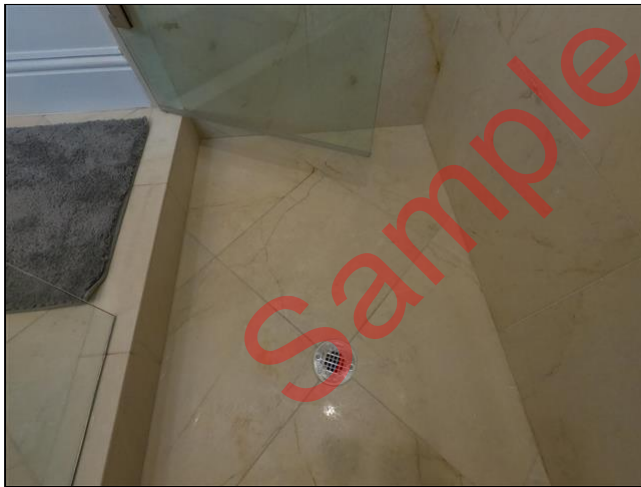
12.12 Item 1 (Picture)

The glass partition in the master bathroom was poorly installed and it is loose. Recommend you discuss options with a qualified contractor and repair as needed.

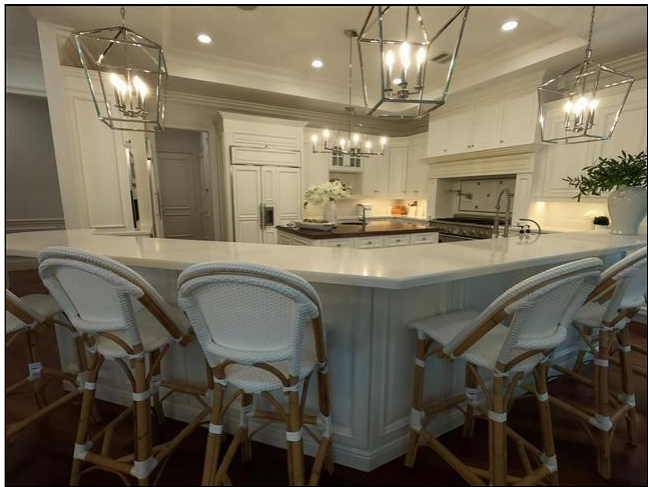
13.5 Item 1 (Picture)

The kitchen cabinets exhibited minor general deterioration commensurate with the age of the home.

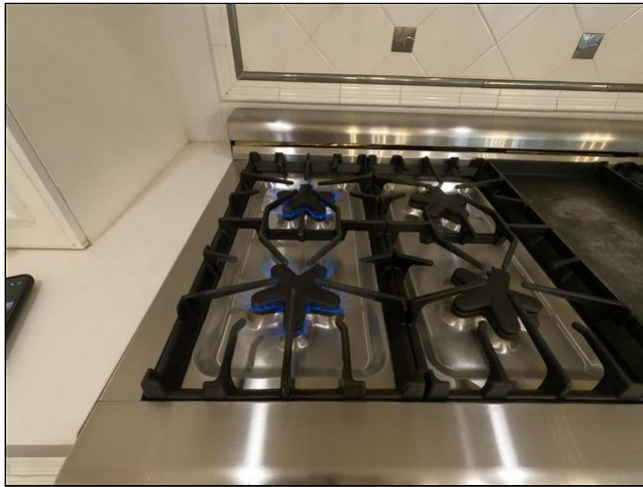
13.8 Item 1 (Picture)

One or more cooktop gas burner failed to ignite when tested. The Inspector recommends service by a qualified technician.

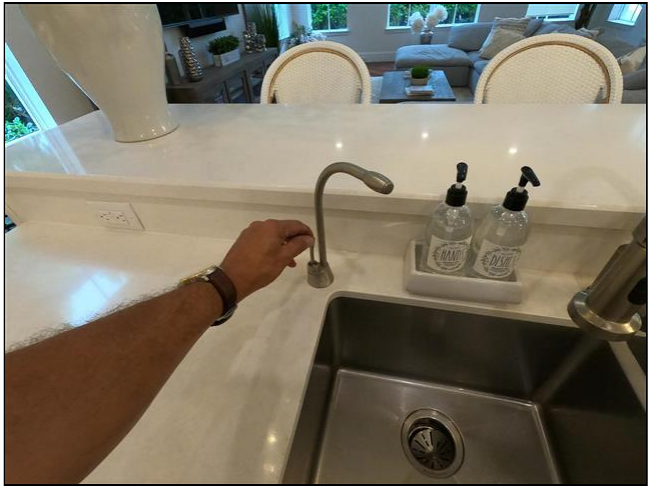
13.16 Item 1 (Picture)

The instant hot Water Heater in the kitchen was not functional. Recommend repairs.

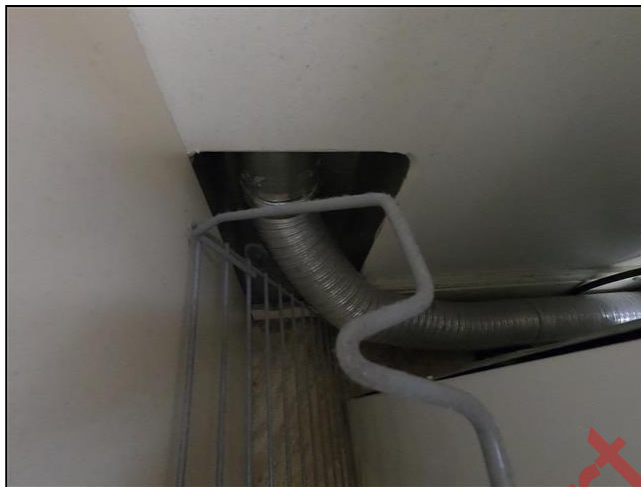
14.4 Item 1 (Picture)

(1) The dryer was vented using an expanding (accordion) vent that is not approved by the Underwriter's Laboratory (UL). This type of dryer exhaust vent is more likely to accumulate lint than a smooth metal vent, creating a potential fire hazard. Excessive lint accumulation can also increase drying time and shorten the dryer's lifespan. The Inspector recommends replacing this plastic vent with a properly-installed, UL-approved dryer vent. All work should be performed by a qualified contractor.

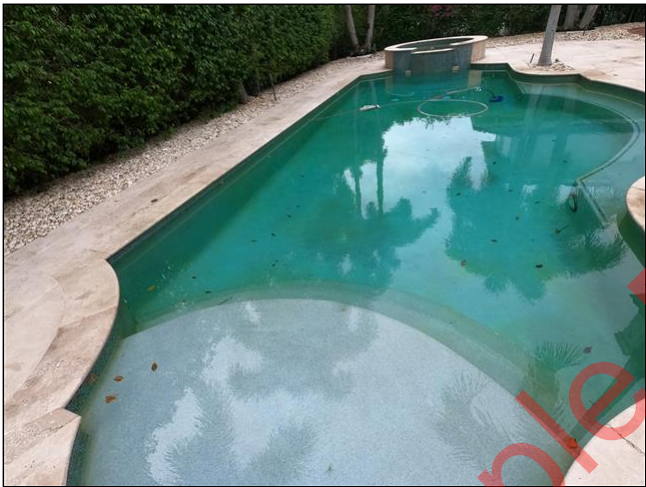
15.1 Item 1 (Picture)

The vessel was constructed of concrete. The pool appeared to have chemical damage resulting in scaling of the portions exposed to water. The Inspector recommends that before the expiration of your Inspection Objection Deadline you consult with a qualified contractor to discuss options and costs for actions that will reduce continuing damage.

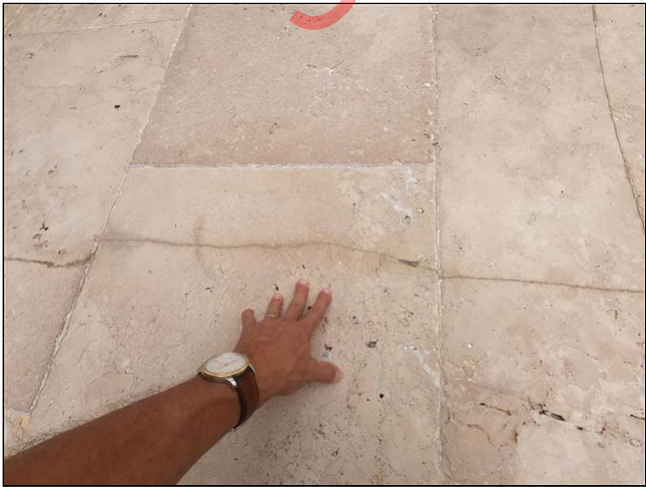
15.2 Item 1 (Picture)

The pool had weathered tile decking. There was one area that had some cracked tiles. Recommend repairs.

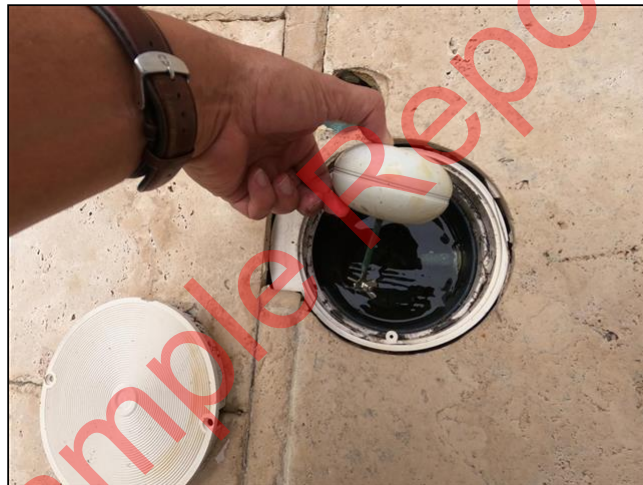
15.6 Item 1 (Picture)

The pool fill was damaged. Recommend repairs.

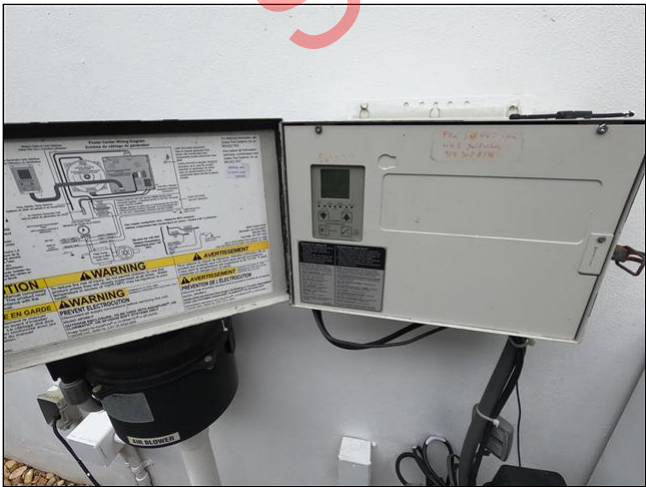
15.8 Item 1 (Picture)

The salt chlorinator was not functional. Recommend repairs.

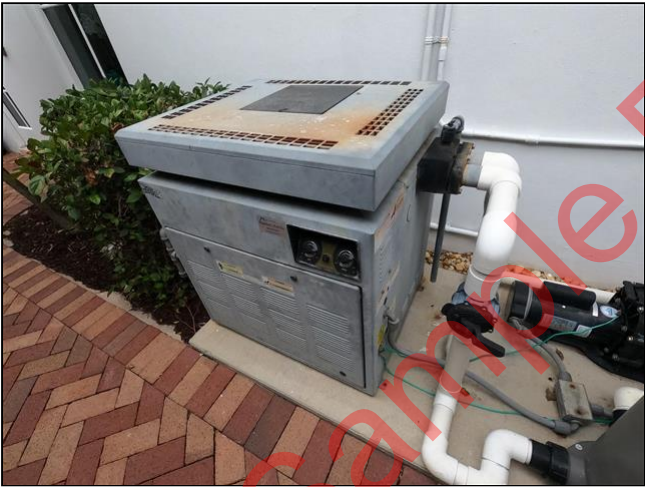
15.10 Item 1 (Picture)

The heater was not functional at the time of the inspection. The burner underneath would not light up. Recommend repairs.

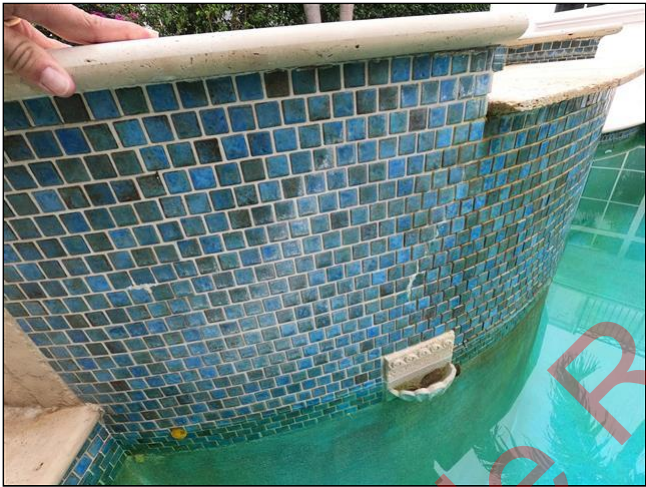
16.0 Item 1 (Picture)

The exterior of the SPA exhibited efflorescence. Recommend repairs. Efflorescence is generally a mineral or salt crystalline compound found in the ground and within concrete that dissolves in moisture that migrates up through the ground and concrete to the tile surface where the moisture evaporates leaving an expansive salt residual.

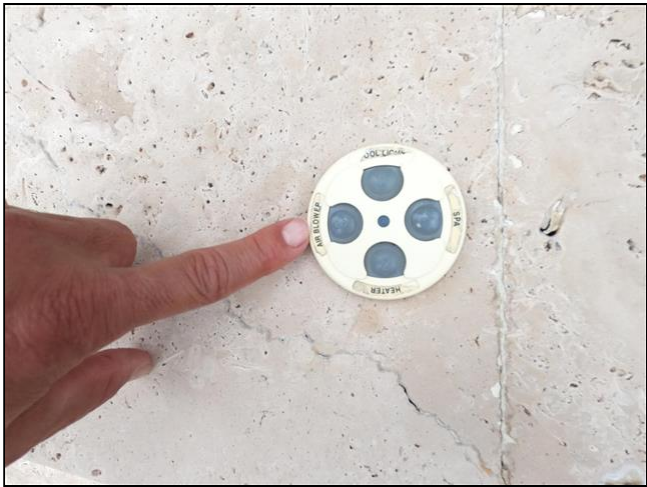
16.7 Item 1 (Picture)

The pool control system was a manual or mechanical type. The SPA can be controlled through a padded switch at the SPA. However, only one out of three buttons worked. Recommend repairs.
