# Home Inspection Report

**Property Address:**

424 NE 5th St  
Boca Raton FL 33432

**Certified Inspectors, LLC**

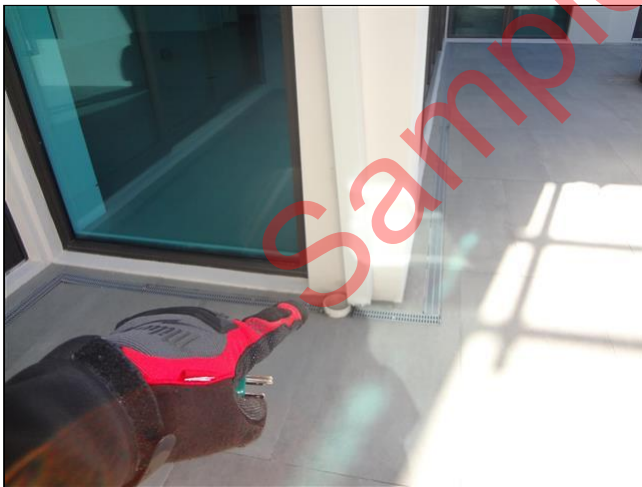
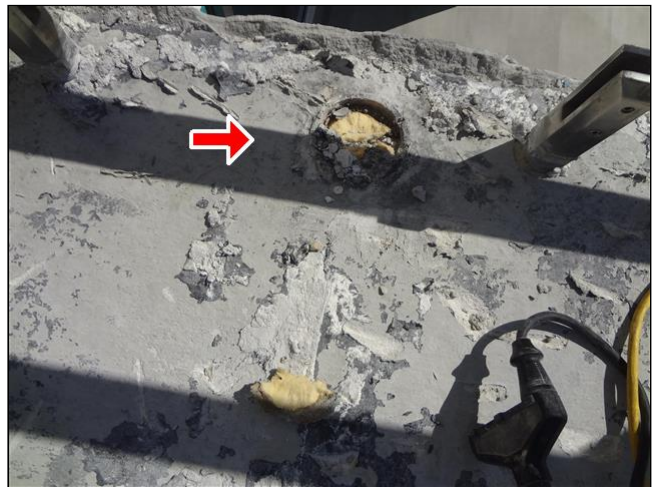
The Inspector observed few deficiencies in the condition of the drainage. One or more downspouts designed to discharge roof drainage was damaged or in disrepair to an extent that may limit its ability to function as designed.

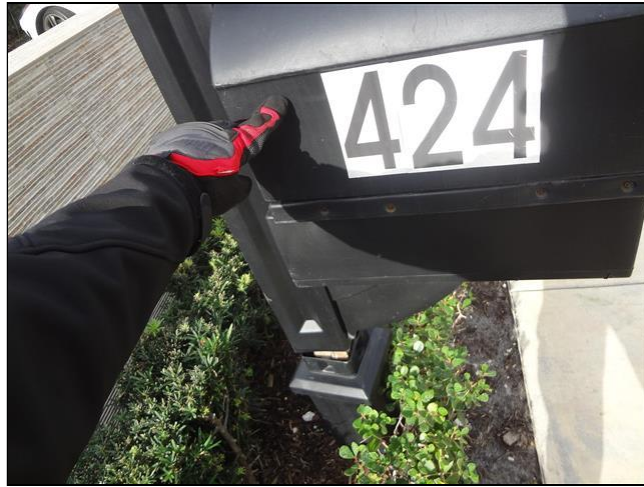
3.8 Item 1(Picture)

The mailbox was poorly secure and will need to be repaired.

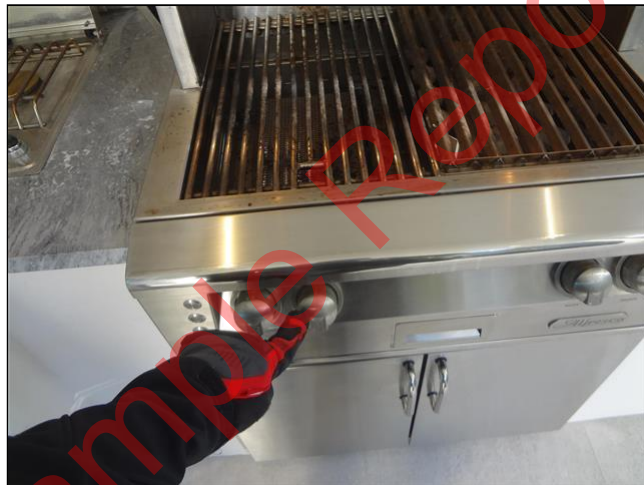
3.9 Item 1(Picture)

The BBQ grill was not working. Other cooking accessories were operating normally except the grill.

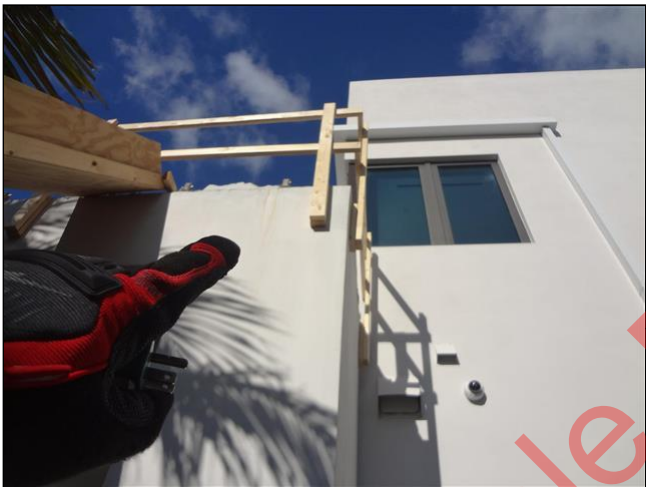
3.11 Item 1(Picture)

Inspector found all 3 balconies undergoing some form of repair. All balcony floors had been removed due to some kind of water infiltration. Determination of the causes of this infiltration lies beyond the scope of a General Home Inspection.

It is inspector's opinion that lack of effective drainage of rain water combined with poor weatherproofing and poor cover installation are the causes of the infiltration. All drains were blocked and the water is forced to drain over the walls below.

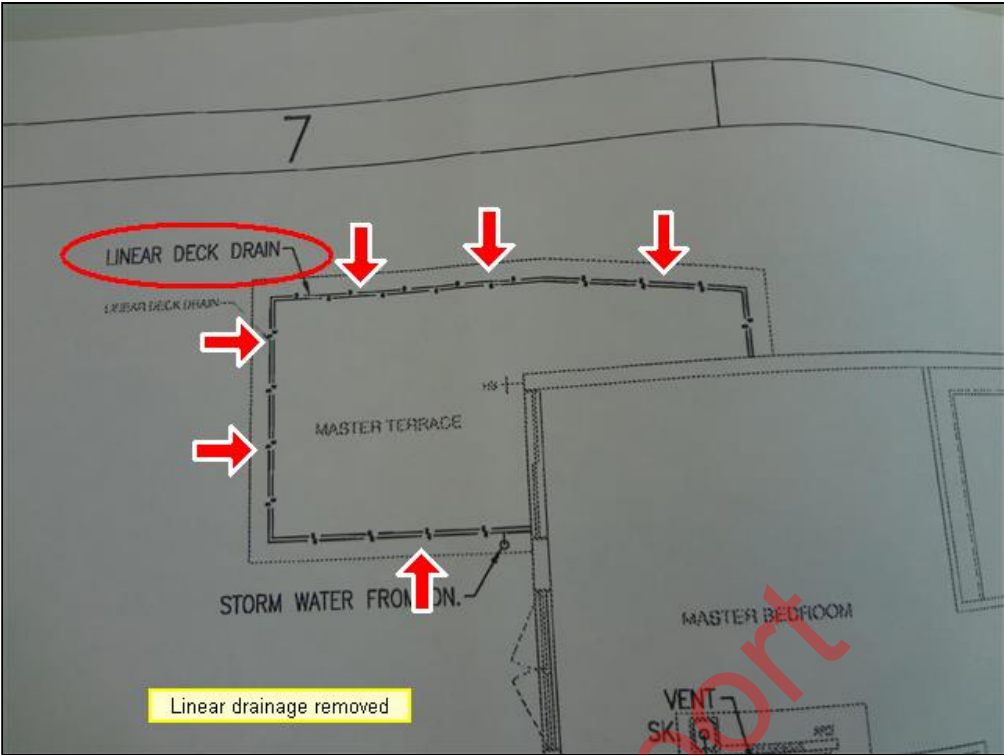
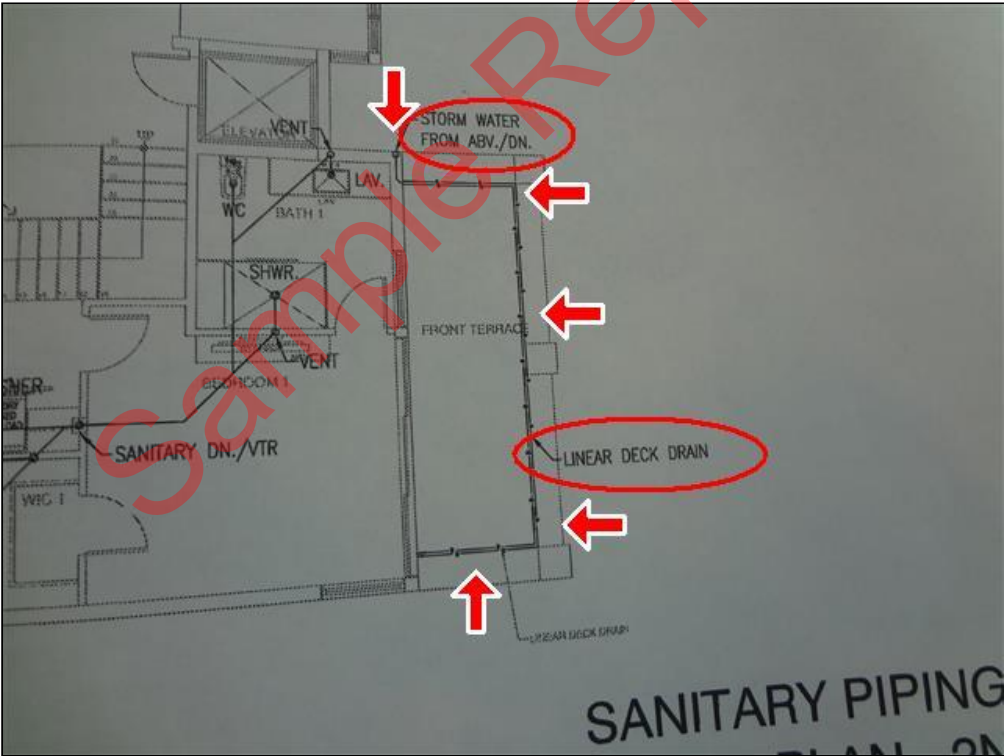
If you look at the plans attached Item 12(Picture) Item 13(Picture) you will see where there should have been a linear drainage system installed at the edge of the balconies. If you don't install effective drainage you may have the same problem in the future or the water will run down the walls and cause other types of problems. You should seek advice from a qualified architect that can design the proper solution to this kind of problem.

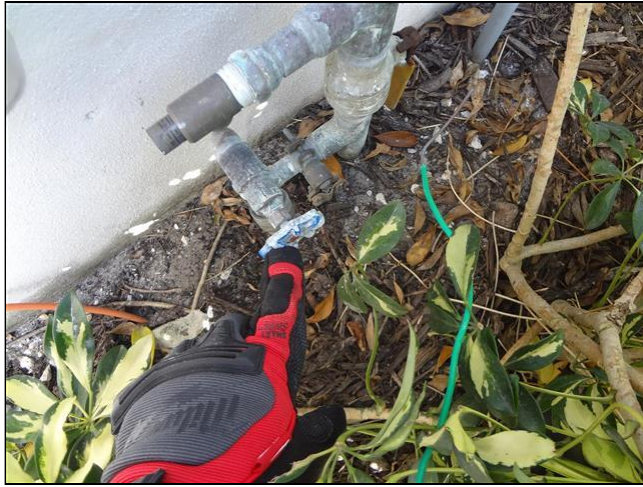
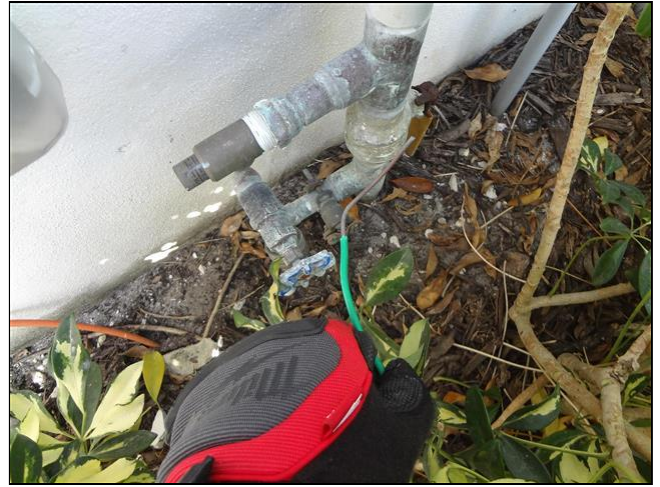
The main water supply pipe served as the grounding electrode for the home electrical service. The grounding wire was disconnected at the time of the inspection. Recommend repair.

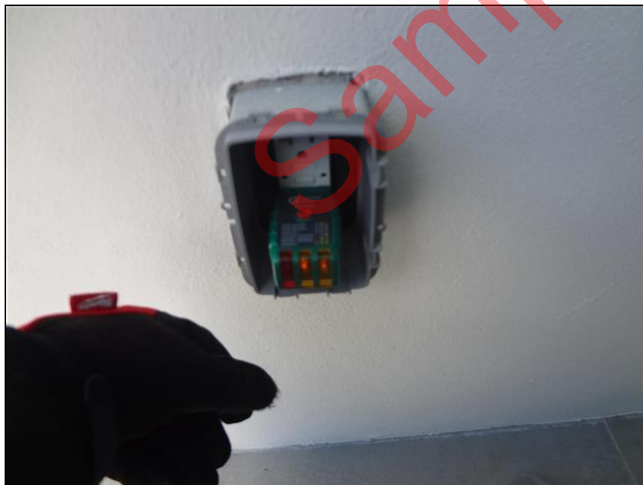
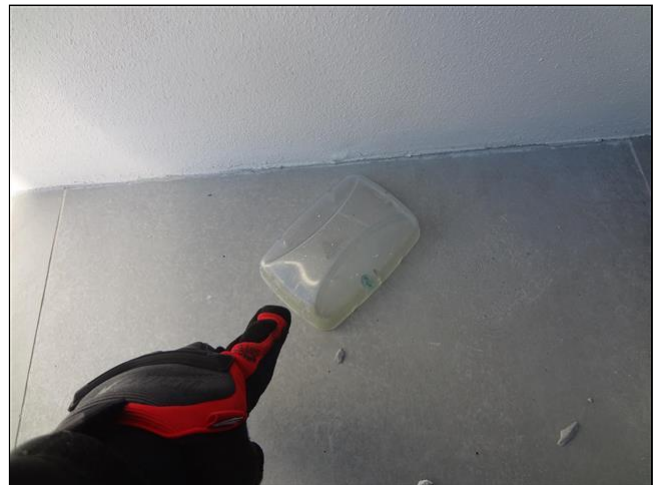
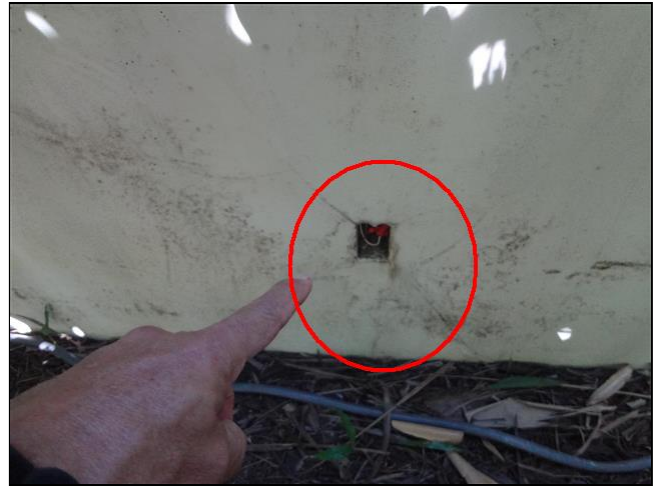
One exterior GFCI outlet at the BBQ area had a broken weather protective cover.

The Inspector recommends repairs by a qualified electrical contractor.

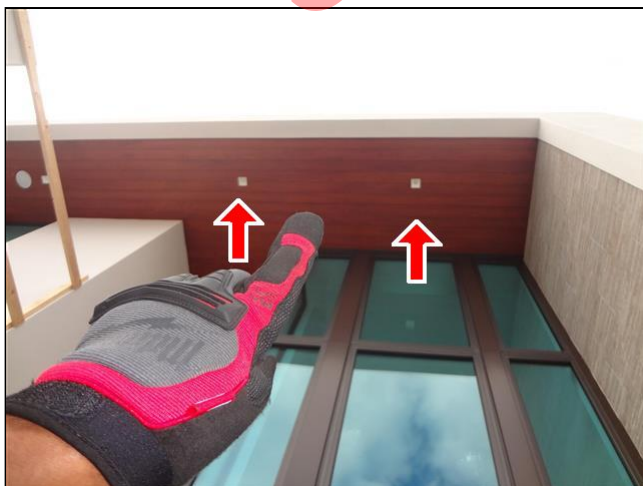
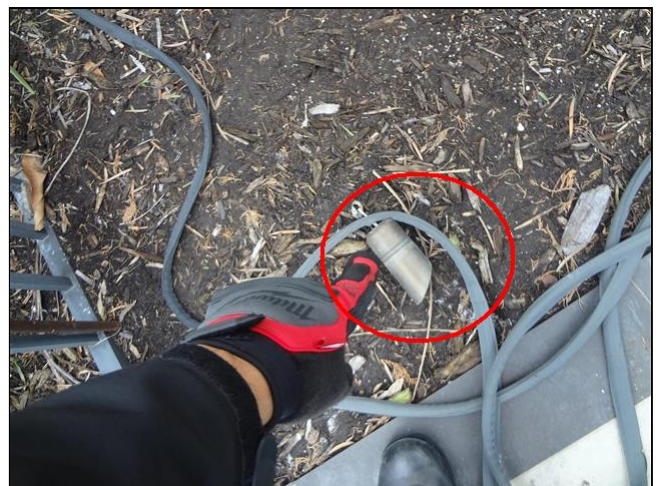
Landscaping lighting was set on a timer and inspector was unable to verify functionality. Some landscaping lighting was damaged. The timer cover was damaged.

One of the light fixtures in the garage did not respond. Recommend repairs.

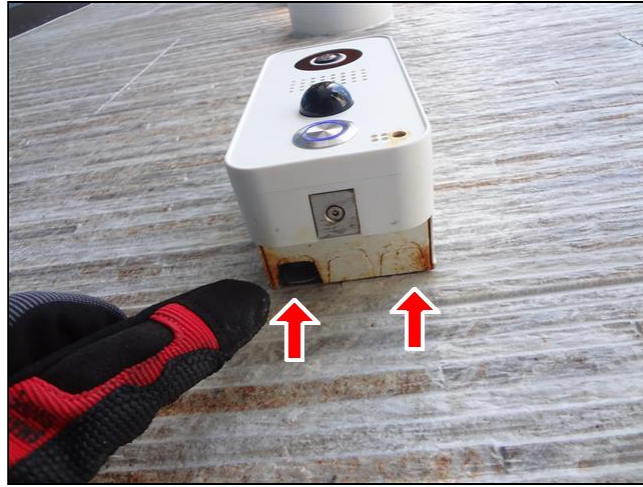
6.18 Item 1(Picture)

The doorbell responded to the switch at the time of the inspection. However, the door bell was getting significantly corroded.

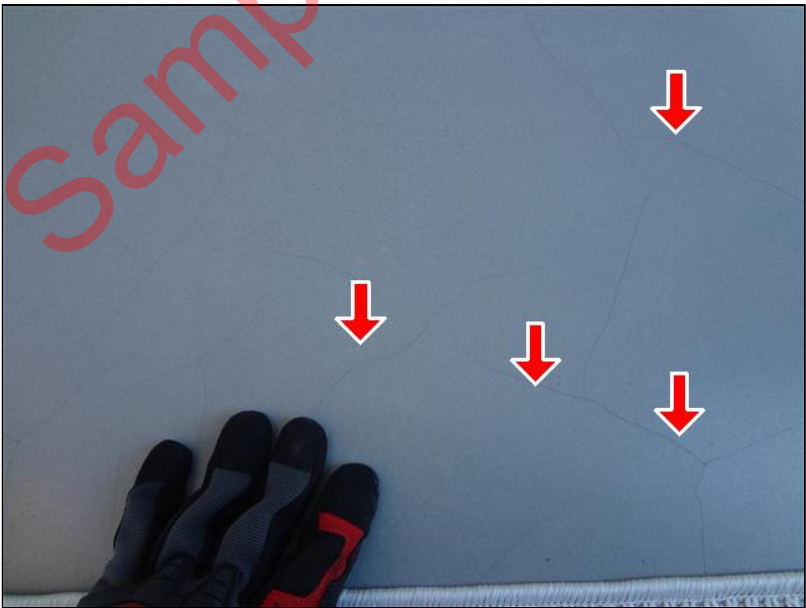
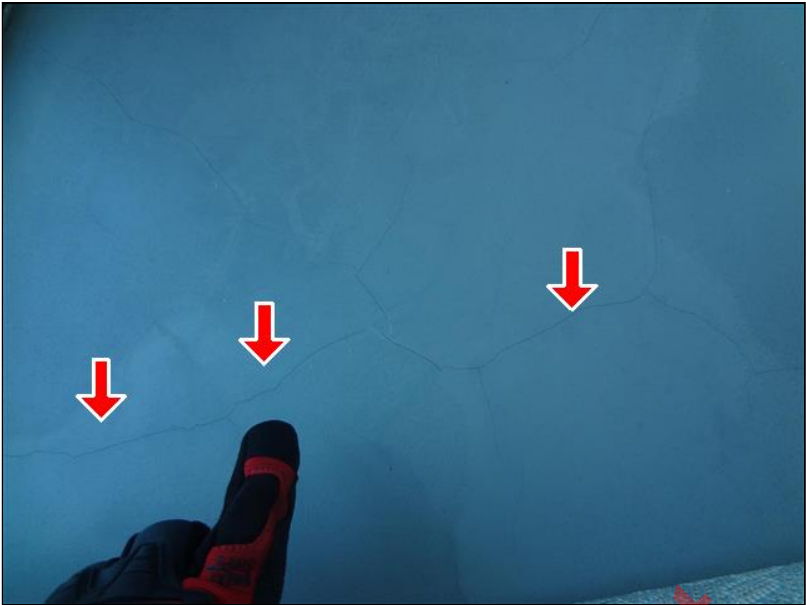
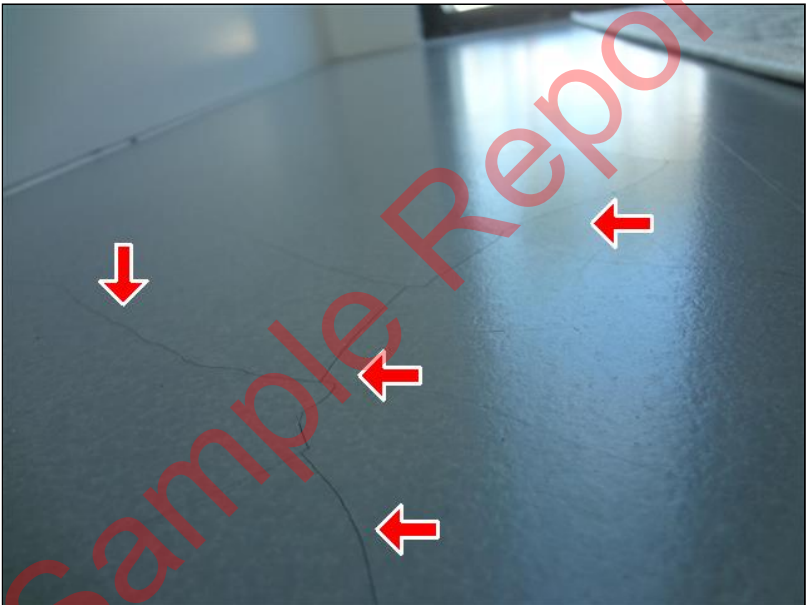
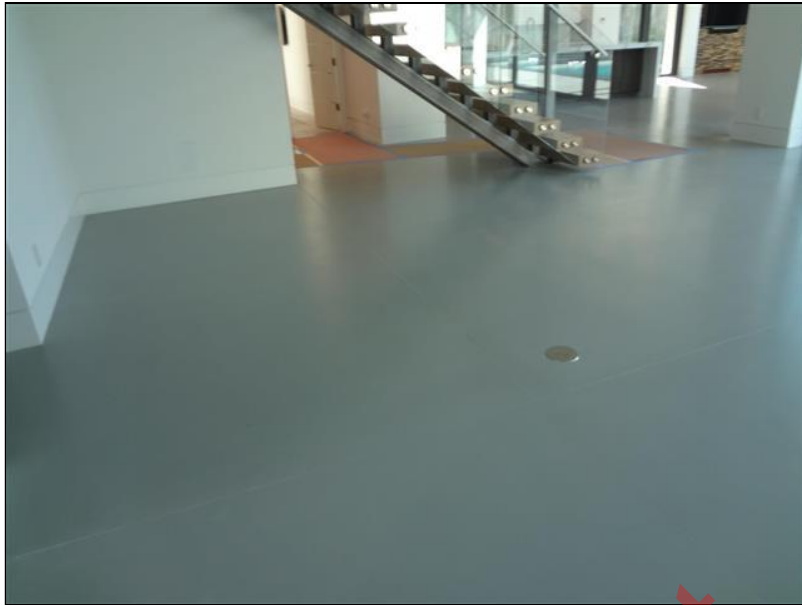
The flooring downstairs was made out of polished concrete covered with some form of finish. The finish was all cracking. The cracks don't appear to be slab related. Recommend asking the owner what kind of material was installed.

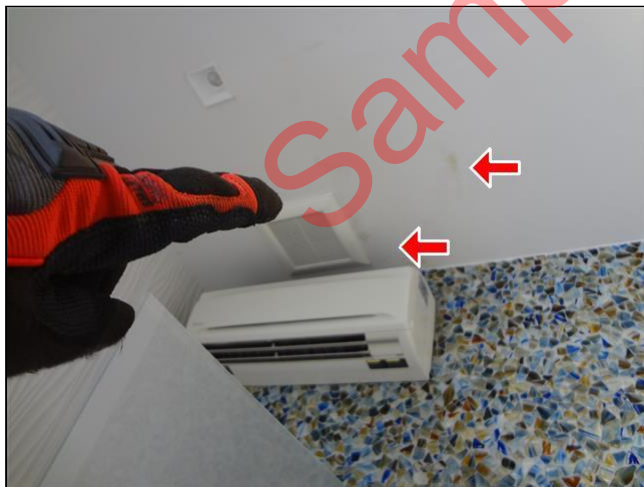
8.2 Item 1(Picture)

The ceiling in the cabana bath exhibited general moderate damage or deterioration at the time of the inspection. It appears that the condensation is being caused by the mixture of cold air around the AC in an environment which is constantly hot and humid air. Recommend repairs and possibly modification on the design as to prevent future problems such as mold.

Inspector also found a hole in the ceiling in the cabana. Recommend repairs.

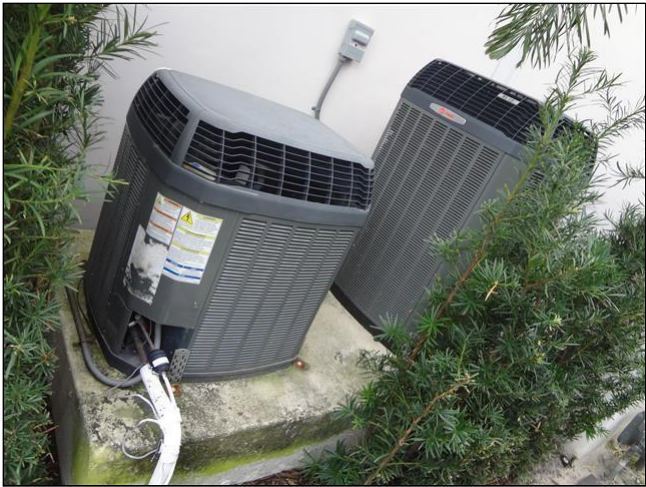
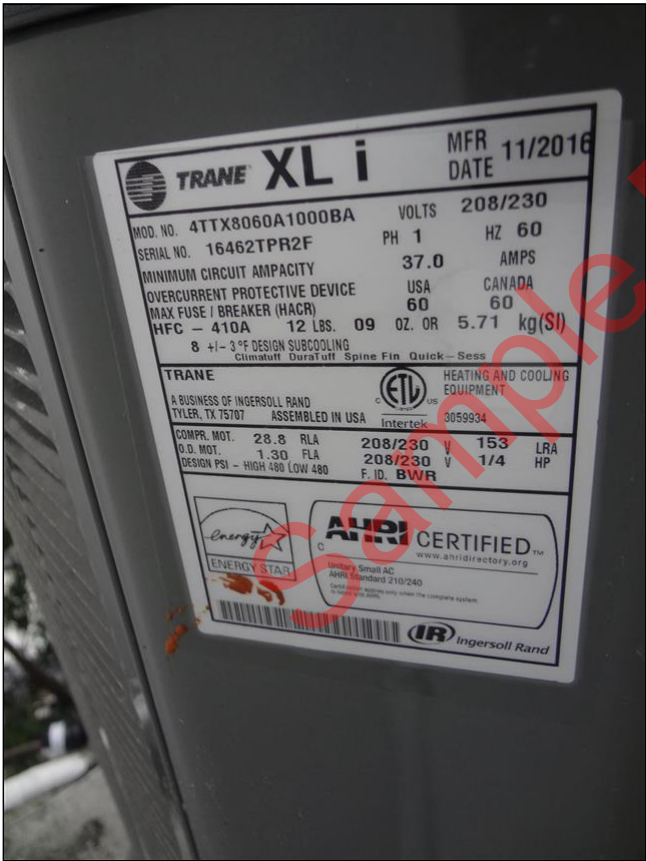
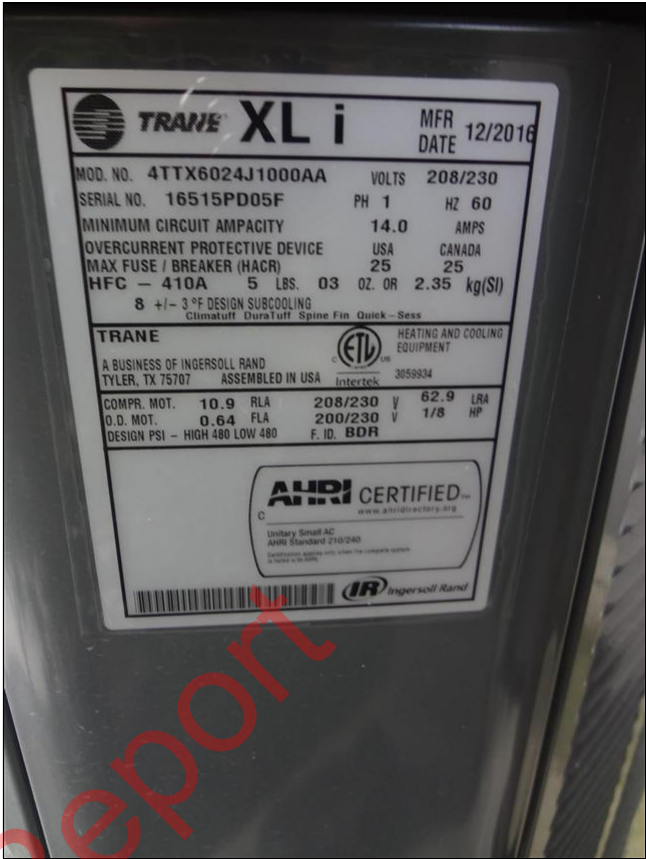
The DIKIN Compressor had a grill that was loose. Recommend repairs.

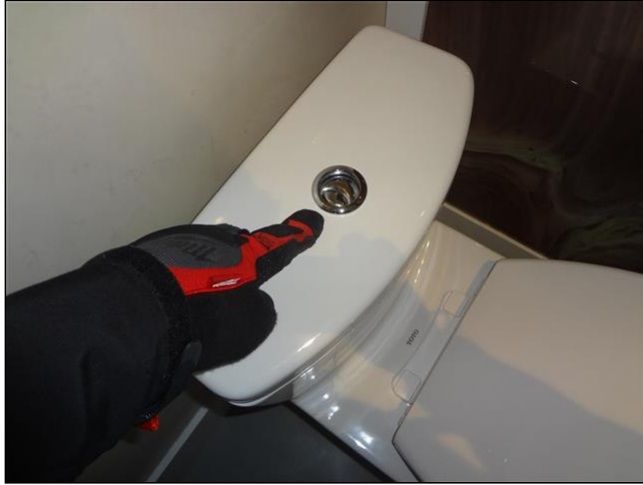
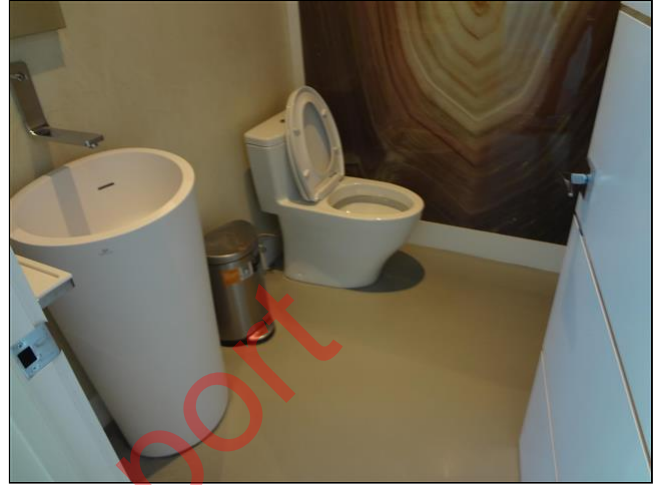
One of the guest bathrooms (1/2 baths) downstairs had a toilet that was malfunctioning. The push button was getting stuck. Recommend repairs.

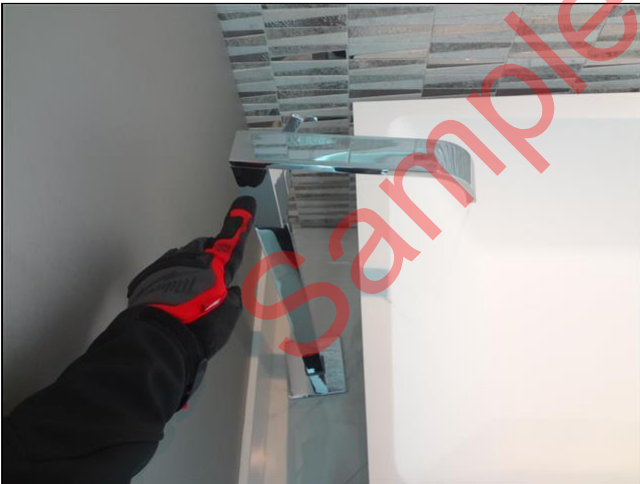
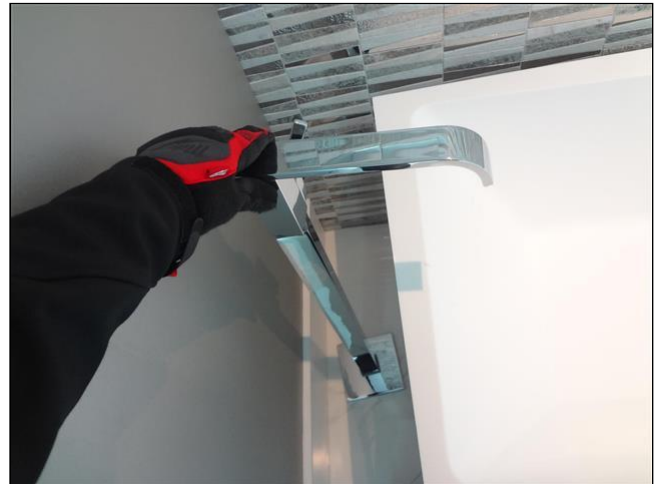
The master bathroom tub faucet was not properly secure. Recommend repairs.

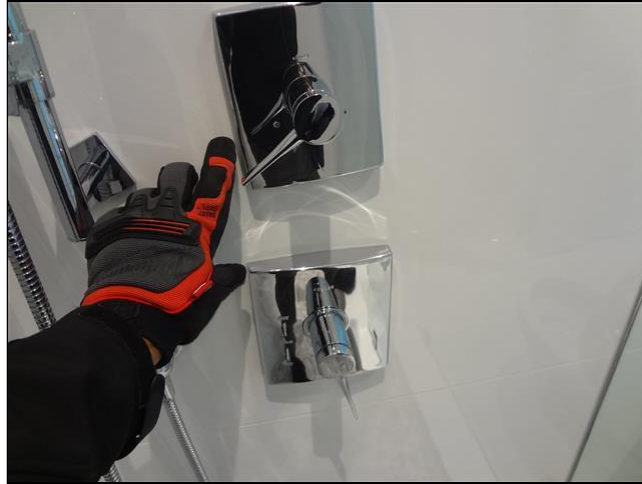
12.11 Item 1(Picture)

The shower in the bathrooms had functional flow and functional drainage at the time of the inspection. One upstairs show had valve covers that were not properly installed and they can be moved with the slightest movement of hand. Recommend repairs.

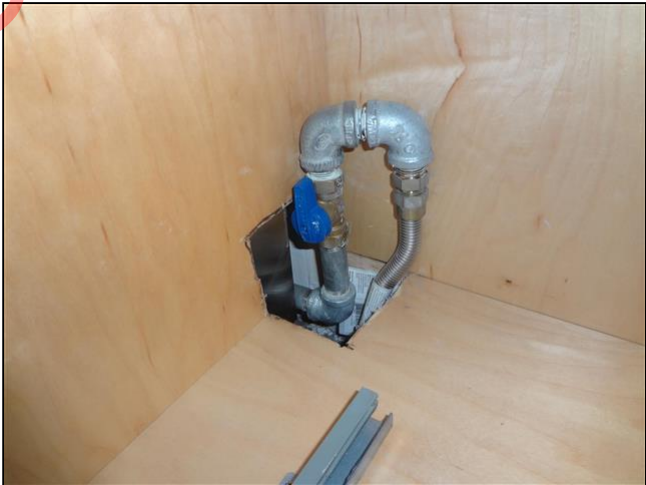
13.3 Item 1(Picture)

A kitchen cabinet had an opening for the gas plumbing. This is perfect entry point for pests. Recommend repairs to seal this area an prevent bugs.

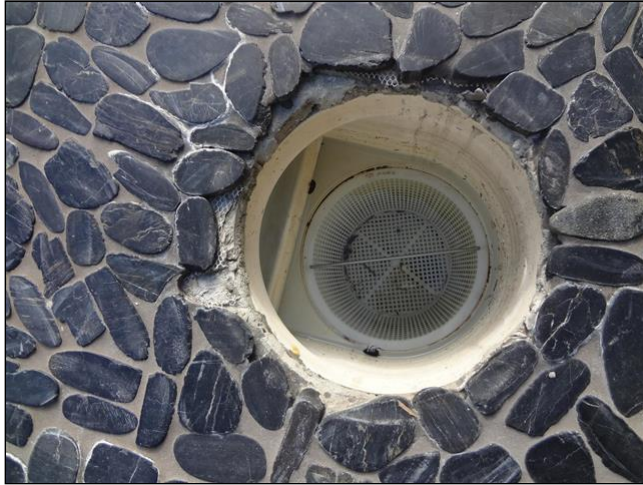
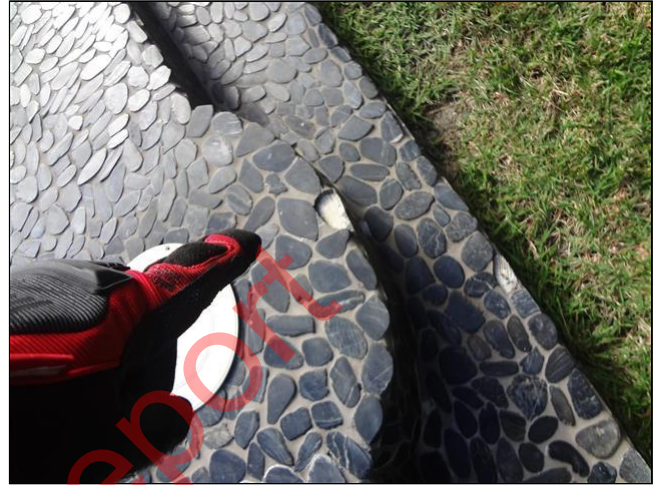
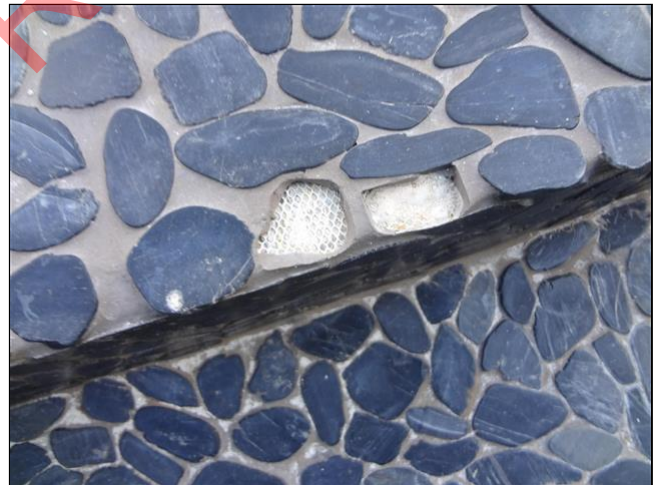
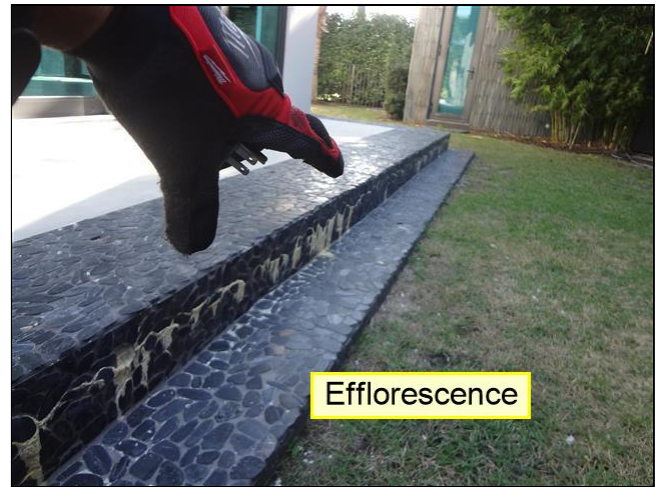
There was significant amounts of efflorescence around the pool deck. Efflorescence is the migration of a salt to the surface of a porous material, where it forms a coating.

The Inspector recommends removal and replacement by a qualified contractor.

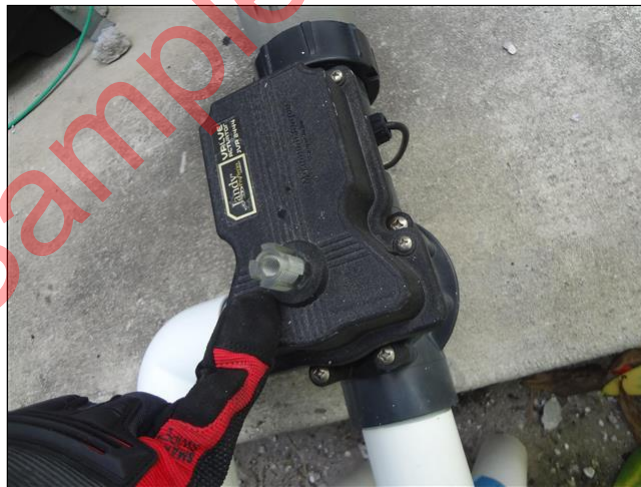
15.13 Item 1(Picture)

One of the actuators missing the handle. Recommend repairs.
