# Seawall Inspection Report

## Waterside on the Intracoastal

**Property Address:**  
2881 NE 32nd St  
Fort Lauderdale FL 33306

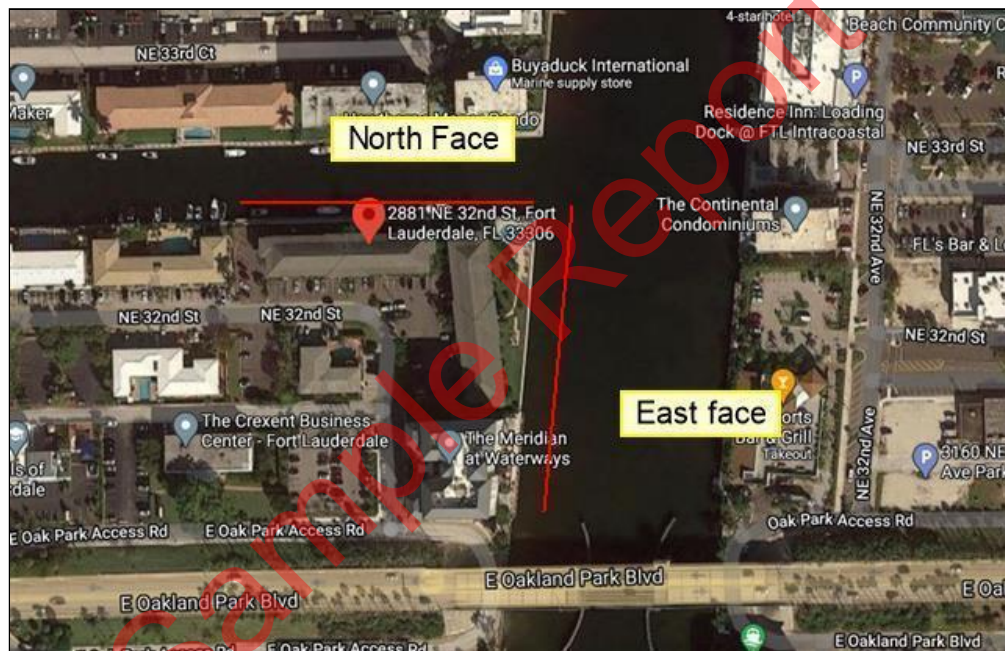
1.0 Item 1(Picture)

Waterside on the Intracoastal is located on a busy waterfront corner off of the main "intracoastal waterway" in Fort Lauderdale, approximately 500 lineal feet North of the E Oakland Park Blvd bridge. The corner is bordered on the North face by a finger canal and on the East face by the main intracoastal waterway. Item 1(Picture)

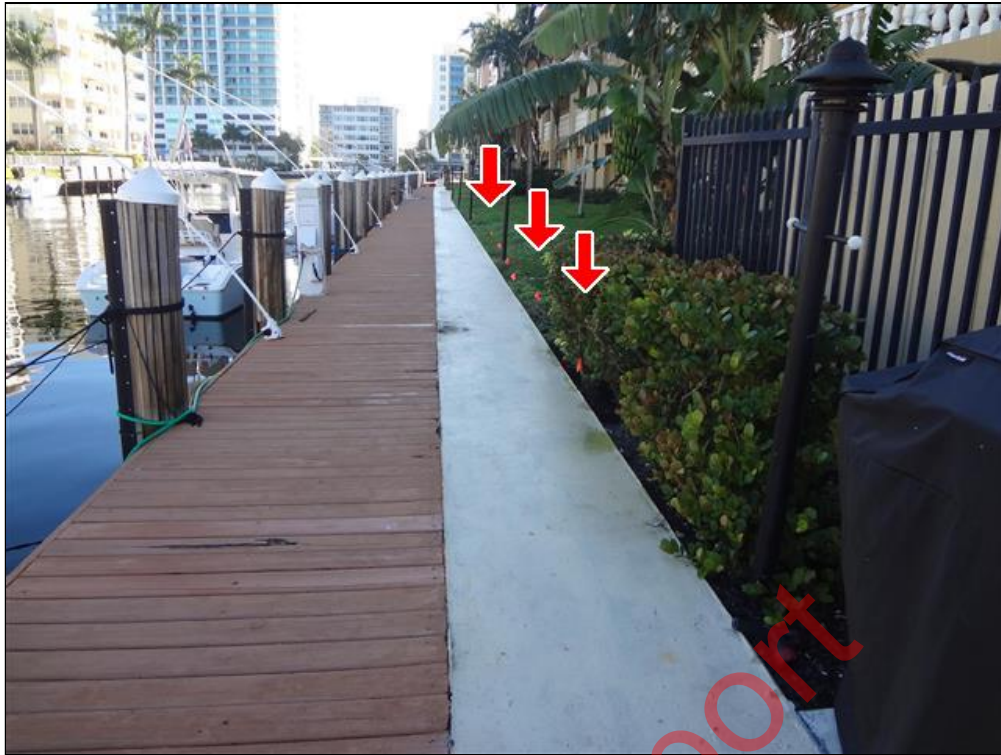
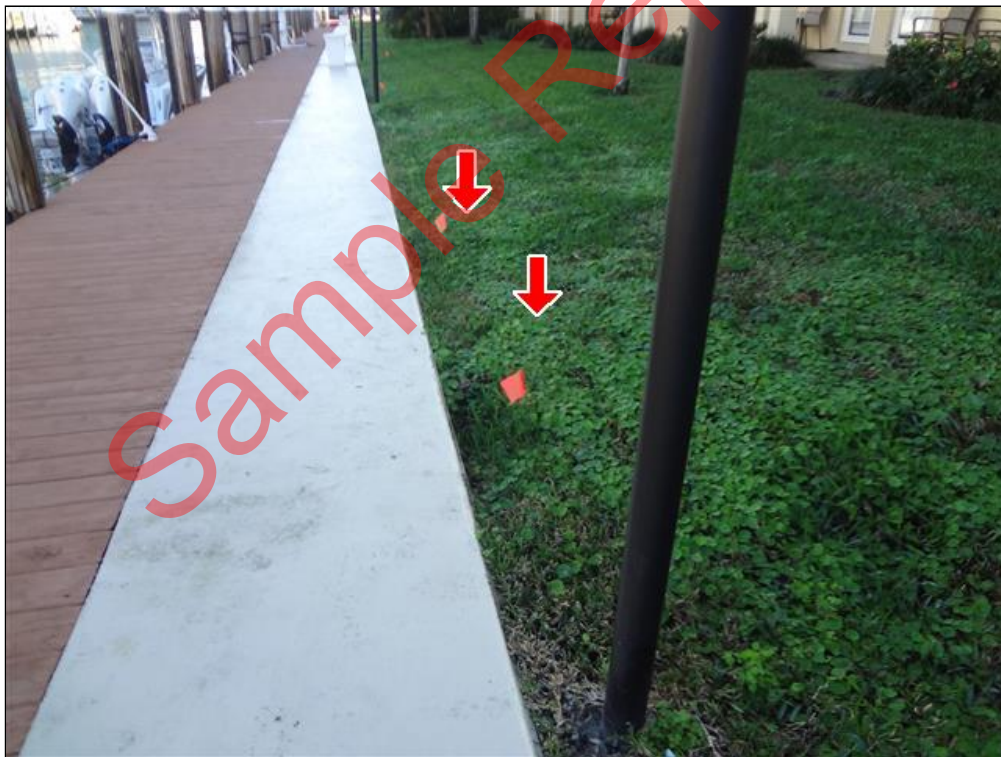
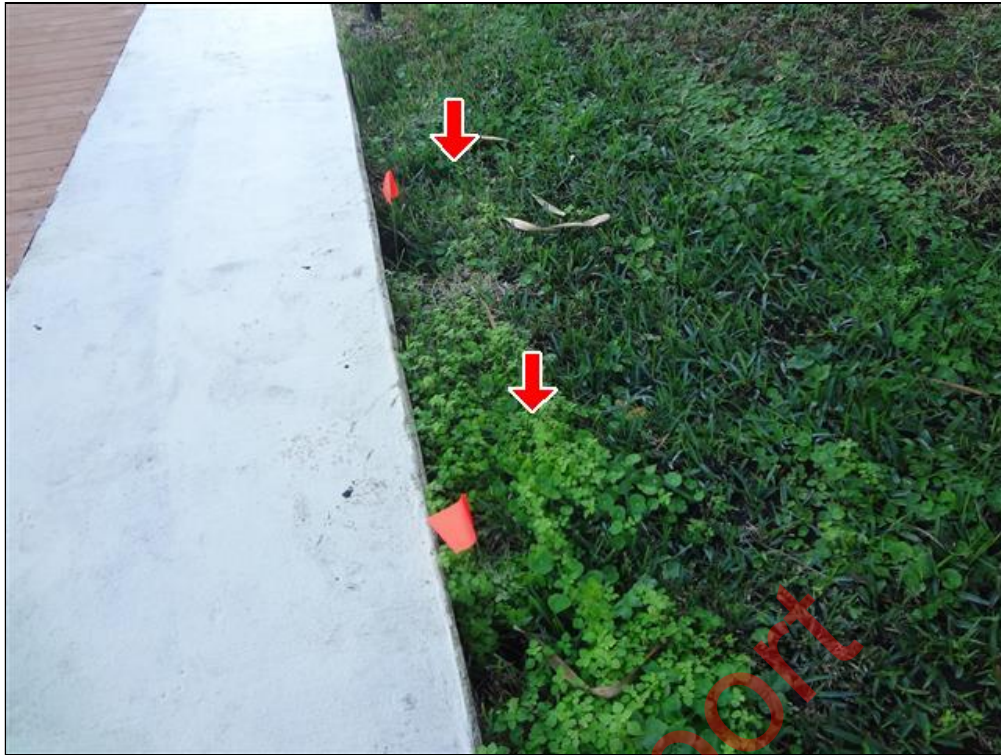
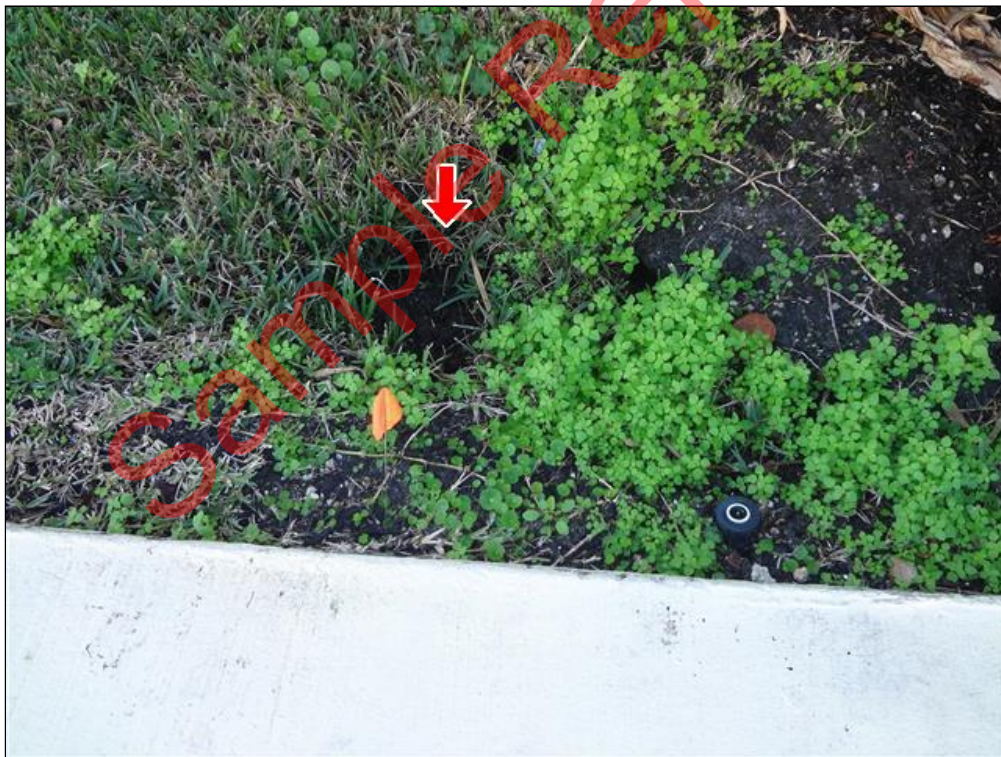
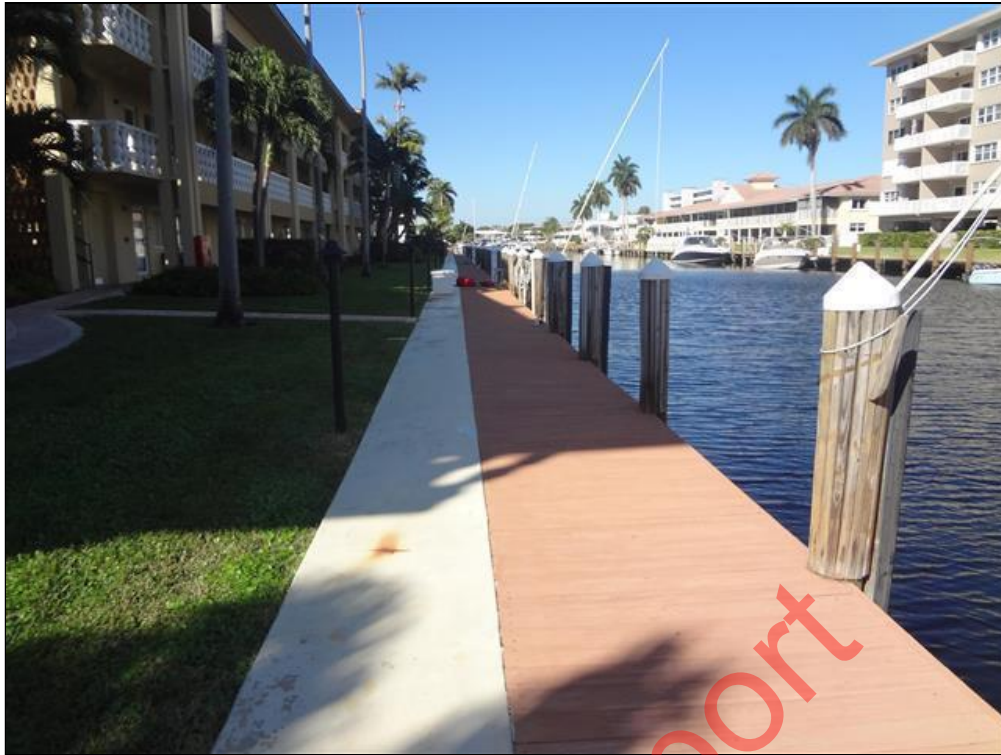
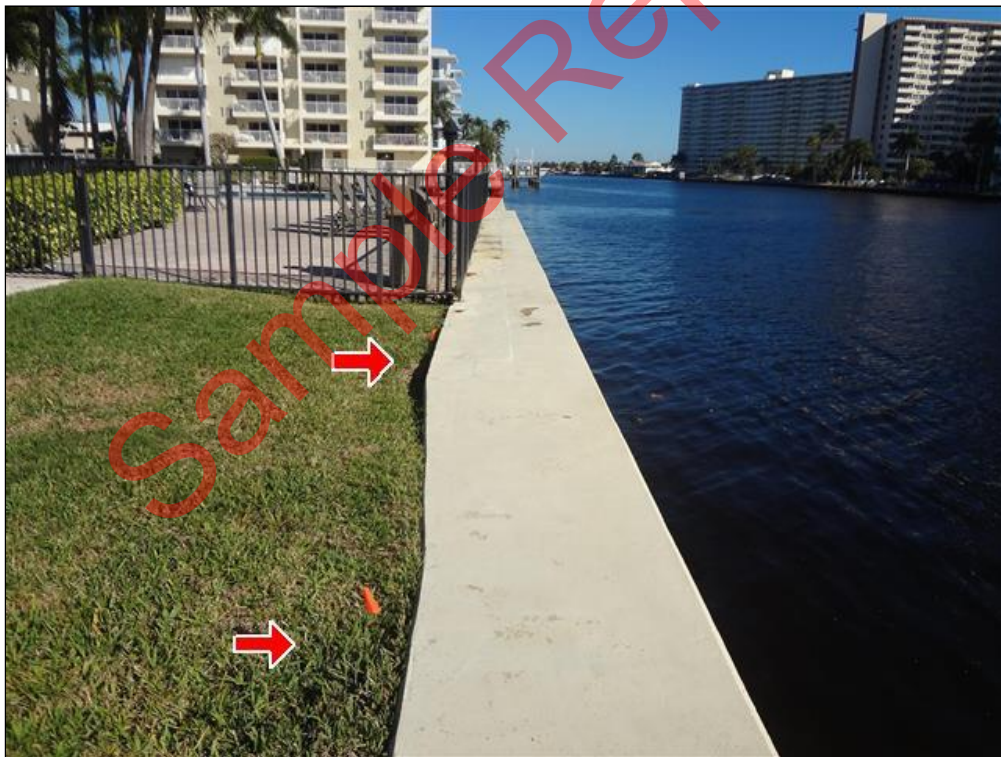
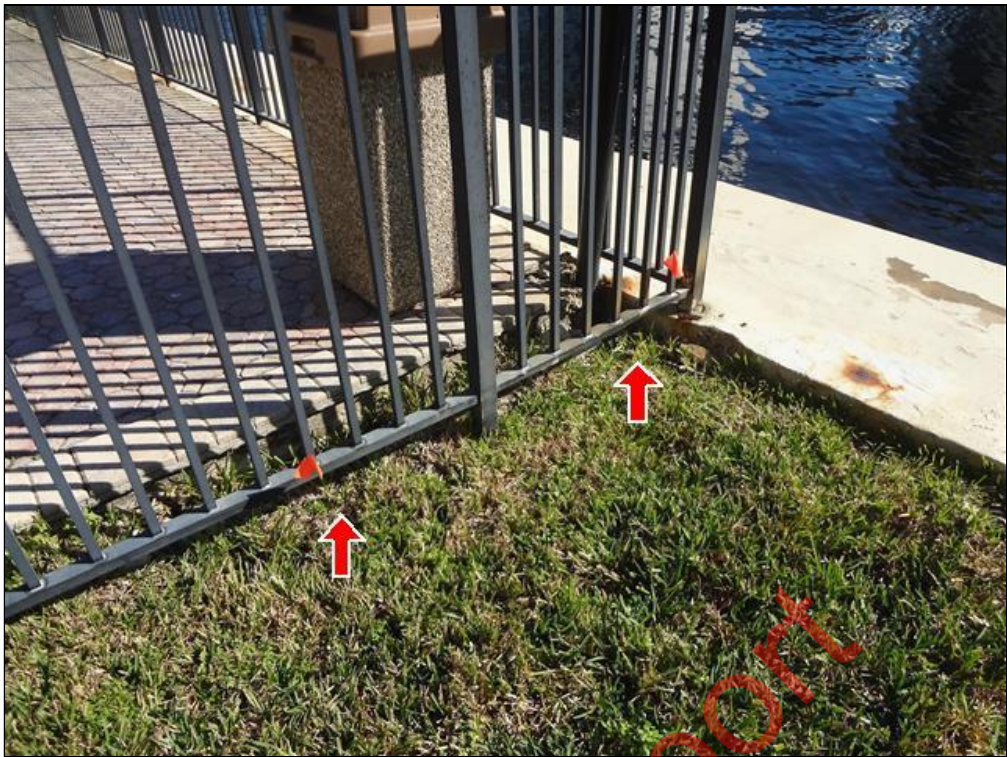
Inspector observed the grounds along the North and East faces of the seawall. Inspector found the grounds to be leveled and well kept. However, inspector found widespread signs of erosion and/or soil de-stabilization on both faces of the seawall. Item 2(Picture) Item 3(Picture) Item 4(Picture) Item 5(Picture) Item 6(Picture) Item 7(Picture) Item 8(Picture)

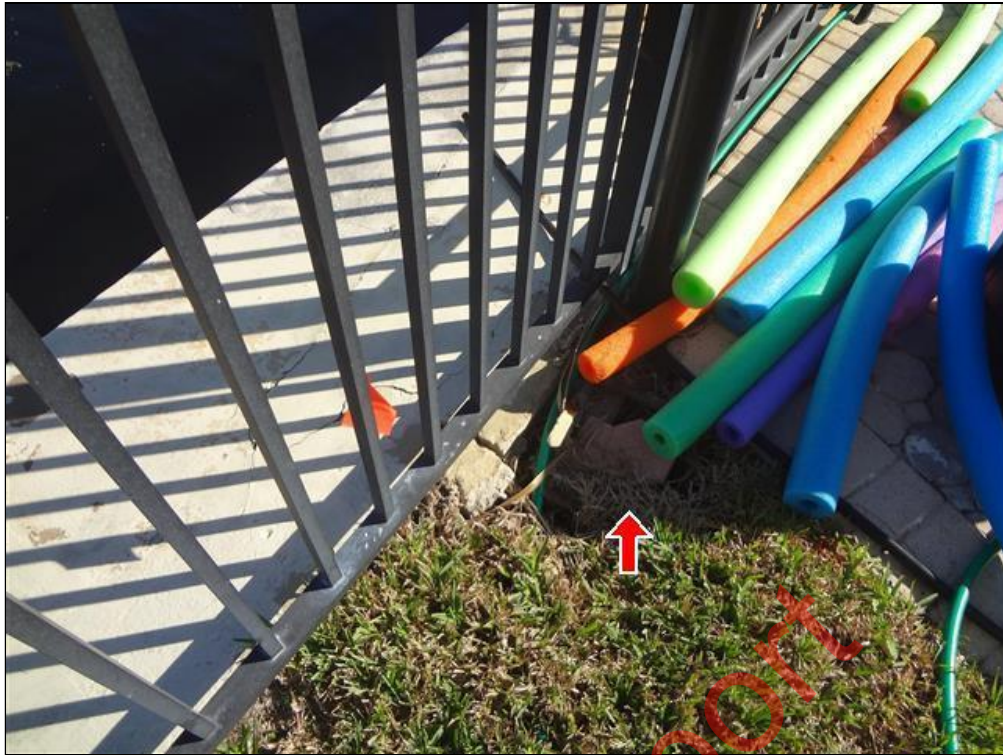
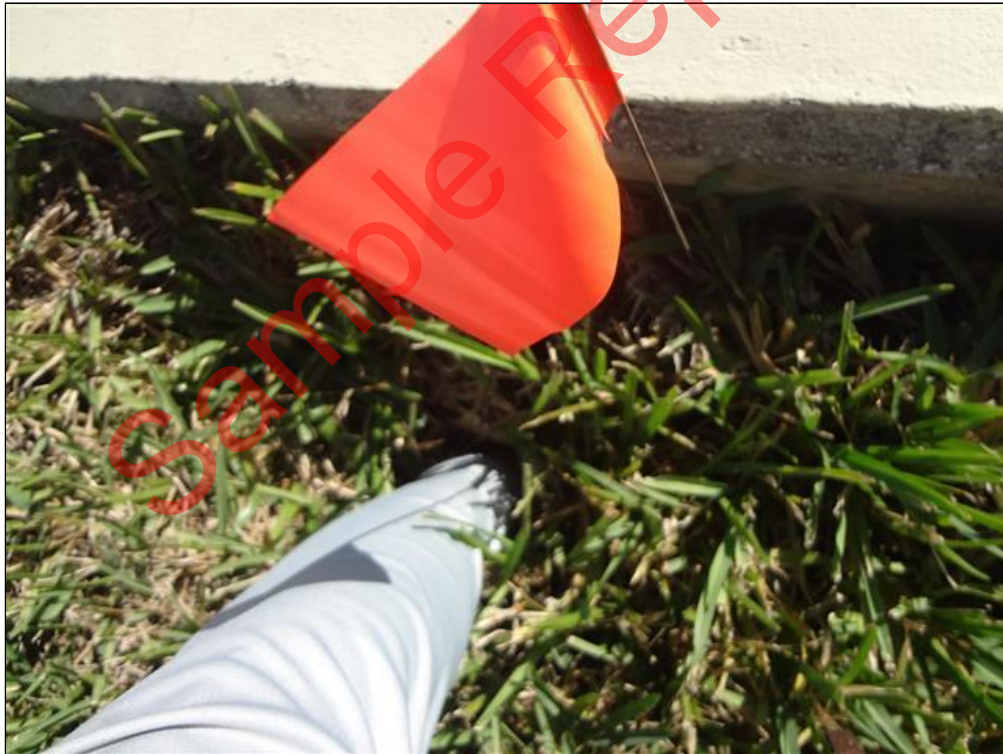
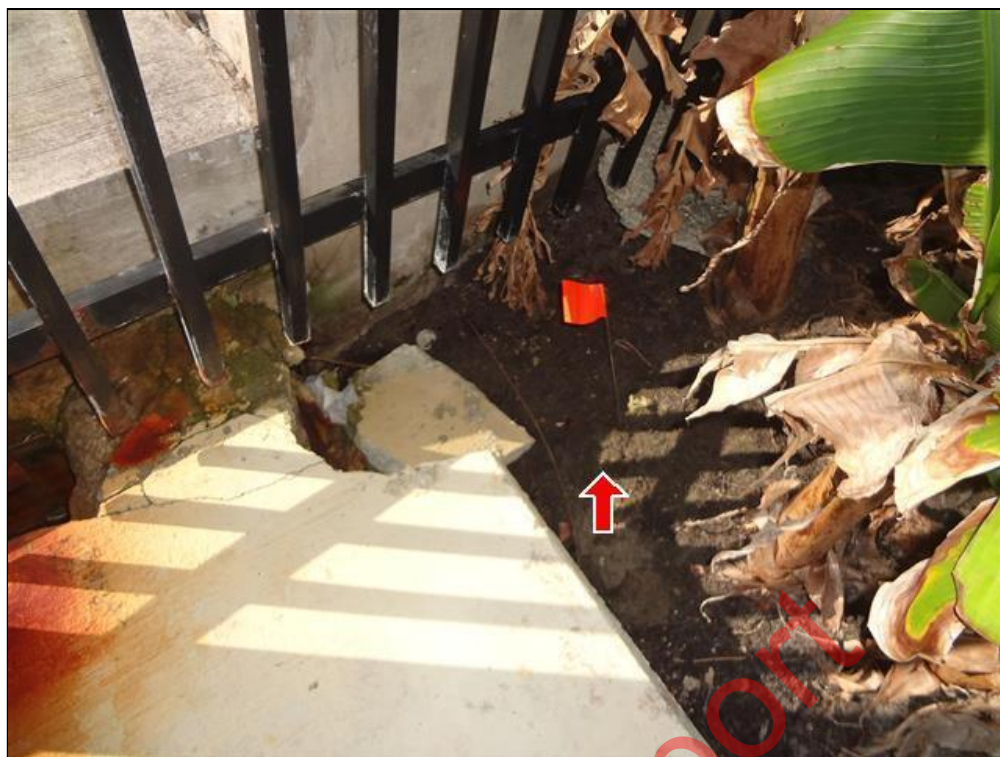
Inspector also found minor signs of soil de-stabilization around the pool area at the time of the inspection. Item 12(Picture) Item 13(Picture) Item 14(Picture)

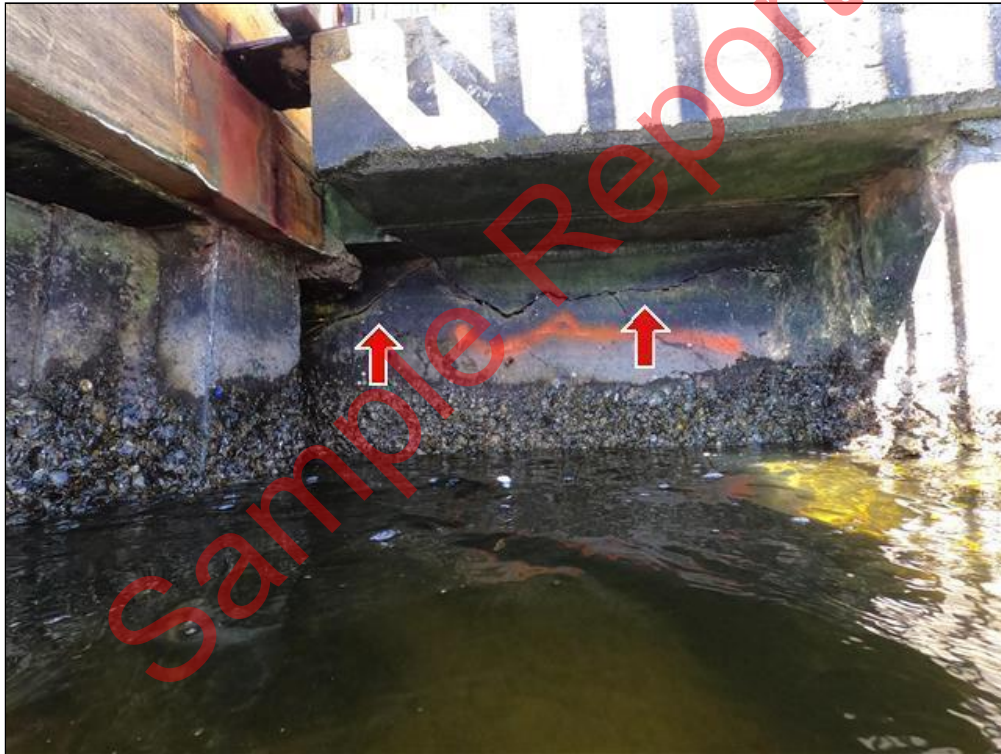
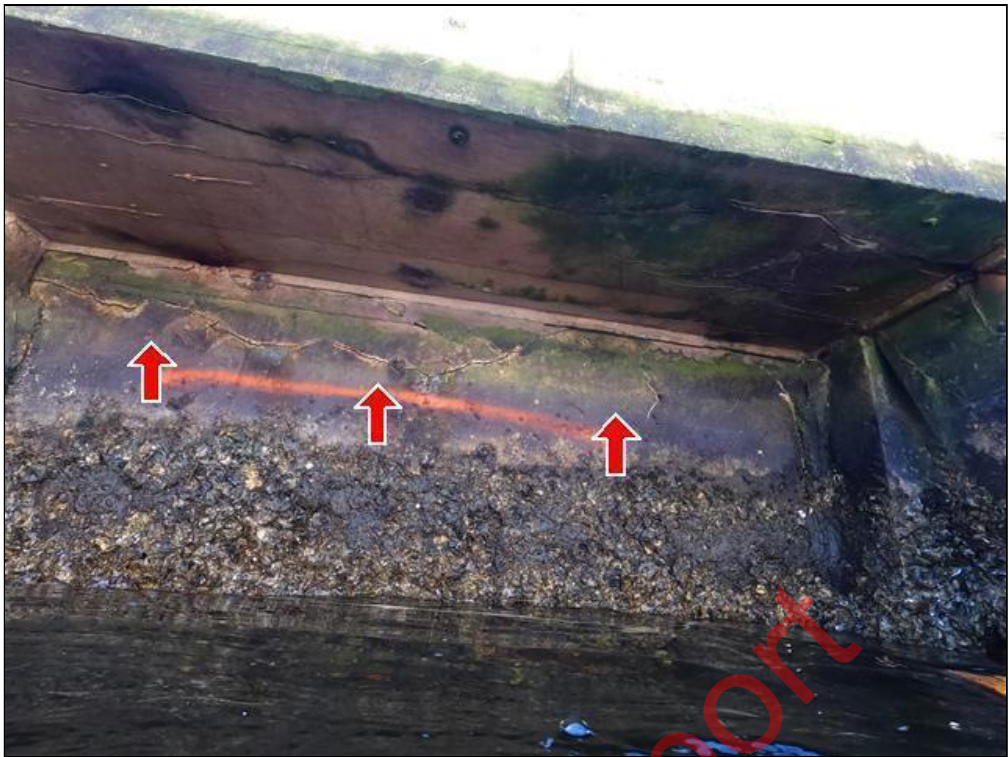
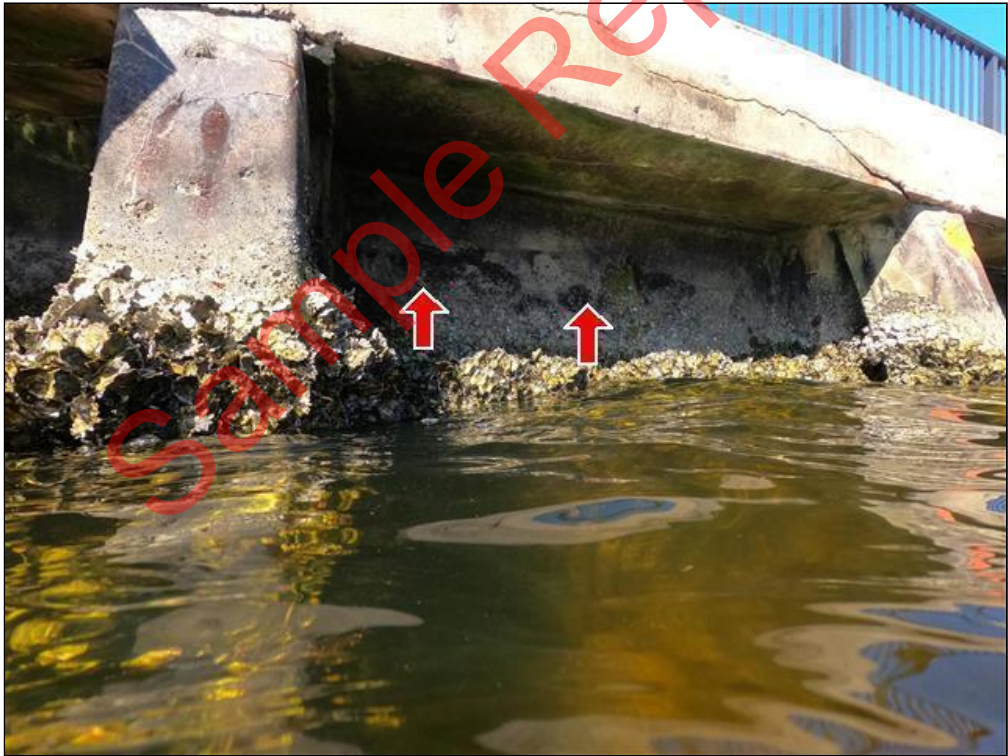
While in the water, inspector found signs of horizontal cracks on the East face of the seawall. Inspector found two panels on the East face of the seawall that exhibited minor horizontal cracks. Therefore, aging, corrosion and uneven hydrostatic pressures are beginning to take its toll on the East face. Item 1(Picture) Item 2(Picture) Item 3(Picture) This, along with the constant boat traffic that generates strong wave action could cause the East face of the seawall to further deteriorate. Inspector marked the damaged panels for ease of identification.

**RECOMMENDATIONS:** Inspector recommend the damaged panels on the East face be repaired or reinforced as to prevent further deterioration and unwanted collapse.

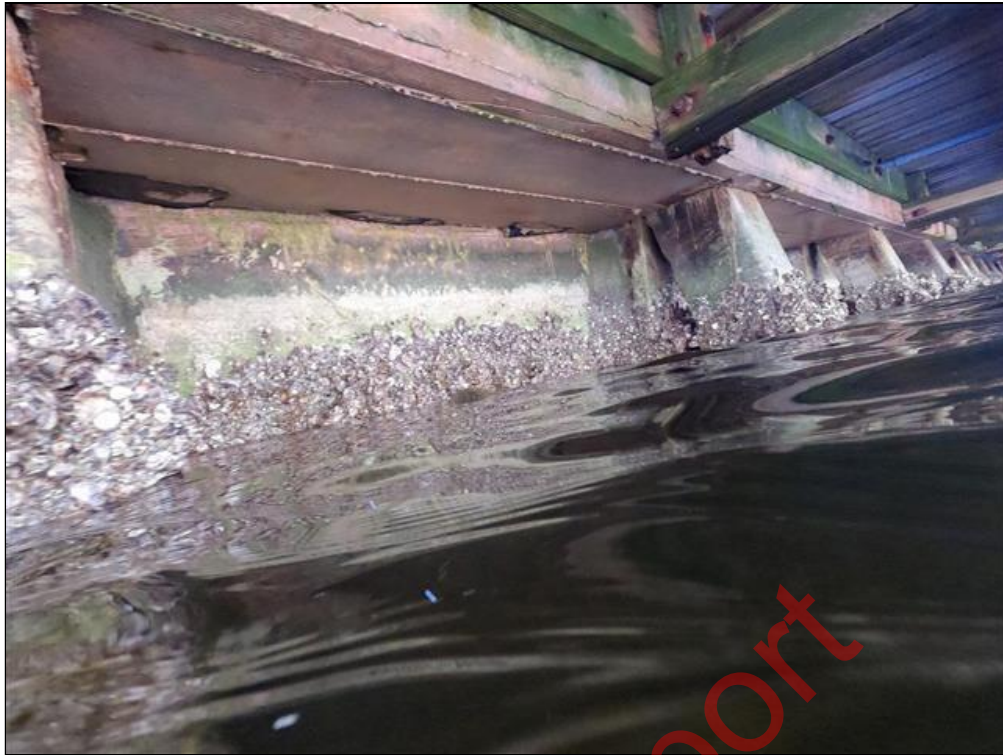
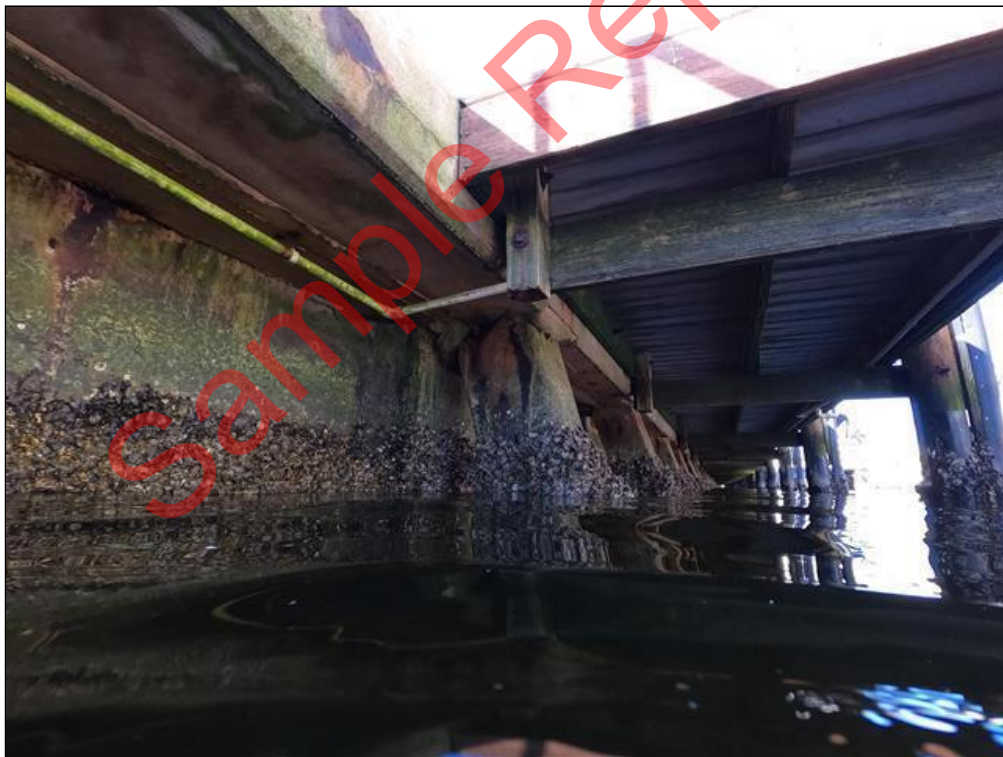
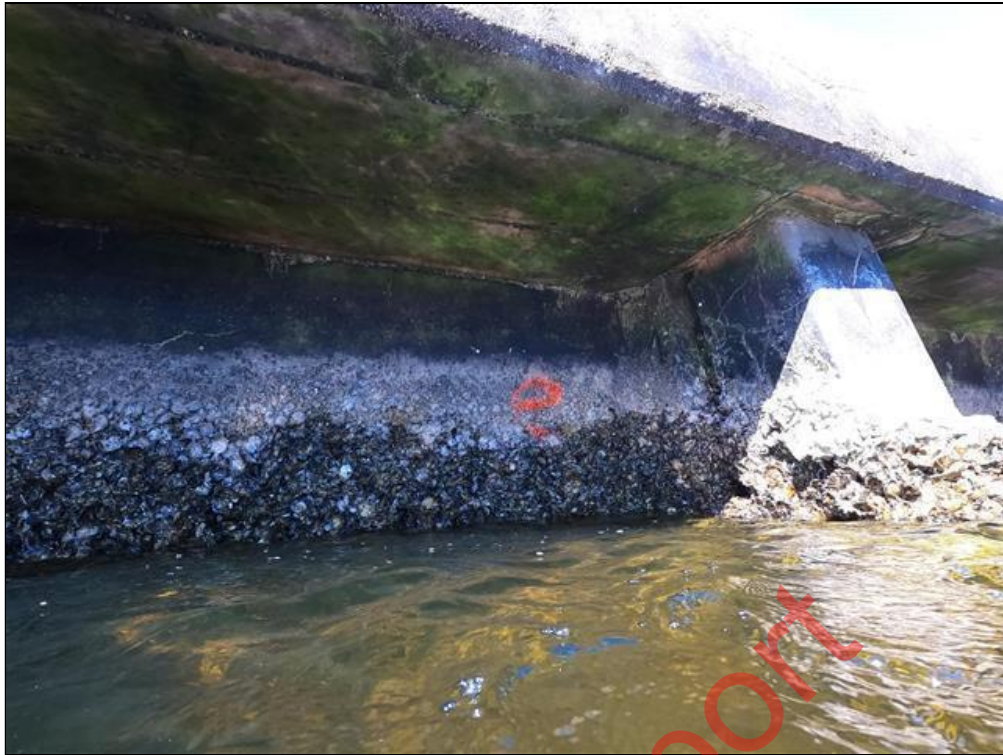
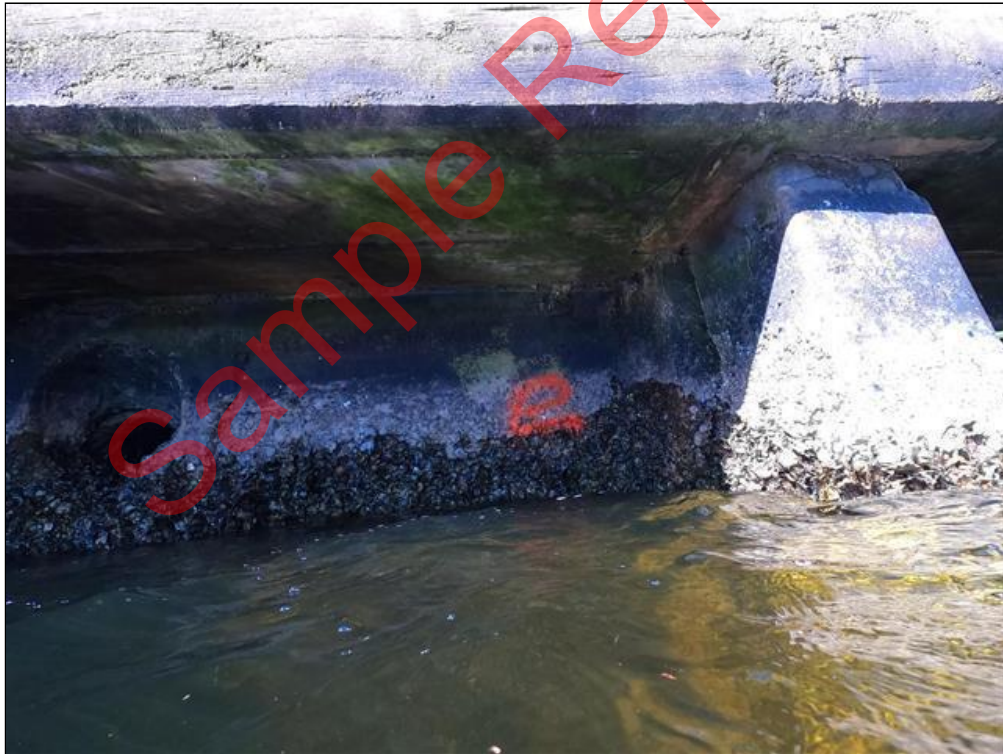
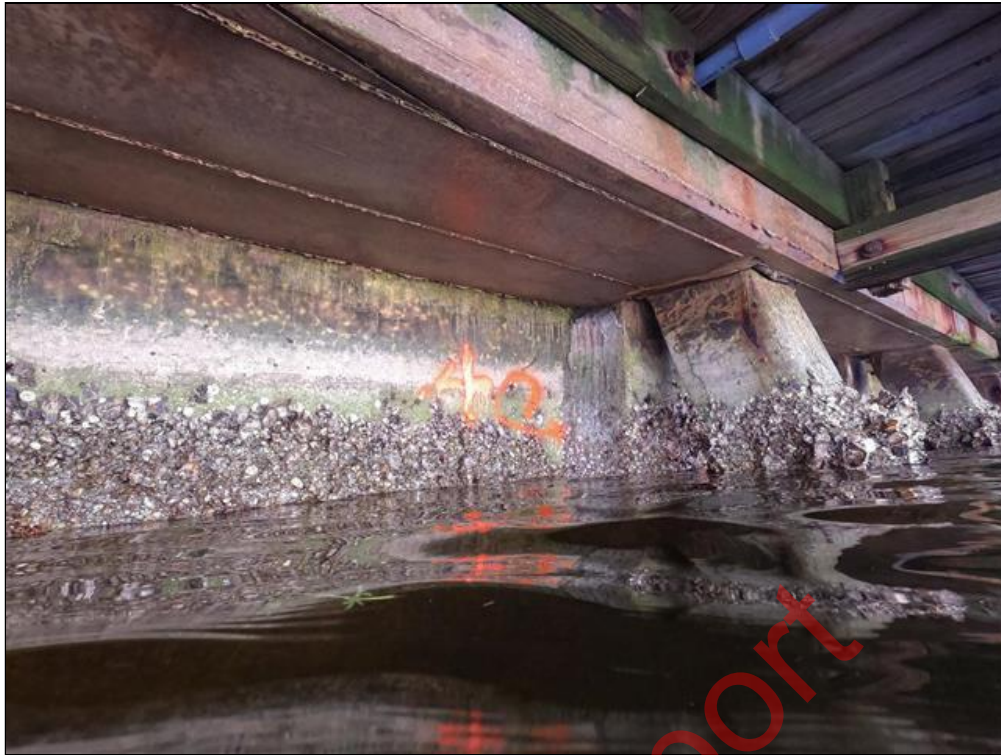
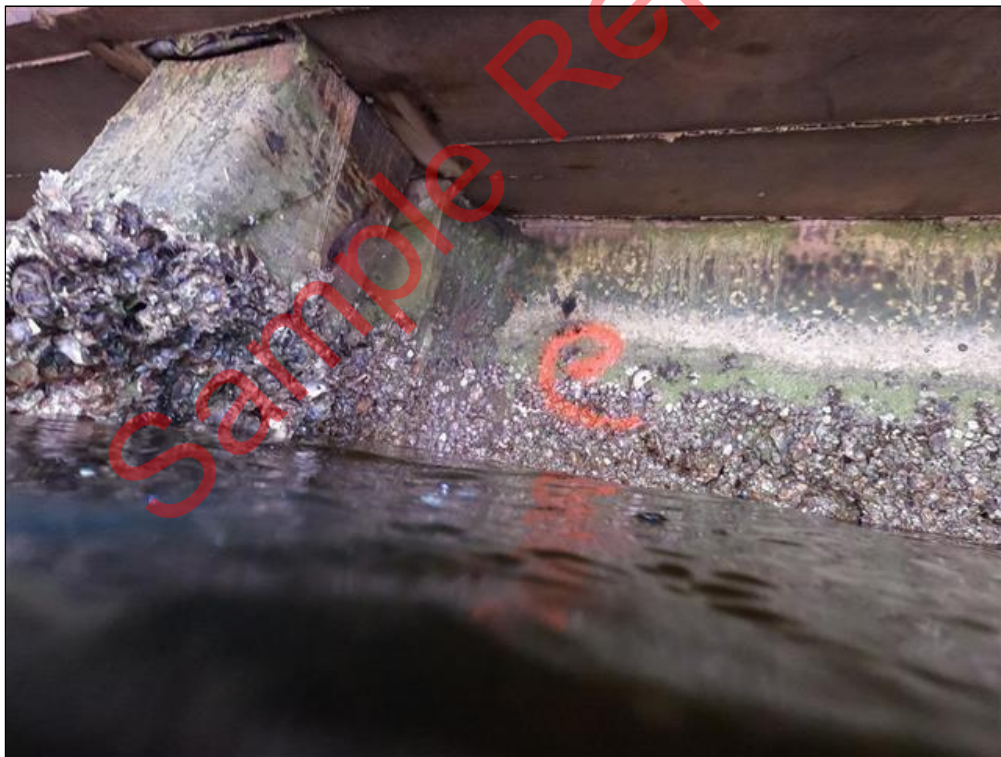
Inspector found no horizontal cracks on the North face. This is an indication that the North side of the property is better balanced than the East side Item 4(Picture) Item 5(Picture) Item 6(Picture) Item 7(Picture) Item 8(Picture) Item 9(Picture) Furthermore, the North side is not exposed to wave action as much as the East side.

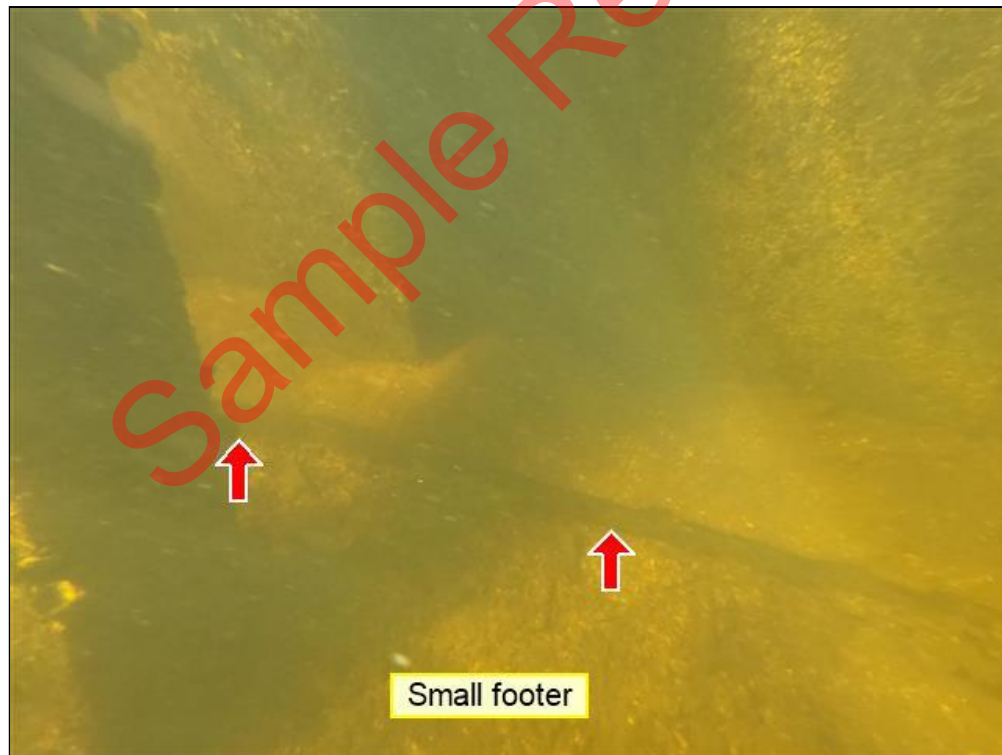
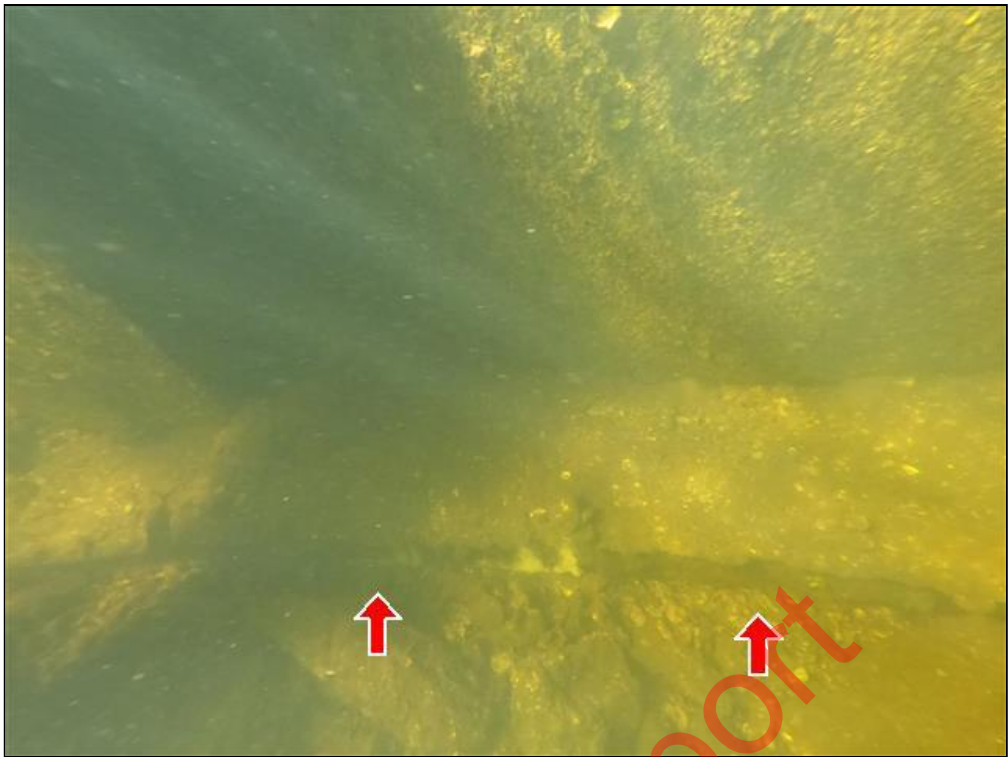
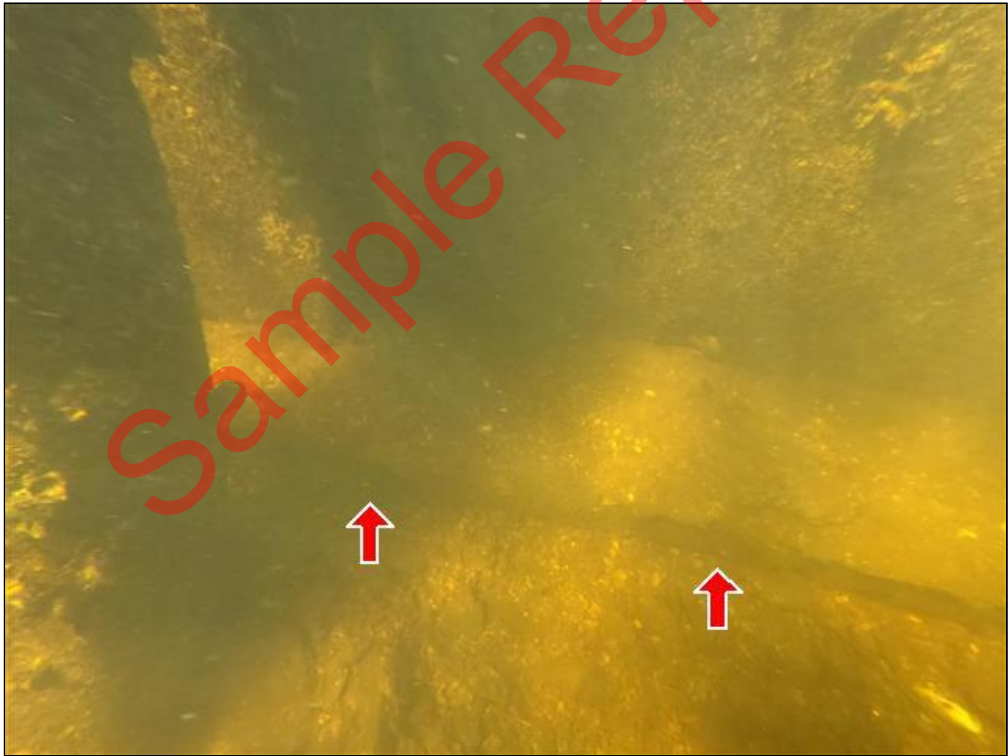
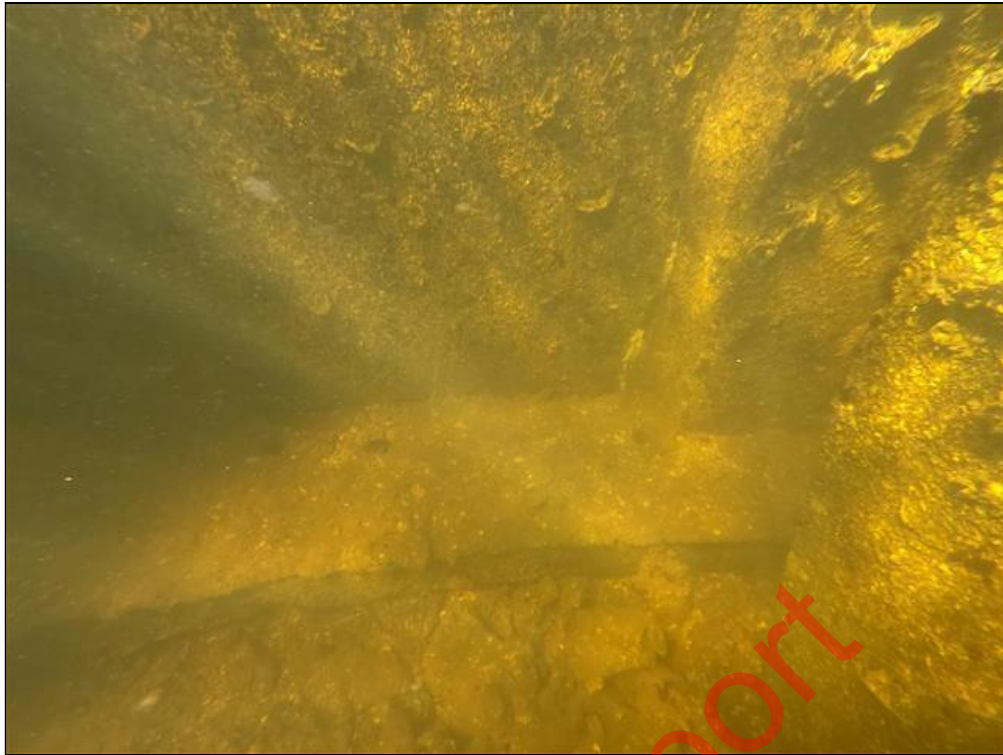
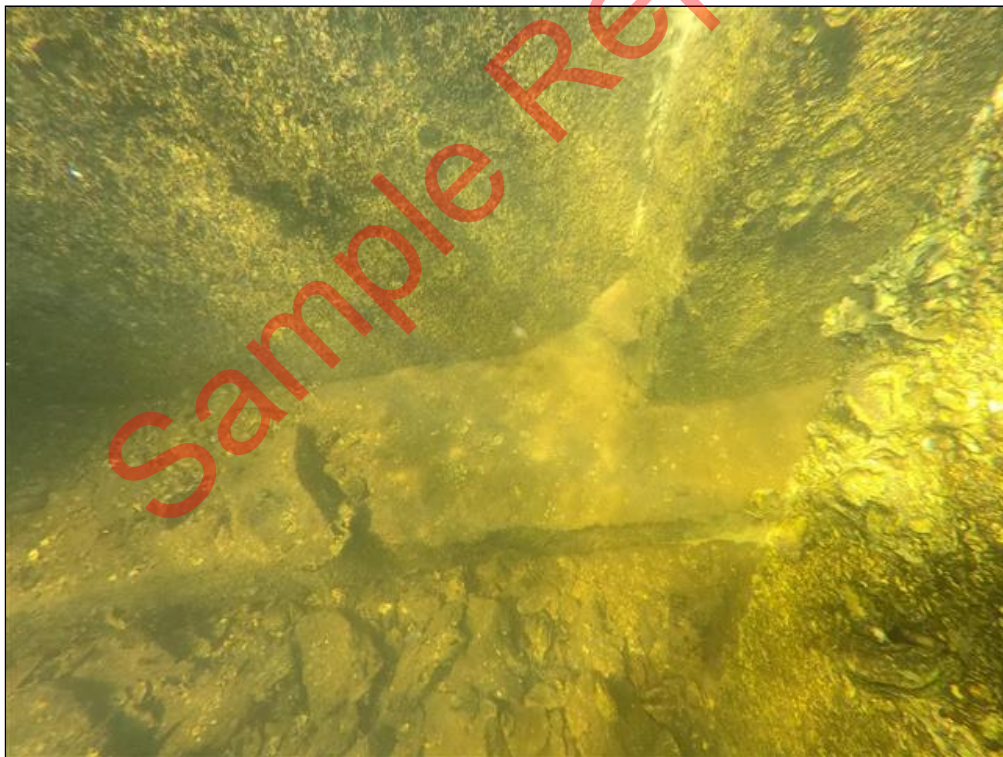
Inspector found a very short footer along the first 3/4 of the East face of the seawall while swimming North. The footer is made out of corrugated vinyl sheet pile and it measures only a short 3" - 6" above

the berm (bottom of the canal). Item 1(Picture) Item 2(Picture) Item 3(Picture) Item 4(Picture) Item 5(Picture)

The small footer on the East face is filled with cement but is not effectively encapsulated and is allowing moderate levels of soil loss. Inspector probed the berm along the edges of the East face of the seawall for penetration. Probe was pushed as much as 6" without reaching the bottom of the panels. Although the panels seem well positioned into the East berm, the soil loss needs to be stopped with the addition of a new footer.

**RECOMMENDATION:** Add a new footer on the East face that can deter the effects of strong wave action and possible toe erosion. That should provide better protection to the ongoing effects of wave action and stop current soil loss.
