# Seawall Inspection Report

## Waterside on the Intracoastal

**Property Address:**  
2881 NE 32nd St  
Fort Lauderdale FL 33306

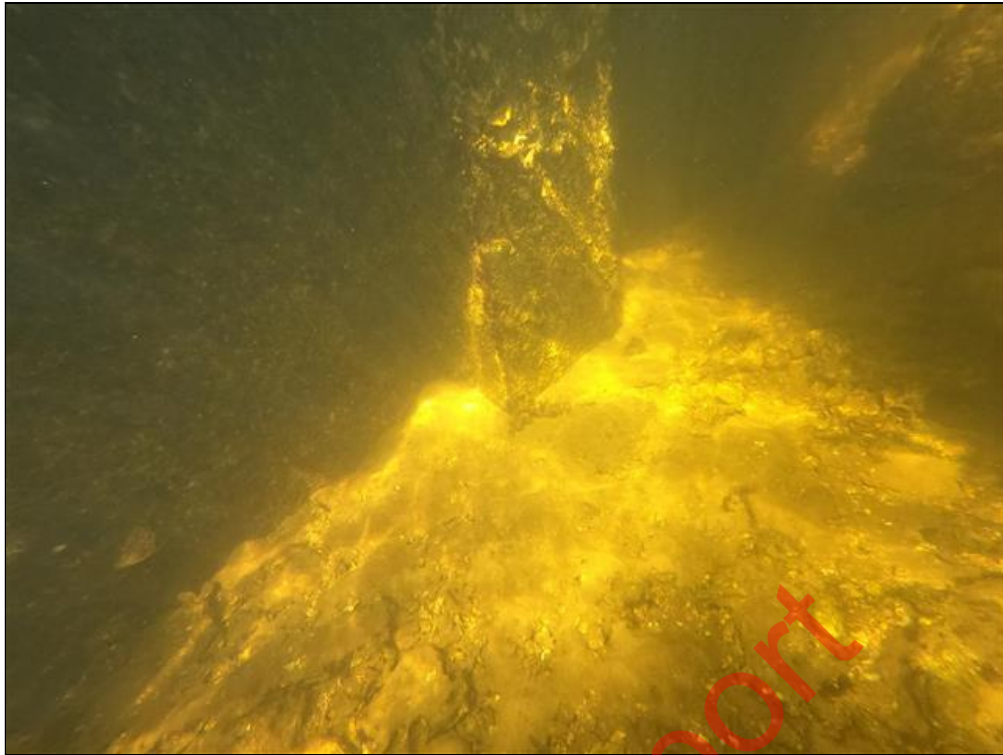
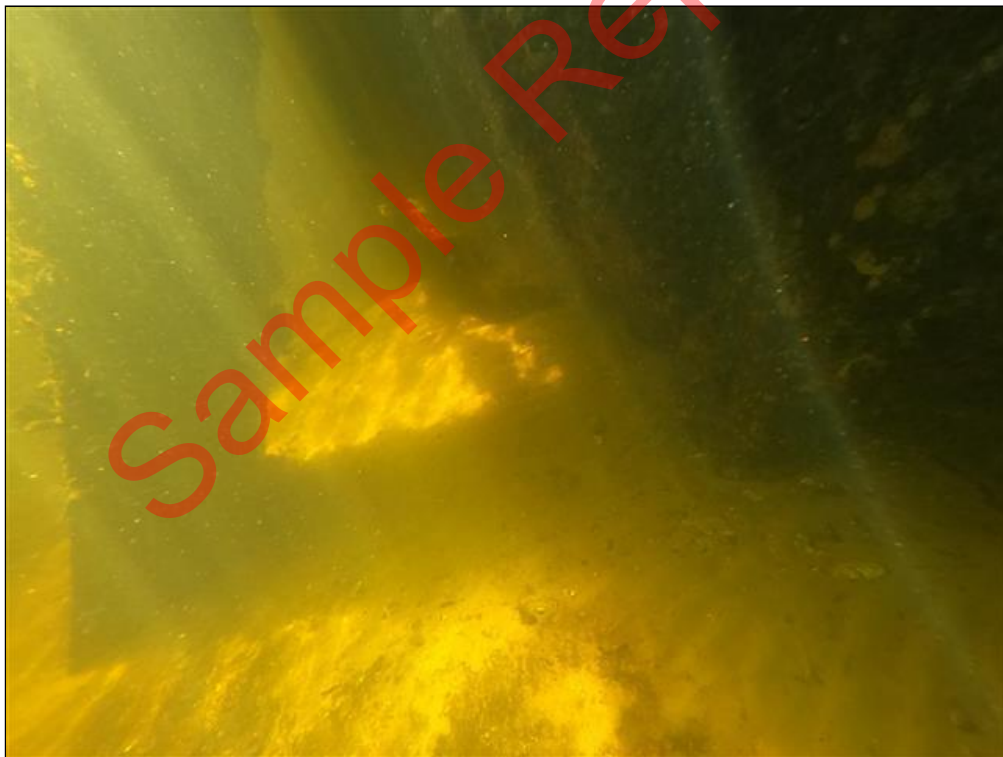
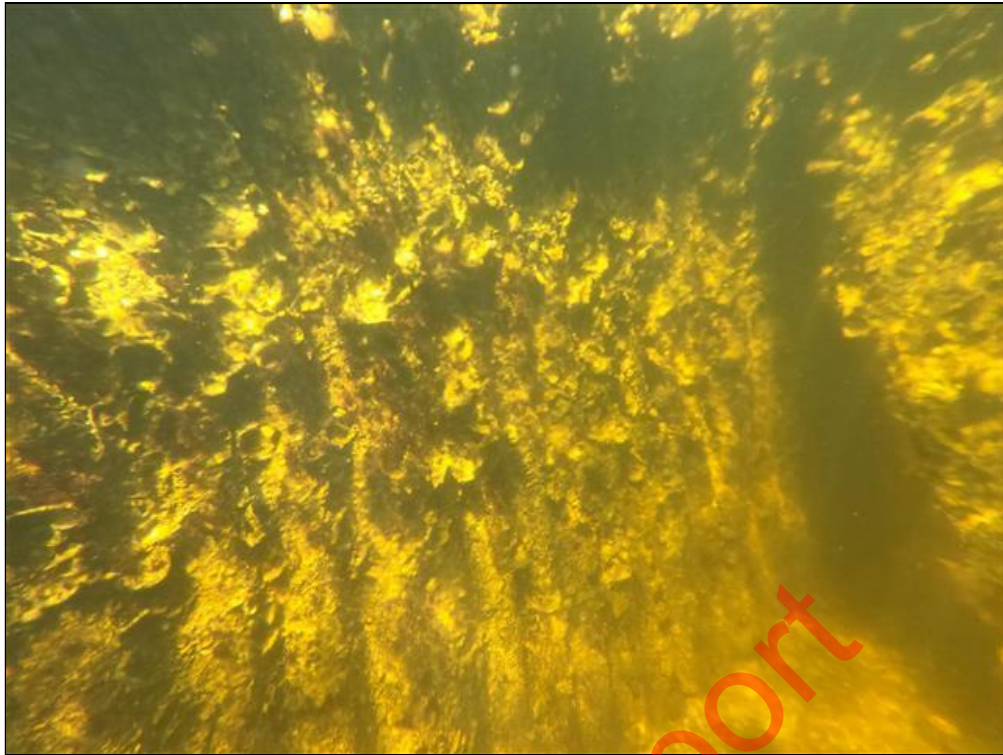
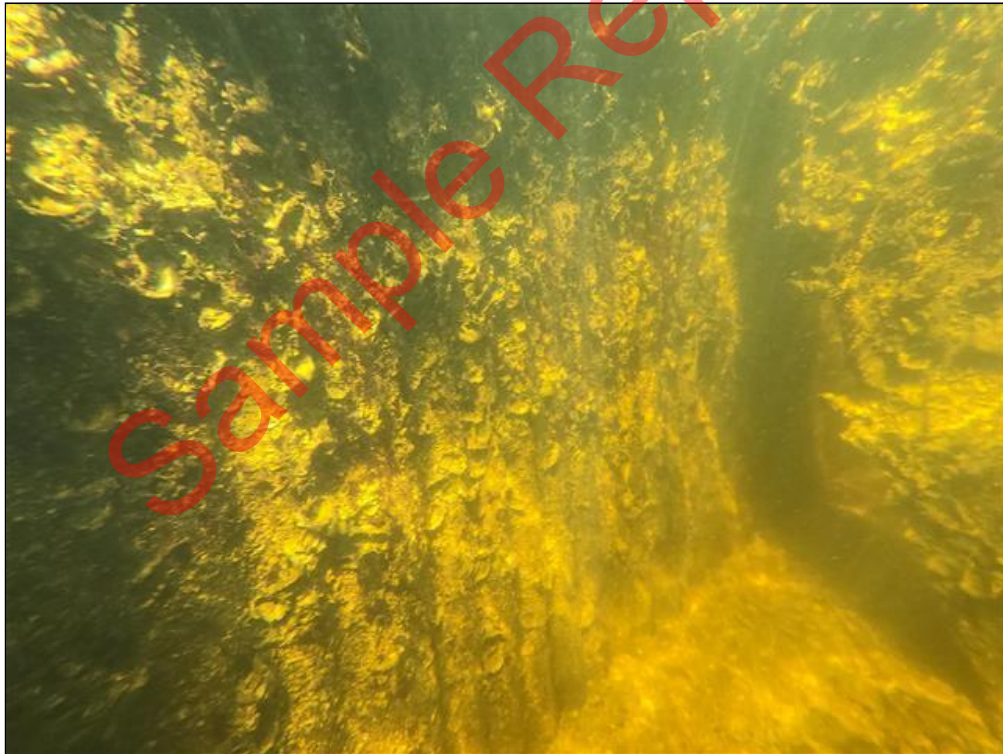
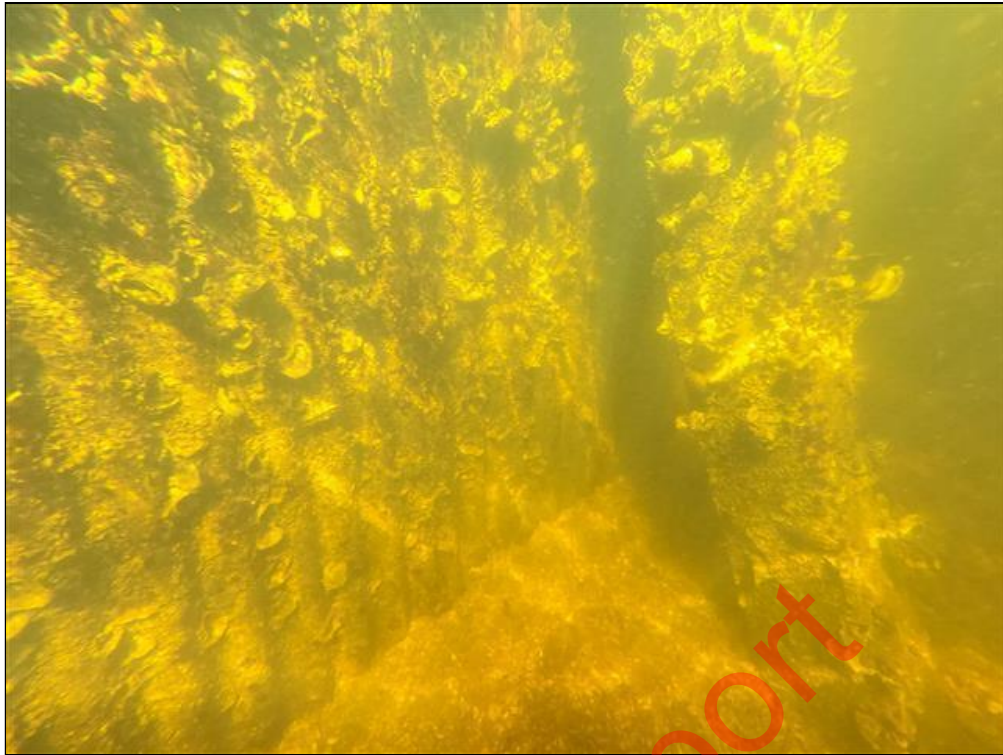
When approaching the last 1/4 of the East face (getting close to the corner) inspector found a taller (larger) footer (20-24") made out of the same material. Section of this sheet pile footer at the corner is allowing soil loss. Item 6(Picture) Item 7(Picture) Item 8(Picture) Item Item 17(Picture) 9(Picture) Item 10(Picture)

**RECOMMENDATION:** Add a new footer on the East face that can deter the effects of strong wave action and possible toe erosion. That should provide better protection to the ongoing effects of wave action and stop current soil loss.

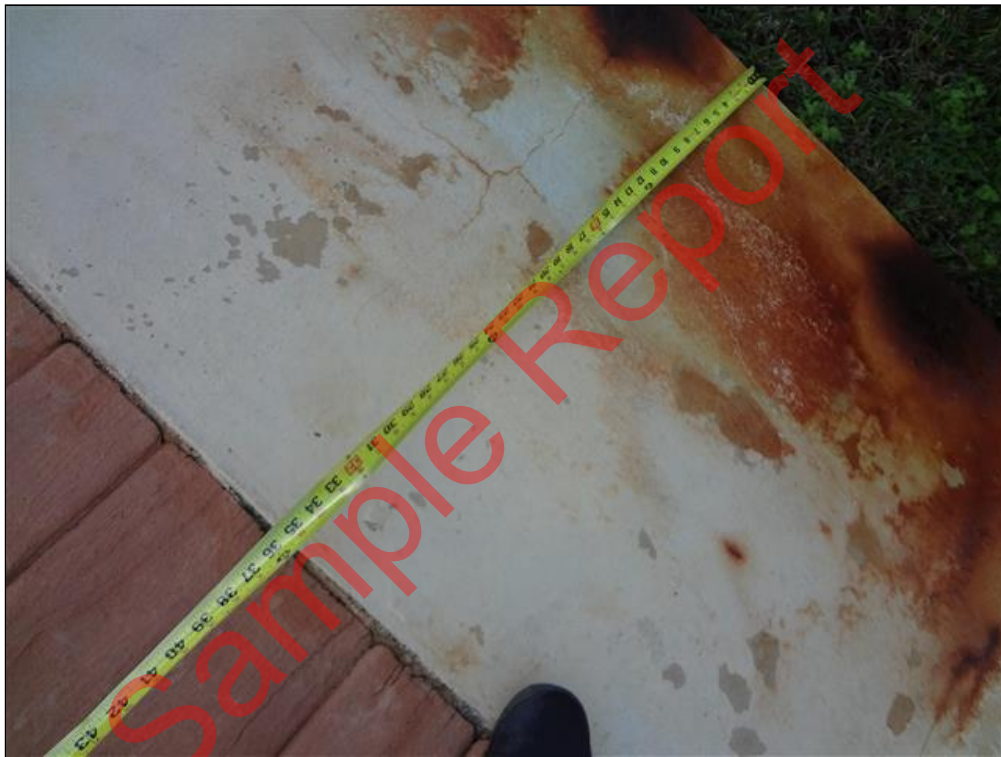
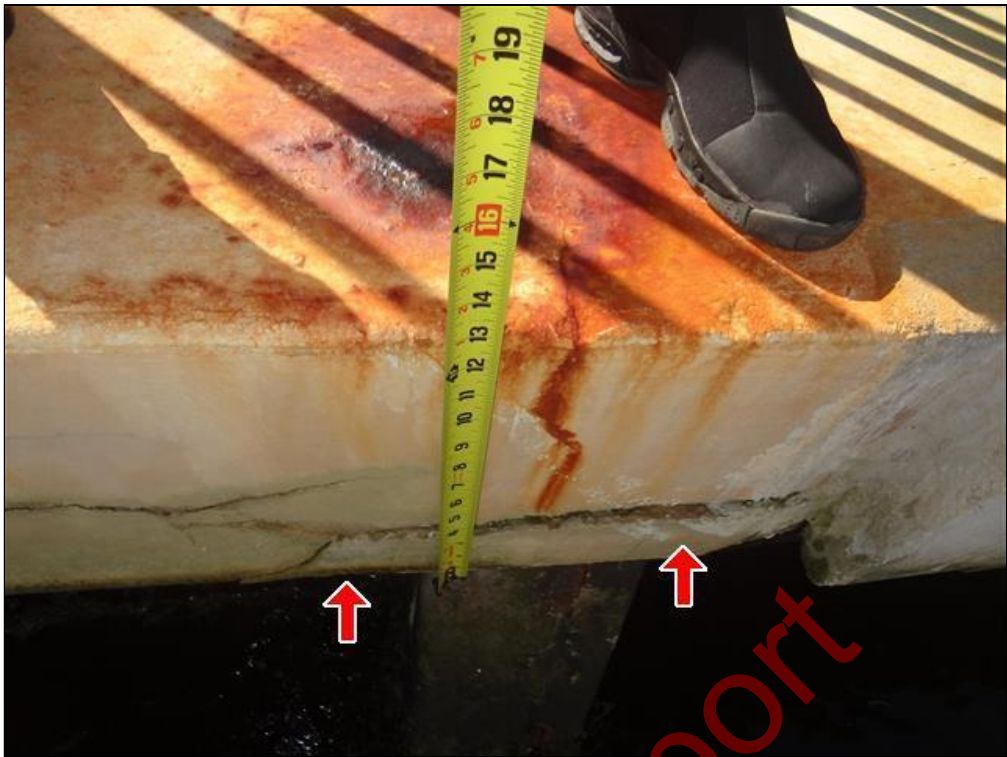
Inspector observed the seawall CAP from both, the landside as well as the waterside. The CAP measures +/- 700 LF in length, 36" wide, and 12" tall. The CAP is +/- 10 LF high (tall) measuring from the berm (bottom of canal). There is no sign of CAP rotation or movement at this time. Item 1(Picture) Item 2(Picture)

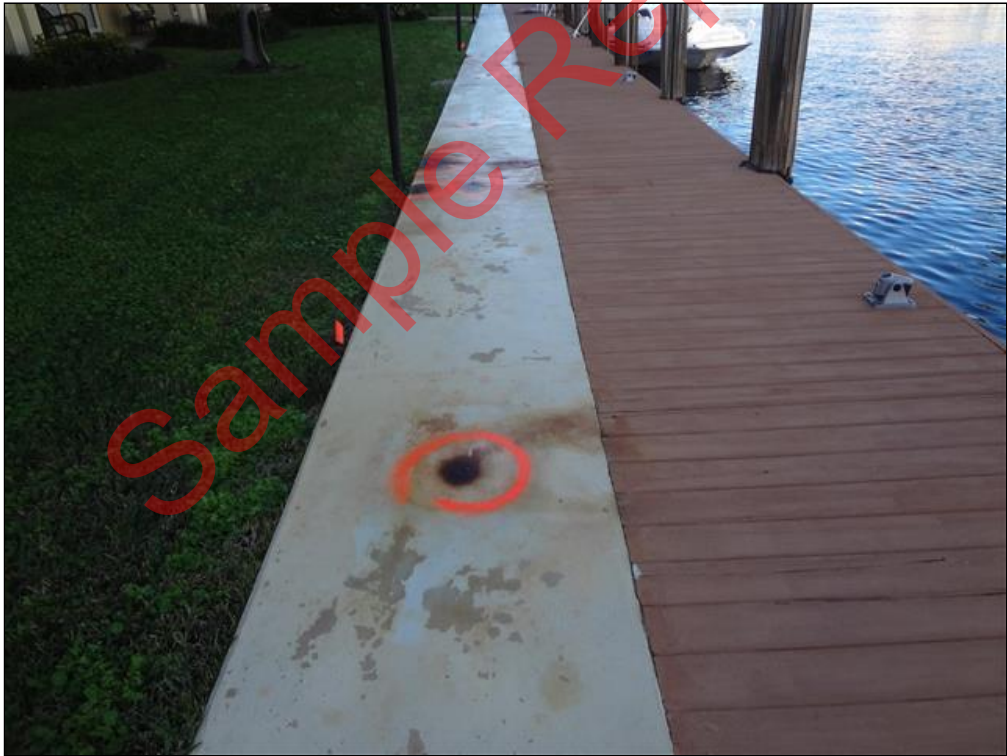
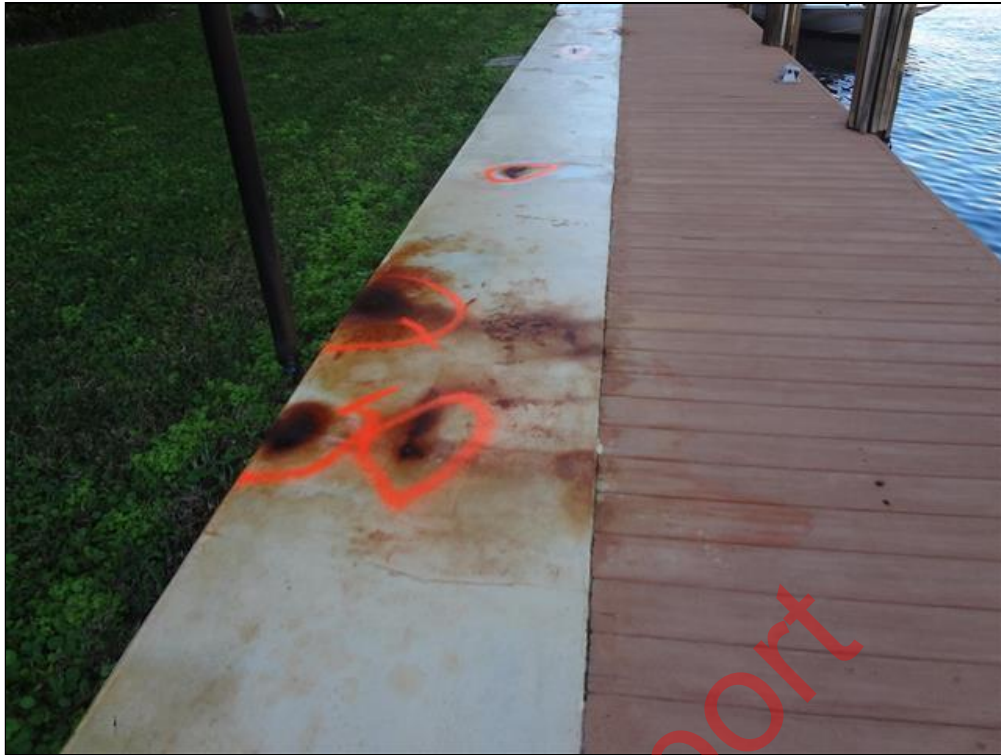
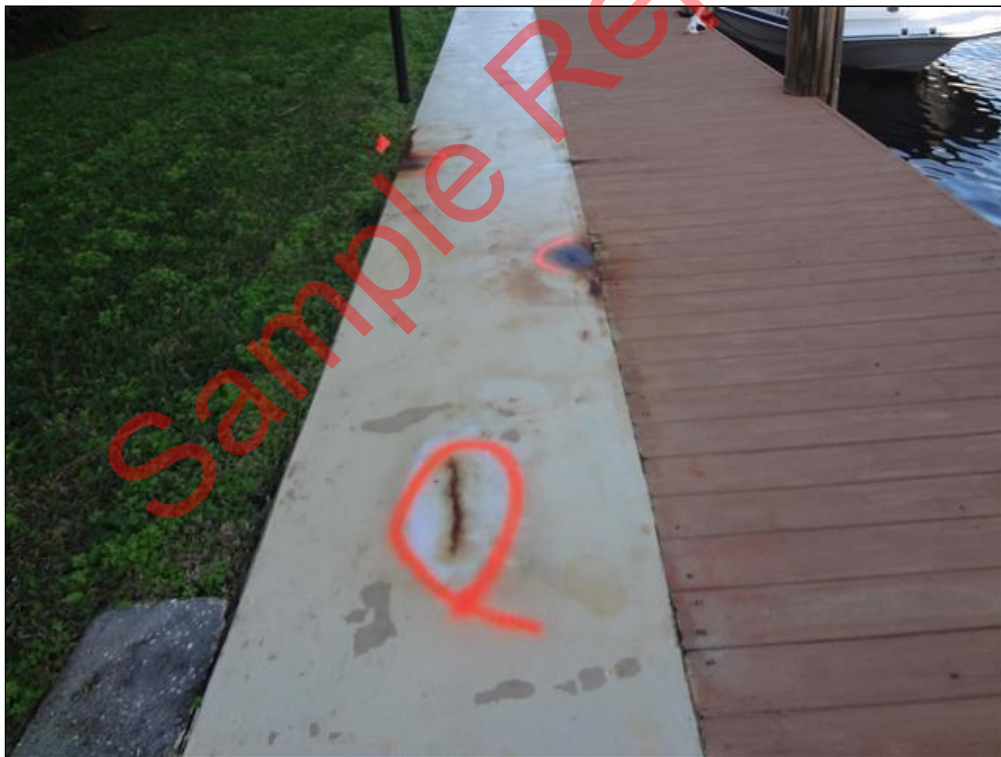
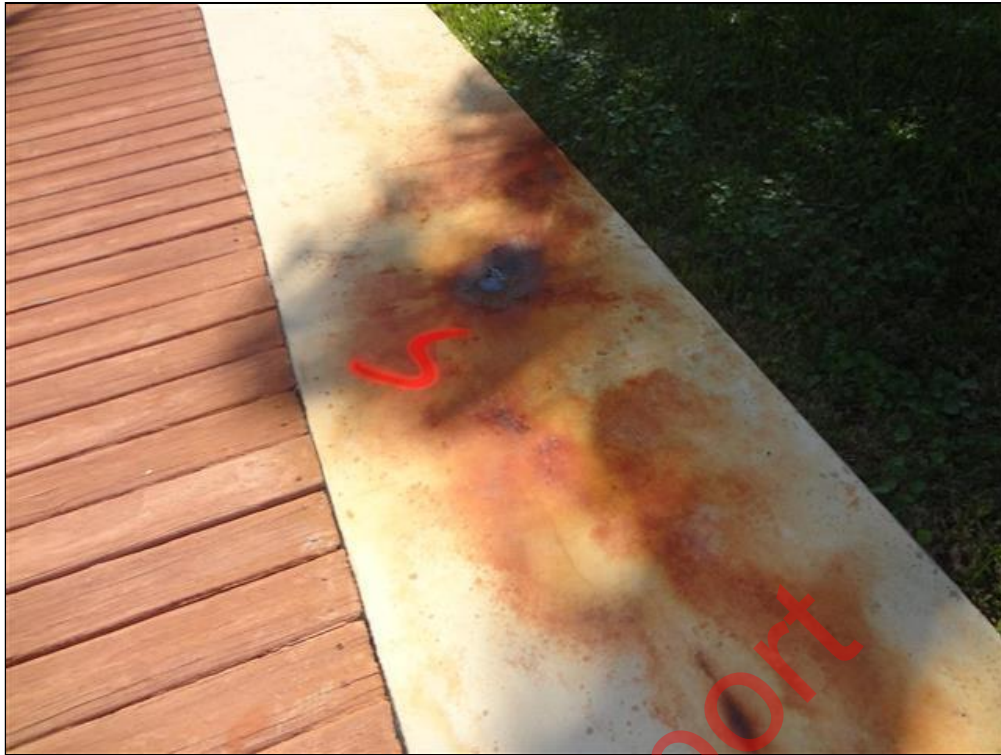
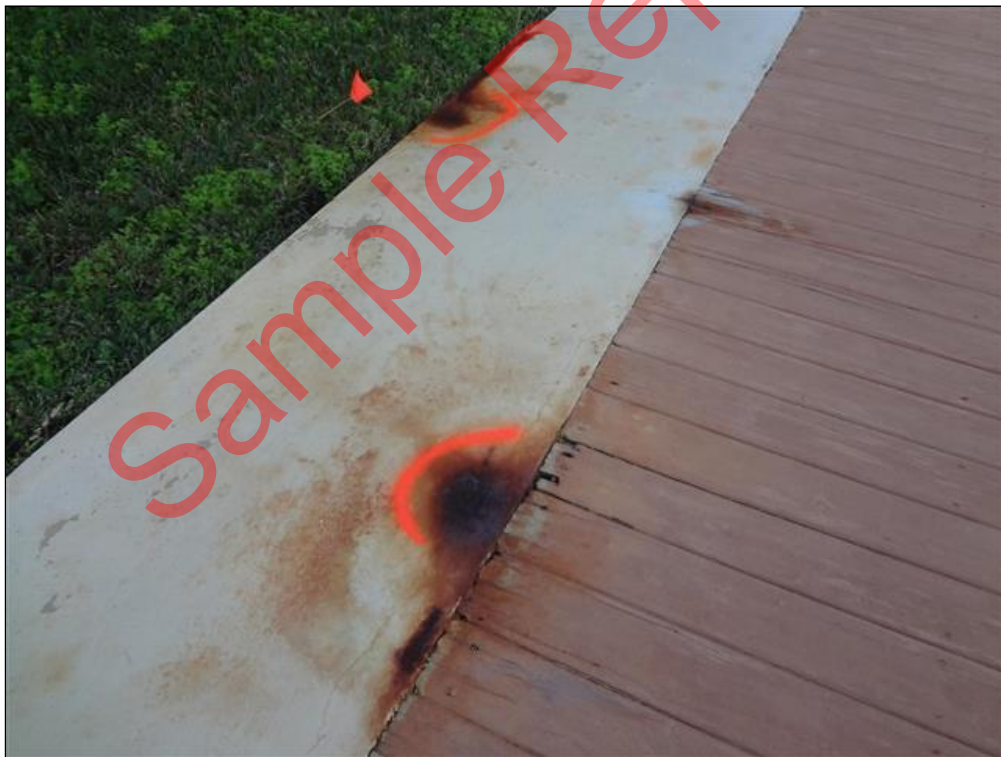
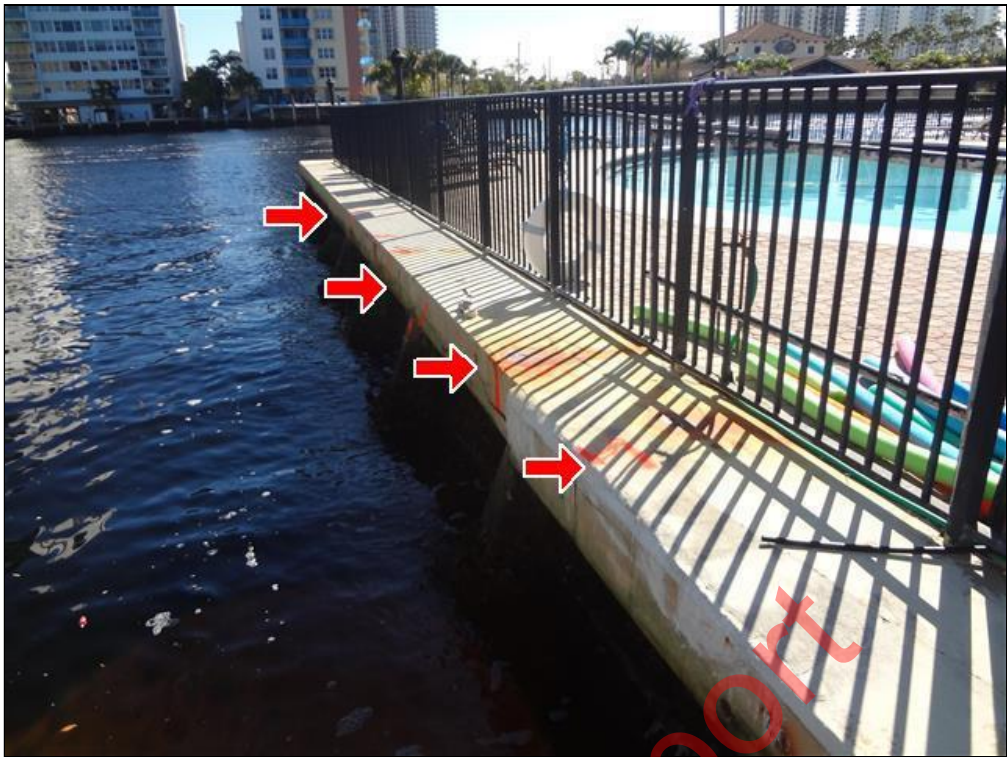
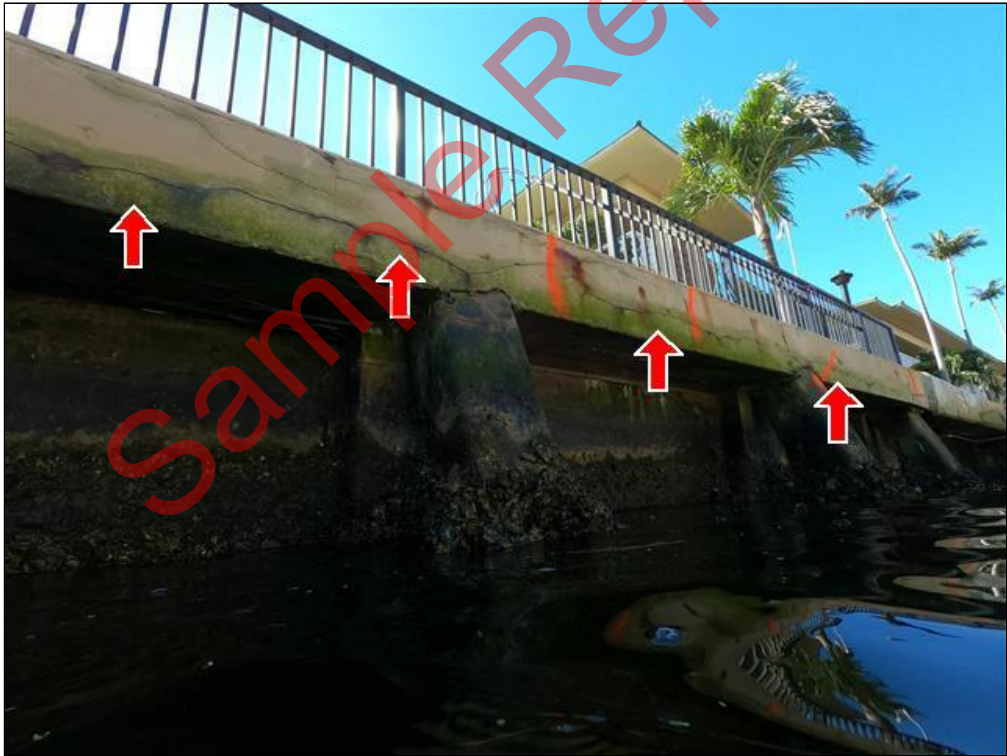
Inspector found moderate to severe levels of deterioration along sections of the North CAP due to steel rod corrosion and concrete spalling on the splash zone. Item 3(Picture) Item 4(Picture) Item 5(Picture) Item 6(Picture) Item 7(Picture) Item 8(Picture) Item 9(Picture)

**RECOMMENDATIONS:** Inspector recommend repairs of the North CAP (concrete restoration) by qualified marine contractor. CAP restoration that can repair/replace corroded steel rods and seal and/or encapsulate the cracks on the concrete CAP can extend seawall life expectancy.

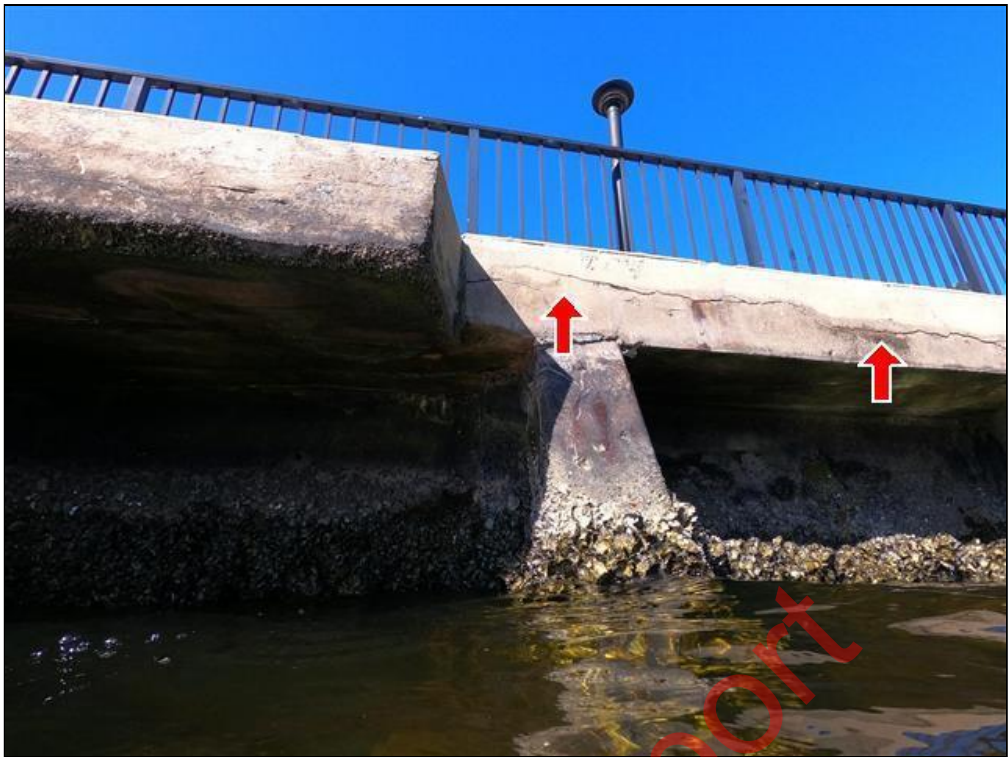
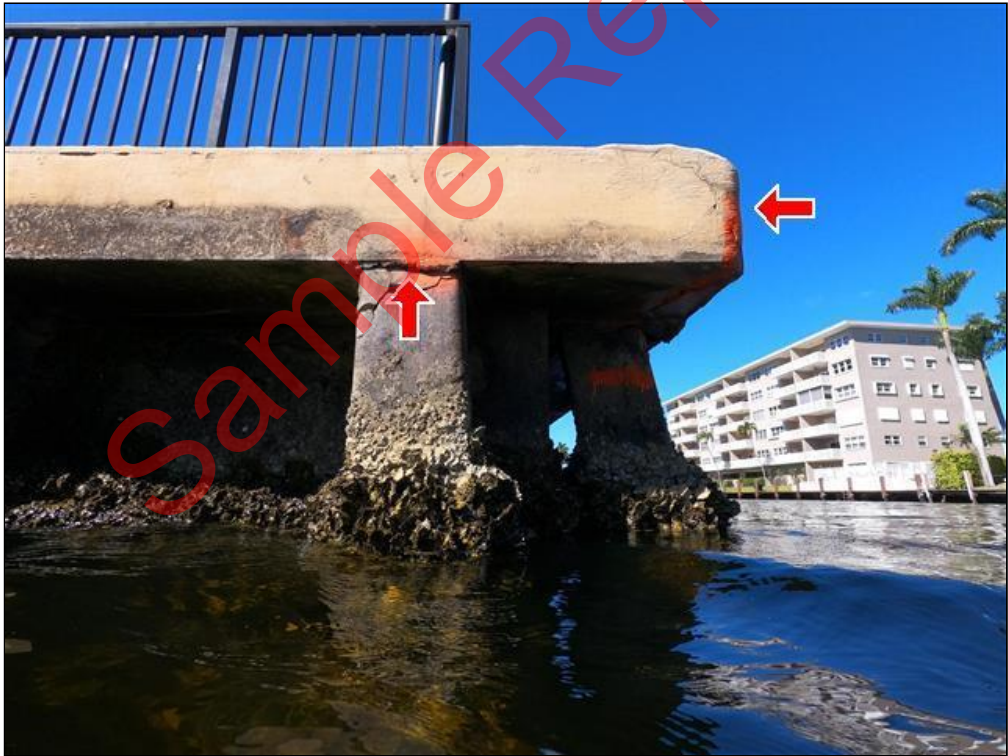
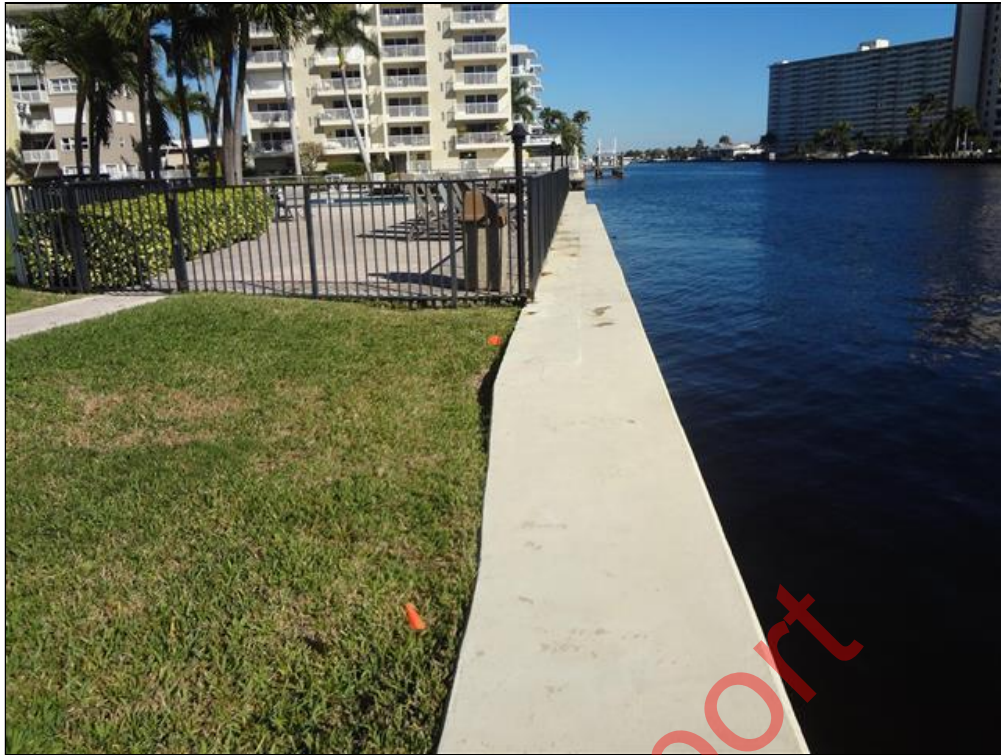
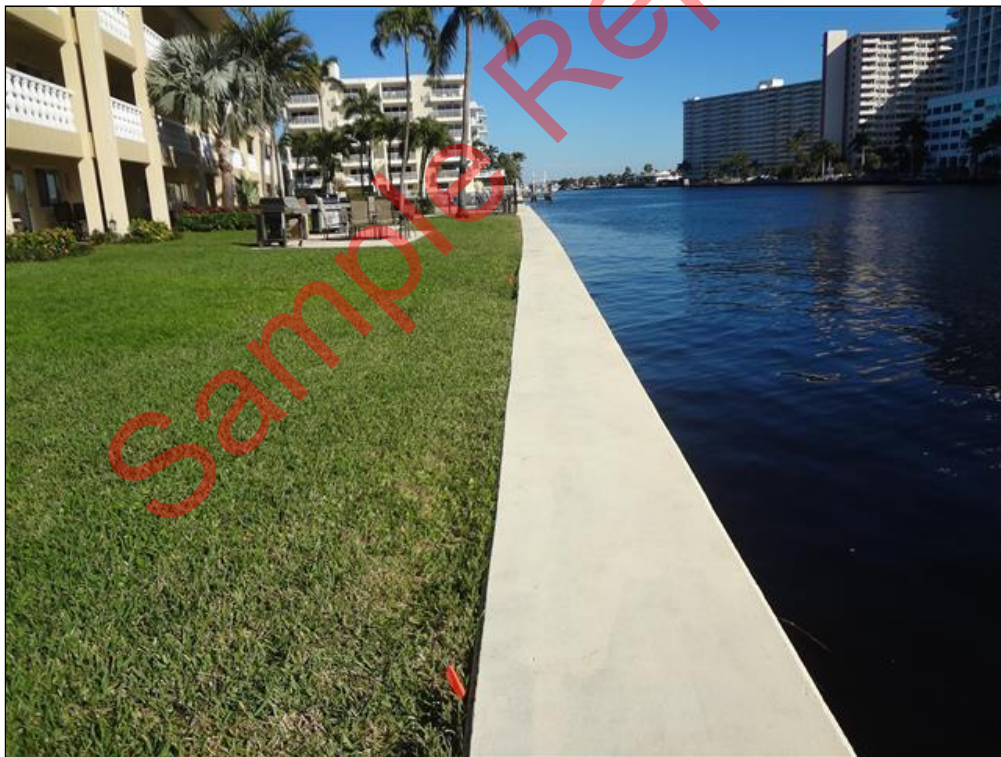
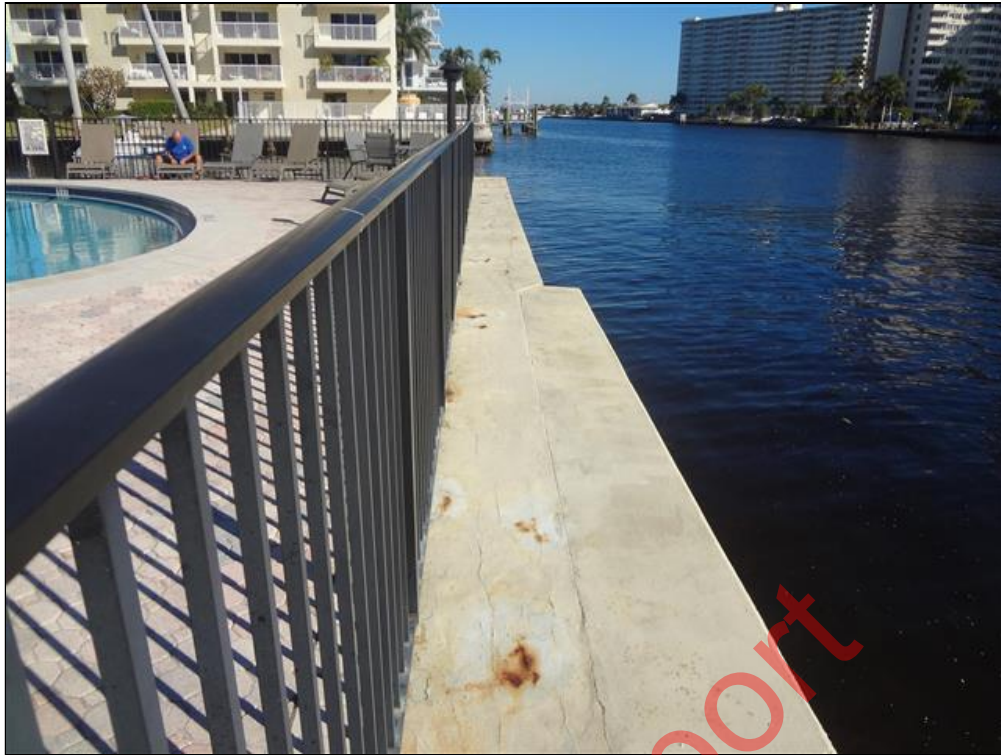
Inspector found moderate to severe levels of deterioration along a smaller portion of the East CAP due to steel rod corrosion and concrete spalling on the splash zone. Item 10(Picture) Item 11(Picture) Item 12(Picture) Item 13(Picture) Item 14(Picture)

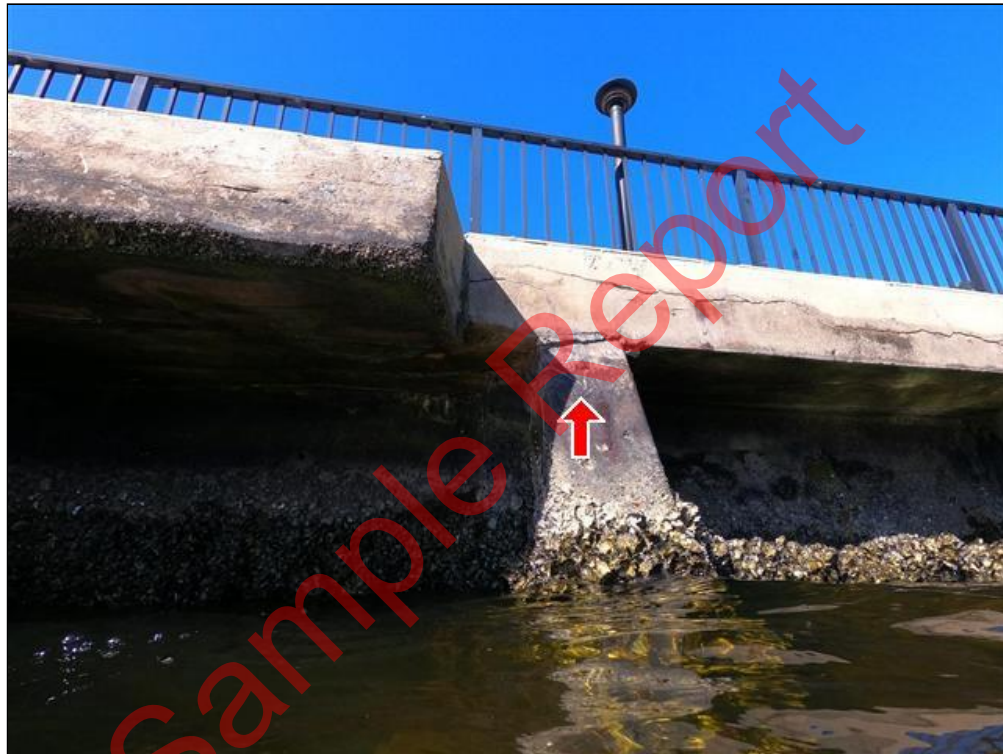
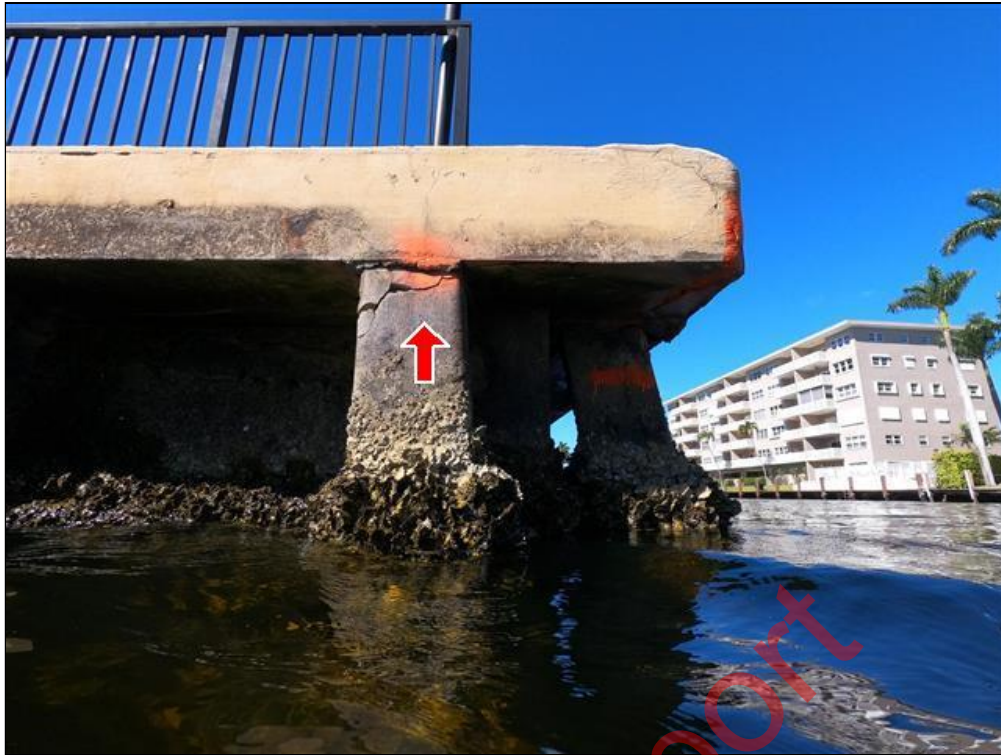
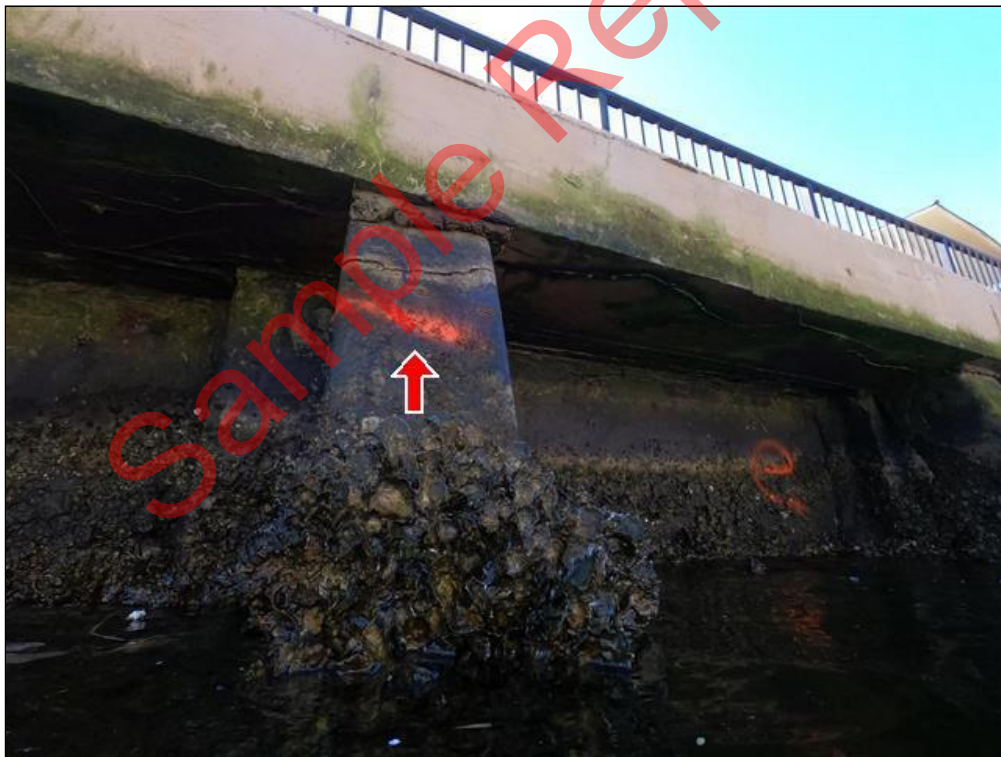
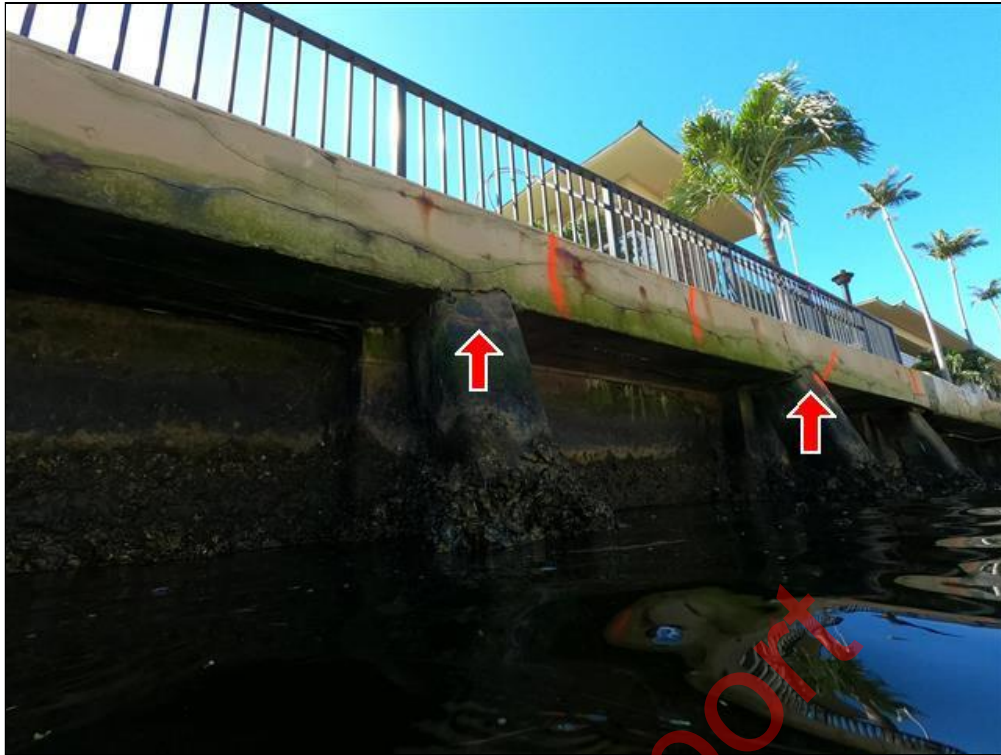
Inspector found moderate levels of deterioration in as many as 6-7 batter piles on the East face of the seawall. Most of the deterioration is located at the splash zone where the pile connects with the CAP. Item 1(Picture) Item 2(Picture) Item 3(Picture) Item 4(Picture) Inspector found no deficiencies with the condition of the batter piles underwater throughout the entire seawall.

**RECOMMENDATIONS:** Inspector recommend repairs of the deteriorating batter piles on the East face by qualified marine contractor.

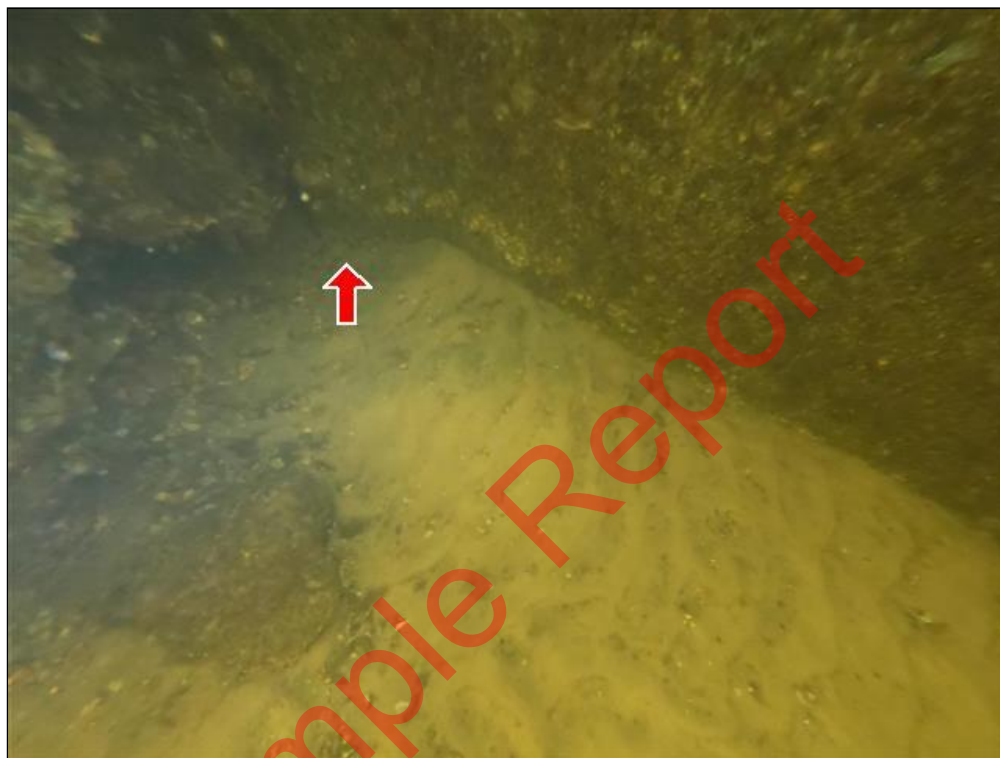
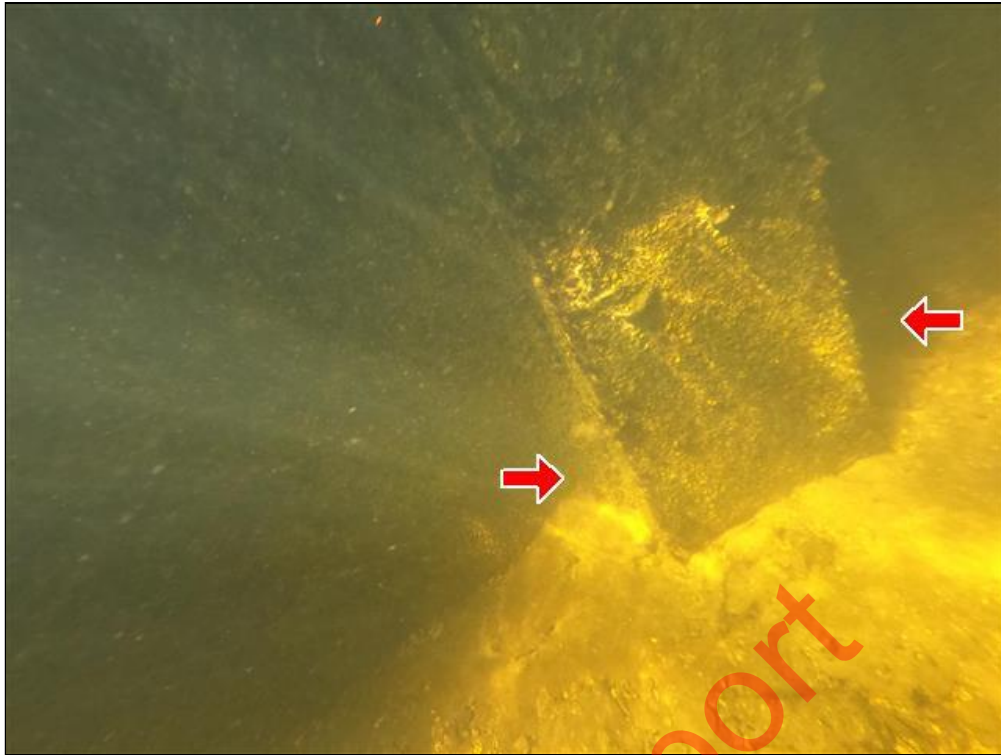
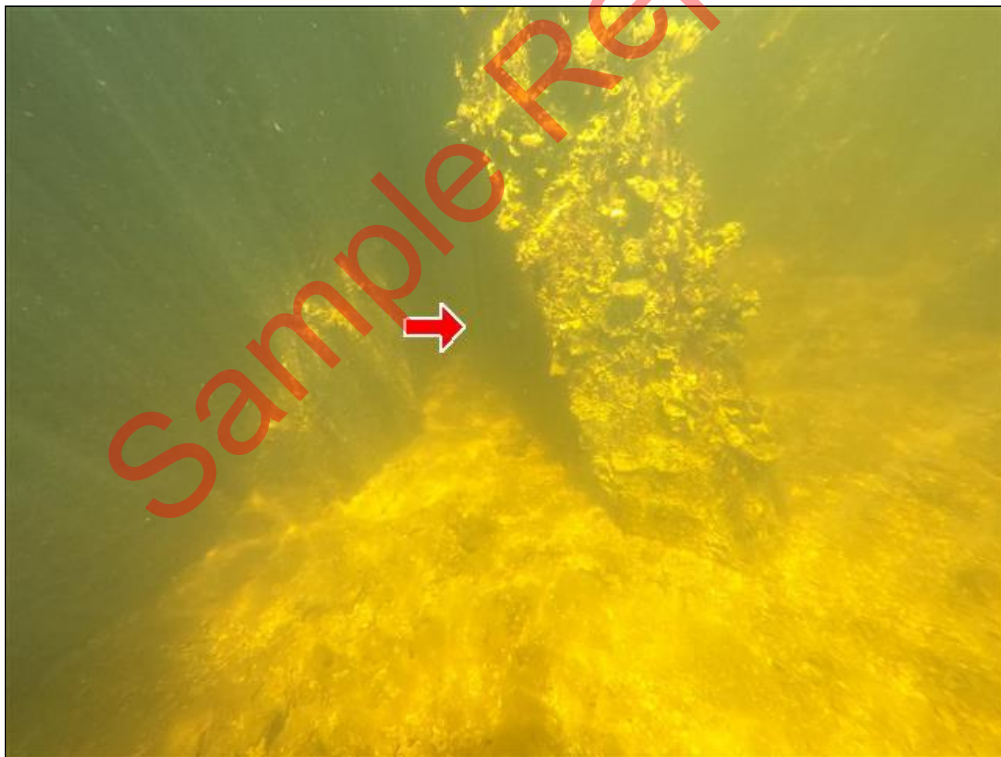
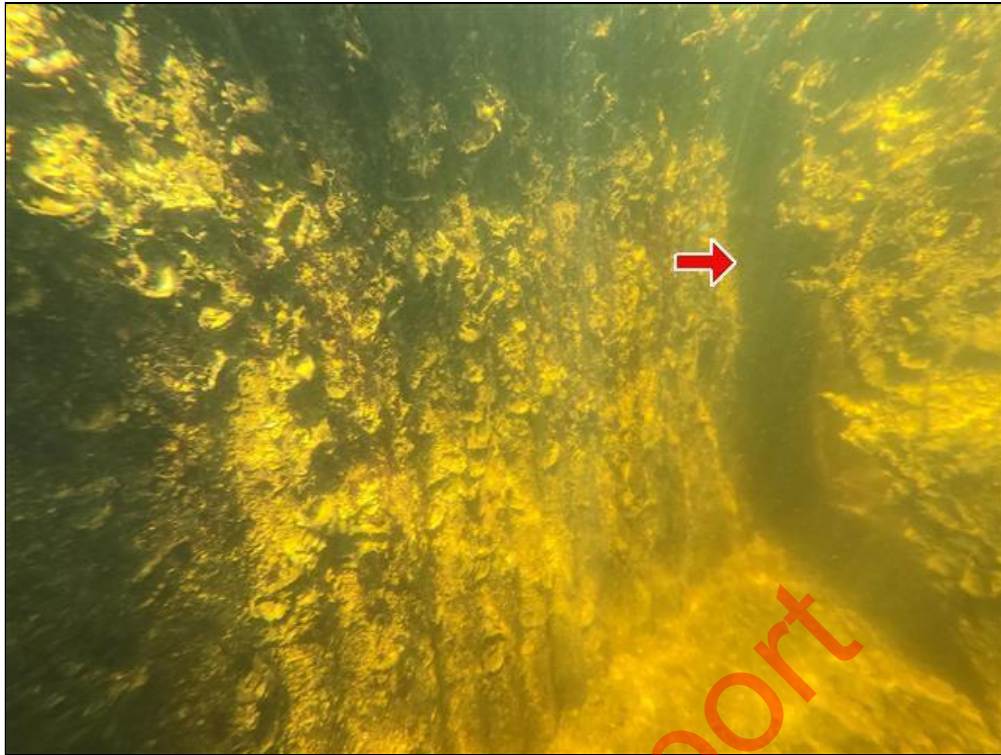
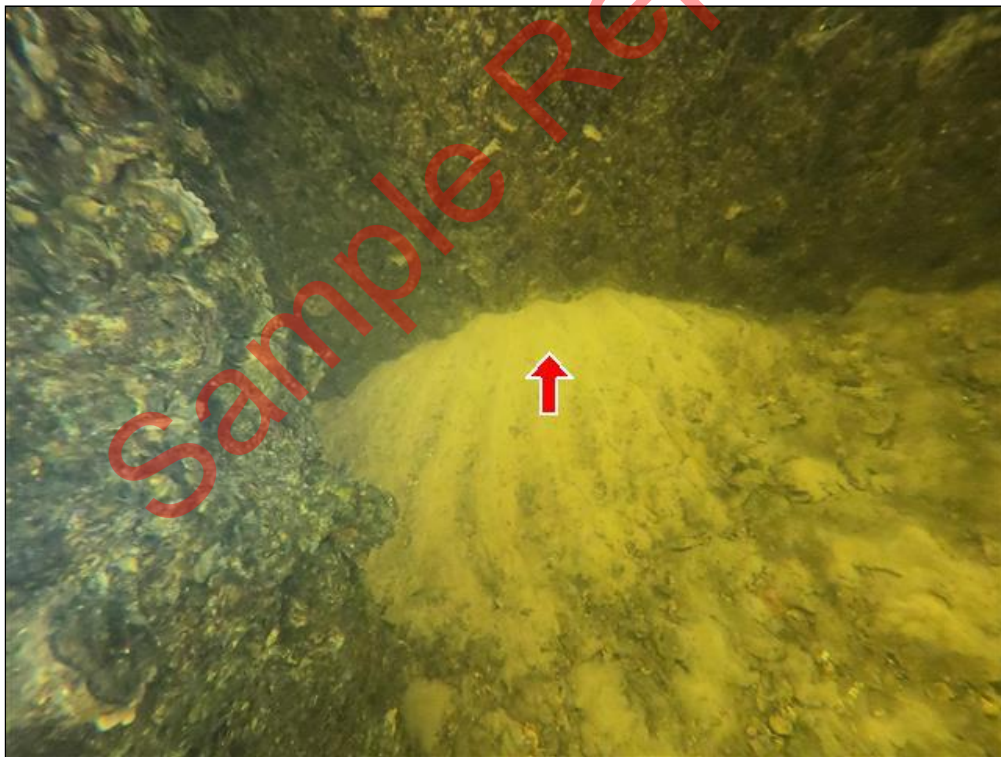
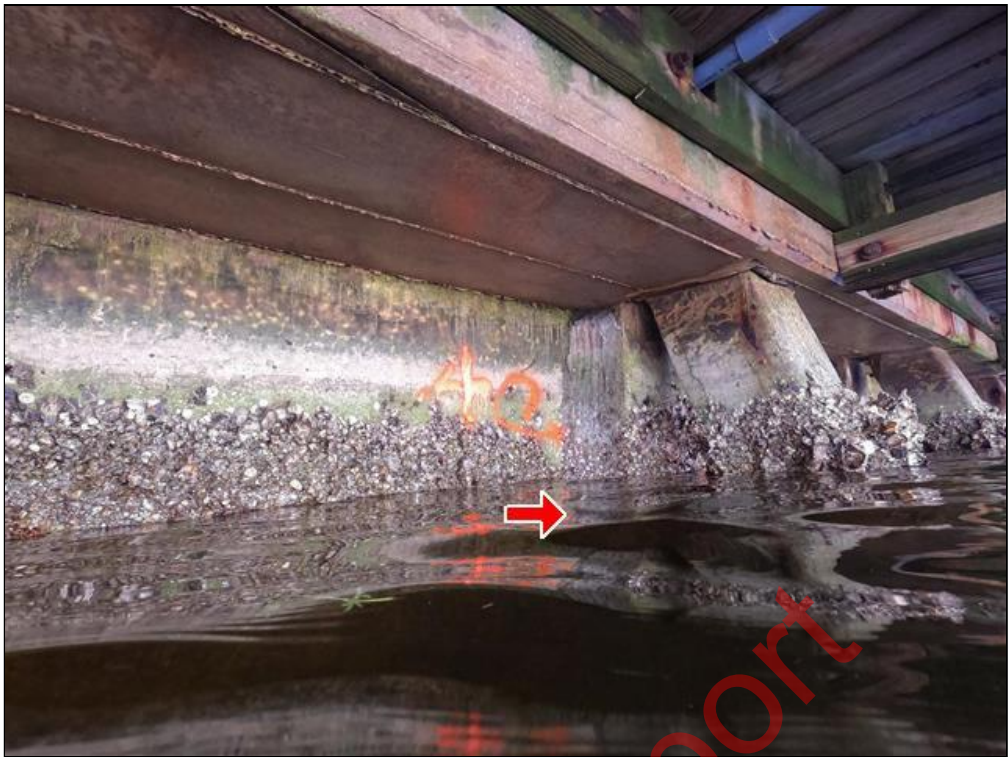
Inspector found widespread damage and loss of seam seals along both faces of this seawall. Inspector marked the seawall for all areas where seam seal loss is leading to erosion. Most of the current soil loss that is evident of the land side is being caused by the failing seam seals. Approximately 70 vertical piles have deteriorating seals on both side.

**RECOMMEDATIONS:** Recommend re-sealing the entire seawall system by qualified marine contractors.
