# Seawall Inspection Report

## Waterside on the Intracoastal

**Property Address:**  
2881 NE 32nd St  
Fort Lauderdale FL 33306

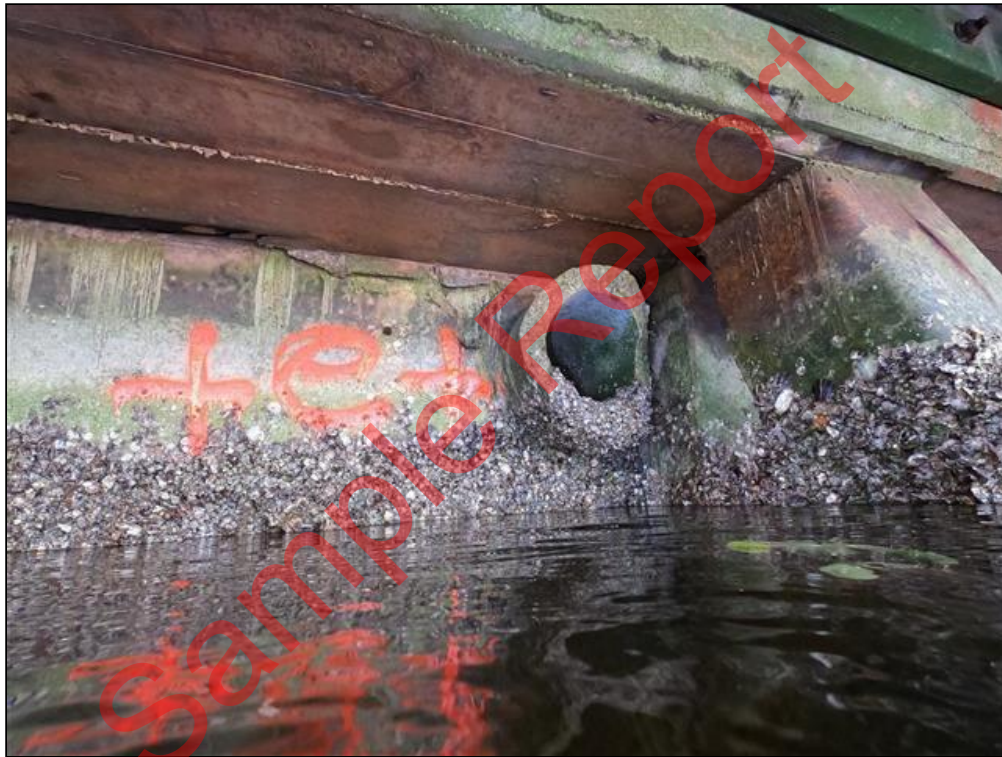
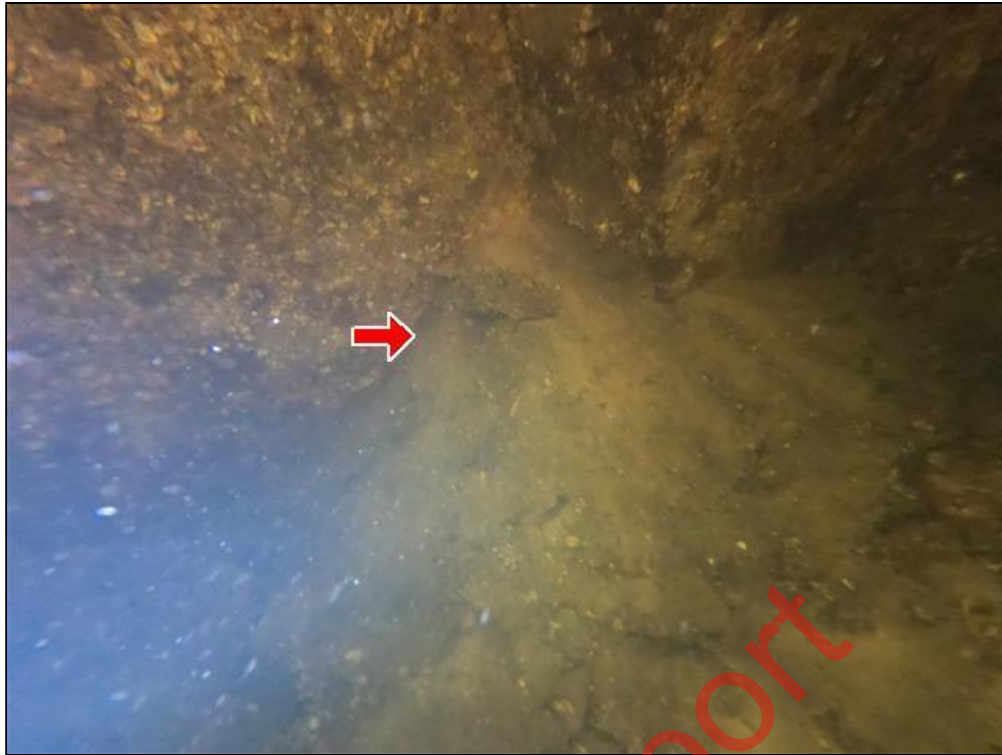
Inspector observed the drainage system. Inspector found only one storm drain along the the entire seawall. The drain appears to be damaged and is pouring large amounts of soil at the bottom of the canal.

**RECOMMENDATIONS:** Inspector recommend repair of this drain to stop further soil loss.
