INSPECTION REPORT  
1512 SW 5th Ave  
Boca Raton FL 33432

INSPECTED BY  
Angelo Menezes  
Certified Inspectors,  
LLC  
HI9467

INSPECTION DATE  
📅 1/12/2026  
🕒 11:00 AM

1. Seawall or Bulkhead

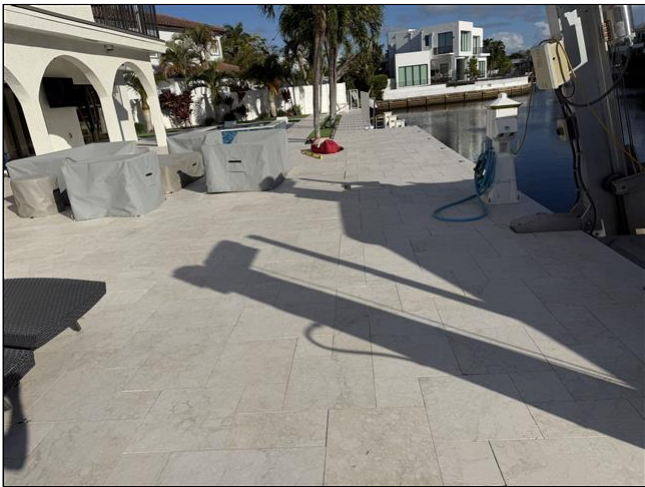
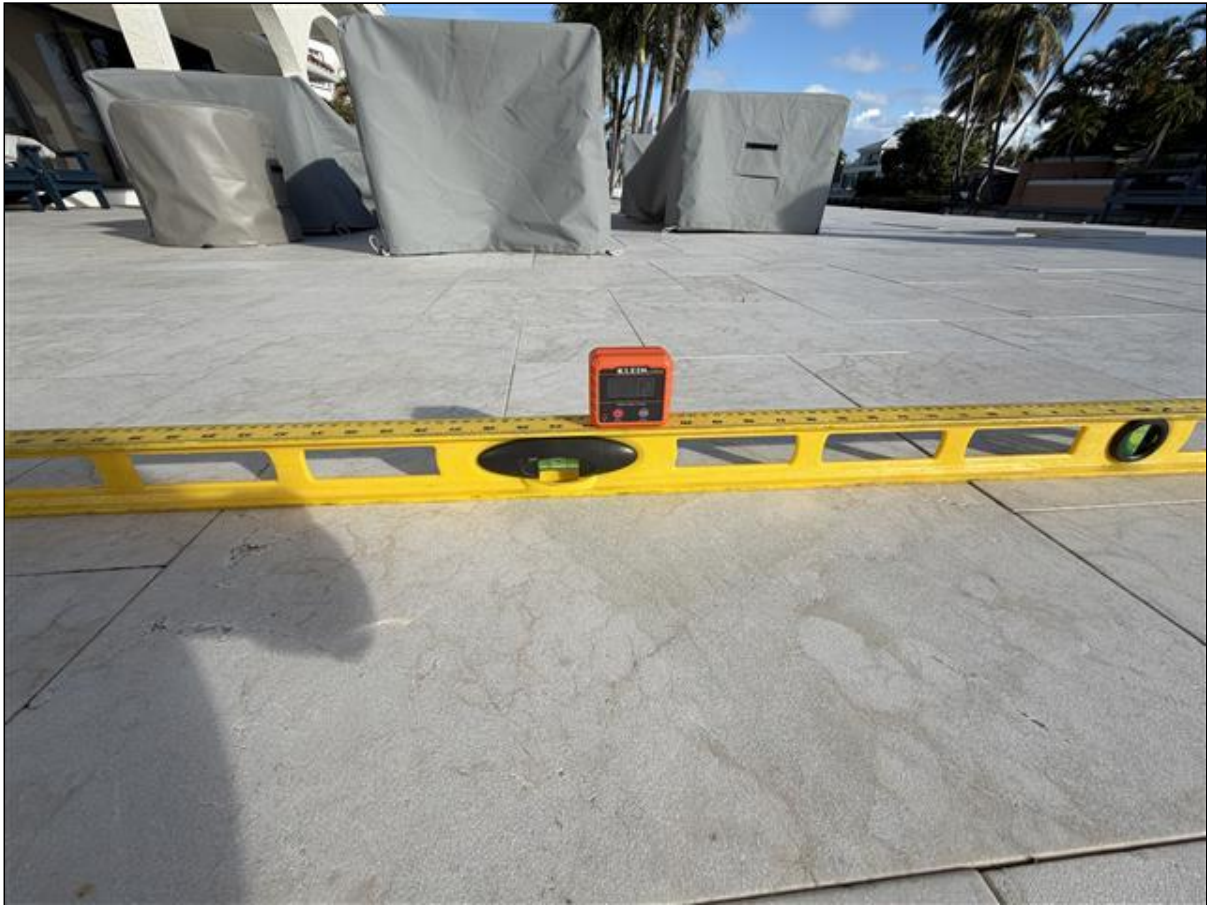
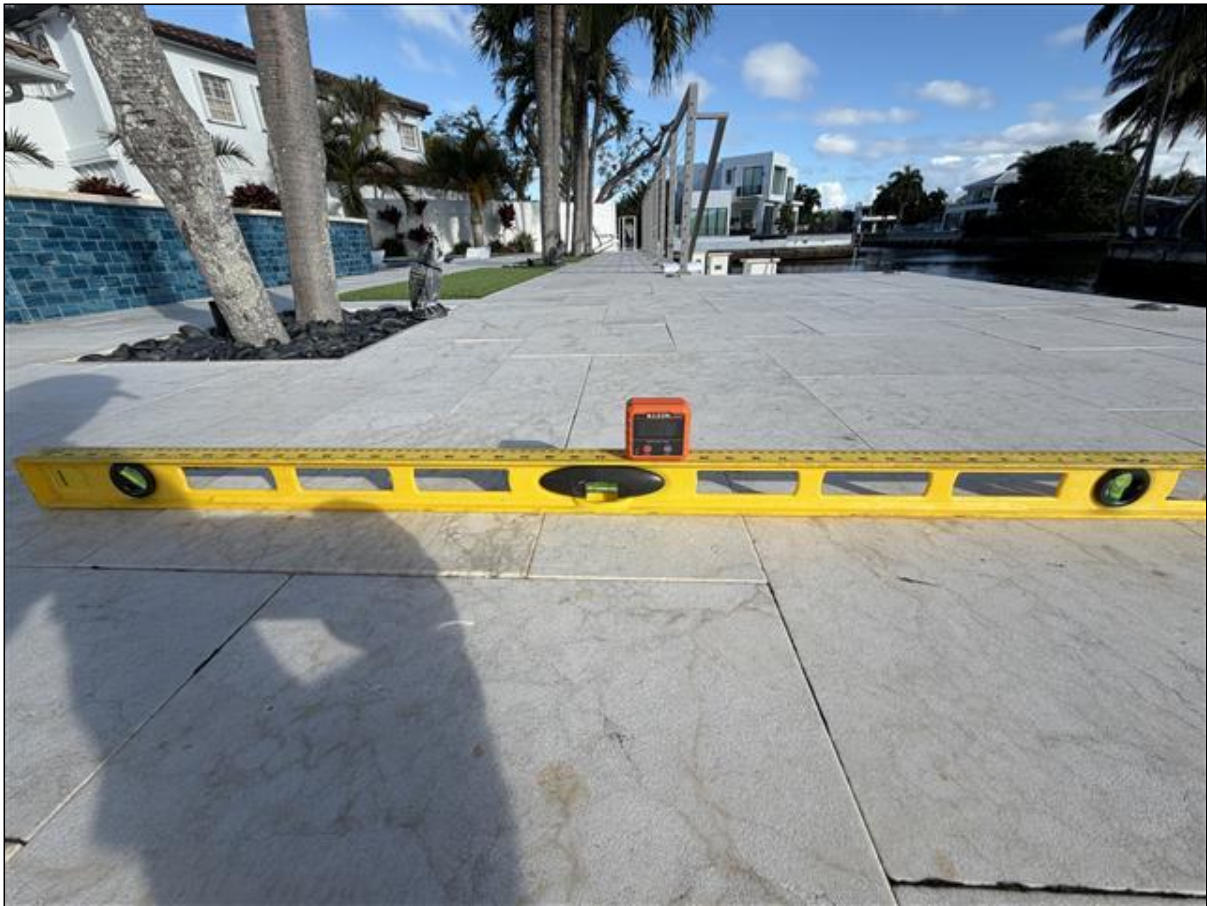
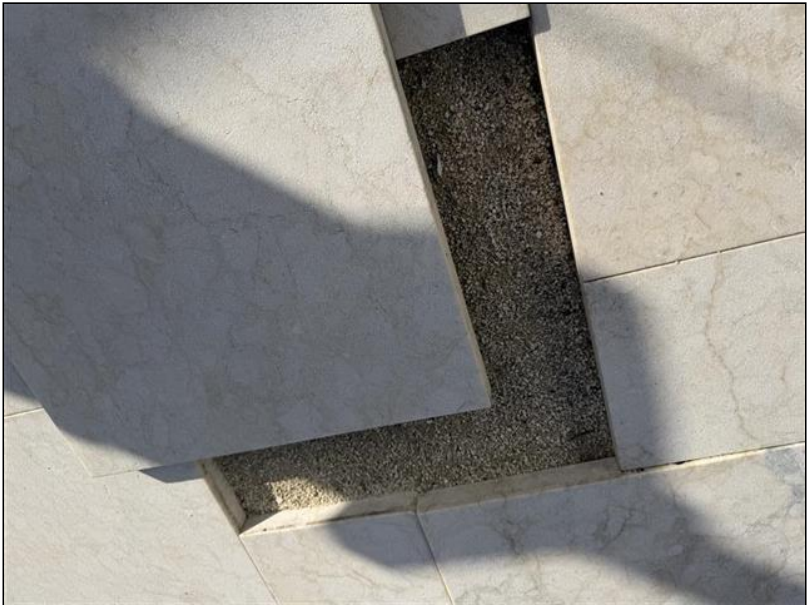
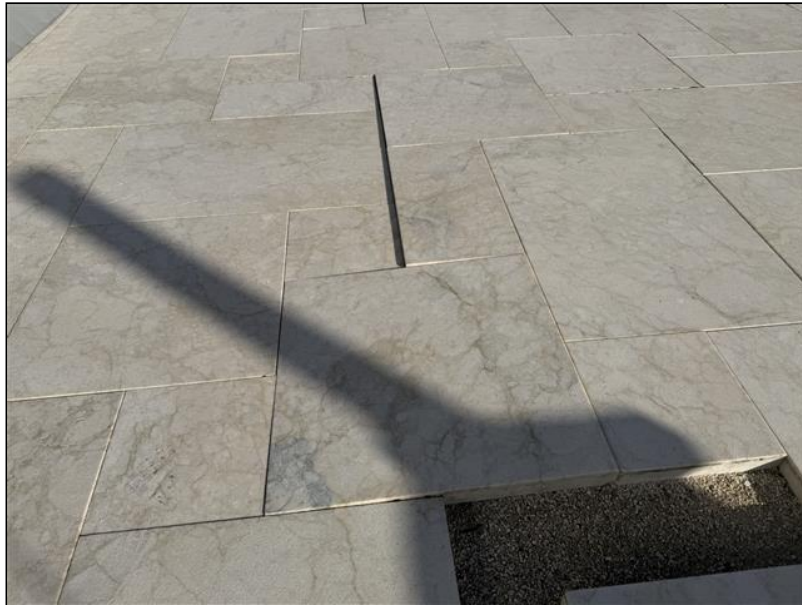
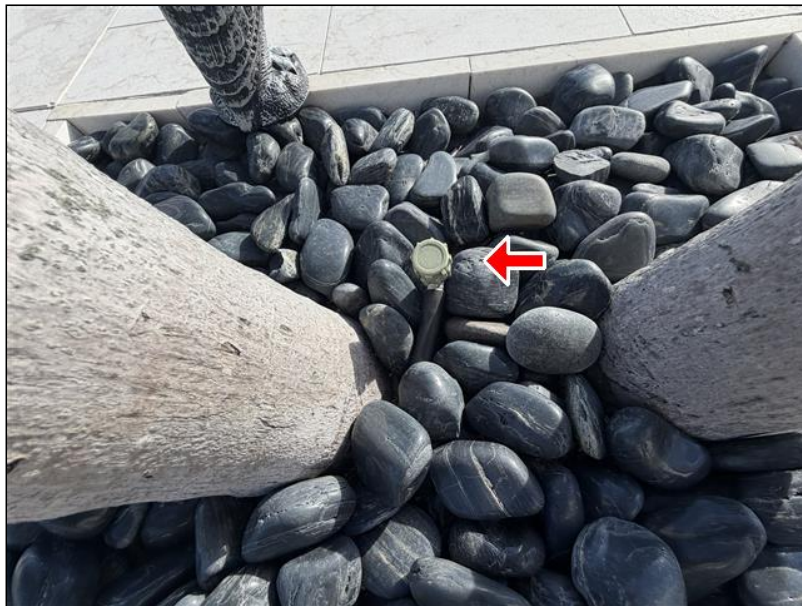
1.0 Grounds

The ground and supporting subgrade near the seawall appear to be experiencing loss of support and differential settlement. Several floor tiles are uneven, displaced, or no longer fully supported, with visible voids beneath some areas, indicating soil migration or washout. The digital level shows localized out-of-plane conditions that are inconsistent with a stable, well-compacted substrate. These conditions are particularly concerning in a waterfront environment, where tidal action, wave energy, and water infiltration can progressively erode underlying soils. It is important to note that the majority of the ground conditions are concealed beneath the tile installation, limiting direct visual confirmation of the extent of soil loss or subgrade deterioration. However, the visible voids, tile movement, and irregular elevations strongly suggest that the concealed areas may be similarly affected.

- Remove select tiles near the seawall to allow direct evaluation of the underlying soil, bedding material, and any drainage or filter fabric present.
- Re-establish proper subgrade support by recompactng soils, replacing lost material, and installing a suitable stabilized base (e.g., compacted aggregate with underground textile separation).
- Consider installing drainage improvements or edge restraints to reduce water intrusion and migration of fines beneath the tiled surface.
- Manage to reduce or minimize the amount of water discharged through the sprinkler system.
- Reset or replace affected tiles after subgrade repairs, ensuring proper slope and uniform support..

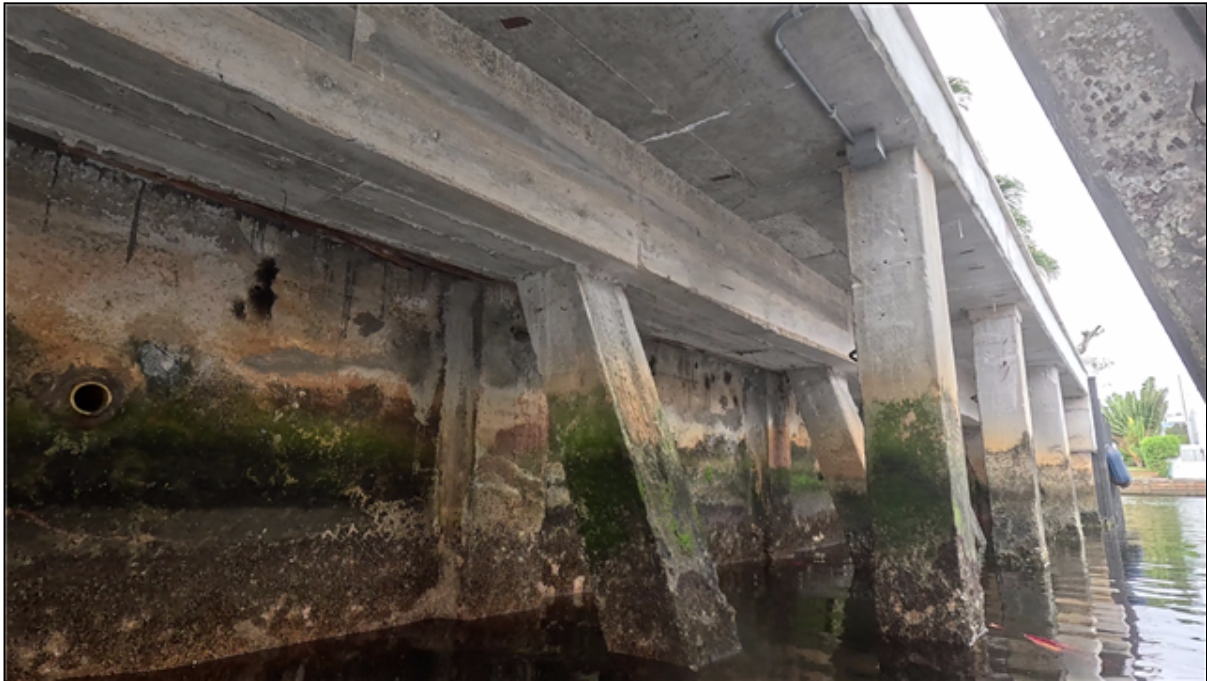
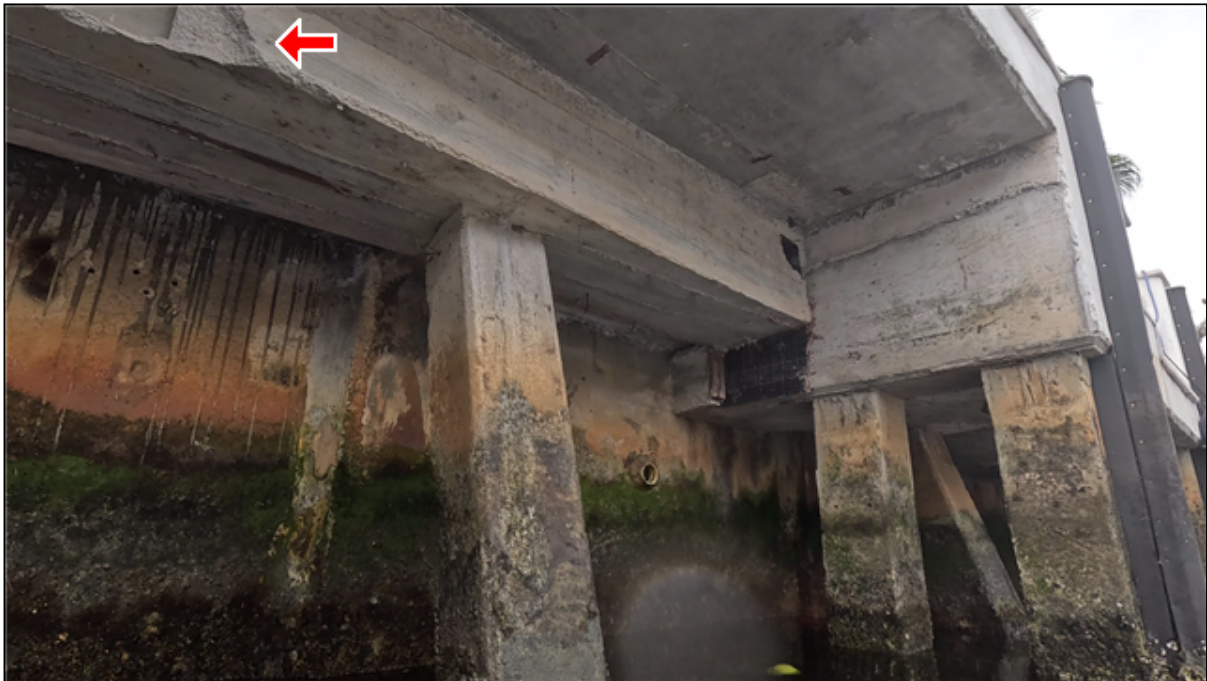
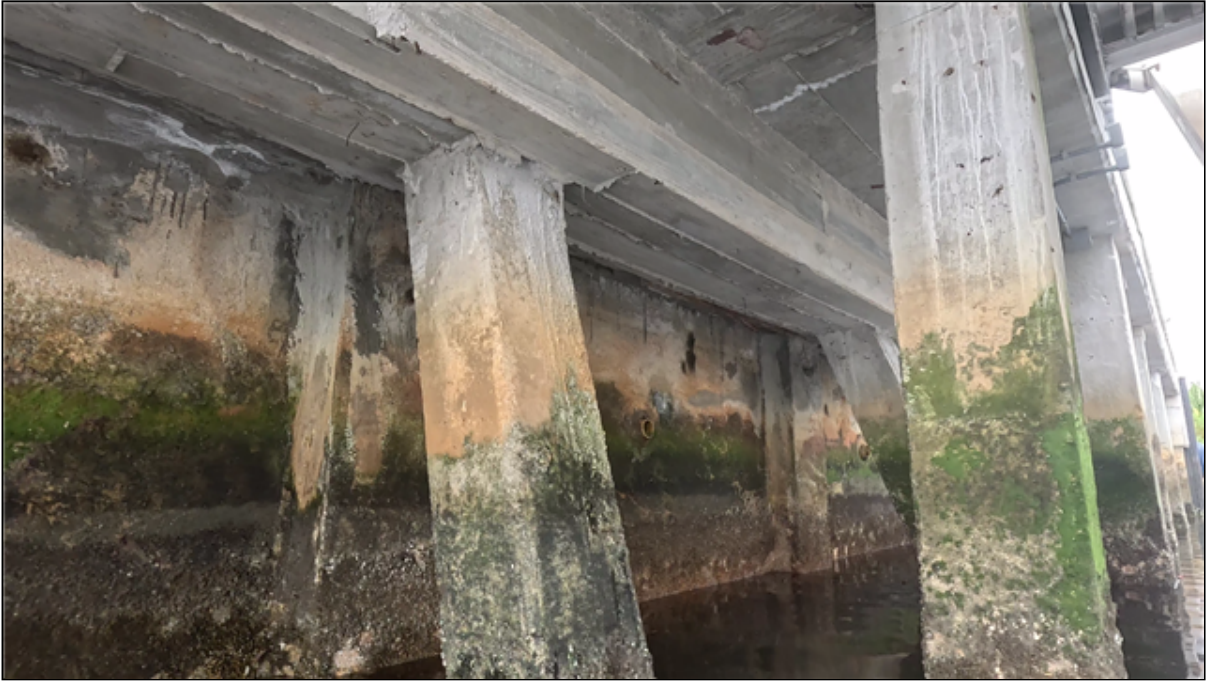
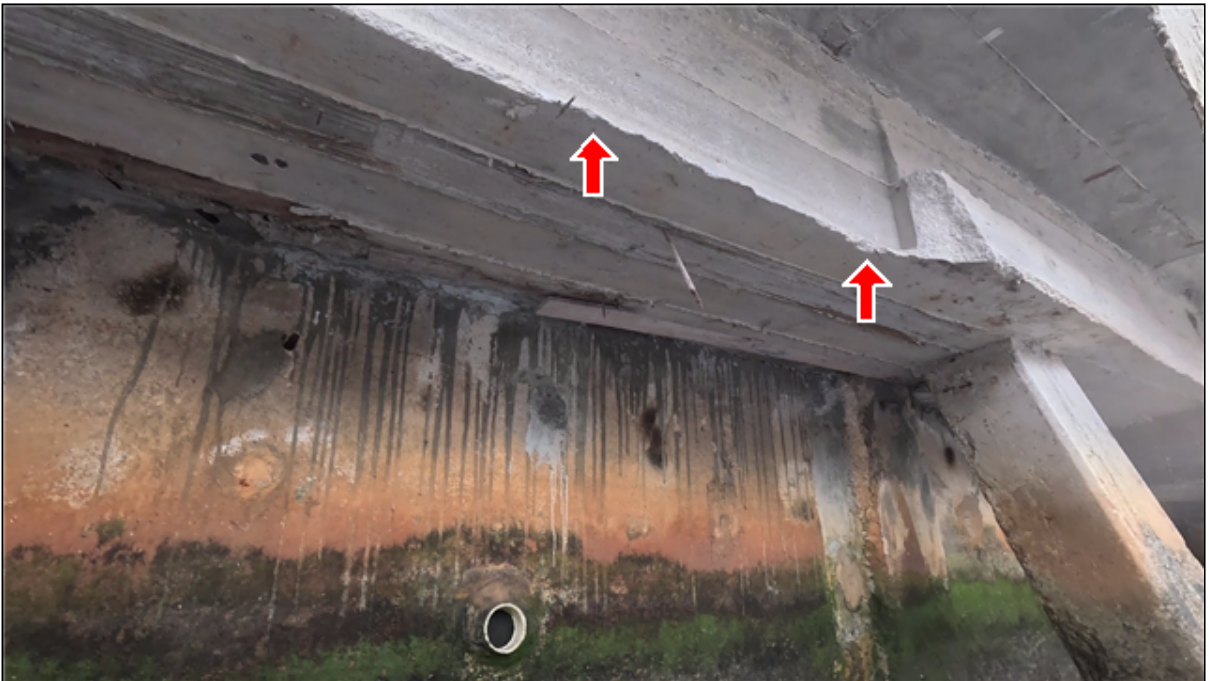
### 1.1 Seawall Cap

The seawall cap exhibited visible signs surface deterioration, staining, biological growth, and localized concrete distress. The underside of the cap shows discoloration, leaching, and streaking consistent with moisture intrusion and saltwater exposure. In several areas, the concrete edges appear roughened and weathered, suggesting surface deterioration.

While no widespread spalling or exposed reinforcement is visible, the staining patterns and deteriorated surface texture indicate that moisture is migrating through the concrete. Similar to the deck area above, much of the condition of the seawall cap is concealed from view, limiting confirmation of internal deterioration. This is particularly true on the interface between the cap, backfill, and reinforcing steel.

- Clean marine growth and staining to allow clearer visual assessment and slow ongoing biological deterioration.
- Repair localized concrete distress using appropriate marine-grade repair materials, including patching, resurfacing, or edge restoration where section loss is identified.
- Seal cracks, joints, and penetrations to reduce water intrusion into the seawall cap and supporting members.

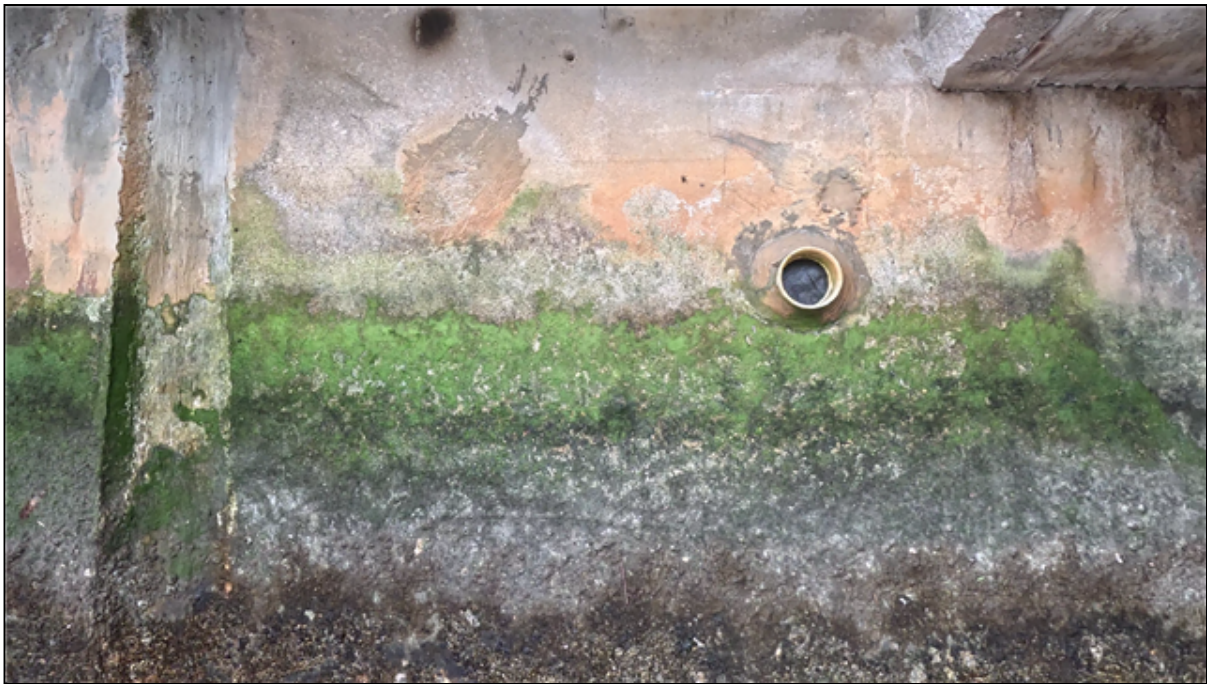
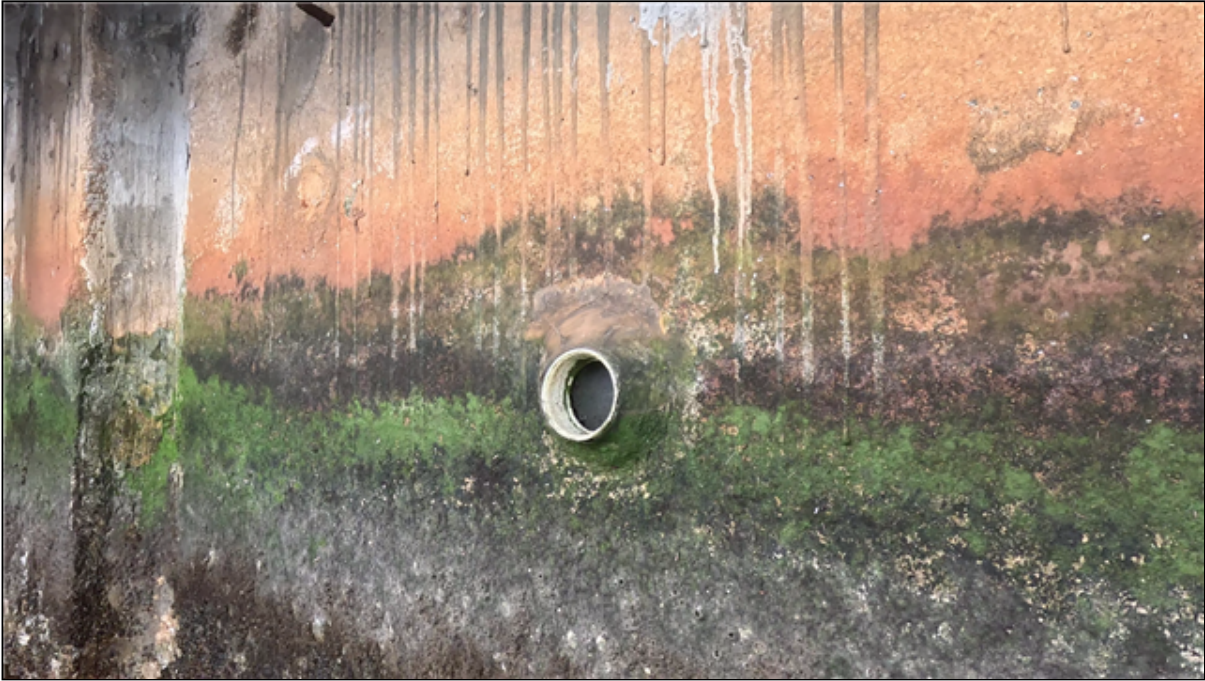
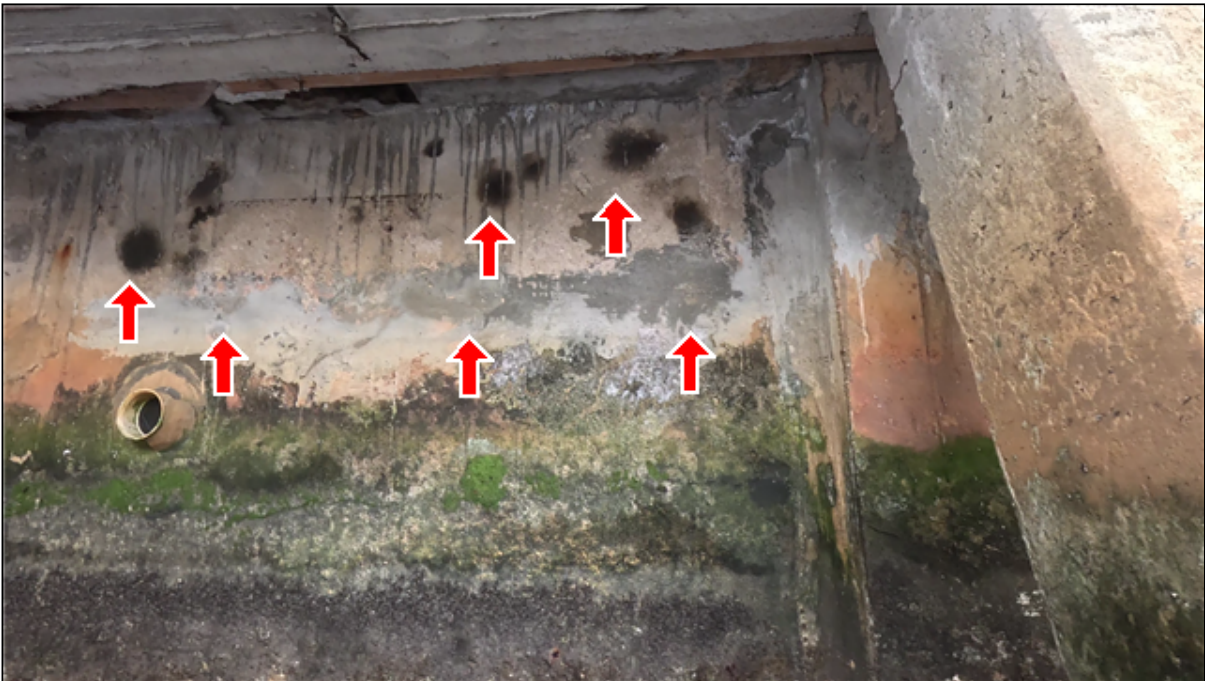
**1.2 Seawall Face**

The reinforced concrete seawall panels exhibit moderate to advanced deterioration consistent with long-term exposure to a marine environment. The panels show pronounced tide-line staining, biological growth, mineral deposits, and widespread discoloration, all of which indicate chronic and repeated wetting from fluctuating water levels. Numerous dark circular patches and linear staining patterns are visible on the panel faces, which are commonly associated with moisture migration through the concrete matrix and corrosion activity at embedded reinforcing steel. In several areas, patch repairs appear to have been performed in the past; however, these repairs are uneven, weathered, and in some locations appear to be debonding or ineffective, suggesting ongoing deterioration behind the repaired surfaces. The visible distress patterns strongly suggest that corrosion-related expansion and moisture intrusion may be occurring internally and could progress if not addressed.

- Retain a qualified marine structural engineer to perform hammer sounding, probing, and nondestructive testing to assess concrete integrity and reinforcing steel condition.
- Clean the seawall panel surfaces to remove biological growth and deposits, which will improve visibility of defects and reduce ongoing surface degradation.
- Consider applying a protective coating, sealant, or corrosion-inhibiting system designed for marine environments to slow moisture ingress and extend the service life of the seawall panels.
- Monitor the seawall periodically for progression of cracking, spalling, or displacement, and plan for more extensive rehabilitation if deterioration continues.

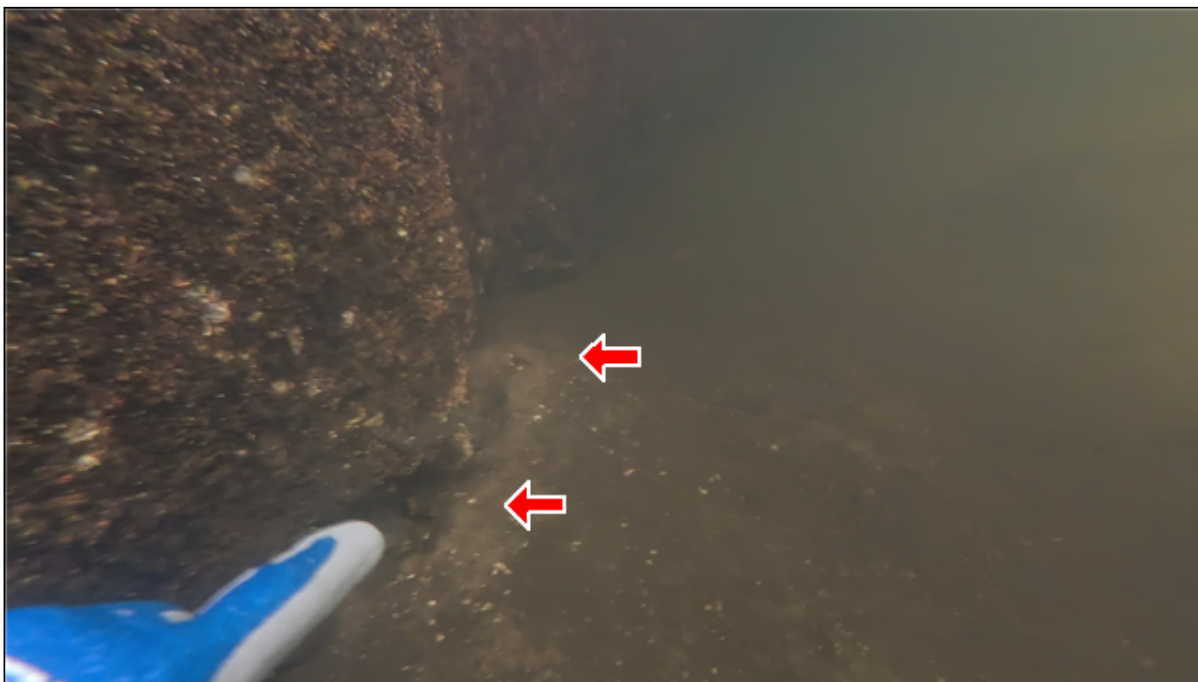
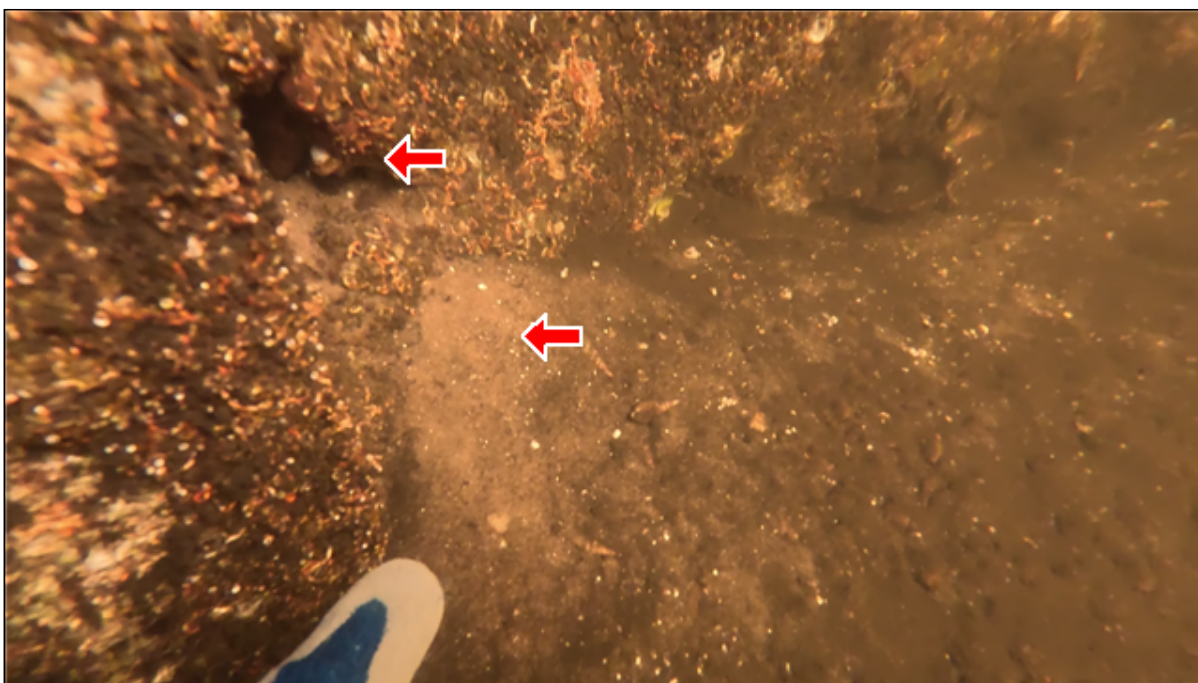
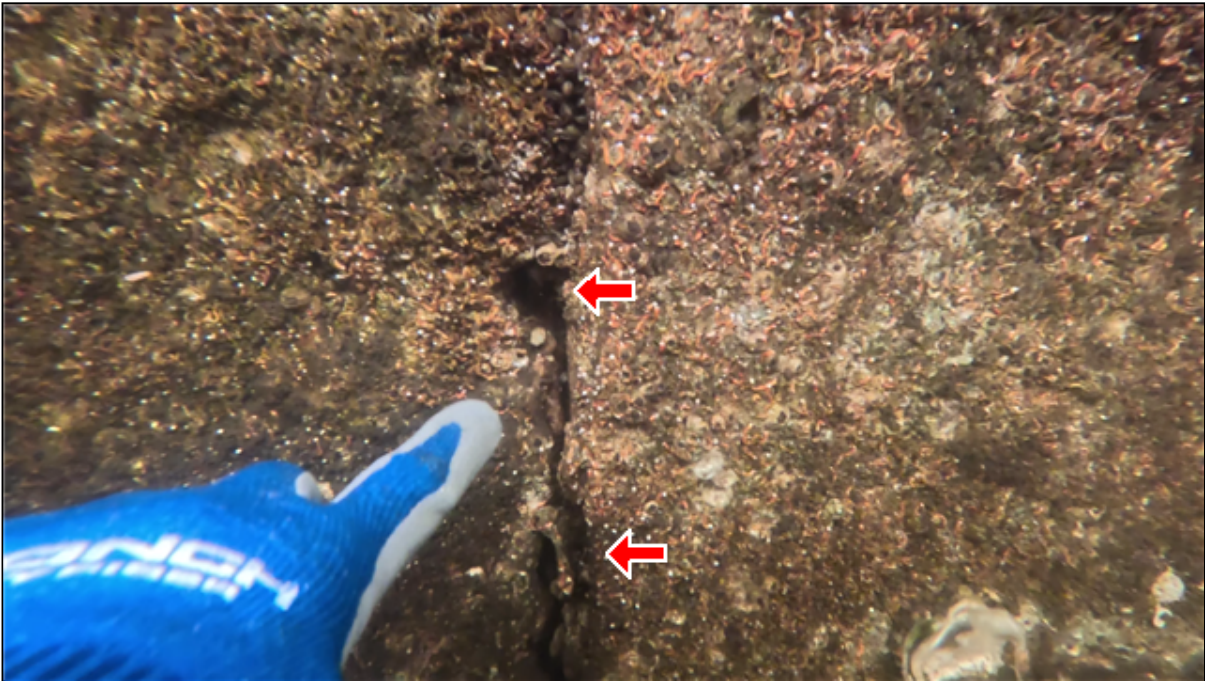
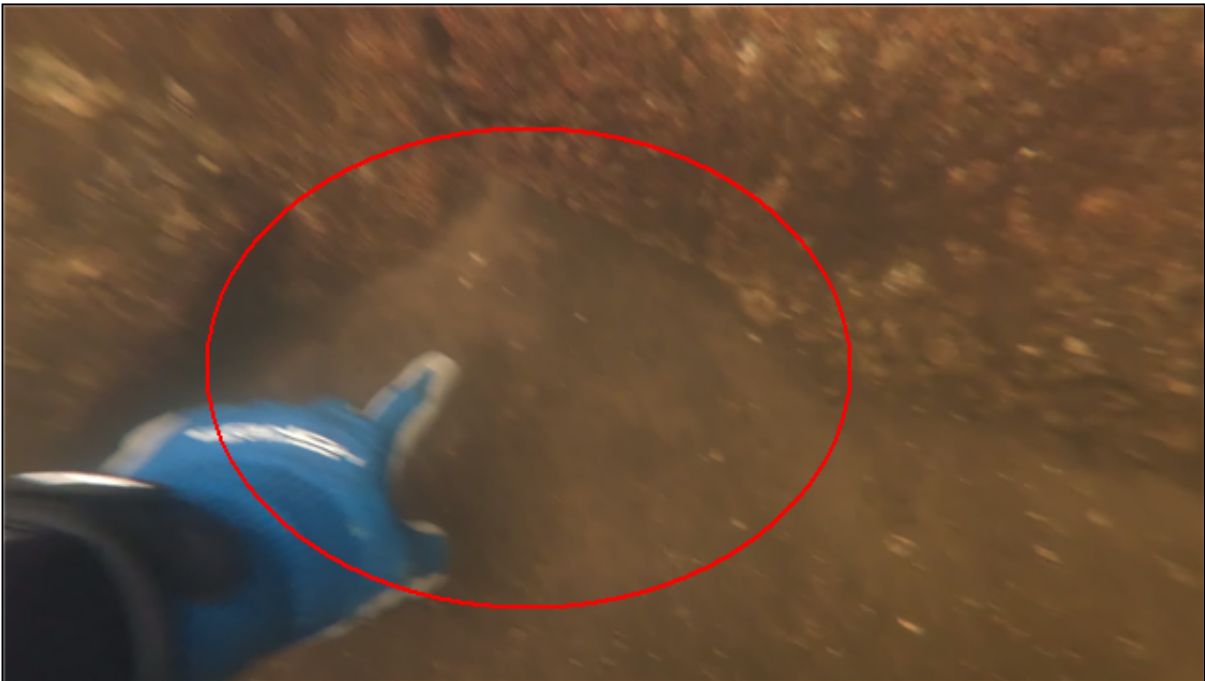
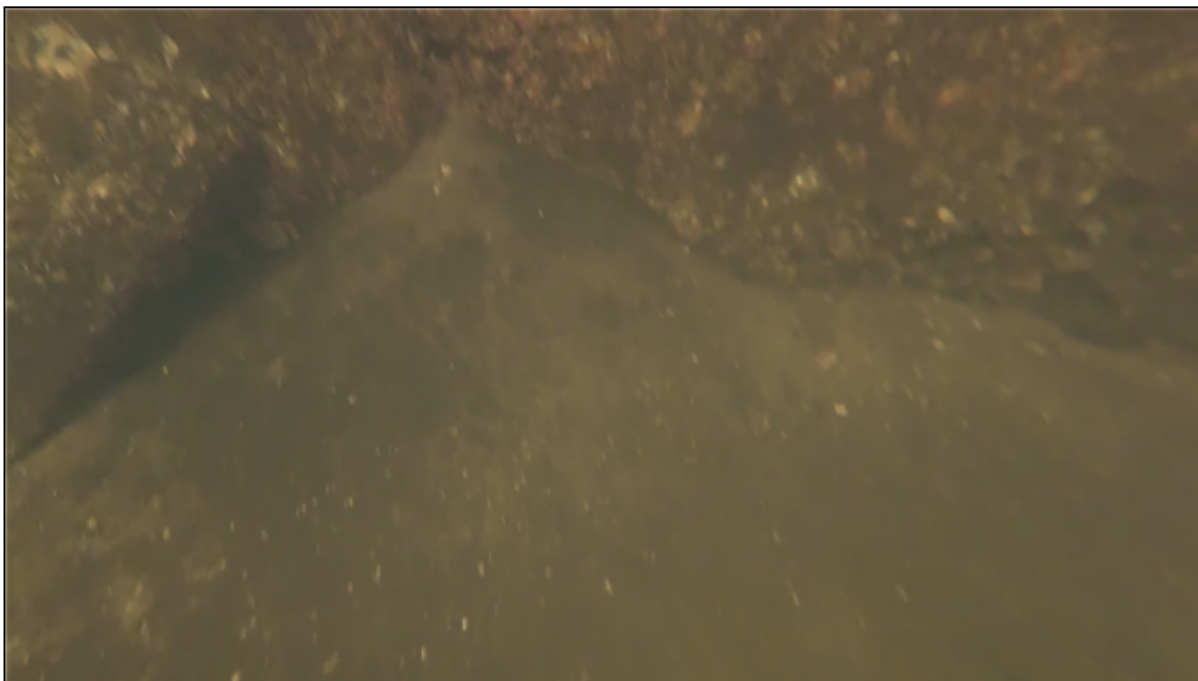
### 1.3 Footings or foundation

The seawall foundation consists of a cast-in-place concrete wall bearing directly onto the berm, with no visible continuous footings. The exposed base of the wall is heavily encrusted with marine growth, indicating prolonged submergence and tidal influence. The images show the wall transitioning directly into sandy substrate, with localized voids and depressions along the toe. No riprap, or footer protection is present at the base of the wall.

Inspector observed loss of supporting soil immediately adjacent to the seawall face, creating undercut conditions beneath the wall. In several locations, voids are visible at the wall-to-soil interface, suggesting that soil has been washing out by tidal action and wave energy. The presence of sediment plumes when disturbed further indicates loose, unstable soils and ongoing erosion. The foundation appears partially undermined in localized areas, reducing effective

bearing capacity and increasing the risk of settlement or rotation of the seawall. The absence of a footer allows continued soil migration which translate into ground destabilization and can compromise structural stability.

- Install foundation protection at the seawall toe, such as riprap over textile fabric or a concrete footer designed for local conditions.
- Install pressure-grout or marine-grade hydraulic cement on existing voids beneath the wall to restore bearing support where feasible.

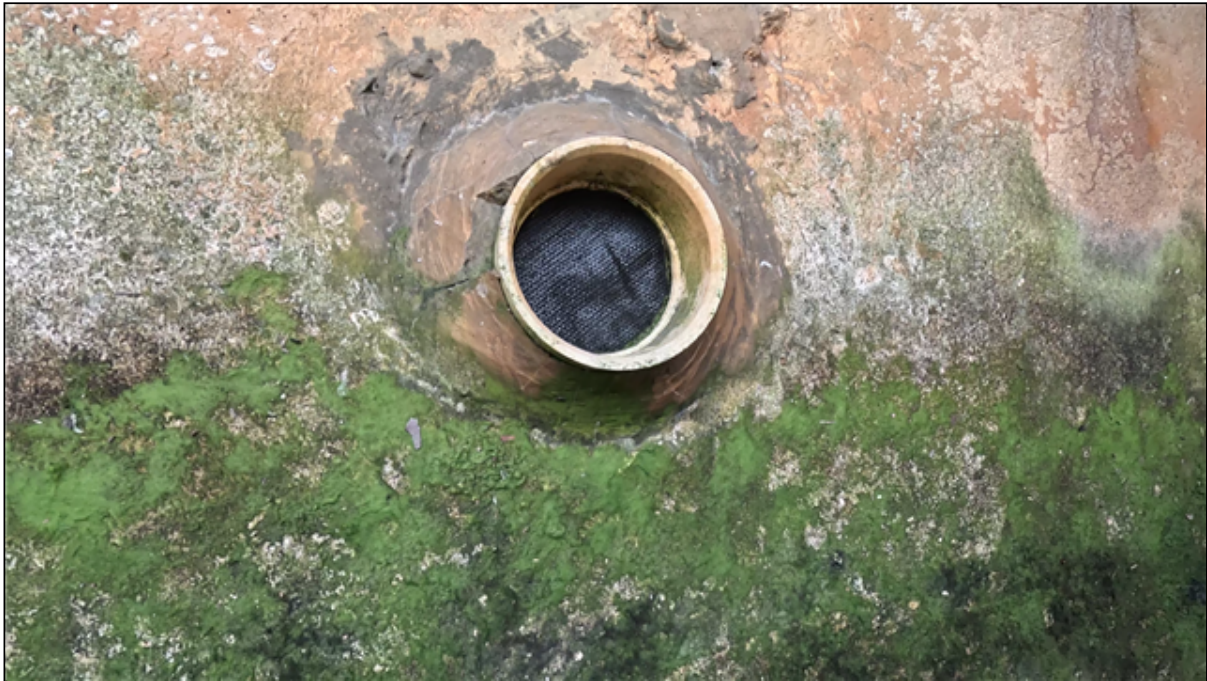
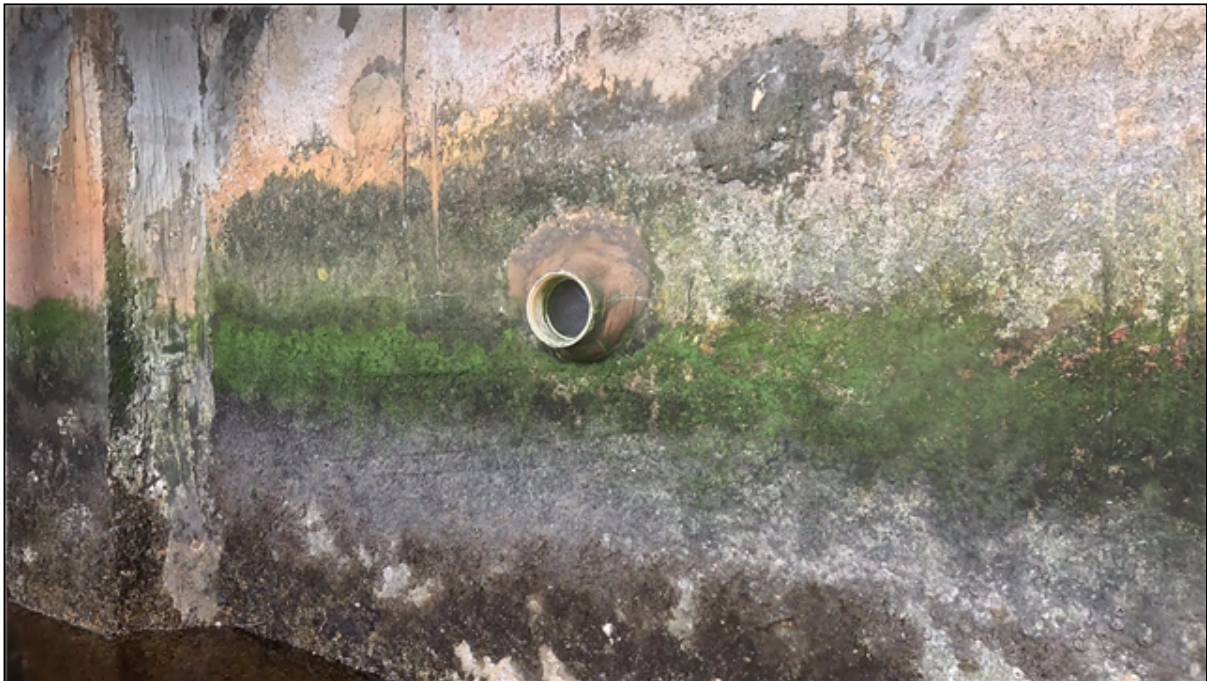
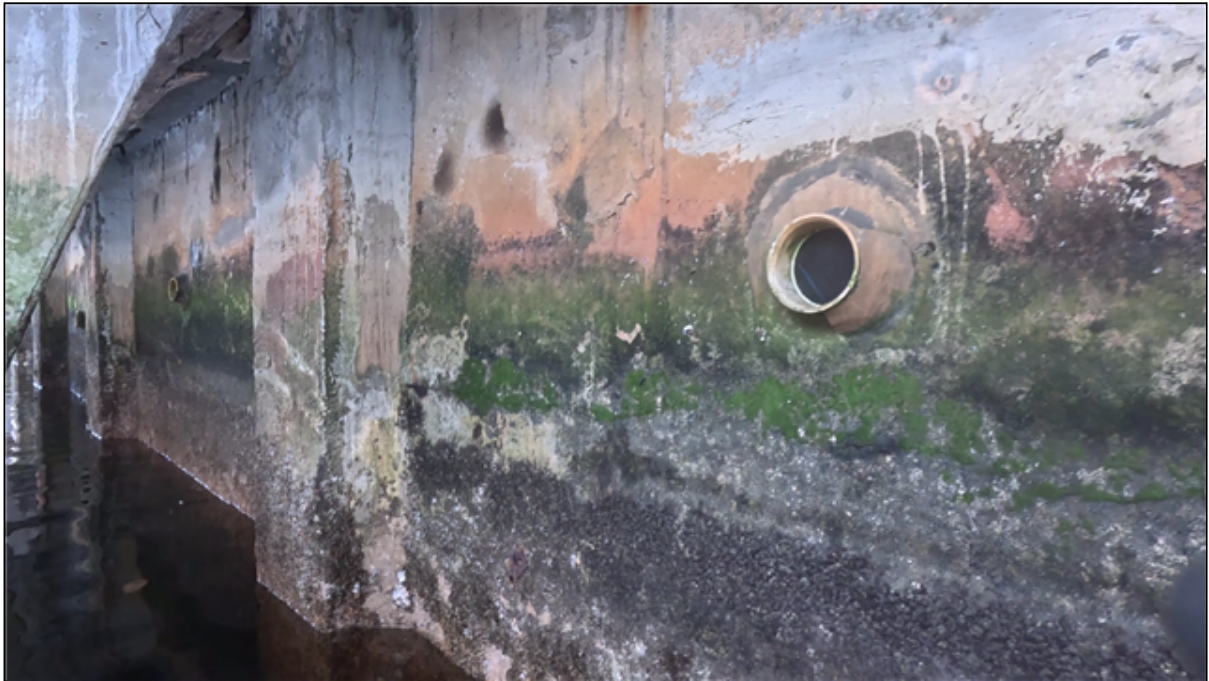
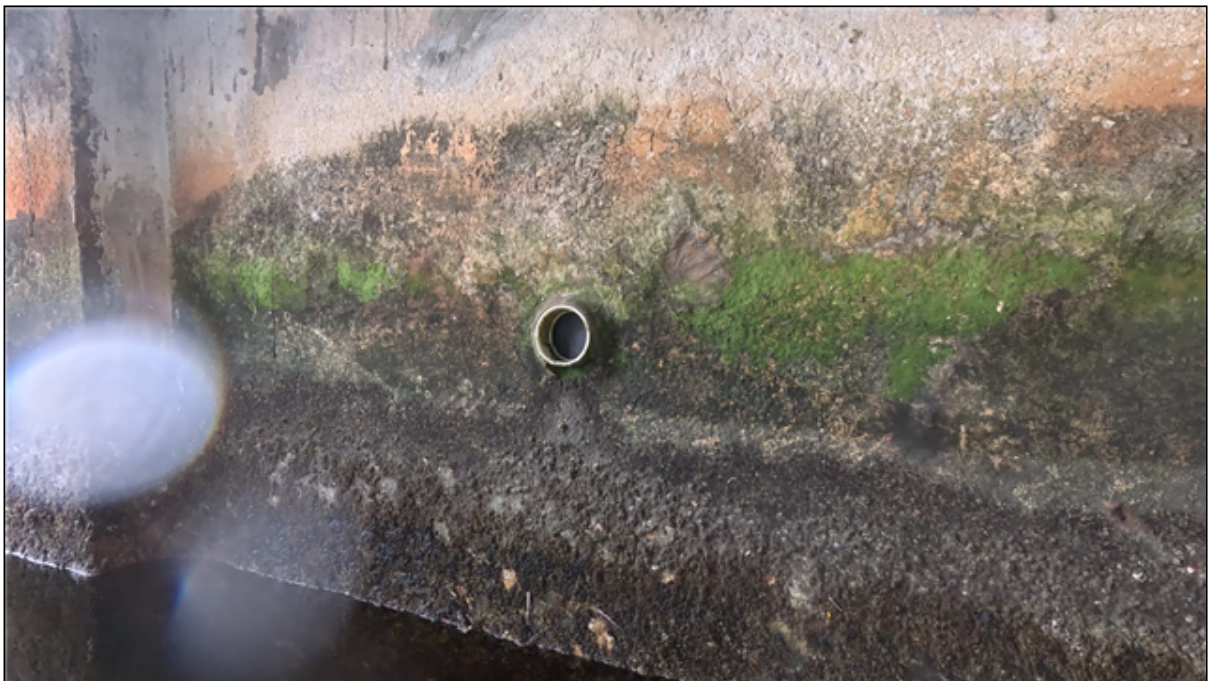
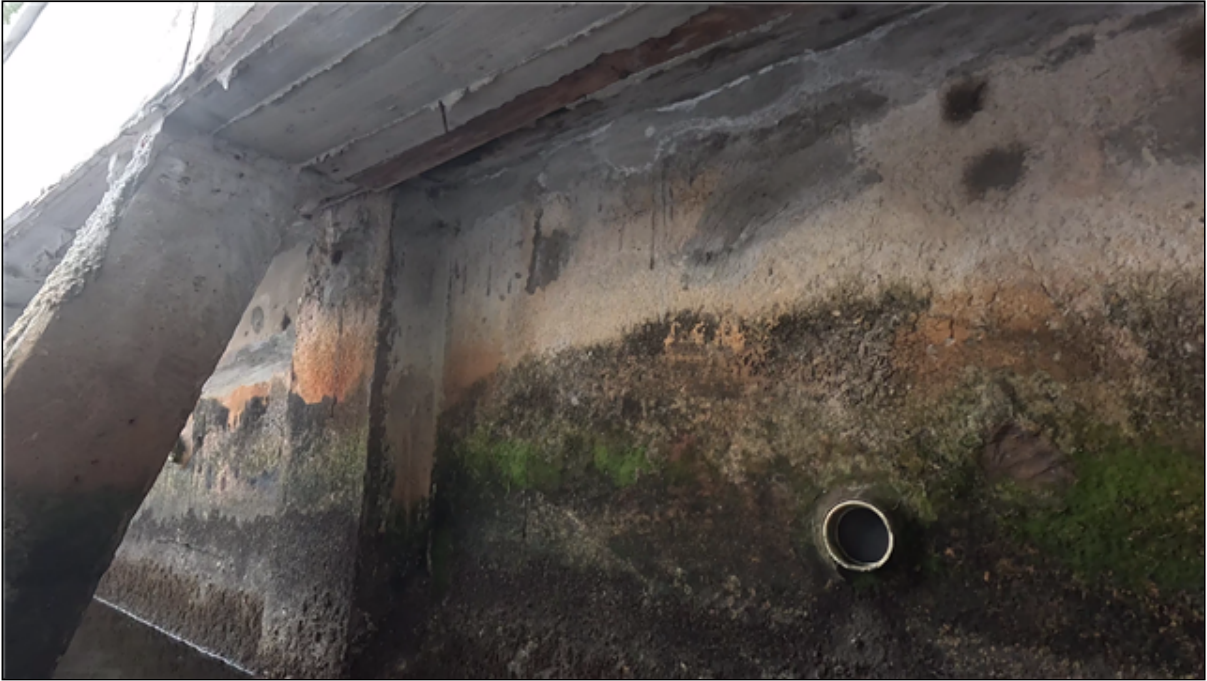
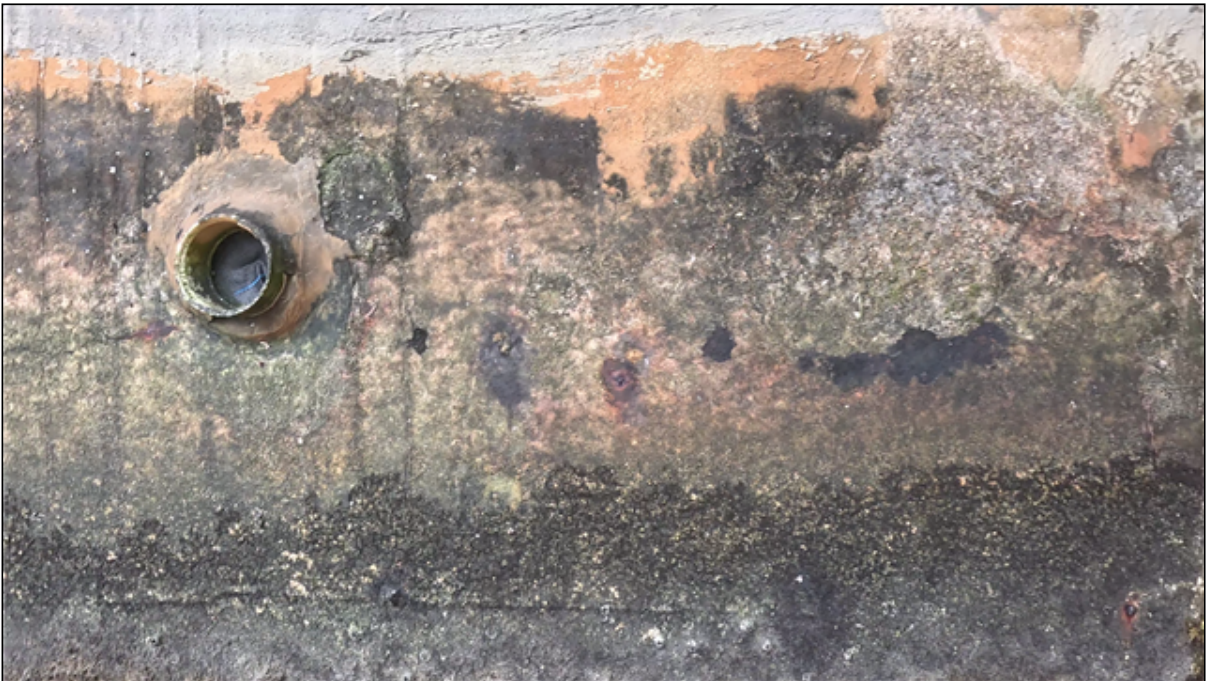
#### 1.4 Drainage or Storm sewer

The seawall drainage system consists of several weep holes penetrating the concrete seawall panels to relieve hydrostatic pressure by allowing groundwater behind the wall to discharge. The drains contain screen material intended to limit soil loss while permitting water flow. The drains show minor deteriorated patching, cracking, or separation between the pipe sleeve and surrounding concrete, which may allow some soil loss or seepage.

- Clean, clear, and flush all drainage outlets to assure proper water flow, including removal or replacement of clogged mesh or screens as necessary.
- Repair or reseal the pipe-to-concrete interfaces using marine-grade, non-shrink repair materials to prevent soil loss and uncontrolled seepage.
- Implement periodic inspection and maintenance of the drainage outlets to ensure continued functionality and to reduce long-term structural risk to the seawall.
