INSPECTION REPORT  
1512 SW 5th Ave  
Boca Raton FL 33432

INSPECTED BY  
Angelo Menezes  
Certified Inspectors,  
LLC  
HI9467

INSPECTION DATE  
📅 1/12/2026  
🕒 11:00 AM

1. Seawall or Bulkhead

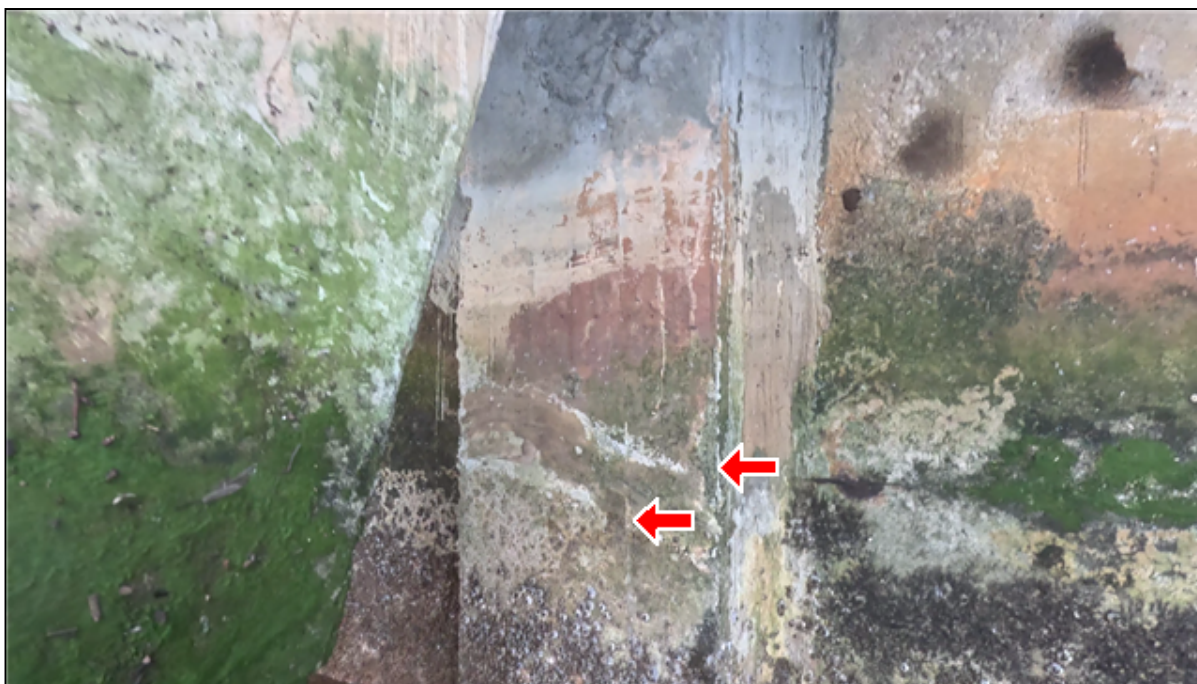
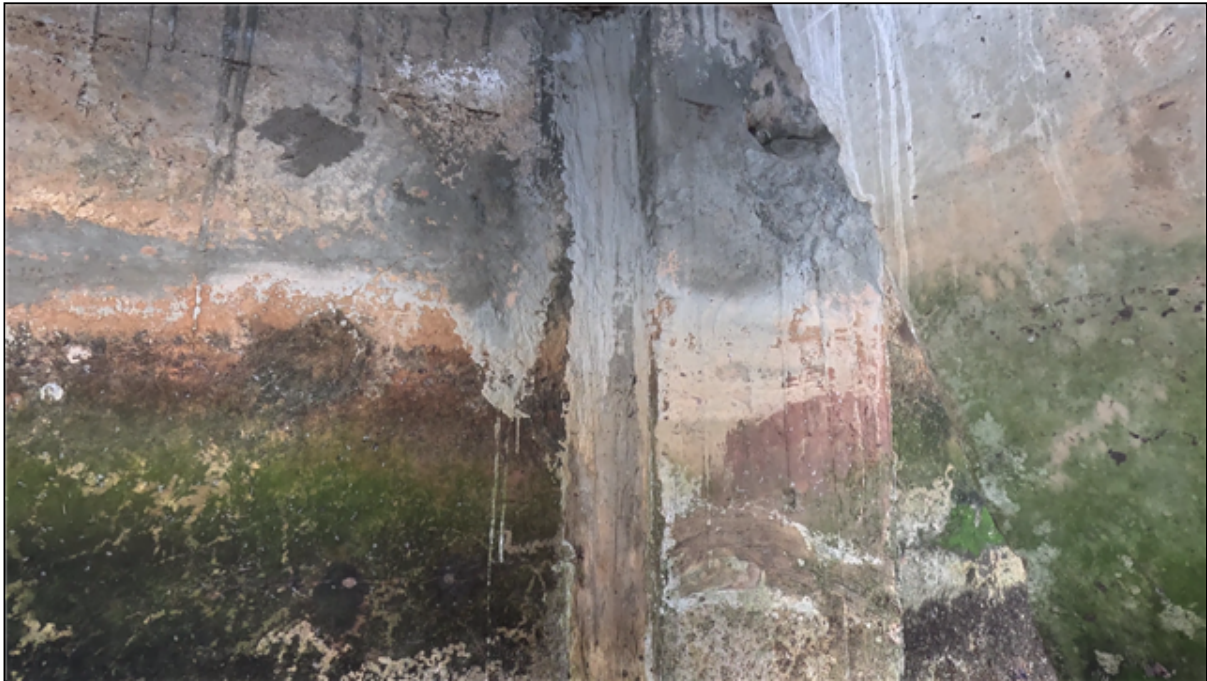
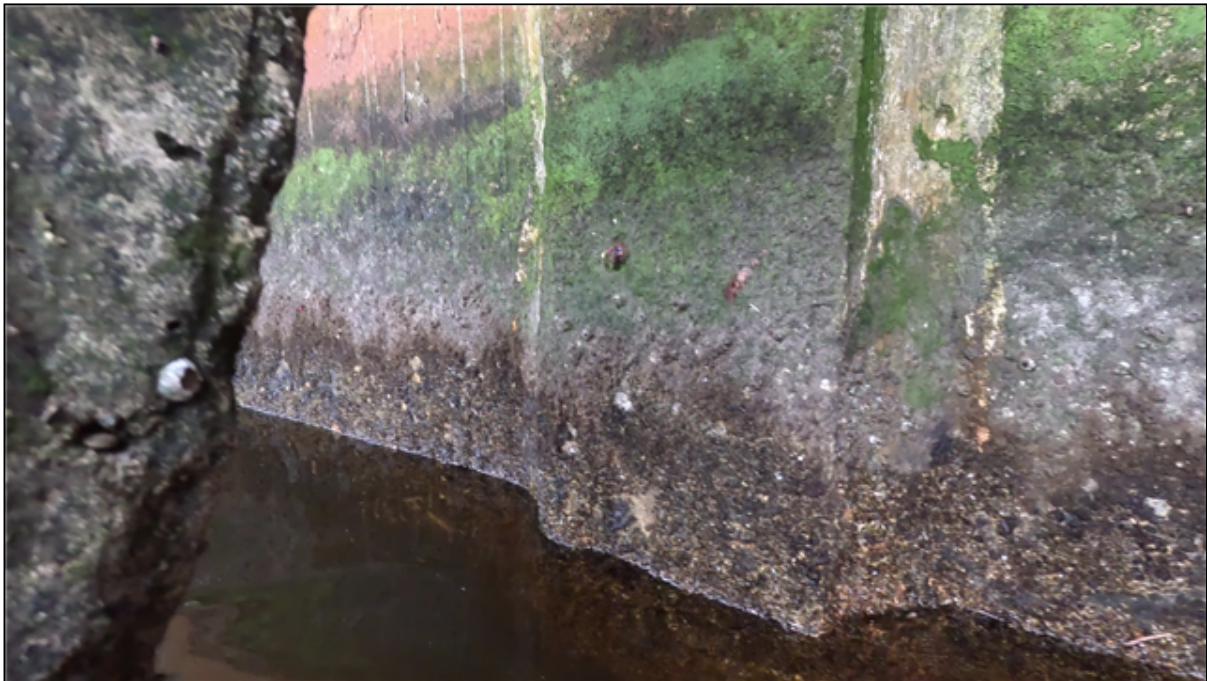
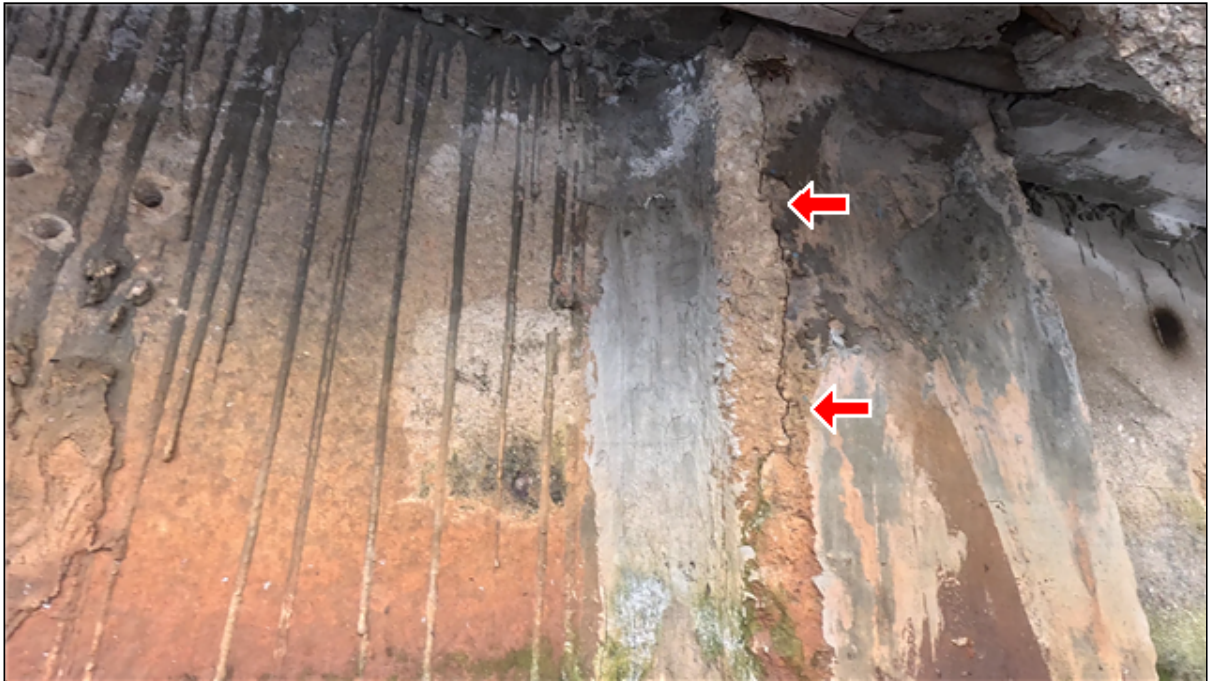
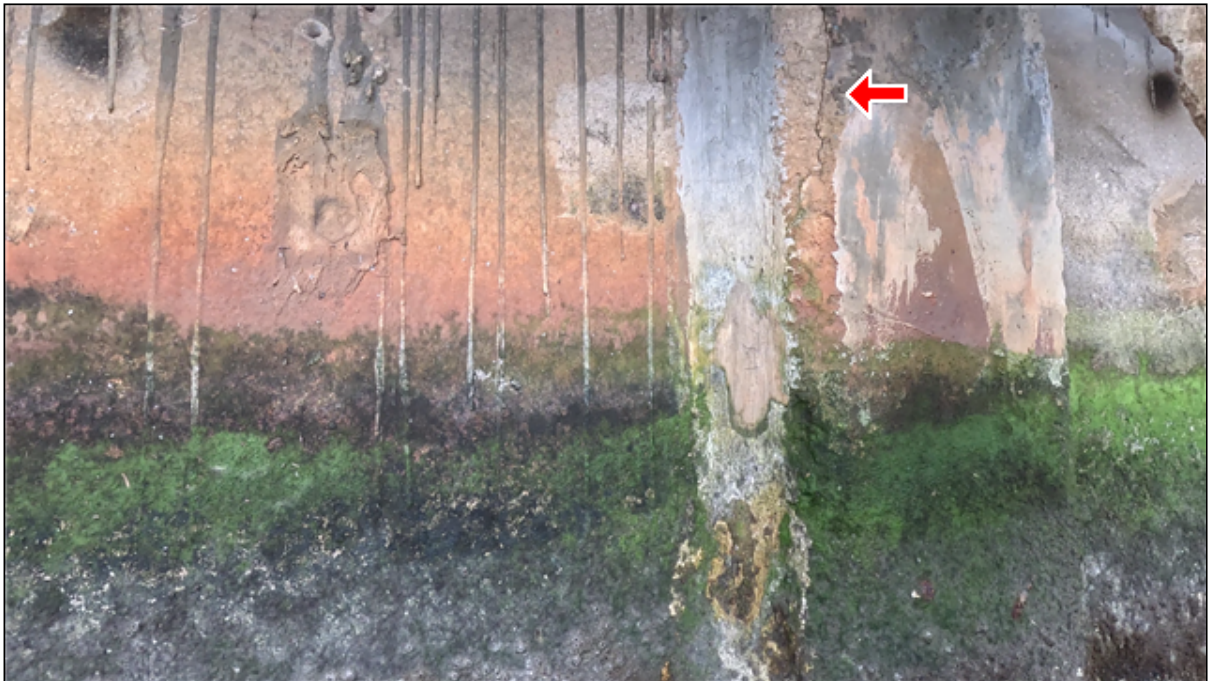
**1.5 Vertical Pilings**

The vertical pilings consist of reinforced concrete support columns extending from below the waterline to the underside of the deck and supporting the panels. These pilings transfer vertical and lateral loads from the supported structure into the underlying soils and are continuously exposed to a tidal marine environment. The concrete pilings exhibit moderate to advanced deterioration consistent with prolonged marine exposure. Pronounced tide-line staining, heavy biological growth, and marine fouling are present along much of the lower and mid-height portions of the pilings, particularly within the splash and tidal zones. Several pilings display cracking, patch repairs, and areas of delamination, suggesting prior attempts to address concrete distress.

- Retain a qualified marine structural engineer to perform hammer sounding, probing, and nondestructive testing to assess concrete integrity and reinforcing steel condition.
- Remove marine growth and clean piling surfaces to better evaluate the extent of cracking, delamination, and section loss.
- Repair deteriorated piling areas using marine-grade concrete repair systems, including removal of unsound concrete, corrosion mitigation of reinforcing steel where exposed, and placement of compatible repair materials.
- Evaluate prior repair areas for bond failure or incompatibility and replace as necessary.

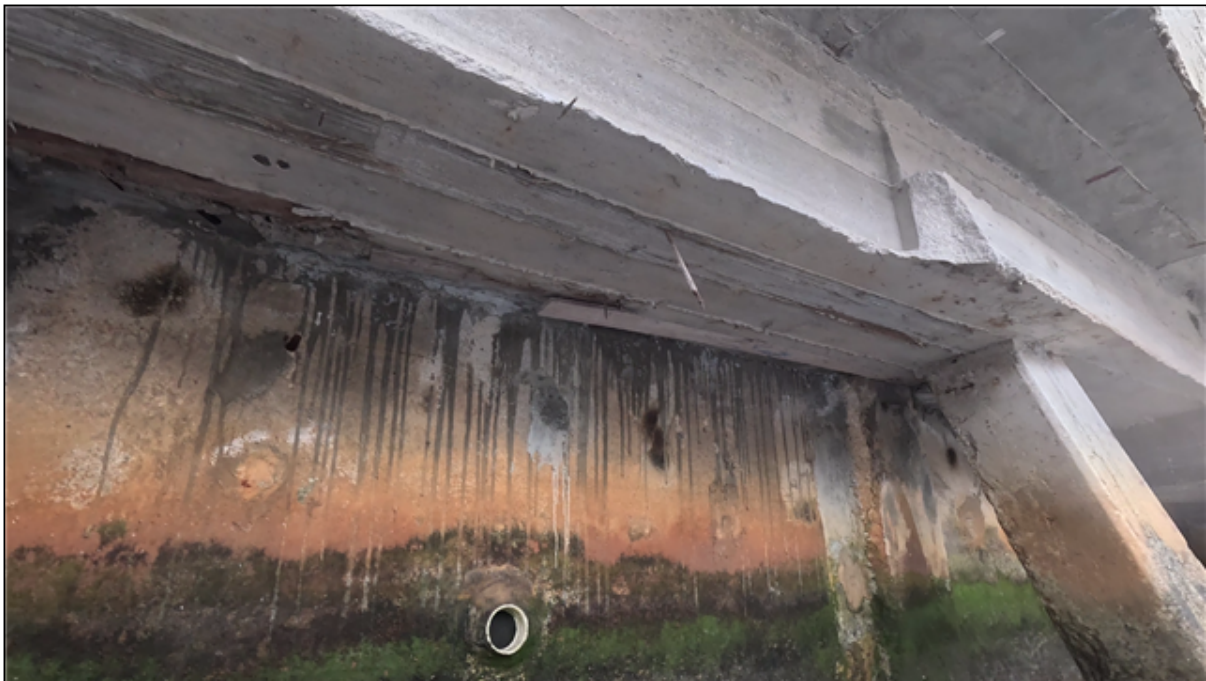
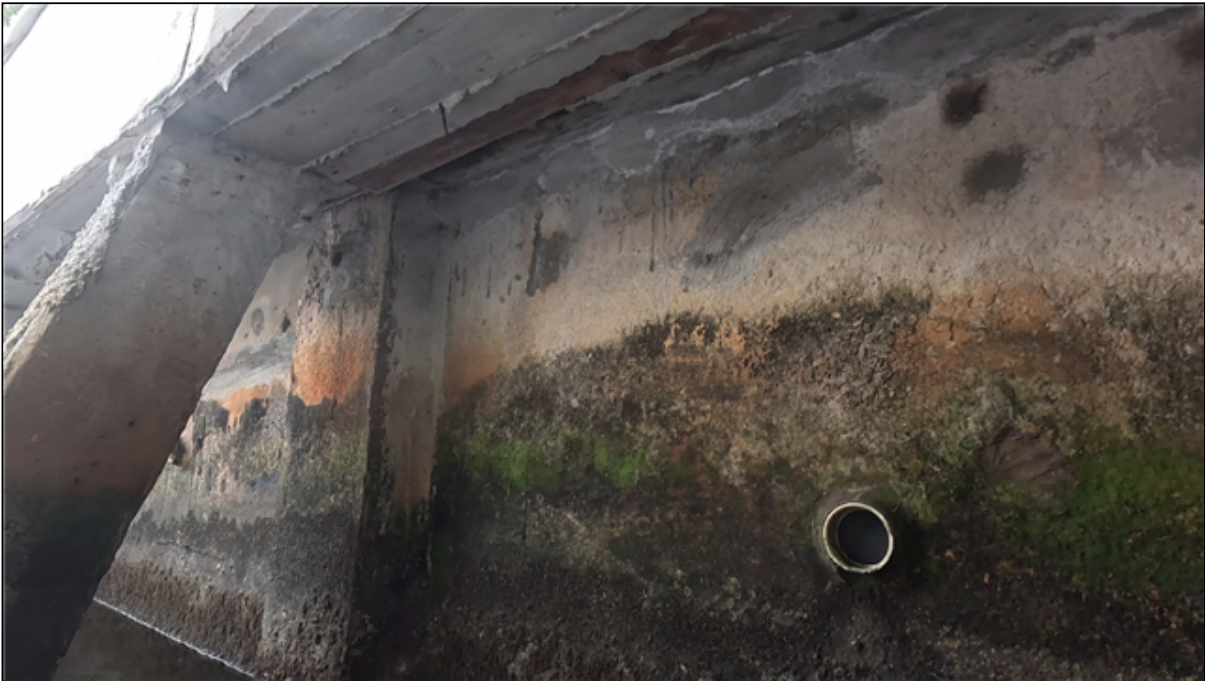
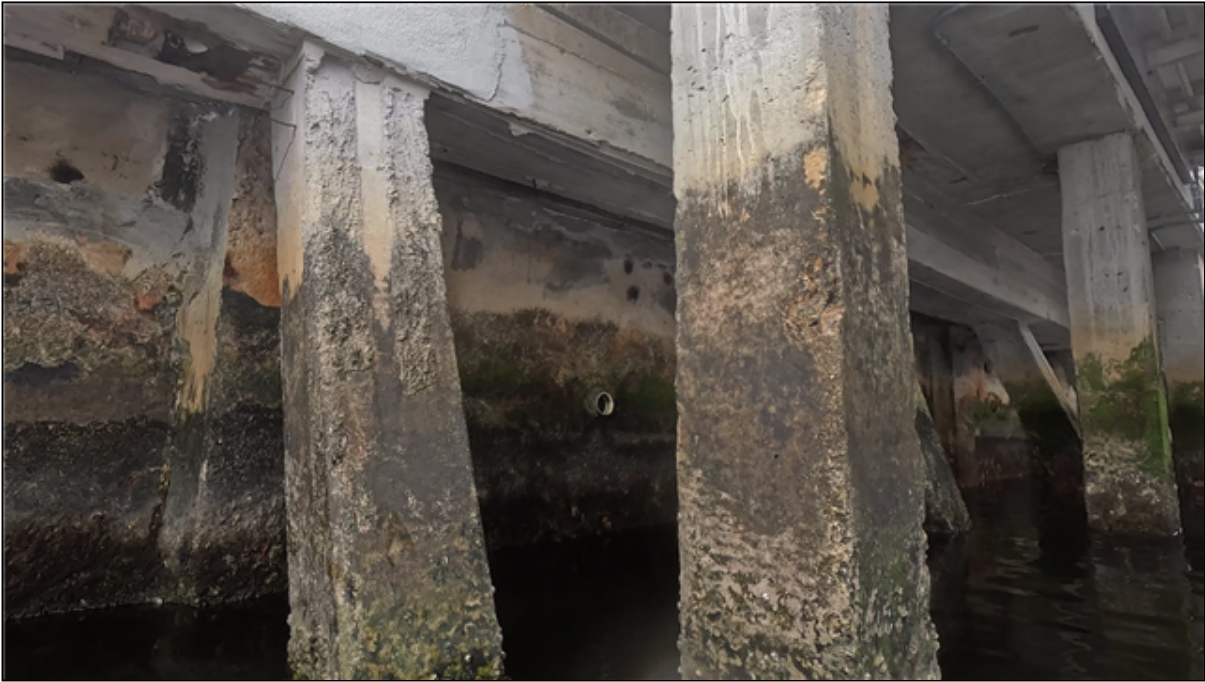
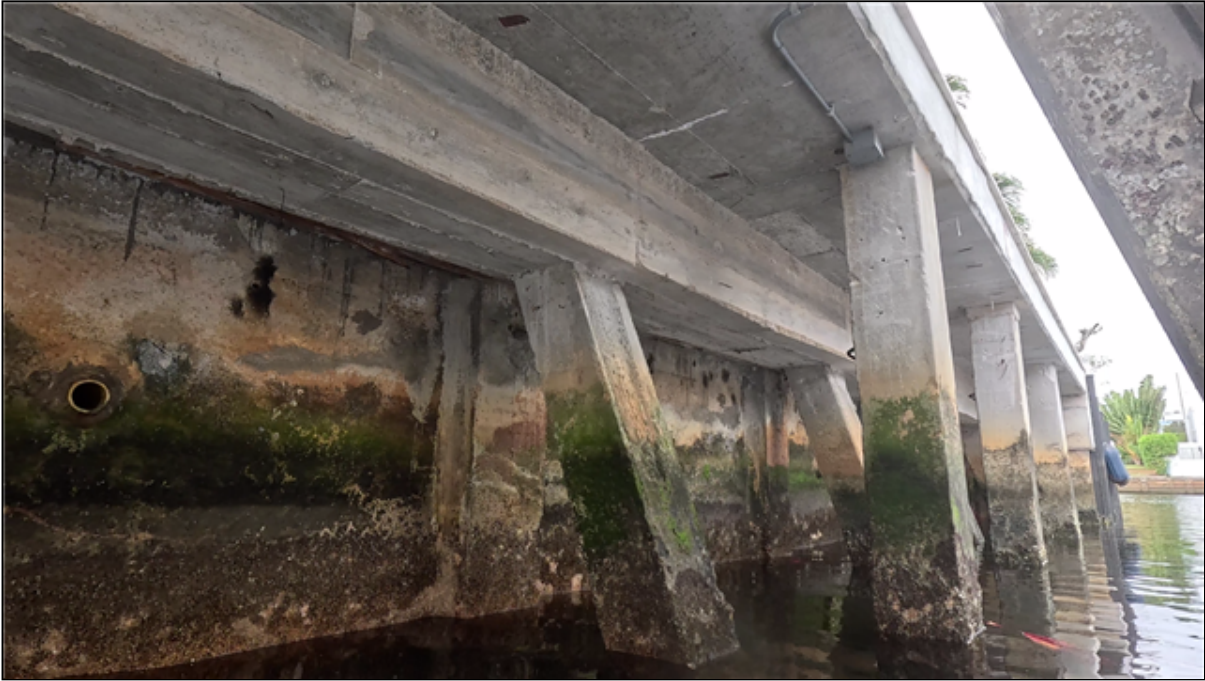
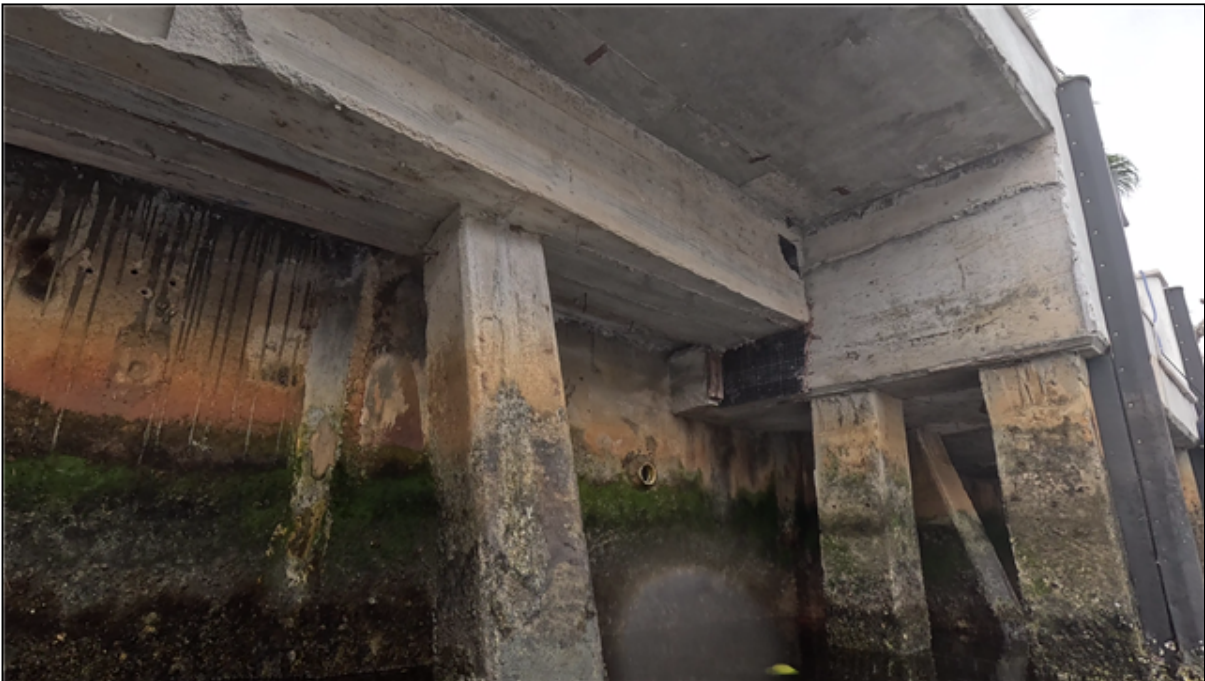
**1.6 Batter Pilings**

The batter concrete pilings exhibit moderate to advanced marine-related deterioration, particularly within the splash and tidal zones. Extensive biological growth, algae accumulation, and marine fouling are present along the lower and mid-height portions of the pilings, clearly defining long-term tidal exposure levels. Surface erosion, roughened concrete texture, and loss of cement paste are evident, especially near and just above the mean waterline, where deterioration is most aggressive.

Vertical and diagonal cracking patterns are visible on multiple pilings, which may be associated with moisture intrusion, chloride penetration, and corrosion of embedded reinforcing steel. While no complete section loss or structural separation is clearly visible in the images, the surface condition indicates that internal deterioration of reinforcement cannot be ruled out without further testing.

Progressive concrete degradation and potential reinforcing steel corrosion reduce effective cross-sectional capacity and may impair the pilings' ability to resist design loads over time.

- Remove marine growth and thoroughly clean piling surfaces to better identify cracking, delamination, and areas of section loss.
- Repair deteriorated concrete using marine-grade repair systems, including removal of unsound material, corrosion mitigation of reinforcing steel where exposed, and placement of compatible, durable repair mortars.
- Evaluate existing patch repairs for effectiveness and replace or upgrade deficient repairs as necessary.

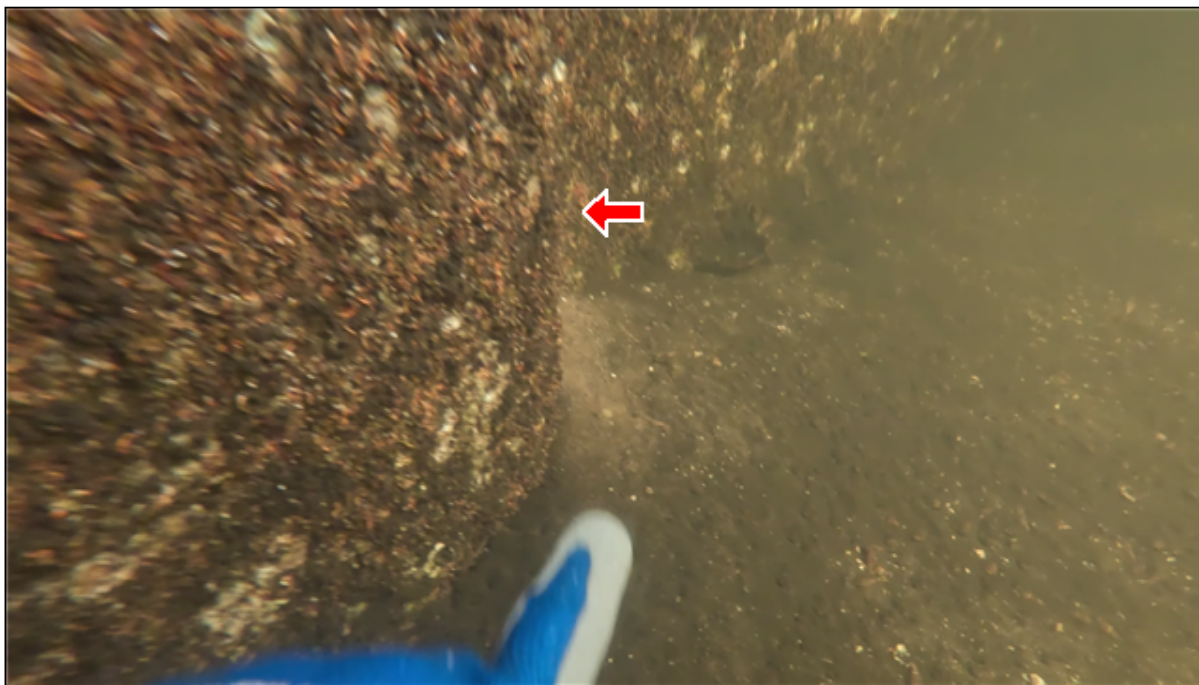
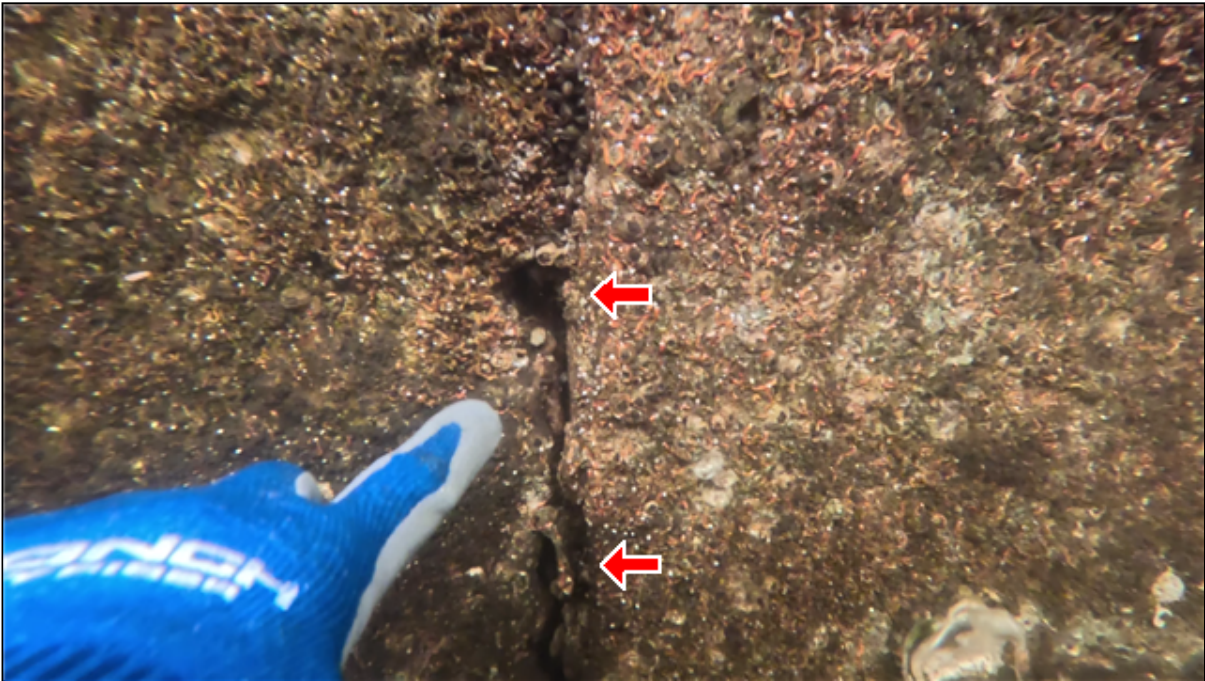
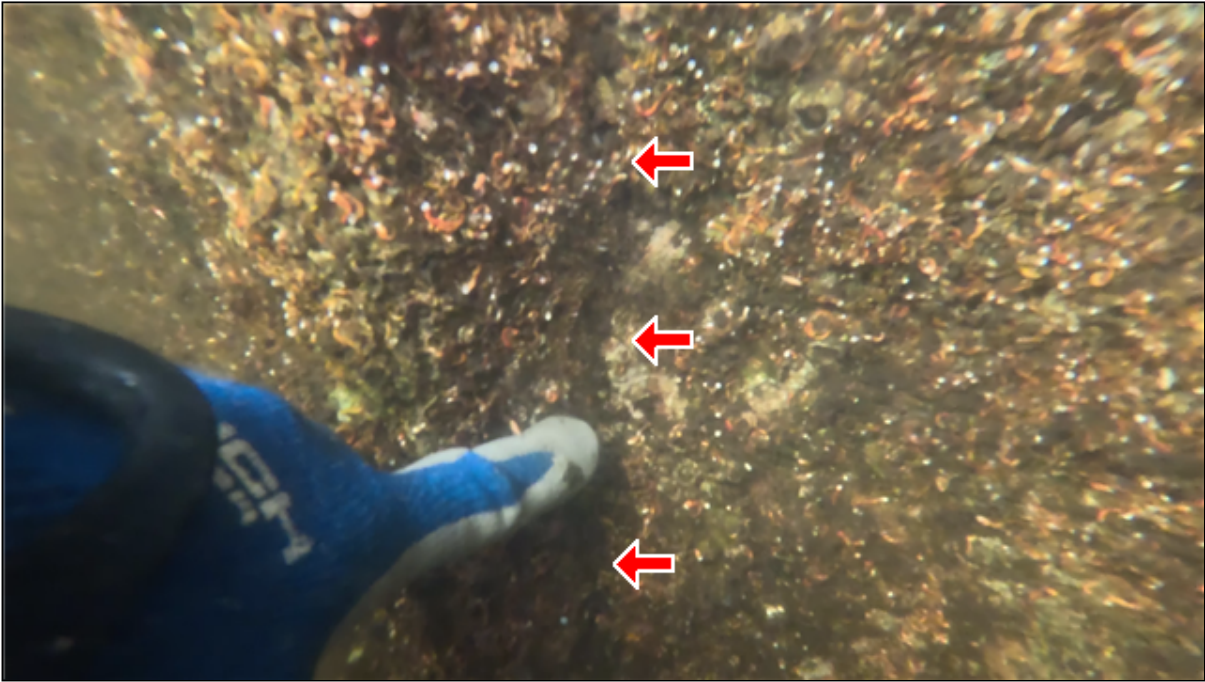
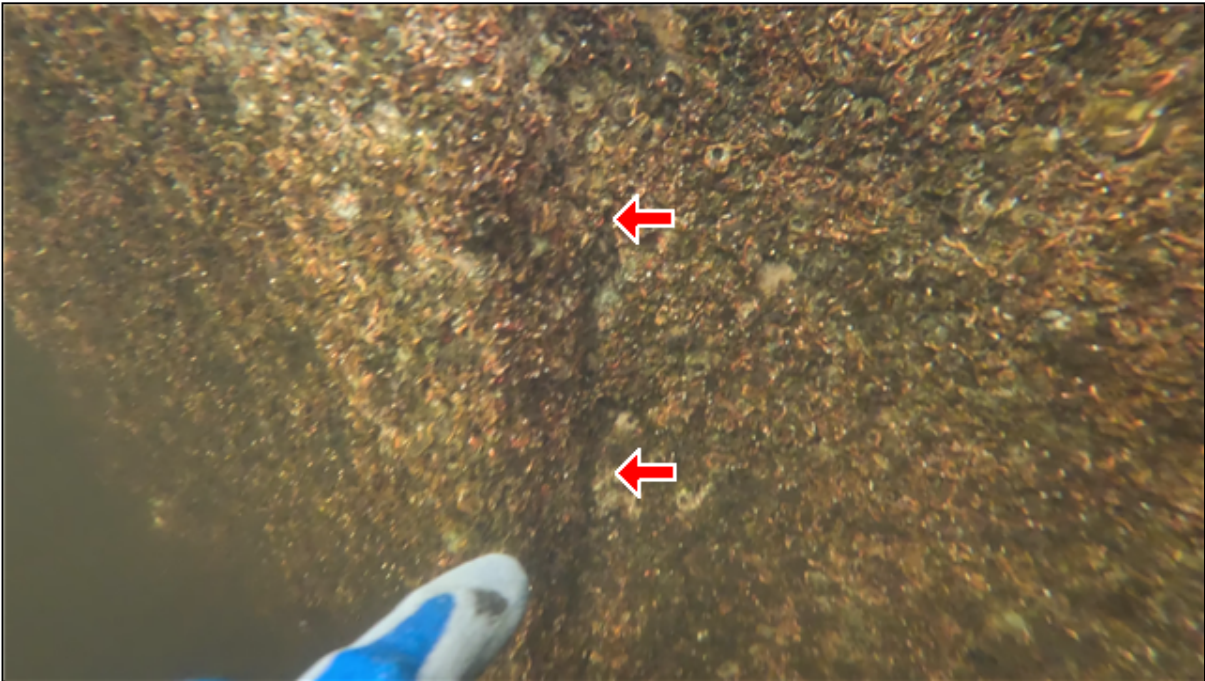
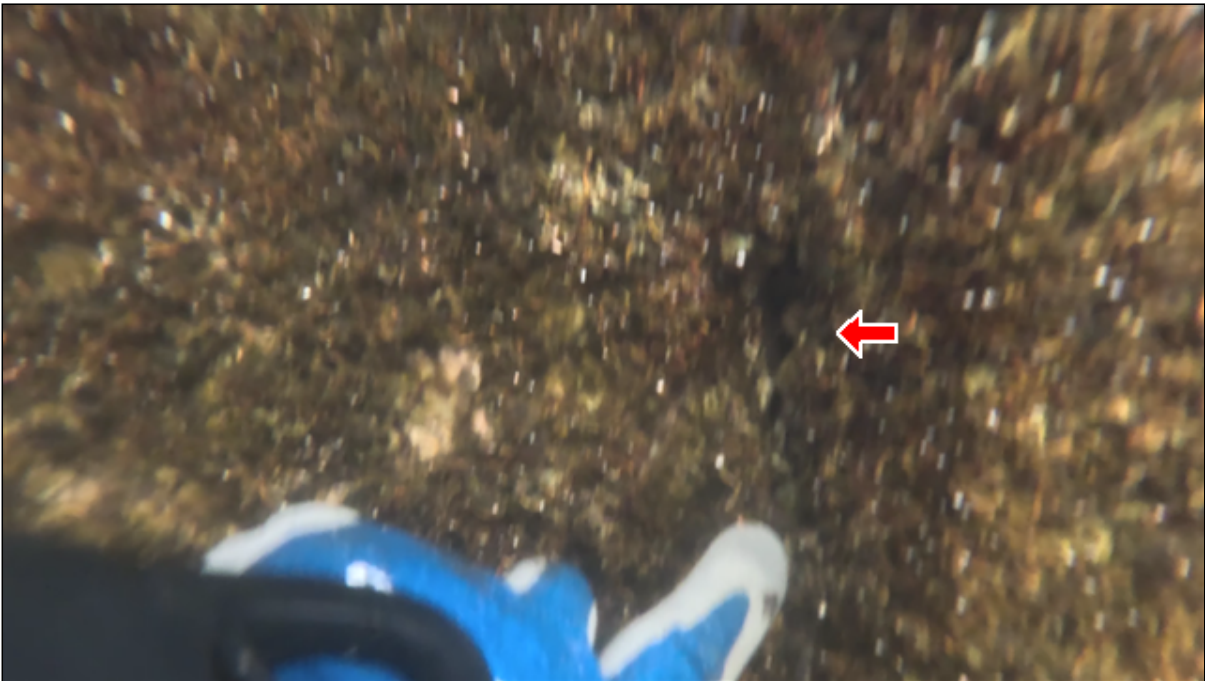
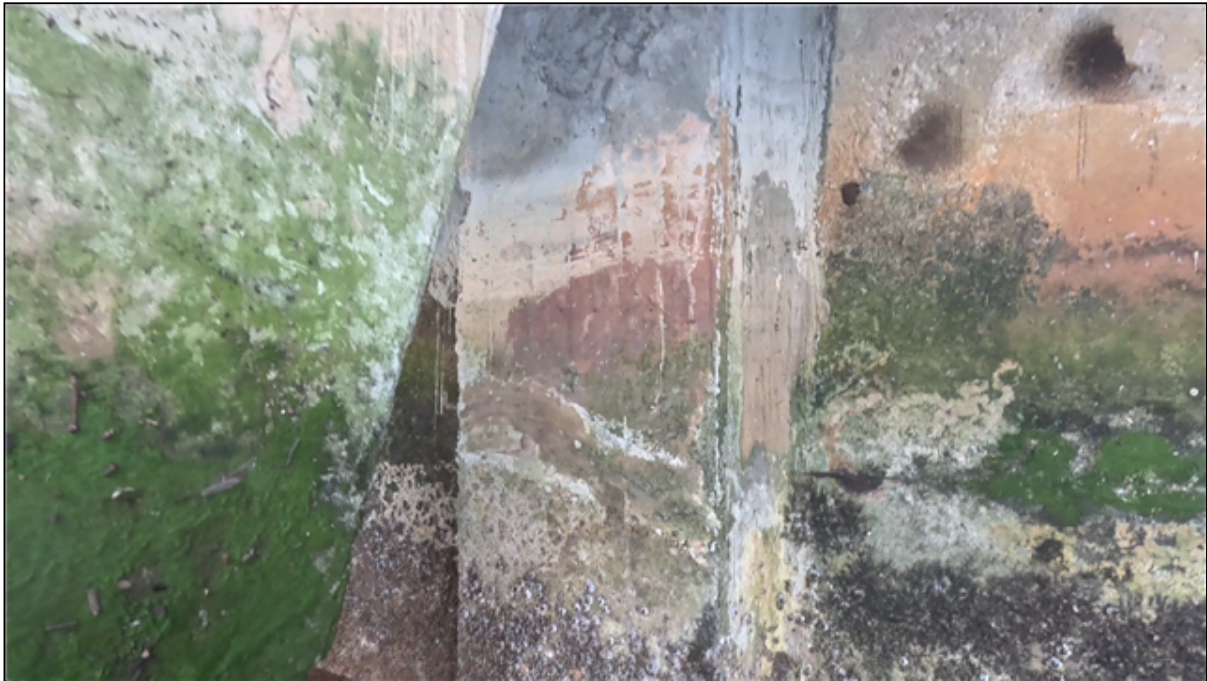
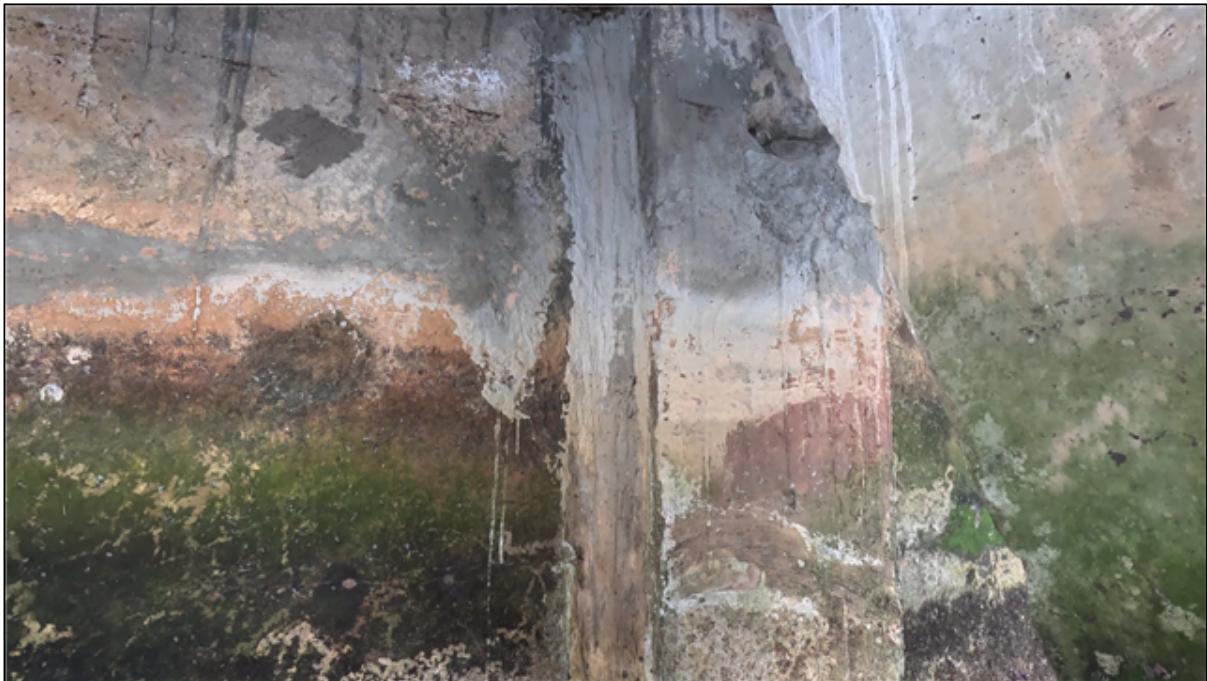
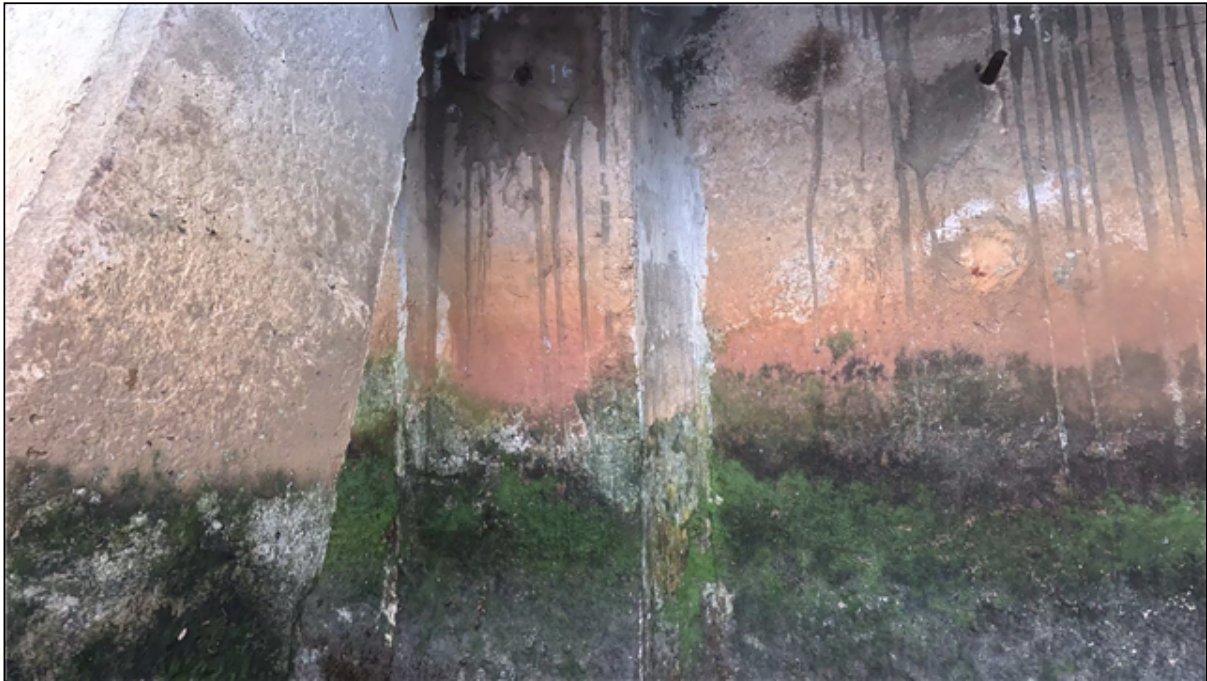
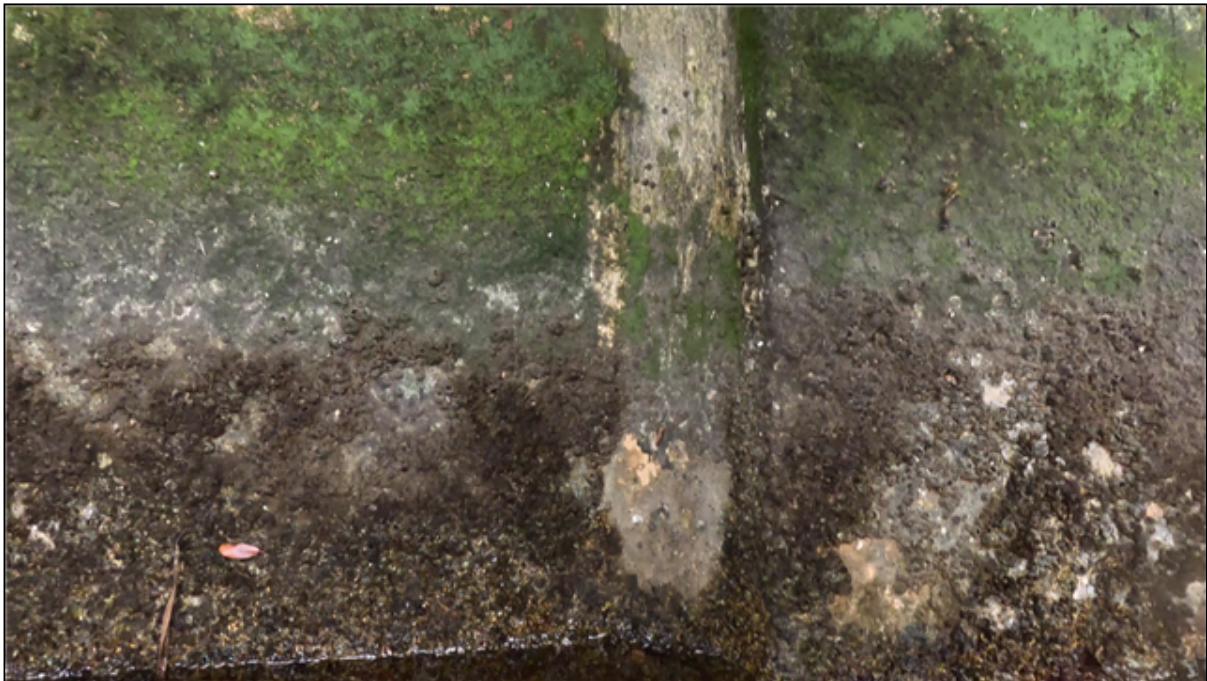
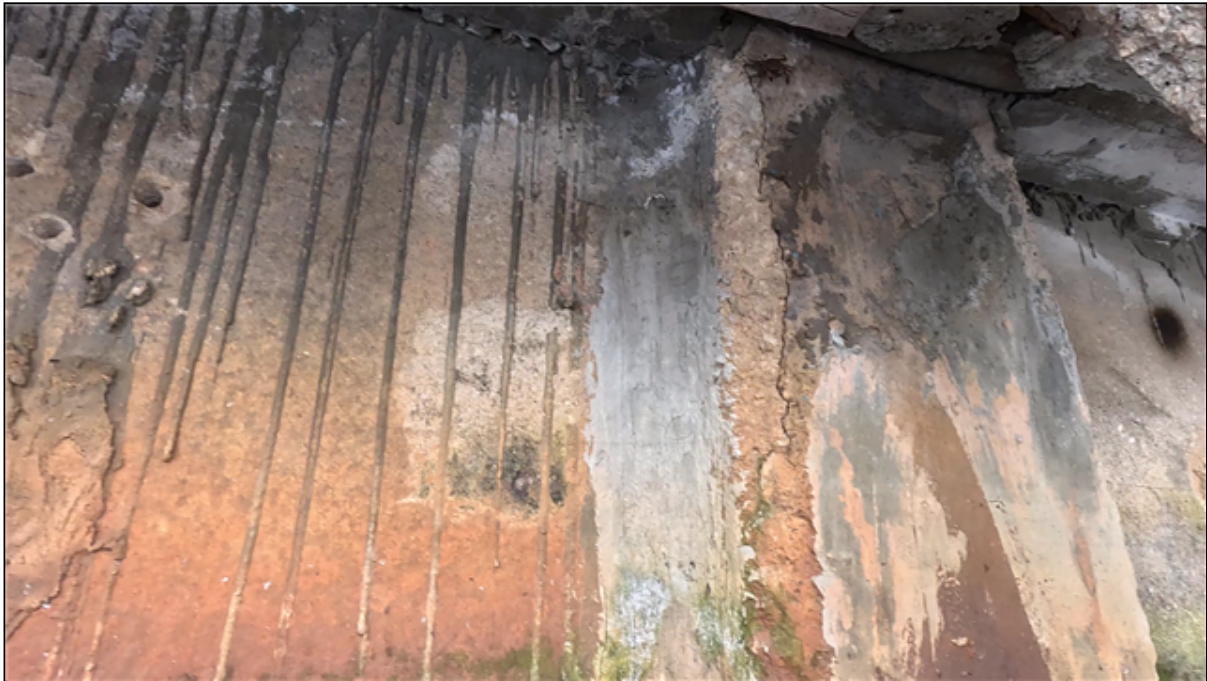
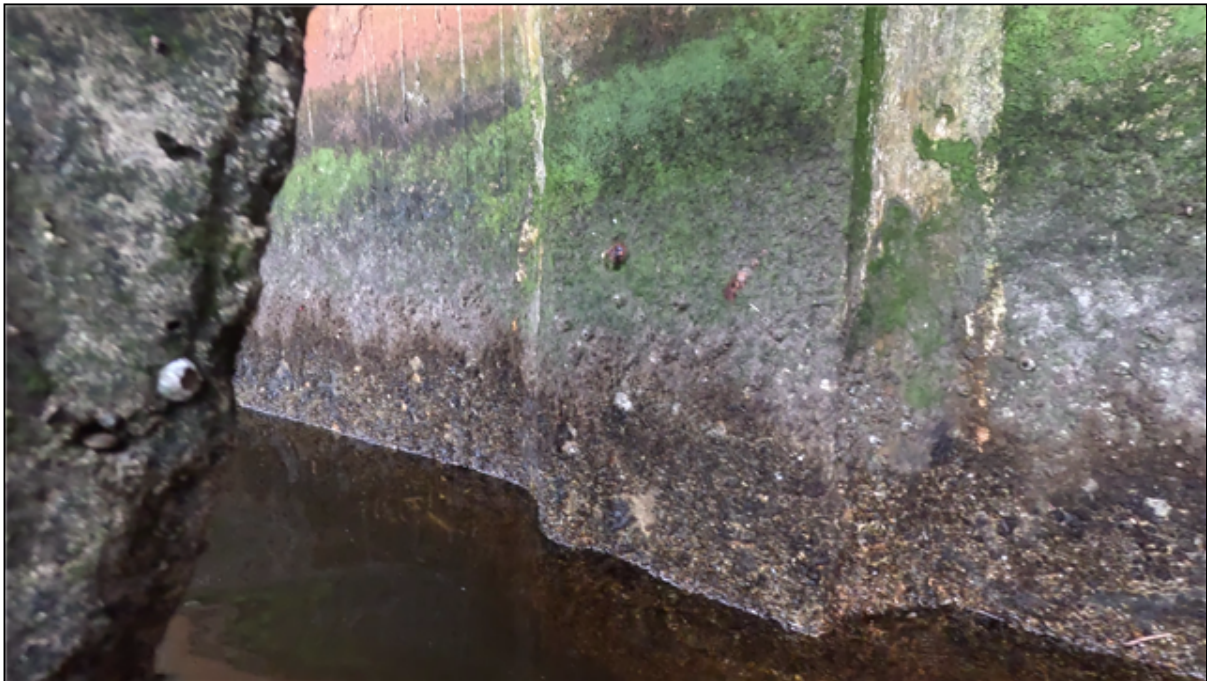
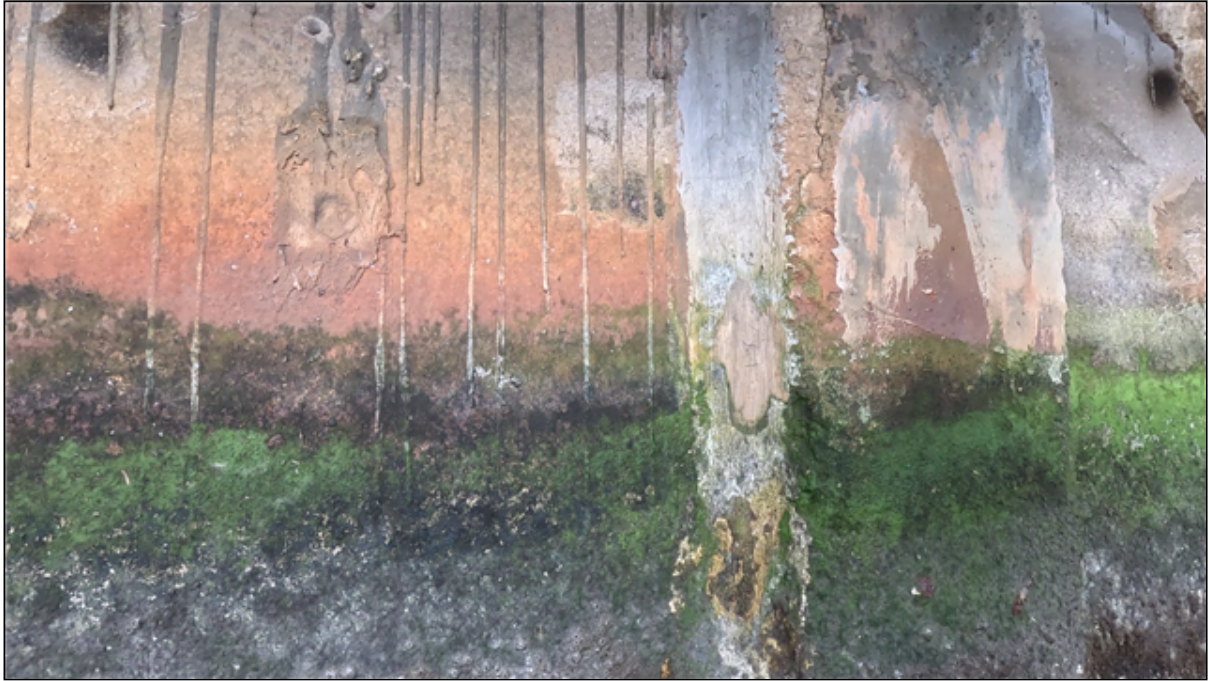
### 1.7 Seam Sealing

Above the waterline, the seam seals show cracking, shrinkage, surface erosion, and debonding from adjacent concrete surfaces. Vertical cracks are visible along the joint lines, and staining patterns suggest that water is migrating through the seams during tidal cycles, wave action, or storm events. While the cement paste remains partially intact in these

areas, it appears brittle and weathered, with reduced effectiveness as a barrier. Drying cycles above water have likely contributed to shrinkage cracking and loss of adhesion over time.

Below the waterline, the seam seals are in noticeably poorer condition. The cement paste is heavily eroded, softened, or partially missing in several locations, with open voids visible at the joint interfaces. Continuous submergence, tidal pumping, and chloride exposure have accelerated leaching of cementitious components, resulting in loss of material and increased permeability. In some areas, the joint appears to be functioning as an open pathway rather than a seal.

- Remove loose, deteriorated, and biologically contaminated cement paste from the vertical seam joints, both above and below the waterline.
- Prepare joint surfaces by cleaning, profiling, and treating as required to promote proper bonding.
- Replace existing cement paste with a hydraulic cement, non-shrink grout, or epoxy-modified mortar designed for tidal and submerged conditions.
- Perform repairs during suitable tidal conditions to ensure proper installation and curing, particularly below the waterline.
- Implement periodic underwater inspections to monitor joint performance and identify early signs of future deterioration.
