INSPECTION REPORT  
Royal Palm  
Boca Raton FL 33432

INSPECTED BY  
Angelo Menezes  
Certified Inspectors,  
LLC  
HI9467

INSPECTION DATE  
📅 8/13/2026  
🕒 11:00:00 AM

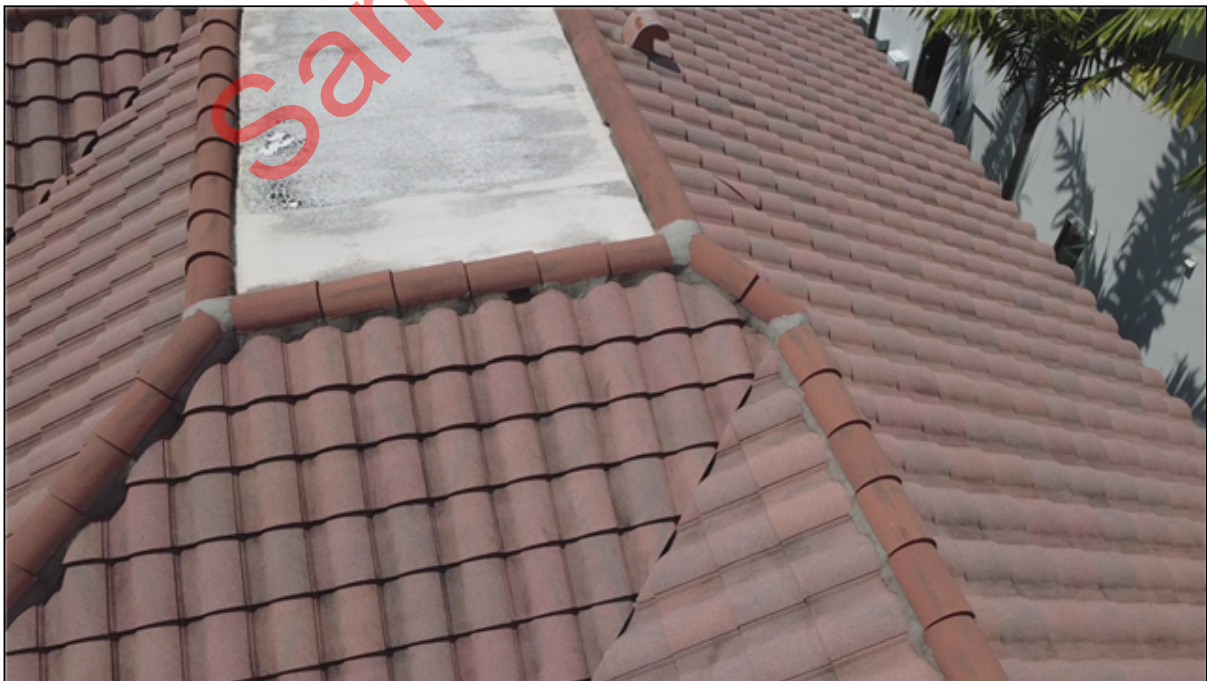
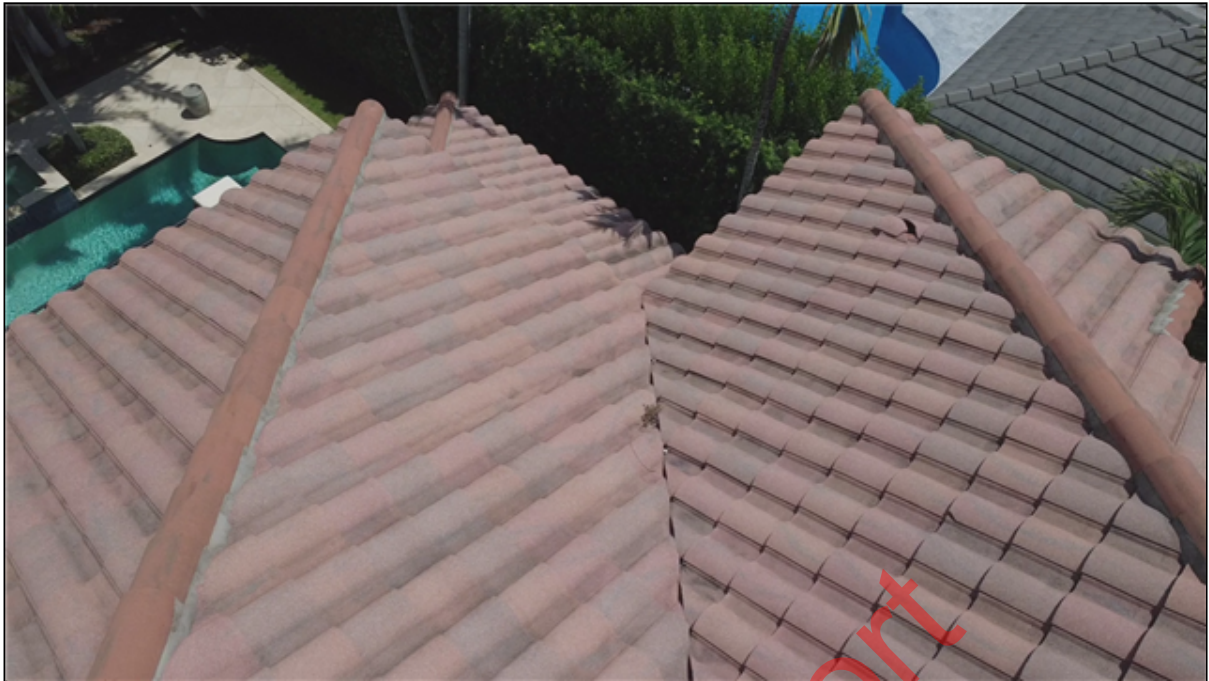
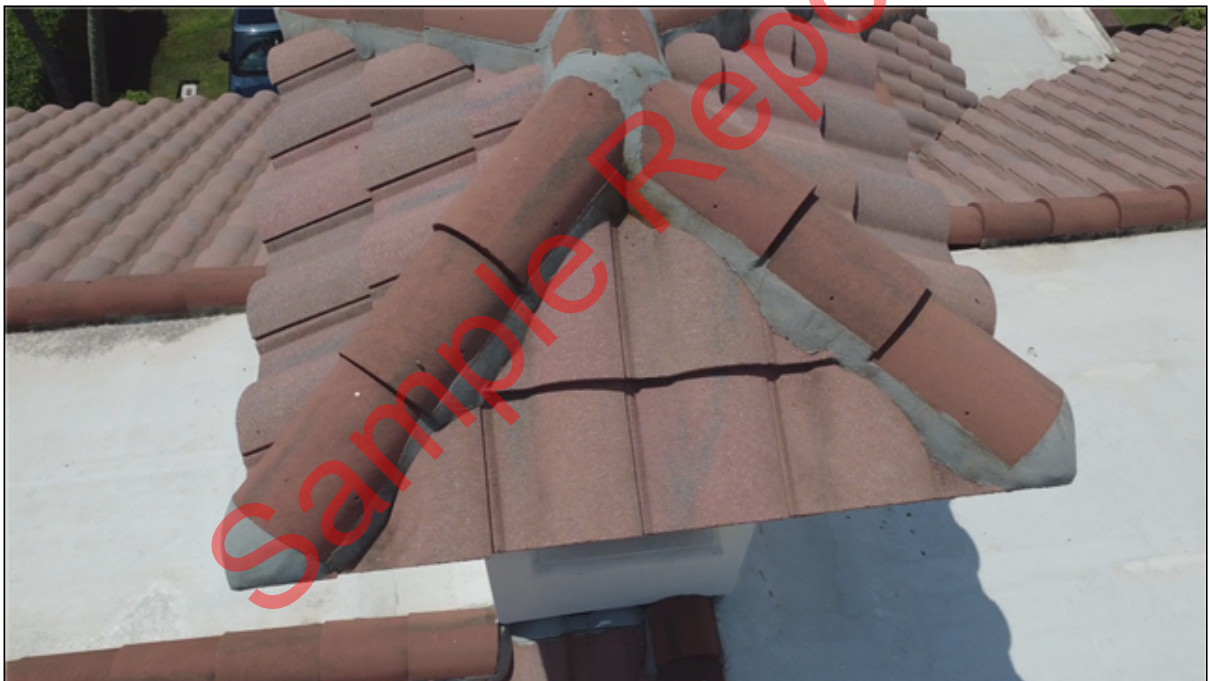
The primary roof covering consists of concrete/clay-style interlocking tile and is reported to be original to the 2009 construction. Overall, the tiled roof was found to be in fair condition for its age. The majority of the tiles remain in place and appear generally serviceable; however, several cracked/broken tiles were observed and should be replaced to maintain the integrity of the roof covering. Several ridge and hip cap tiles also exhibit deterioration or loss of the cementitious/mortar bedding and pointing used to secure and seal these areas. These conditions can increase the potential for water intrusion, particularly during wind-driven rain. Repairs should include replacement of damaged tiles and restoration/resealing of deteriorated ridge and hip cap mortar by a qualified roofing contractor. Given the roof's age of approximately 17 years, continued maintenance and periodic professional evaluation are recommended.

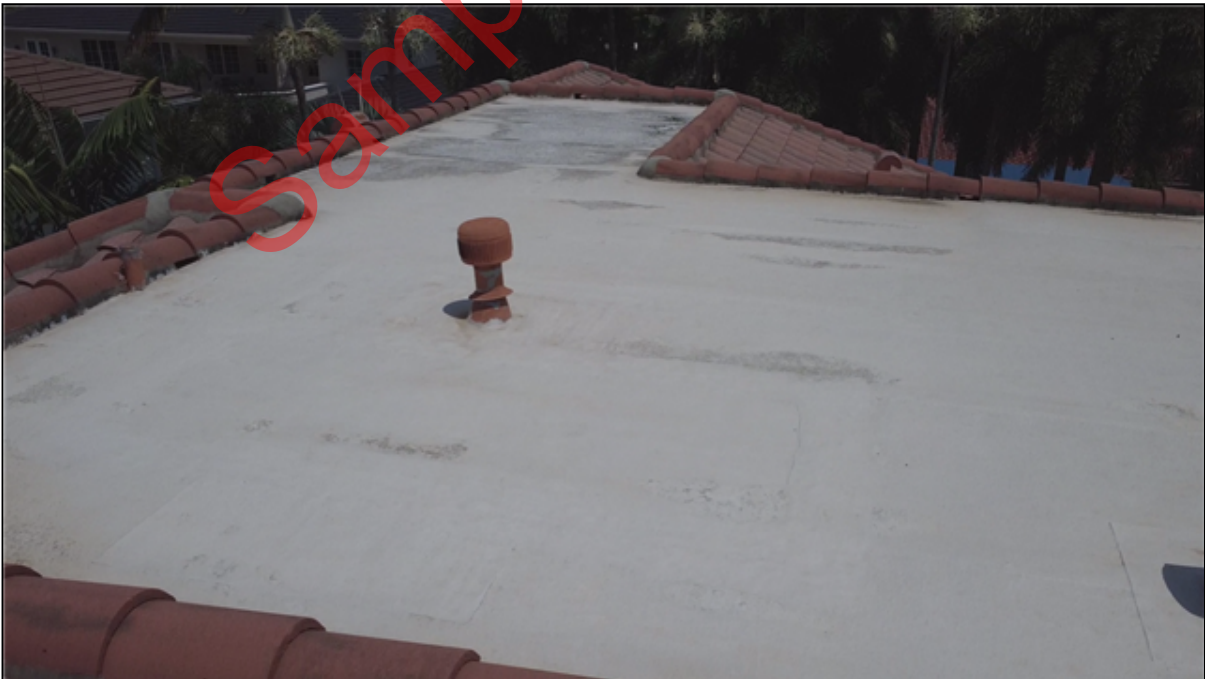
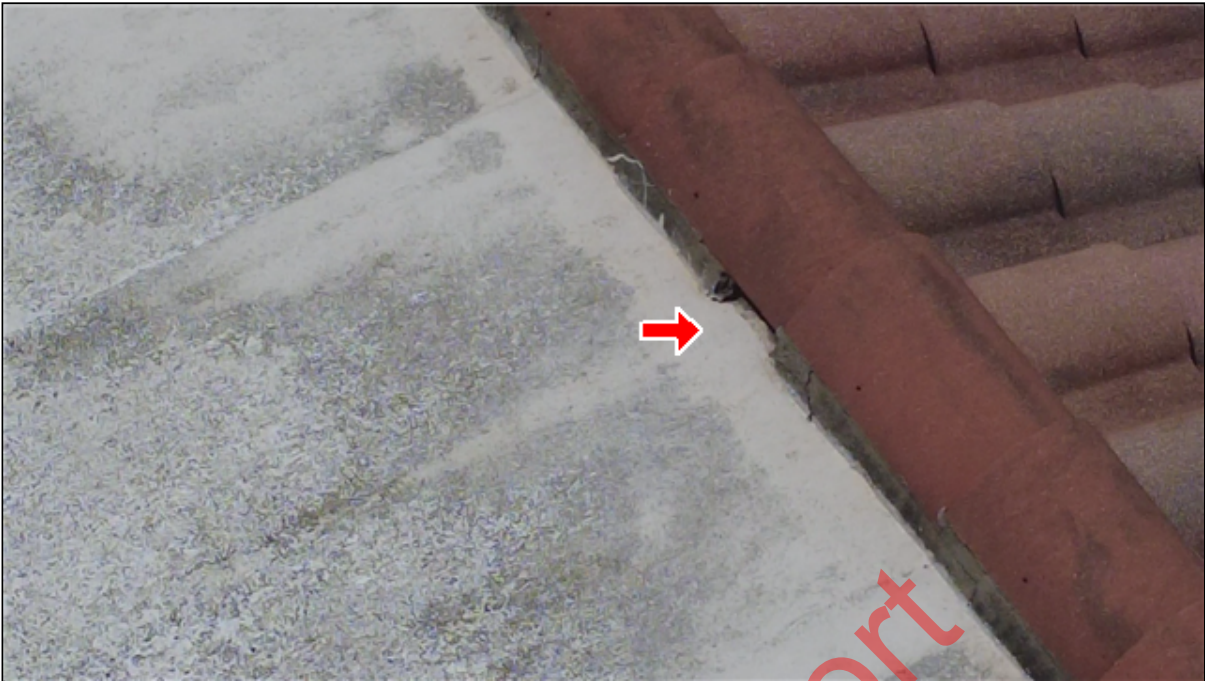
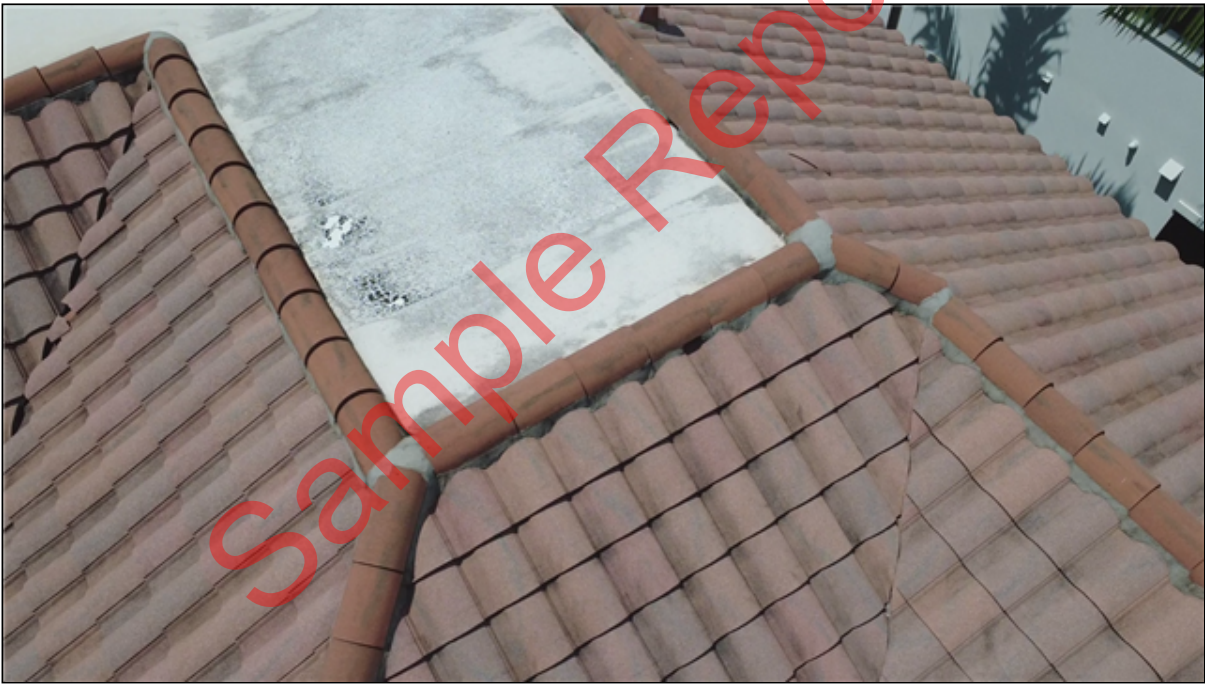
The flat roof sections consist of a low-slope roof membrane/coating system, which appears to have been coated or resurfaced. The surface exhibits weathering, discoloration, areas of surface deterioration, and localized cracking/aging of the coating, particularly around the perimeter and adjacent to the tile roof transitions. The roof-to-tile interfaces and areas beneath the ridge caps should receive particular attention, as these transitions are susceptible to water intrusion if the underlying flashing or waterproofing has deteriorated. No determination of the remaining service life can be made from a visual inspection alone, and concealed conditions beneath the coating cannot be evaluated. The flat roof should be maintained and monitored, with repairs to deteriorated areas and a more detailed evaluation by a qualified roofing contractor recommended as appropriate.

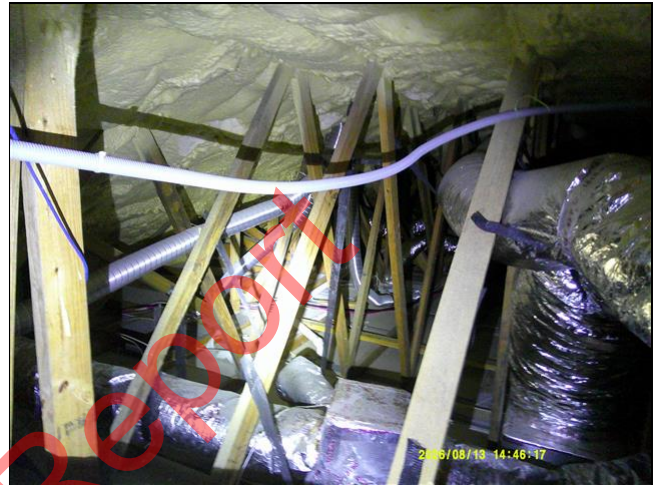
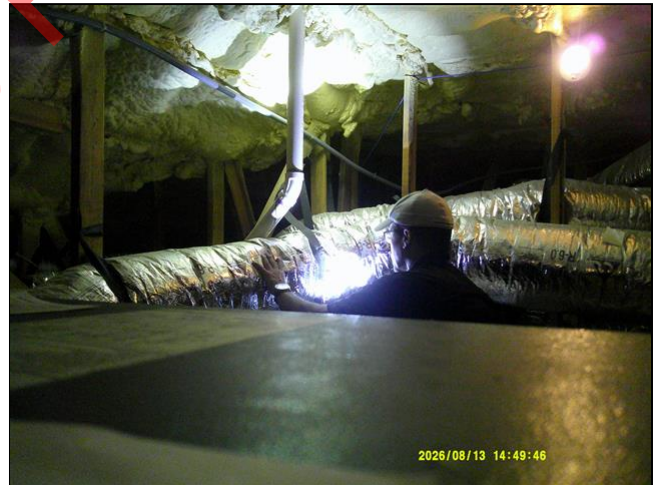
The attic is insulated with spray-applied foam insulation at the underside of the roof deck, with additional insulation present in various areas. The insulation appears generally continuous over the accessible portions of the roof deck and provides a substantial thermal barrier. However, localized areas of separation, gaps, irregular application, and exposed/unfinished foam were observed, including areas where the foam appears to have been applied around roof framing and mechanical components. These conditions may reduce the effectiveness of the insulation and air-sealing system in those locations.

Because the insulation is applied directly to the underside of the roof deck and much of the roof structure is concealed, the full extent and uniformity of the installation could not be verified. The insulation should be maintained in its present condition, with localized areas of deficient or deteriorated foam evaluated and repaired by a qualified insulation contractor as needed.

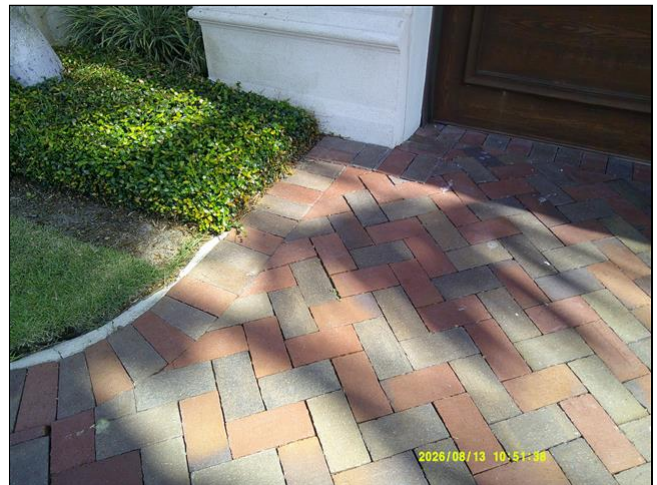
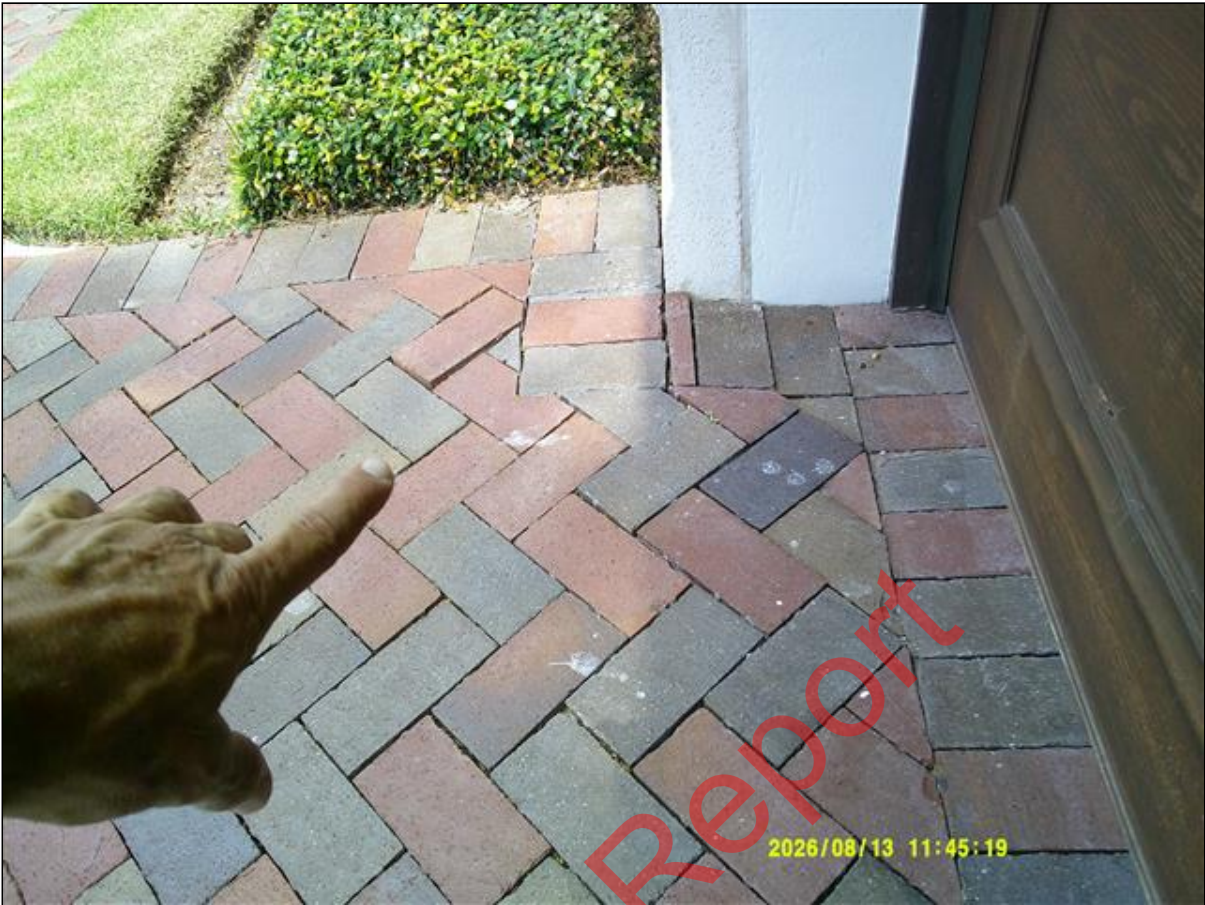
### 3.1 Driveway

The driveway consists of interlocking concrete pavers. The driveway was generally functional; however, several areas exhibited localized settlement and displacement of individual pavers, resulting in uneven surfaces and open joints. Some pavers were loose or raised relative to adjacent pavers, creating potential trip hazards and progressive deterioration.

Standing water was also observed at the driveway/street interface at the time of inspection. This may indicate localized low areas or inadequate surface drainage. The area should be monitored during rainfall and corrected as necessary to promote positive drainage away from the residence and driveway surface.

Recommendation: Have a qualified paver/driveway contractor reset and re-level displaced or settled pavers, restore proper joint spacing, and evaluate drainage at the street transition. Repairs should be performed as needed to reduce trip hazards and prevent further settlement.

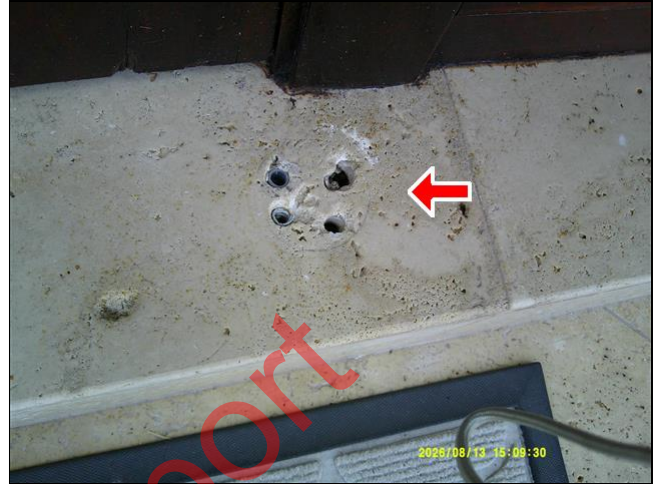
A localized area of damaged/drilled stone was noted at the base of the entry door, with several open holes and surface deterioration. These openings should be properly patched/sealed to help prevent water intrusion and insect entry and to restore the finish.

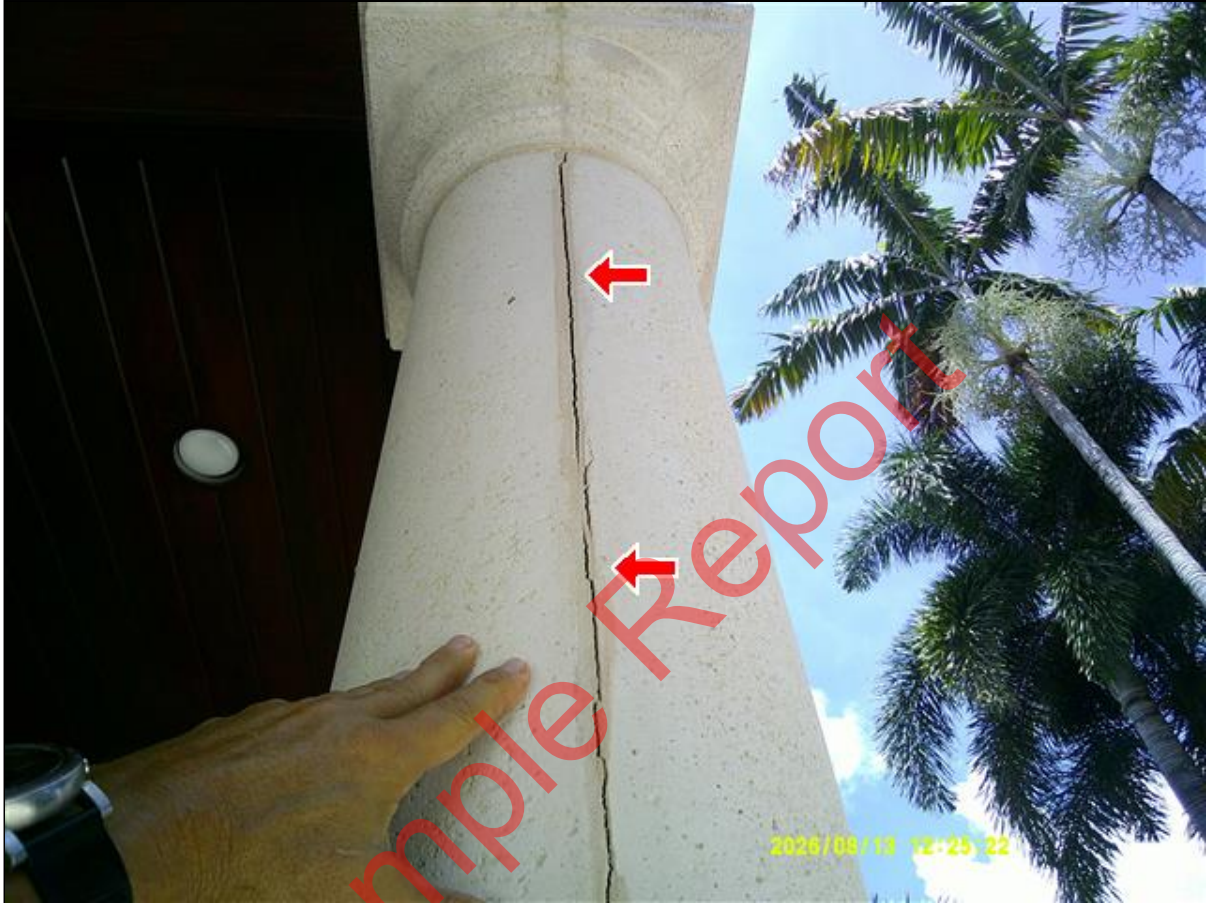
### 3.6 Patio

The covered outdoor patio includes a dedicated BBQ area supported by several decorative columns. Deteriorated grout and open/separated joints were observed at the column finishes, including a pronounced vertical separation at one column. The condition may permit moisture intrusion into the assembly and could contribute to further deterioration if left unaddressed.

Recommend repair/repointing of the deteriorated joints by a qualified masonry/stucco contractor and evaluation of the affected column for any concealed moisture-related or substrate deterioration.

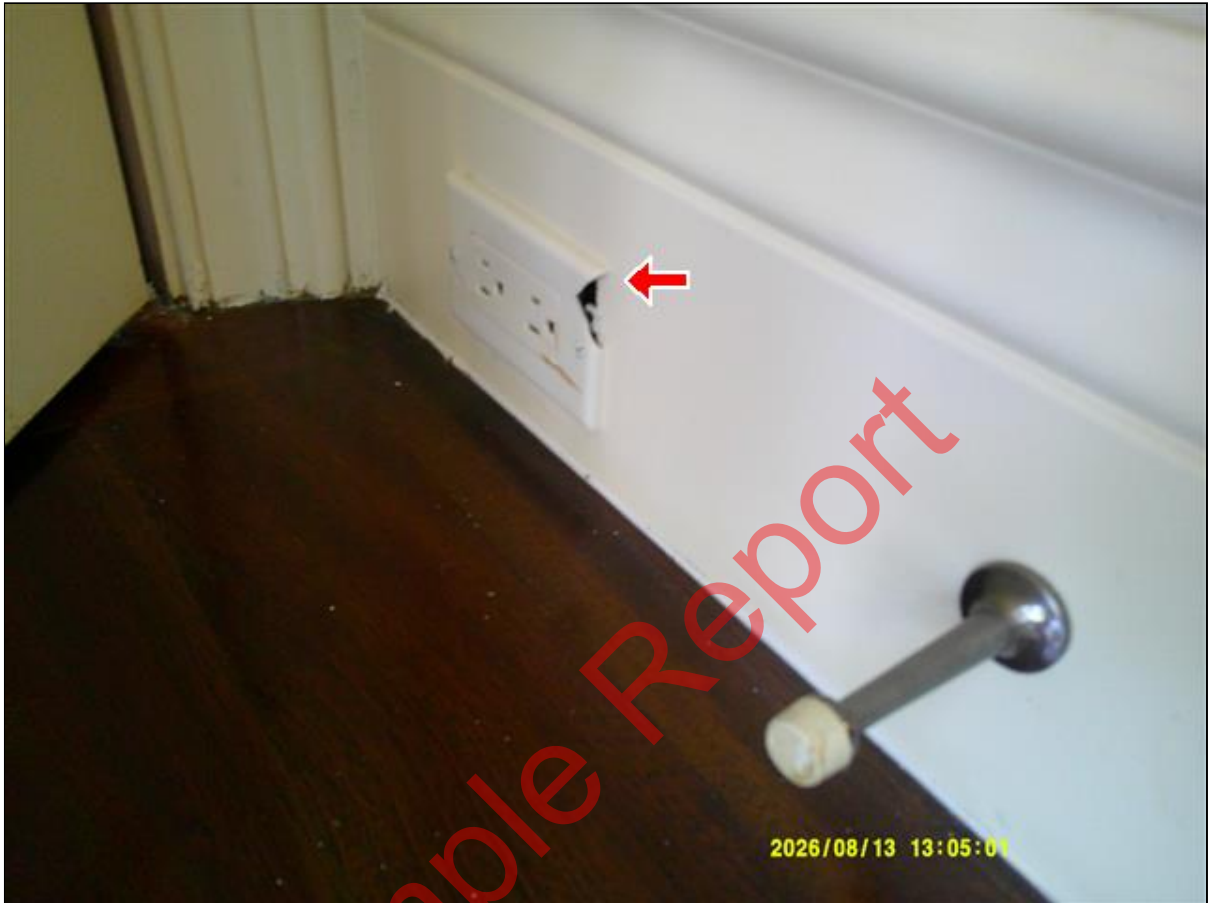
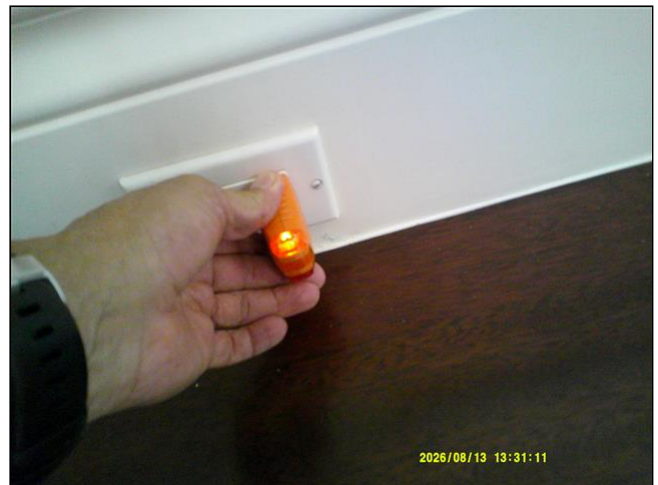
Several receptacles located in the office and theater areas tested with an open ground condition, indicating that the equipment grounding connection may be missing, interrupted, or otherwise improperly connected at these locations. This condition was observed primarily on one side of the home and may be related to the electrical irregularities noted elsewhere in the same area. A damaged/broken receptacle cover plate was also observed and should be replaced. Recommend evaluation by a qualified licensed electrician to determine the cause of the open-ground conditions, verify proper equipment grounding and bonding, and make necessary corrections.

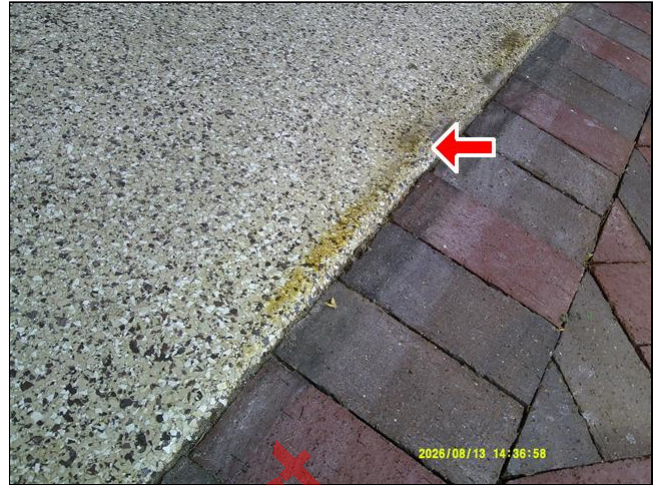
The garage floors are finished with a decorative epoxy/flaked coating over concrete. The coating was generally serviceable; however, localized cracking, deterioration, and discoloration were observed, particularly along portions of the perimeter and at transitions/edges. Some areas exhibited staining and minor surface deterioration. These conditions should be monitored and repaired as needed to prevent further deterioration of the underlying concrete and coating.

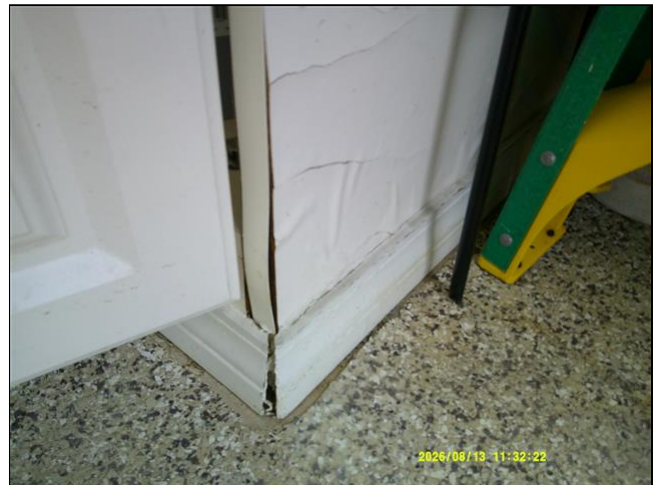
The garage cabinets exhibited evidence of water damage and moderate deterioration, including localized discoloration and deterioration of cabinet materials. The source of the water exposure could not be determined as part of the inspection. The affected cabinets should be further evaluated, and damaged components should be repaired or replaced as appropriate.

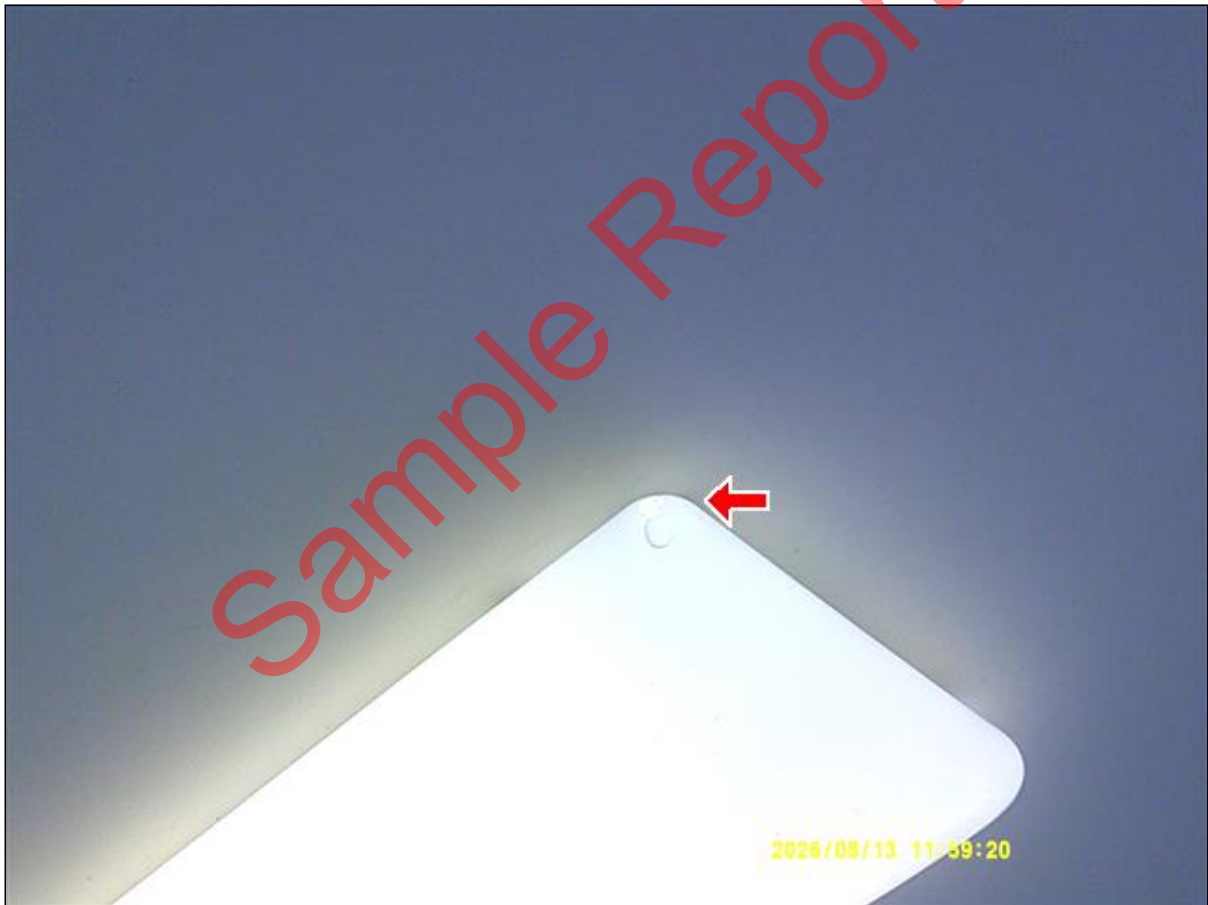
The garage lighting fixtures exhibited damaged and/or missing protective covers. The fixtures serving the right-side garage were missing their covers, while the fixture in the left-side garage had a damaged cover. The affected fixtures should be repaired or replaced to provide proper protection for the electrical components and restore the fixtures to serviceable condition.

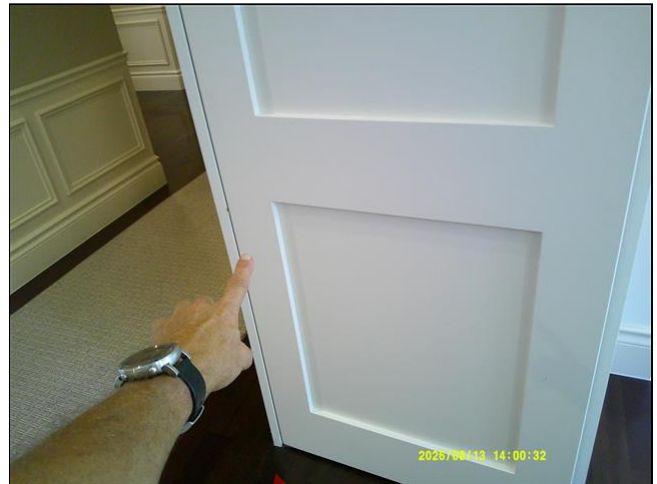
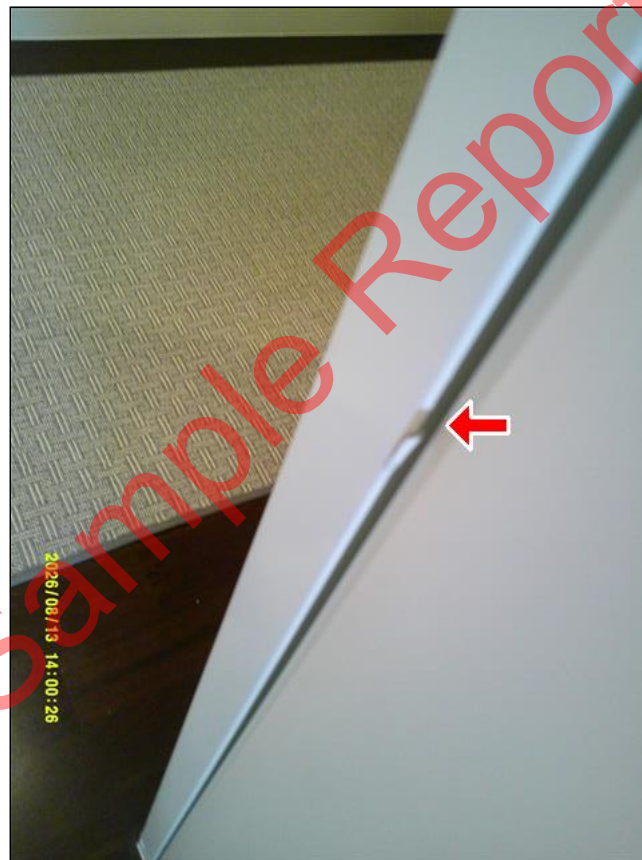
A set of double interior doors leading to the den was observed to have minor cosmetic damage and wear. The doors remained generally functional, with no significant operational deficiency noted. Minor repair or touch-up is recommended as desired to restore the appearance and finish.

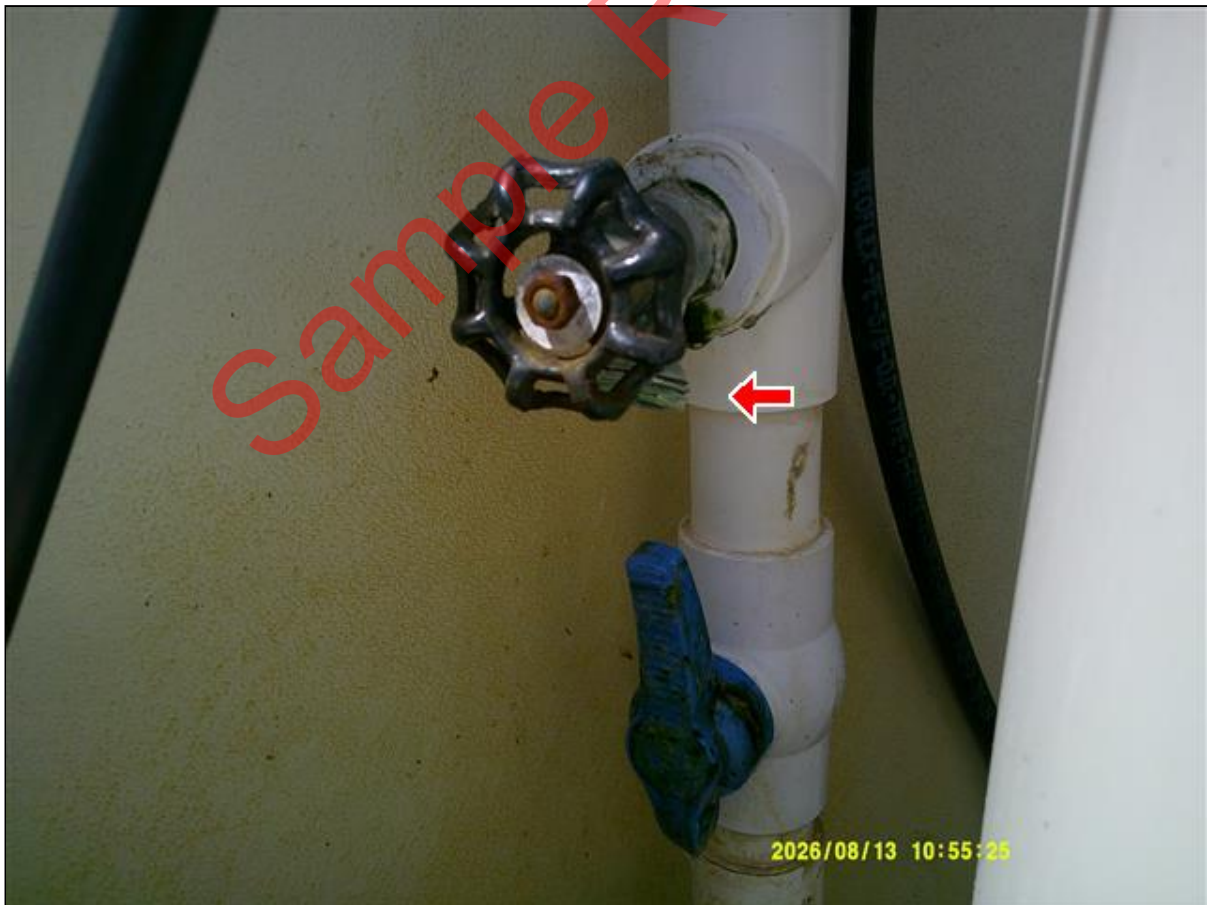
Visible leakage was observed at portions of the plumbing serving the system. The system was not operated, physically manipulated, or functionally tested as part of the inspection; therefore, the operational condition and performance of the filtration/treatment equipment could not be determined. Further evaluation and servicing by a qualified water-treatment/plumbing contractor is recommended.

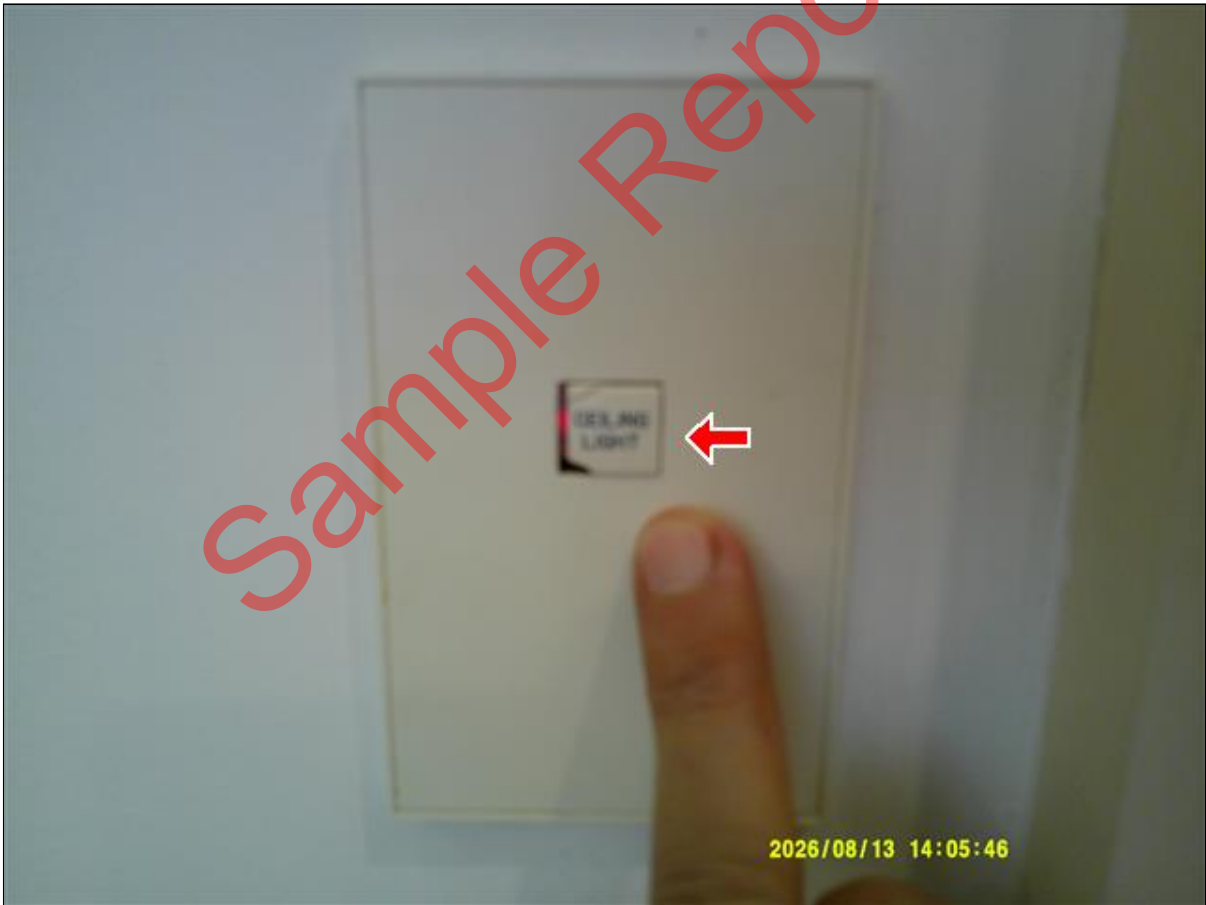
Several GFCI-protected receptacles in the bathrooms exhibited the same open-ground condition previously identified at other receptacles in the residence, particularly on the affected side of the home. Although the GFCI devices responded to testing where tested, an open-ground condition indicates that the equipment grounding connection may be missing, interrupted, or improperly connected. This condition should be evaluated as part of the previously recommended electrical investigation. In addition, one switch in a guest bathroom was observed with a cracked/damaged cover or switch component and should be replaced.

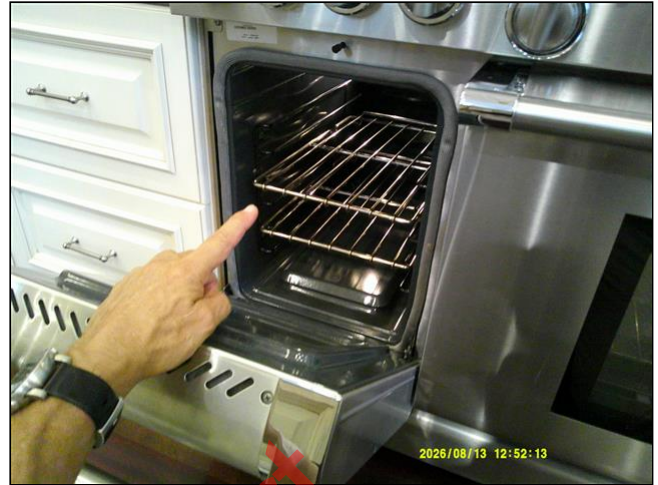
the ovens did not, and given the previously documented electrical fault affecting this portion of the home, the oven malfunction may be related to an electrical supply or control issue, although the exact cause could not be determined during the inspection. Evaluation by a qualified appliance technician and licensed electrician is recommended to determine the cause and restore proper operation of both ovens.

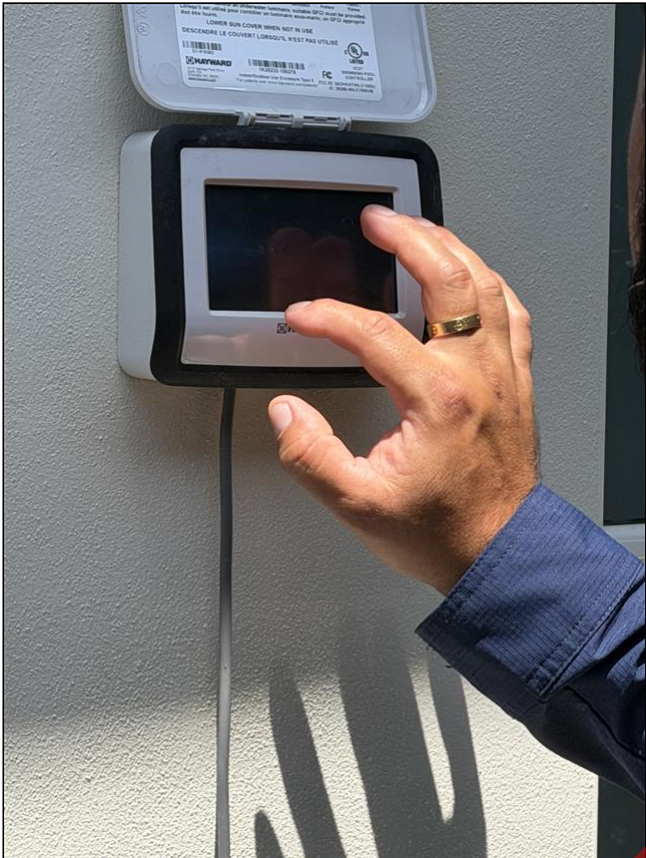
deactivated pool controls inside theater/data closet

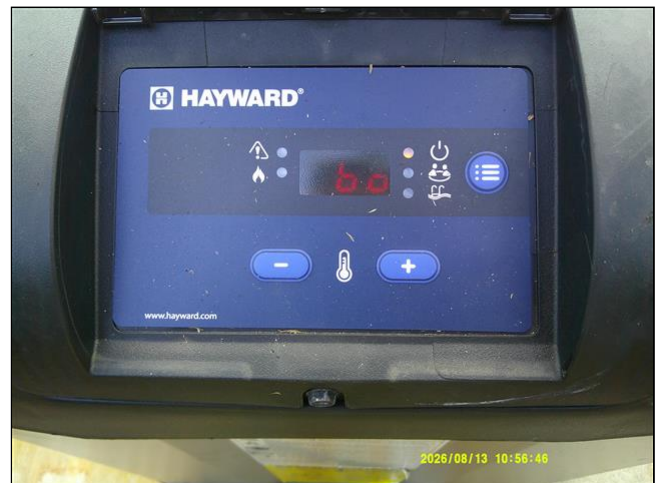
The heater appeared generally intact from the accessible exterior; however, its functional condition remains undetermined. Recommend evaluation by a qualified pool-heating/Hayward service technician, including verification of the heater, controls, gas supply, ignition, heating operation, and communication with the OmniPL automation system.

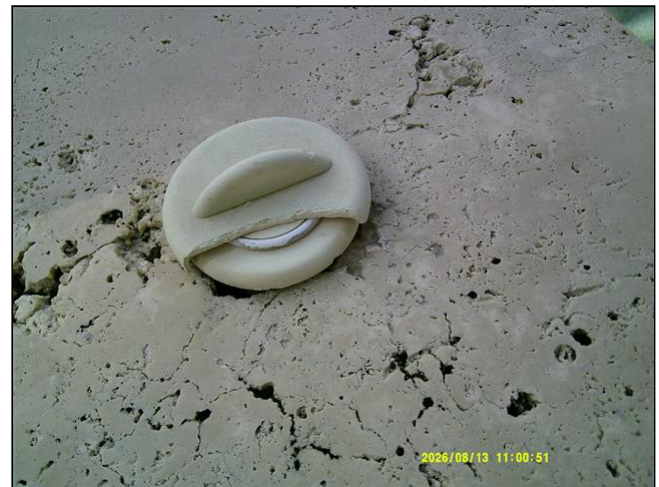
The spa is equipped with hydrotherapy jet and circulation fittings integrated into the spa vessel. The accessible fittings were generally intact; however, localized mineral buildup, staining, and deterioration were observed around some of the fittings and their surrounding seals/finish. One or more fitting covers also showed signs of age-related deterioration. The condition of concealed portions of the jet assemblies and associated plumbing could not be determined through visual inspection. Recommend cleaning and servicing the affected fittings and replacing deteriorated covers, seals, or fittings as necessary. A qualified pool contractor should also verify proper operation of the spa jet system and inspect the fittings for secure attachment and watertight connections.
