# Infrared Thermographic Report

For Building Safety Inspection

**SRA LINCOLN THEATER LLC**

551 Lincoln Rd  
Miami Beach FL 33139

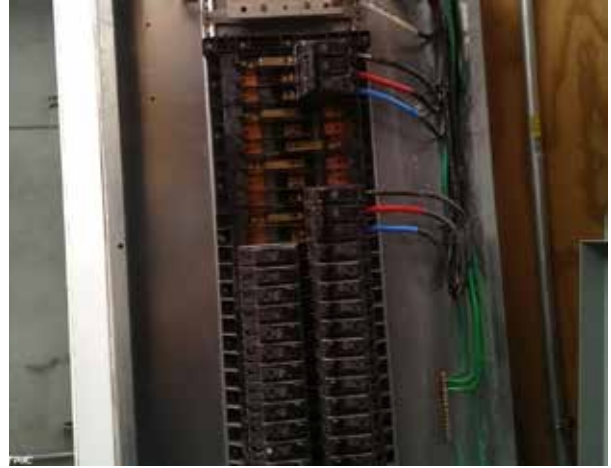
H&M EXT 125 AMP 208/120 V

Based solely on test parameters in this thermographic report, no temperature abnormalities were detected at the time of the inspection. Therefore, no further recommendation for repairs is currently needed.

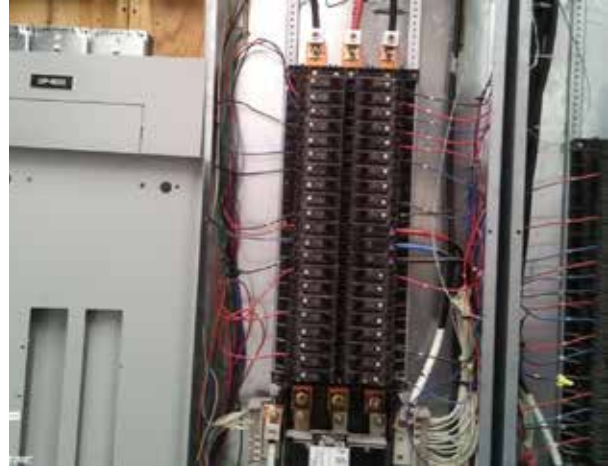
H&M LCP SEC TI 225 AMP 208/120 V

Based solely on test parameters in this thermographic report, no temperature abnormalities were detected at the time of the inspection. Therefore, no further recommendation for repairs is currently needed.

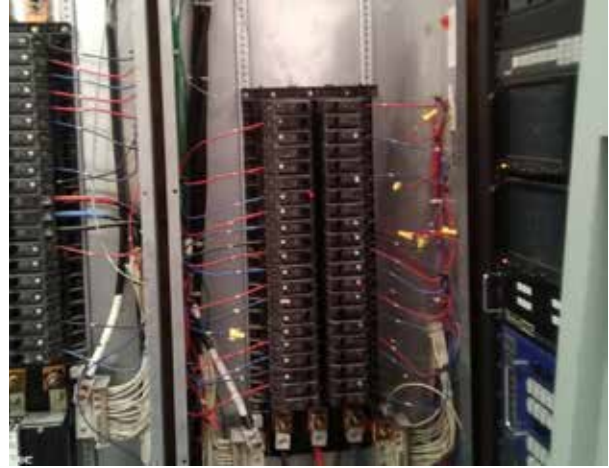
H&M LCP SECT II 225 AMP 208120 V

Based solely on test parameters in this thermographic report, no temperature abnormalities were detected at the time of the inspection. Therefore, no further recommendation for repairs is currently needed.

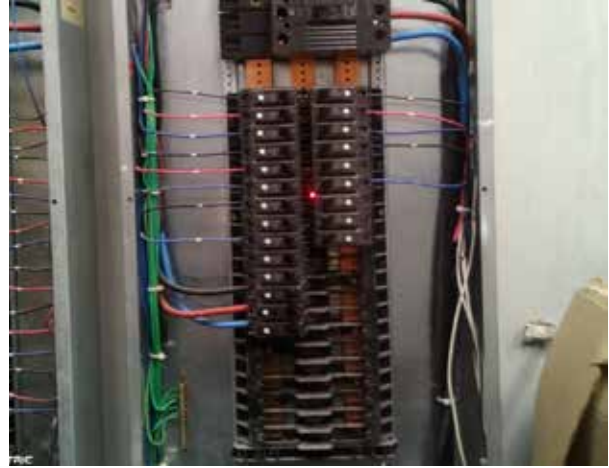
H&M LP5 125 AMP 208/120V

Based solely on test parameters in this thermographic report, no temperature abnormalities were detected at the time of the inspection. Therefore, no further recommendation for repairs is currently needed.

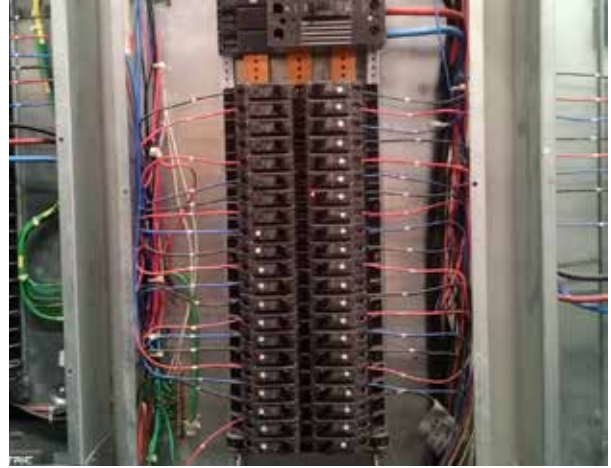
H&M LP2 125 AMP 208/120V

Based solely on test parameters in this thermographic report, no temperature abnormalities were detected at the time of the inspection. Therefore, no further recommendation for repairs is currently needed.

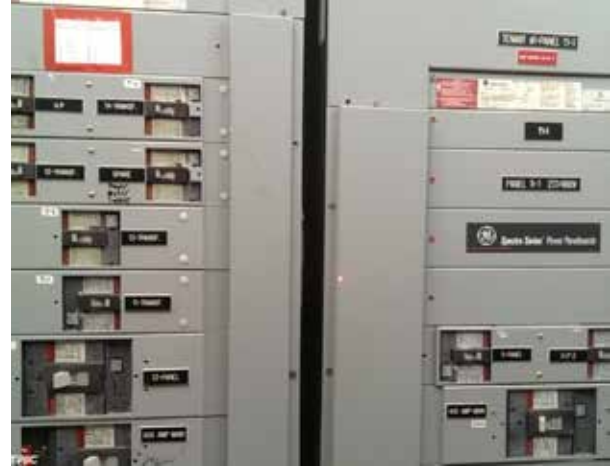
### H&P Tenant Panel T1-A & T1-1

Based solely on test parameters in this thermographic report, no temperature abnormalities were detected at the time of the inspection. Therefore, no further recommendation for repairs is currently needed.

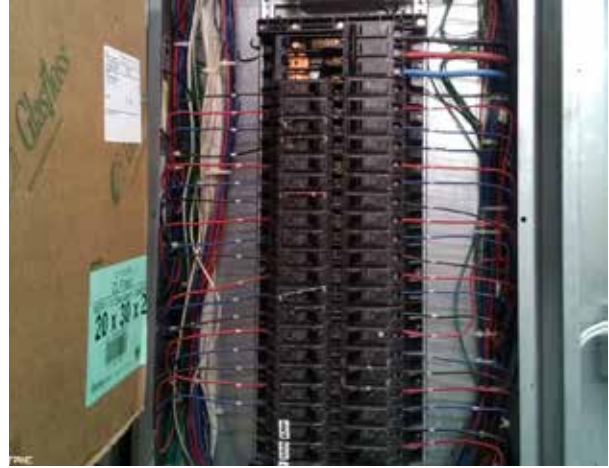
H&M LP3 125 AMP 208/120V

Based solely on test parameters in this thermographic report, no temperature abnormalities were detected at the time of the inspection. Therefore, no further recommendation for repairs is currently needed.

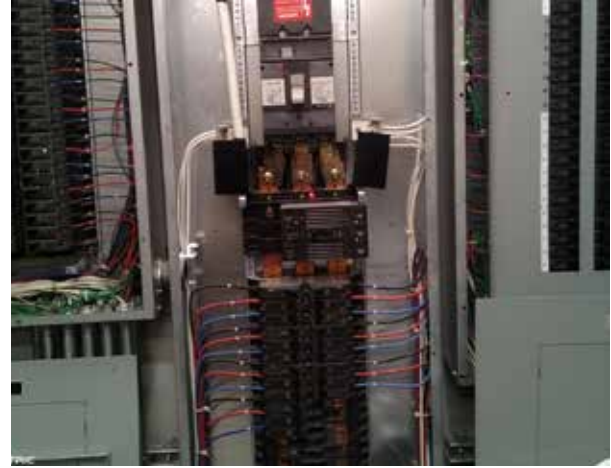
H&M LP4 400 AMP 208/120 V

Based solely on test parameters in this thermographic report, no temperature abnormalities were detected at the time of the inspection. Therefore, no further recommendation for repairs is currently needed.

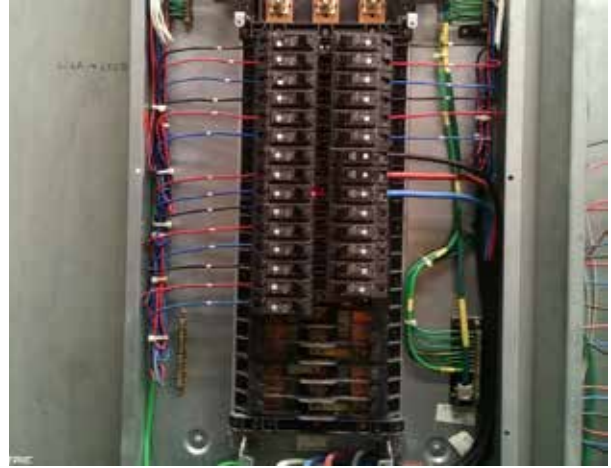
H&M LIGB 125AMP 208/120 V

Based solely on test parameters in this thermographic report, no temperature abnormalities were detected at the time of the inspection. Therefore, no further recommendation for repairs is currently needed.

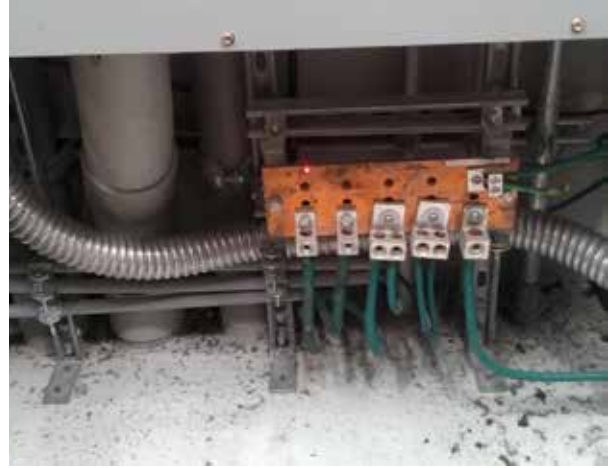
### H&M Ground

Based solely on test parameters in this thermographic report, no temperature abnormalities were detected at the time of the inspection. Therefore, no further recommendation for repairs is currently needed.

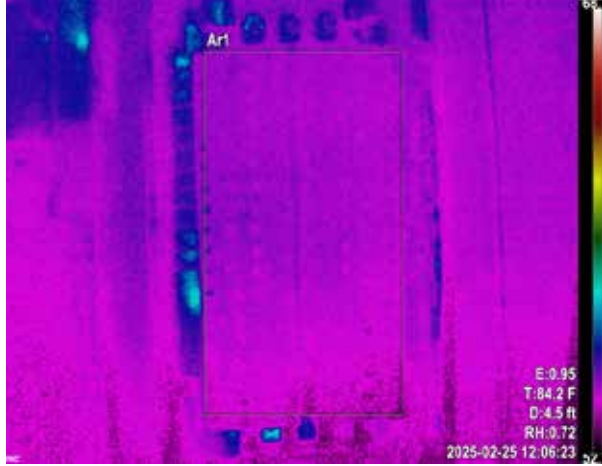
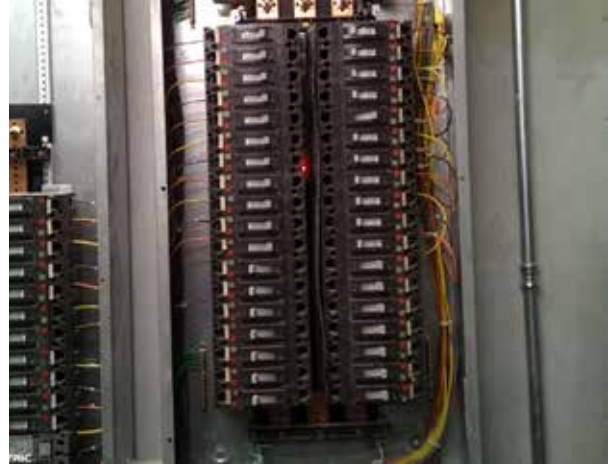
H&M HP1 125AMP 400/277 V

Based solely on test parameters in this thermographic report, no temperature abnormalities were detected at the time of the inspection. Therefore, no further recommendation for repairs is currently needed.

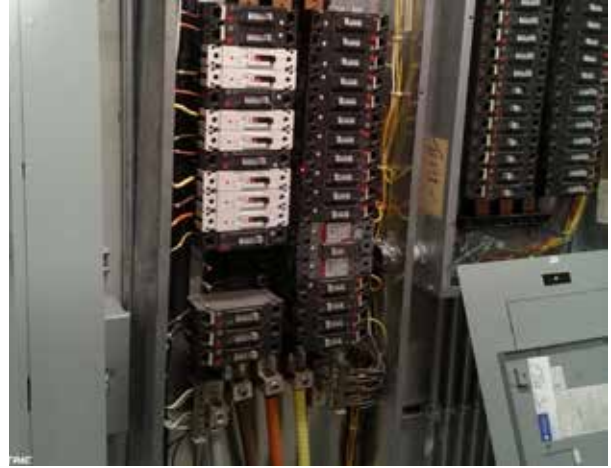
H&M HP2 400 AM 480/227 V

Based solely on test parameters in this thermographic report, no temperature abnormalities were detected at the time of the inspection. Therefore, no further recommendation for repairs is currently needed.

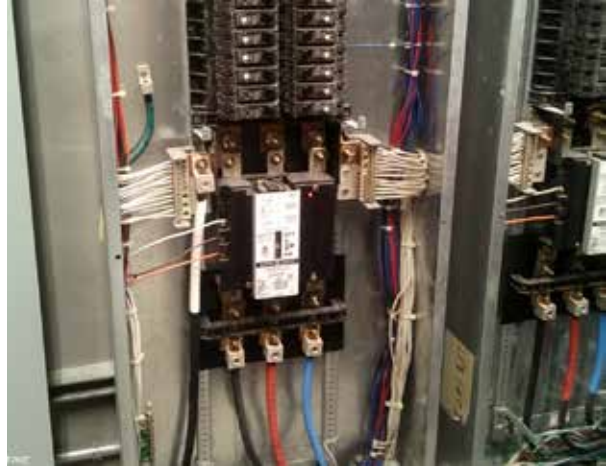
H&M LP1 Section 2 225 AMP 208/120 V (1 of 2)

Based solely on test parameters in this thermographic report, no temperature abnormalities were detected at the time of the inspection. Therefore, no further recommendation for repairs is currently needed.

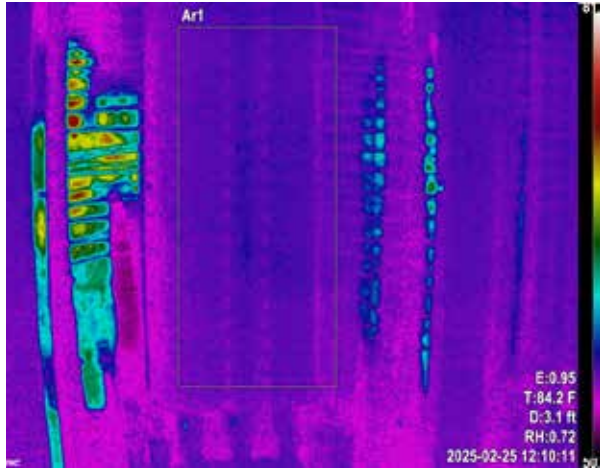
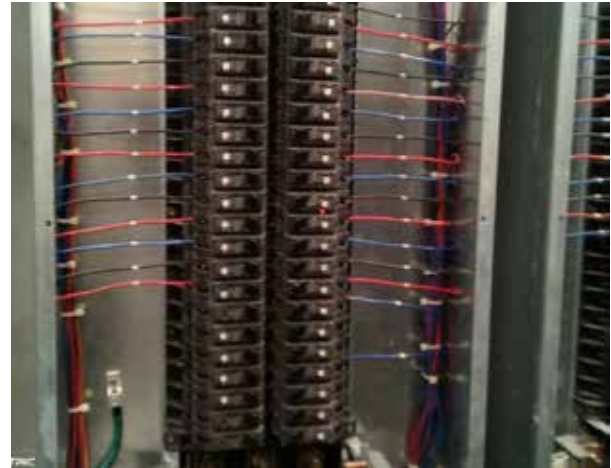
H&M LP1 Section 2 225 AMP 208/120 V (2 of 2)

Based solely on test parameters in this thermographic report, no temperature abnormalities were detected at the time of the inspection. Therefore, no further recommendation for repairs is currently needed.

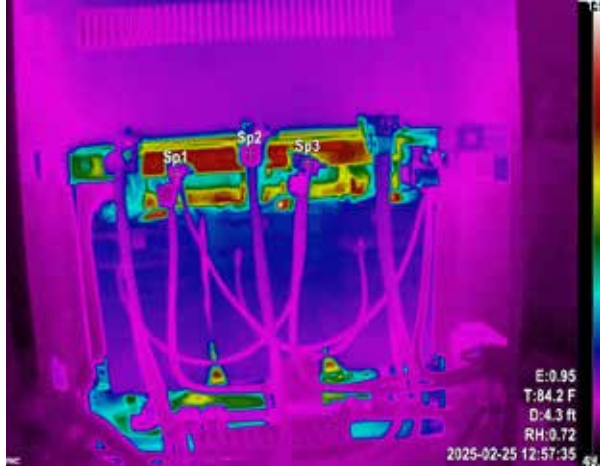
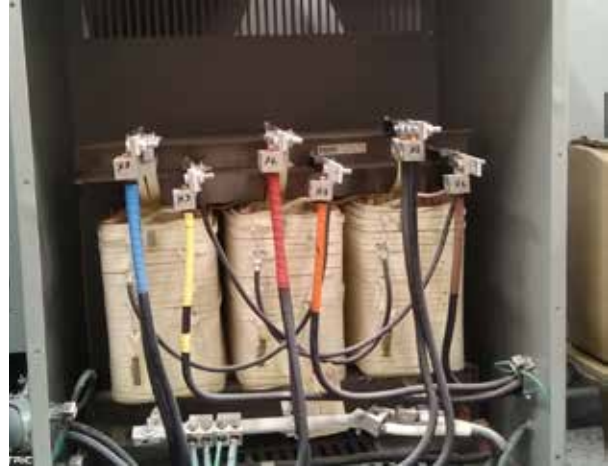
### H&M Transformer T1 112 KVA

Based solely on test parameters in this thermographic report, no temperature abnormalities were detected at the time of the inspection. Therefore, no further recommendation for repairs is currently needed.

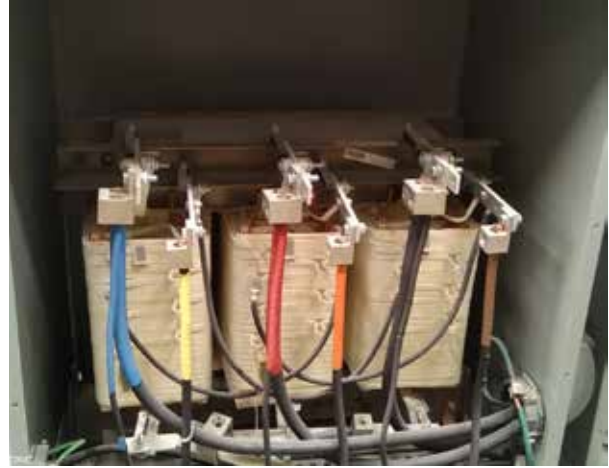
### H&M Transformer T2 112 KVA

Based solely on test parameters in this thermographic report, no temperature abnormalities were detected at the time of the inspection. Therefore, no further recommendation for repairs is currently needed.

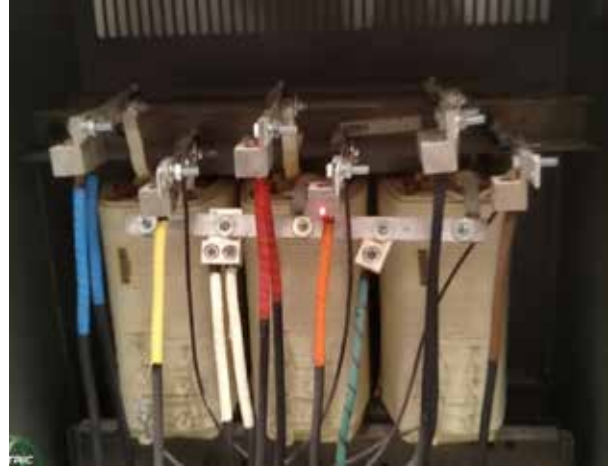
### H&M Transformer T3 70KVA

Based solely on test parameters in this thermographic report, no temperature abnormalities were detected at the time of the inspection. Therefore, no further recommendation for repairs is currently needed.

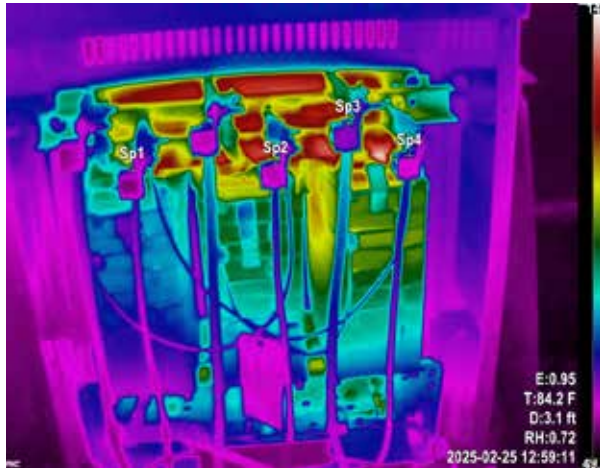
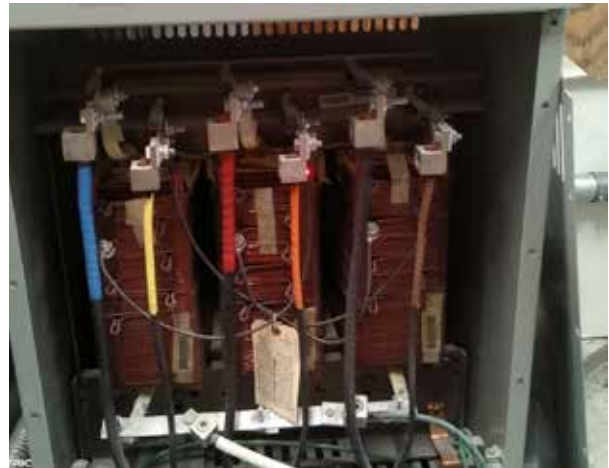
H&M Transformer T4 45 KVA

Based solely on test parameters in this thermographic report, no temperature abnormalities were detected at the time of the inspection. Therefore, no further recommendation for repairs is currently needed.

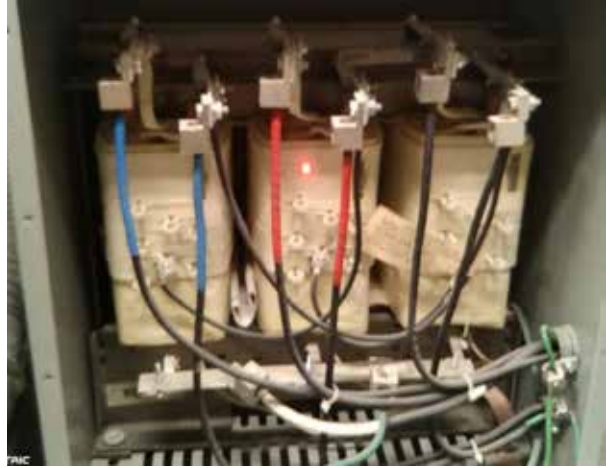
### H&M Transformer T5 112 KVA

Based solely on test parameters in this thermographic report, no temperature abnormalities were detected at the time of the inspection. Therefore, no further recommendation for repairs is currently needed.

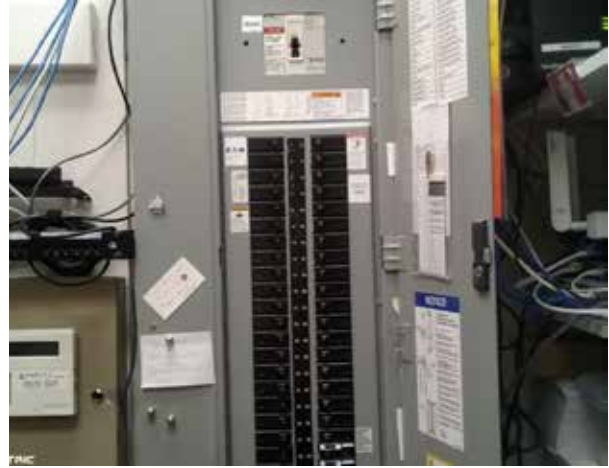
551 SWATCH Panel L 100 AMP 208/120 V

Based solely on test parameters in this thermographic report, no temperature abnormalities were detected at the time of the inspection. Therefore, no further recommendation for repairs is currently needed.

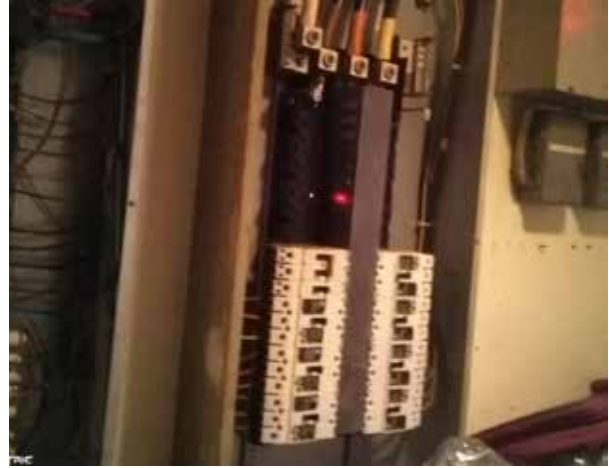
551 TAPELIA Panel B 225 AMP 200/120 V

Based solely on test parameters in this thermographic report, no temperature abnormalities were detected at the time of the inspection. Therefore, no further recommendation for repairs is currently needed.

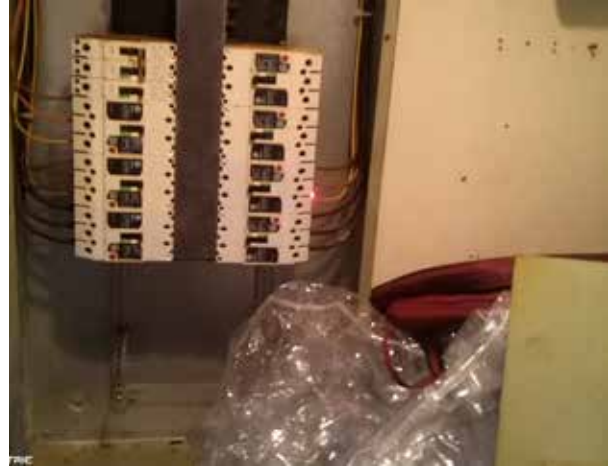
551 TAPELIA Panel HMDP 400 AMP 480-277 V (1 of 2)

Based solely on test parameters in this thermographic report, no temperature abnormalities were detected at the time of the inspection. Therefore, no further recommendation for repairs is currently needed.

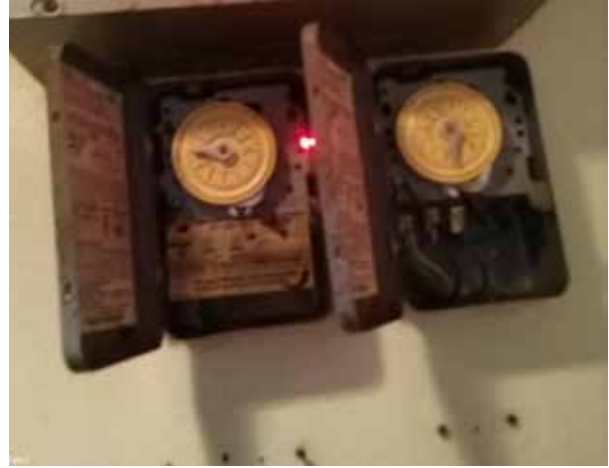
### 551 TAPELIA Timer

Based solely on test parameters in this thermographic report, no temperature abnormalities were detected at the time of the inspection. Therefore, no further recommendation for repairs is currently needed.

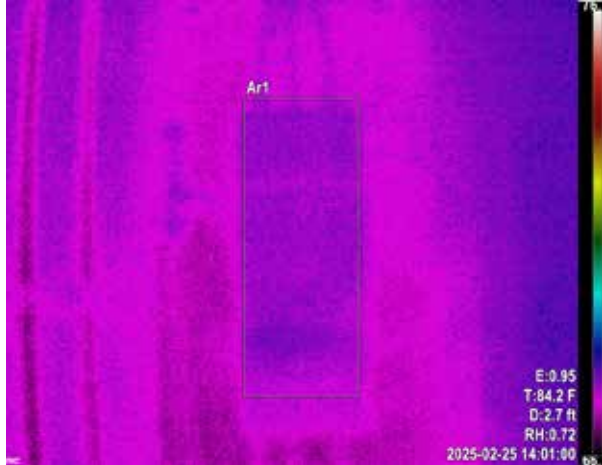
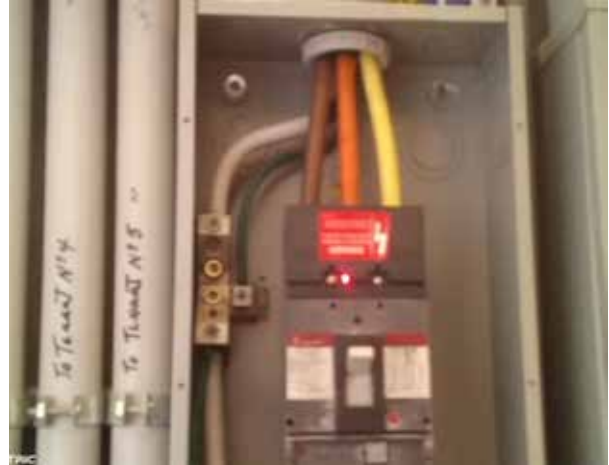
### TAPELIA ELECTRIC ROOM Main 400 AMP 1 of 5 Tenants 3,4,5

Based solely on test parameters in this thermographic report, no temperature abnormalities were detected at the time of the inspection. Therefore, no further recommendation for repairs is currently needed.

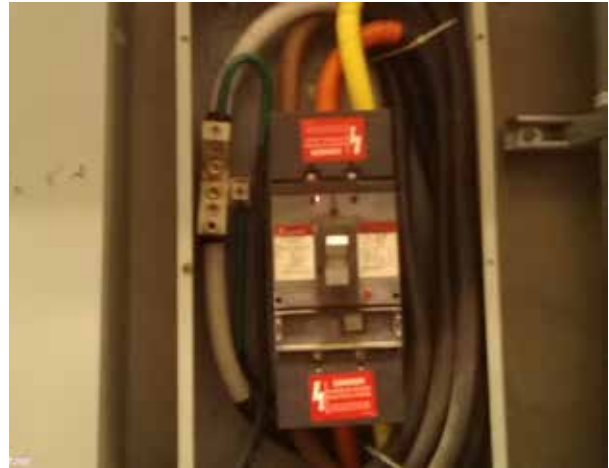
**TAPELIA ELECTRIC ROOM Main 400 AMP 2 of 5**

Based solely on test parameters in this thermographic report, no temperature abnormalities were detected at the time of the inspection. Therefore, no further recommendation for repairs is currently needed.

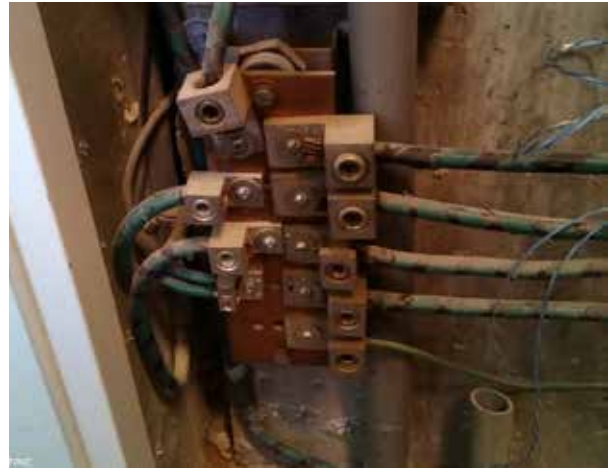
### TAPELIA ELECTRIC ROOM Ground

Based solely on test parameters in this thermographic report, no temperature abnormalities were detected at the time of the inspection. Therefore, no further recommendation for repairs is currently needed.

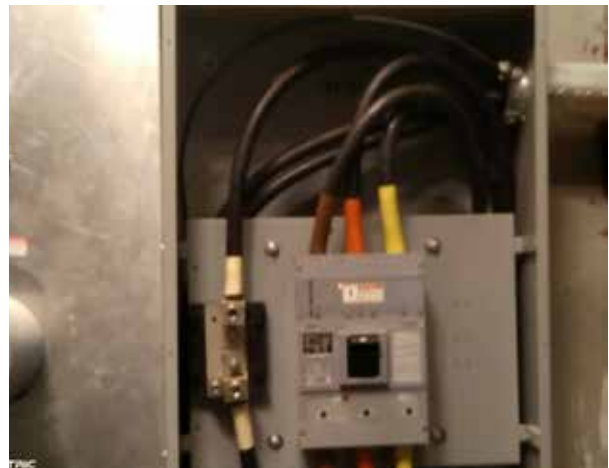
**TAPELIA ELECTRIC ROOM Main 5 of 5 400 AMP 277/480 V**

Based solely on test parameters in this thermographic report, no temperature abnormalities were detected at the time of the inspection. Therefore, no further recommendation for repairs is currently needed.

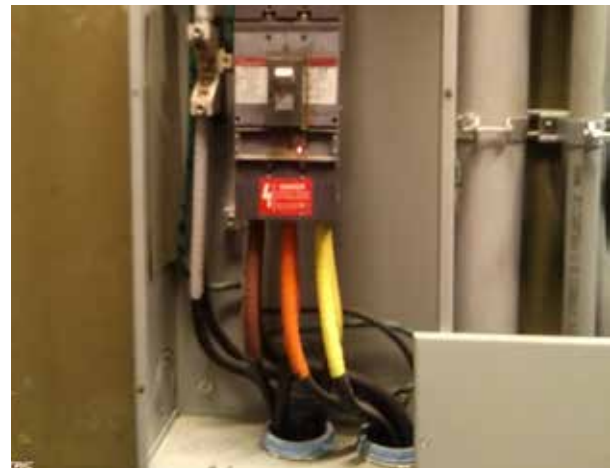
**TAPELIA ELECTRIC ROOM Main 400 AMP 3 of 5**

Based solely on test parameters in this thermographic report, no temperature abnormalities were detected at the time of the inspection. Therefore, no further recommendation for repairs is currently needed.

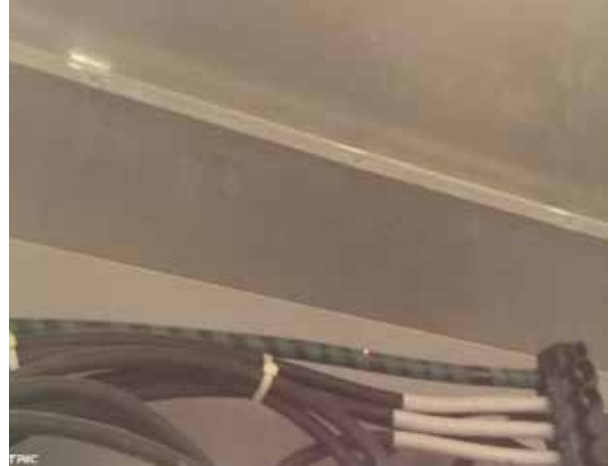
### TAPELIA ELECTRIC ROOM Gutter (1 of 2)

Based solely on test parameters in this thermographic report, no temperature abnormalities were detected at the time of the inspection. Therefore, no further recommendation for repairs is currently needed.

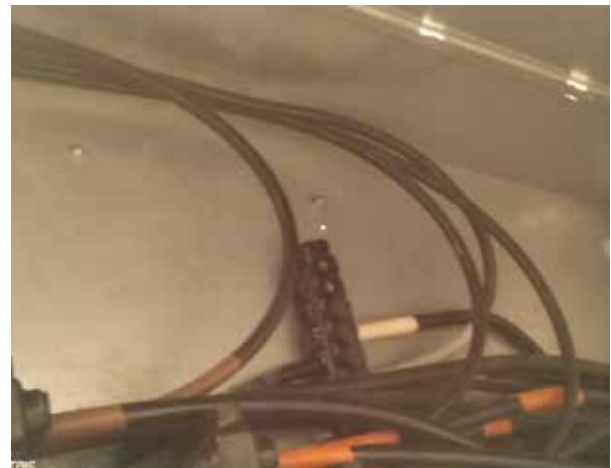
### TAPELIA ELECTRIC ROOM Gutter (2 of 2)

Based solely on test parameters in this thermographic report, no temperature abnormalities were detected at the time of the inspection. Therefore, no further recommendation for repairs is currently needed.
