## Sample New Construction Inspection Report

**INSPECTED PROPERTY ADDRESS:**  
Lotus Edge  
Boca Raton FL 33434

This Summary Report presents the conditions identified during the September 18, 2026 construction/pre-closing inspection that warrant attention, correction, clarification, or follow-up by the builder. It is intentionally condensed and does not reproduce every chapter or checklist item contained in the complete field inspection checklist. Chapters that do not appear in this Summary were reviewed as part of the inspection but are not included because no reportable deficiency or condition requiring summary-level discussion was identified in those areas. The complete field checklist remains the detailed inspection record, while this Summary is intended to focus the builder and client on the specific conditions requiring attention.

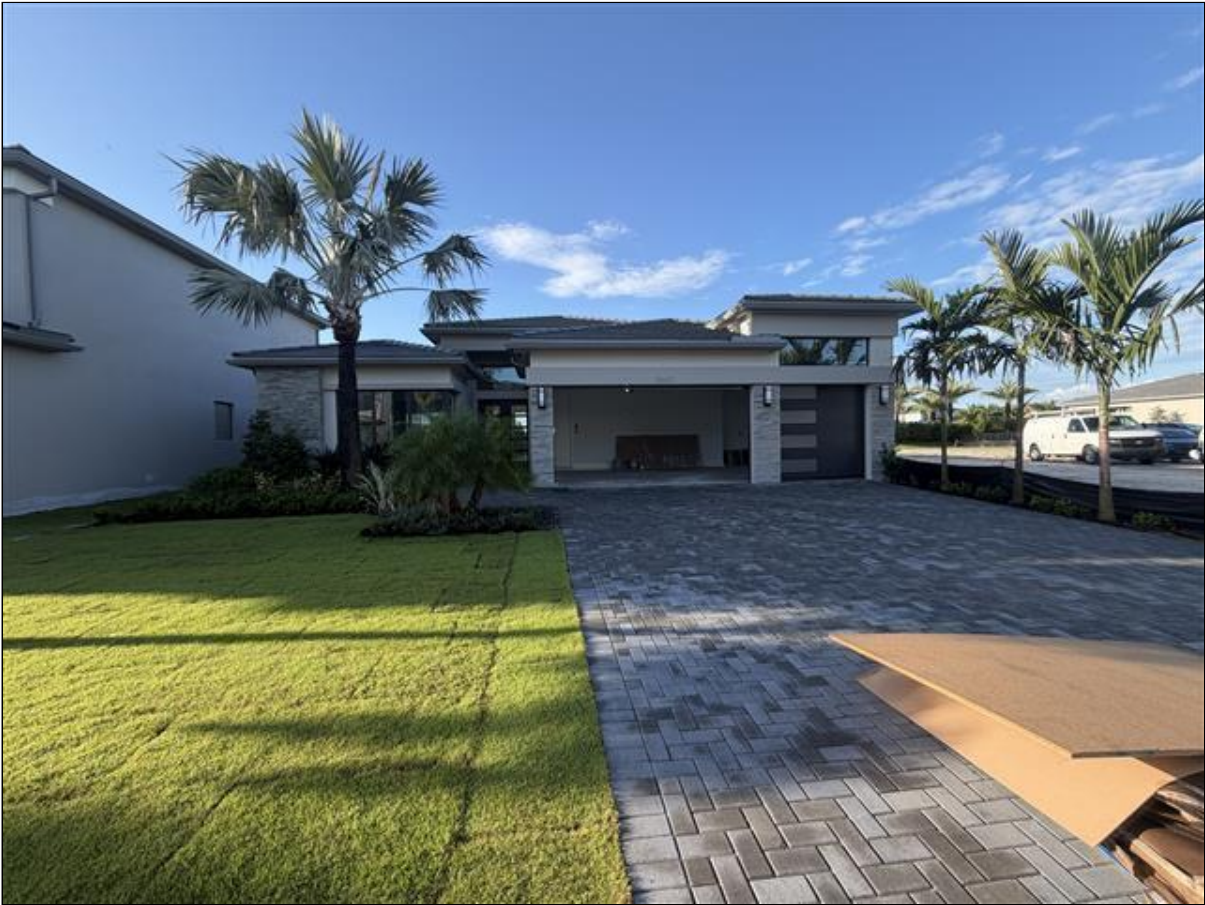
1.0 Item 1 (Picture)

During the inspection, significant water-management concerns were observed along the left side of the property. A neighboring property downspout discharges at or near the dividing fence, and the observed conditions indicate that during periods of heavy rainfall, water can flow toward Lot 412. Saturated soil and areas of water accumulation were visible in this area. In addition, a downspout near the HVAC equipment was observed discharging in a manner that is washing away mulch and soil, while another discharge near the left side of the garage appears to be affecting the paver area and may contribute to loss of joint sand. These conditions should be reviewed with the builder and addressed as appropriate to establish positive and controlled drainage away from the residence and finished areas.

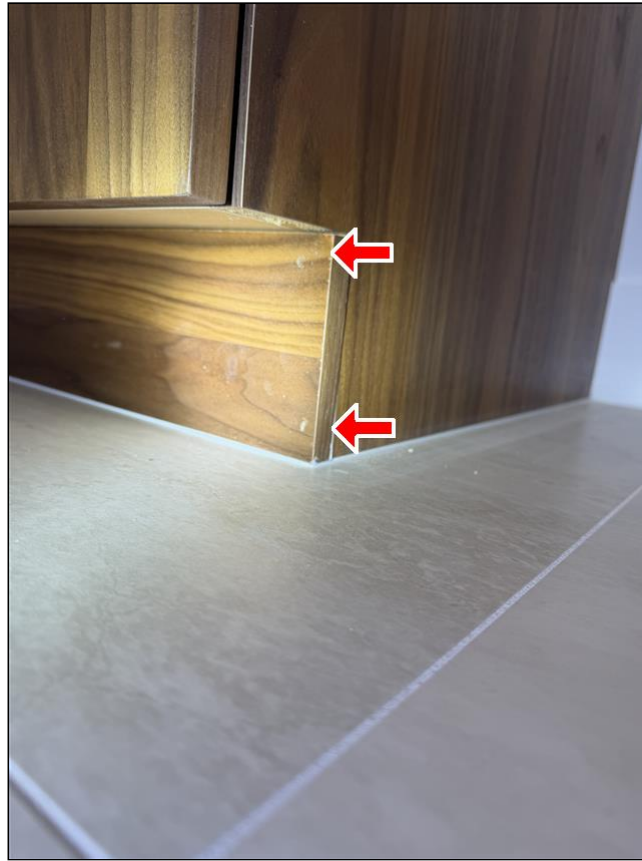
2.0 Item 1 (Picture)

Visible construction-related workmanship concerns were identified around the kitchen work area. Excess adhesive/glue was observed near the cooktop, and scratches and exposed nail heads were observed on portions of the kitchen island and adjacent pantry cabinetry near the refrigerator. Scratched cabinet faces and poorly nailed cabinet panels were also observed. At the time of inspection, cleaning of the work area was still in progress, so the builder should complete the cleaning and perform a final review of the affected cabinetry and surrounding finishes to ensure that construction residue and visible damage have been properly addressed.

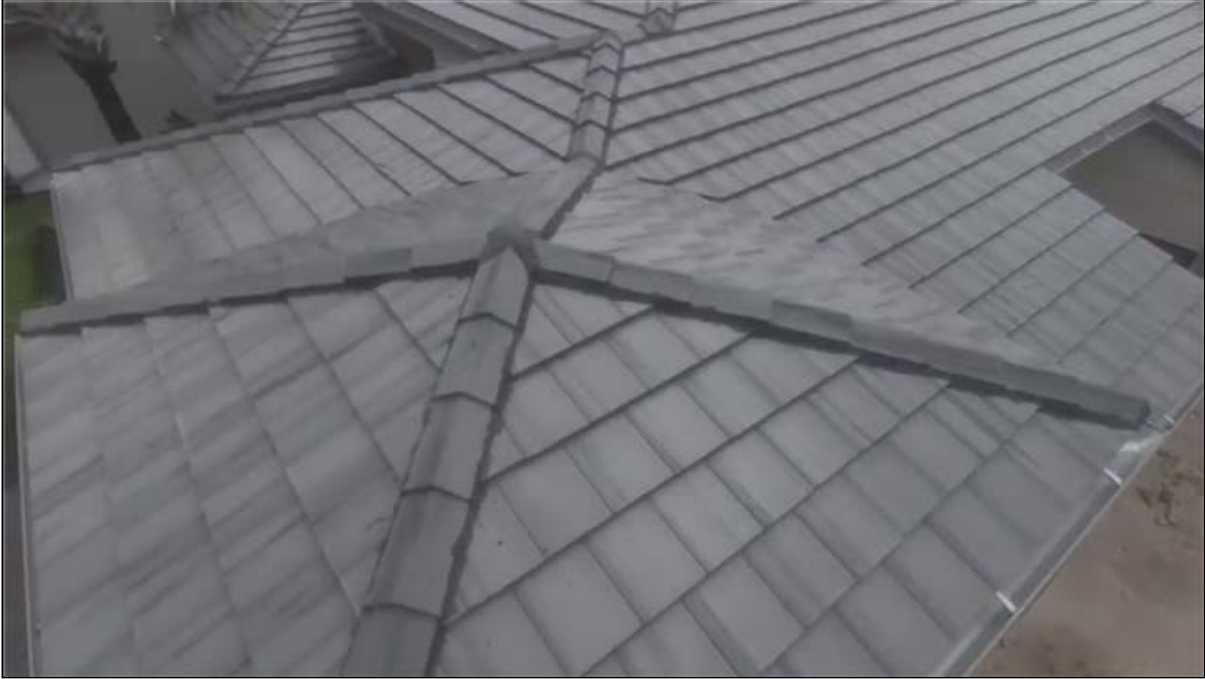
3.0 Item 1 (Picture)

The roof was visually examined from the accessible vantage points permitted at the property. A cracked roof tile was observed on the front roof slope. Because the roof covering is a finished component and the builder's site policy restricts

roof access, the observation is limited to visible conditions from permitted vantage points. The cracked tile should be identified to the builder for repair or replacement and the surrounding area reviewed to ensure the repair is properly completed.

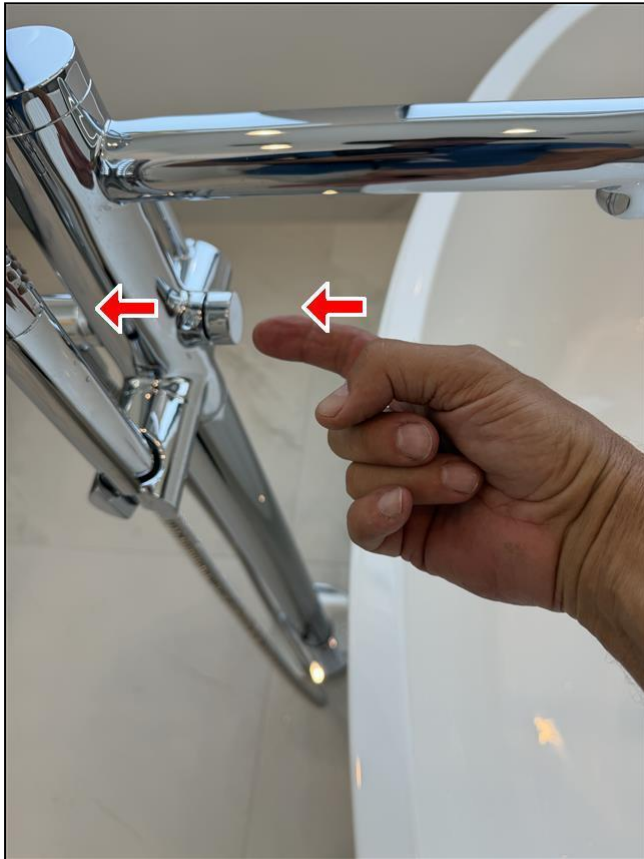
4.0 Item 1 (Picture)

A concern was identified at the primary bathroom tub/shower fixture configuration. The handheld shower controls did not operate as expected and may have a missing component or require adjustment. In addition, the shower valve/trim assembly appeared loose and was not properly secured. These conditions should be reviewed and corrected by the builder/plumbing contractor, with the completed installation checked for proper assembly and secure attachment. The inspection did not include destructive investigation or independent sewer-system testing.

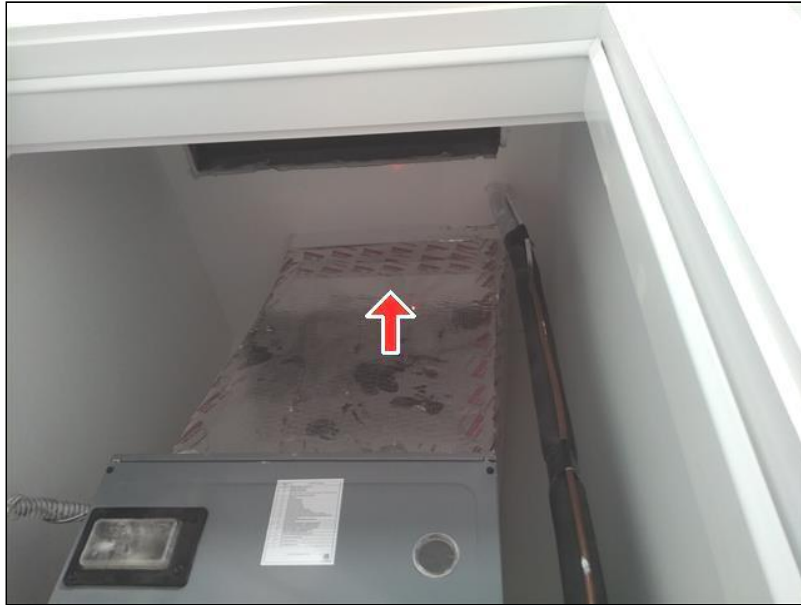
5.0 Item 1 (Picture)

A visible HVAC concern was identified at HVAC System #2. The upper portion of the plenum exhibited evidence of air leakage, which was also documented with infrared imaging. This condition should be reviewed by the HVAC contractor and properly sealed as necessary.

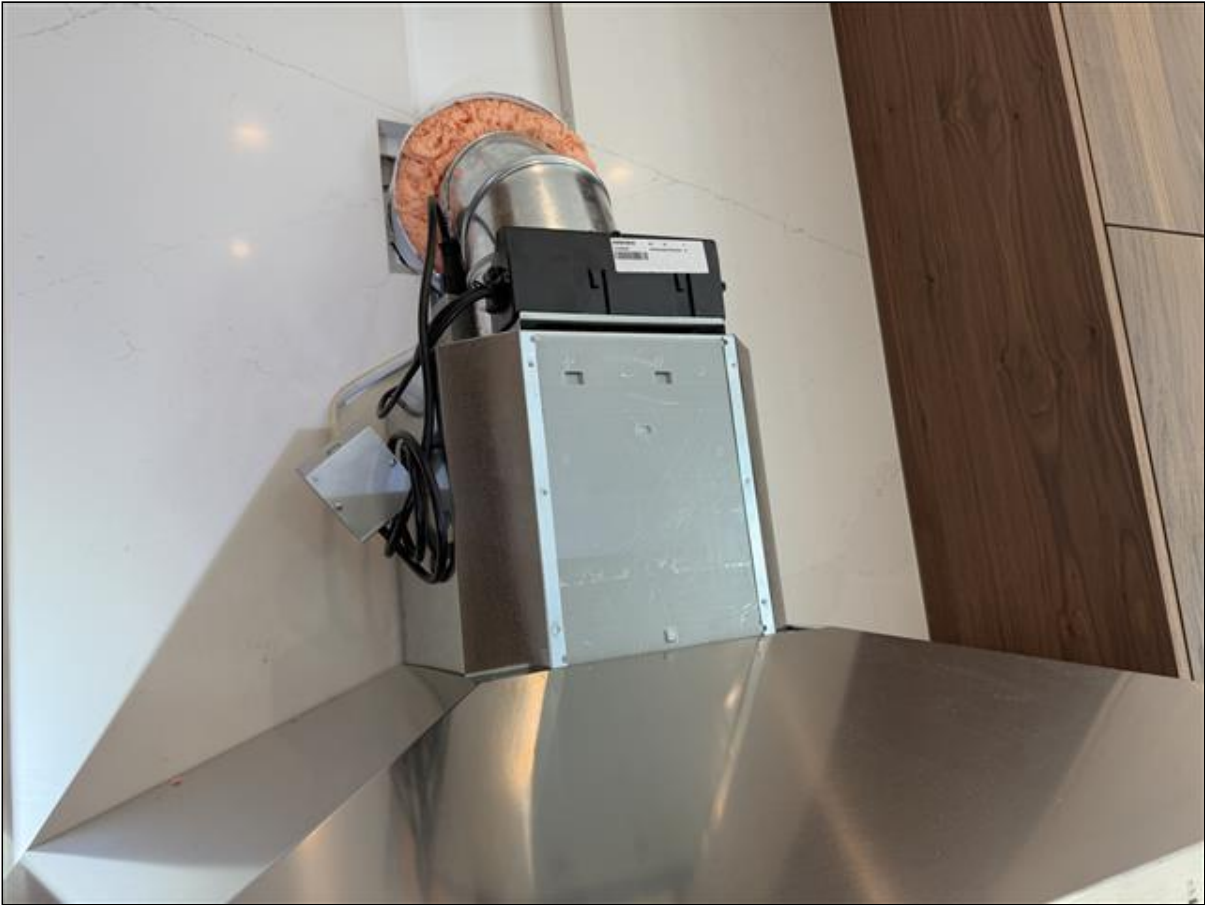
5.1 Item 1 (Picture)

The kitchen hood was still in the process of being installed at the time of inspection; consequently, its final installation, duct-cover configuration and completion could not be considered finished at the time of this report. The builder should complete the installation and conduct its normal final quality-control review before closing.

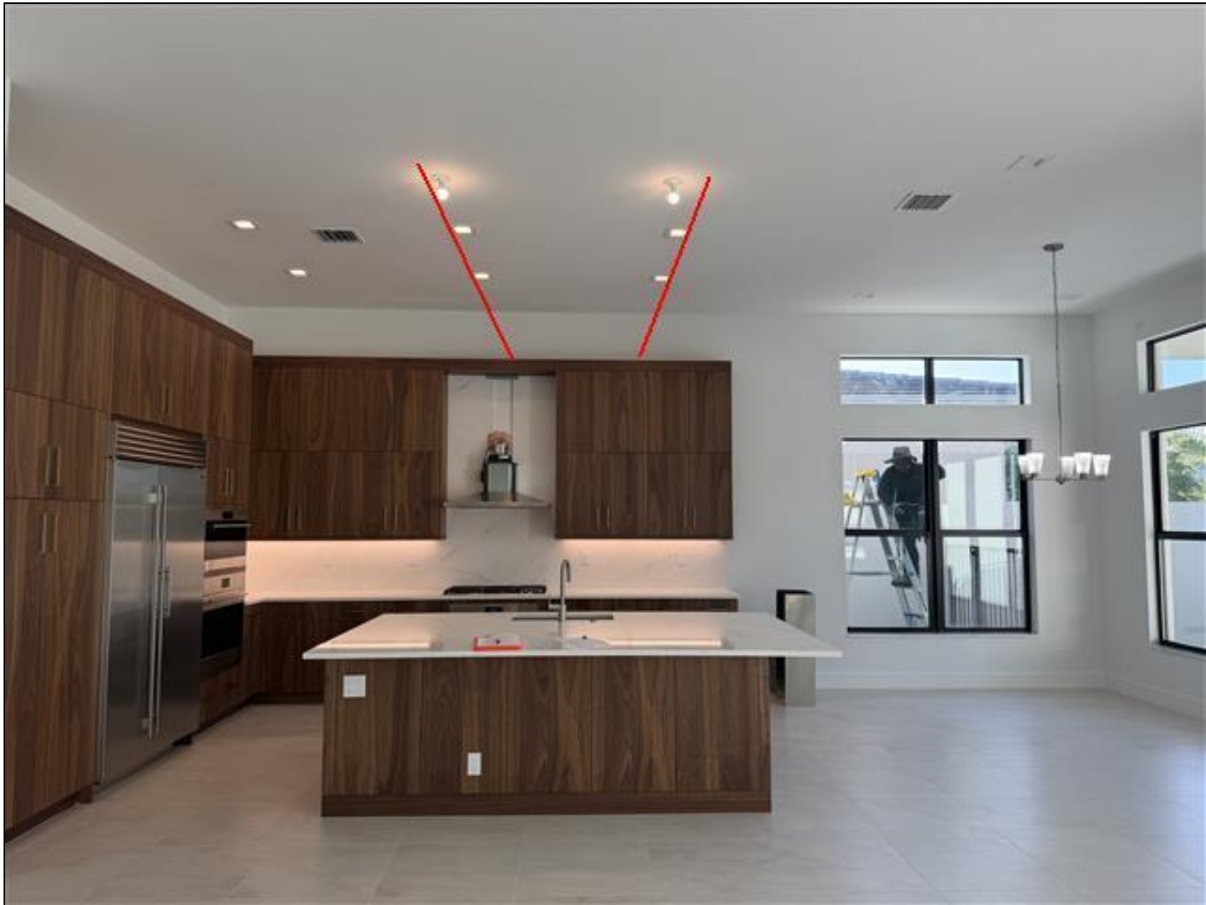
6.0 Item 1 (Picture)

A discrepancy was noted in the kitchen ceiling lighting configuration. The documented location of the second kitchen island junction box does not appear to align cleanly with the recessed-light layout observed in the finished ceiling. The available information does not establish whether this was an intentional design decision or an installation discrepancy. The builder should compare the completed installation with the approved electrical/lighting plan and confirm that the junction-box and recessed-light locations are consistent with the intended configuration.

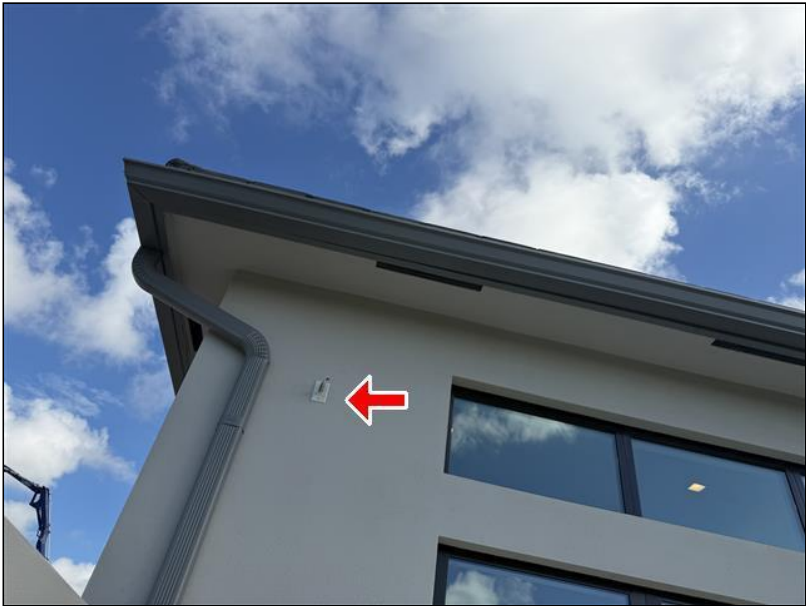
7.0 Item 1 (Picture)

The inspection identified a discrepancy involving the exterior camera prewire locations. The Lot 412 documentation calls for five exterior Cat6 camera locations, including three at the rear, one at the right-side atrium and one at the front. Only four visible camera-prewire locations were observed during the inspection. Because the wiring paths themselves are concealed and were not traced, the missing location should be reconciled by the builder against the approved low-voltage plan and construction documentation. The builder should identify the intended fifth location and confirm that the required prewire was installed.

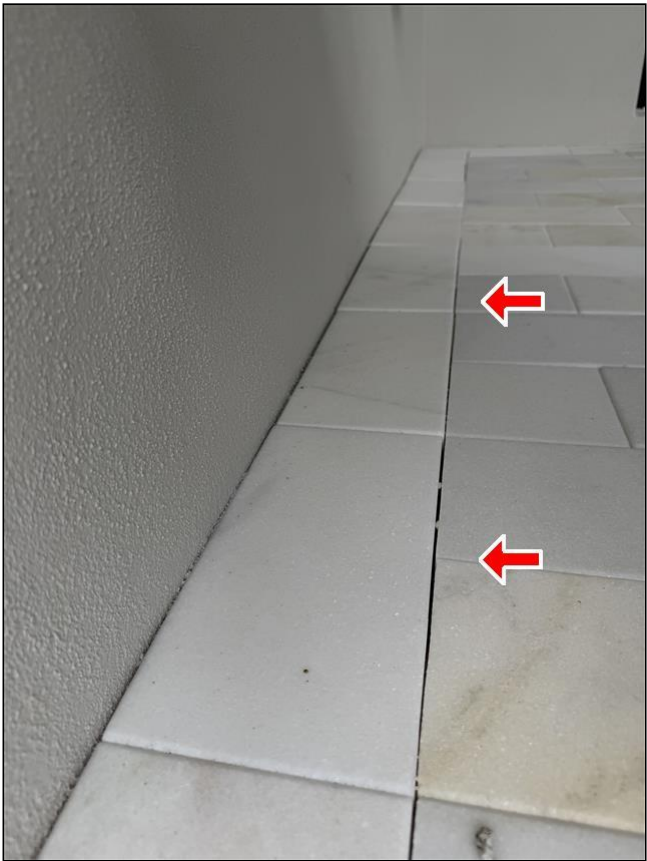
8.0 Item 1 (Picture)

Several deficiencies were observed in the covered-patio marble paver installation. The pavers were intended to be installed in a running-bond configuration using the selected Arctic White material; however, several areas exhibited visible misalignment and/or chipped or damaged tiles. These conditions should be reviewed by the builder and the

affected pavers properly repaired or replaced so that the finished installation is consistent and free of visible installation damage.

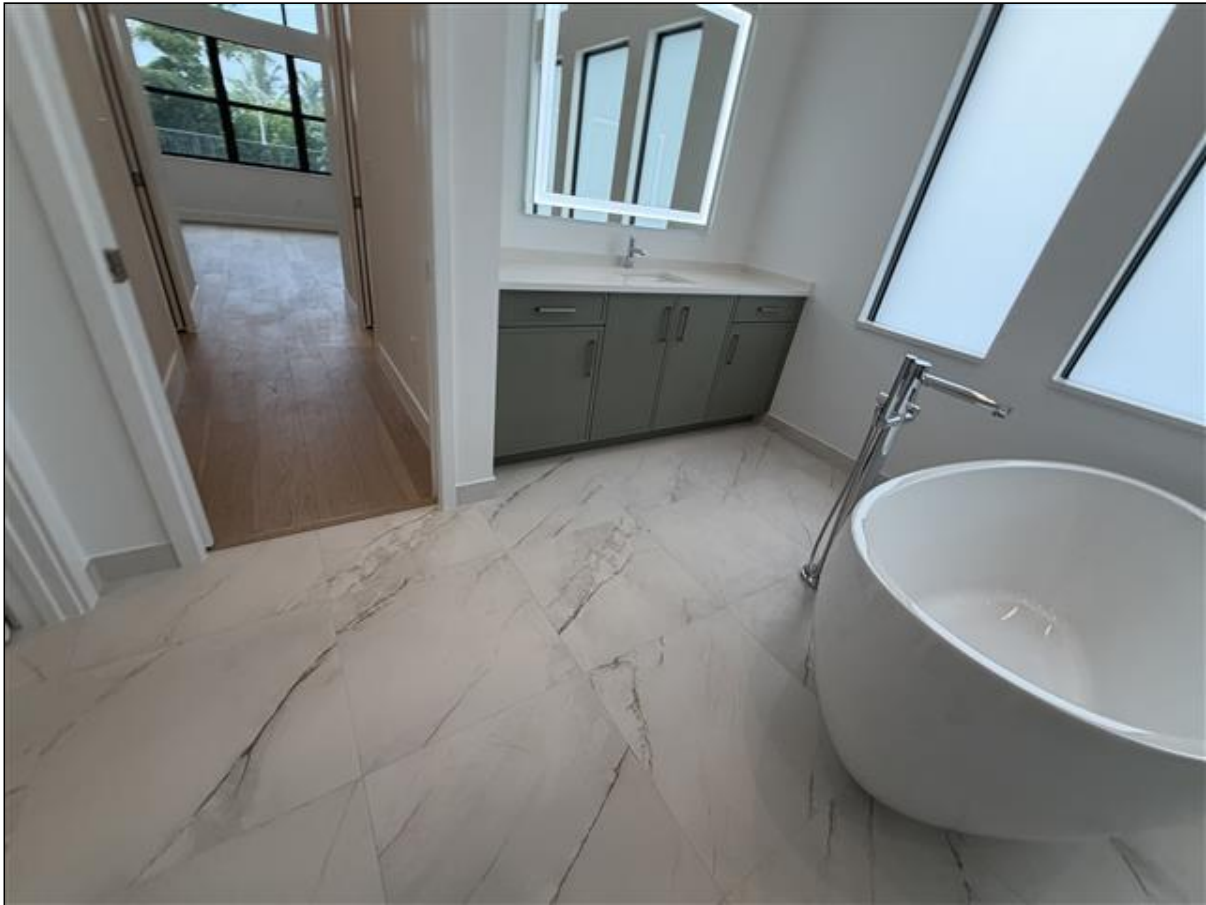
9.0 Item 1 (Picture)

Two conditions were identified in the primary bathroom. First, the HER vanity configuration does not appear to contain the specified three-bank drawer arrangement to the right of the knee space; the installed configuration contains no blank drawers in that location. Second, the freestanding tub handheld-shower control assembly did not appear to operate properly and may have a missing component. The builder should compare the installed vanity configuration with the approved selections/exhibit and have the handheld-shower assembly reviewed and corrected as necessary.

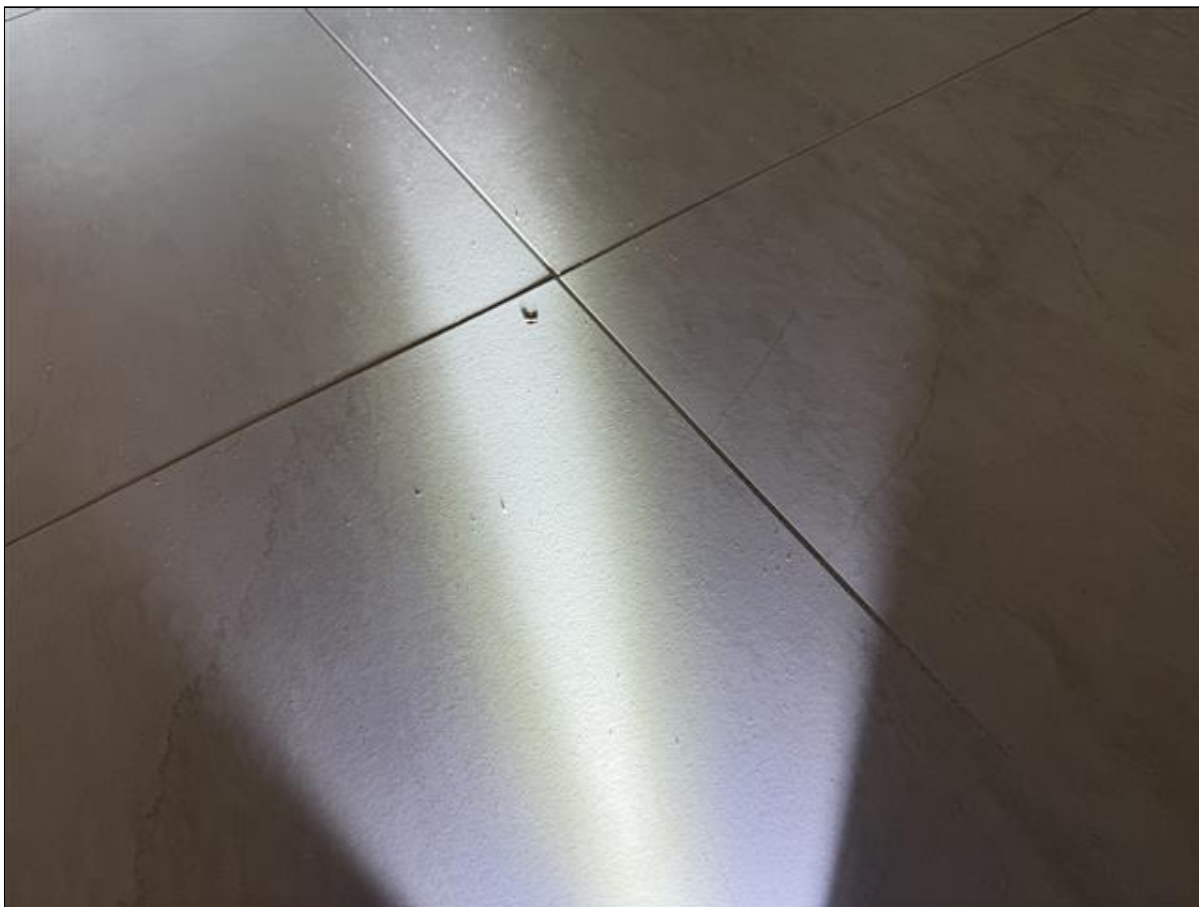
10.0 Item 1 (Picture)

Visible tile-installation concerns were identified in several areas of the home. Using reflected/critical lighting from a rolling flashlight, areas of apparent tile lippage were observed, where adjacent tile surfaces are not consistently flush with one another. These conditions should be reviewed by the builder's tile contractor to determine which areas require correction. The observations concern visible installation characteristics rather than the selected tile color, material or product specification.

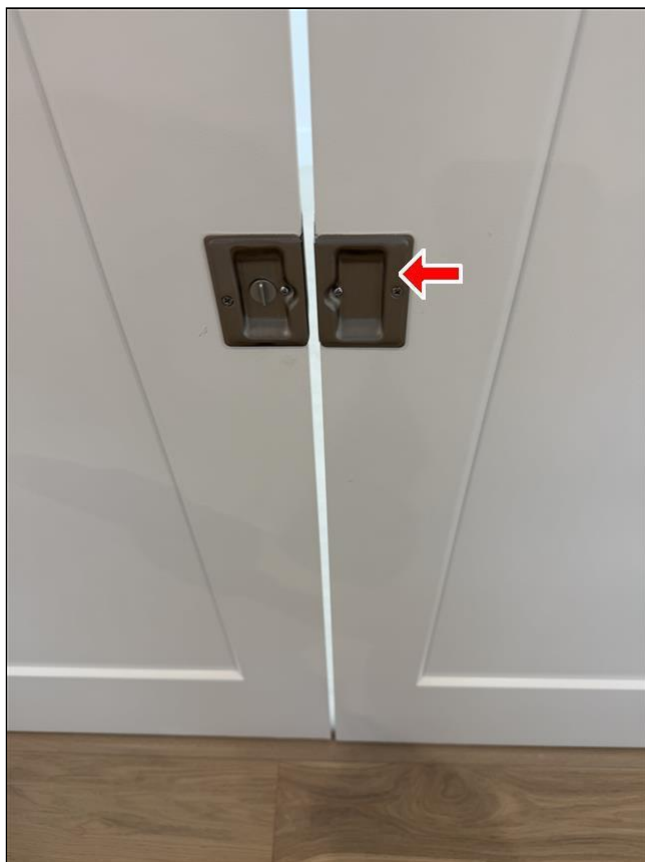
11.0 Item 1 (Picture)

A functional alignment concern was observed at the den pocket doors. The doors do not appear to align sufficiently to allow the latch to engage properly. This should be adjusted by the builder so that the completed doors align and operate as intended. In addition, the interior surface of the front door was observed to be dirty and should be cleaned as part of the final construction cleaning.

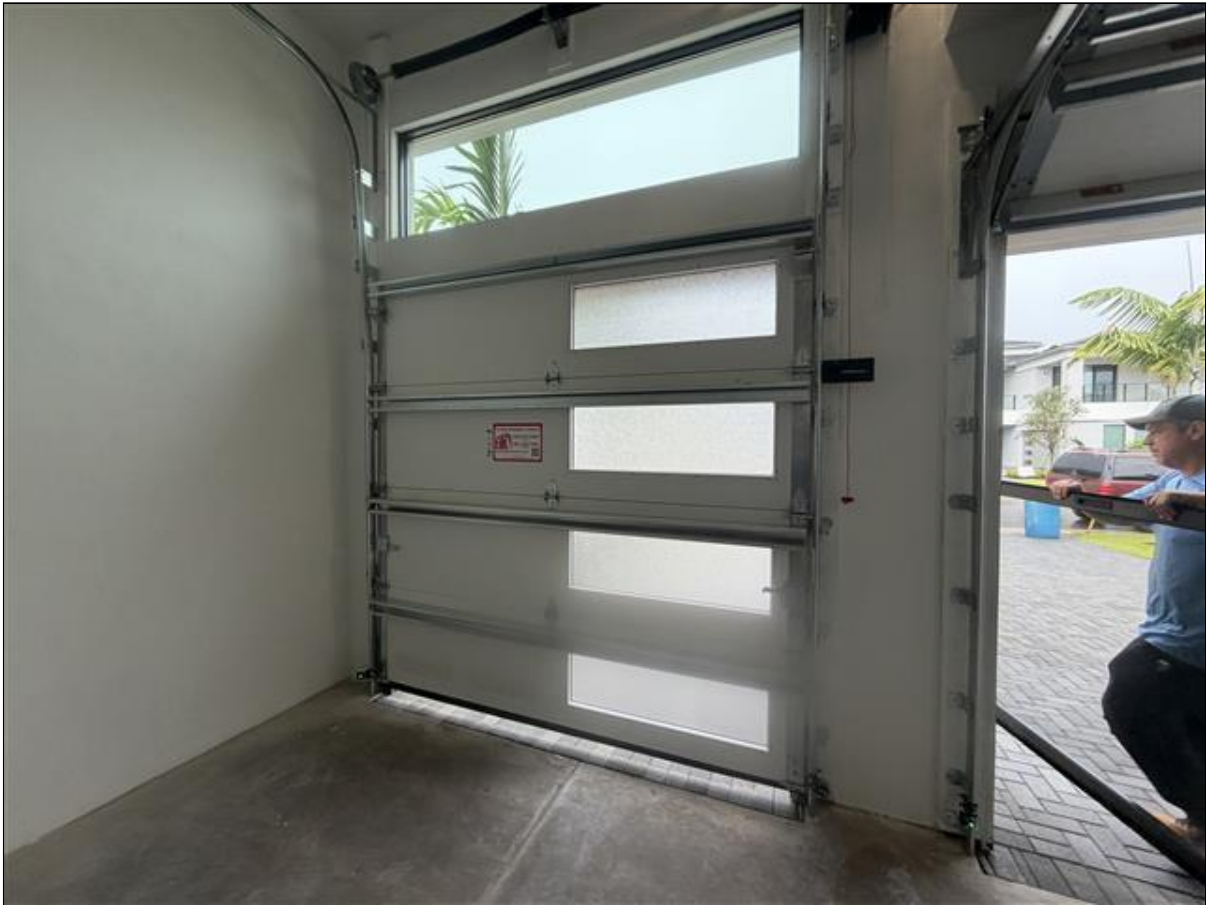
12.0 Item 1 (Picture)

The inspection identified a discrepancy involving the garage wireless keypads. The Lot 412 documentation calls for keypad provisions associated with both garage doors, including the one-car garage. During the inspection, the second keypad expected at the inside-left return of the smaller garage was not observed. The builder should compare the installed configuration with the approved plan and confirm whether the second keypad is missing, incomplete or located elsewhere.
