### **Roof Inspection Report**

**Property Address:**  
7329 Reserve Creek Dr  
Port St. Lucie FL 34986

8/26/2025

Sample Report

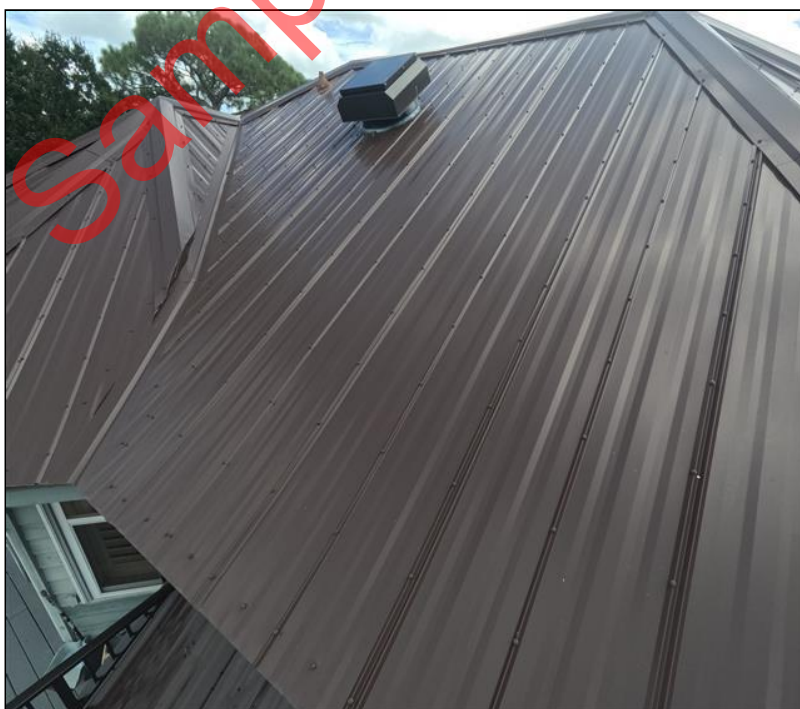
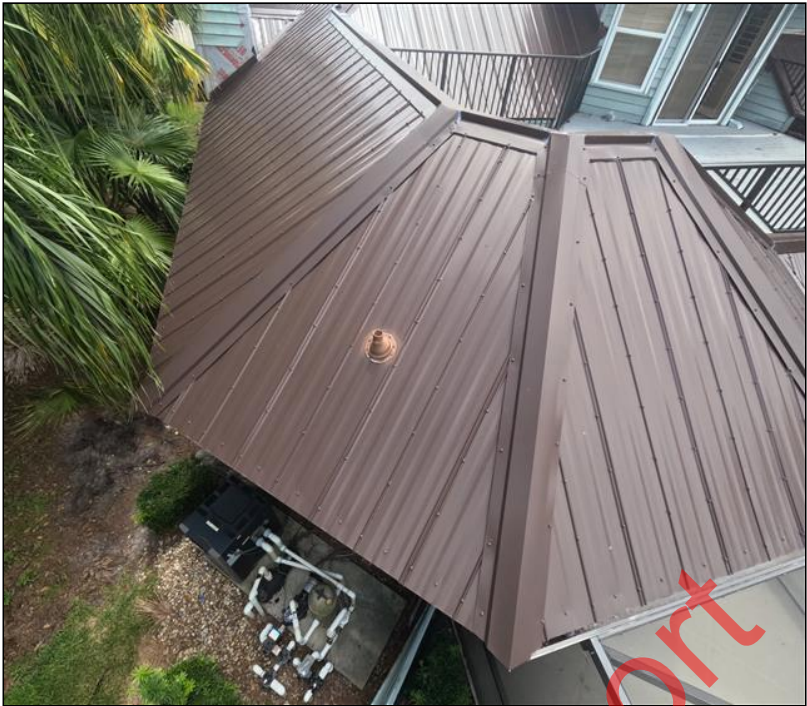
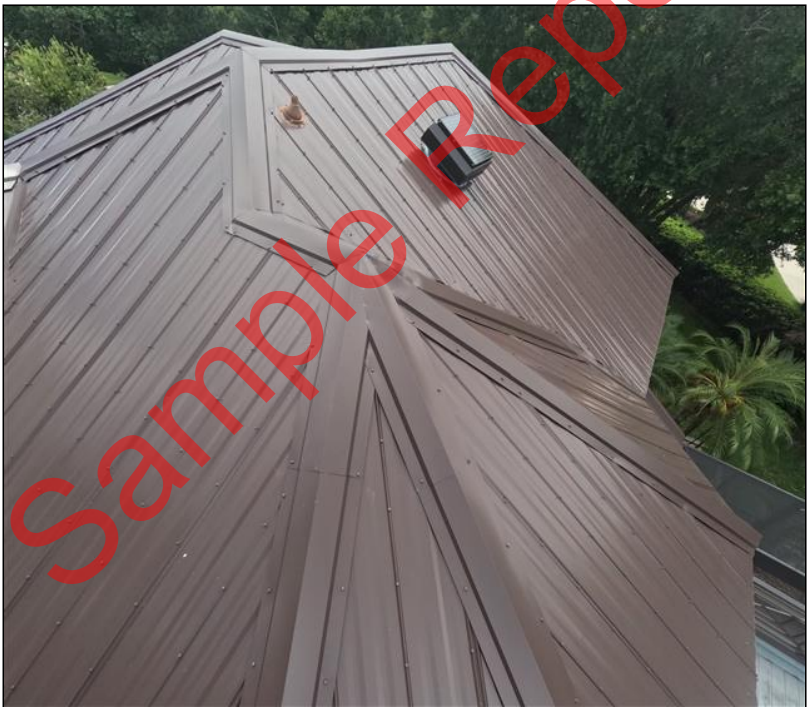
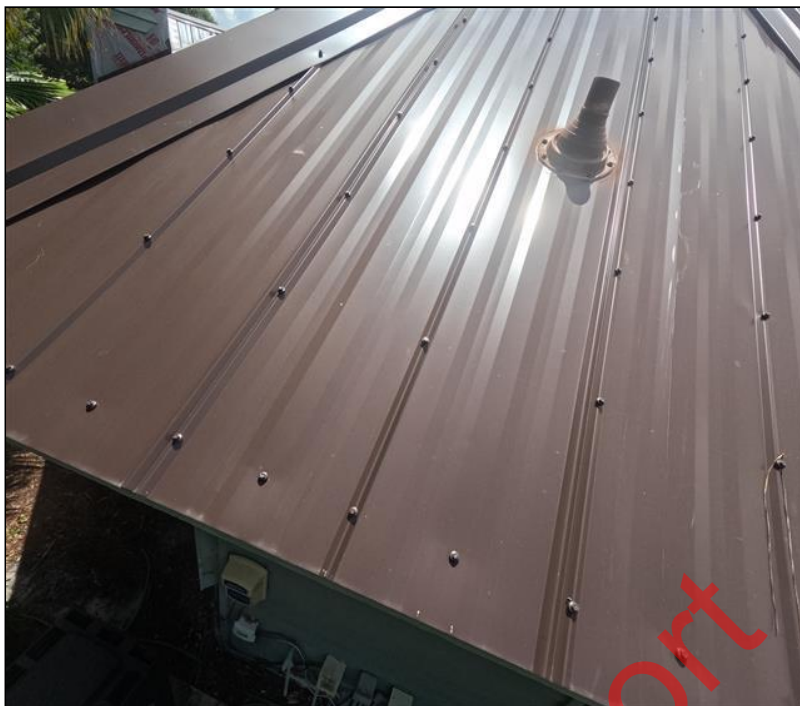
Inspector observed no deficiencies with the condition of the plumbing or combustion vents at the time of the inspection.

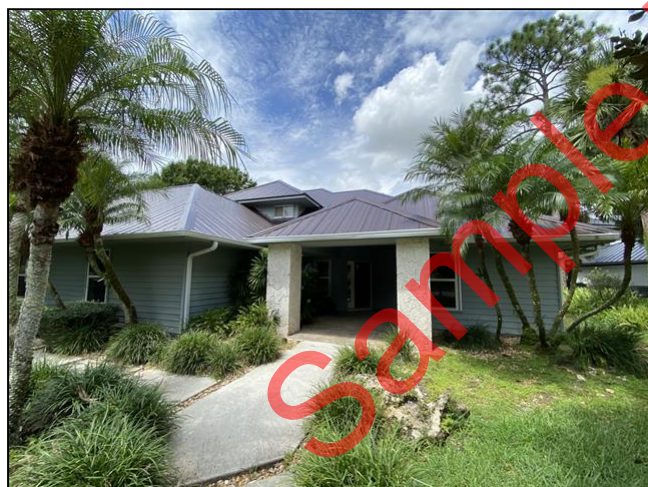
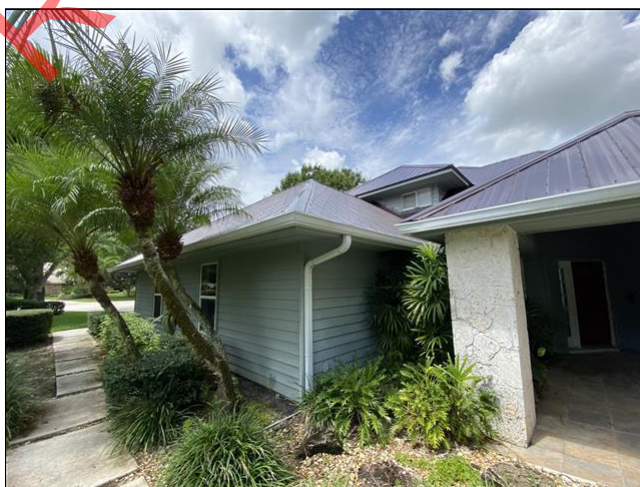
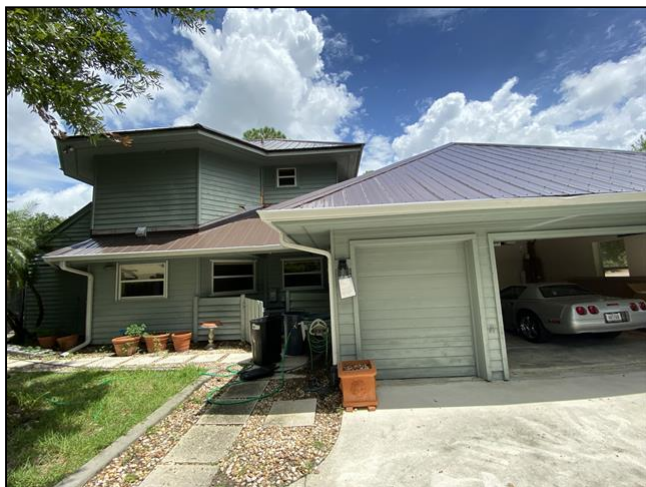
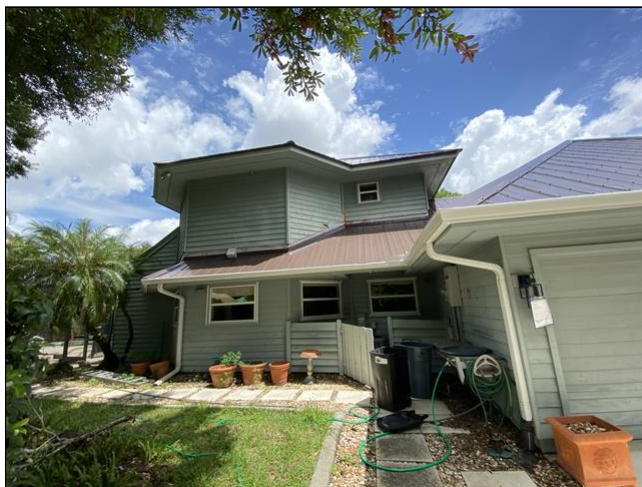
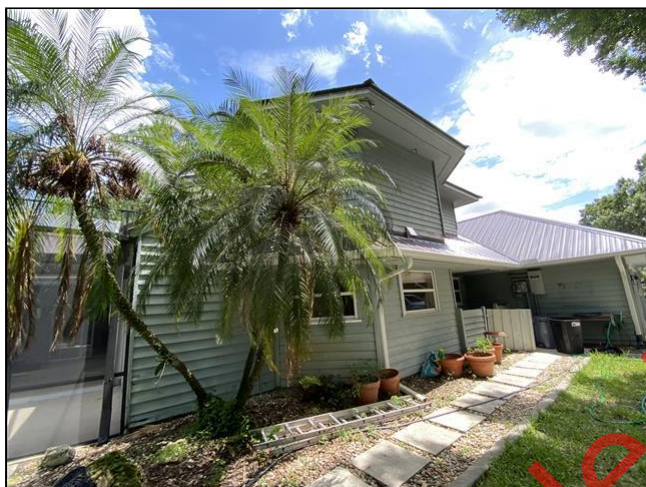
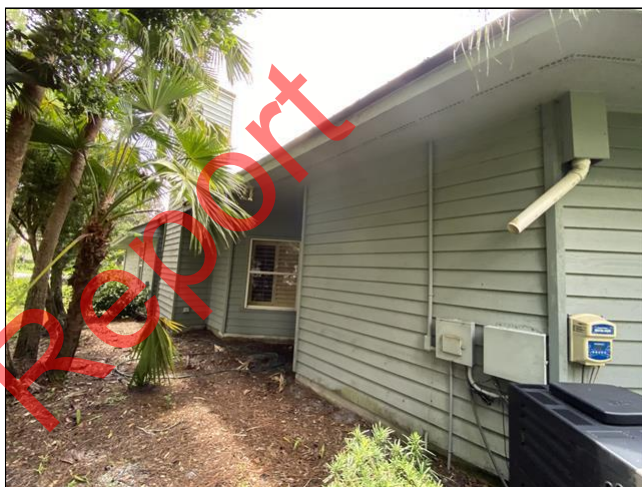
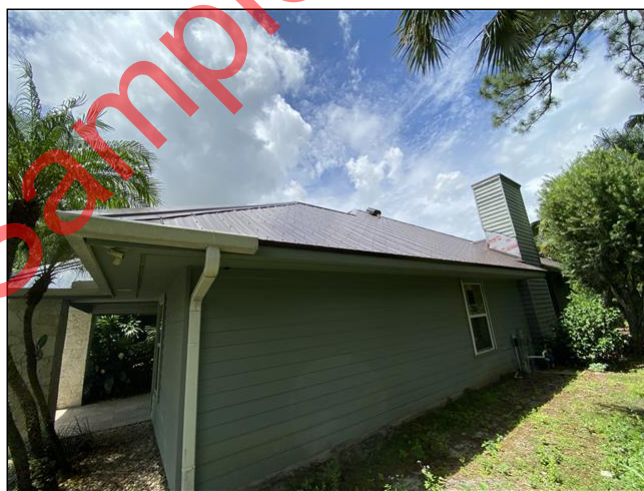
### 1.8 Fascia Boards

Inspector observed no deficiencies with the condition of the fascia boards.
