### **Property Condition Report**

#### **Palomino Farms, LLC**

8087 Palomino Dr  
Wellington FL 33467

4/10/2026

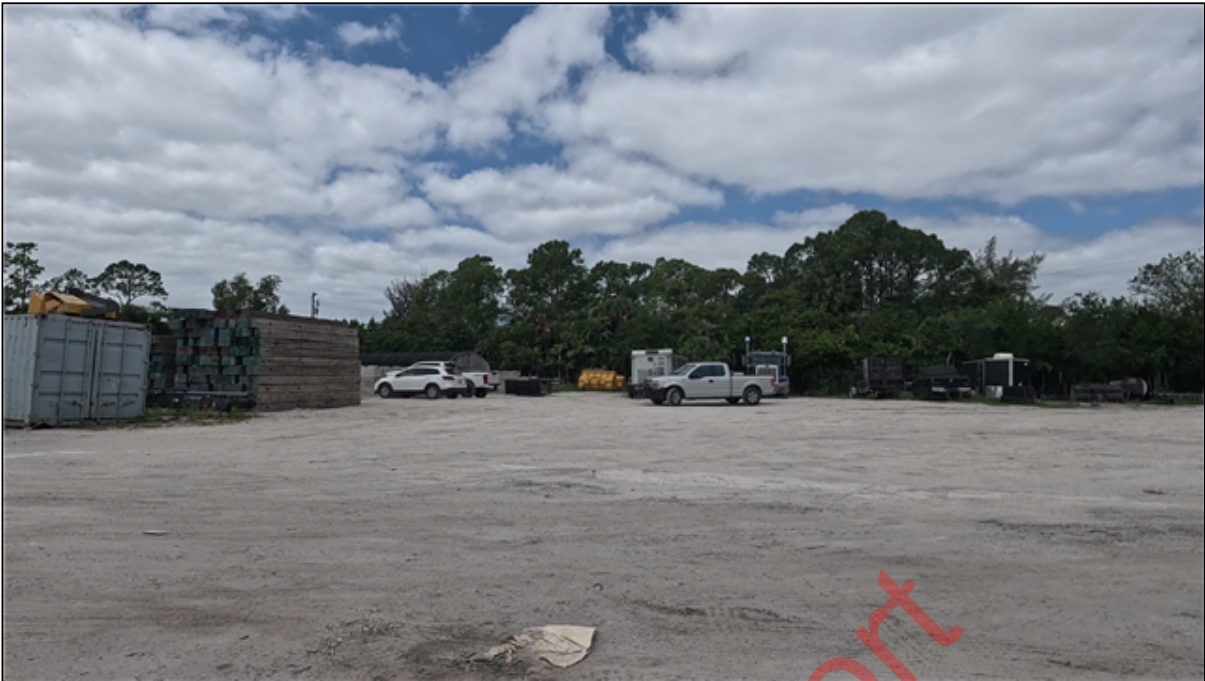
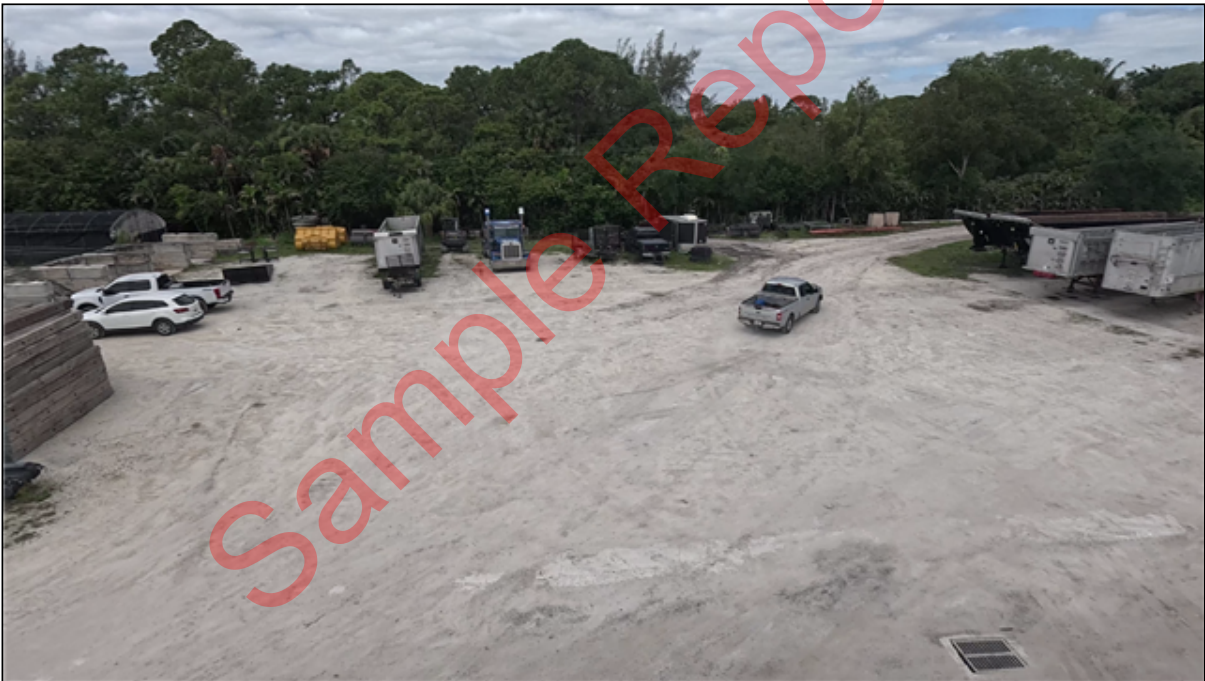
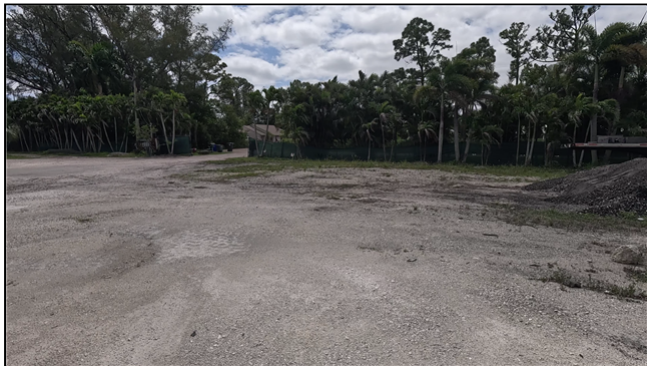
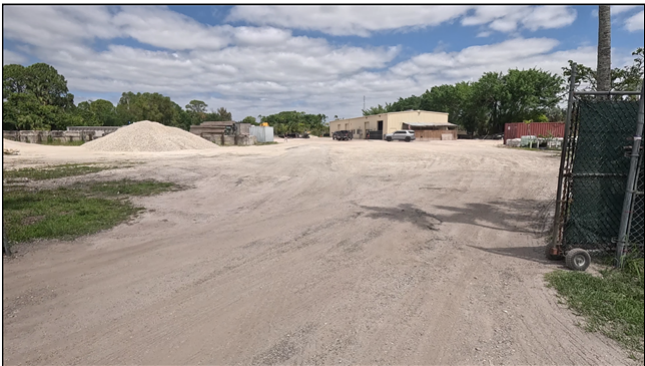
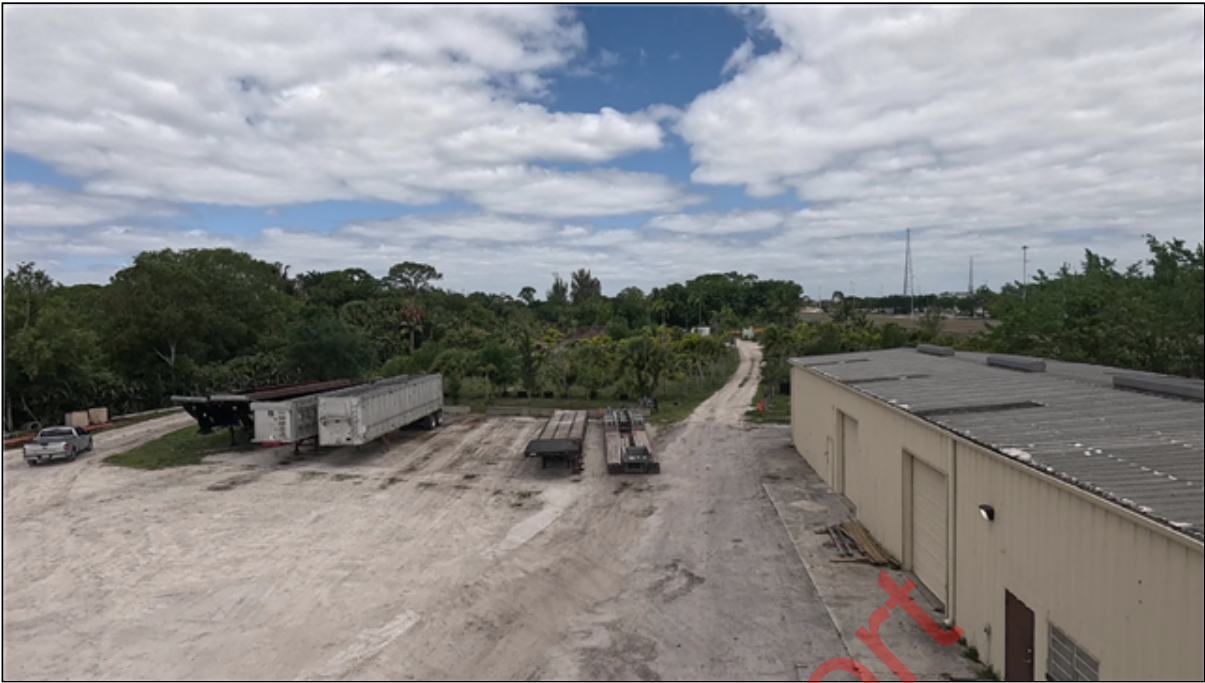
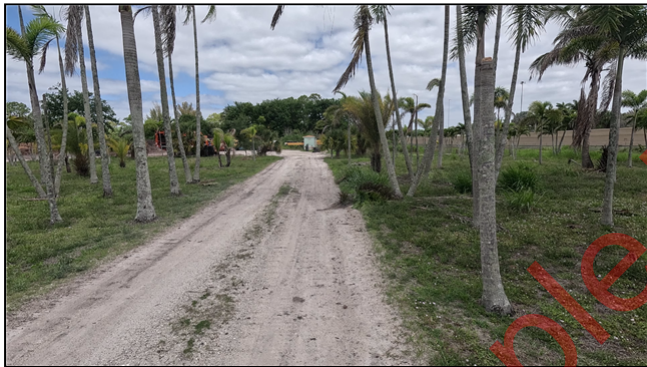
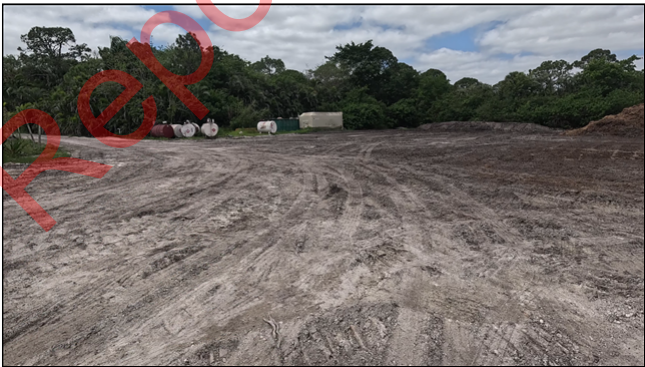
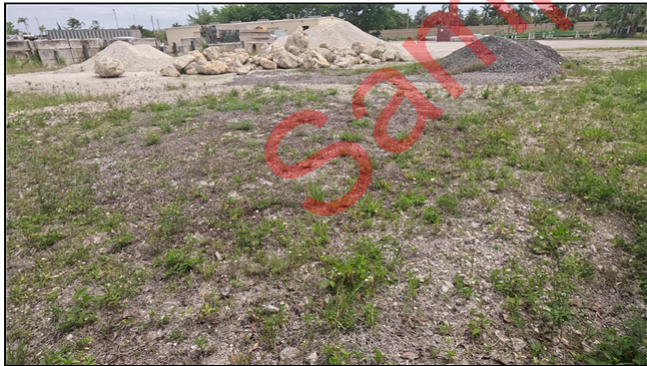
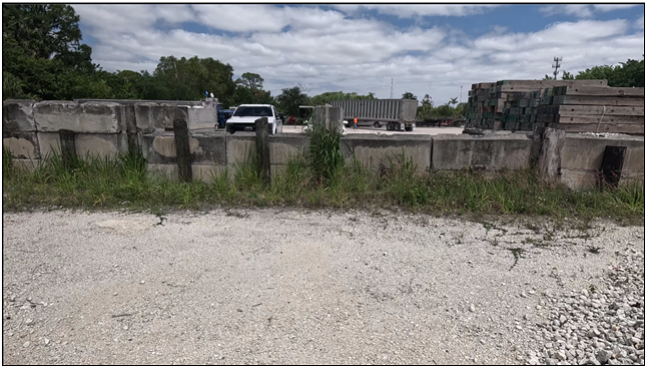
Overall, while the site remains operational, a phased improvement plan is recommended to enhance drainage, reduce maintenance, and improve long-term durability.

- Spot grading and aggregate replenishment: \$0.50 – \$1.50/SF (affected areas)
- Full regrading with new aggregate: \$1.50 – \$3.50/SF
- Optional asphalt paving (select areas): \$4.00 – \$8.00/SF

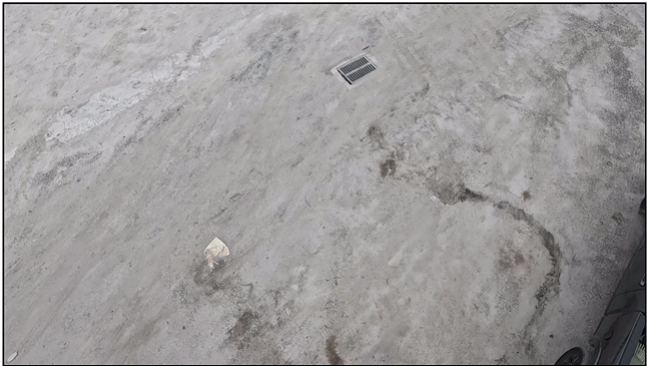
Overall, the drainage system is serviceable but exhibits signs of age and limited infrastructure. Proactive maintenance and phased improvements are recommended to enhance performance and reduce the risk of water-related operational impacts.

- Canal cleaning/vegetation removal: \$5,000 – \$20,000 (depending on scope and permitting)
- Regrading and drainage improvements: \$1.50 – \$4.00/SF (affected areas)
- New catch basins and piping: \$3,000 – \$8,000 per structure
- Comprehensive drainage upgrades: \$25,000 – \$100,000+ (site-dependent)

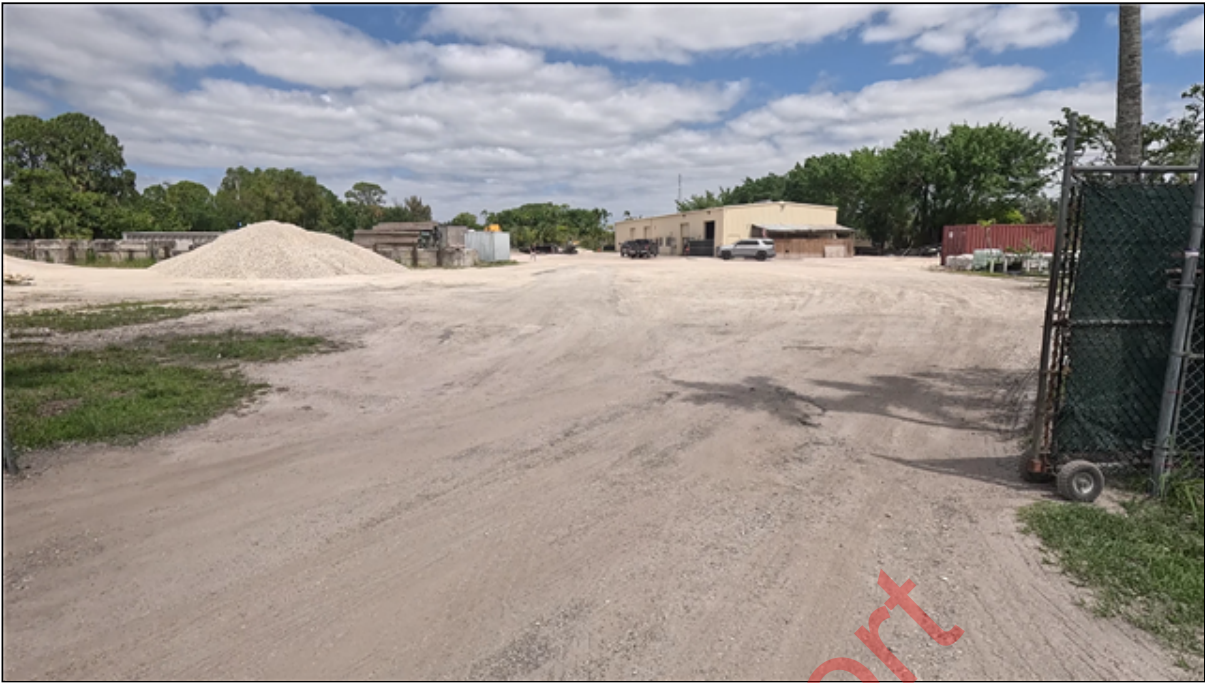
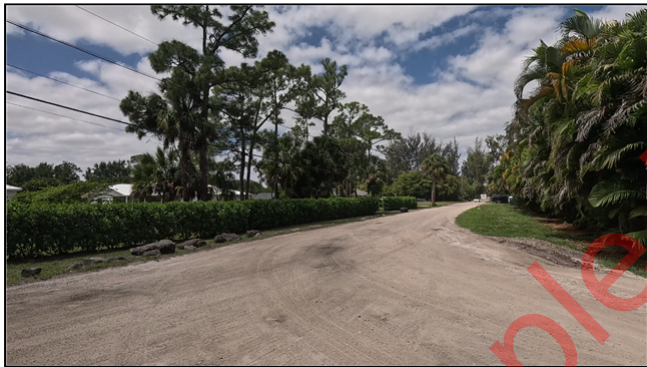
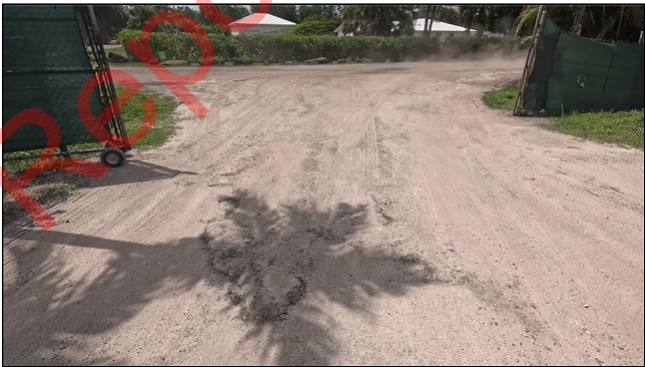
Overall, ingress and egress are considered adequate for current use but would benefit from incremental upgrades to improve durability, safety, and all-weather performance.

- Grading and aggregate improvements: \$0.50 – \$1.50/SF
- Stabilized millings/treated base: \$2.00 – \$4.00/SF
- Asphalt paving (drive lanes): \$4.00 – \$8.00/SF

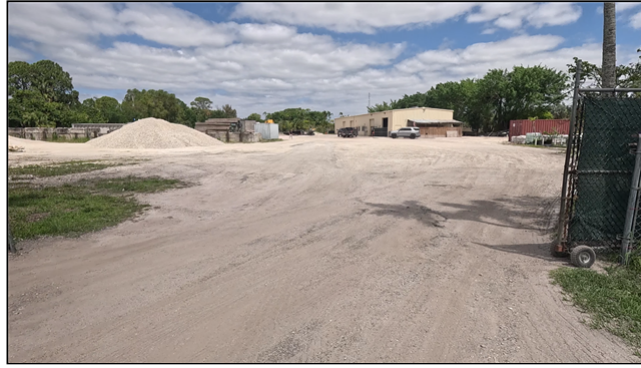
In summary, the driveways are unpaved and exhibit typical wear associated with long-term use. While currently functional, they would benefit from regrading, resurfacing, or eventual paving to improve durability, drainage, and overall site performance.

- Grading and aggregate replenishment: \$0.50 – \$1.50 per sq. ft.
- Stabilized surface (millings/treated base): \$2.00 – \$4.00 per sq. ft.
- Asphalt paving: \$4.00 – \$8.00 per sq. ft.

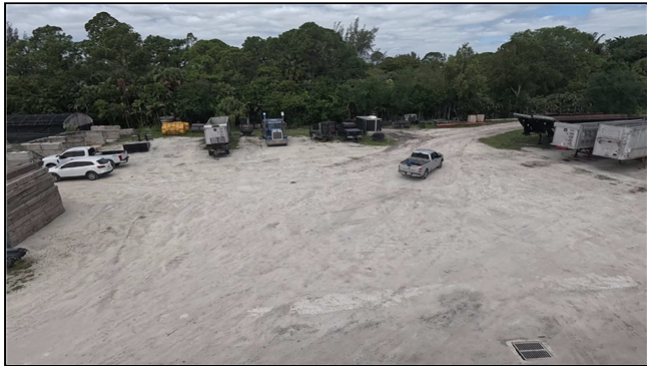
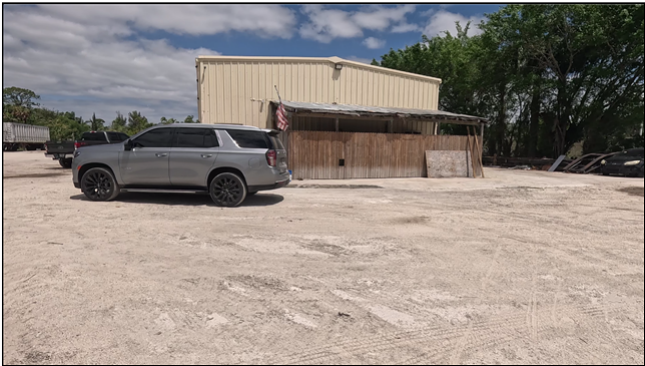
Overall, while the site provides sufficient space for parking, the absence of formal improvements represents a functional limitation and may warrant phased upgrades depending on operational needs and regulatory considerations.

- Stabilized gravel/millings parking area: \$2.00 – \$4.00/SF
- Asphalt paved parking: \$5.00 – \$9.00/SF
- Striping and signage: \$500 – \$2,500 depending on scope
- ADA upgrades (signage, access aisle, minor improvements): \$1,500 – \$5,000

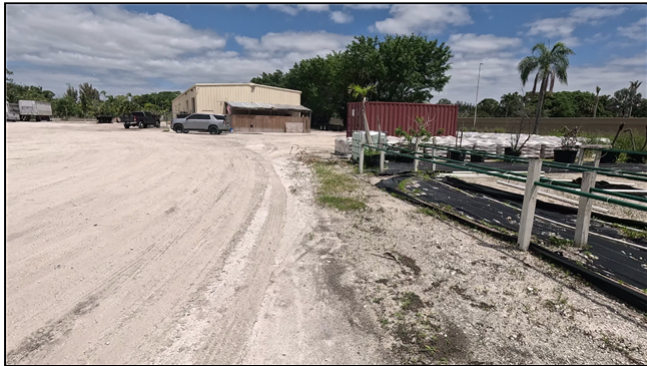
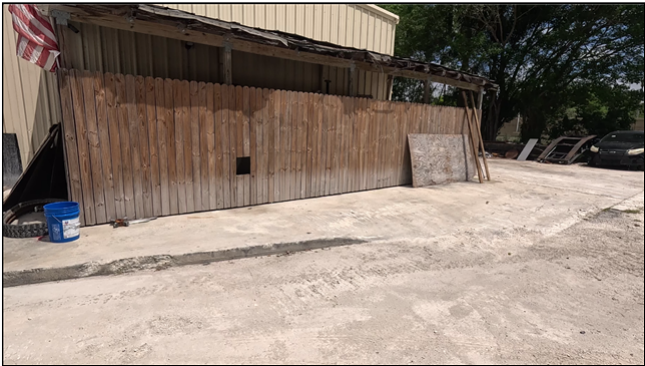
Overall, the lack of curbing and the informal nature of the swale system are consistent with the property type and age but limit drainage control and site durability. Targeted improvements would enhance stormwater management and reduce ongoing maintenance demands.

- Swale regrading and cleaning: \$1.00 – \$3.00/SF (affected areas)
- Concrete curbing installation: \$25 – \$50 per linear foot
- Swale stabilization (riprap/geotextile): \$15 – \$40 per linear foot (depending on design)

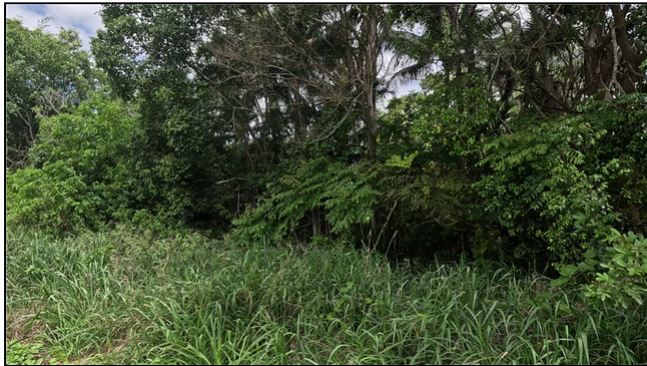
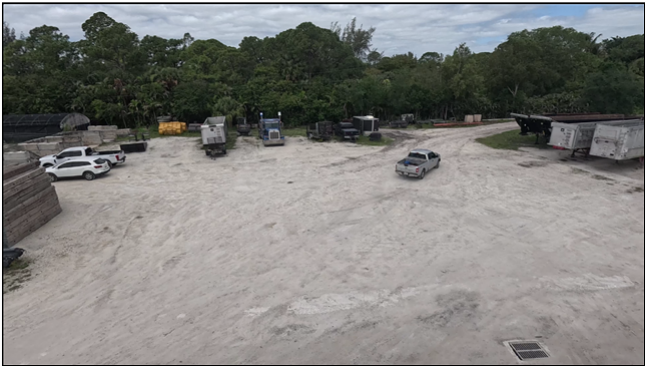
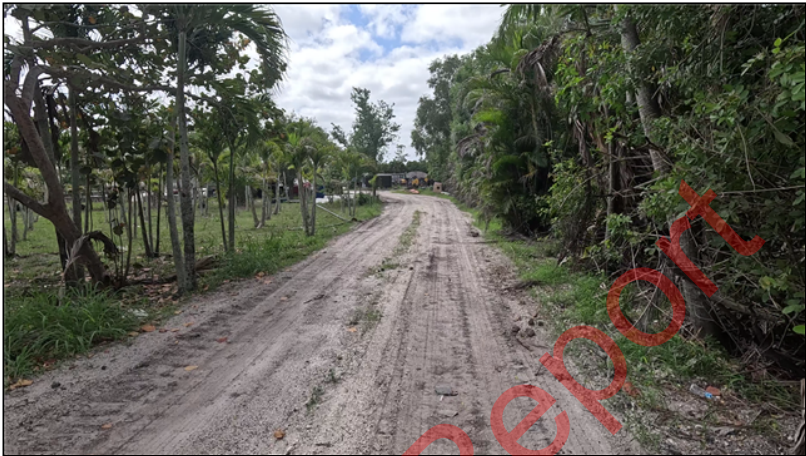
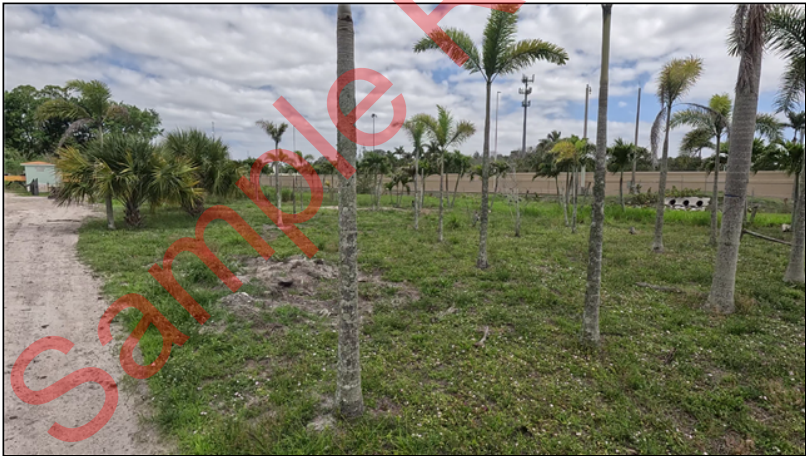
In summary, the landscaping is minimal and largely unmanaged, consistent with the property's industrial use. While functional, it would benefit from routine maintenance and selective improvements to enhance accessibility, reduce risk, and improve overall site appearance.

- Vegetation clearing and trimming: \$500 – \$3,000 (site-dependent)
- Ongoing maintenance: \$100 – \$500 per month
- Basic landscaping improvements: \$2,000 – \$10,000+

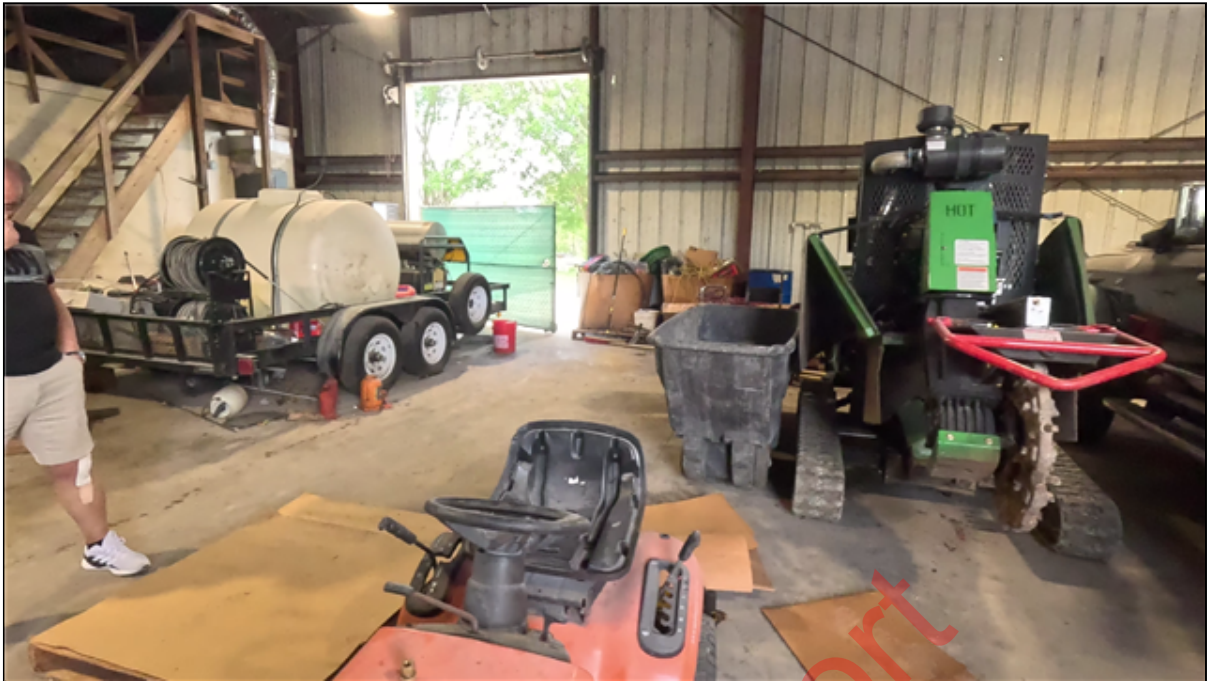
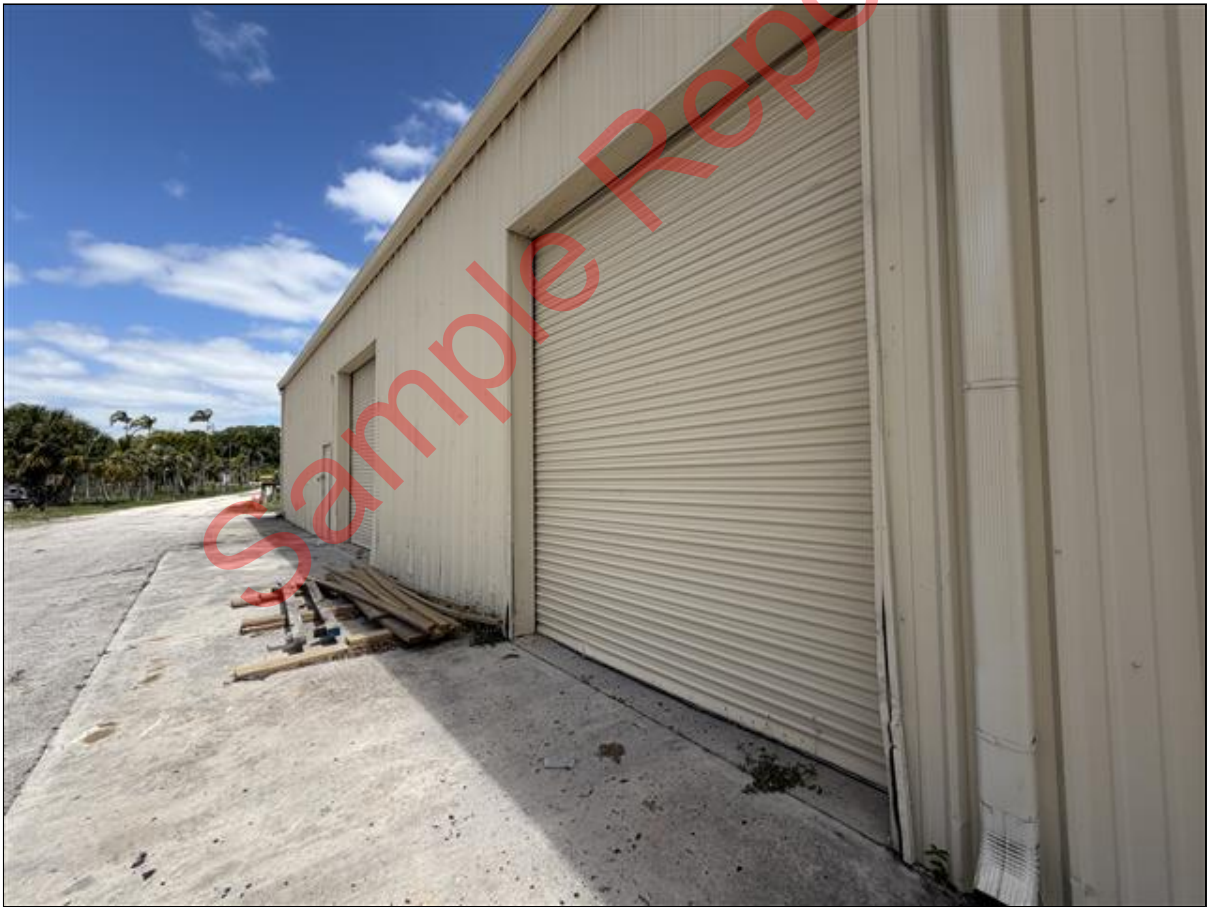
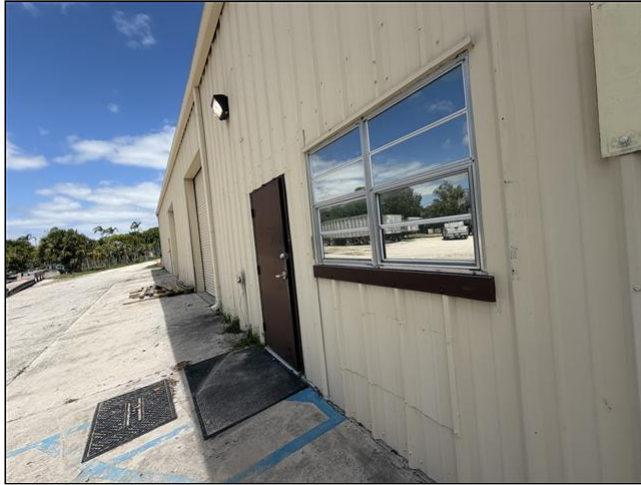
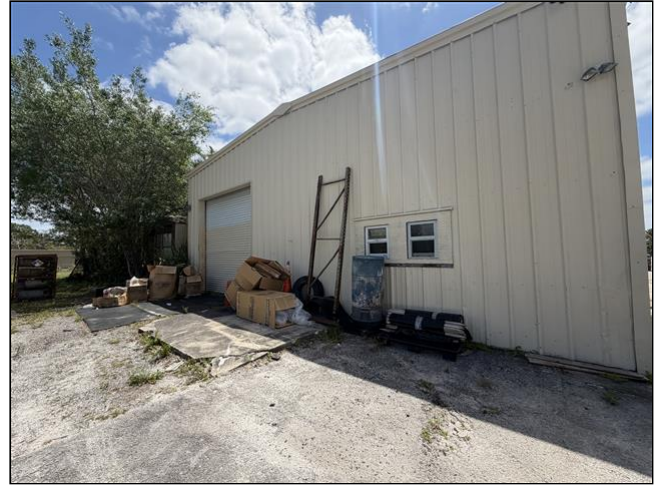
Overall, the foundation appears to be performing its intended function, with observed deficiencies largely consistent with age and use. Continued maintenance and localized repairs should allow the slab system to remain serviceable, though long-term planning should account for incremental rehabilitation as the structure continues to age.

- Crack sealing and minor repairs: \$3 – \$8/SF (affected areas)
- Concrete patching/spall repair: \$5 – \$15/SF (localized areas)
- Concrete sealing/coating: \$2 – \$6/SF
- Partial slab replacement: \$10 – \$20/SF

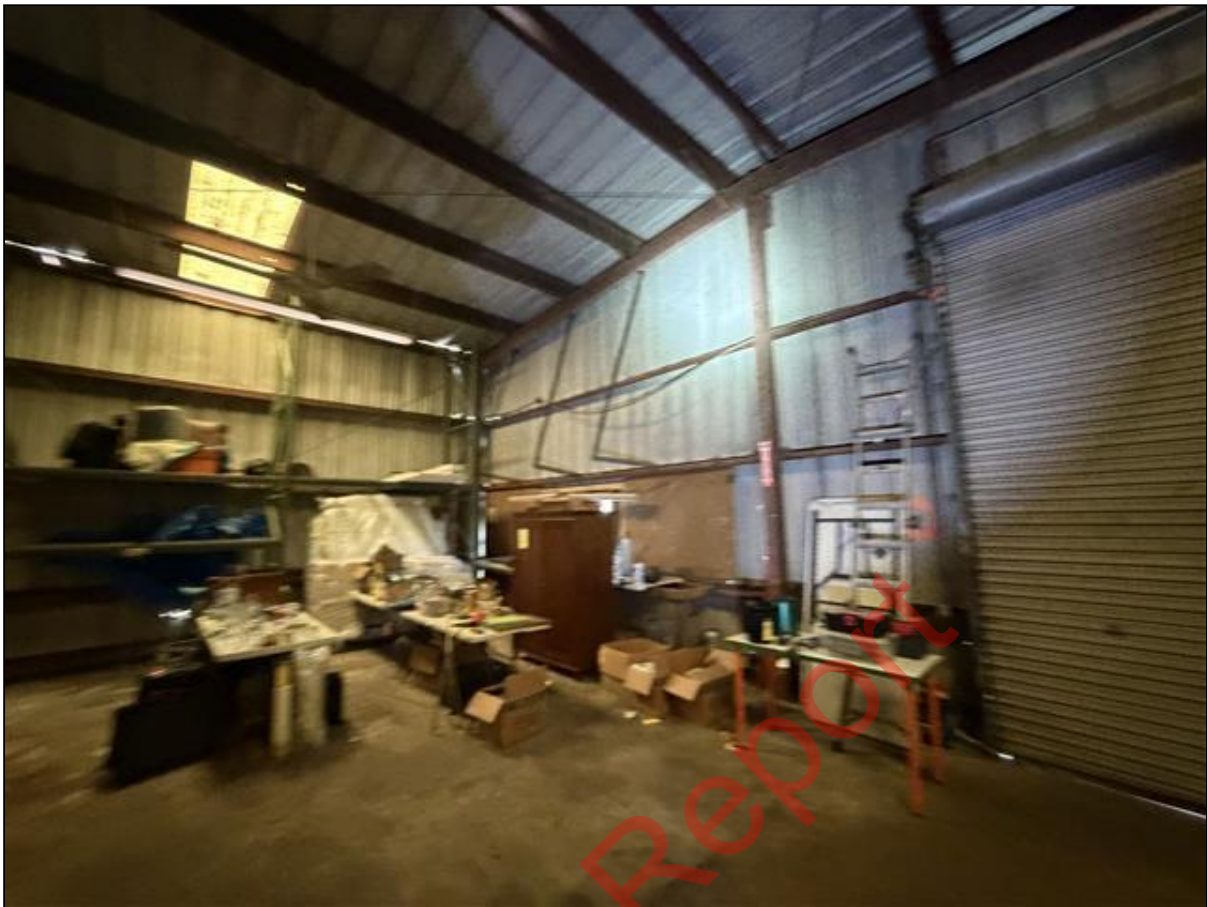
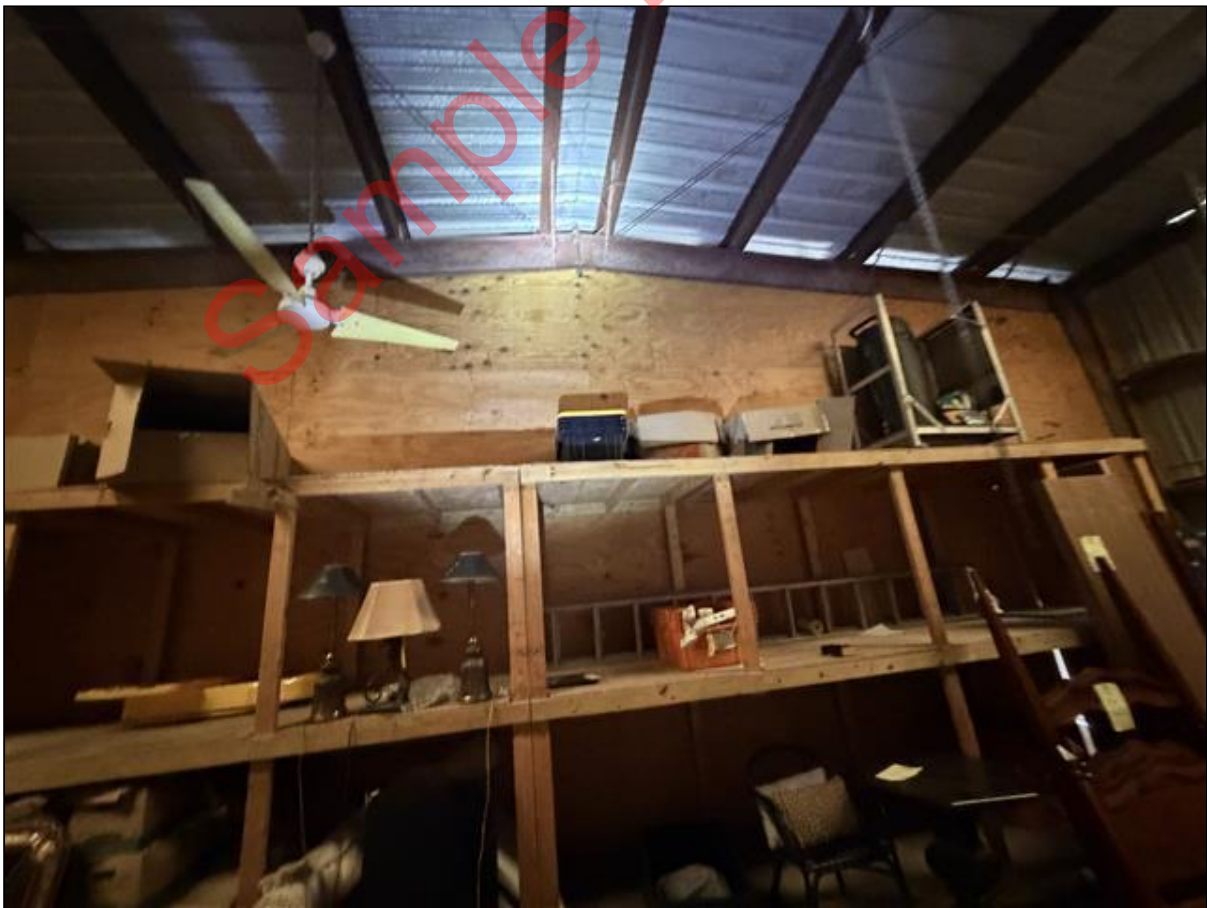
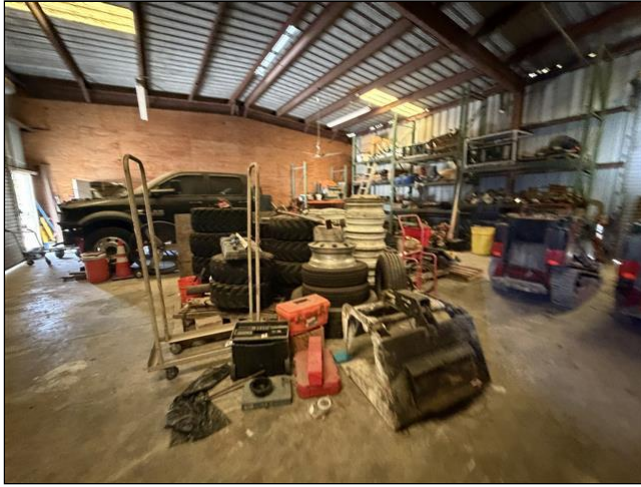
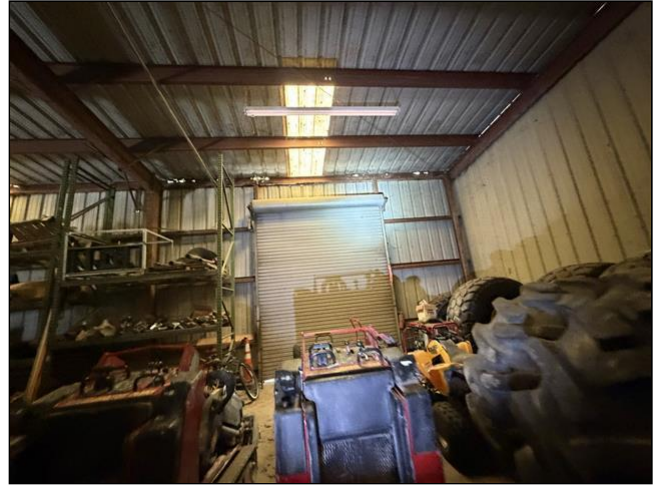
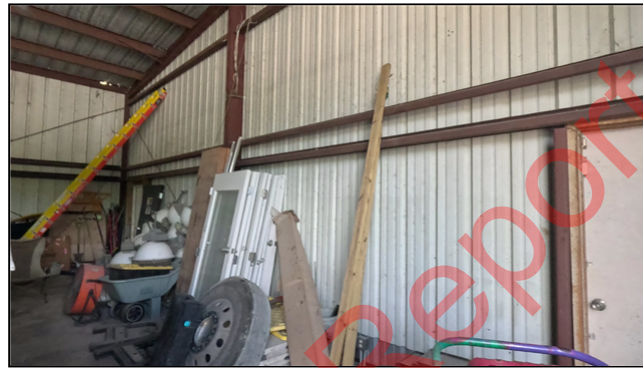
Overall, while the structural framing remains functional, the observed corrosion—particularly areas with section loss—represents a meaningful condition concern. Proactive repair and protective treatment are essential to preserve structural integrity and extend the service life of the system.

- Structural engineering evaluation: \$3,000 – \$10,000
- Localized steel repair/reinforcement: \$2,500 – \$10,000 per affected area
- Steel cleaning and recoating: \$4 – \$10/SF of steel surface area
- Selective member replacement (purlins/girts): \$50 – \$150 per linear foot

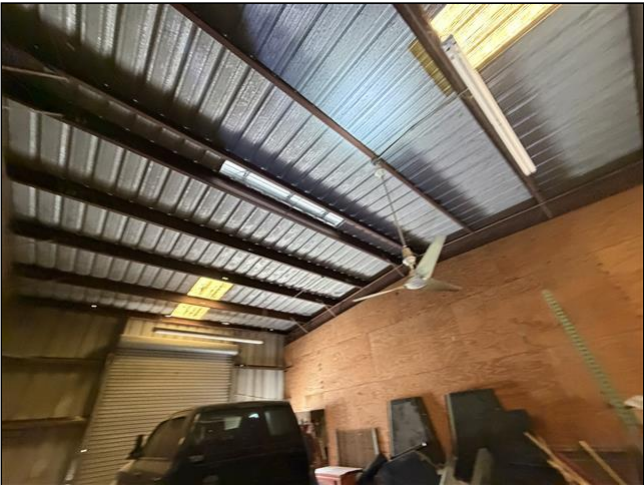
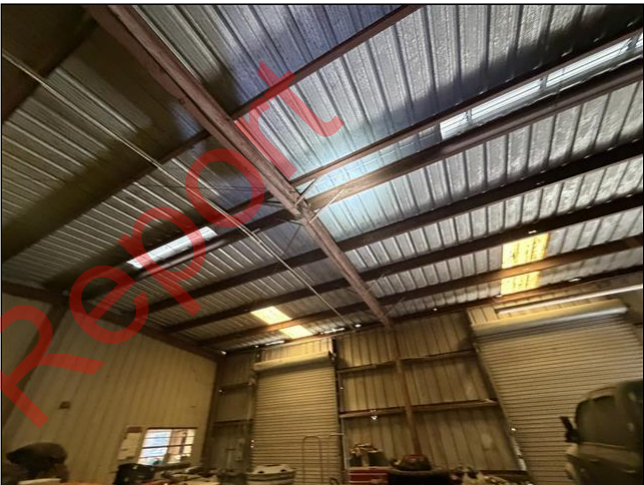
In summary, the roof framing and decking are typical for the building type and remain structurally functional, but exhibit age-related corrosion and exposure to moisture. Timely roof repairs and corrosion mitigation are essential to extend the service life of the system.

- Steel cleaning and coating: \$4 – \$10 per sq. ft. (steel surface area)
- Localized steel repair: \$2,000 – \$8,000 (per area)
- Roof decking replacement (with reroof): \$8 – \$15 per sq. ft. (incremental cost)

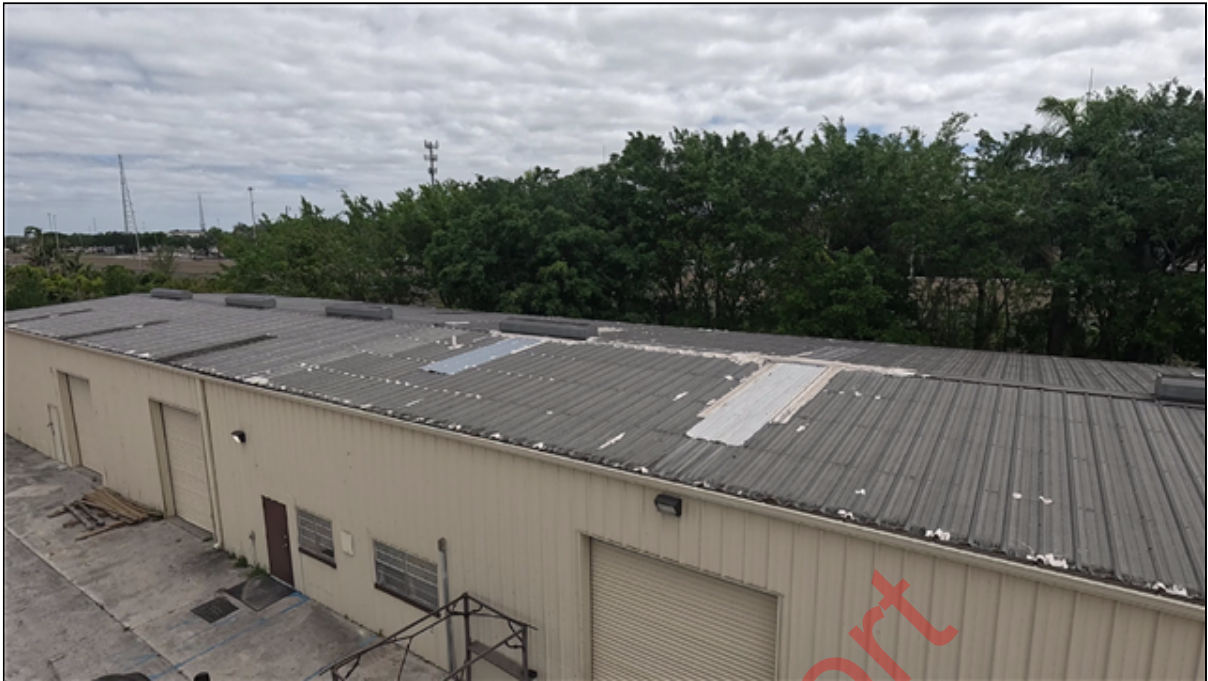
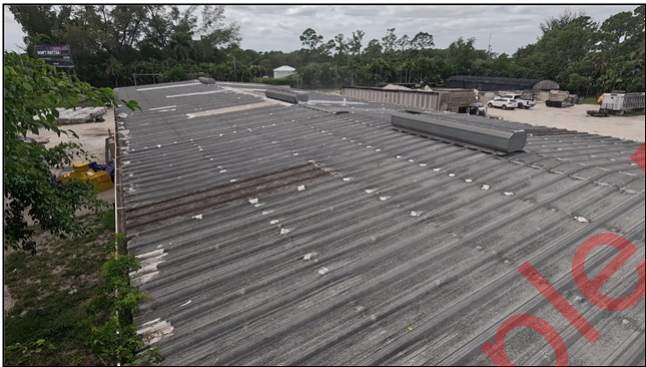
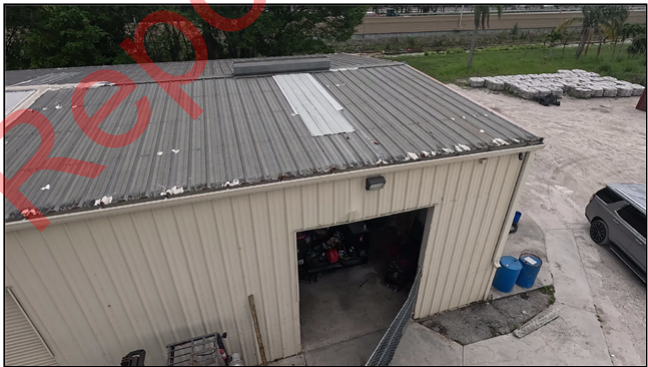
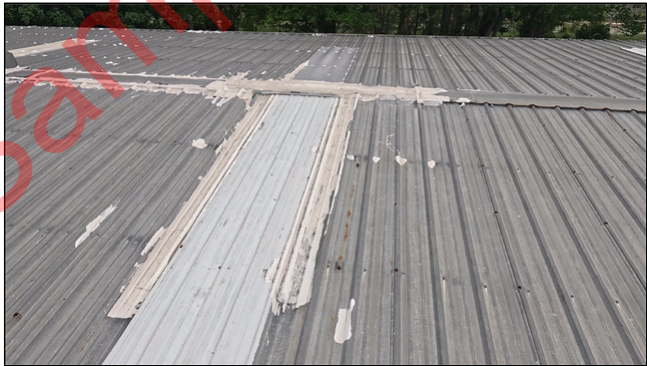
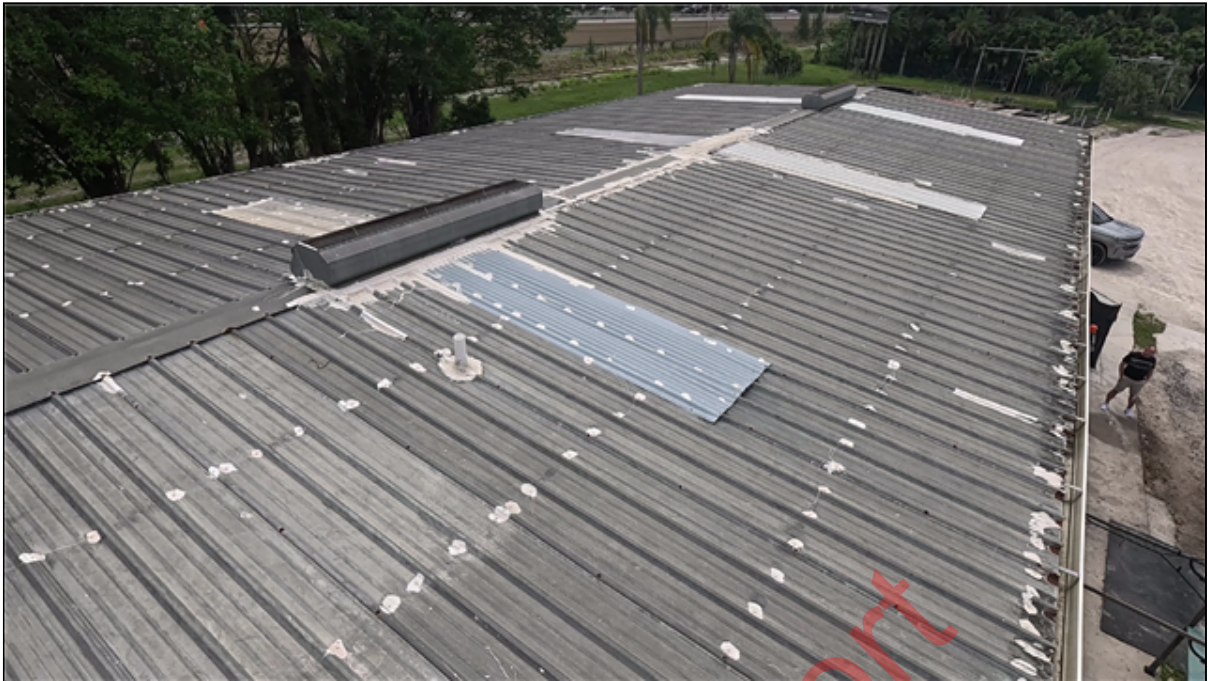
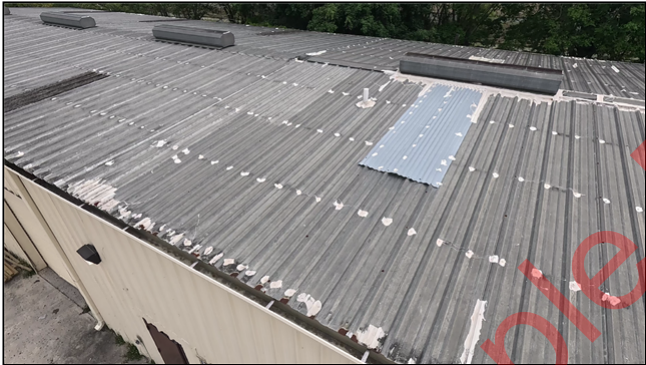
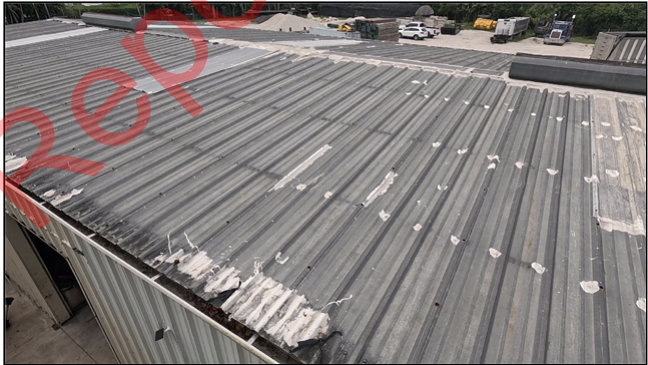
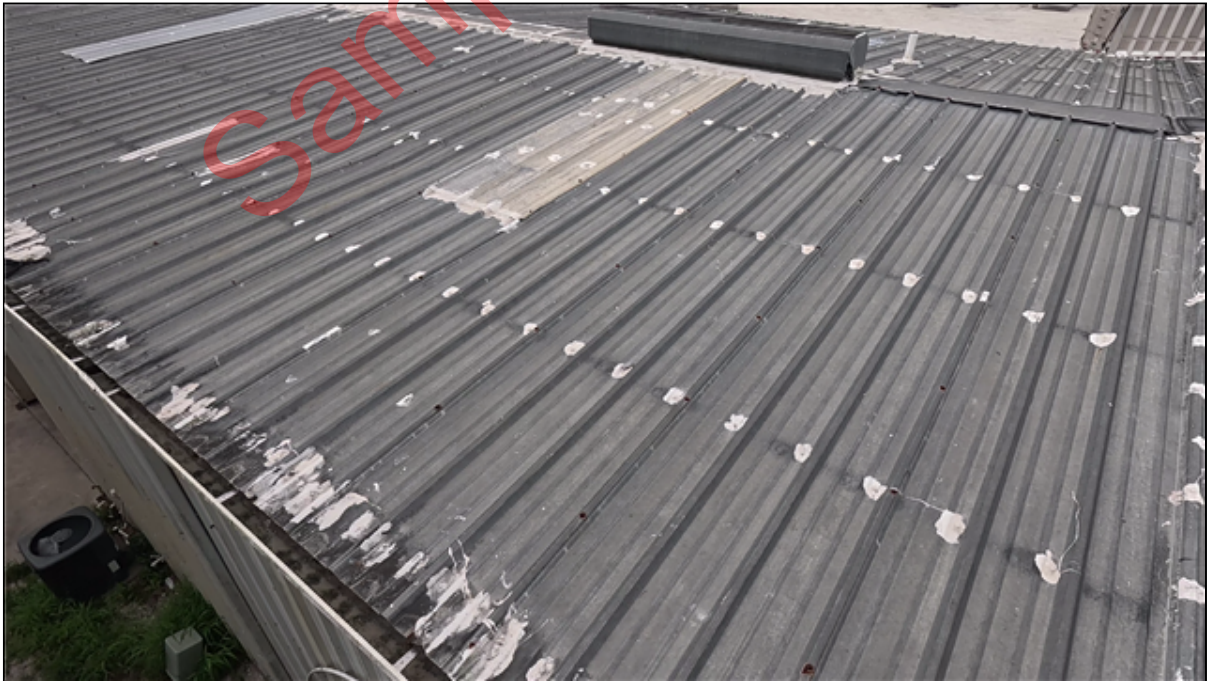
The subject property is improved with a corrugated metal panel roofing system, consistent with light industrial construction typical of the early 1980s. Based on the observed condition, the roof appears to be original or near-original to the building (circa 1983), making it approximately 40+ years old. The roofing panels exhibit widespread signs of age-related deterioration, including oxidation, surface wear, and numerous prior repairs. Evidence of ongoing maintenance is visible in the form of sealant applications at fasteners, seams, and penetrations, as well as isolated panel replacements with newer, mismatched materials. These patchwork repairs indicate a reactive maintenance approach and suggest a history of active leakage.

Panel edges, particularly along the eaves, show advanced corrosion and material loss, which is a critical concern as these areas are more vulnerable to wind uplift and water intrusion. The fastener pattern appears inconsistent, with many exposed fasteners having been sealed over—likely due to fastener back-out or gasket failure. Roof-mounted elements, including vents and raised curb structures, also show heavy sealant buildup, indicating repeated attempts to address flashing failures. Overall, the system is considered to be at or beyond its typical service life expectancy.

Extensive oxidation and corrosion of metal panels, particularly at edges; multiple prior repairs with heavy sealant use; likely fastener fatigue and gasket failure; evidence of active or historical leaks; inconsistent panel replacements; aging and potentially compromised flashing at penetrations and roof transitions.

- Immediate to Short-Term (0–1 year): Continue active leak management as needed (sealant, fastener replacement) to maintain short-term functionality, particularly if ownership horizon is limited.
- Short-Term (1–3 years): Budget and plan for full roof replacement. Interim coating systems may be considered, but only as a temporary measure and if substrate conditions are verified as suitable.
- Replacement Scope: Removal of existing panels (or retrofit over existing, if structurally appropriate), installation of new code-compliant metal roofing system with concealed fasteners or improved exposed fastener system, upgraded underlayment, and new flashing details at all penetrations and transitions.

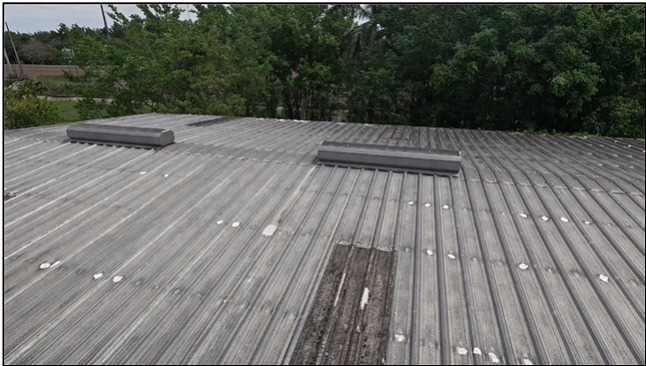
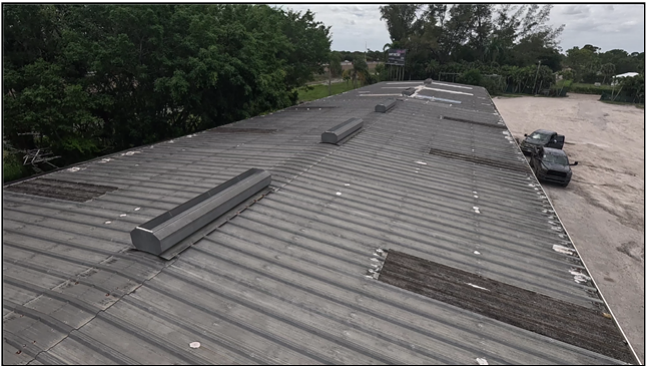
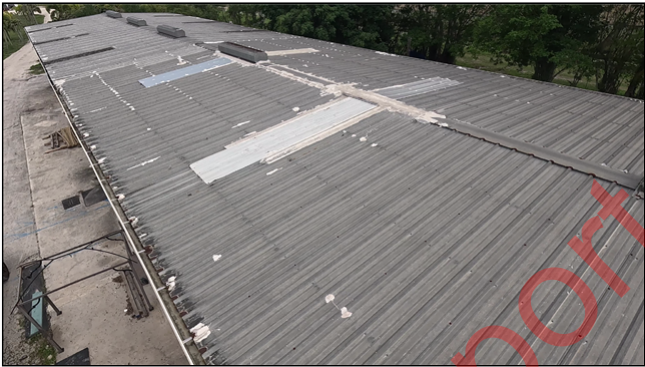
Visible conditions include aging and deteriorated sealant, inconsistent flashing details, and localized patching around penetrations. Several areas exhibit excessive or layered sealant application, suggesting prior leakage or ongoing maintenance efforts. Transitions between original roofing panels and patched sections appear particularly vulnerable to water intrusion, especially under wind-driven rain conditions common in South Florida. While no active leaks were confirmed at the time of inspection, these conditions are considered high-risk due to the reliance on maintenance-based waterproofing rather than durable flashing assemblies.

Aging and deteriorated sealant at penetrations; inconsistent and non-uniform flashing methods; evidence of repeated patching and repairs; potential vulnerability to water intrusion at seams and transitions; reliance on sealant rather than integrated flashing systems.

- Immediate to Short-Term (0–2 years): Inspect and reseal all roof penetrations using compatible, high-quality roofing sealants; remove and replace failing or excessive patching where necessary to establish uniform detailing.
- Short-Term (1–3 years): Upgrade critical penetrations with improved flashing assemblies (e.g., prefabricated boots, reinforced curbs) to reduce reliance on sealants alone.
- Mid-Term (3–7 years): Coordinate full penetration flashing upgrades with future roof replacement to implement a fully integrated, long-term watertight system.

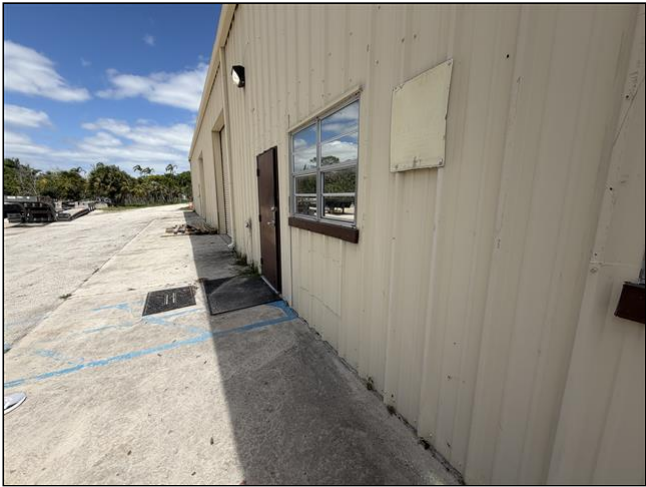
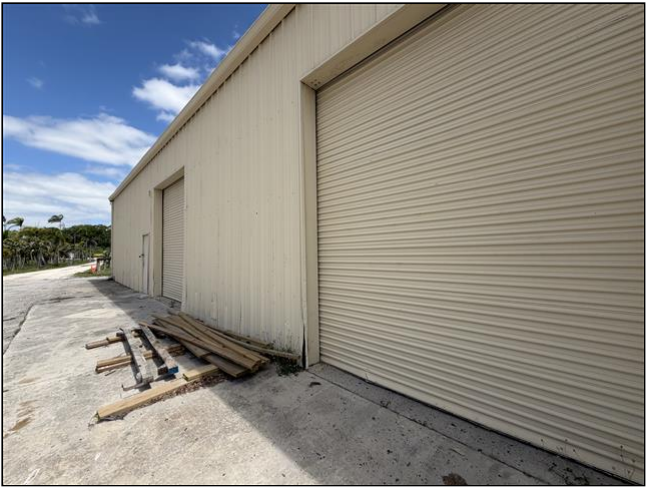
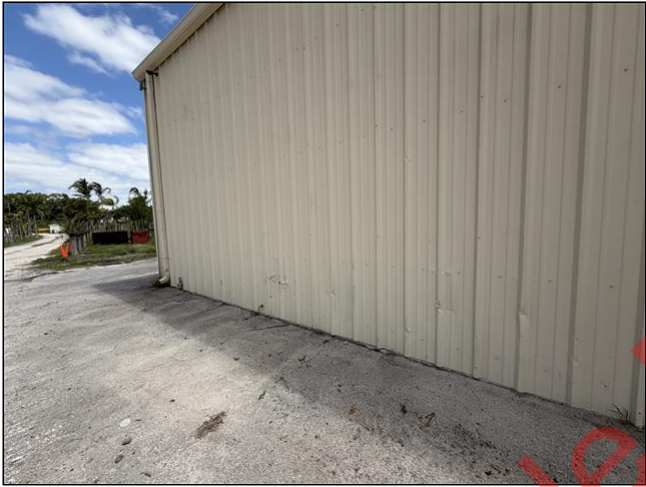
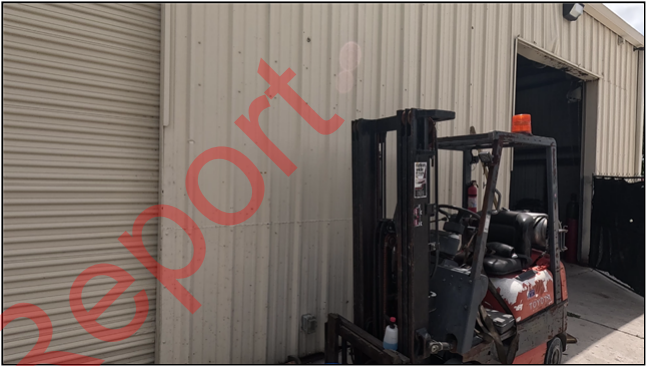
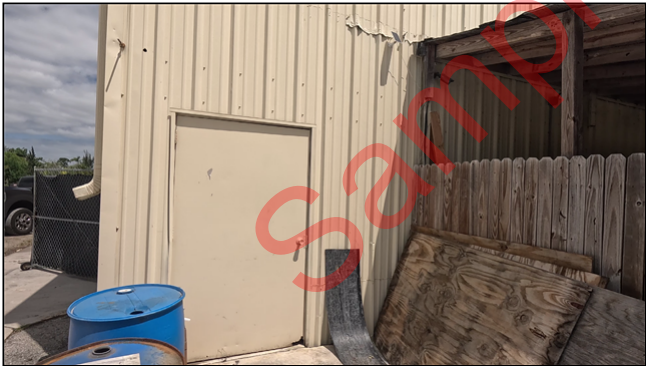
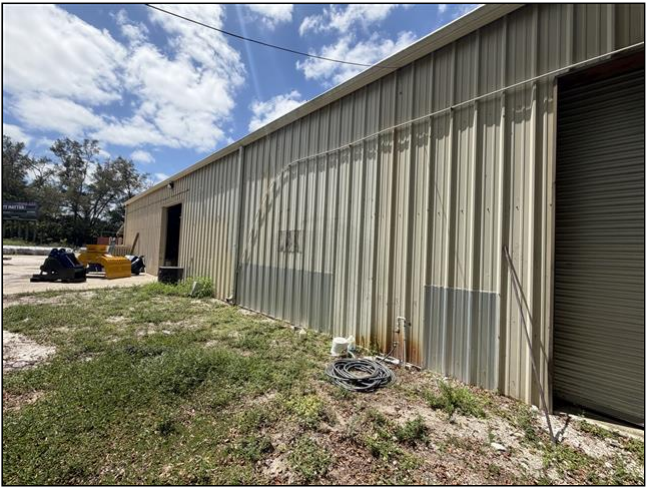
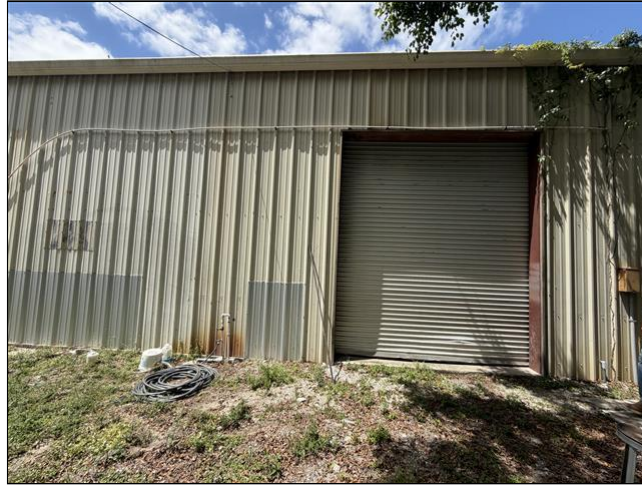
Overall, the exterior wall system is typical for the building type and remains functional, but exhibits age-related wear and deferred maintenance. Targeted repairs and protective measures would improve weather resistance, extend service life, and reduce the likelihood of progressive deterioration.
