### **Property Condition Report**

#### **Palomino Farms, LLC**

8087 Palomino Dr  
Wellington FL 33467

4/10/2026

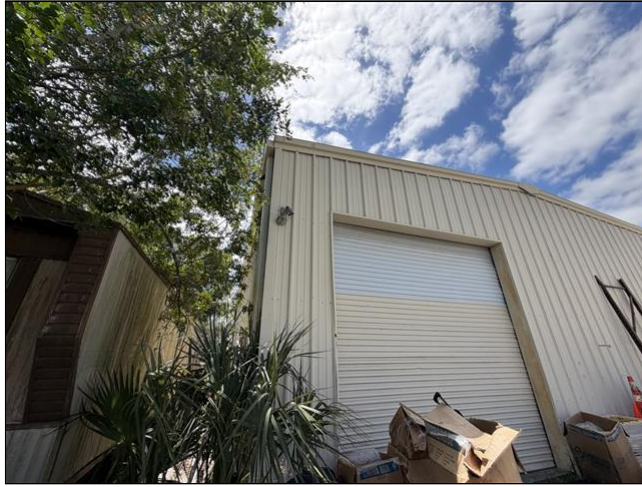
Overall, the fascia and trim system is basic and typical for this type of structure, with no soffit system present. While currently functional, these components show signs of aging and would benefit from targeted maintenance and integration with improved roof drainage measures.

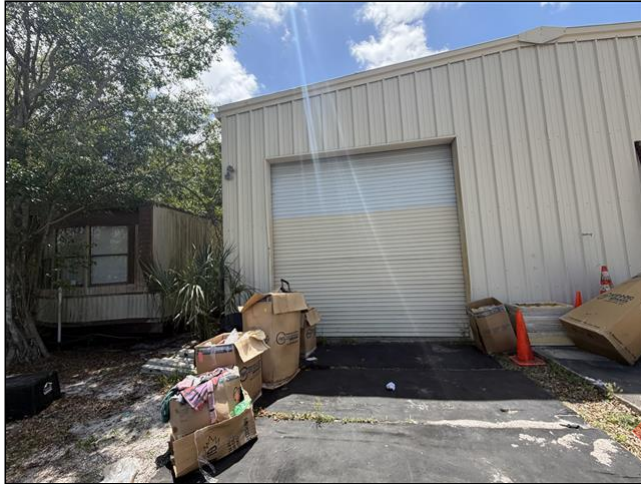
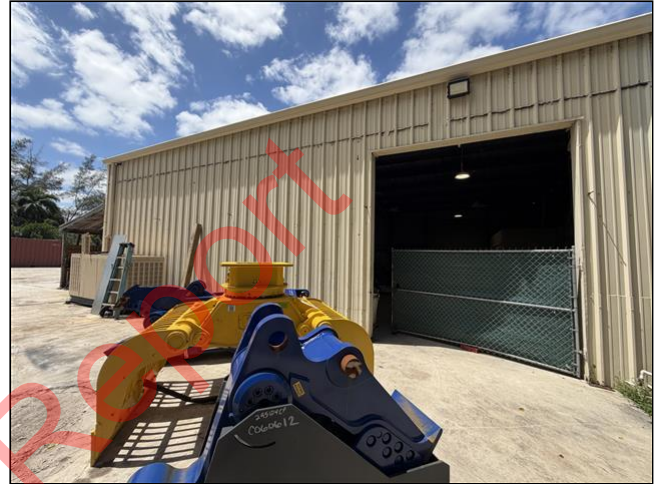
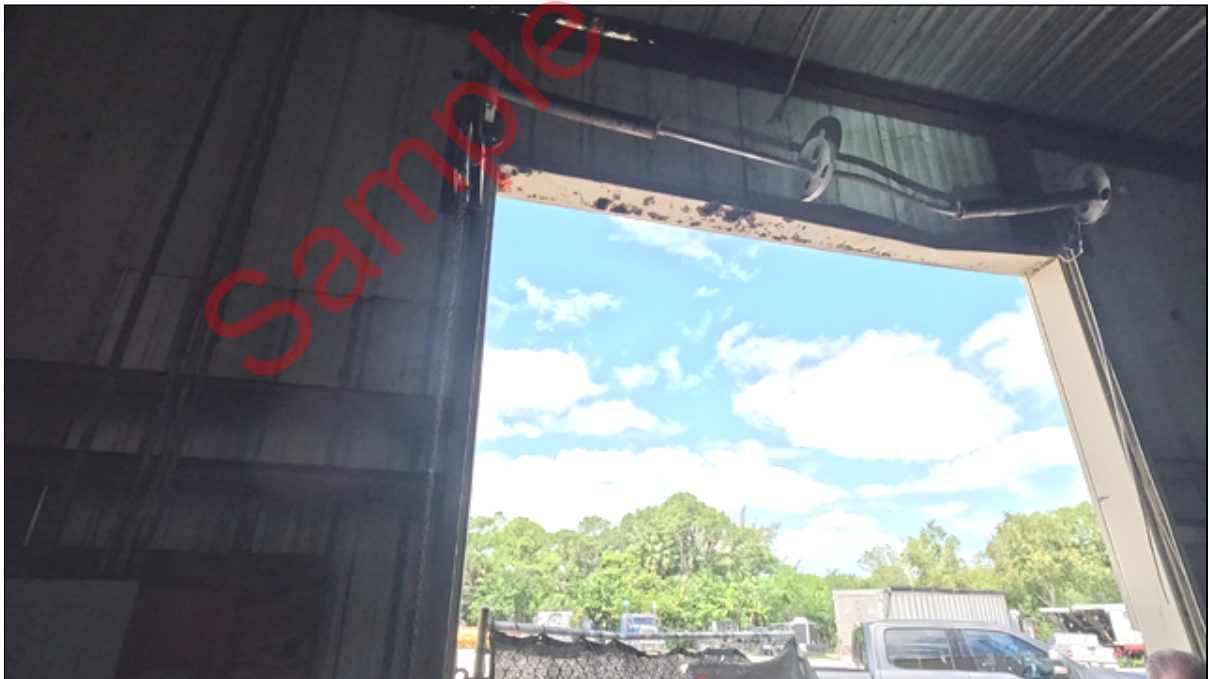
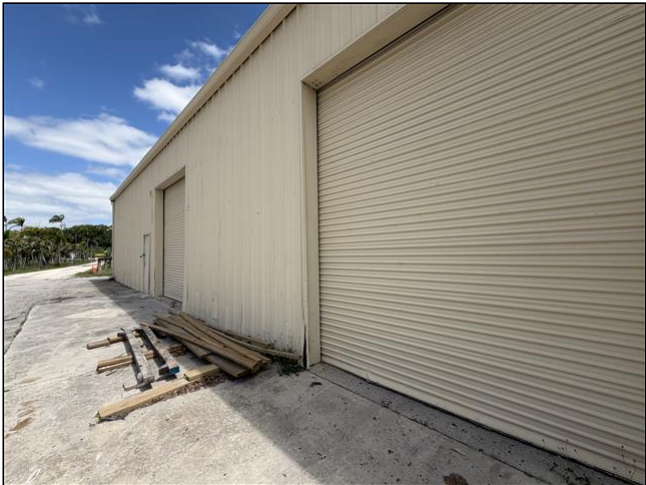
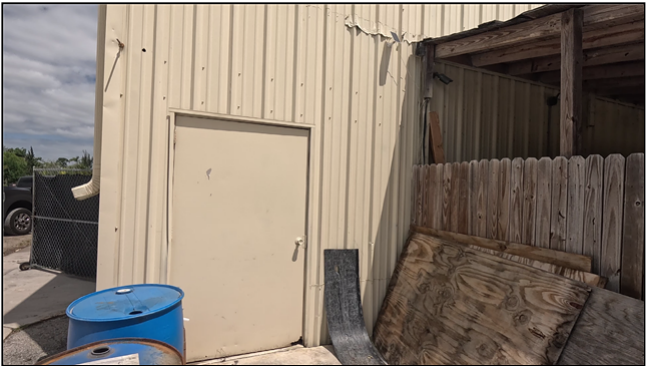
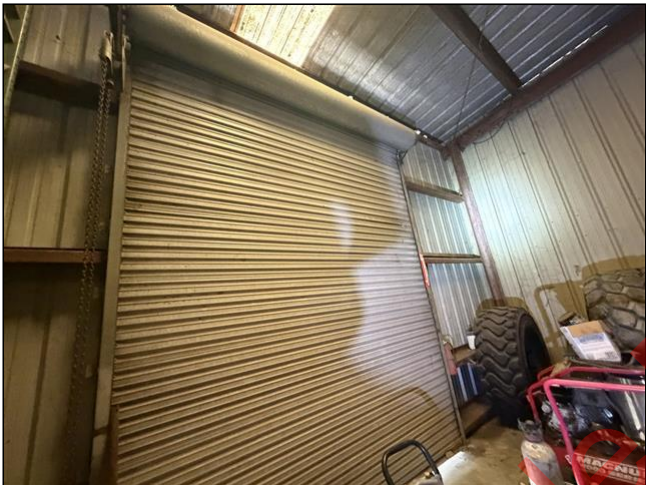
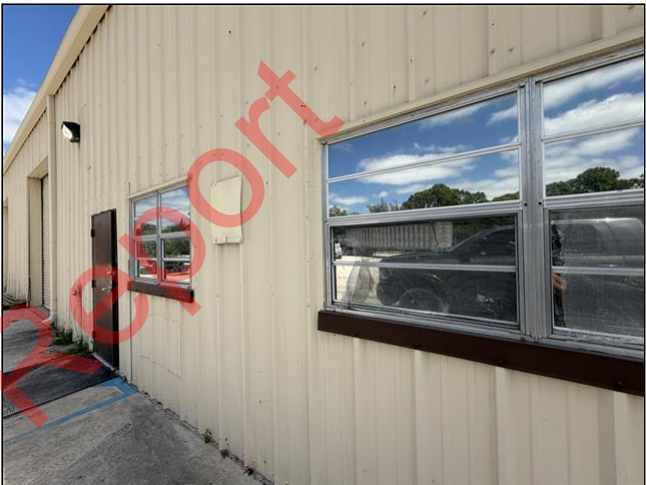
Overall, the door and window systems are typical for the building type but exhibit significant age-related deterioration and functional deficiencies. Repair and replacement—particularly of the overhead doors—should be considered a priority to restore usability, improve security, and reduce the potential for moisture intrusion at wall openings.

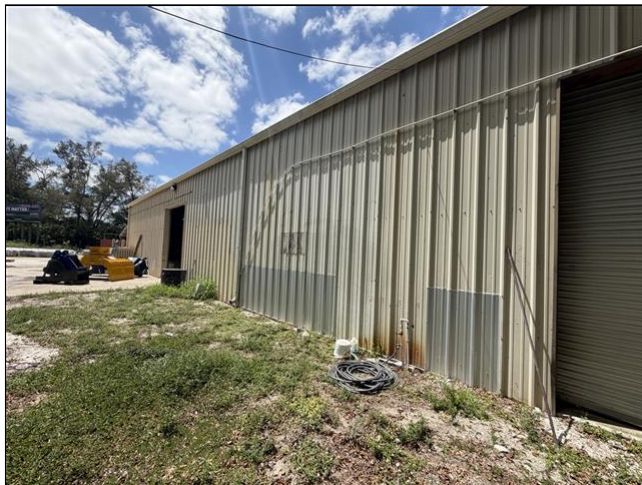
Overall, the plumbing supply system is simple and currently functional but limited in extent and reflective of its age. Targeted upgrades to valves, fittings, and protective components would improve reliability, extend service life, and reduce the likelihood of leaks or failures.

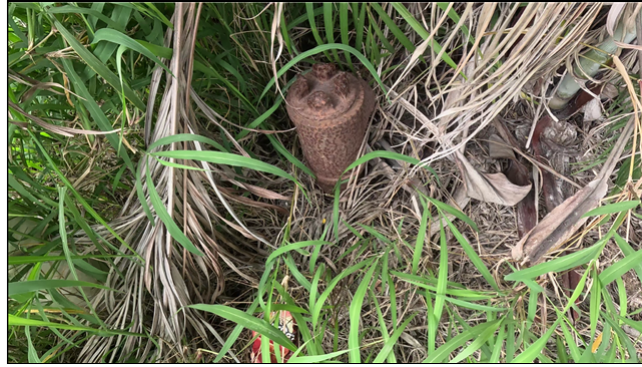
Overall, the DWV system is functional and adequate for the building's limited plumbing demand but is likely original or partially original and therefore aged. Proactive inspection and targeted maintenance—particularly of vent penetrations and concealed piping—are recommended to mitigate the risk of future failures.

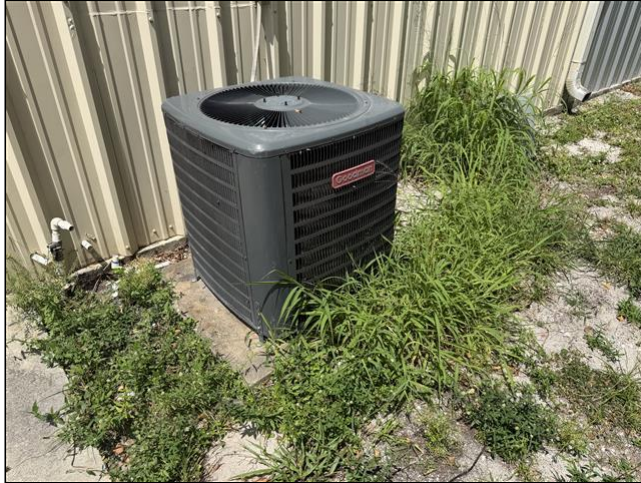
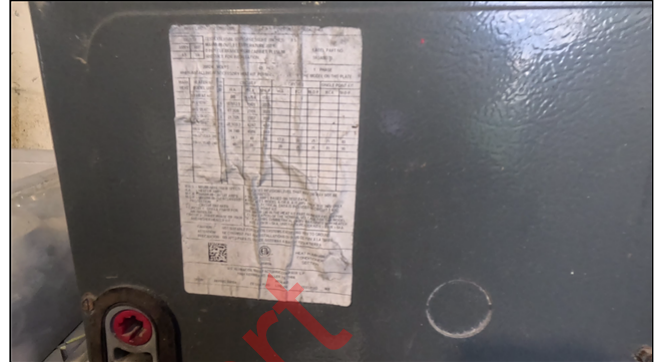
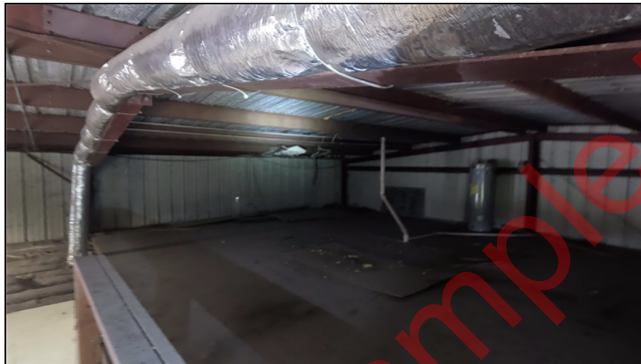
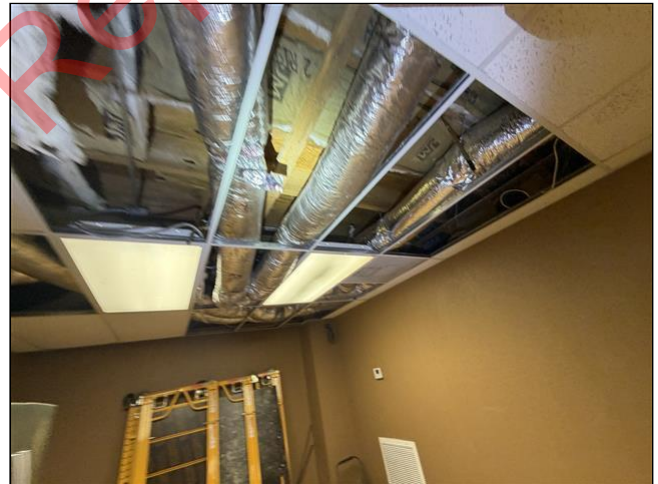
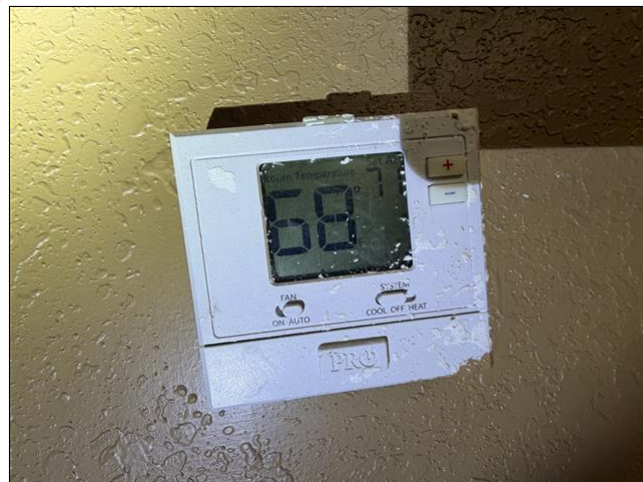
In summary, the mechanical system is currently non-functional and exhibits multiple deficiencies consistent with age and deferred maintenance. System replacement, along with associated duct and drainage improvements, should be anticipated to restore reliable operation and meet typical performance standards.

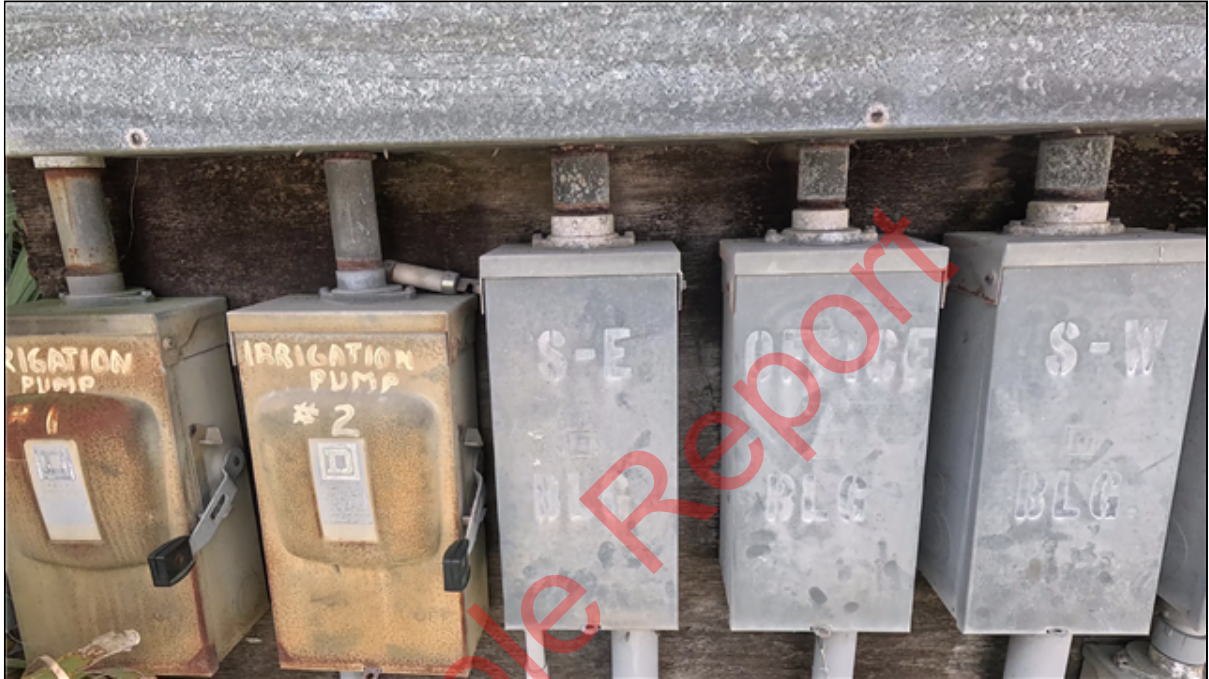
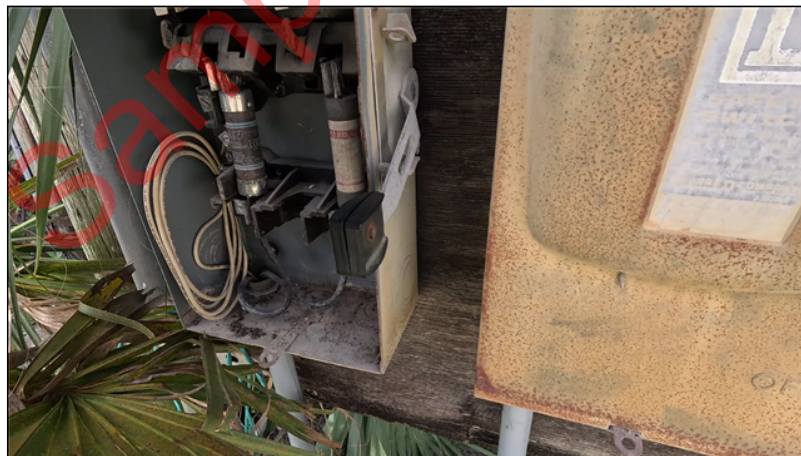
Overall, the electrical system shows significant deterioration due to age and environmental exposure. The extent of corrosion and observed deficiencies warrants a proactive approach, with near-term replacement of major components recommended to ensure safety, reliability, and compliance with current standards.

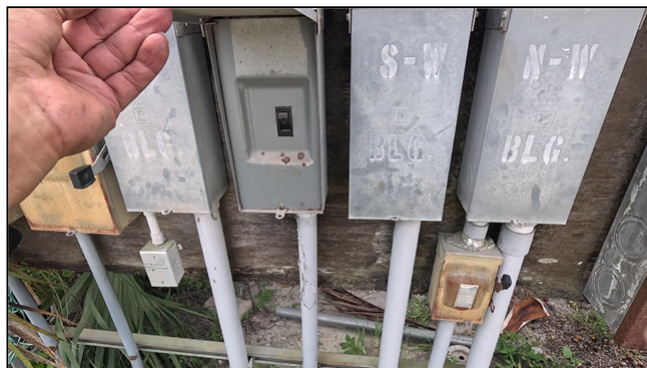
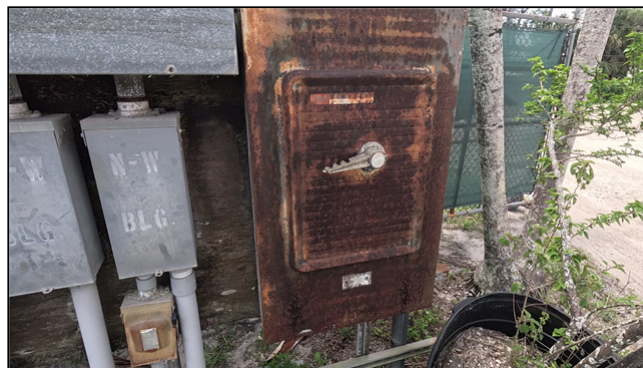
## 16.1 Electric Distribution

The panel enclosure exhibits extensive corrosion throughout, including the door, hinges, and interior components. Rust is visible along the cabinet edges, breaker mounting area, and lower section of the enclosure, indicating prolonged exposure to moisture and a high-humidity environment. The panel door is compromised, with visible deterioration and a damaged latch/closure, preventing proper closure. This condition limits the enclosure's ability to provide adequate protection against contact and environmental exposure.

Interior observation shows multiple breakers installed, with mixed labeling that appears incomplete and inconsistent. Some circuits are handwritten and not clearly identified, reducing usability and increasing the risk during operation or maintenance. The lower portion of the panel shows debris accumulation and possible corrosion at conductor terminations. Conduit entries appear present; however, given the overall condition, proper sealing and bonding/grounding integrity could not be fully verified.

The panel's condition suggests it has exceeded its intended service life and may not reliably perform under normal or fault conditions. The extent of corrosion and physical deterioration raises concern for internal component degradation, including bus bars, breaker connections, and grounding continuity.

Severe corrosion throughout panel enclosure; deteriorated and non-secure door/closure; rust within breaker compartment; debris accumulation inside panel; incomplete and inconsistent circuit labeling; potential moisture intrusion; aging breakers and internal components; overall degraded condition.

- Immediate to Short-Term (0–1 year): Replace existing panelboard with new code-compliant load center; install new breakers and properly label all circuits; verify grounding and bonding; correct any damaged or corroded conductors; ensure proper enclosure rating for environment (NEMA-rated if applicable).
- Short-Term (1–3 years): Evaluate overall distribution layout and upgrade as needed for capacity, safety, and compliance; organize and standardize circuit identification.
- Mid-Term (3–7 years): Implement routine inspection and maintenance program, particularly due to environmental exposure conditions.

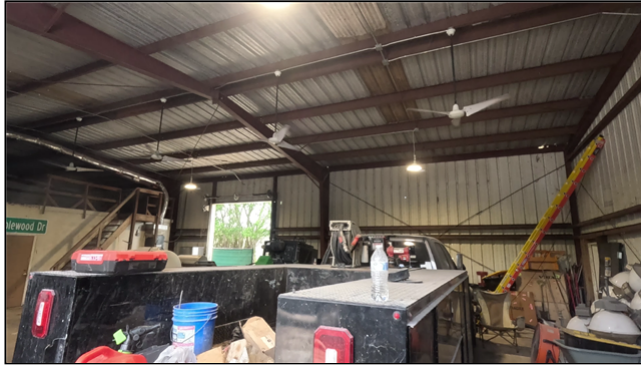
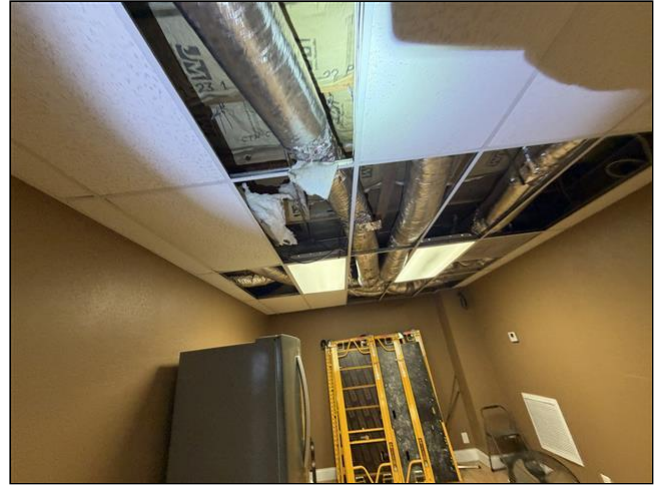
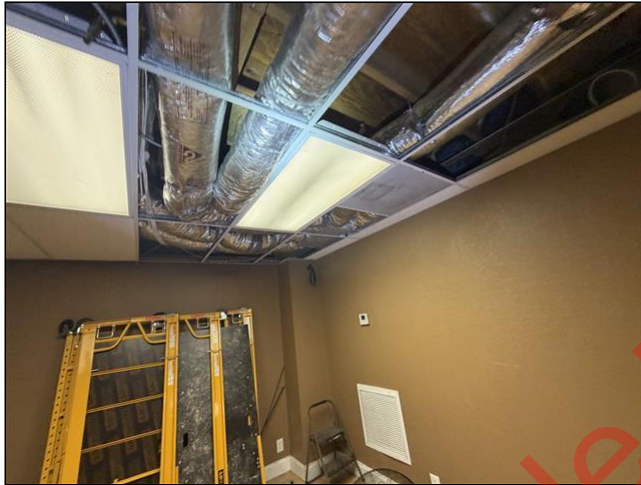
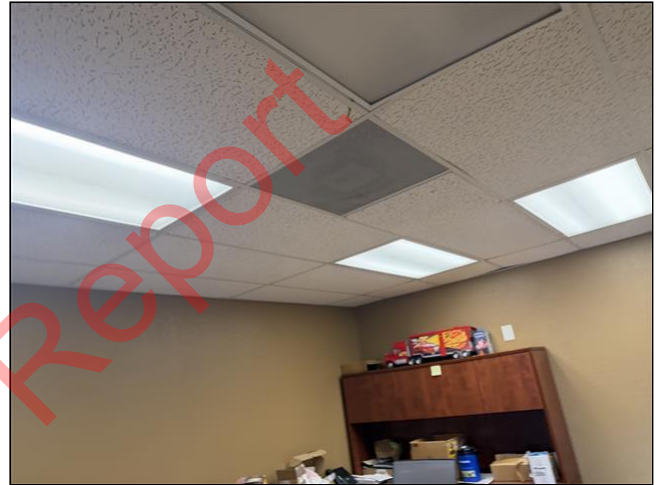
Within the warehouse, lighting coverage appears inconsistent, with only one side of the space observed to have fully functional illumination. Several fixtures on the opposite side appear non-operational or inadequately illuminated, resulting in uneven light distribution across the workspace. This condition may impact visibility and safety during operations. The fixtures themselves appear older, and some exhibit signs of age and reduced output.

In the office areas, the lighting system is generally functional; however, there are missing or displaced ceiling tiles, exposing ductwork and creating gaps around light fixtures. While most fixtures appear operational, the overall condition reflects deferred maintenance and incomplete ceiling finishes.

No emergency lighting or battery backup units were clearly observed during the inspection, and their presence and functionality should be verified, particularly given the mixed-use nature of the building.

Partial lighting outage in warehouse (only one side functional); uneven illumination; aging fixtures with reduced output; missing/displaced ceiling tiles in office areas; exposed ceiling components; lack of clearly visible emergency lighting; general deferred maintenance.

- Immediate to Short-Term (0–2 years): Repair or replace non-functional warehouse light fixtures; restore full illumination coverage; replace missing ceiling tiles; verify and install emergency lighting as required.
- Short-Term (1–3 years): Upgrade warehouse lighting to energy-efficient LED high-bay fixtures for improved output and reduced operating costs.
- Mid-Term (3–7 years): Continue phased upgrades of office lighting to modern LED systems and address ceiling system improvements.

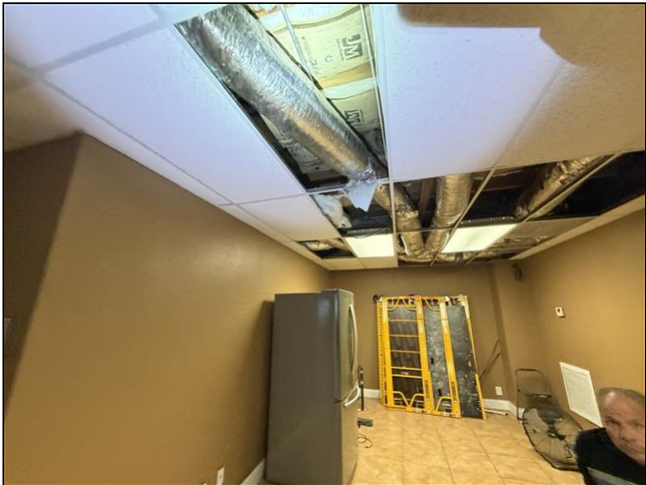
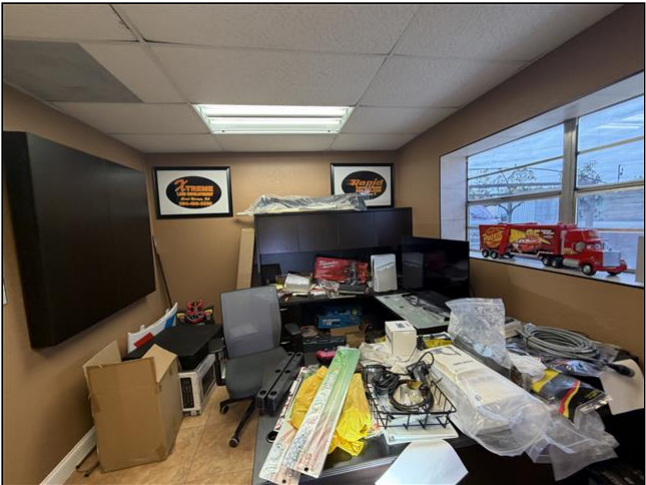
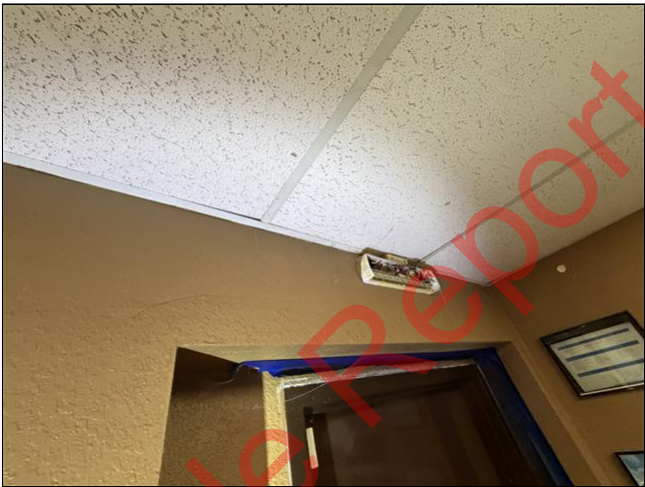
Based on a visual inspection of accessible areas, a limited presence of smoke/heat detection devices was observed. A ceiling-mounted device was noted in the storage/mechanical room; however, overall detector coverage throughout the structure appears incomplete and inconsistent, particularly within the warehouse/shop area and office spaces.

Within the office areas, ceiling-mounted devices were not consistently observed in all rooms. Additionally, portions of the drop ceiling are missing or displaced, exposing ductwork and creating gaps that can impair proper detector performance and smoke migration patterns.

No fire alarm control panel, annunciator, or monitored alarm system components were observed during the inspection. It is unclear whether the existing device(s) are standalone units or part of a larger system. Testing of detectors was not performed, and operational status could not be confirmed.

Limited and inconsistent detector coverage; lack of clearly appropriate detector types for warehouse conditions; missing/damaged ceiling tiles affecting detection performance; unknown system type (standalone vs monitored); no visible fire alarm panel or system integration; unknown maintenance/testing history.

Repair/replace missing ceiling tiles to restore proper environmental separation for detection performance.

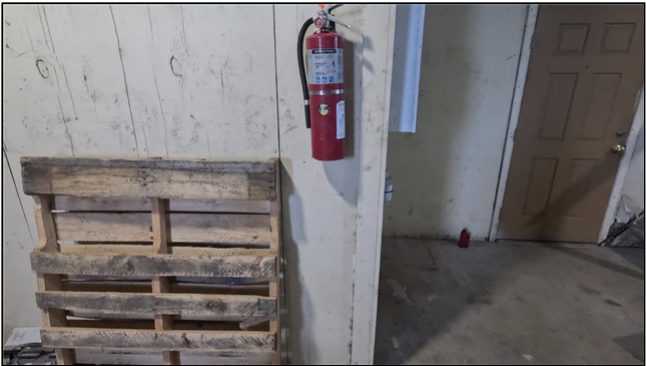
17.1 Fire Extinguishers

Portable fire extinguishers are installed at select locations within the building, including both warehouse/shop areas and office spaces. The units observed are wall-mounted, multi-purpose (ABC-type) extinguishers intended for general fire protection coverage. Placement appears generally appropriate for visibility and access; however, coverage throughout the entire facility could not be fully confirmed.

The extinguishers appear to be in generally serviceable condition, with no visible physical damage noted at the time of inspection. Inspection/service tags are present on at least one unit, indicating prior maintenance; however, tag details and full compliance with annual inspection requirements were not fully verified. Proper mounting height and accessibility appear acceptable, although some units may be located near stored materials, which could impede immediate access in an emergency.

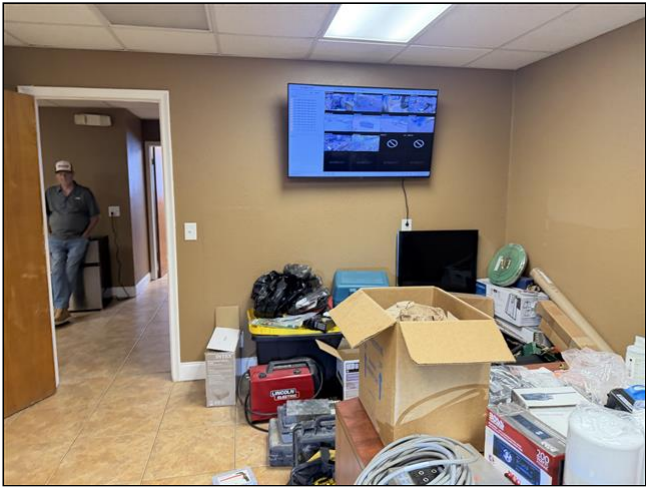
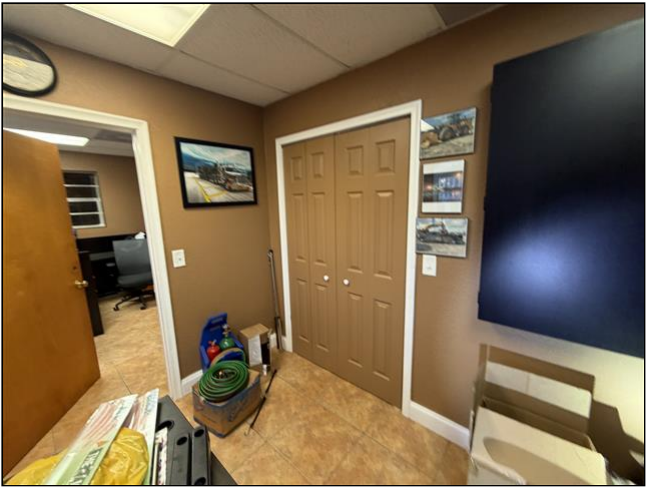
In summary, emergency lighting and exit signage were not observed and may be absent, which poses a notable life safety risk. Installation and verification of compliant systems are strongly recommended to ensure safe egress and adherence to applicable codes.

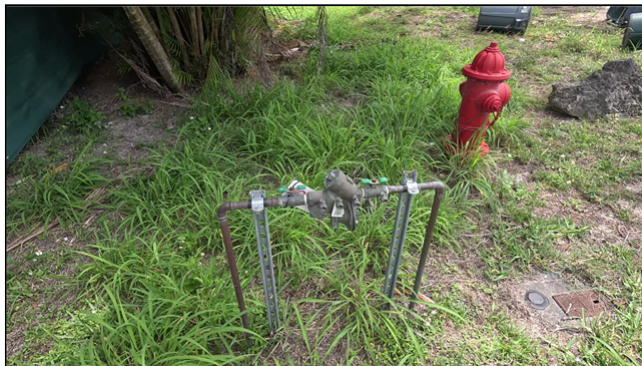
17.4 Fire Hydrants

In summary, a fire hydrant is located near the building and appears serviceable; however, vegetation clearance and verification of testing, maintenance, and fire flow capacity are recommended to ensure reliable emergency use.

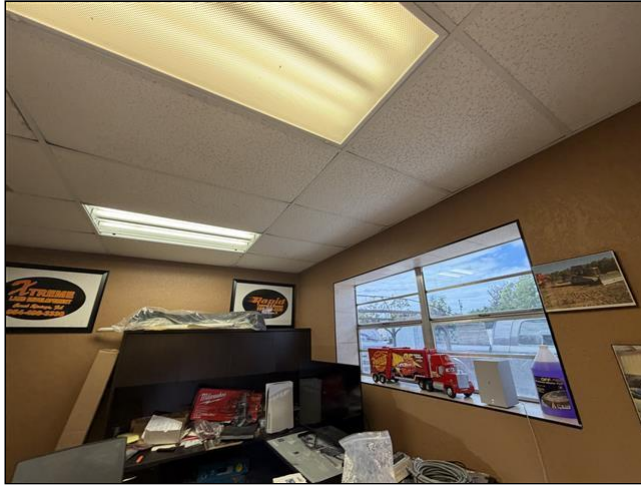
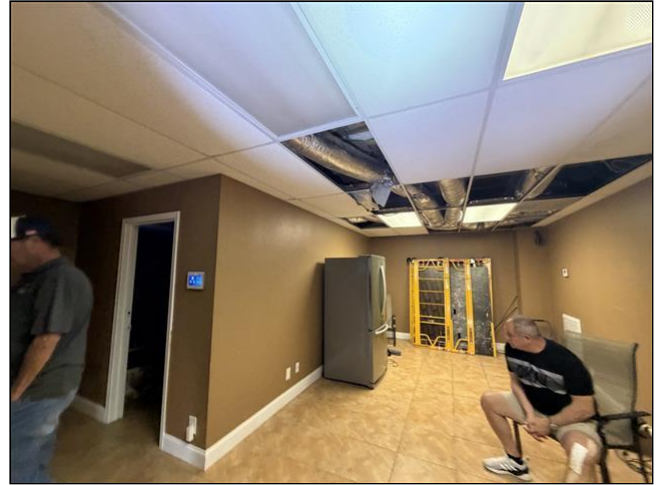
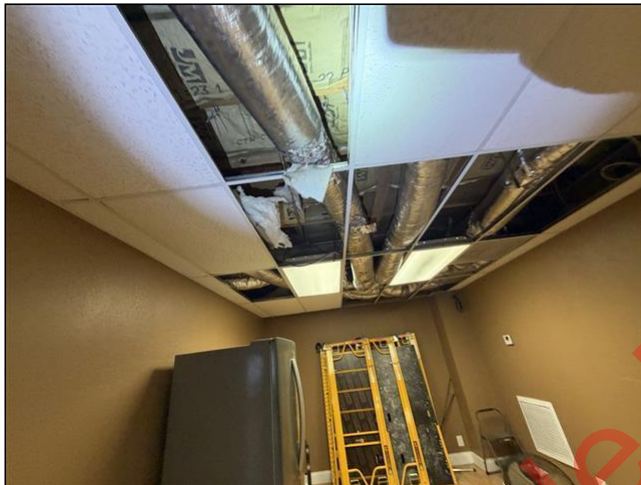
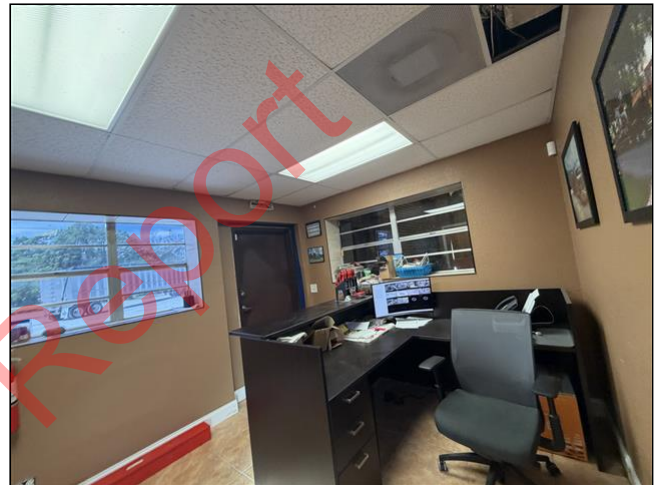
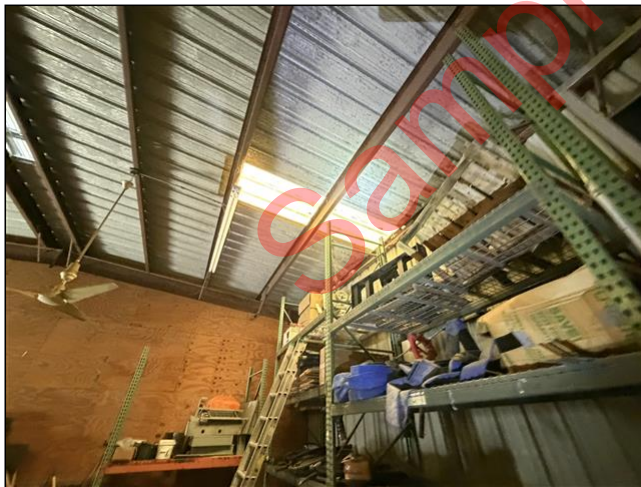
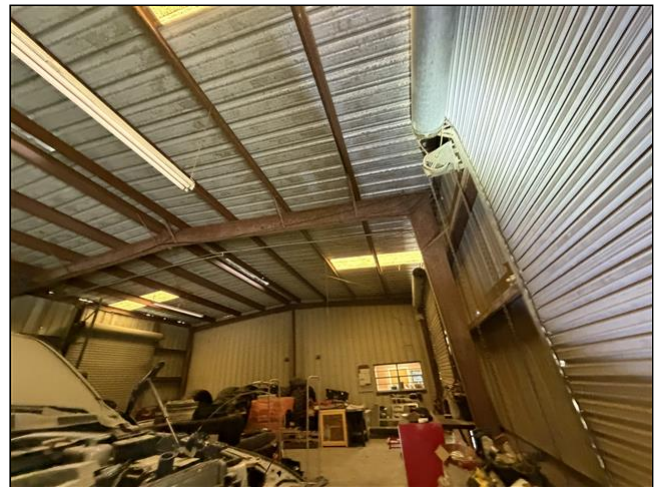
18.1 Ceilings

In summary, the warehouse ceiling is typical and serviceable, while the office suspended ceiling system exhibits visible deficiencies and deferred maintenance. Repairs and tile replacement are recommended to restore functionality, appearance, and protection of above-ceiling systems.

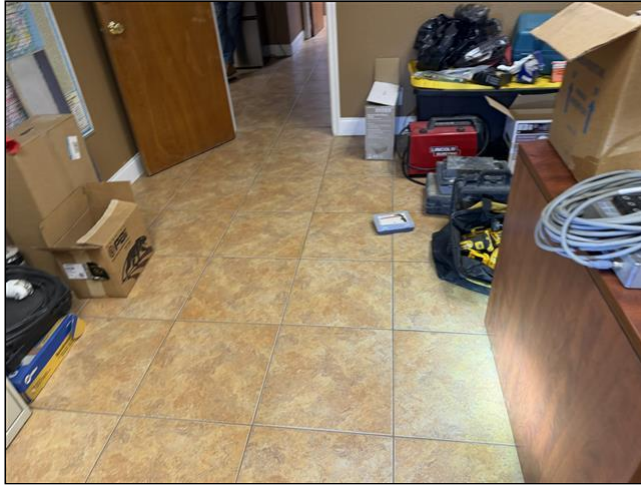
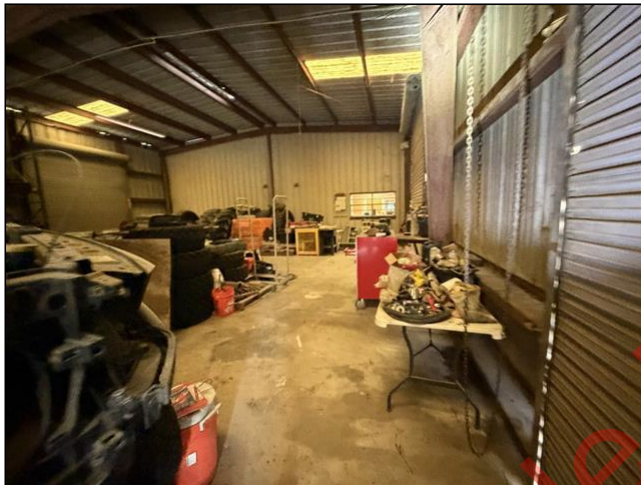
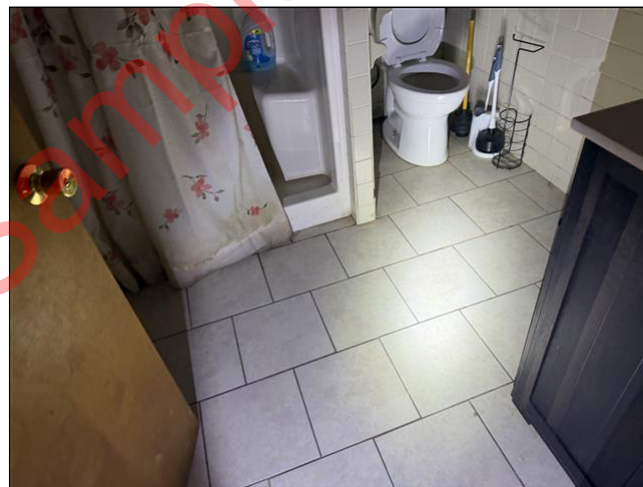
## 18.2 Flooring

The building contains a combination of concrete slab flooring in the warehouse/shop areas and finished tile flooring in the office spaces. The warehouse flooring consists of a sealed or previously coated concrete slab-on-grade, while the office areas are finished with ceramic or porcelain tile over a concrete substrate.

In summary, the flooring systems are serviceable and appropriate for their respective uses. The warehouse slab exhibits expected wear and would benefit from cleaning and recoating, while the office tile flooring remains in generally good, functional condition with routine maintenance recommended.

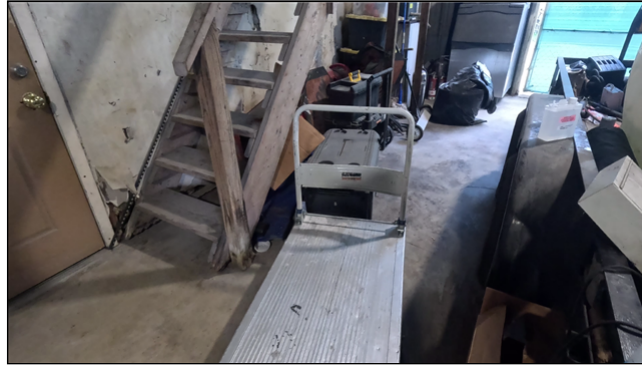
### 18.3 Staircase

The building includes a staircase providing access to the mezzanine/storage level within the warehouse area. The stair system appears to be a utilitarian installation consistent with light industrial use, constructed of wood with open or partially enclosed risers.

In summary, the mezzanine staircase is present and appears functional for basic access; however, its configuration and safety features should be verified and potentially upgraded to meet current standards and reduce risk, particularly if used regularly.

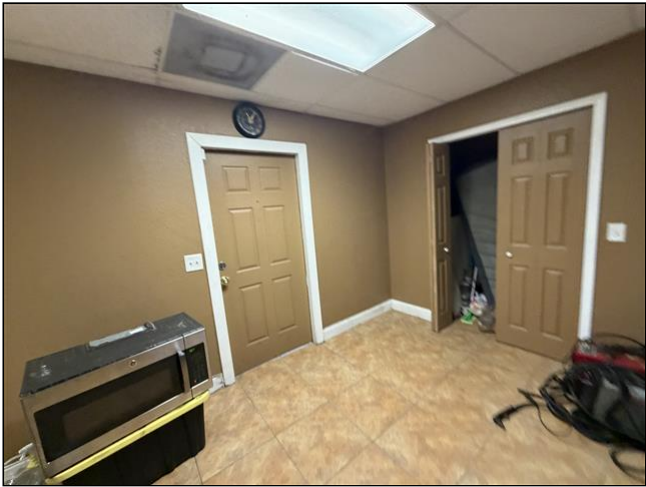
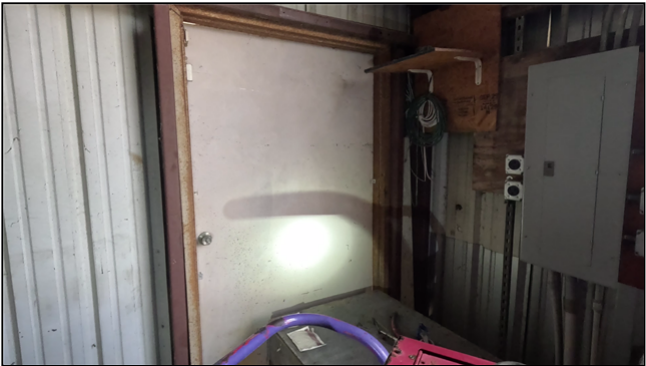
#### 18.4 Interior Doors

In summary, the interior doors are functional and typical for the building type, with minor wear observed. Routine maintenance and selective upgrades are recommended to maintain proper operation and ensure compliance with any applicable safety requirements.

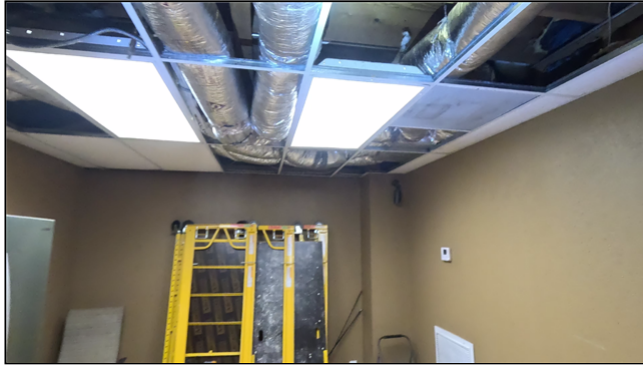
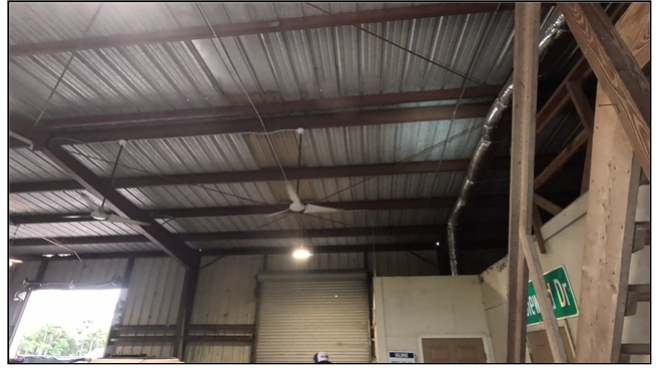
18.5 Light Fixtures

In summary, the lighting system provides adequate illumination in the office areas but is deficient in the warehouse due to partial inoperability and aging components. Repairs and upgrades—particularly conversion to LED—are recommended to improve performance, safety, and efficiency.

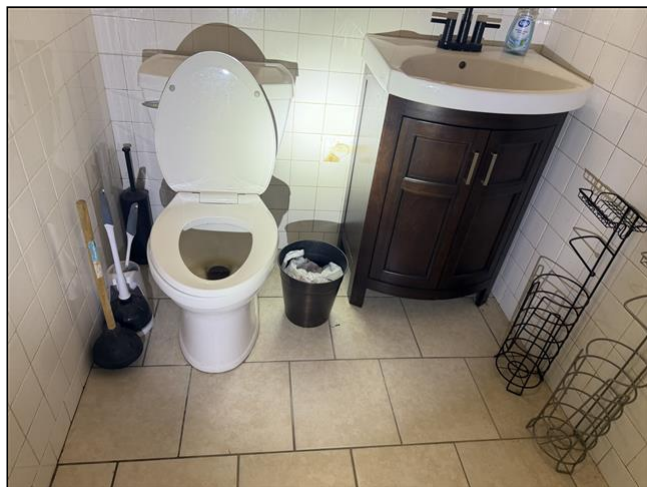
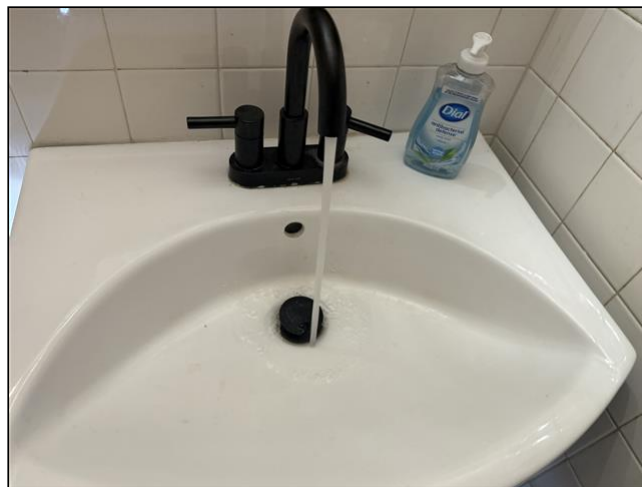
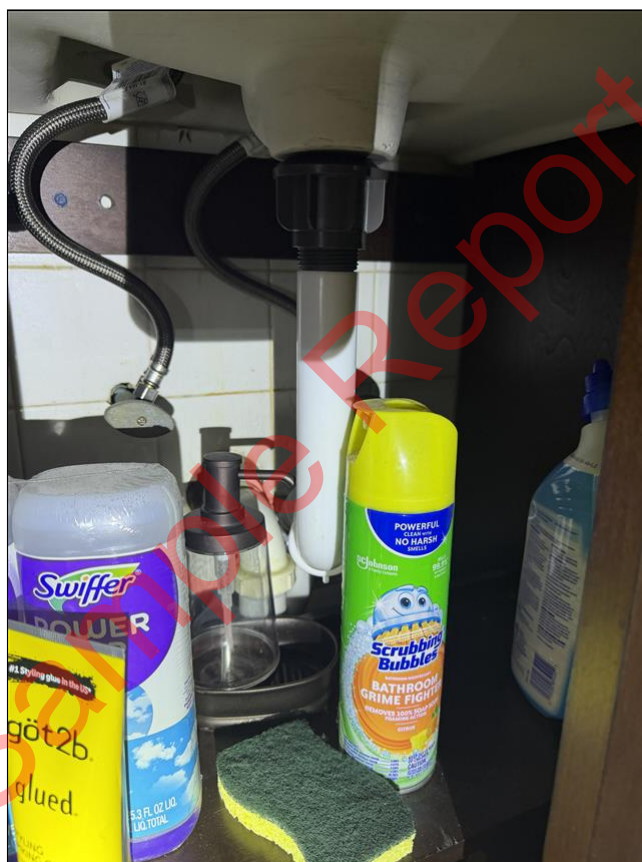
**18.6 Plumbing Fixtures**

In summary, the plumbing fixtures are present and appear functional for basic use, though they are limited in number and show typical wear. Routine maintenance and gradual upgrades are recommended to improve reliability, efficiency, and overall condition.
