### **Property Condition Report**

Undisclosed Address  
Palm Beach Gardens FL 33403

9/13/2023

Subject: Property Condition Report 3168 Northlake Blvd, Palm Beach Gardens, FL

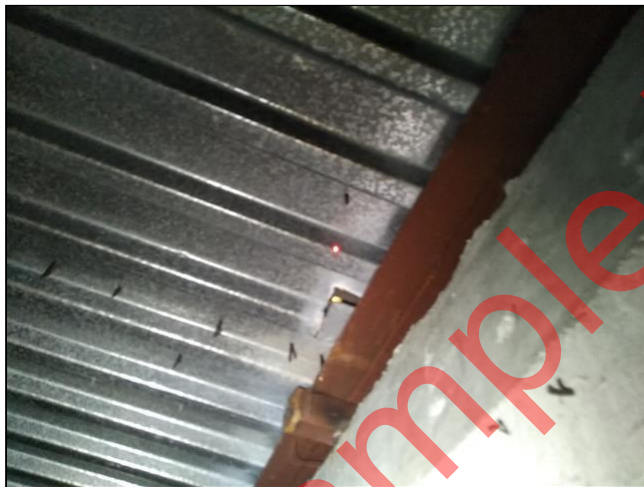
9.2 Item 1 (Picture)

- 3) Good - No major signs of age or wear, may need replacement during the loan term.
- Overall building framing appear in good condition. Framing failure was not observed.
  - Some roof deck was damaged or poorly installed where you could see the sun light coming through.
  - Periodic monitoring of building framing is recommended.

Evidence of damaged metal decking was observed. Recommend repair of the roof deck where light can be seen coming through.

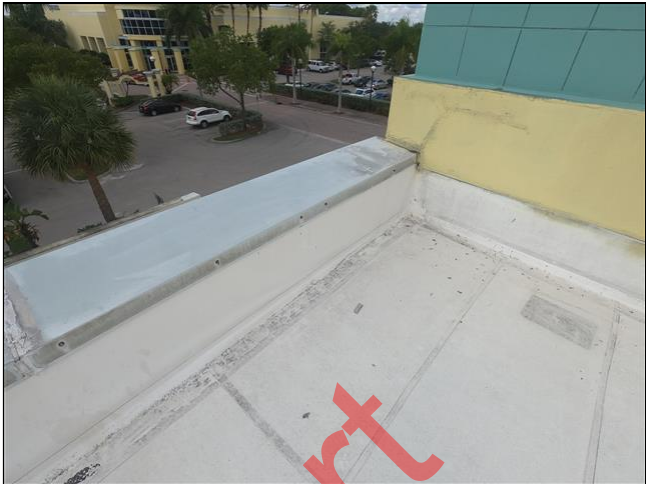
10.2 Item 2 (Picture)

Exterior walls go far above the roof plane as large parapets. The parapets are capped with the same TPO roof material to protect against water. Exterior joints of the parapets exhibited severe deterioration. Several caulk lines are damaged and in need of maintenance.

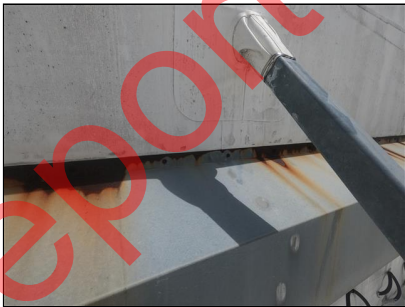
10.5 Item 4 (Picture)

- The roof appears well designed leveraging the aspects of good roof drainage via tapered insulation, internal downspouts, and emergency scuppers.
- Inspector observed several areas where the membrane has been punctured and repairs have been made.
- Inspector observed several pieces of debris including cement blocks that were left on the roof. There were also, several loose HVAC condensate lines found.

- As evidenced by the various leaks observed on the underside, the roof coverings needs to be maintained and repaired as needed.
- Provide continued monitoring of roof repairs for potential failure or roof leaks.
- Monitor continued deterioration of the roof surfacing and take action as needed to avoid water intrusion.
- Plan for the replacement of the TPO in the next 5-10 years.

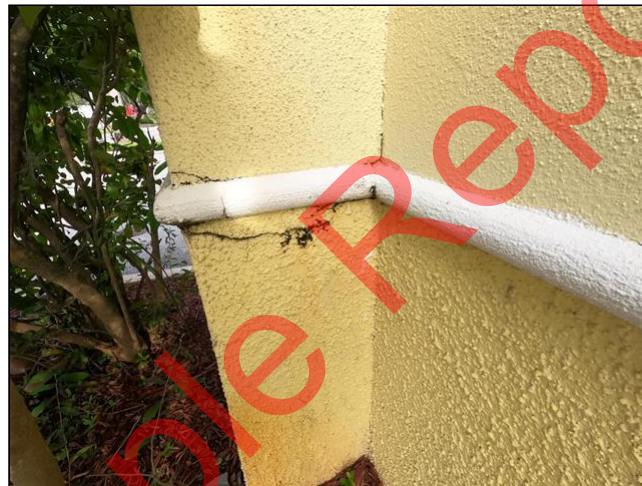
11.1 Item 3 (Picture)

The soffits appears to consist of exterior rated gypsum board. The architectural trim consist of foam inserts. Some areas of the architectural foam in the back of the building exhibited moderate levels of deterioration.

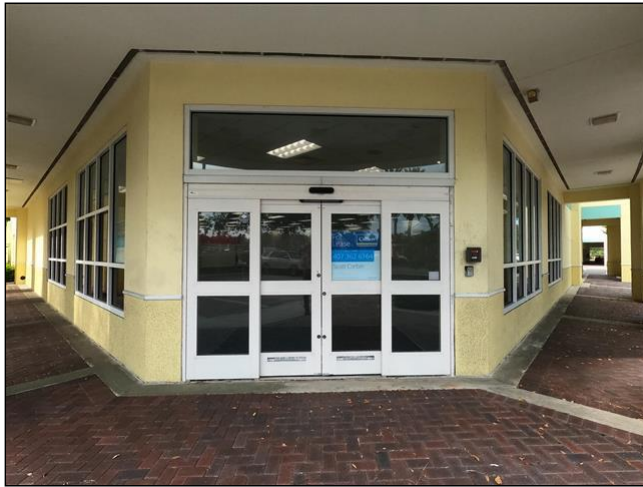
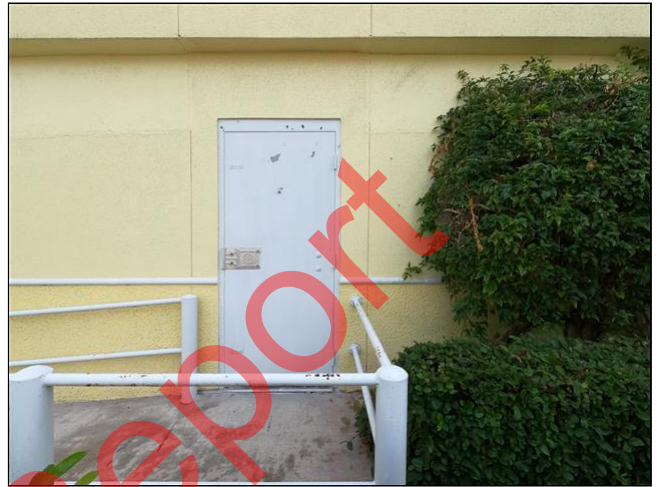
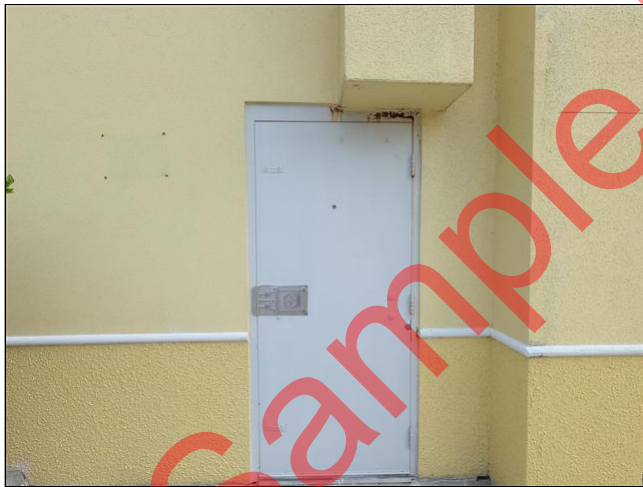
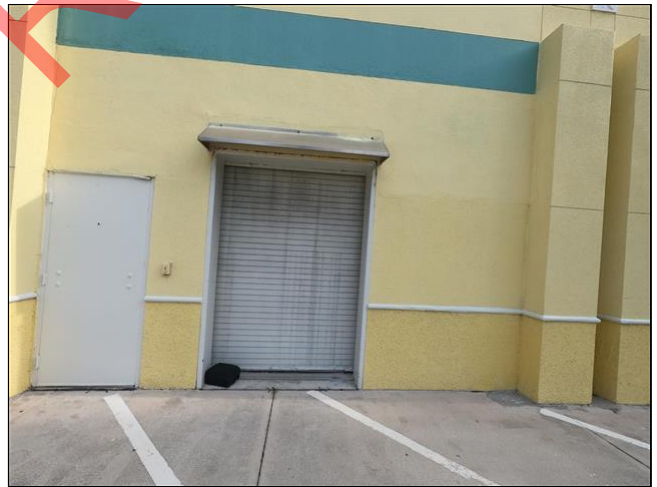
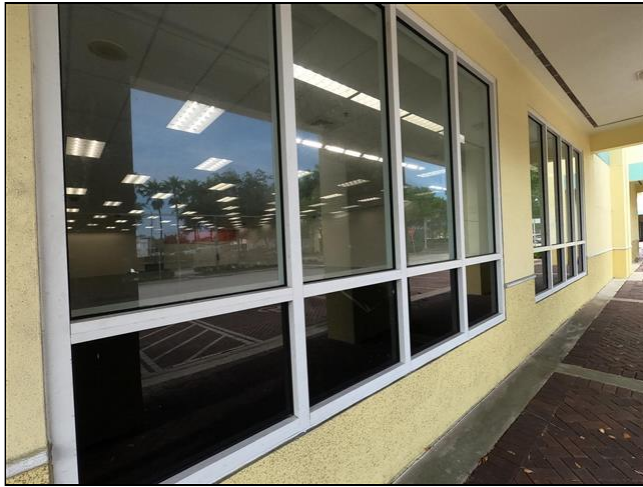
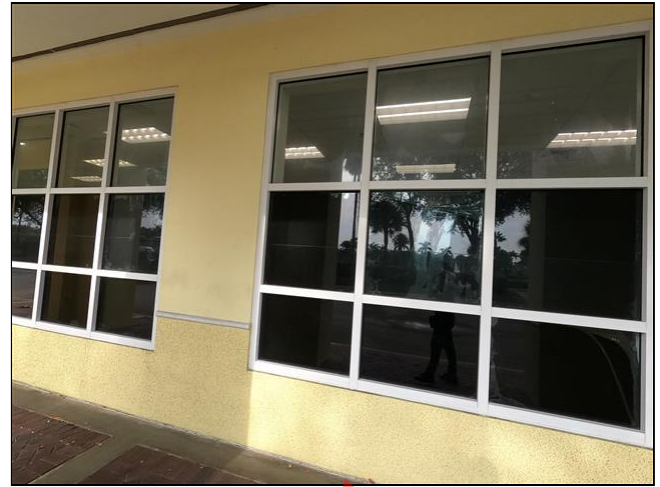
Observed exterior service doors on the back of the building were typically painted hollow core insulated metal doors set in painted metal frames with panic hardware. Observed windows were impact resistant. Sealant and gaskets around the windows appeared to be old and deteriorated.

- Rear doors exhibited severe levels of deterioration and corrosion. Front, sliding glass door was functional at the time of the inspection.
- Dock doors were also observed to be in fair operating condition.

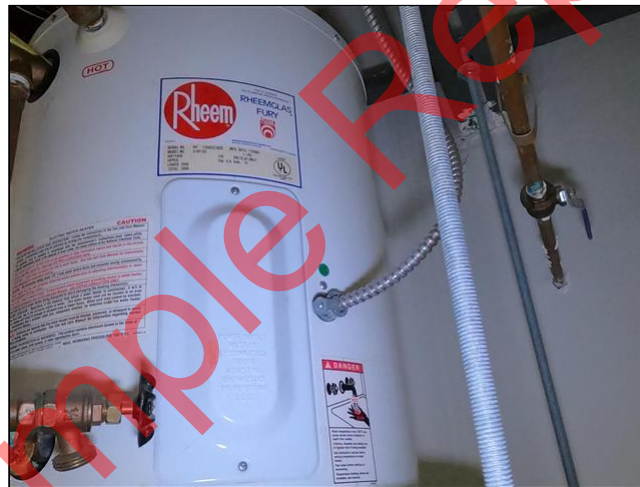
12.2 Item 1 (Picture)

Observed a small 15 gallon tank water heater located in the dock area in the back of the building.

- The plumbing, sanitary drainage, and vent systems were reported to be in fair overall condition.
- Hot water heater was not functional. Routine maintenance is anticipated.
- External flushmounted water faucets were secured from unauthorized use.

- Inoperable or obsolete equipment: Hot water heater was not functional.
- Leaks, corrosion or deterioration: No plumbing leaks, corrosion or deterioration was noted or reported.
- Problematic piping: No polybutylene (PB) or cast iron piping was noted by or reported to Certified Inspectors, LLC. Cast iron pipe was available only for vent stacks and sprinkler system.
- Sewage/Grease/Oil backups or spills: No concerns were noted or reported.
- Insufficient Pressure: No evidence of insufficient water pressure was reported.
- Inadequate hot water: Hot water heater was not functional.

Minor physical deficiency/deferred maintenance was observed. Plumbing systems will need to be serviced as part of regular maintenance program. Recommend repair or replace hot water heater if you intend to use it.

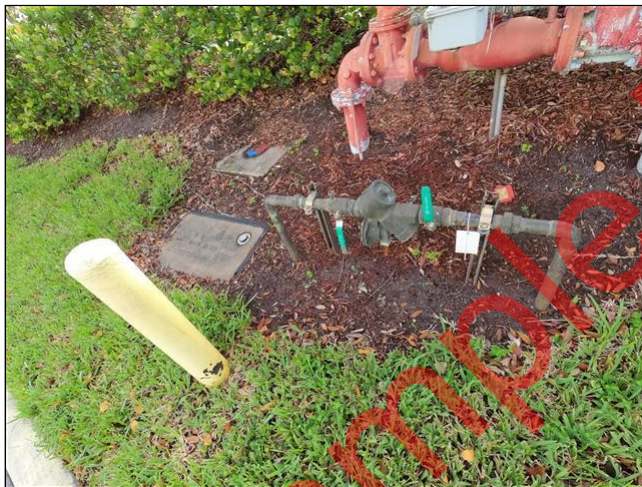
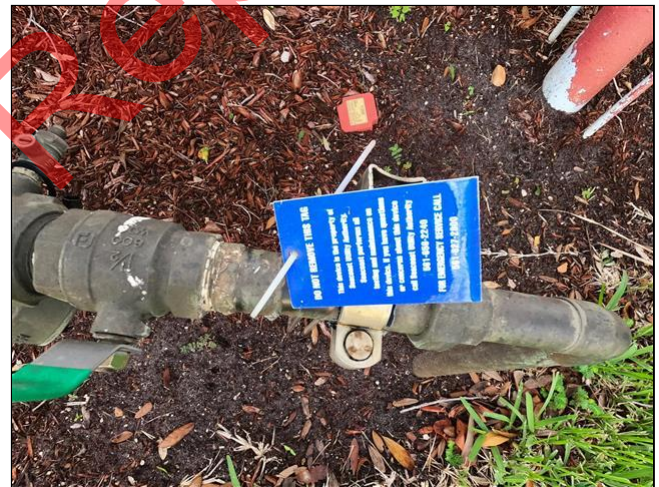
The building is equipped with a backflow preventer to protect clean water from contaminated water. Backflow preventers are supposed to be inspected each year. You will need to arranged the inspections each year.

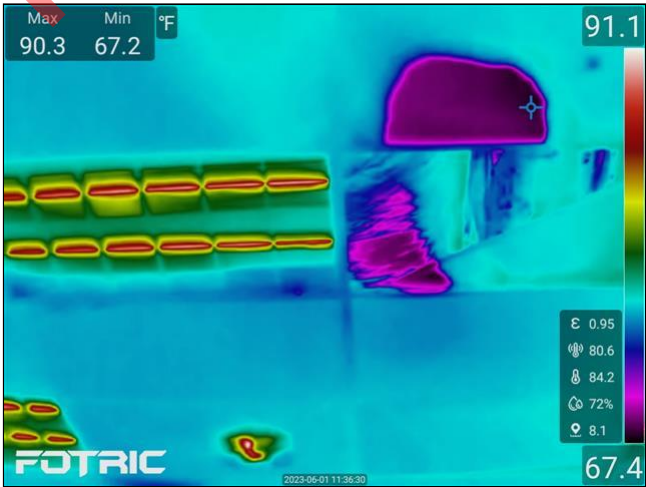
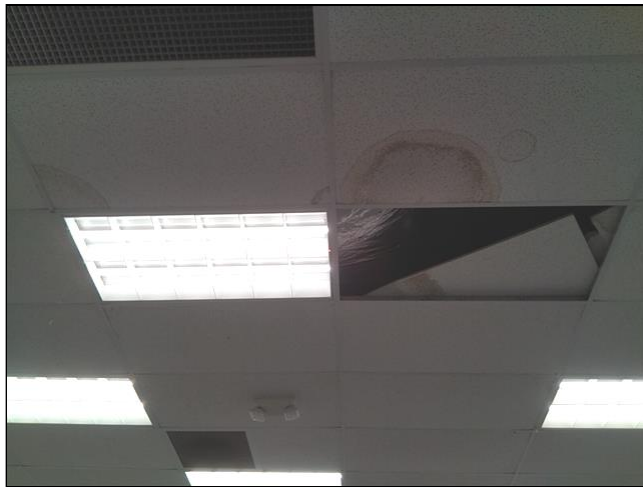
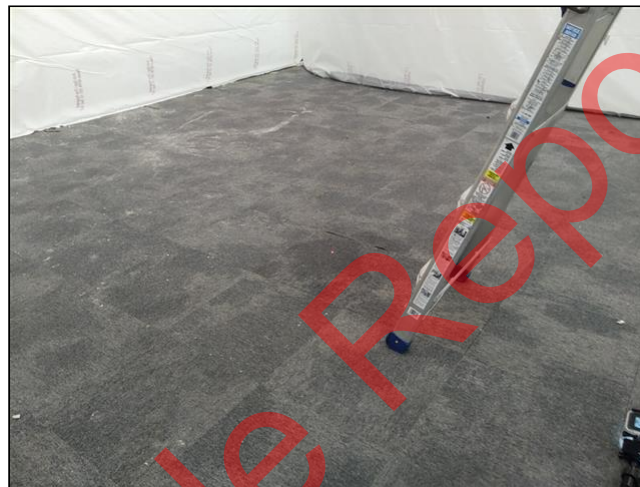
Inspector observed that two of the RTUs were not functional at the time of the inspection (one for the warehouse and one for the office area). Inspector observed that the thermostats associated with the malfunctioning equipment were without battery.

Inspector observed some duct leak that was generating a large amount of condensation. Cold air that escapes the duct and mixes with the hot ceiling cavity air creates condensation. Recommend repair of the damaged duct line.

- Inoperable/obsolete equipment: Two RTUs were not functioning.
- Insufficient capacity: No concerns regarding the HVAC capacity was observed.
- Other: No other concerns relating to the HVAC systems were noted or reported.

Repair or replace the non-functional HVAC systems. The regular changing of the air conditioning filters, cleaning of drip pans and keeping the drain lines clear as well as cleaning of the condenser coils should be handled as part of routine maintenance.

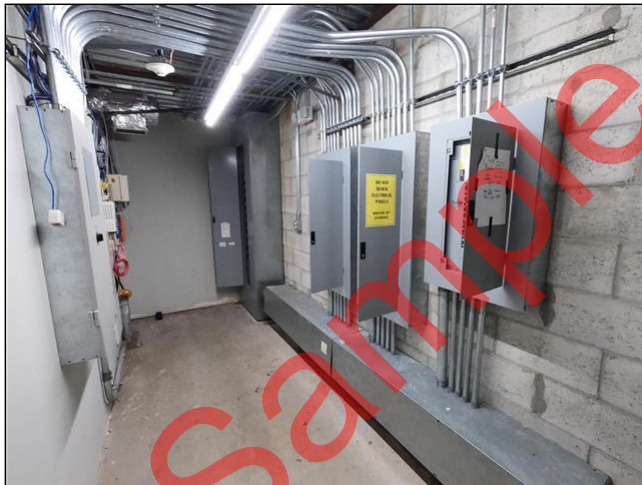
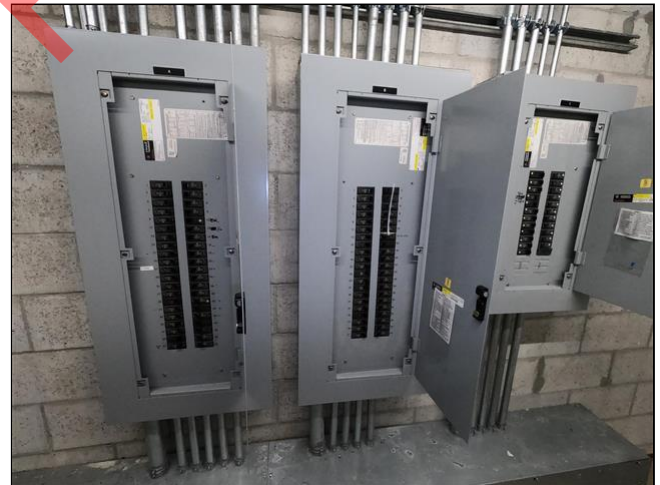
There was also an unidentified electrical panel (marked Z2) in the back of the building by the loading dock. The system was secured with padlocks and was not able to be inspected.

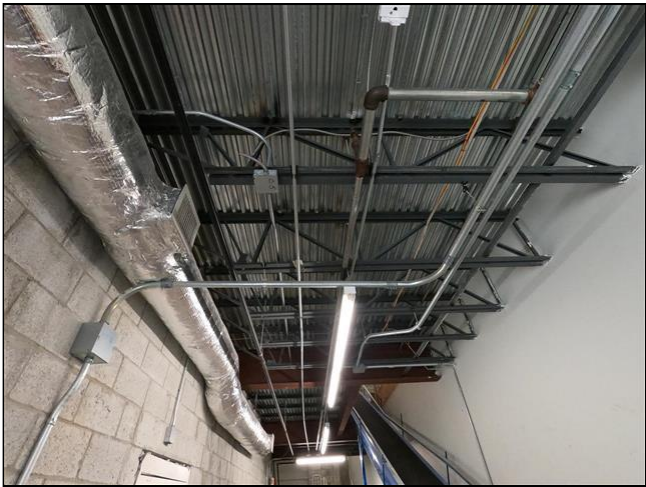
14.2 Item 1 (Picture)

Copper branch wiring is used throughout the subject property. Much of the wiring is encapsulated with galvanized steel conduit.

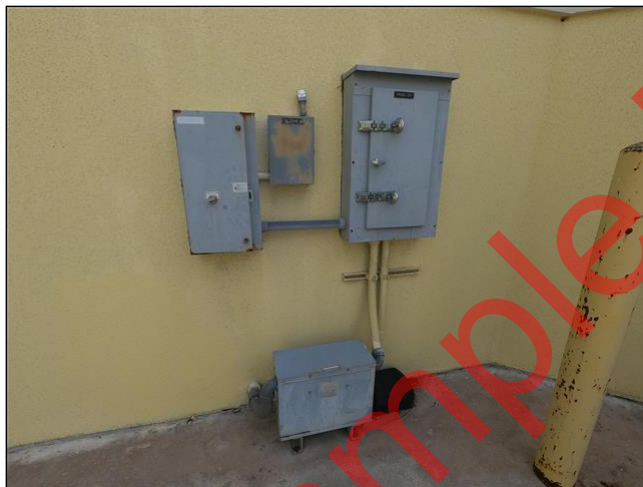
14.9 Item 1 (Picture)

- Inadequate capacity: No evidence of inadequate electrical capacity was observed.
- Aluminum wiring: No aluminum branch wiring was observed.
- GFCI: In general, GFCI receptacles were present in the wet areas.
- Other: There was locked electrical panel (marked Z2) in the back of the building by the loading dock. The system was secured with padlocks.

No physical deficiencies/deferred maintenance or immediate / short term needs were noted. The electrical system should be maintained as part of routine maintenance, including periodic infrared surveys. Recommend electrical evaluation of the exterior panel Z2 and hardware in the back of the building.

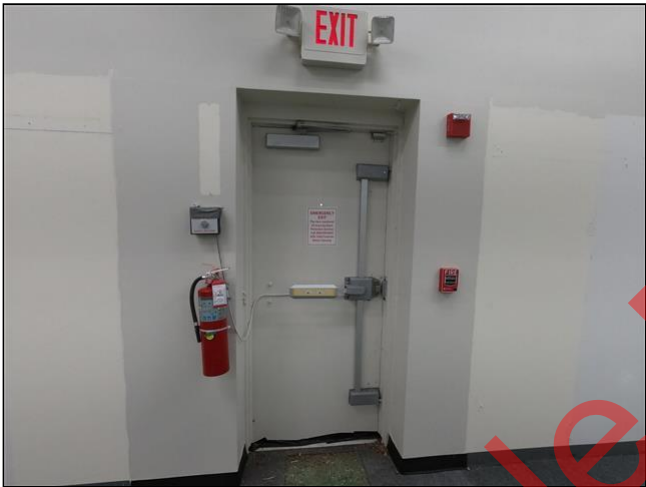
15.0 Item 1 (Picture)

Smoke/ heat detectors are present throughout the buildings.

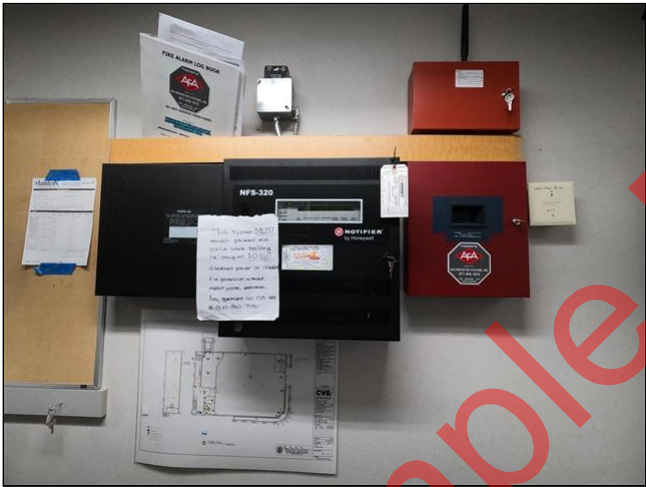
15.2 Item 1 (Picture)

The building is equipped with a Fire Control Panel connected to the Fire Department. The FCP is located inside the small utility office on the NW corner of the building.

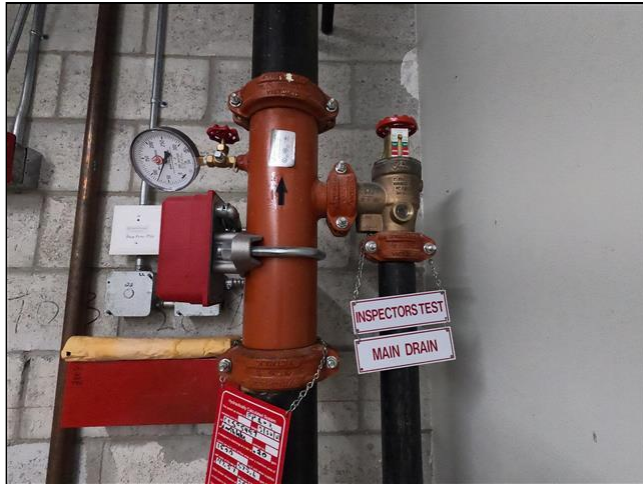
15.6 Item 1 (Picture)

The building has a fire sprinkler with a wet type fire suppression system. There are post indicator valves, audible flow alarms, pull stations, outside stem & yoke (OSY) connections, strobes and fire department connections.

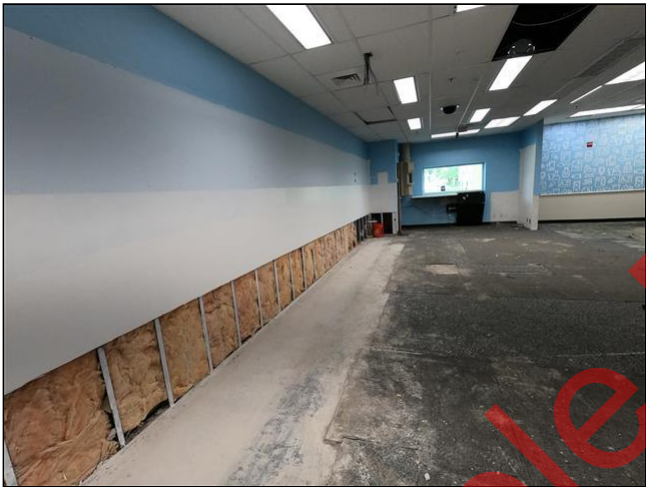
16.0 Item 1 (Picture)

The interior walls consist primarily of painted gypsum board. FRP was installed in the restroom walls. Walls on the back of the warehouse is unfinished CMU.

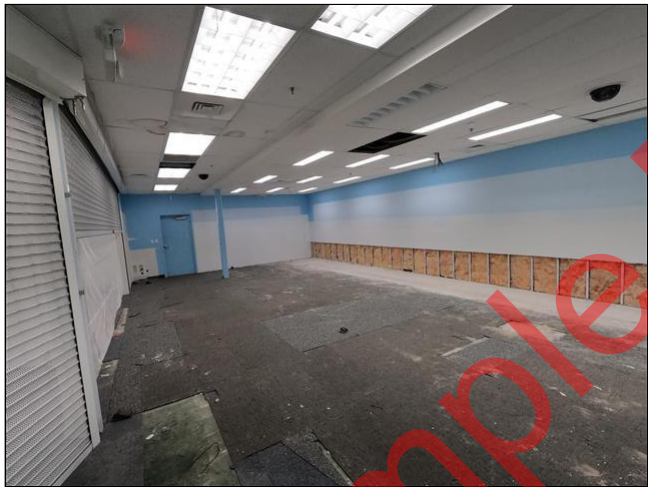
16.1 Item 1 (Picture)

The ceilings are primarily suspended ceiling systems with either 2'x2' or 2'x4' lay-in acoustical ceiling panels and light fixtures or gypsum board. The mezzanine has an open ceiling where you can see part of the metal roof deck.

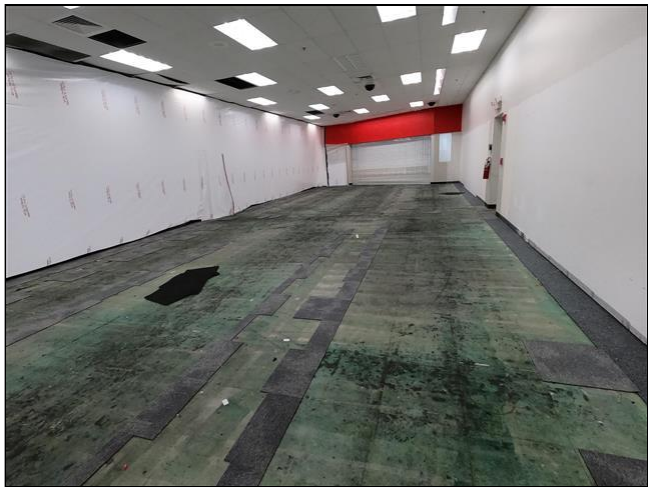
16.2 Item 1 (Picture)

Flooring consists of a commercial grade carpeting and vinyl tile in the restrooms.

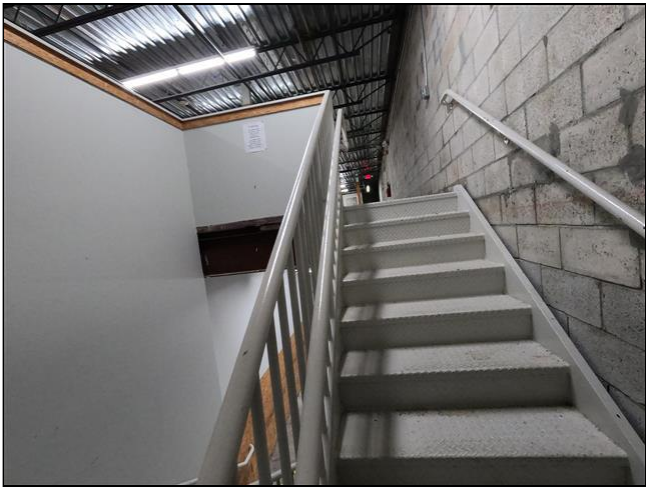
16.3 Item 1 (Picture)

There are two steel staircases leading to the mezzanine. The staircase are equipped with a steel railing system and they are part of the exit access through the rear portion of the building.

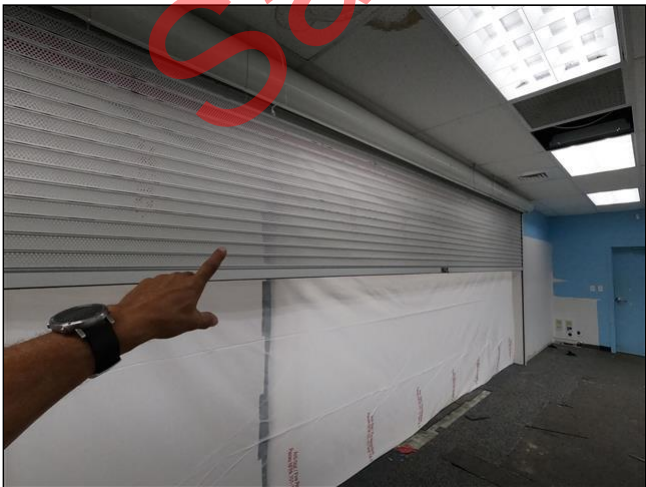
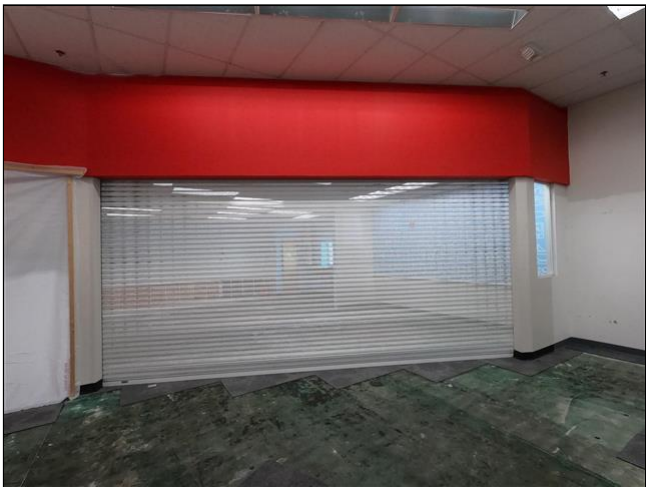
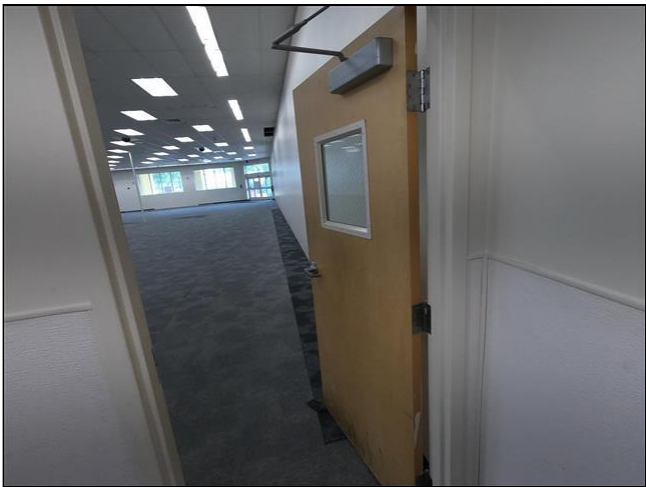
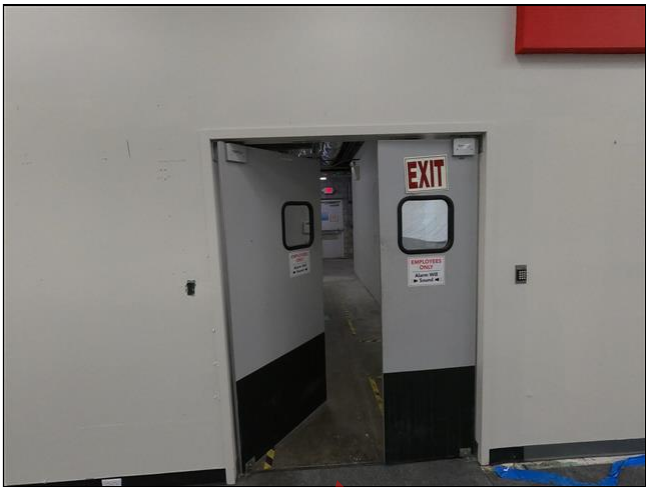
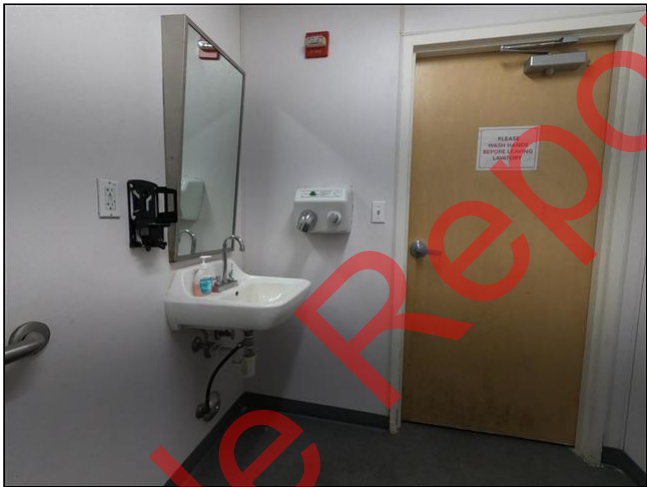
Interior doors ranged from conventional, stained, solid core doors set in painted wood or metal frames. There is also two roll up metal security door that was used for protection of regulated drugs stored in the building. These doors were locked and were not tested.

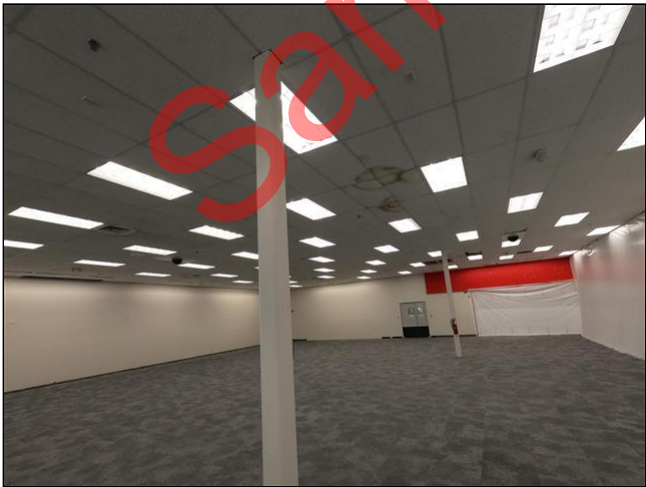
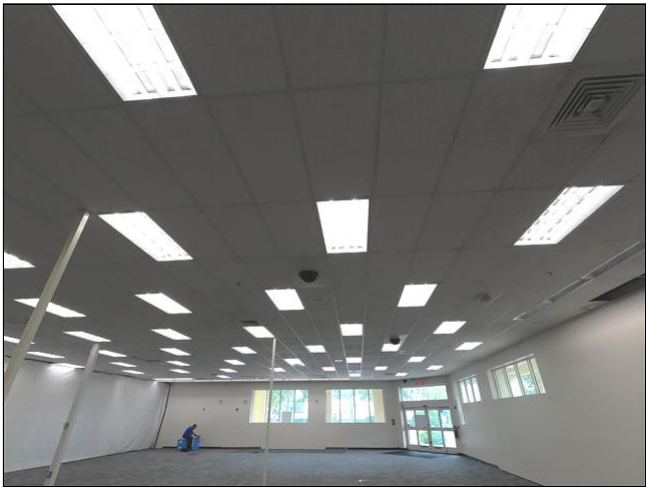
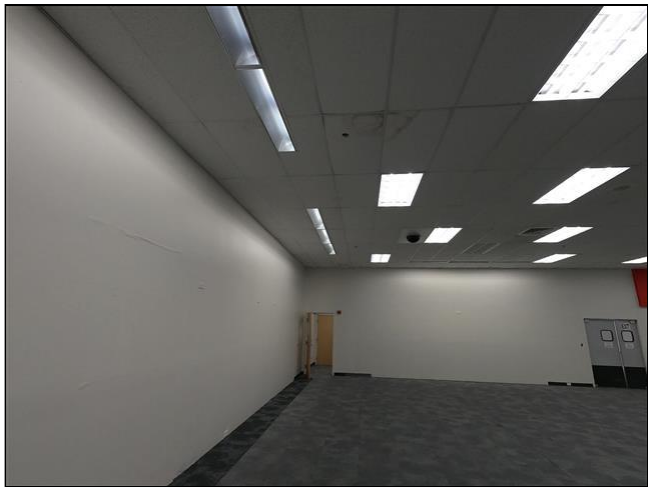
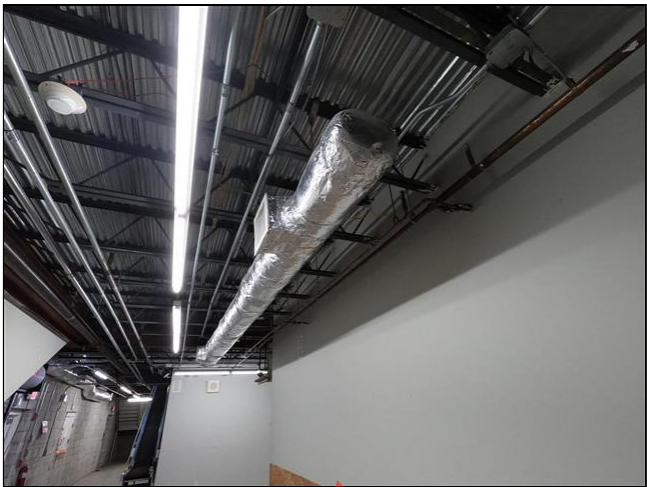
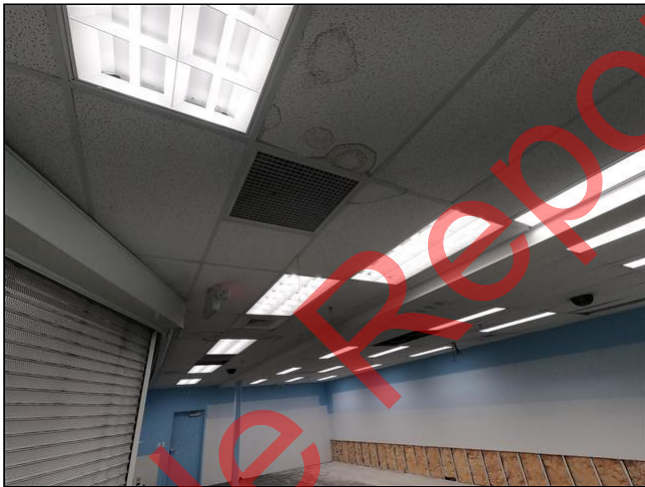
Primary lighting in the building is provided by a variety of suspended fluorescent ceiling fixtures and a variety of incandescent, and halogen lighting.

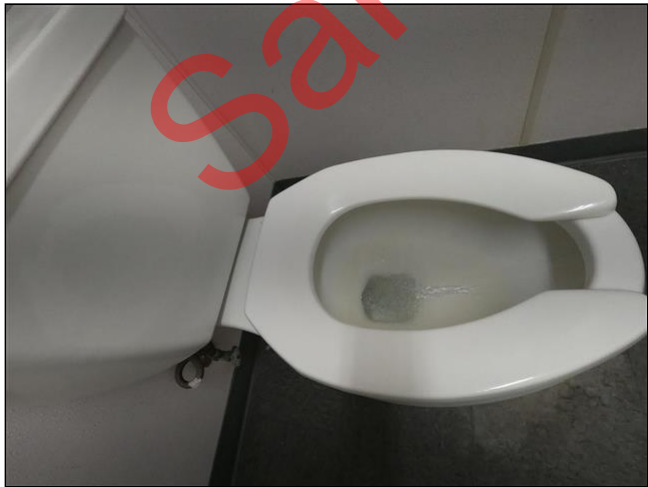
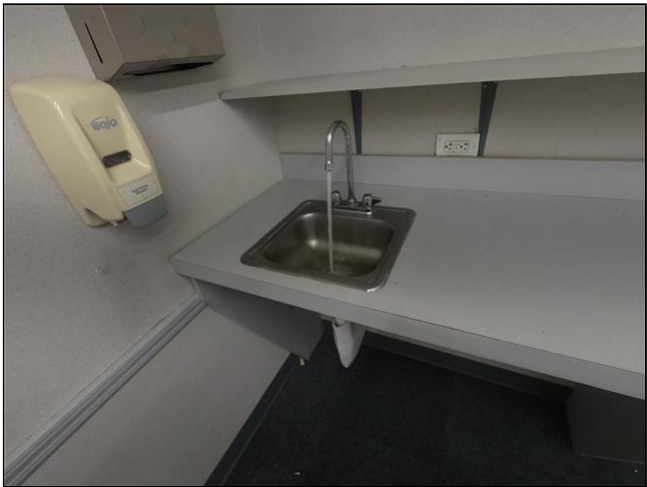
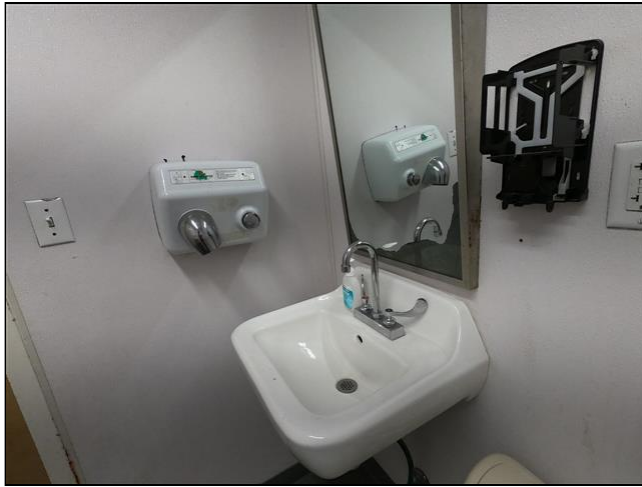
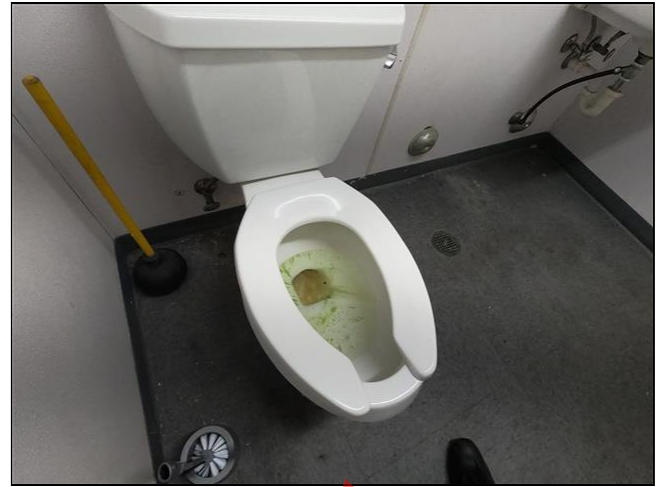
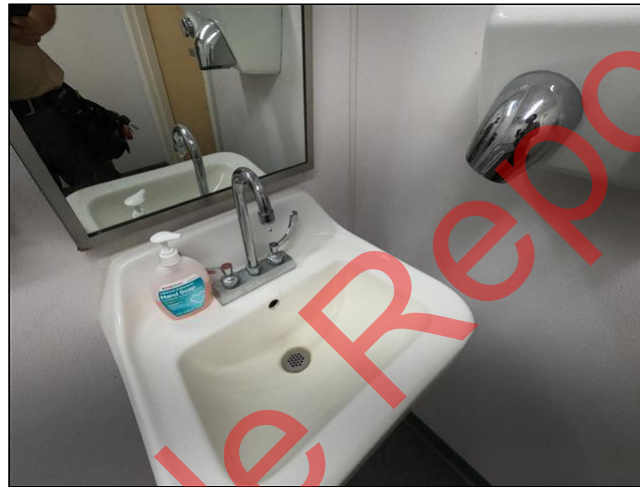
There are two restrooms in the back of the building. The restrooms include standard toilets and sinks. All fixtures appears to comply with ADA standards. But this is not an ADA audit. So, you should not rely on this statement to assume accuracy of every ADA requirement.

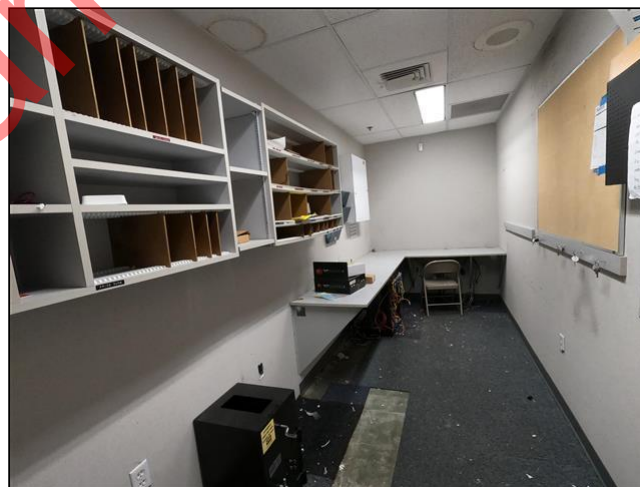
16.7 Item 1 (Picture)

There is minimum furnishings or cabinets left in the building. The furnishings are made of plywood and laminate finish.

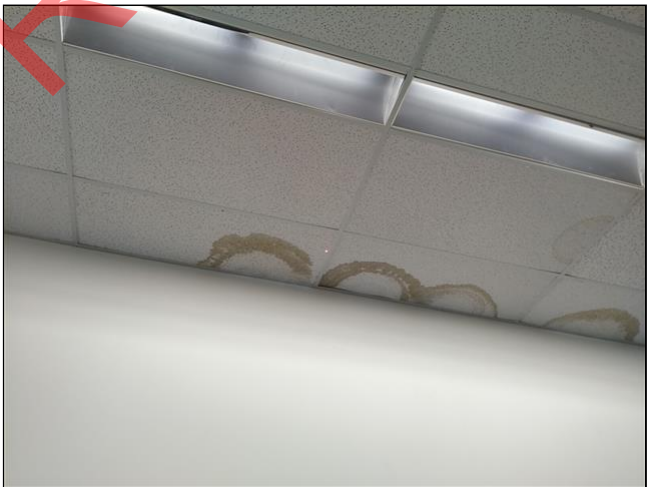
16.9 Item 2 (Picture)

Moderate wall, ceiling, flooring and surface finish damage was observed. Ceiling damaged ceiling tiles were caused by several roof leaks and HVAC duct leaks. Furnishings were old and exhibited moderate levels of deterioration. Some light fixtures were not functional r had damaged light bulbs.

- Some physical deficiencies/deferred maintenance or immediate / short term needs were noted.
- Maintenance, repair, and replacement of the walls, ceilings, flooring and furnishings is needed.
- Some light fixtures will need to be repaired or replaced.
- Ceiling tiles will have to be replaced and source of leak repaired
