# Dock Inspection Report

**Mrs. Bonnie Guenther**  
**Conquistador Homeowner's Association**

**Property Address:**  
1800 SE St Lucie Blvd  
Stuart FL 34996

July 17th, 2021

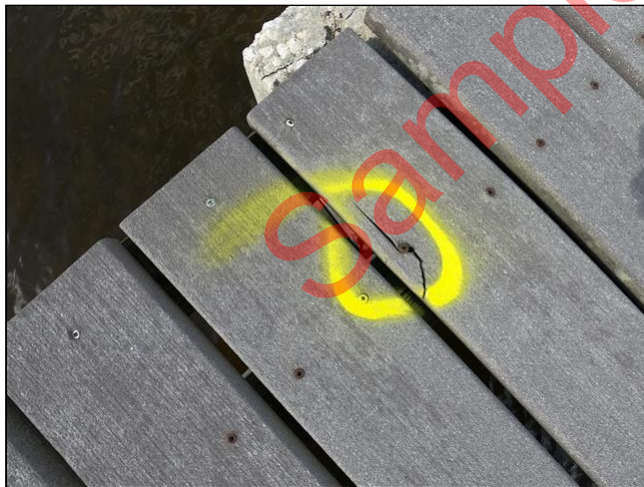
1.1 Item 3 (Picture)

The deck exhibited minor signs of deterioration with some boards beginning to crack around some of the screws.

Some boards are not properly installed and not leveled with the rest of the deck. This is a trip hazard which should be corrected to prevent trip and fall accidents.

Also, there are several screw heads sticking out of the deck boards. Several screws are corroded as they stick out of the boards. This also represents a risk of injury and possible trip hazard.

Recommend repair or replacement of all damaged deck boards, re-placement of corroded screws, and re-tightening of all deck boards.

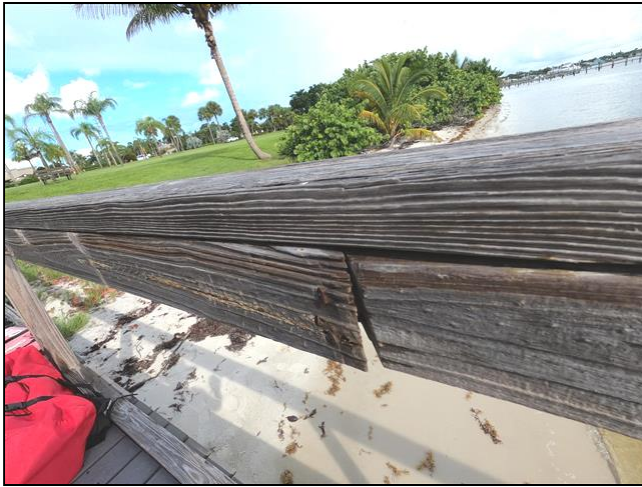
1.2 Item 9 (Picture)

There is a wood deck rail on the entire left extension of the dock. The wood is very old and exhibited moderate levels of deterioration due to exposure to weather and sun.

Inspector found that several deck railing joints were separating or splitting. This represents a risk as people can get insured by corroded screws and splinters.

Inspector also found that a large portion of the railing was loose. The area is represented by the first 160 lineal feet of deck railing.

Recommend repair or replacement of all deck railings where the joints are separating, torn, or has corroded screws. Recommend repair or replacement of the section of railing that is loose. Recommend application of deck painting once every couple of years to extend the life of the wood railings.

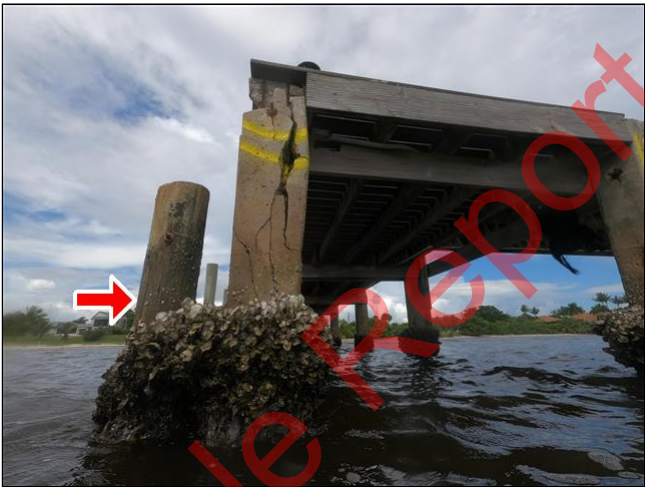
1.3 Item 4 (Picture)

There are also some wood piles installed at the end of the dock to serve as temporary support for old concrete piles that collapsed. Those wood piles are intended to be temporary and should not be considered as permanent solution. Recommend those wood piles be removed and replaced by qualified marine contractor.

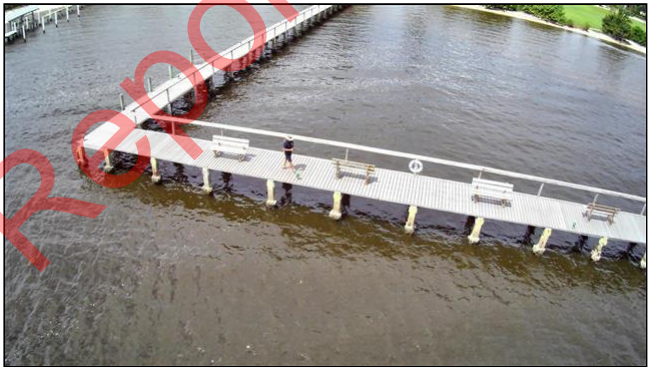
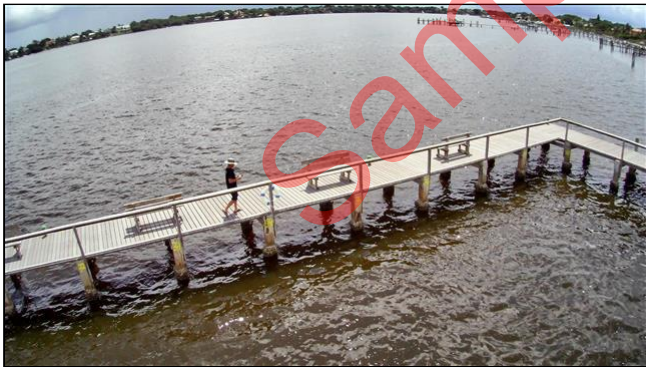
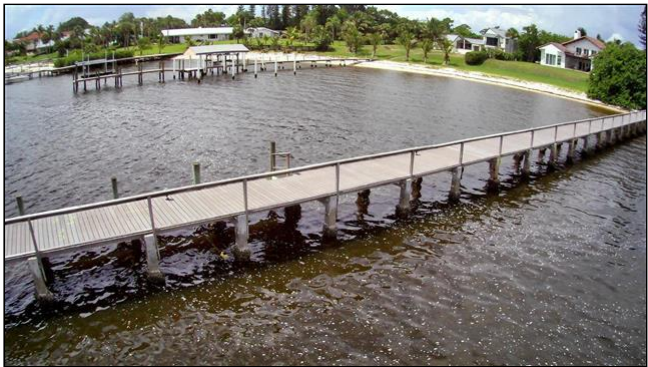
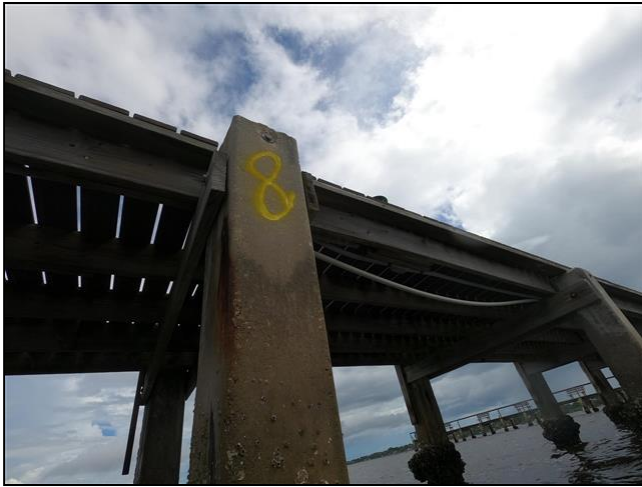
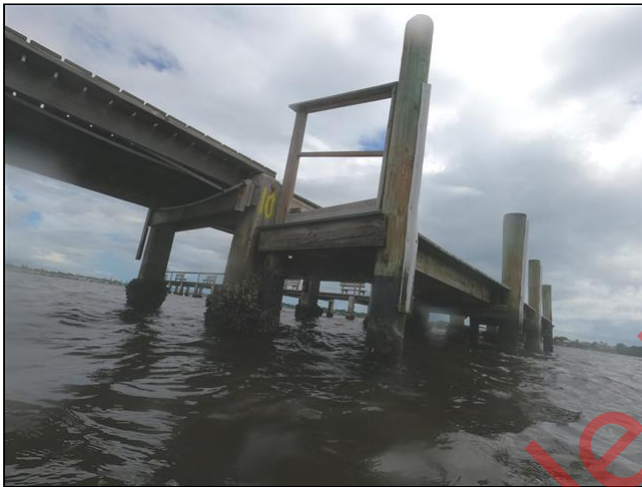
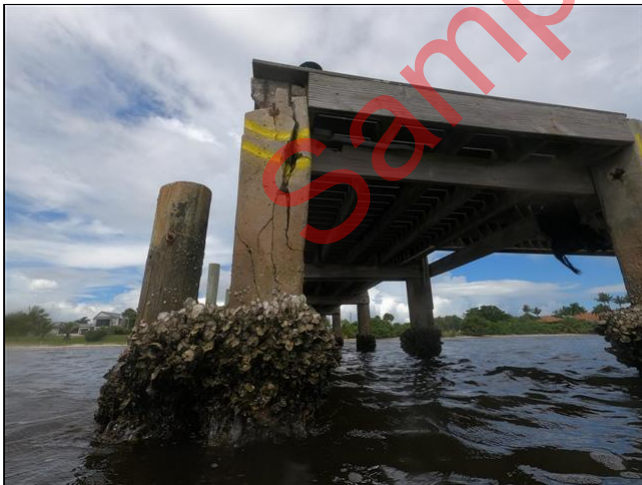
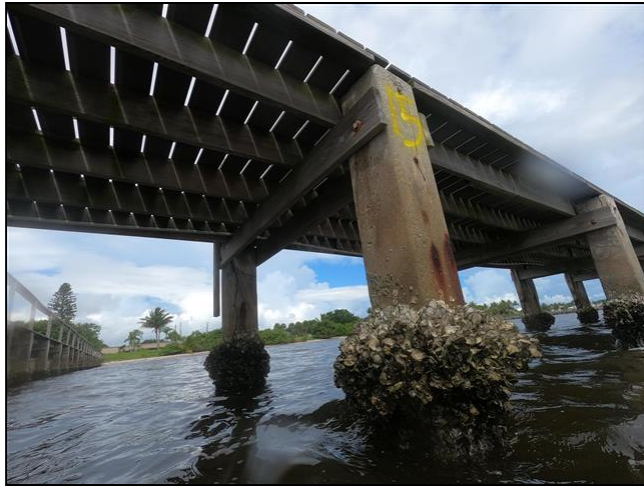
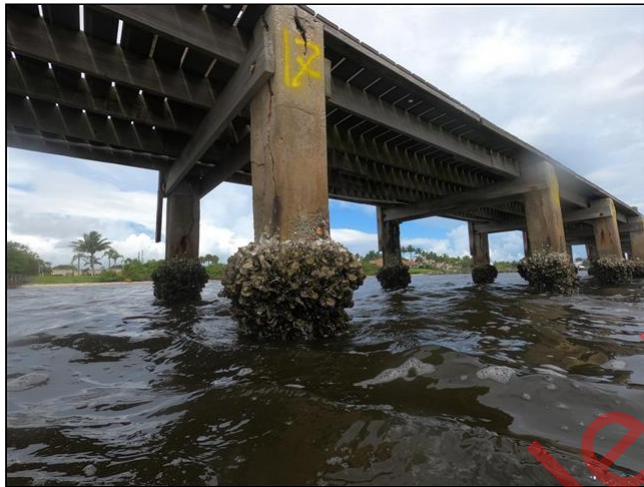
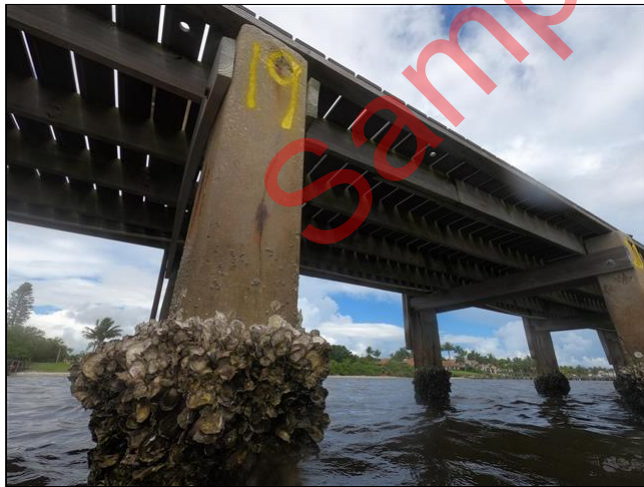
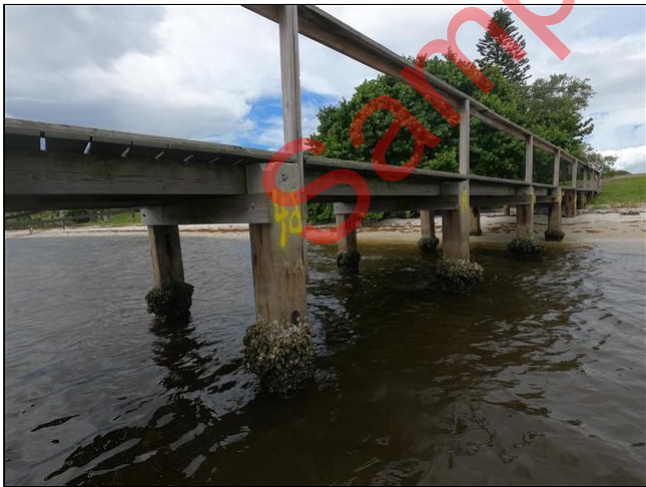
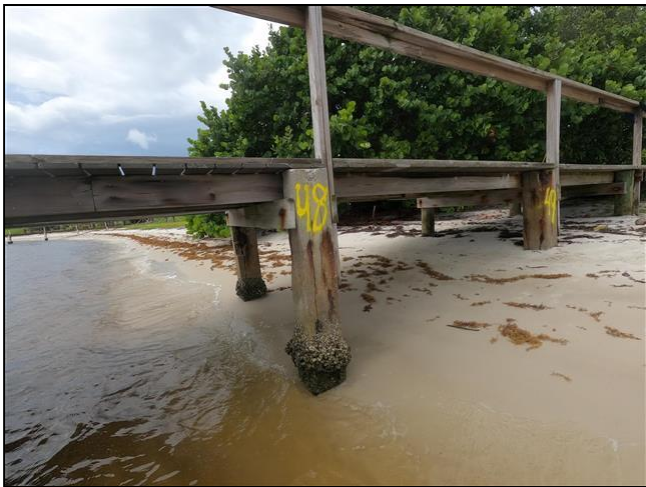
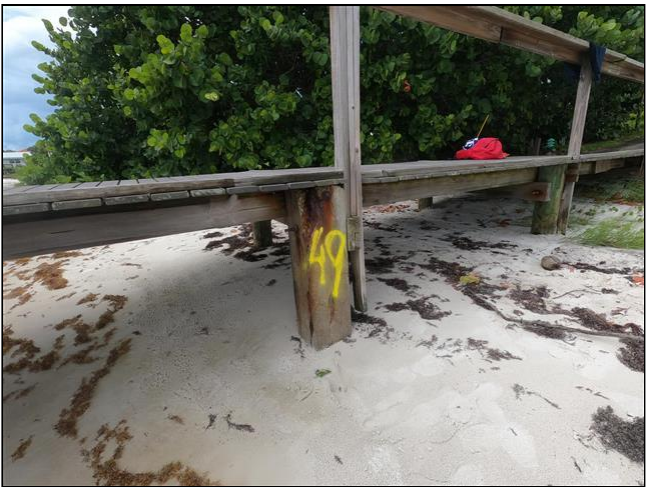
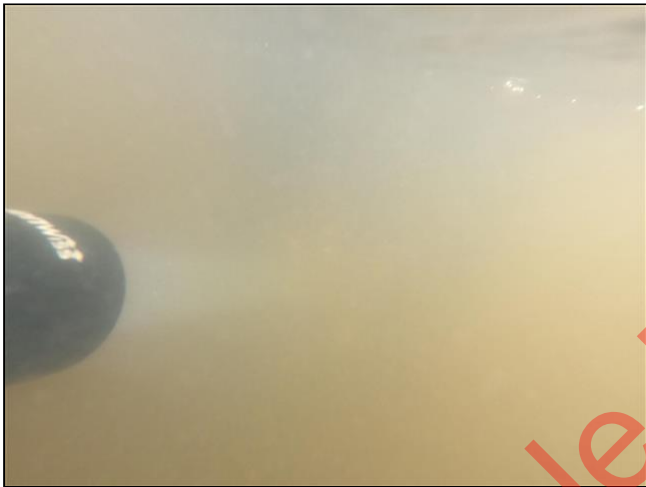
The top of the concrete piles are exposed to the greatest amount of movement (pressure) caused by wave and wind action. Therefore, when the dock moves (or is shaken), due to effects of wave and wind action, the concrete crack and expose the steel rebars inside. When left unattended for long periods of time, the steel rebar corrodes and expands causing further deterioration and weakening of the structure.

There are approximately 76 concrete piles supporting this 400 lineal feet dock. Inspector counted 49 of them in severe stage of deterioration. Most of the damaged concrete piles are beyond repair and should be replaced in its entirety. All work should be performed by a qualified marine contractor.

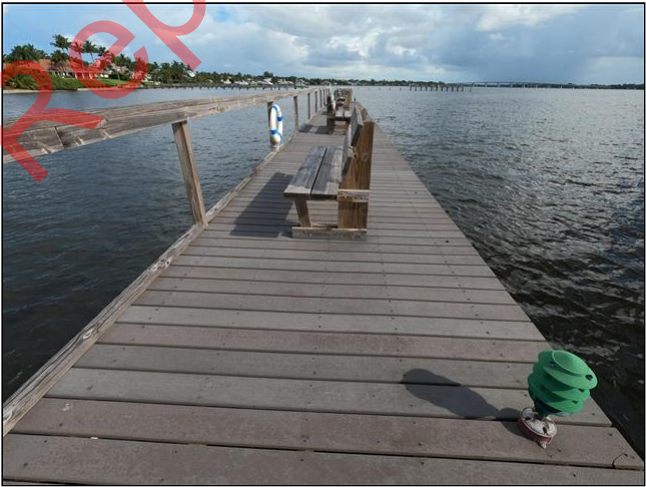
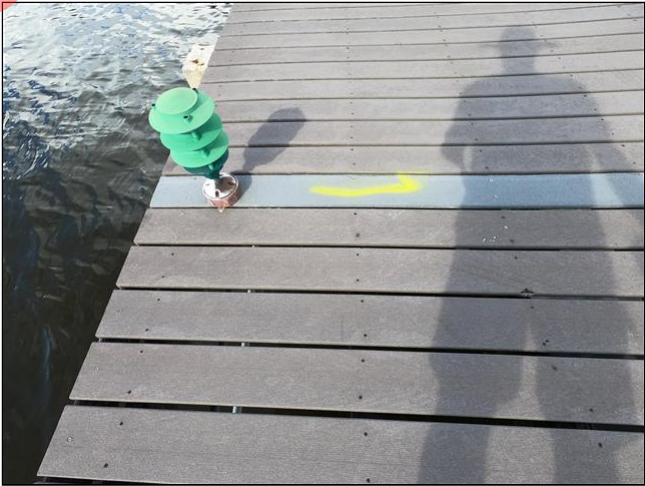
Some dock lighting was not functional at the time of the inspection. Recommend repairs.
