# General Home Inspection Report

**Property Address:**

2280 W Silver Palm Rd  
Boca Raton FL 33432

**Certified Inspectors, LLC**

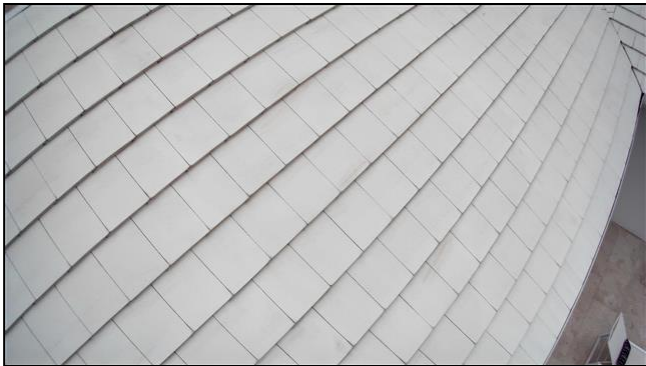
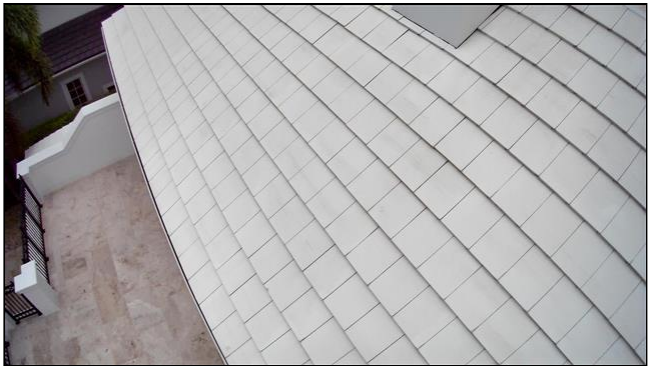
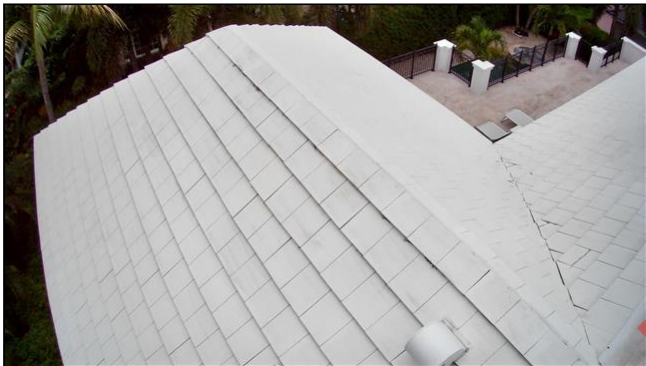
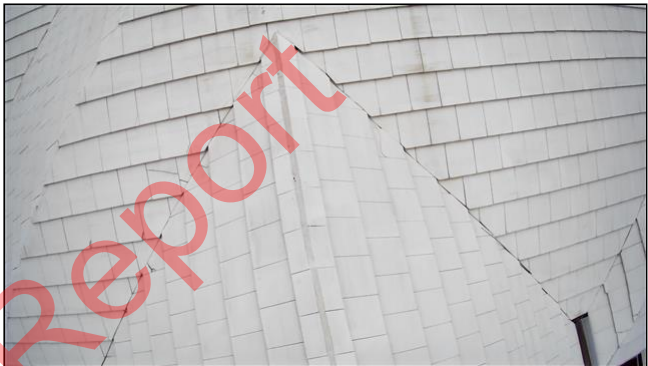
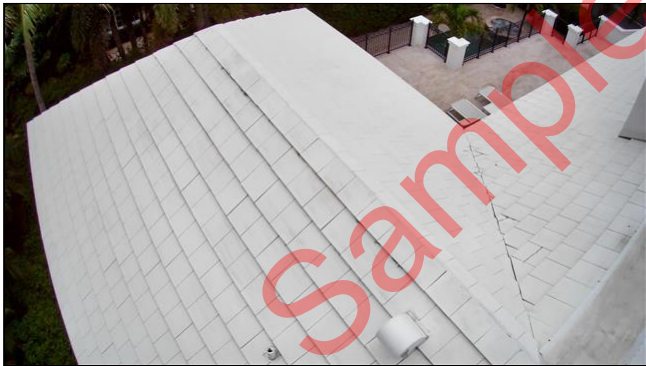
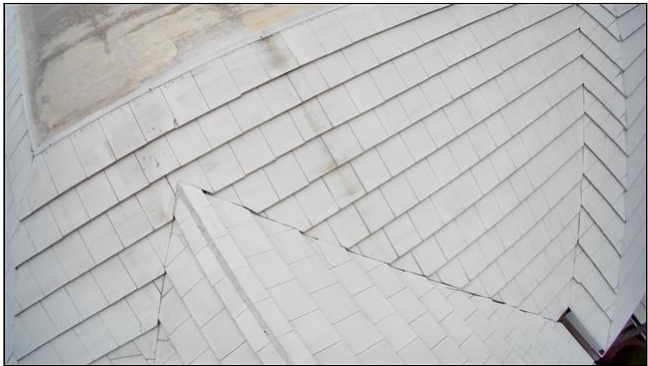
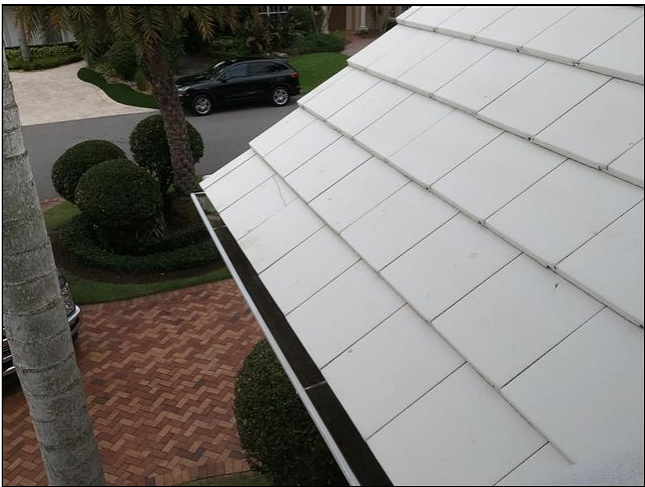
The roof had cracked and/or broken concrete roof tiles that should be replaced to help prevent damage from moisture intrusion to the home materials, the roof structure and to prevent development of microbial growth such as mold. The Inspector recommends that before the expiration of your Inspection Objection Deadline you consult with a qualified contractor to discuss options and costs for repairs.

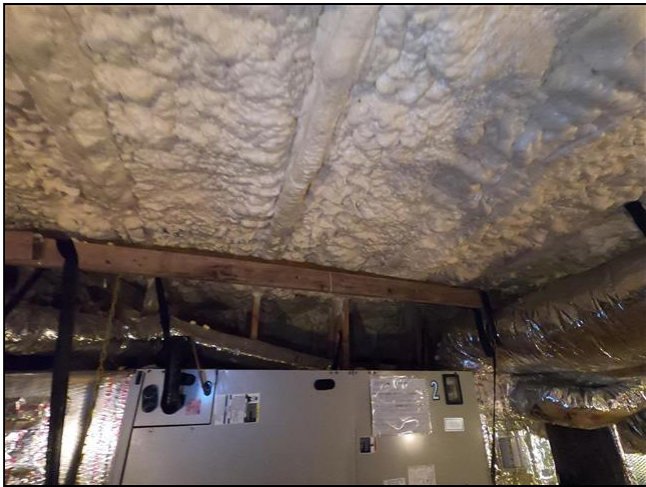
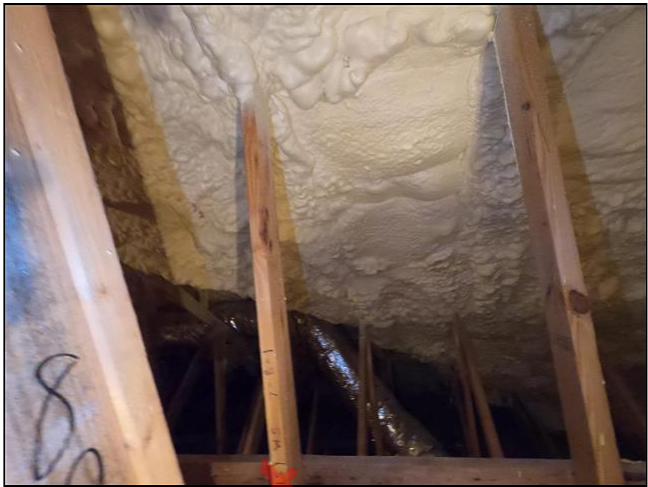
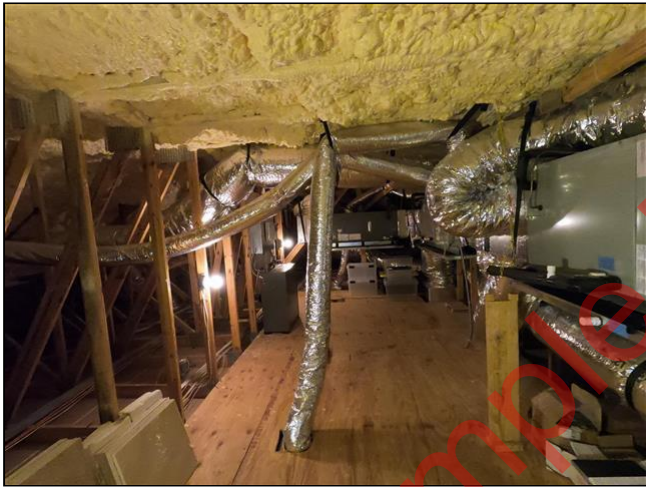
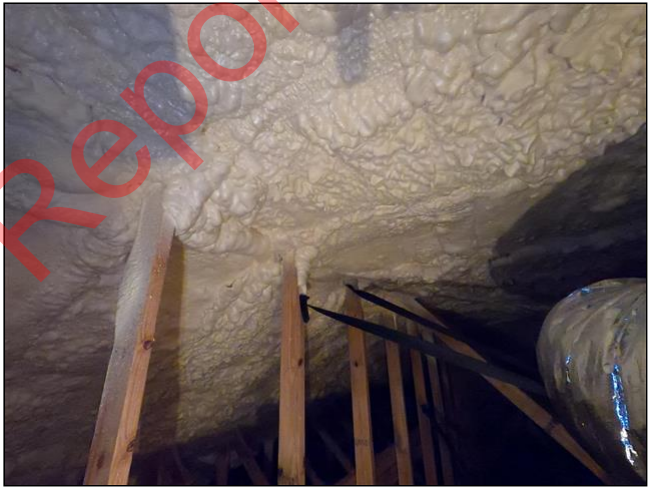
The attic floor was insulated with Icynene.

(2) The attic floor insulation depth averaged approximately 6 to 8 inches. The Inspector recommends installing additional insulation to comply with local energy codes

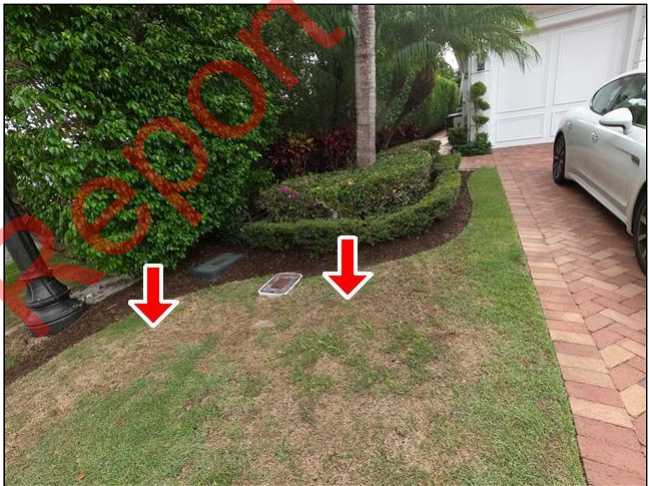
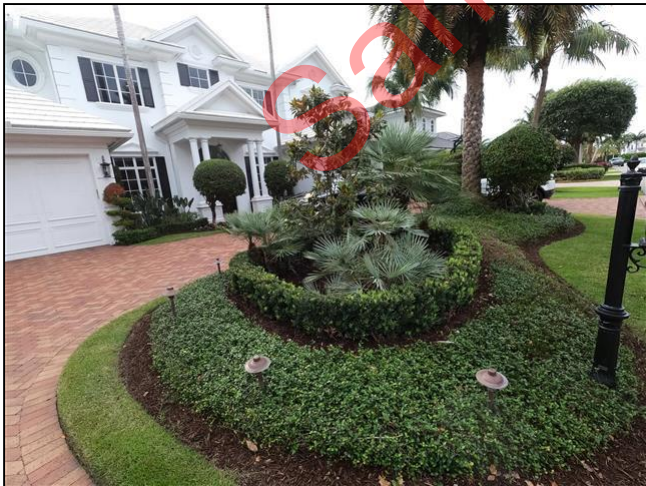
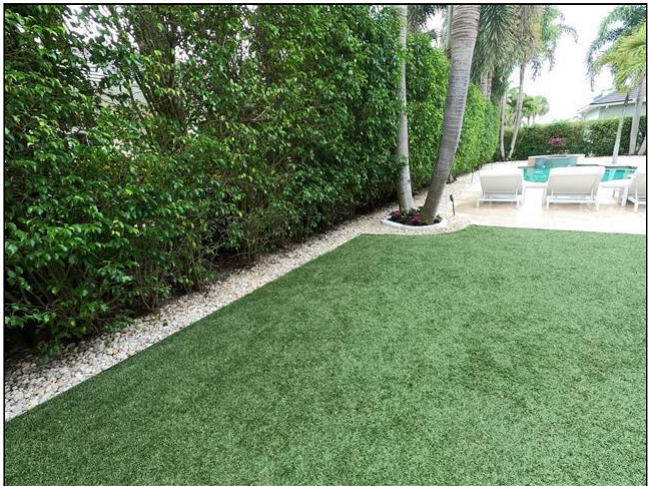
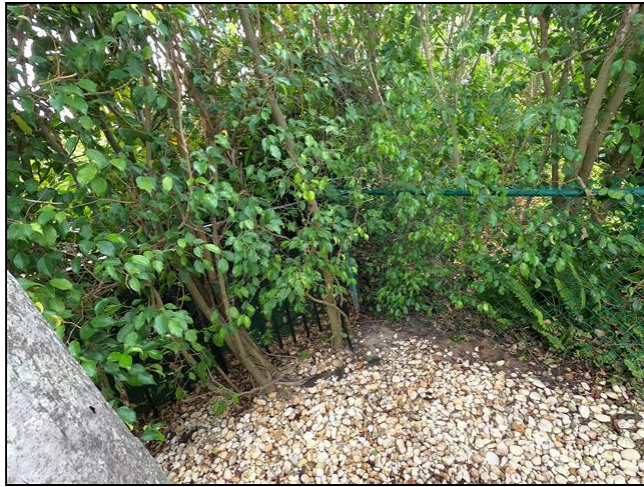
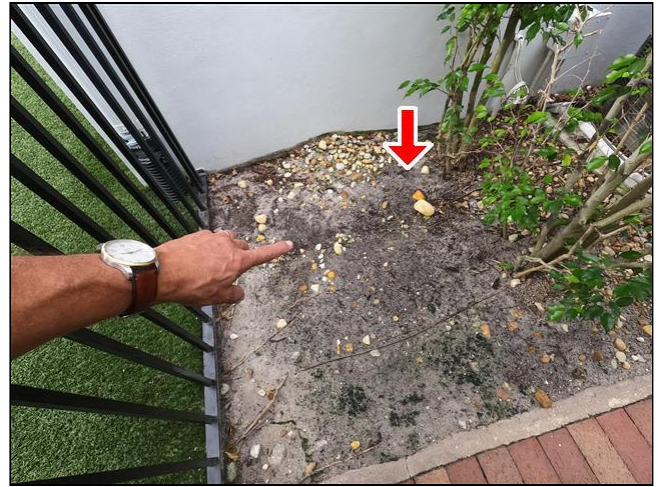
The building site was relatively level and flat. Inspector found some poor ground cover or dying grass in some areas of the home. Recommend evaluation by professional landscaper.

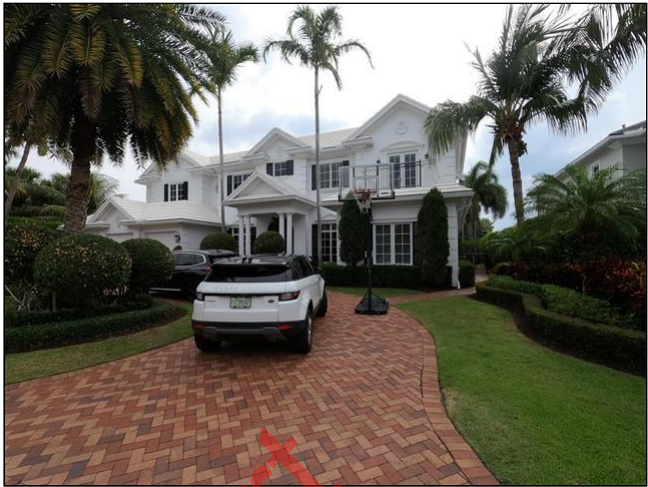
3.2 Item 2 (Picture)

Some pavers were cracked in the driveway.

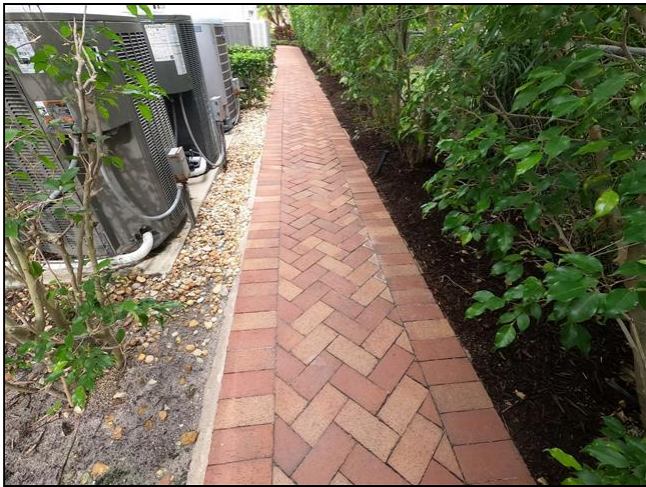
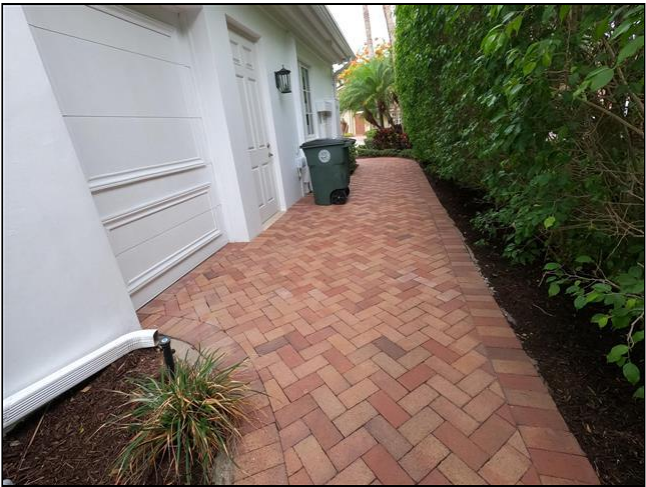
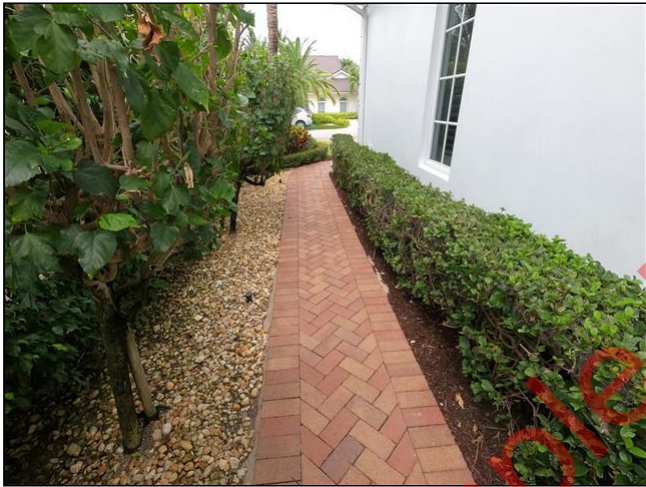
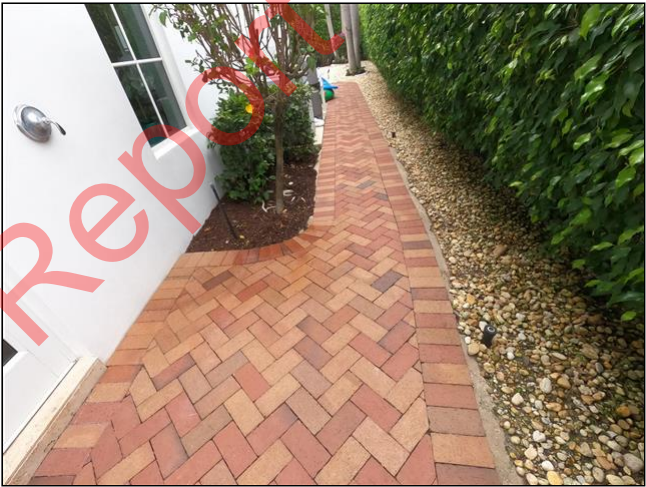
At the time of the inspection, the Inspector observed no deficiencies in the condition of the home walkways at the time of the inspection.

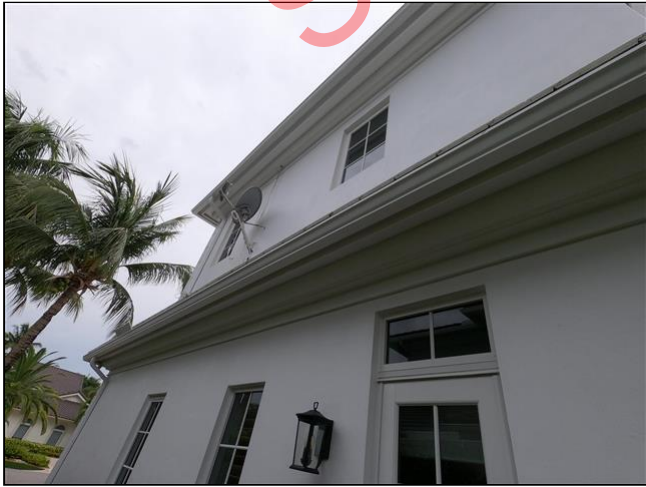
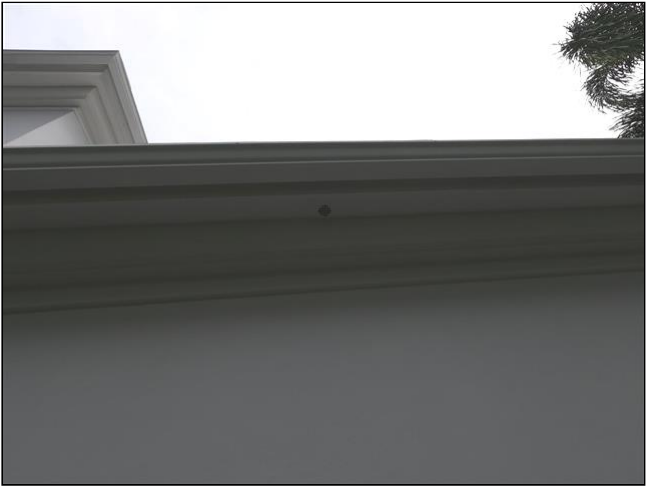
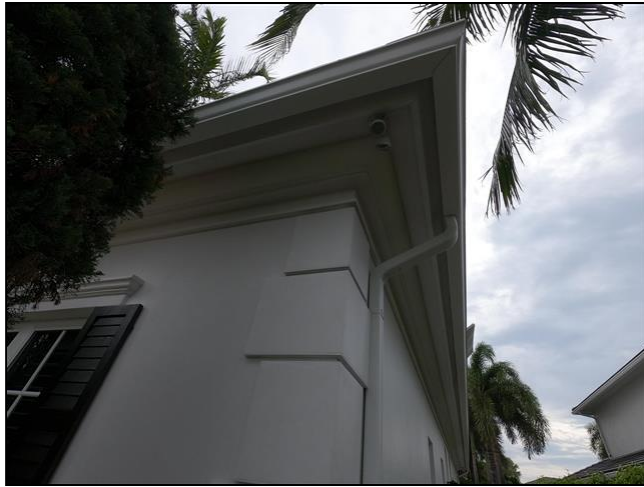
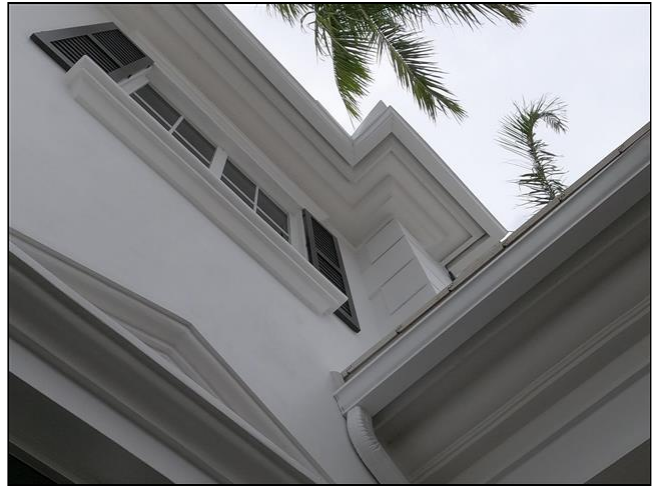
At the time of the inspection, the Inspector observed no deficiencies in the condition of exterior trim.

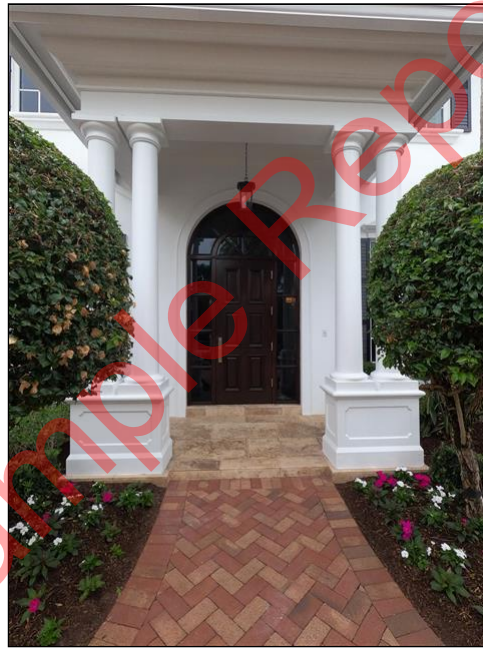
3.5 Item 1 (Picture)

At the time of the inspection, the Inspector observed no deficiencies in the condition of the porch.

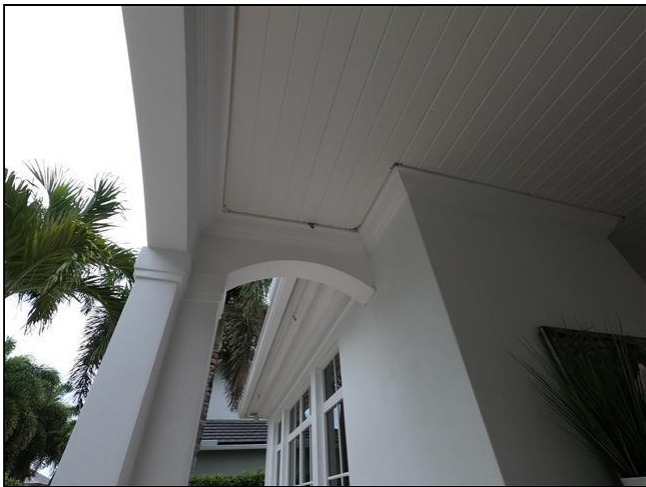
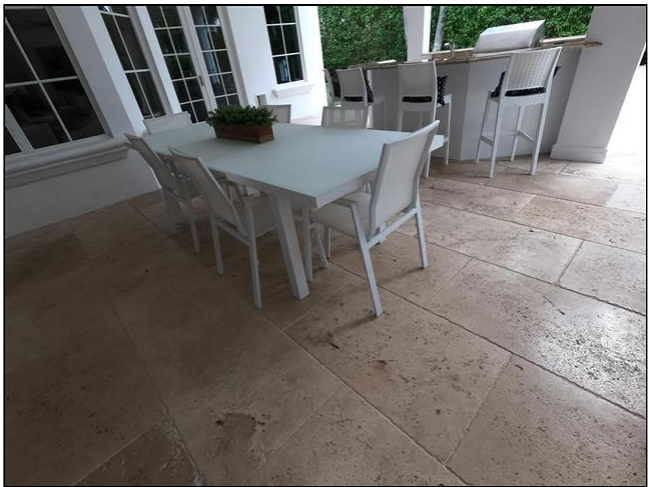
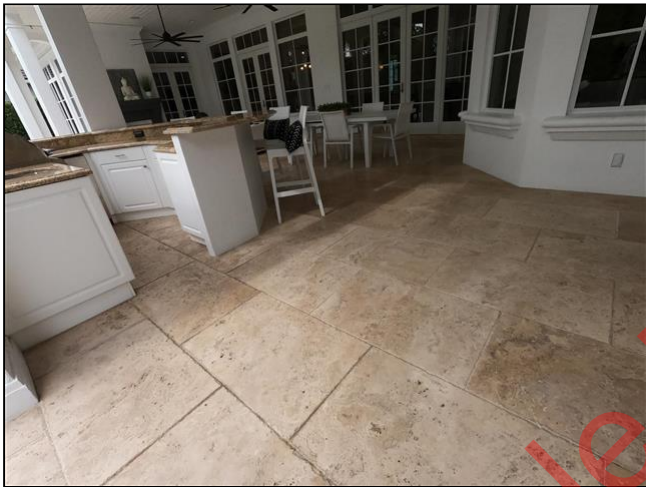
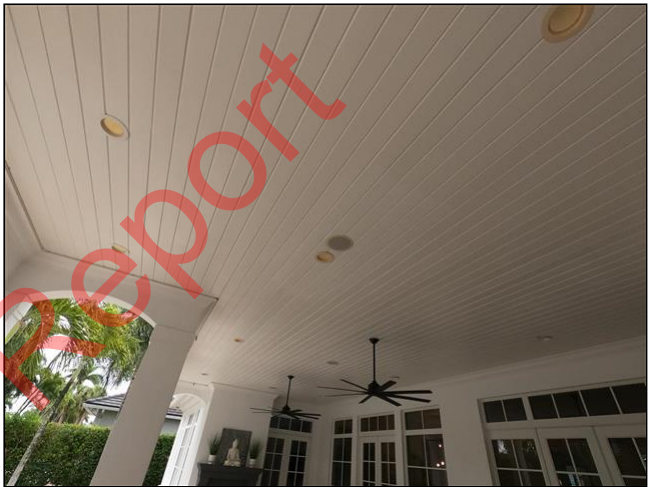
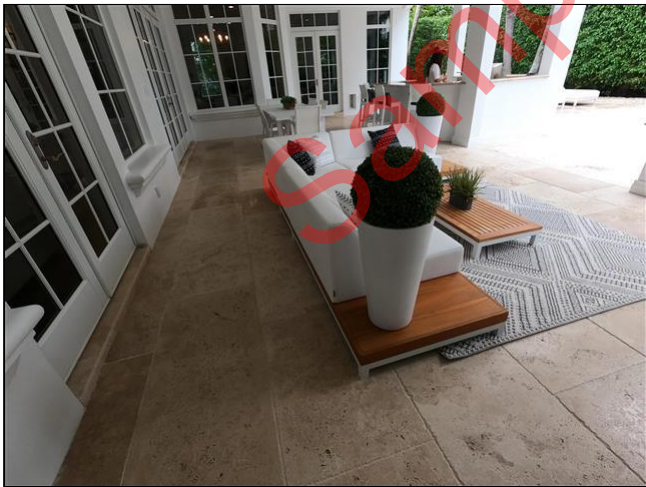
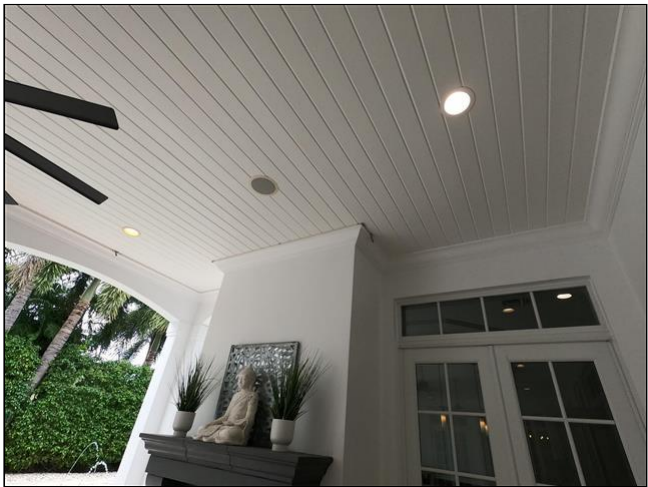
The Inspector observed no deficiencies in the condition of this patio at the time of the inspection.

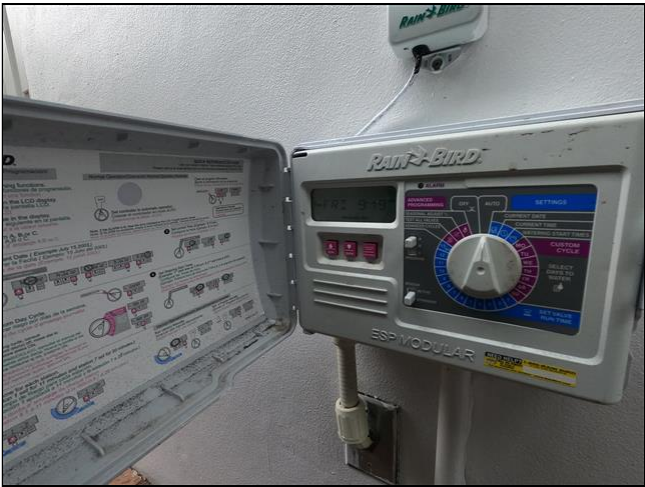
3.7 Item 1 (Picture)

At the time of the inspection, the Inspector observed no deficiencies in the condition of the landscape irrigation (sprinkler) system.

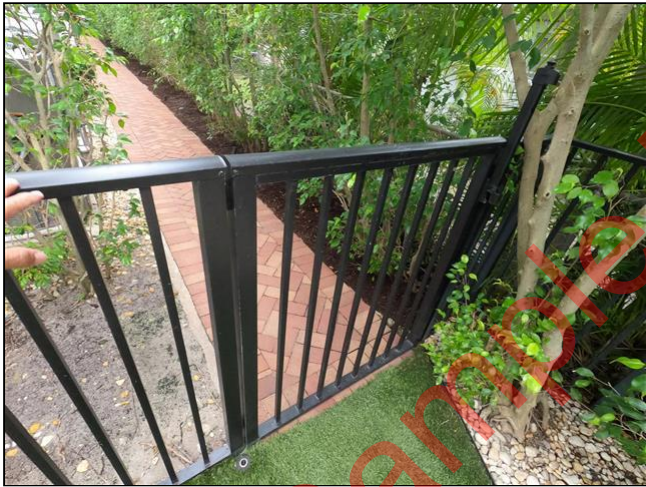
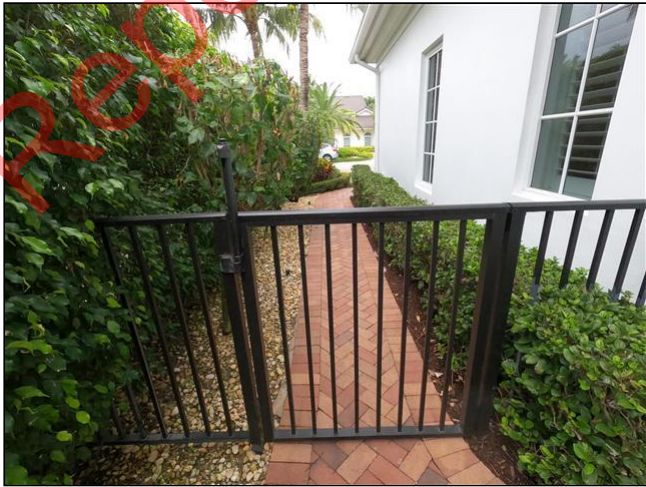
The inspector observed no deficiencies in the condition of the fences at the time of the inspection.

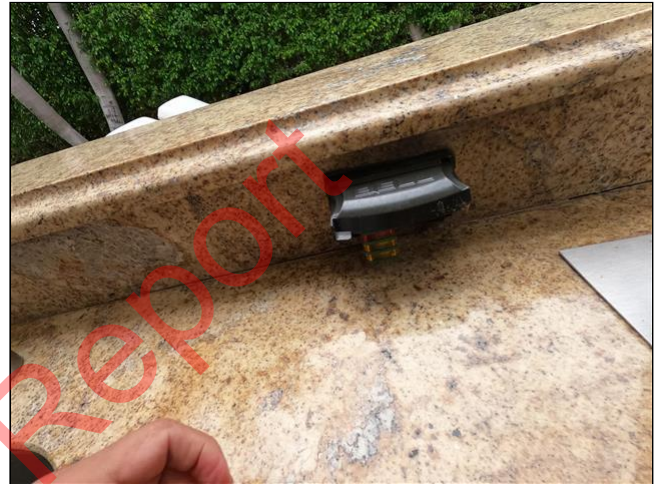
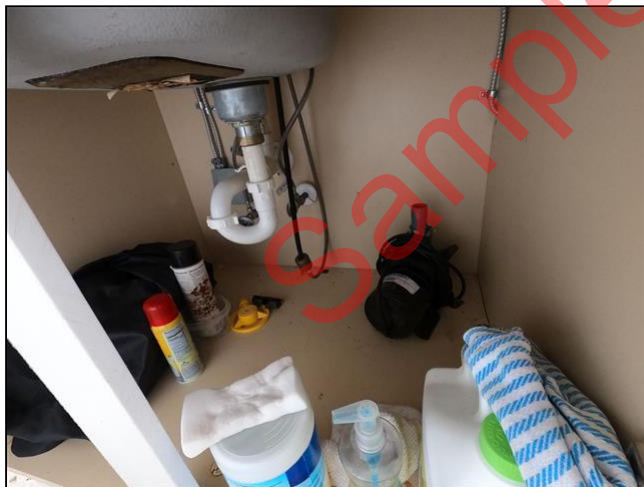
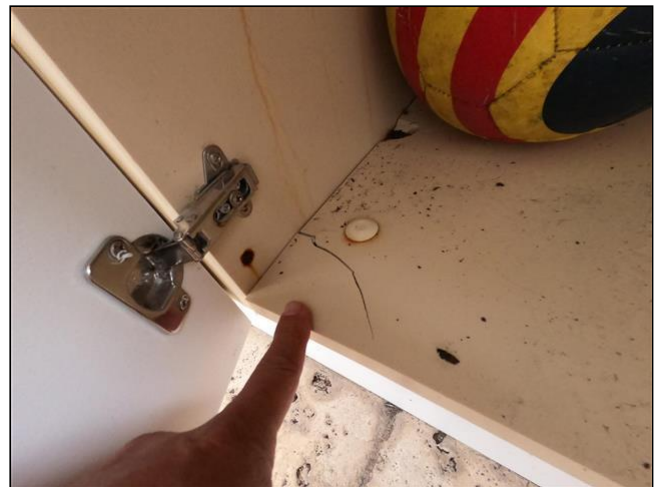
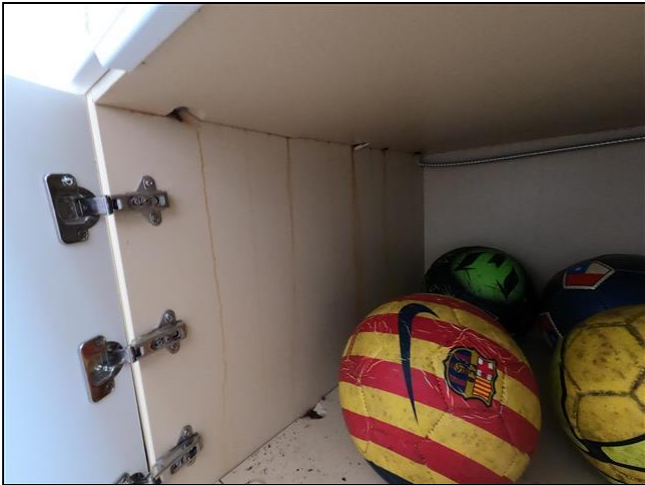
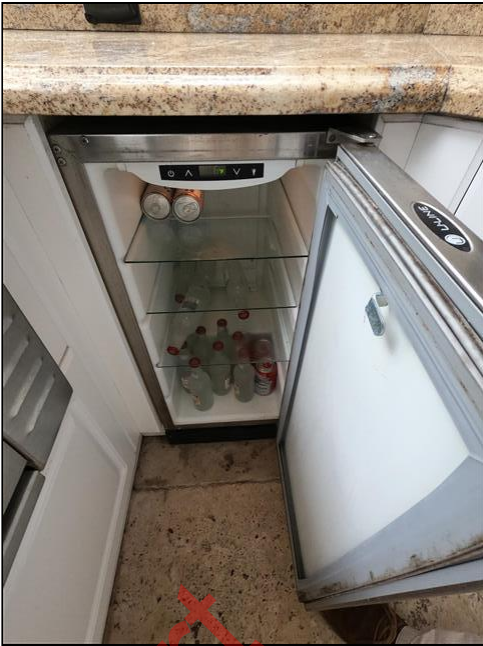
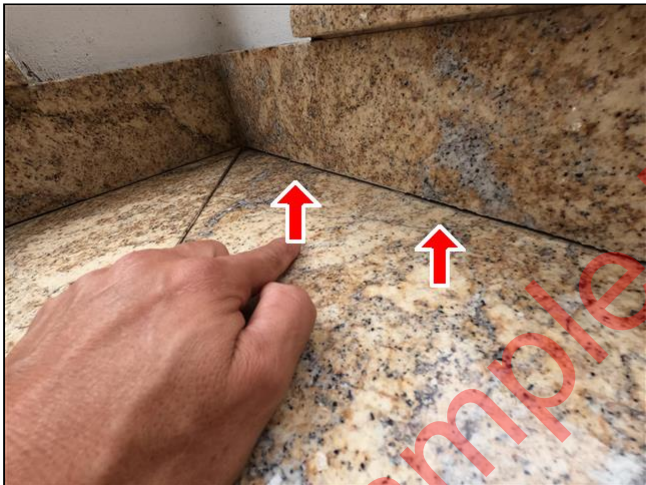
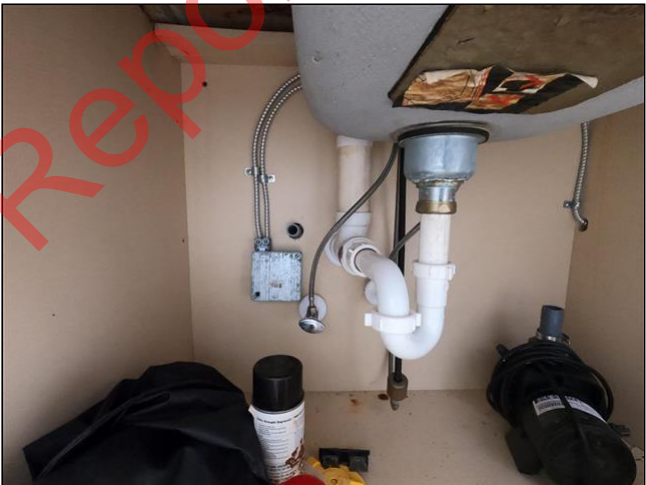
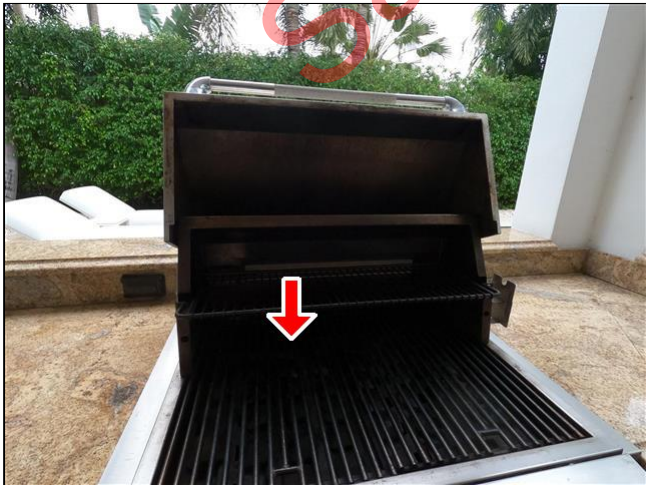
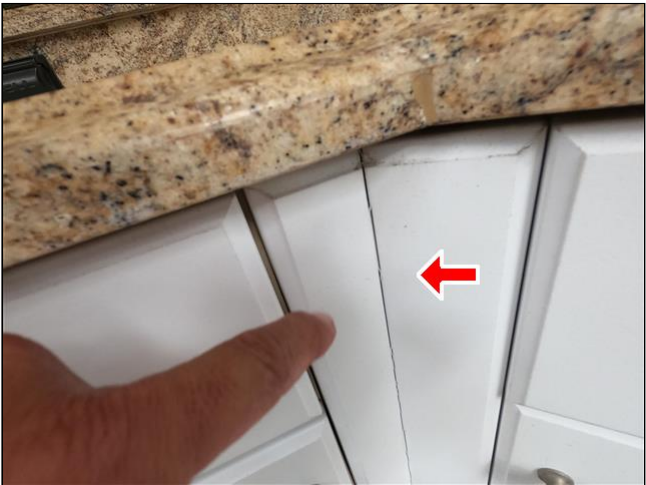
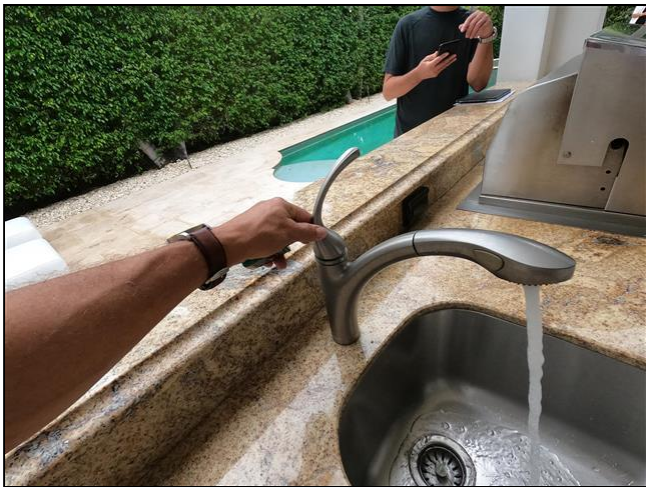
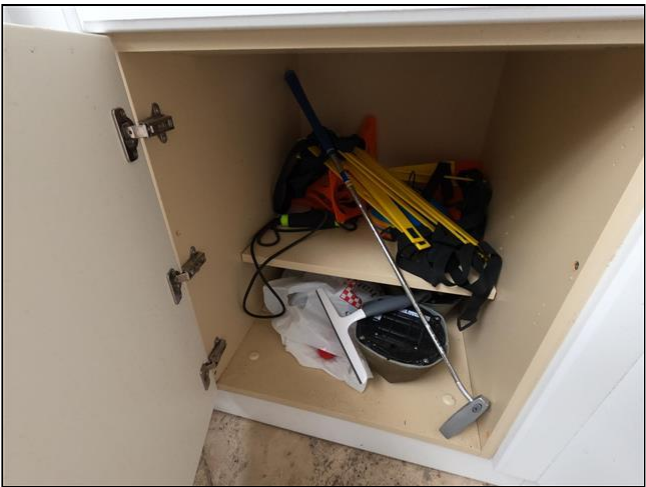
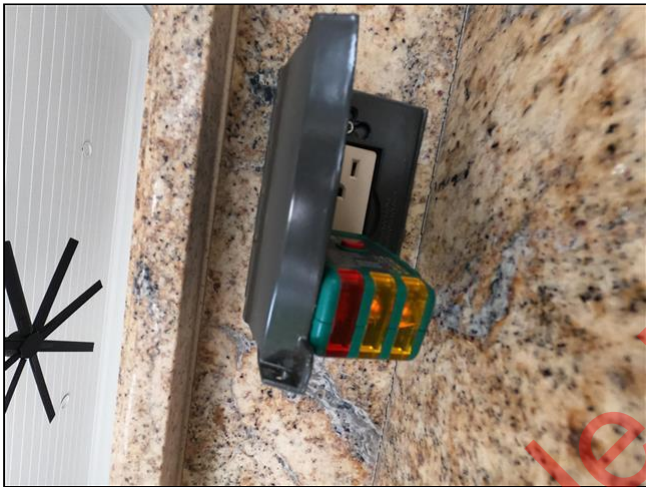
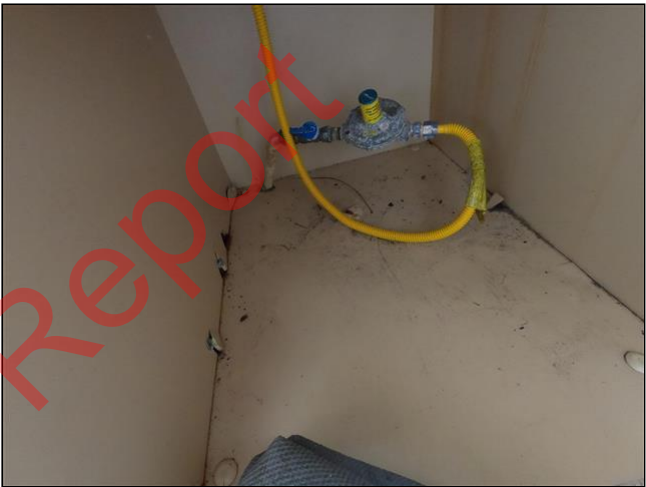
Inspector found several deficiencies with the condition of the outdoor kitchen:

1. The grill lighter was not functional. You have to light up the grill manually.
2. The cabinetry exhibited minor deterioration in several areas.
3. The counter had missing ground along the edges of the backsplash.
4. The small refrigerator and the grill had minor signs of corrosion.

Recommend repairs.

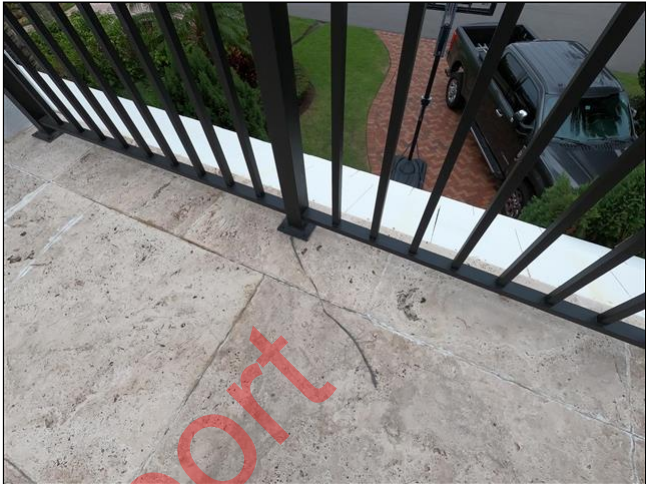
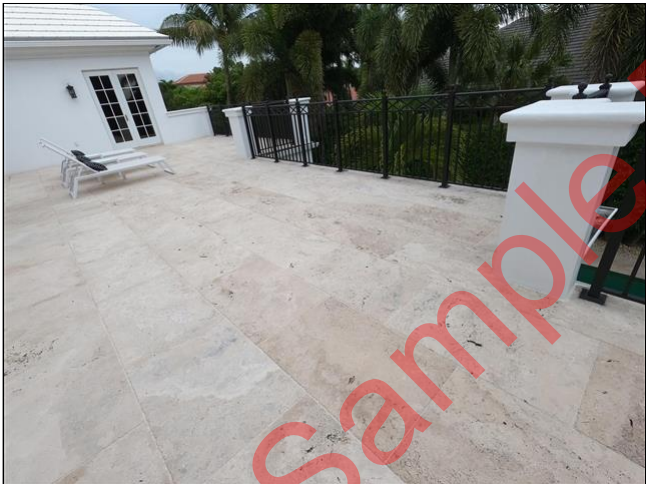
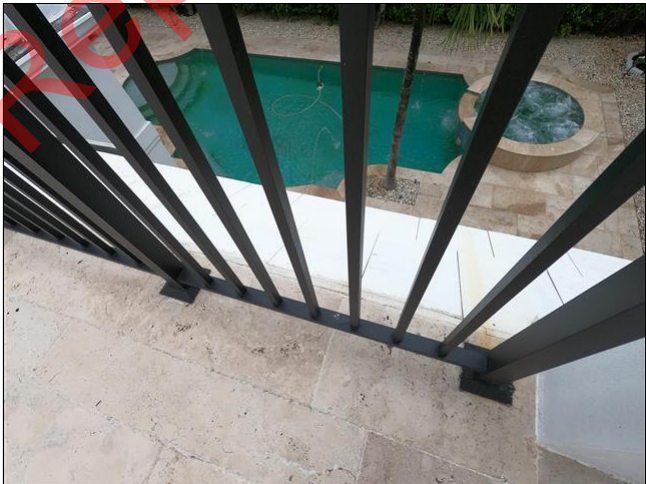
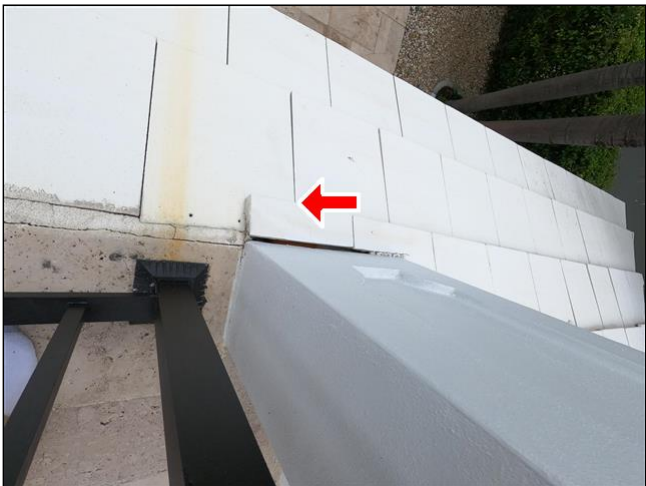
The railings of the balconies in the rear of the home were loose. This is a major safety hazard that needs to be corrected immediately.

Another section of railing was held by corroded screws. The corrosion is staining the walls below. Recommend repairs.

The Inspector observed no deficiencies in the condition of Stucco covering exterior walls. However, there is a rust stain coming from the corrosion of the screws used to hold the railings upstairs. Recommend repair.

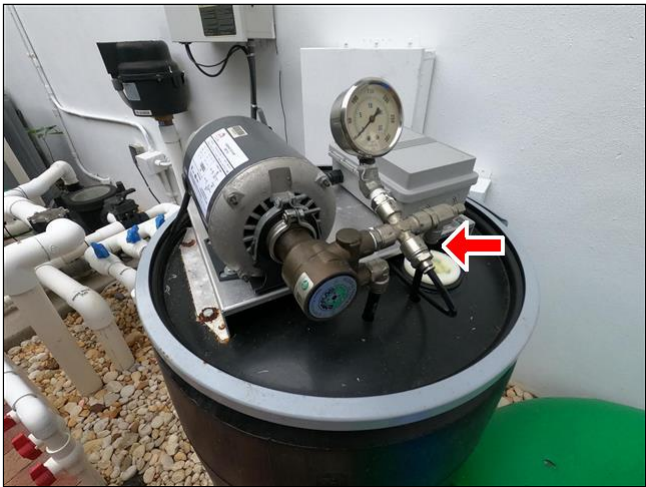
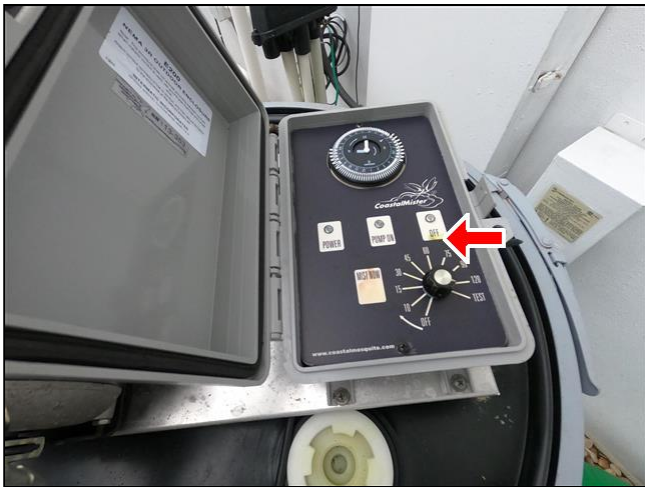
The MosquitoNix Misting System was not functional. Inspector attempted to run the system but it did not respond. Recommend repairs.

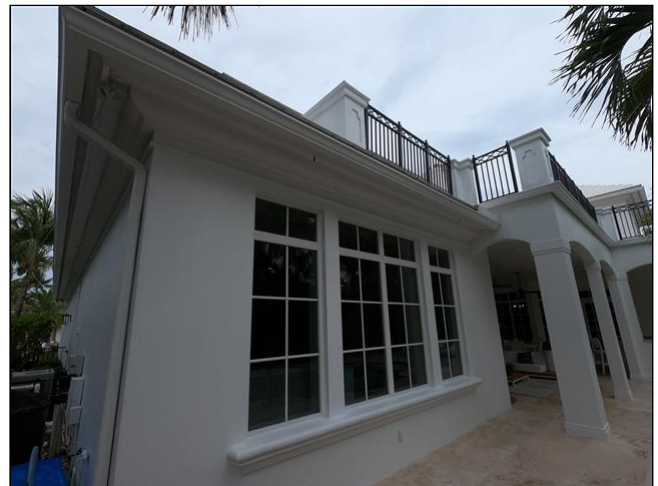
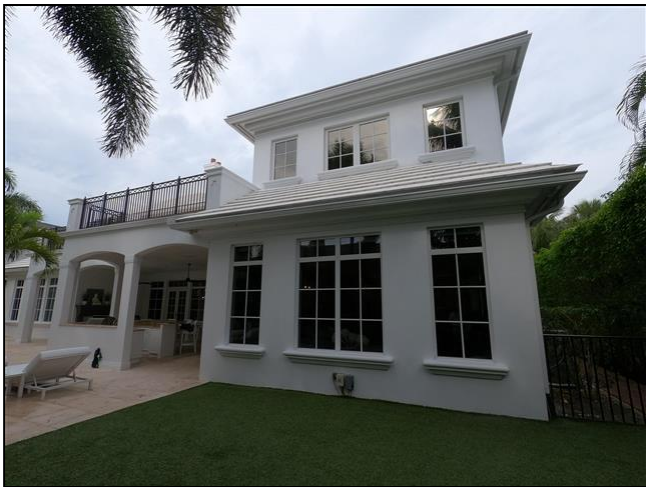
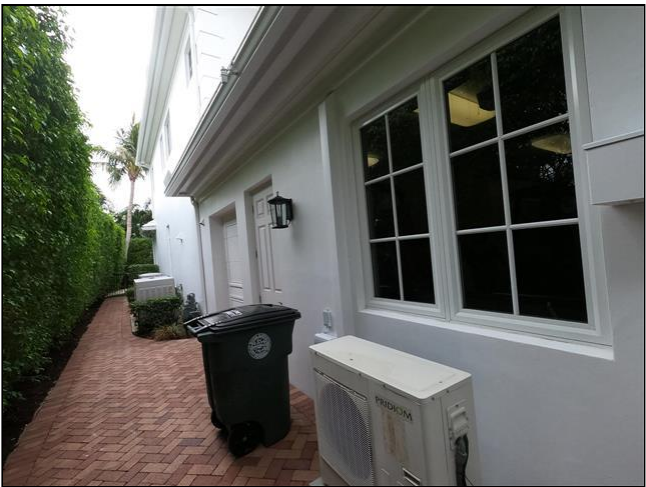
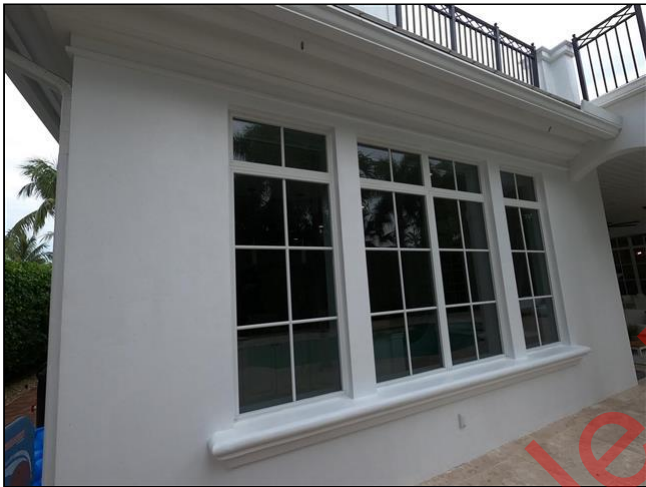
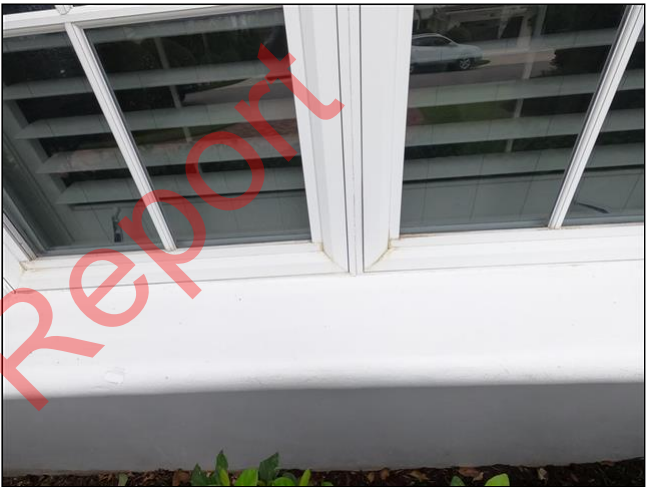
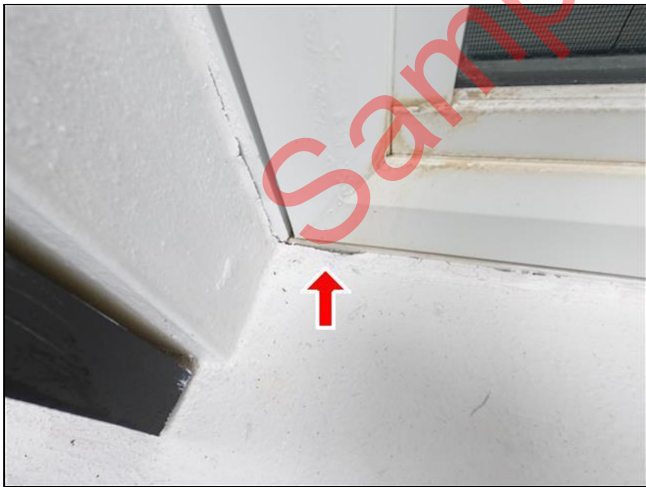
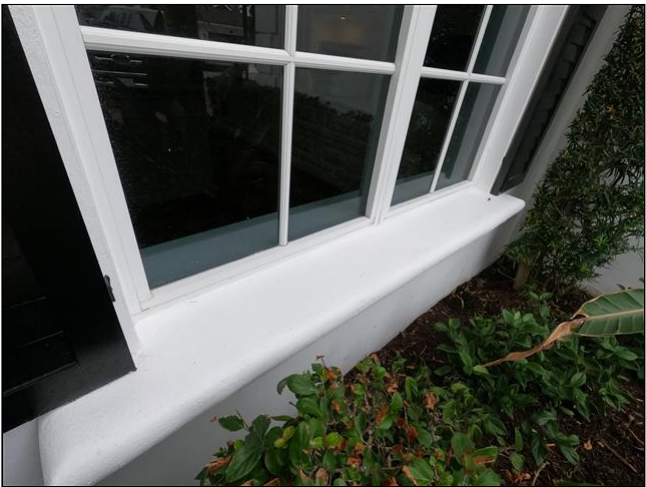
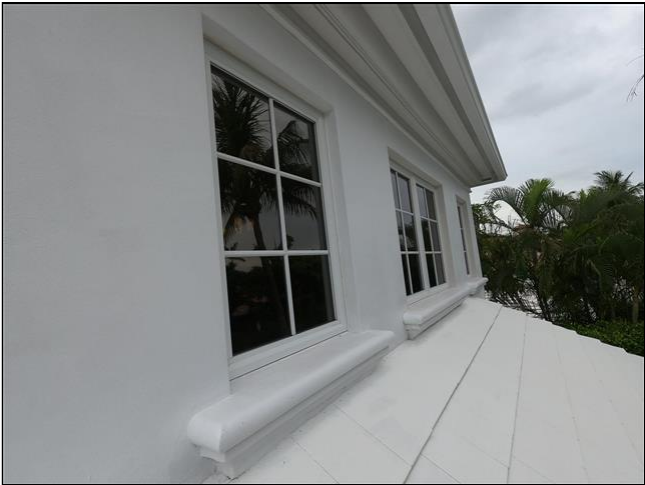
Some windows has started to deteriorate the caulking. Recommend repairs.

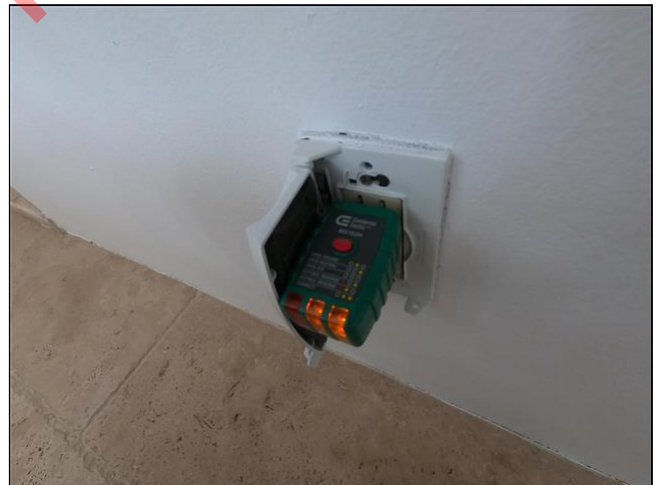
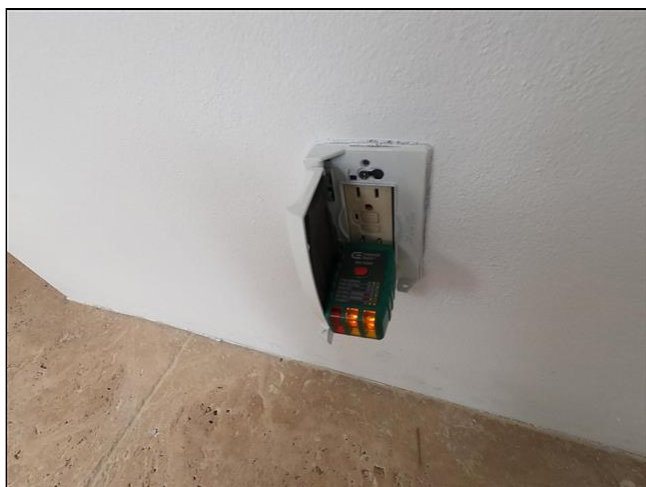
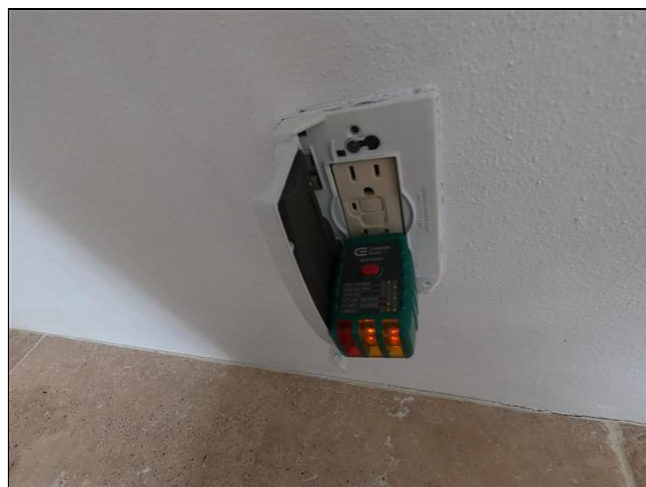
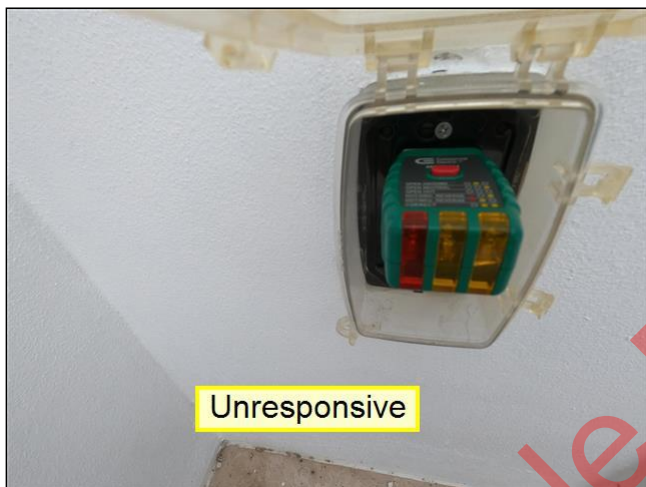
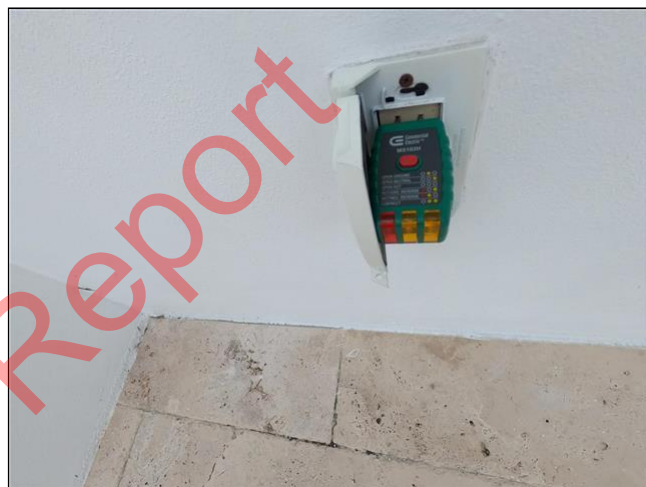
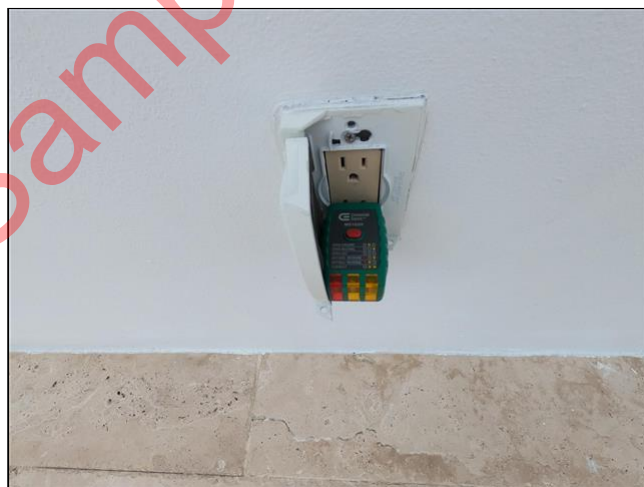
Some exterior conventional electrical receptacles were inoperable at the time of the inspection and should be replaced by a qualified electrical contractor. One receptacle had a broken weather guard. The Inspector recommends that all exterior electrical receptacles be provided with ground fault circuit interruptor (GFCI) protection for safety reasons.
