# General Home Inspection Report

**Property Address:**

2280 W Silver Palm Rd  
Boca Raton FL 33432

**Certified Inspectors, LLC**

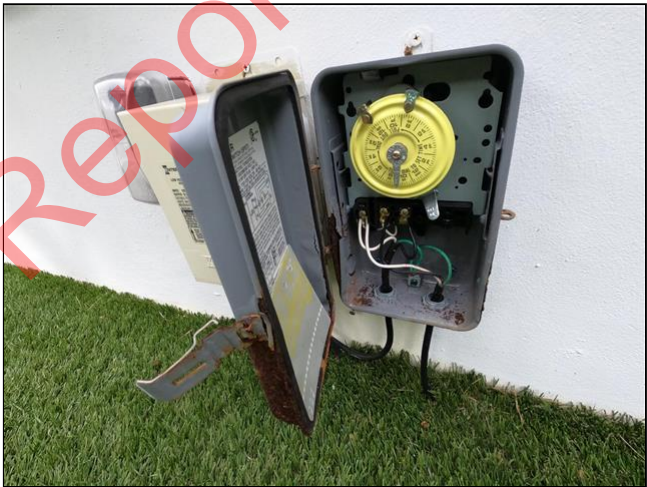
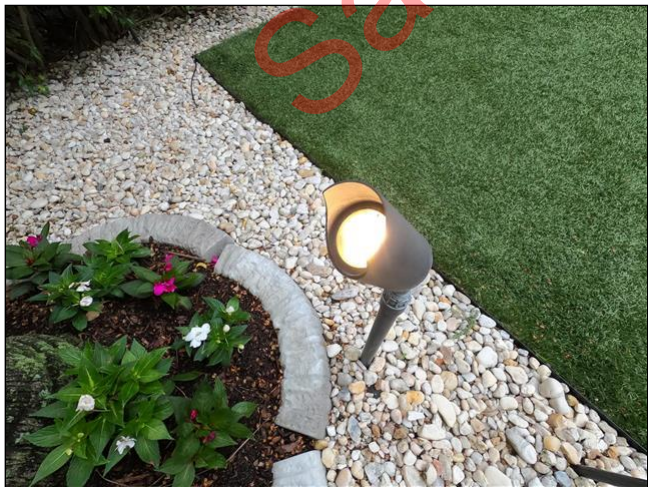
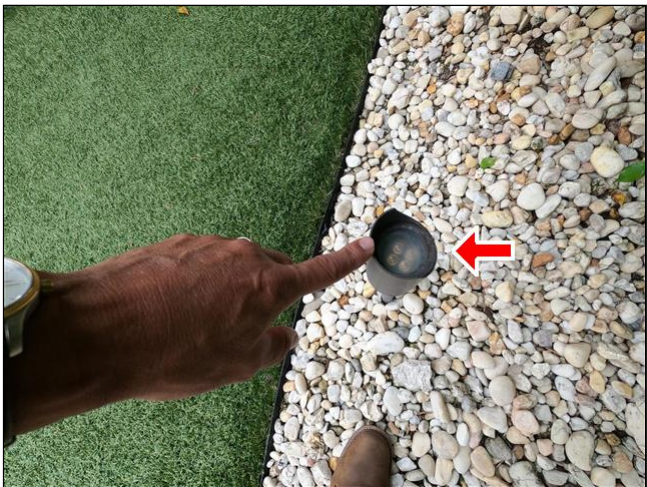
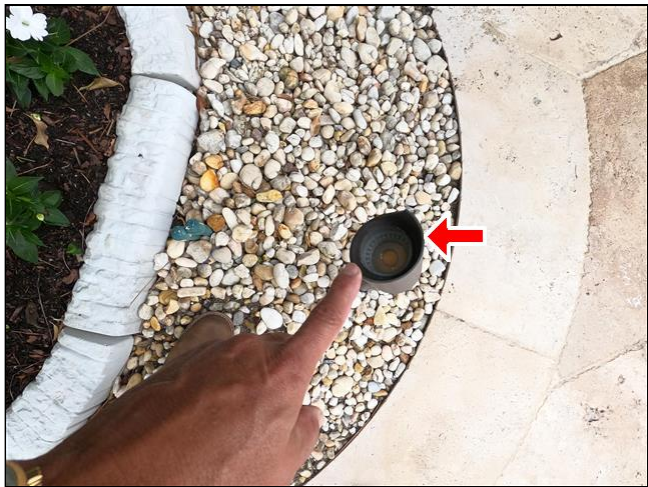
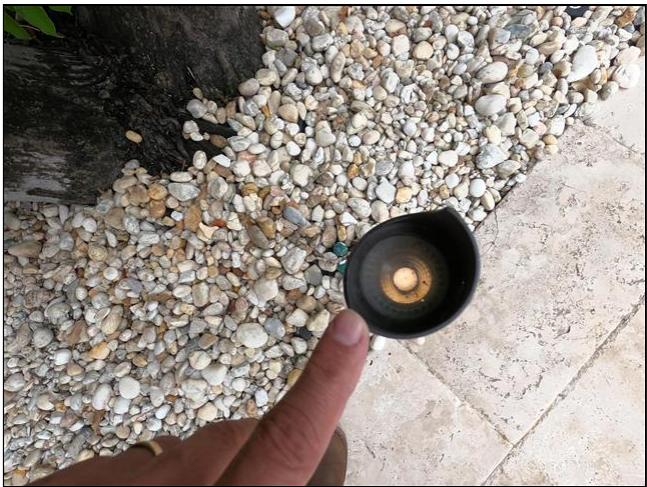
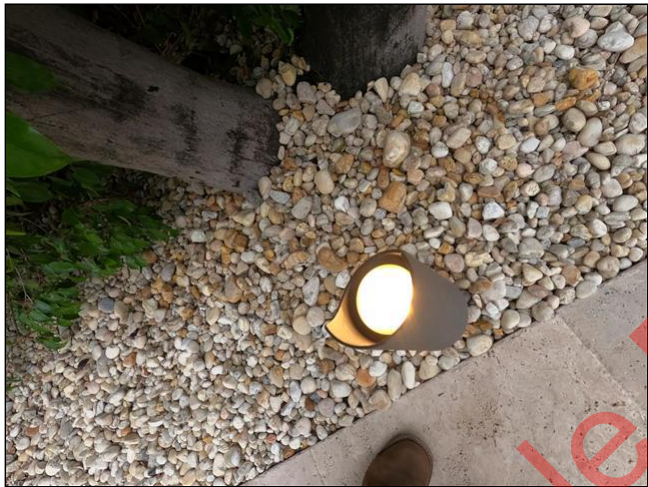
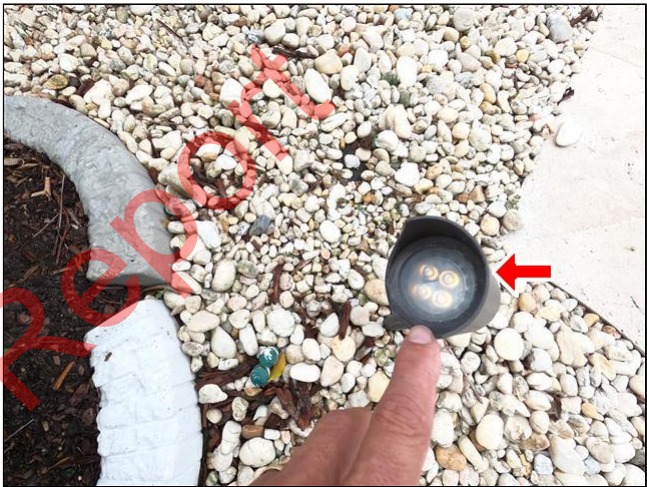
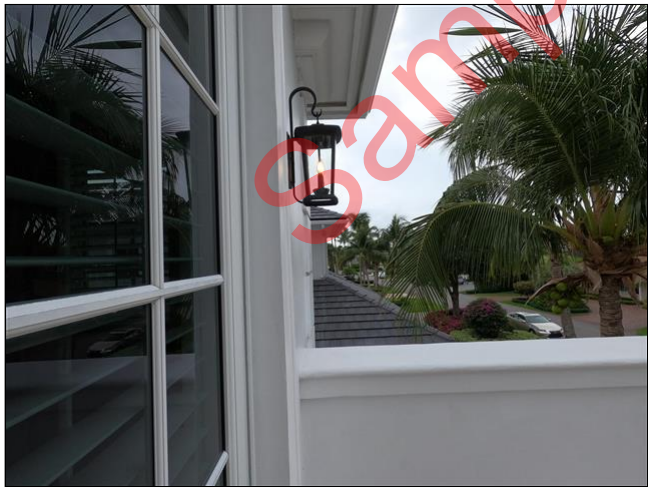
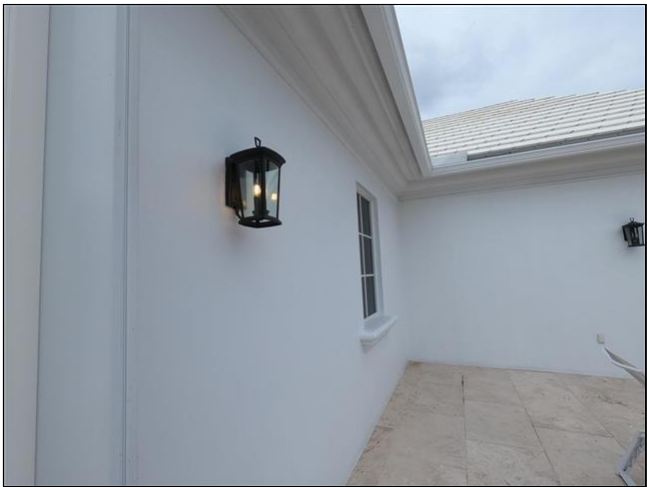
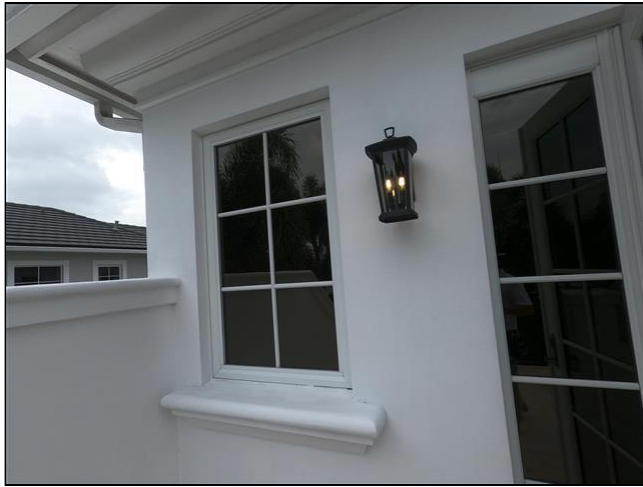
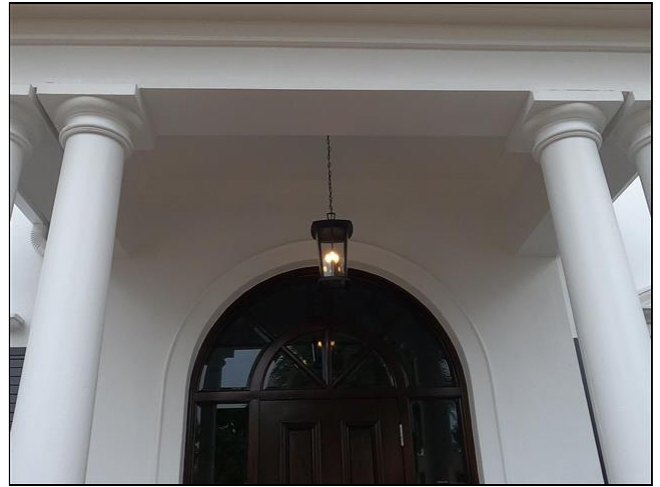
Several landscape lighting was not functional. Recommend repairs by qualified contractor.

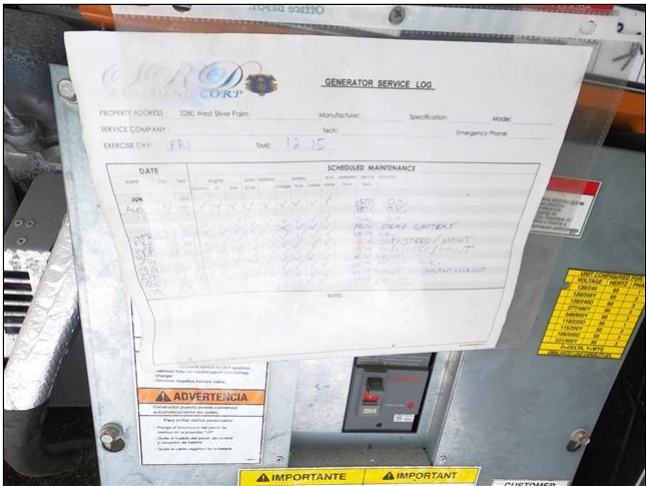
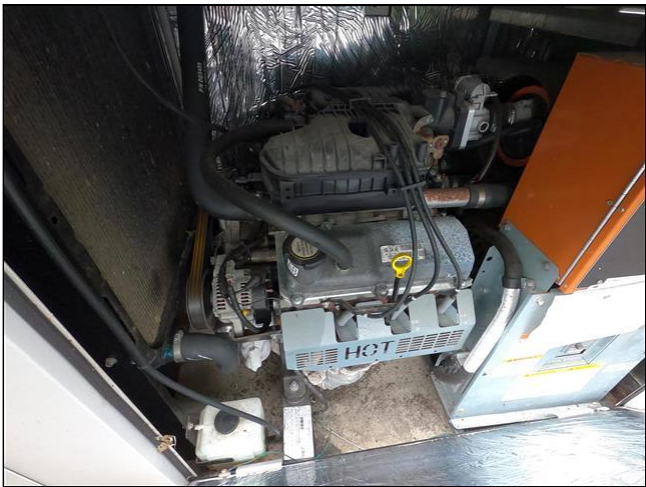
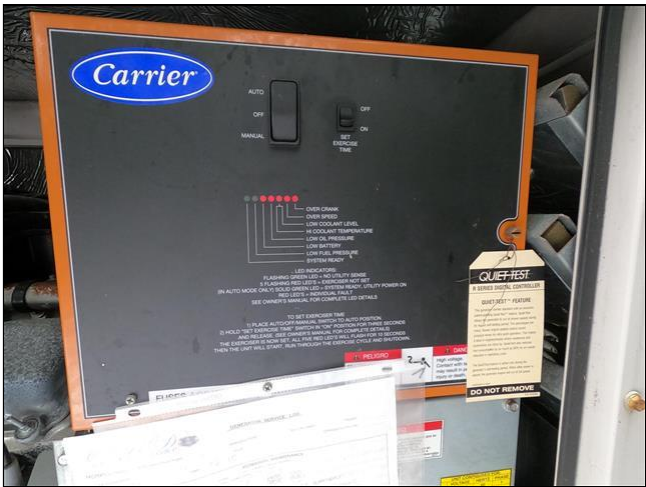
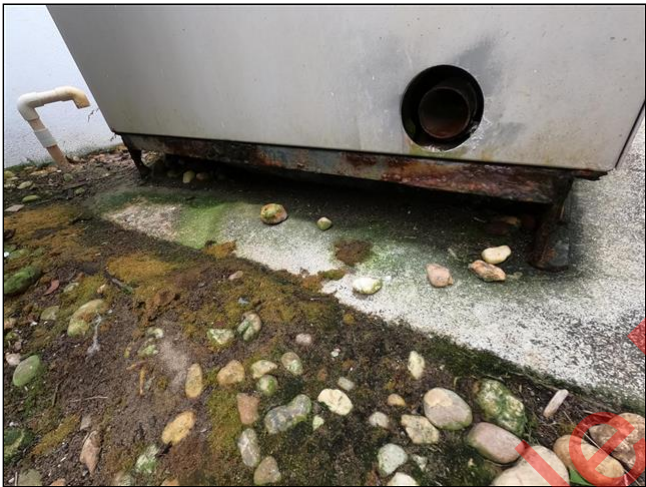
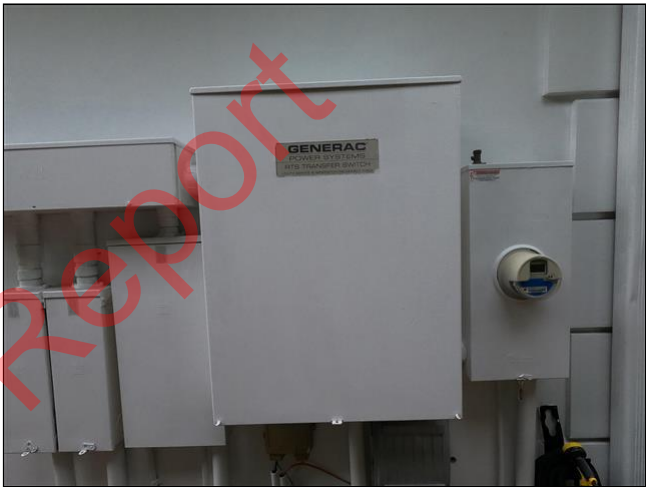
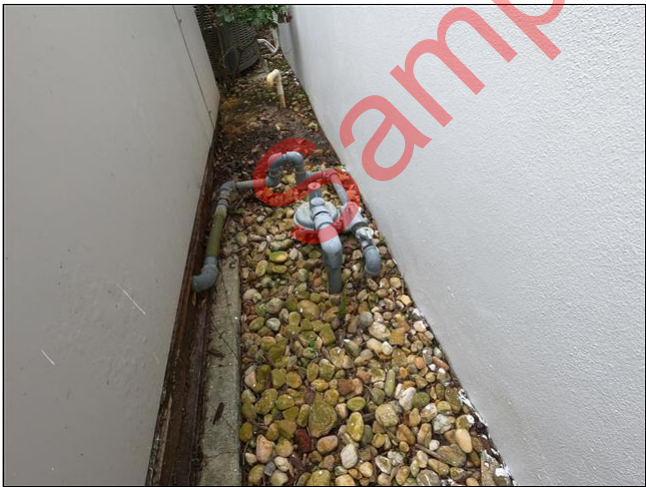
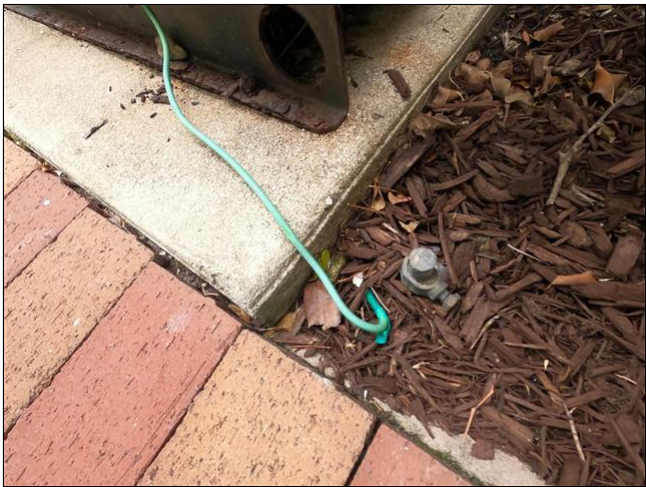
The home was equipped with a Carrier Whole House Generator. It appears that the generator is a 48 Kw unit capable of powering the entire home. The Generator was tested at the time of the inspection and it was functional. However, the generator exhibited a slow start at the time of the inspection. The battery appears to be bad. According to the homeowner, the generator is not being professionally maintained. Recommend you contract with a generator company that can service the unit regularly. Watch the video on Youtube.

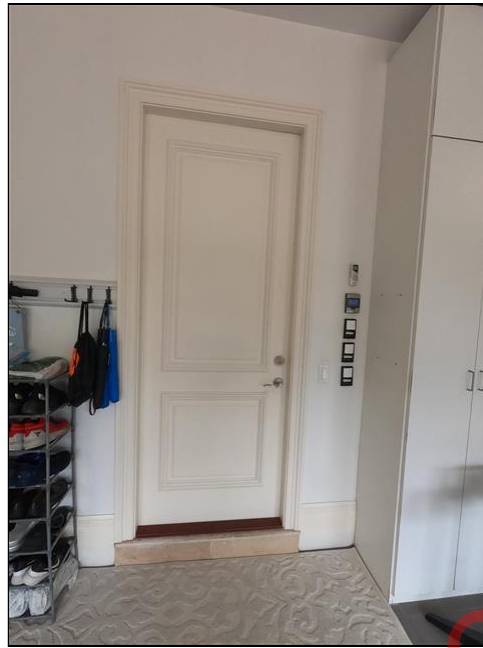
7.1 Item 1 (Picture)

The conventional door between the garage and the interior exhibited light wear and/or deterioration commensurate with its age.

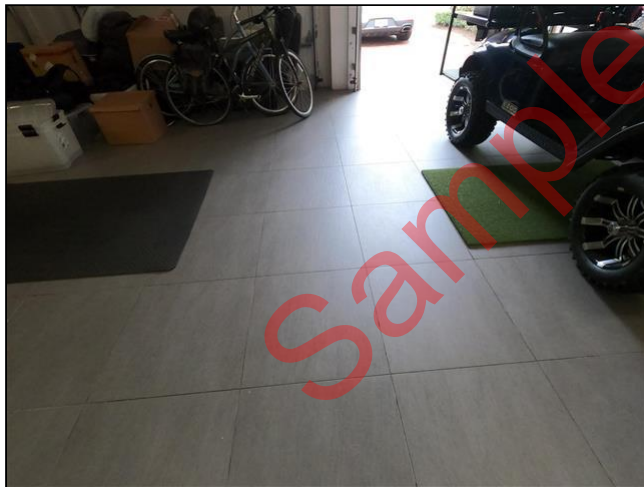
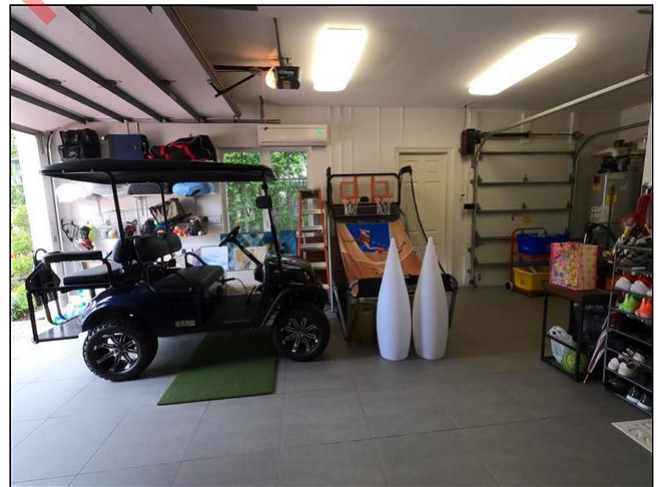
(1) At the time of the inspection, the occupant's belongings significantly limited the Inspector's view of the garage floor.

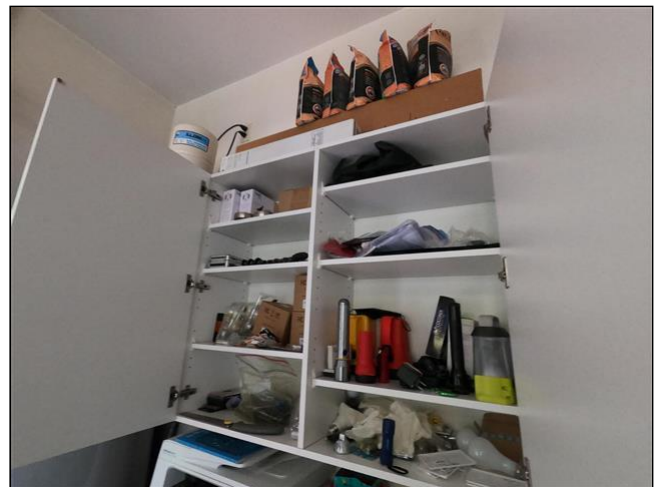
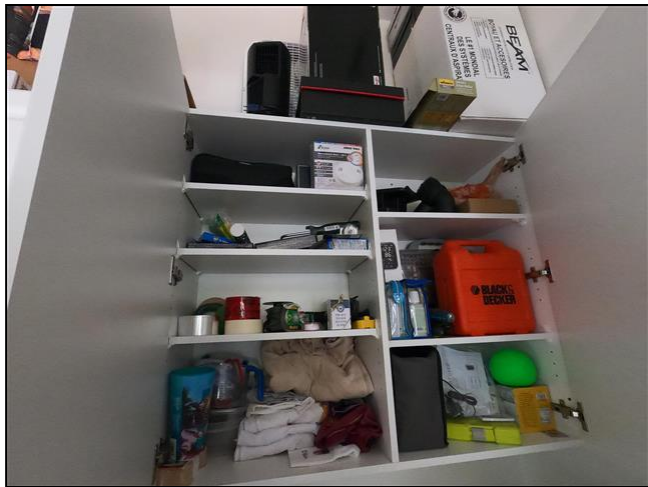
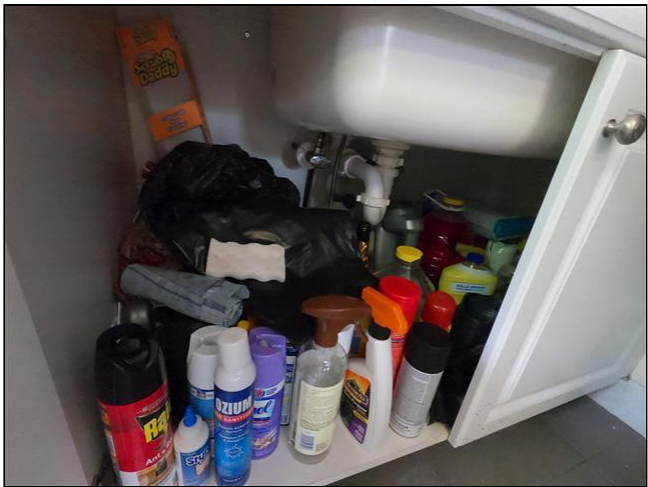
The cabinets in the garage exhibited moderate levels of deterioration typical of a garage.

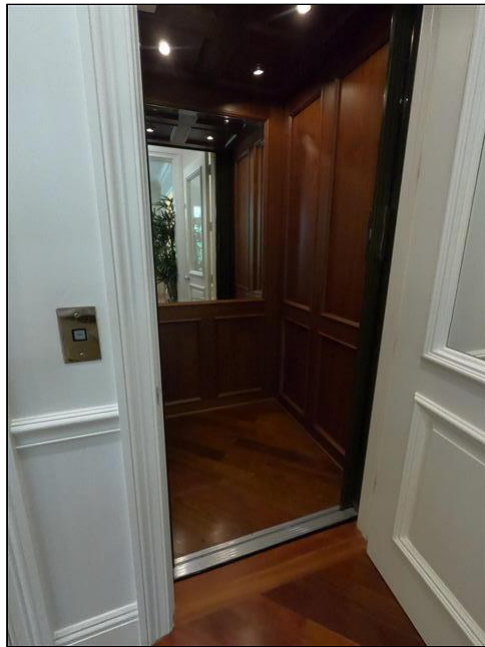
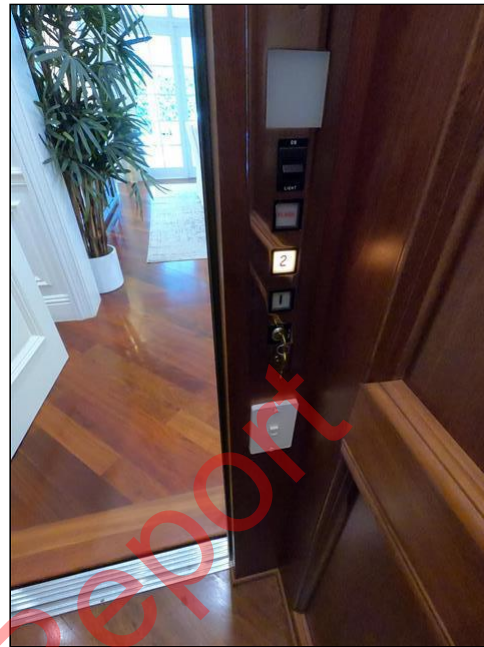
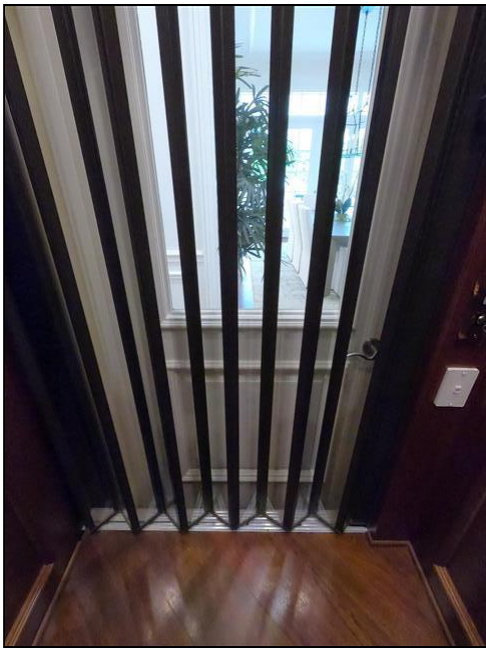
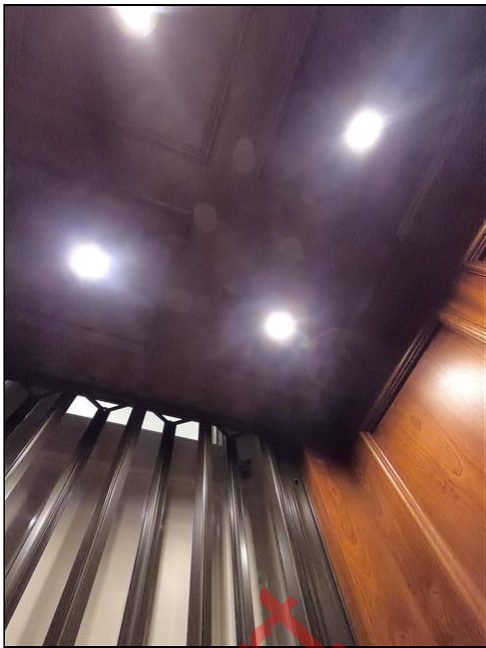
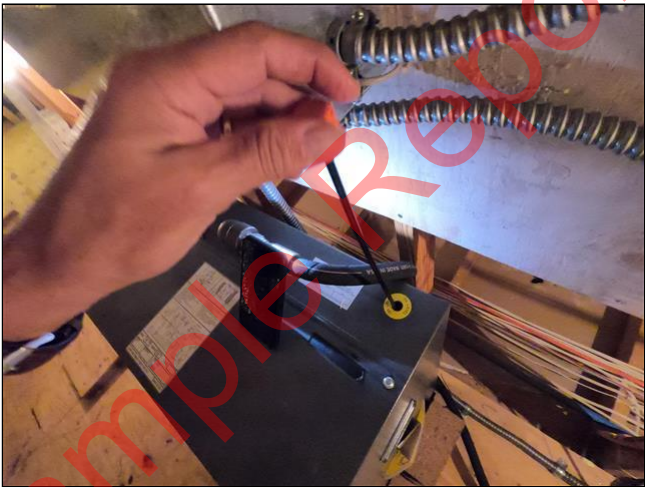
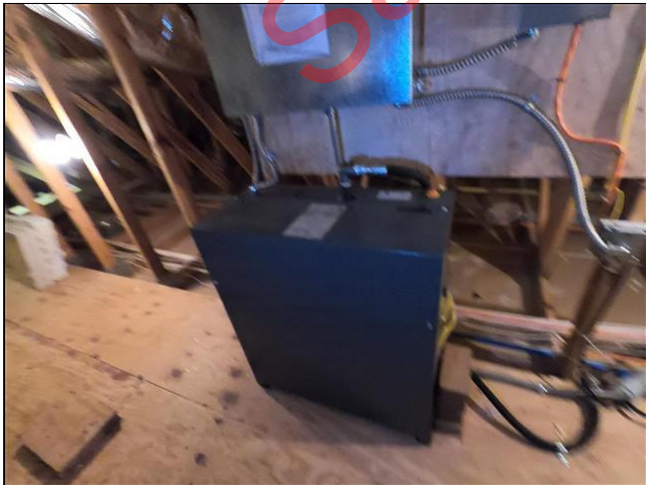
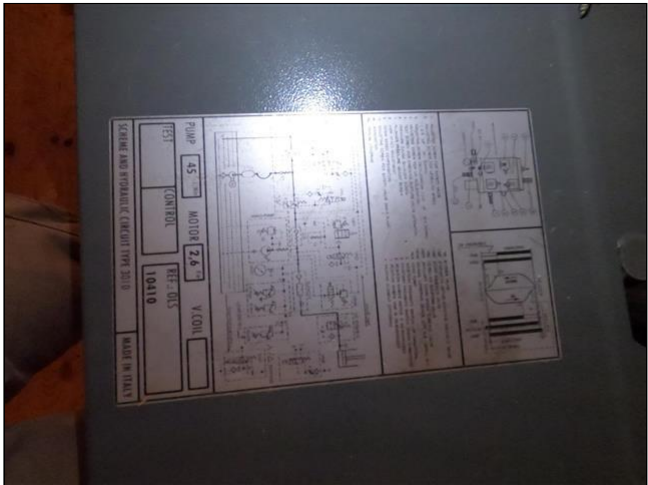
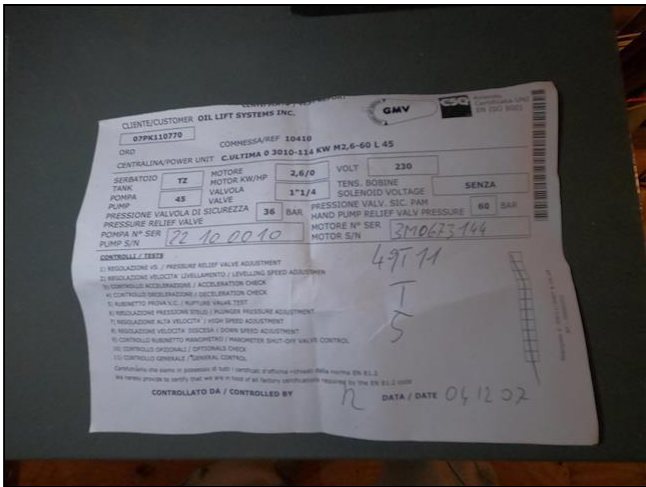
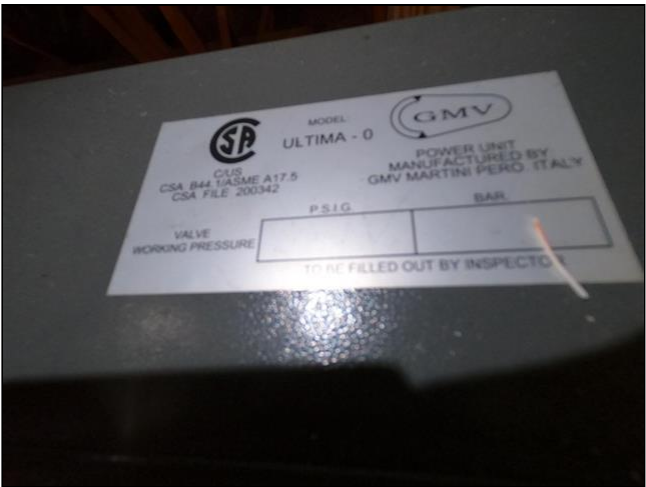
Inspector operated the elevator. The elevator was functional and operating at a satisfactory manner at the time of the inspection. Inspector observed the elevator safety check form and it appears the last time serviced was back in 2007. The elevator equipment is located in the attic. The elevator equipment should be a fire extinguisher near the equipment room (in this case the attic).

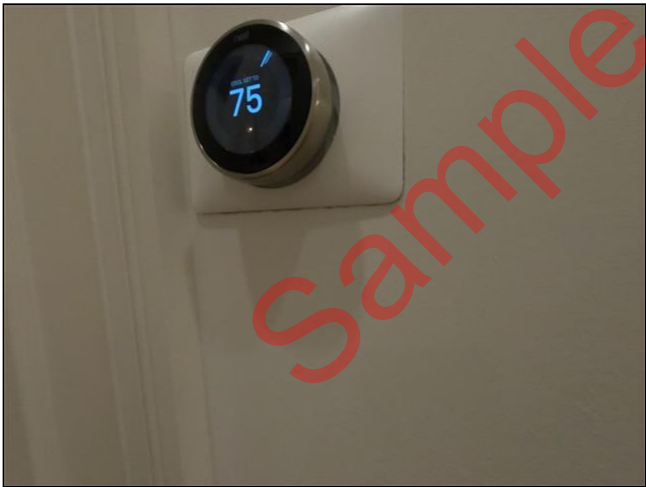
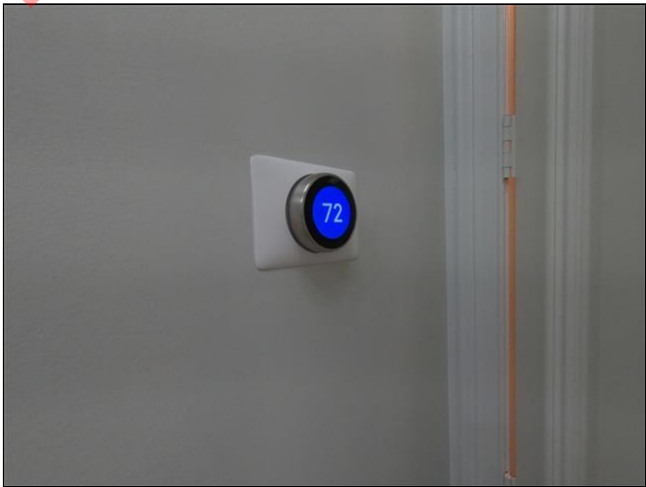
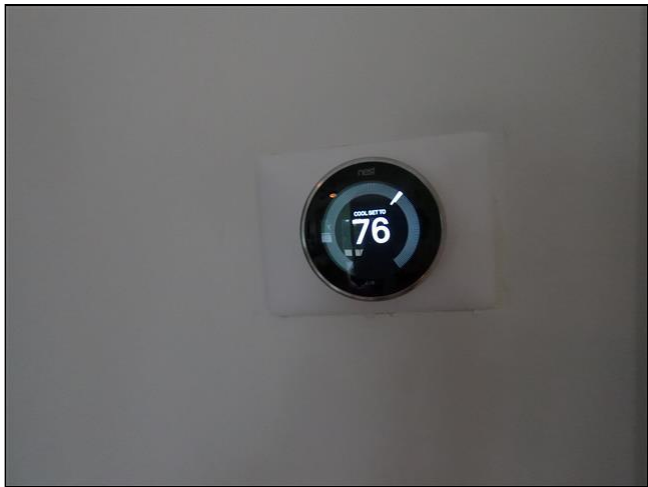
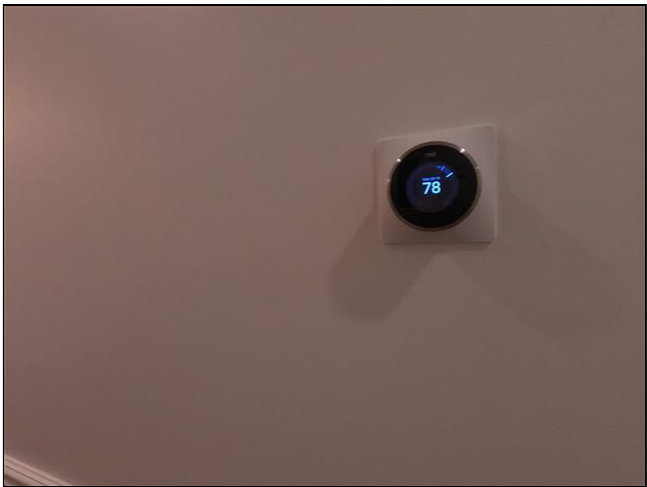
The thermostat for this furnace was located in several areas. The heater and the air-conditioning were controlled by a programmable thermostat. Heating and cooling costs can be reduced by programming the thermostat to raise and lower home temperatures at key times.

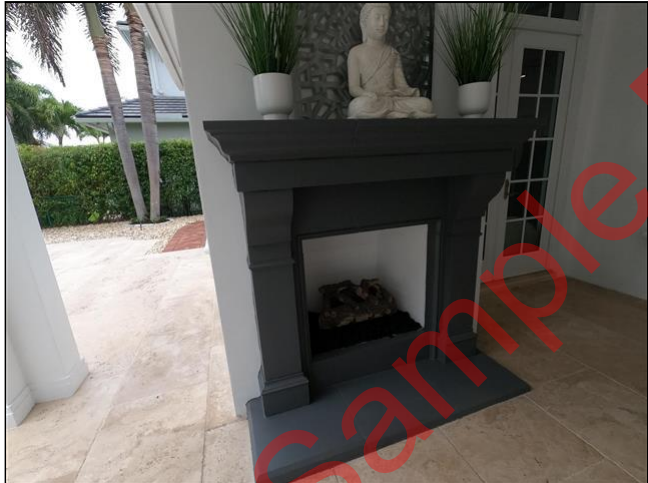
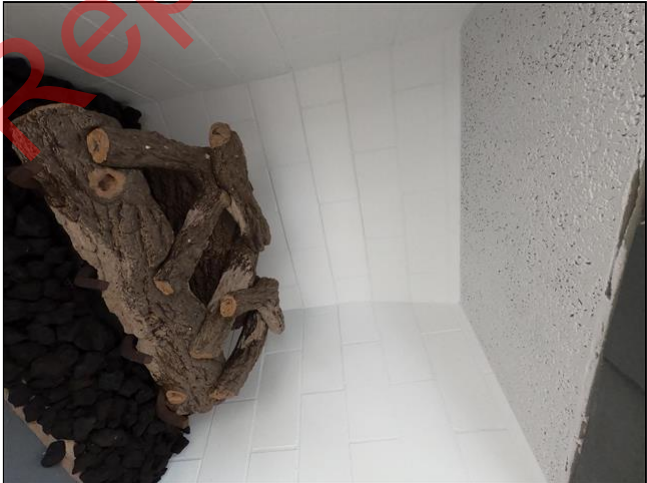
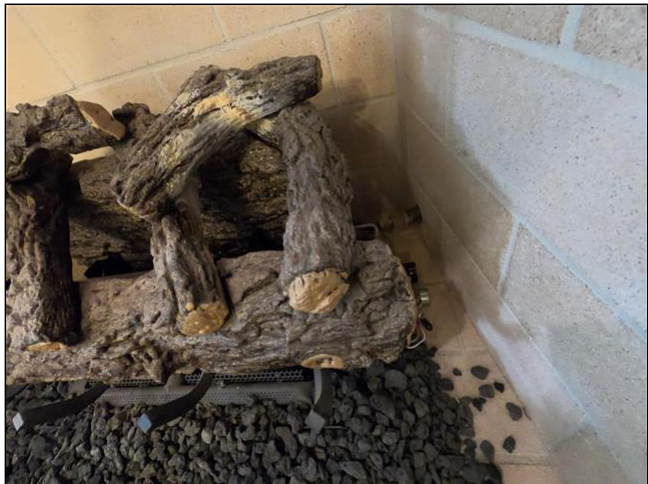
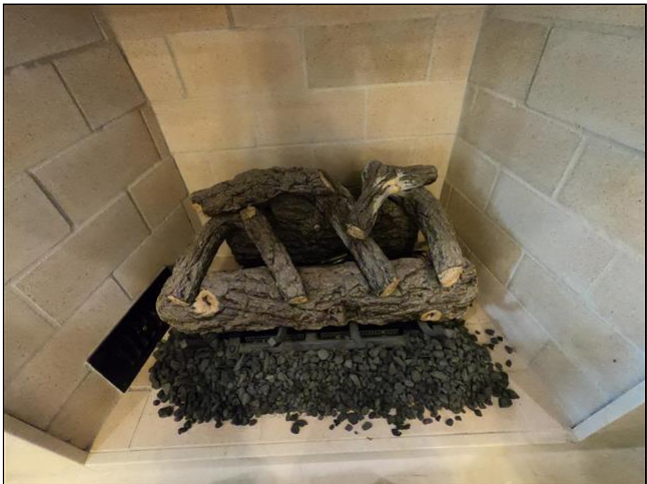
There are two inactive fireplaces in the home. The chimney that would support these fireplaces appears to be a fake since there are no flue for exhaust gases.

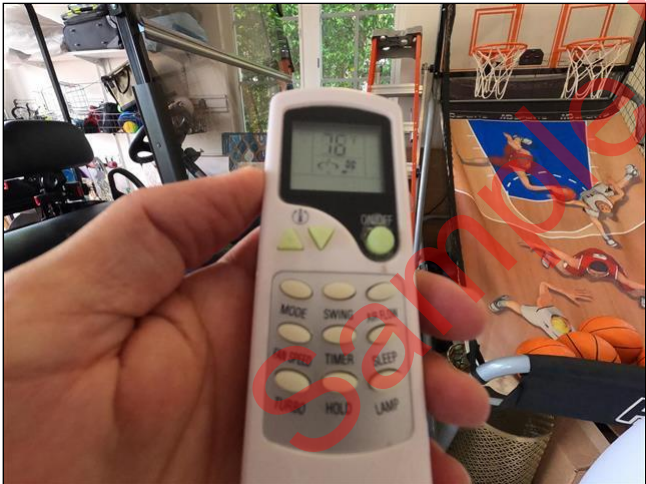
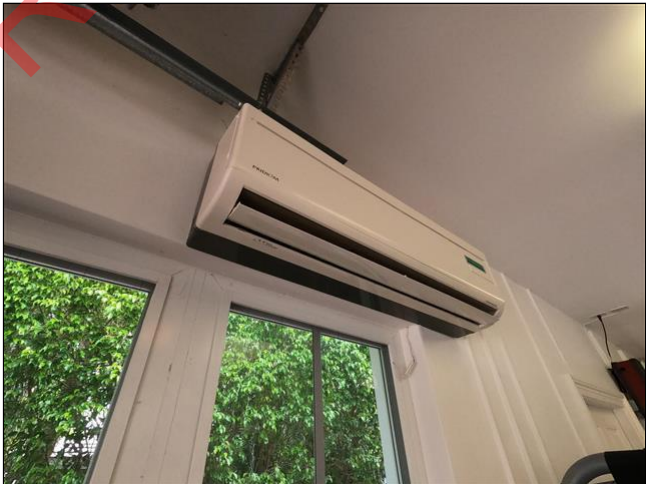
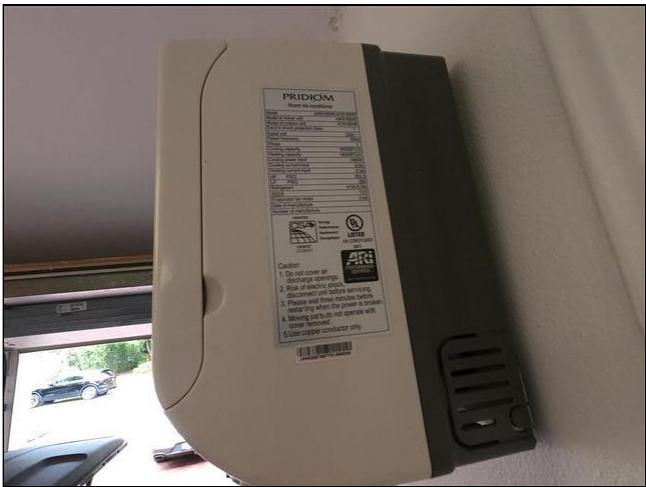
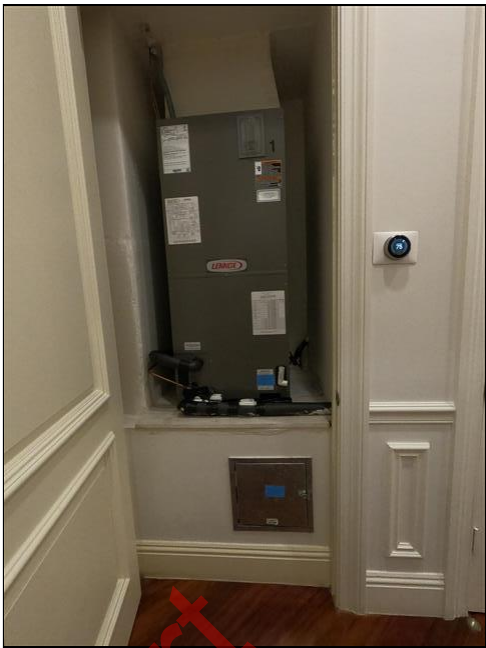
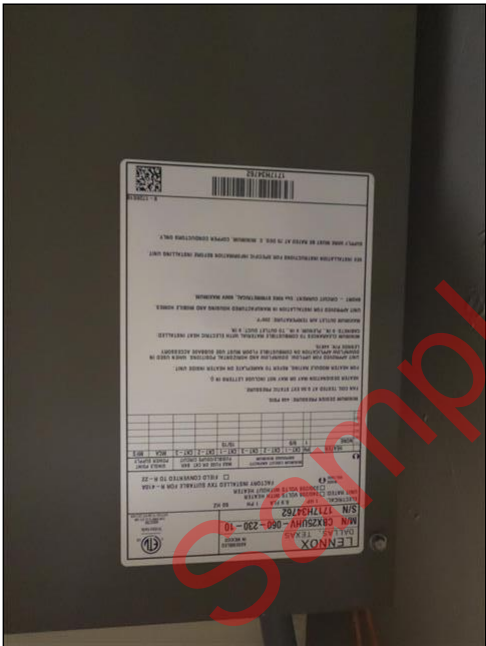
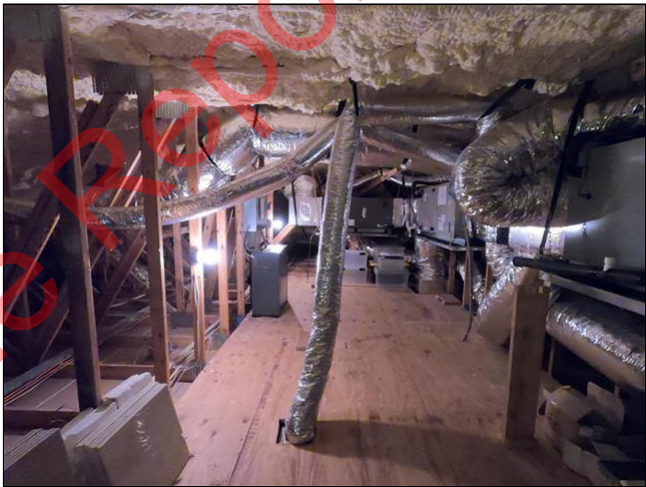
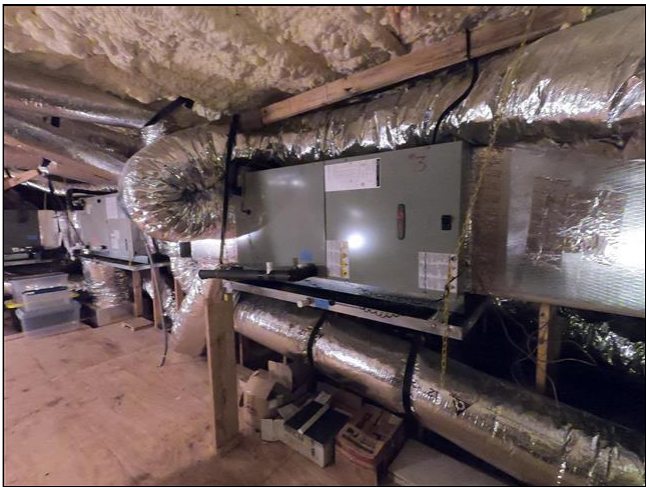
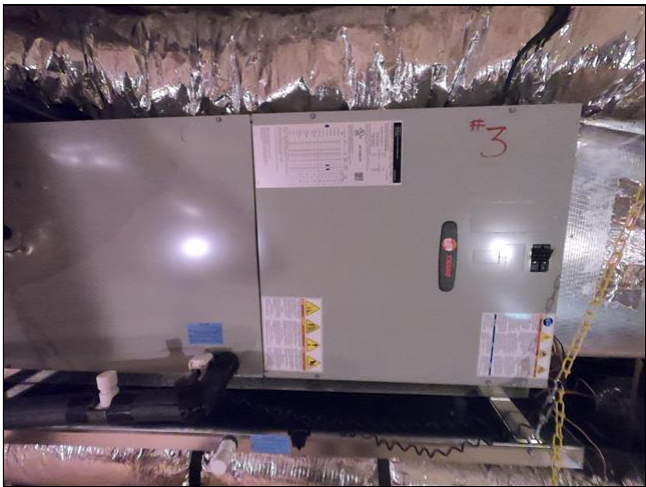
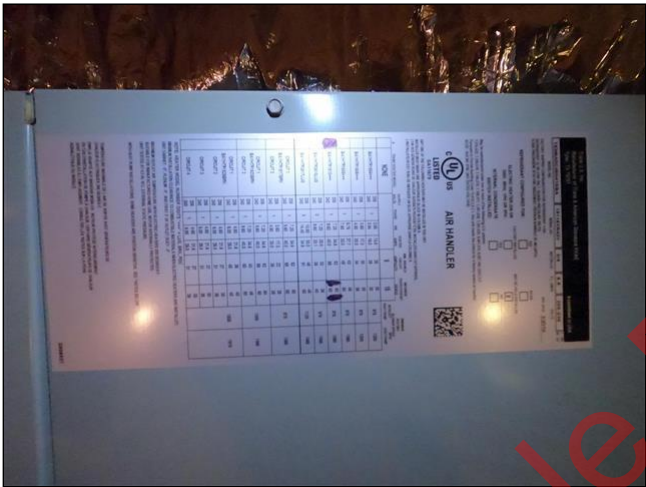
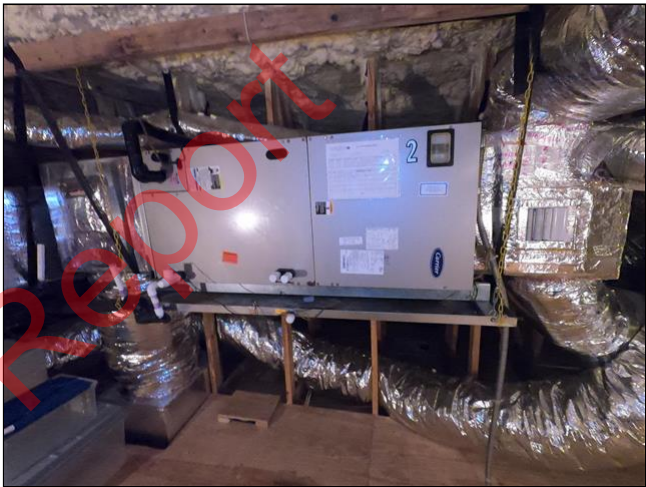
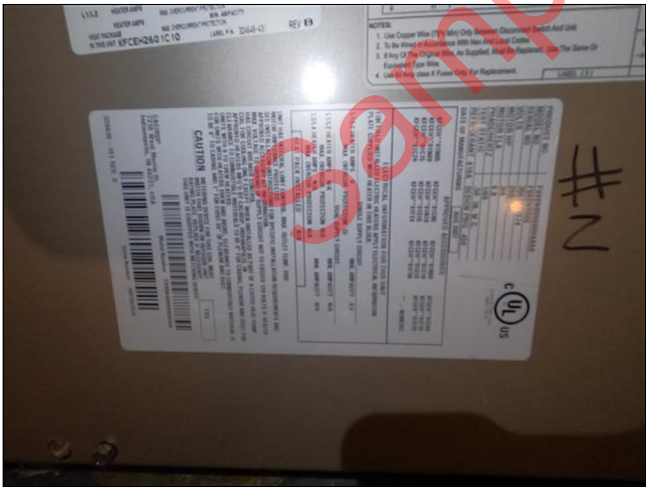
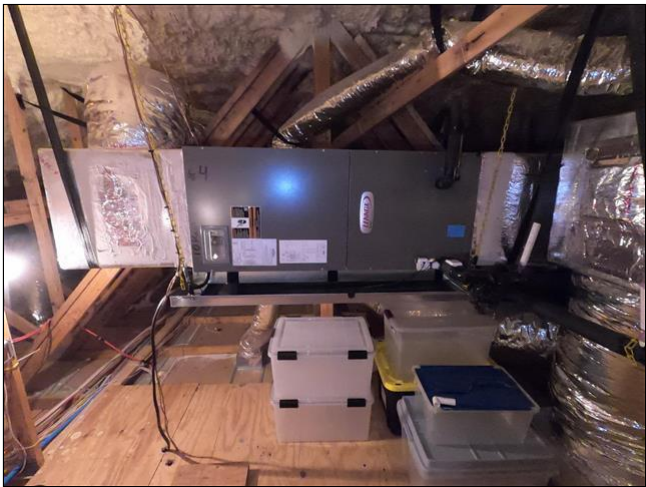
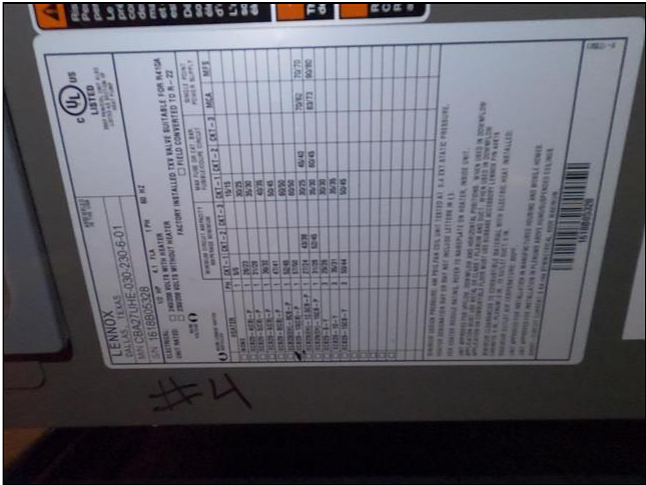
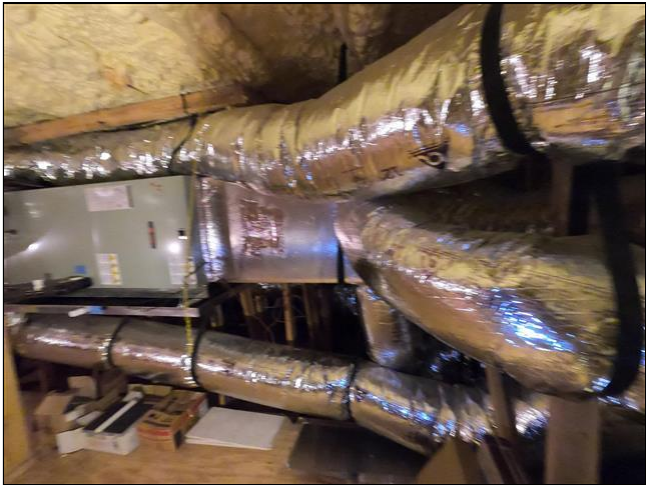
There are five AC units in this home. Their ages are 2007, 2019, 2018, 2017, 2018. The air conditioning system were split system in which the cabinet housing the compressor, cooling fan and condensing coils was located physically apart from the evaporator coils. As is typical with split systems, the compressor/condenser cabinet were located at the home's exterior so that the heat collected inside the home could be released to the outside air. Evaporator coils designed to collect heat from the home interior were located inside a duct at the furnace.

At the time of the inspection, the Inspector was unable to determine the age of the mini-split system in the garage. Inspector observed no deficiencies in the condition of the air-conditioning systems. The differences in air temperature measured at supply and return registers fell within the acceptable range of between 14 and 22 degrees F.

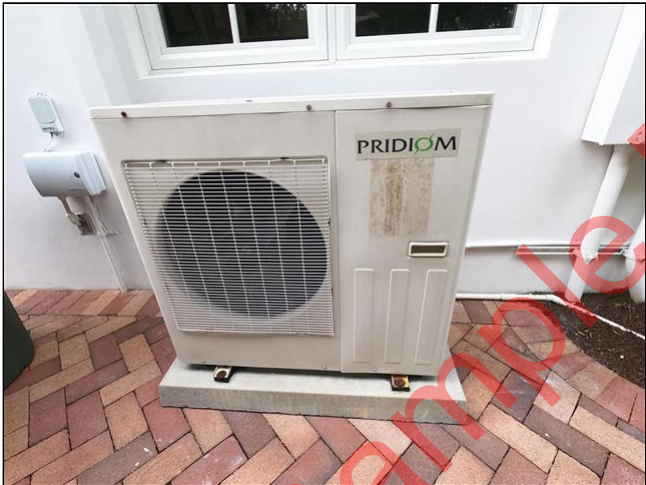
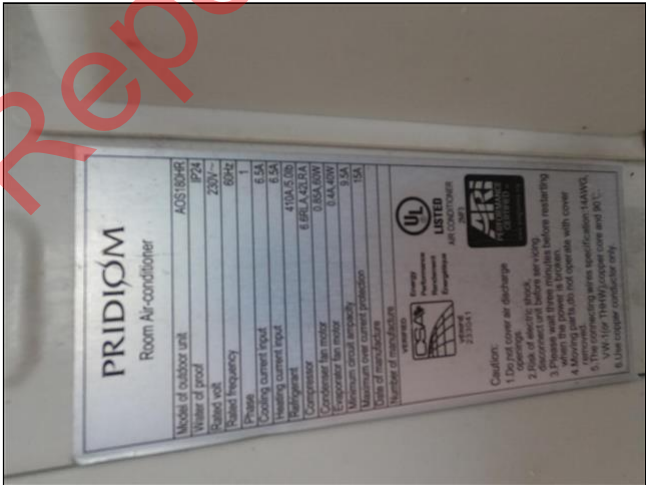
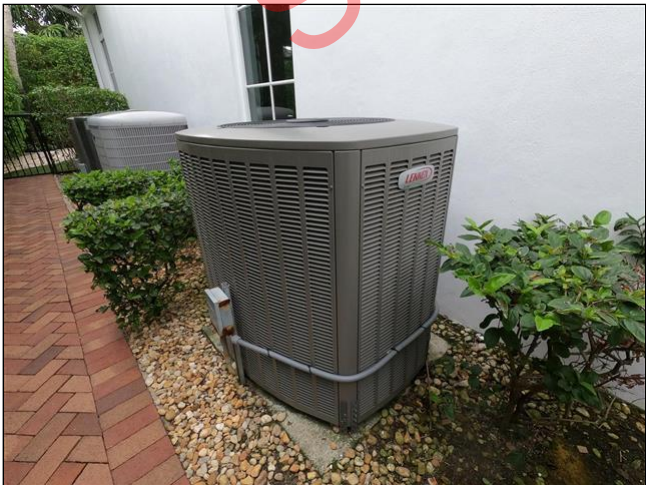
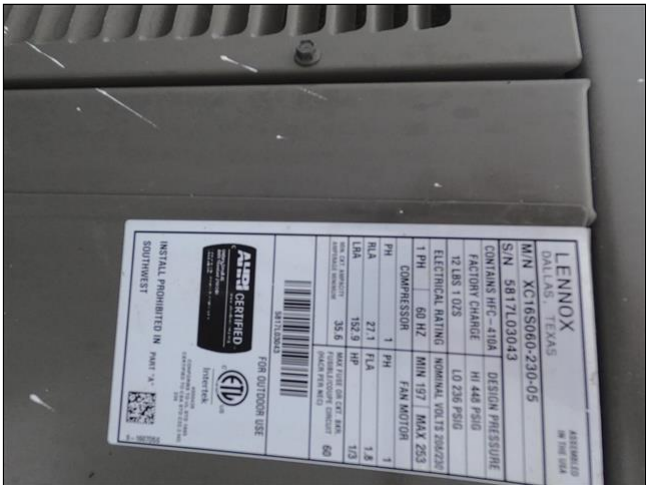
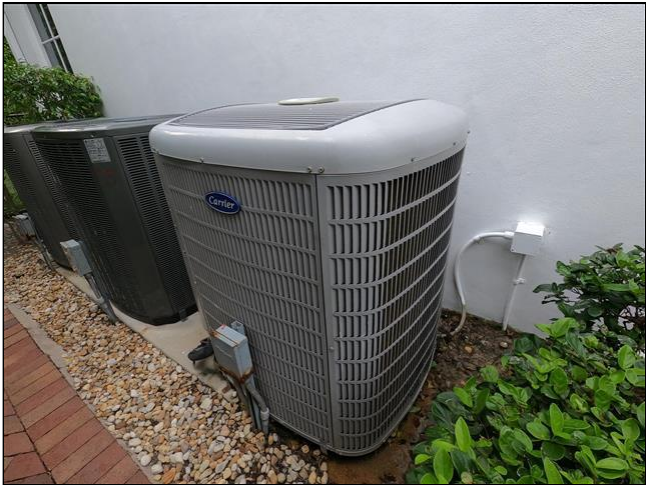
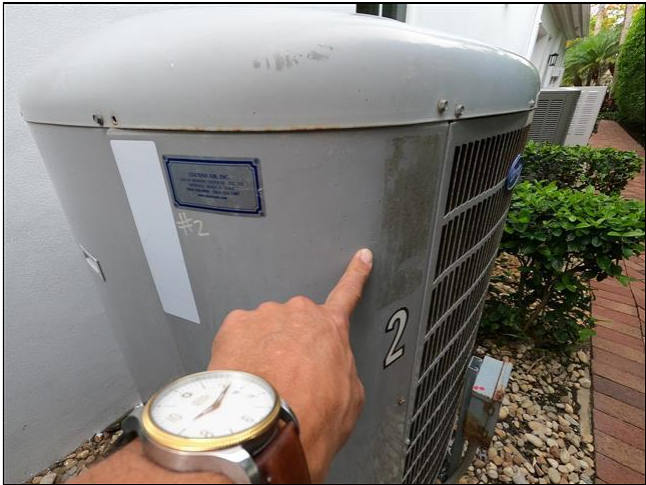
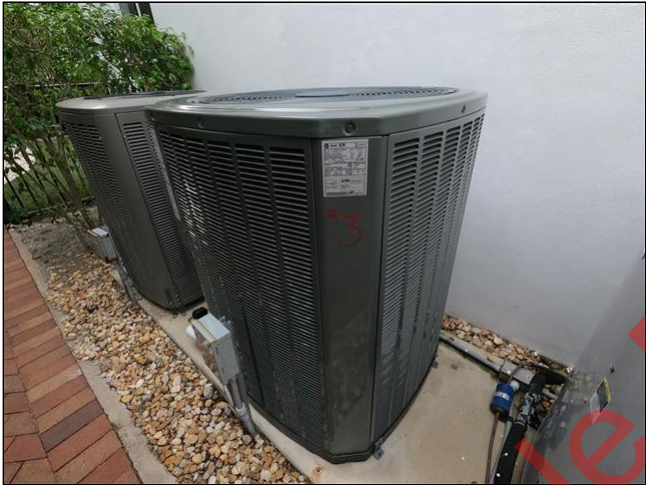
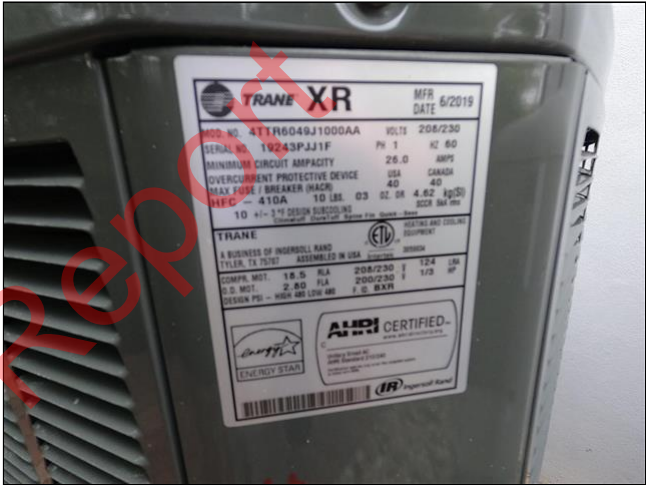
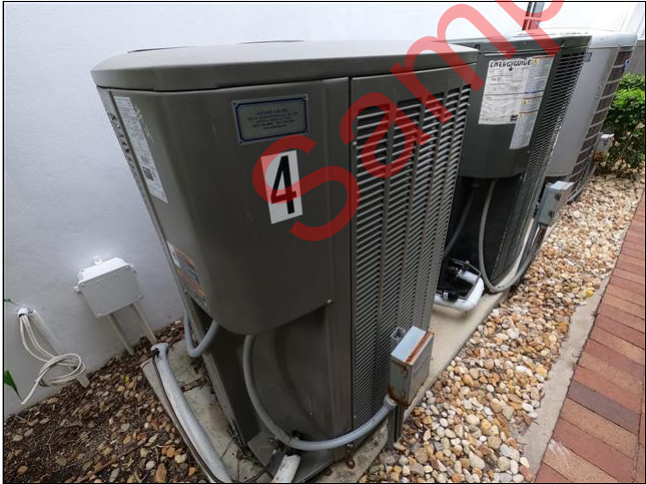
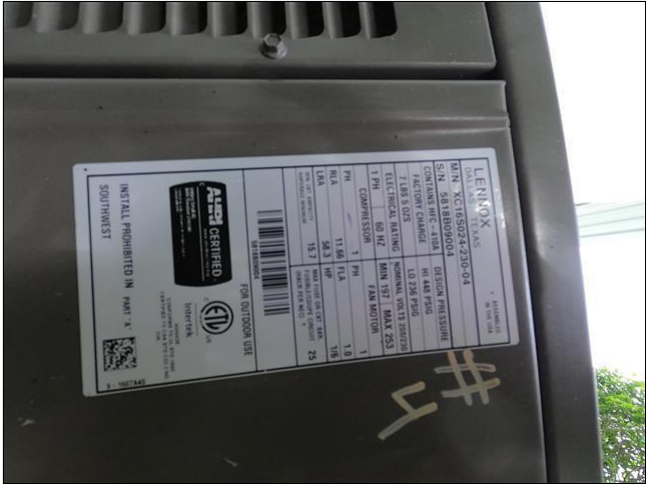
The compressors responded to the controls at the time of the inspection and produced cool air. Air temperatures produced by an compressors will typically lower as those produced by an air-condition system that uses evaporative coolers. One Compressor was missing the manufacturer's label.

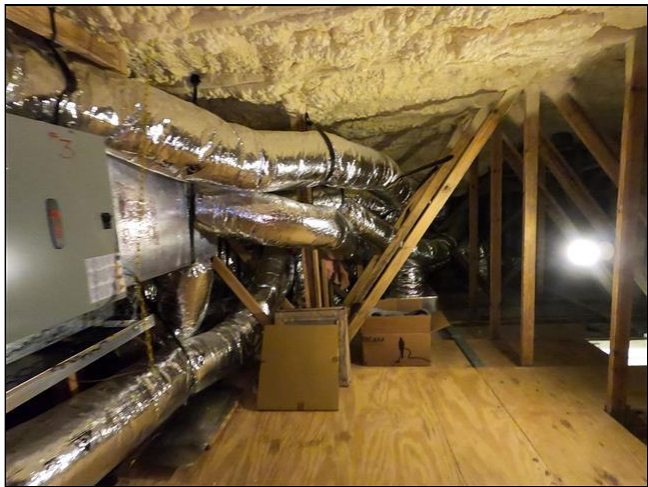
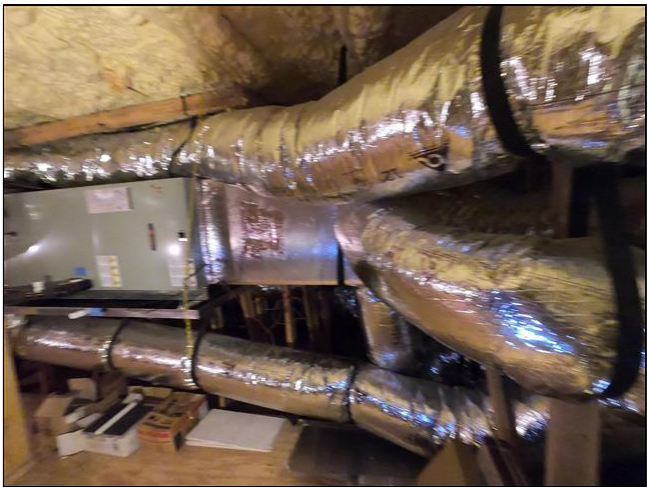
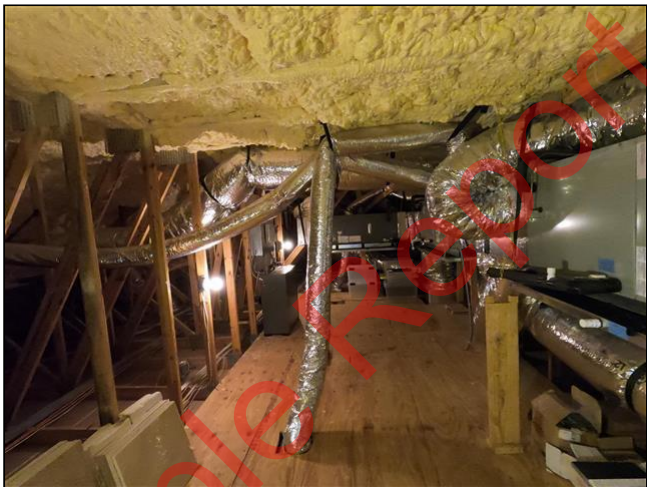
Inspector found no deficiencies with the condition of the ductwork at the time of the inspection.

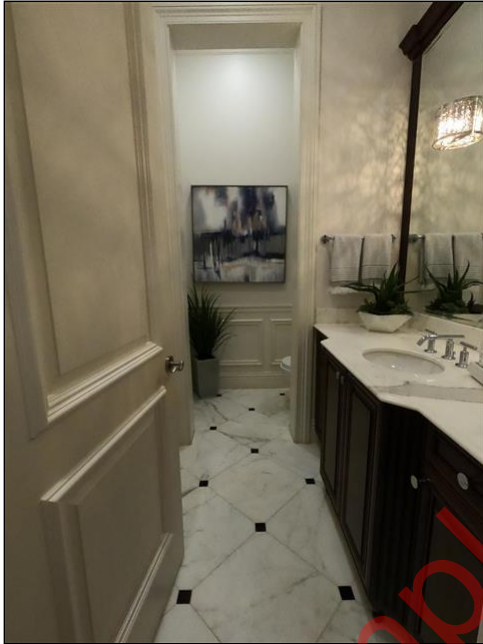
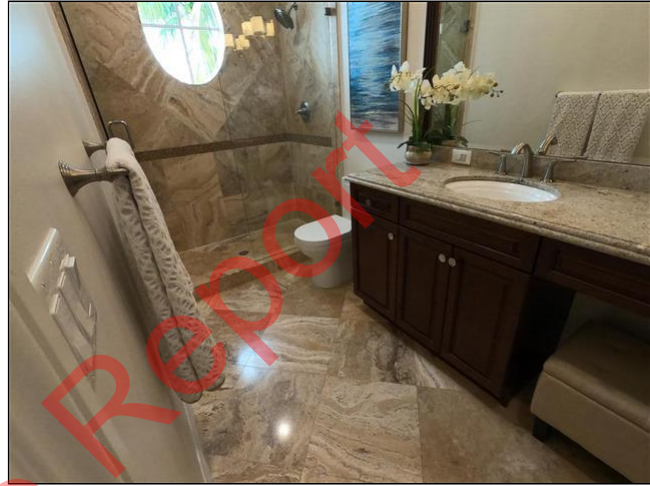
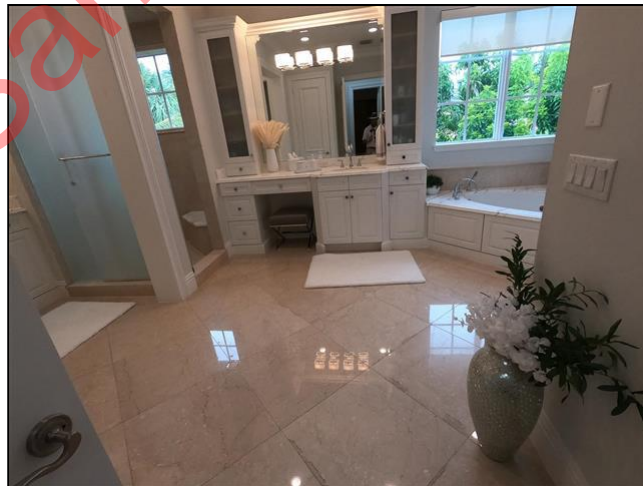
At the time of the inspection, the Inspector observed no deficiencies in the condition of the floor in the bathrooms.
