# General Home Inspection Report

**Property Address:**

2280 W Silver Palm Rd  
Boca Raton FL 33432

**Certified Inspectors, LLC**

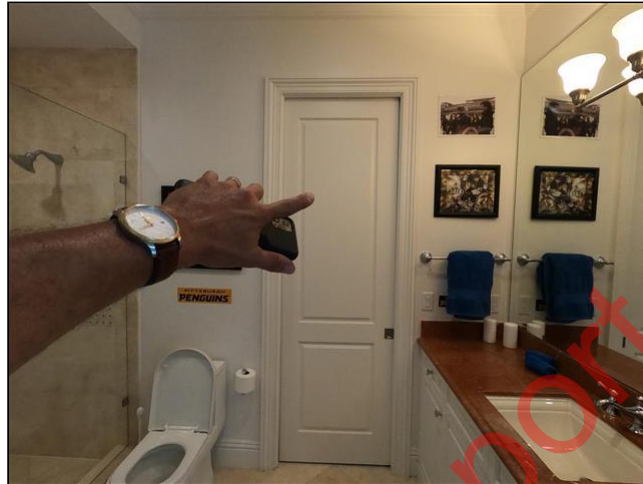
12.3 Item 1 (Picture)

Difficulty in operating the sliding glass door in the 1st shared bathroom appeared to be caused by worn or out-of-adjustment rollers. The Inspector recommends service by a qualified contractor.

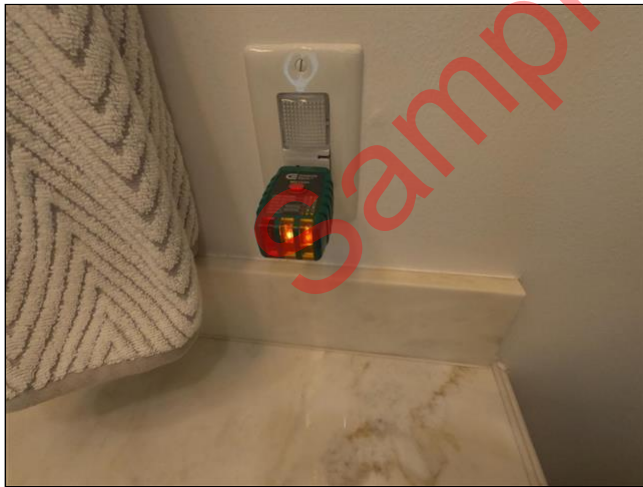
12.4 Item 1 (Picture)

Electrical receptacles in the guest bathroom had ground fault circuit interrupter (GFCI) protection which responded to testing in a satisfactory manner at the time of the inspection. The inspector tested a representative number of accessible receptacles only.

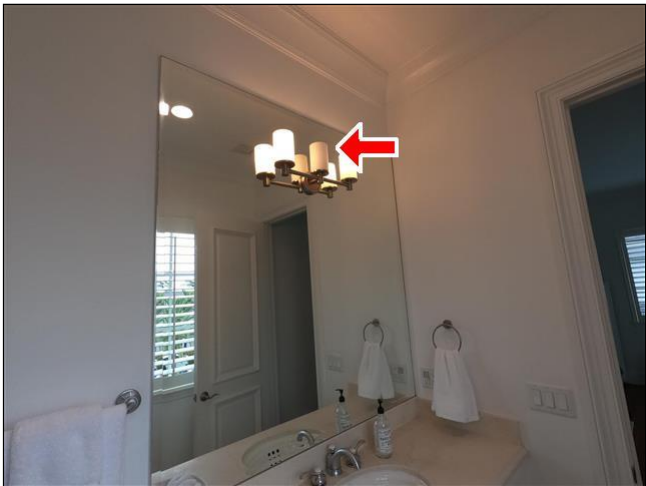
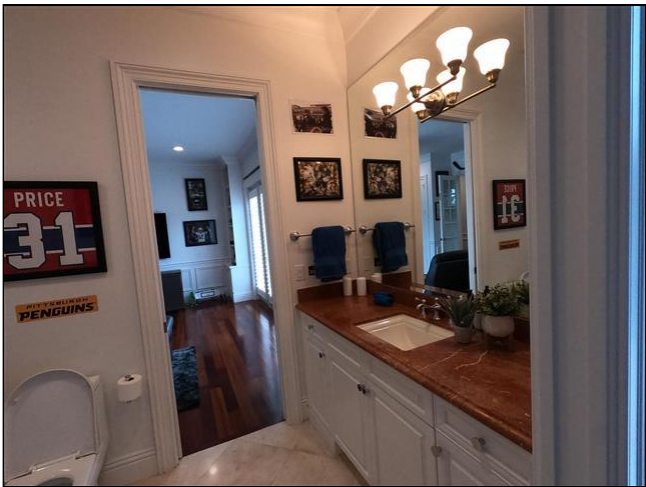
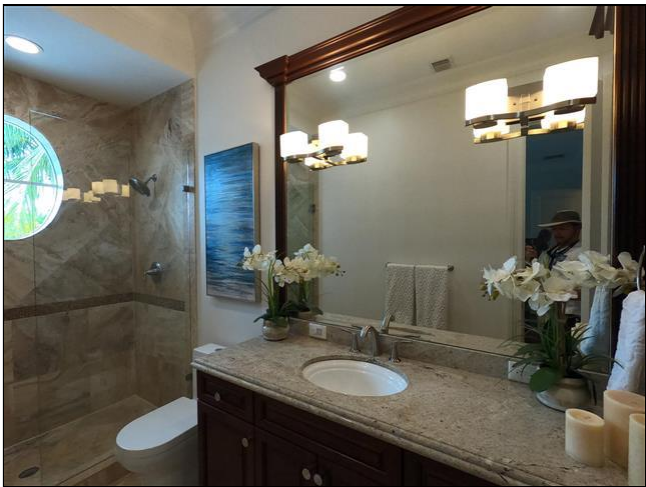
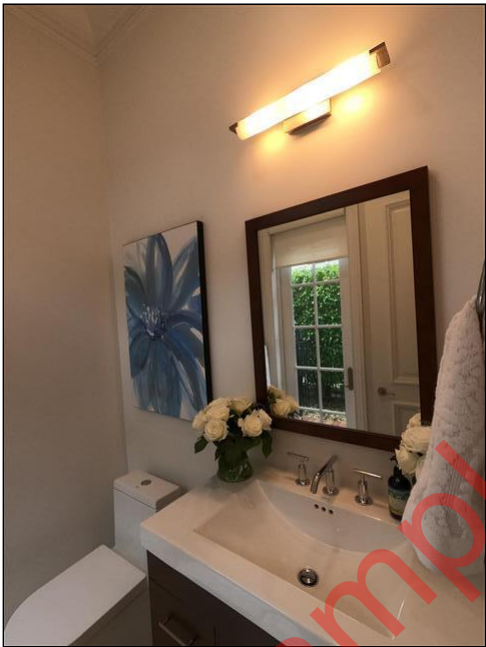
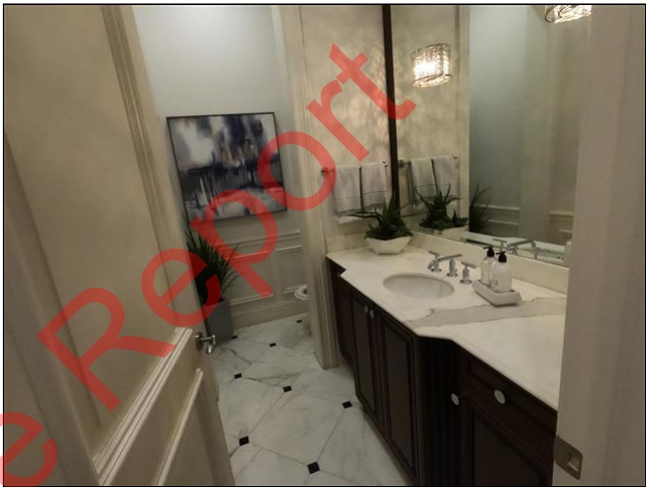
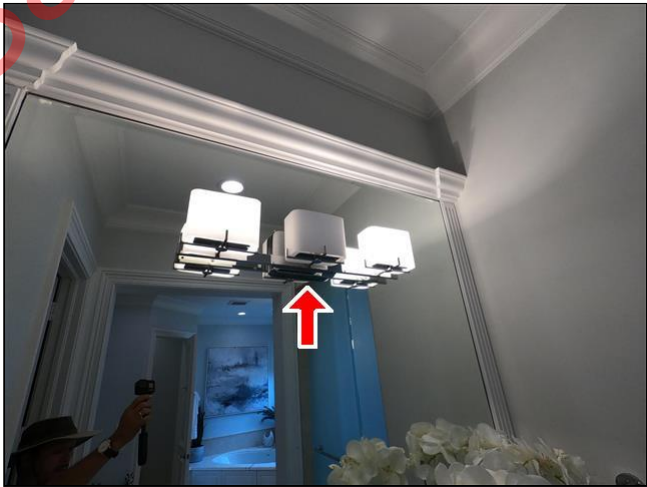
A light fixture in the two guest bathroom did not respond to the switch. The bulb may need to be replaced or there may be a problem with the switch, wiring or light fixture. If after the bulb is replaced this light still fails to respond to the switch, this condition may represent a potential fire hazard and the Inspector recommends that an evaluation and any necessary repairs be performed by a qualified electrical contractor.

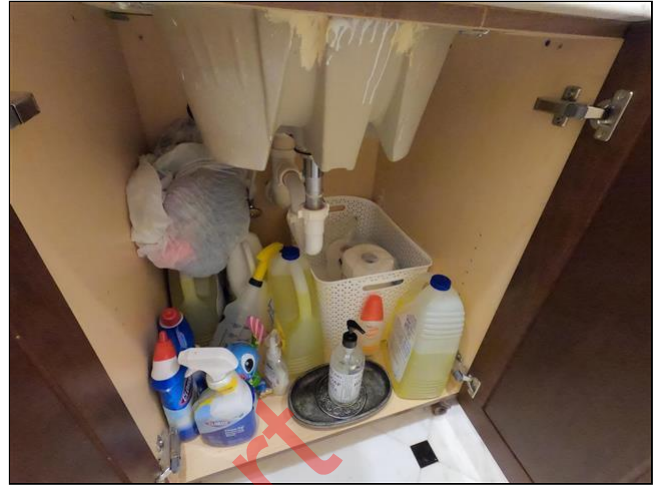
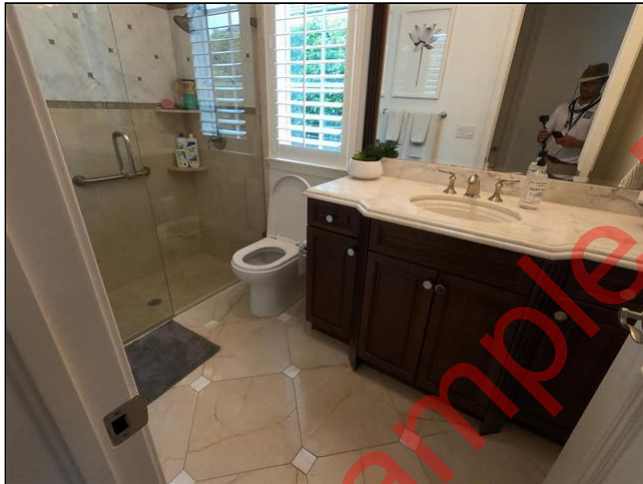
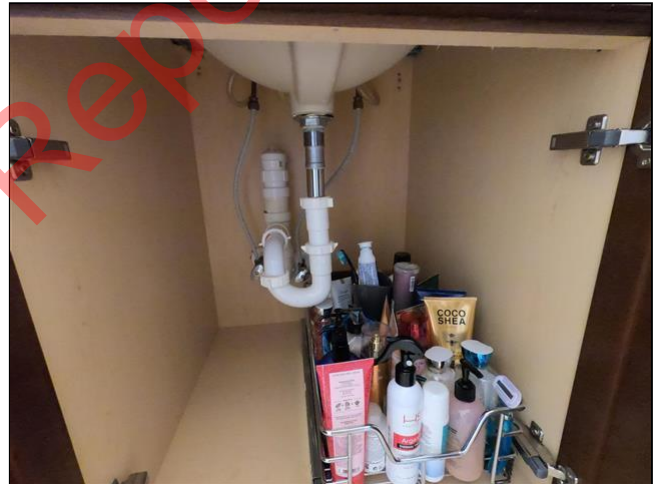
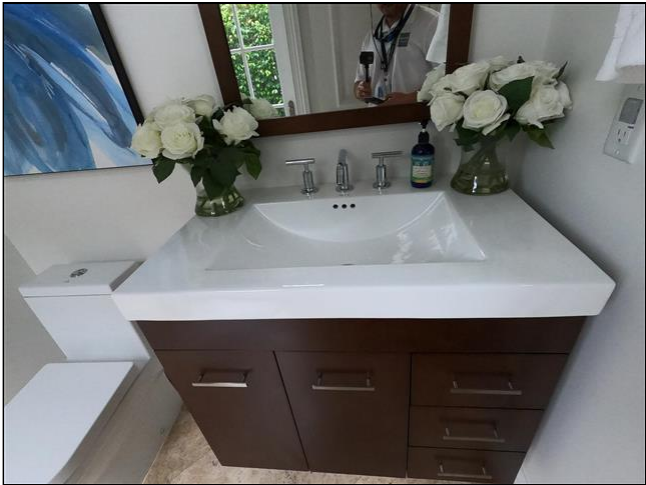
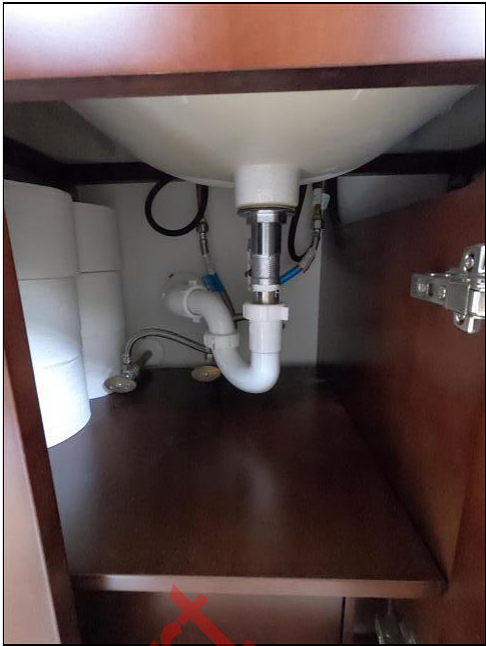
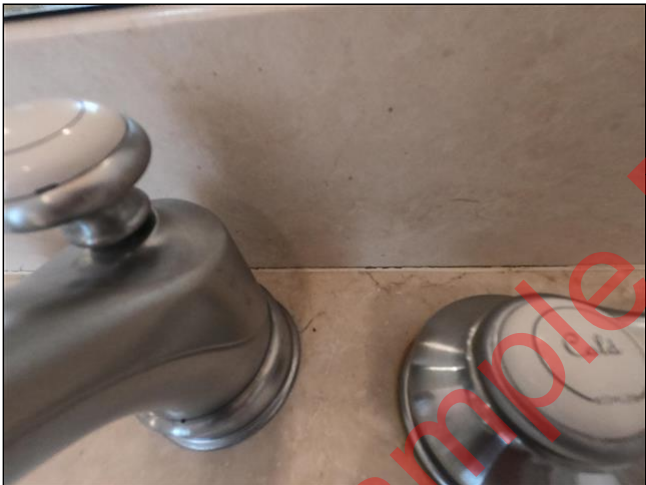
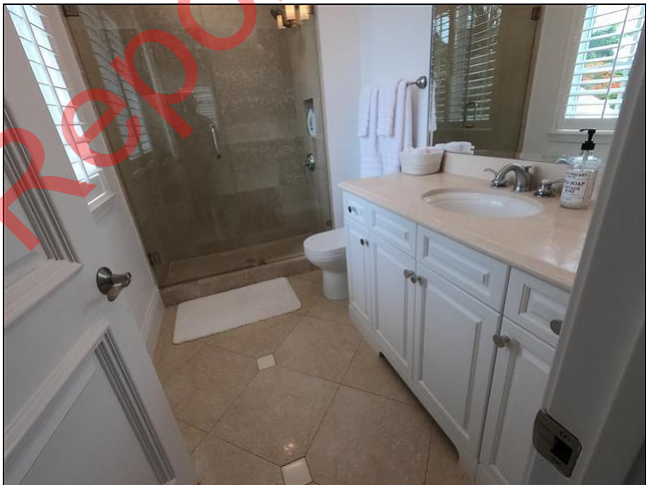
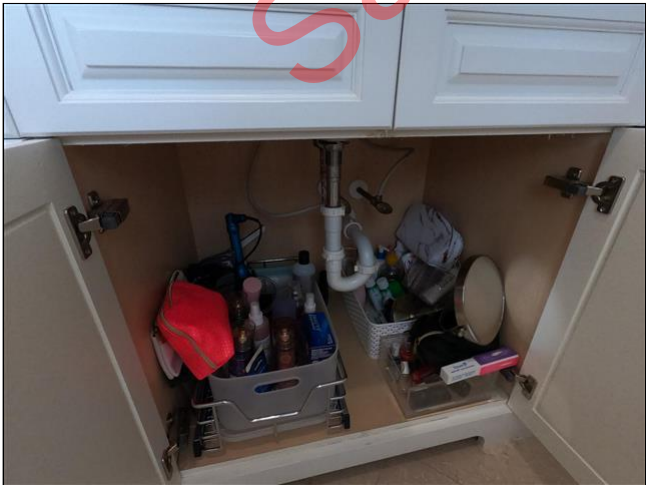
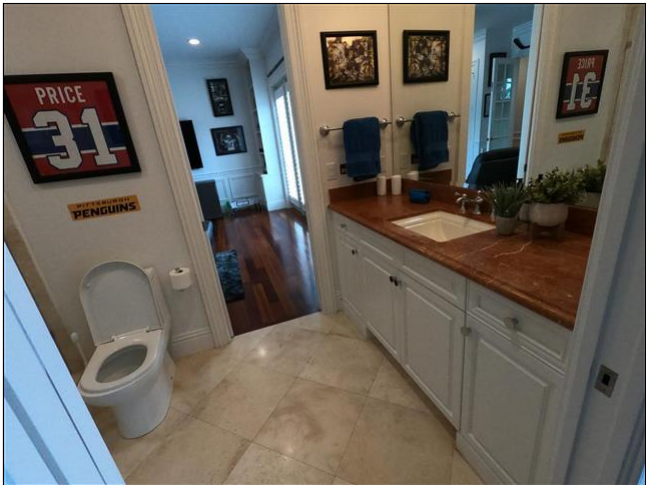
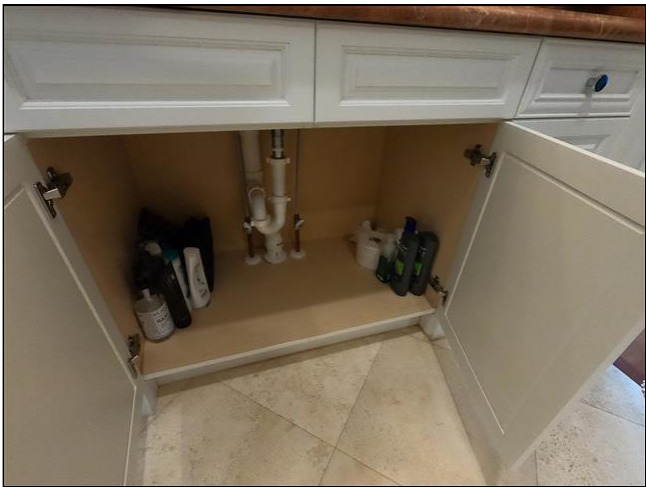
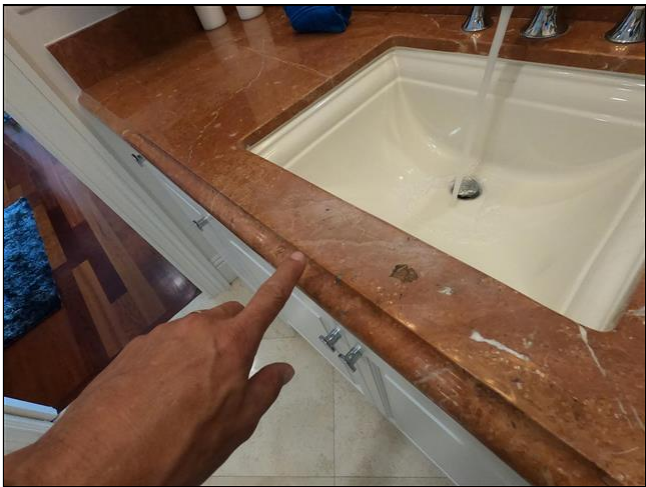
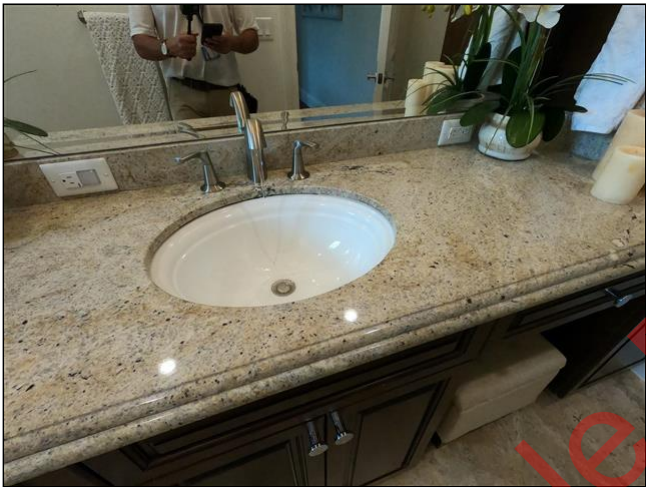
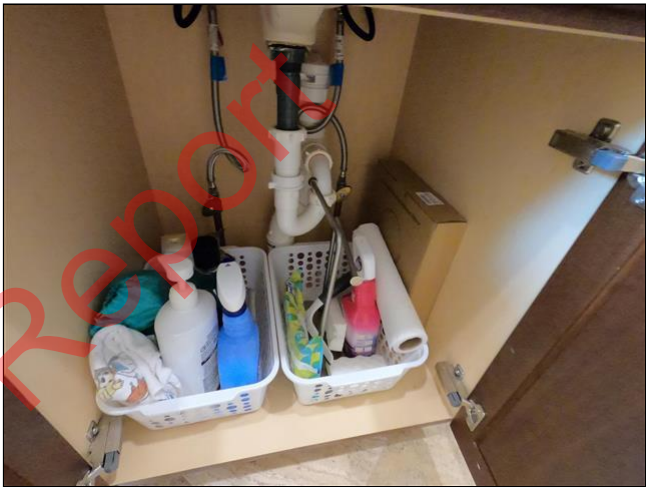
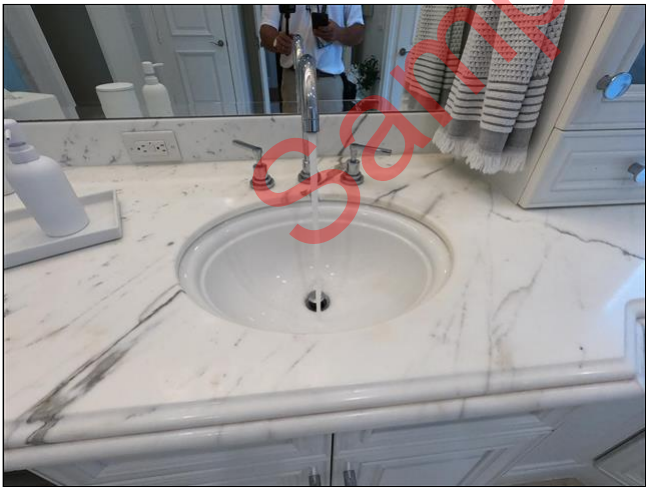
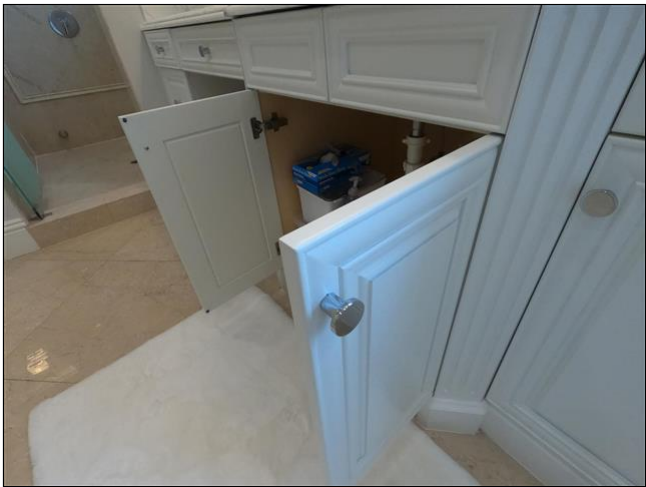
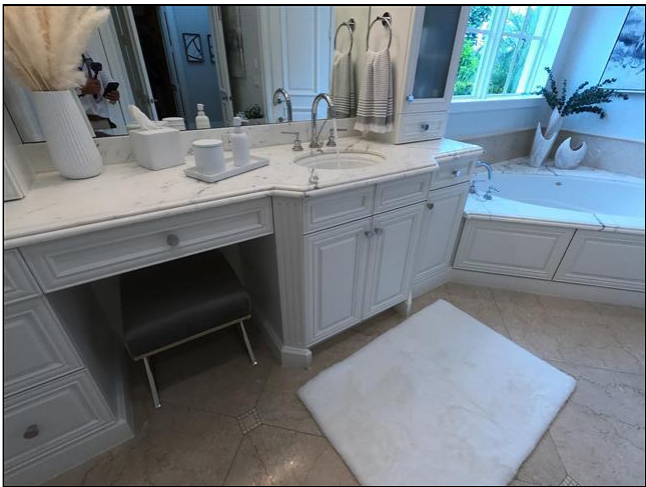
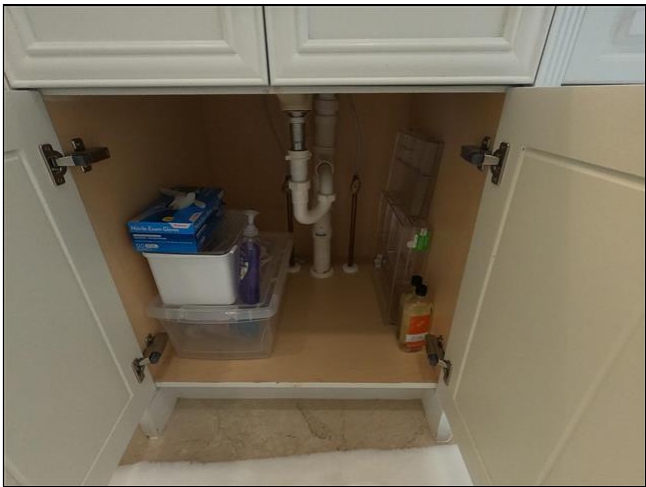
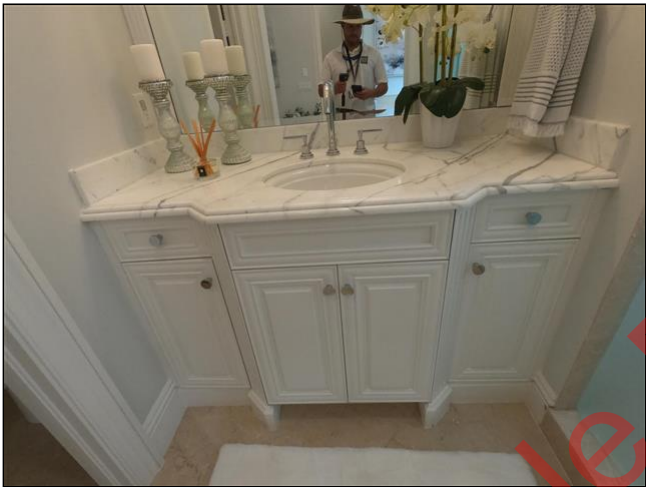
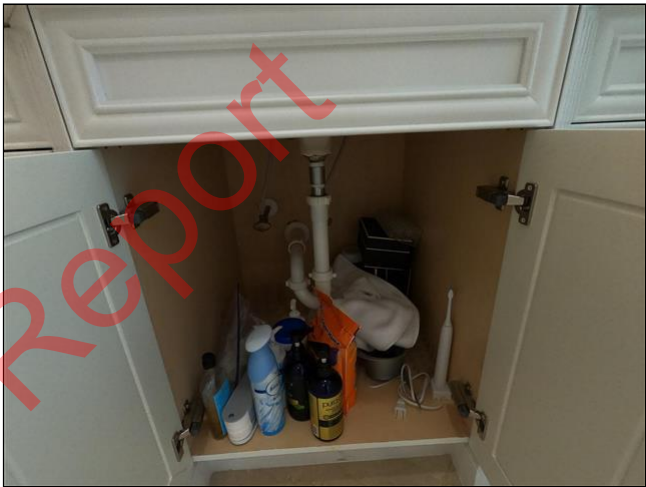
Cabinets in the bathrooms exhibited minor general deterioration commensurate with the age of the home.

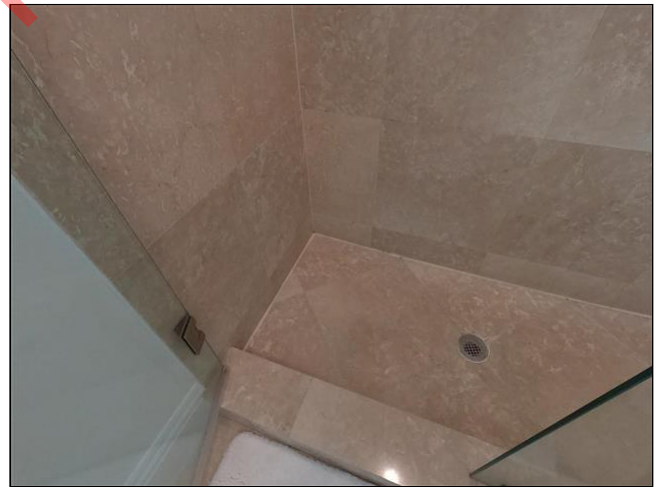
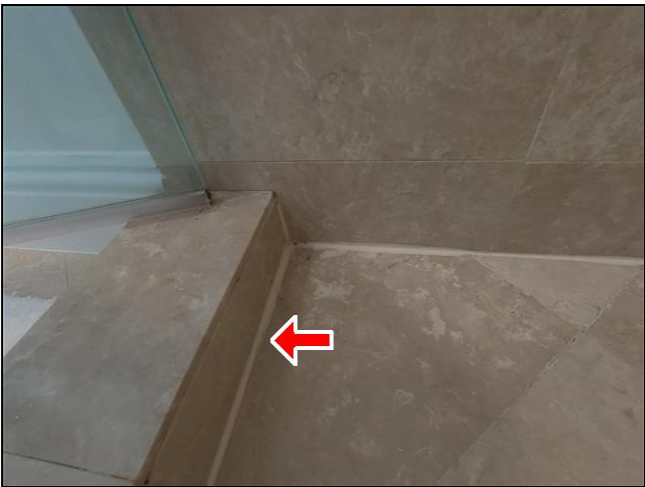
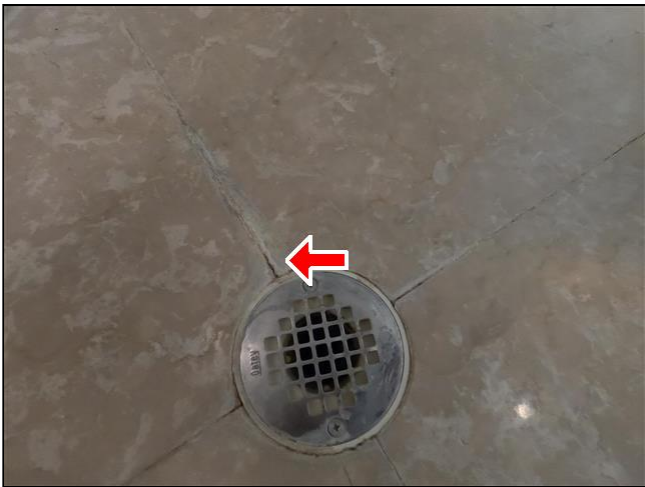
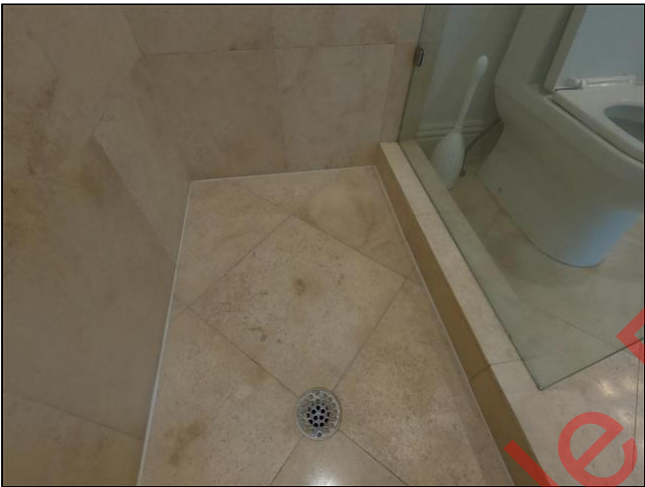
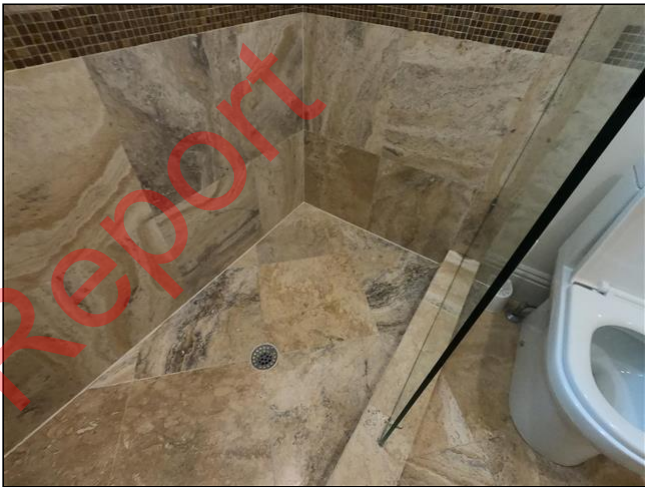
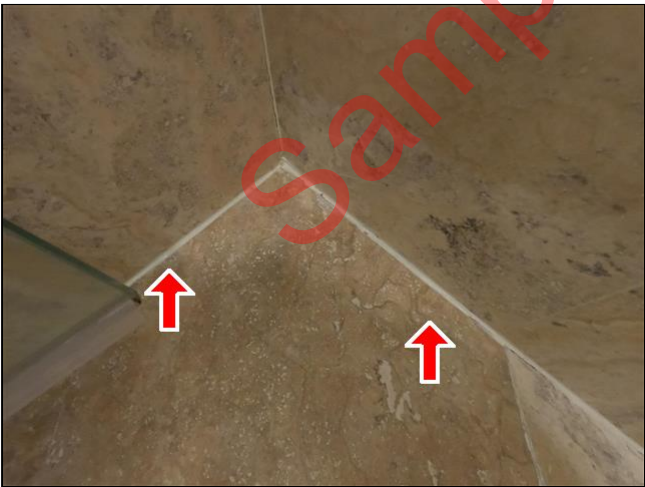
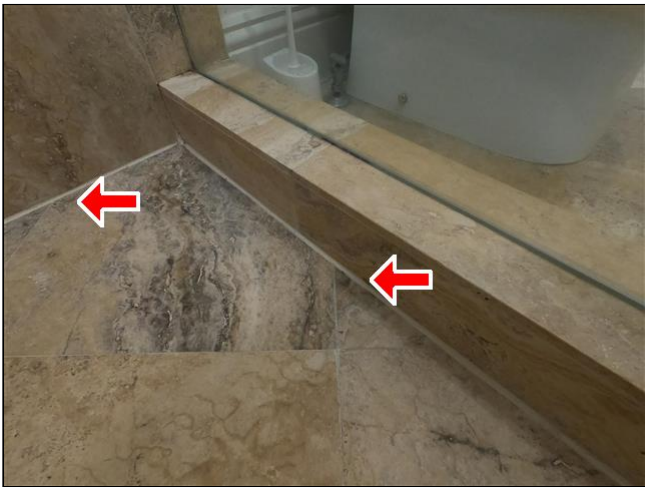
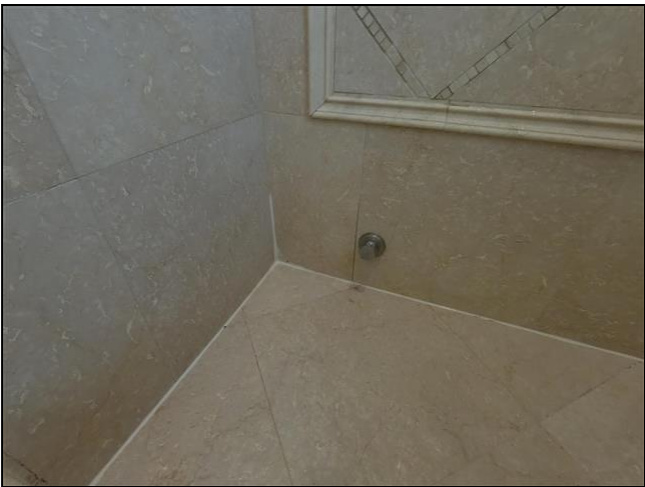
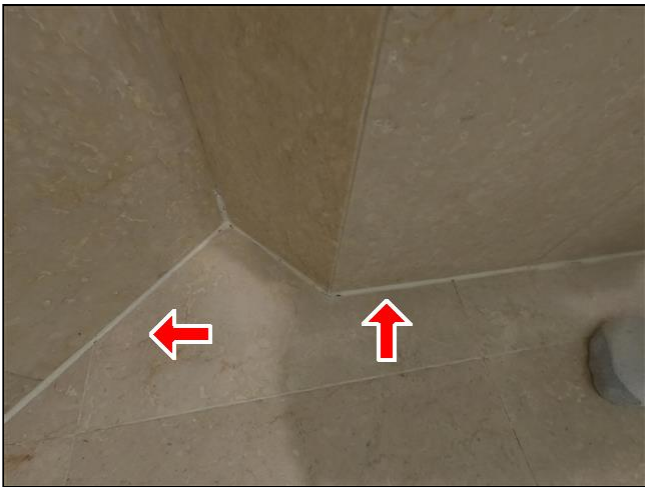
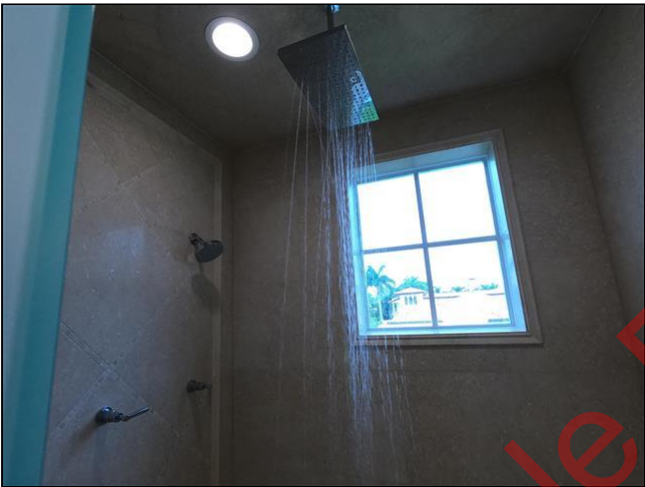
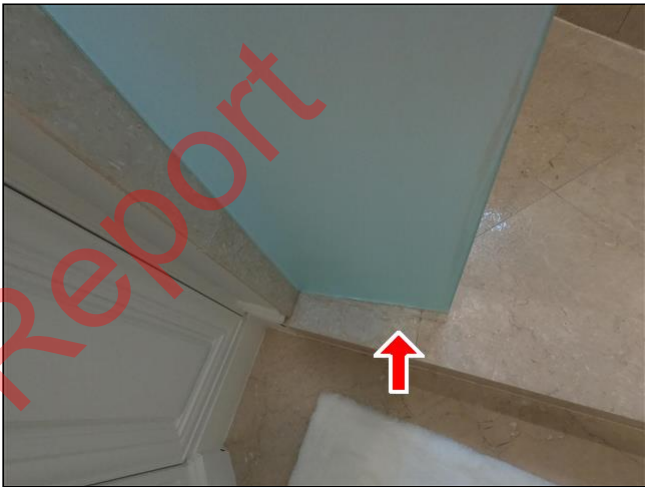
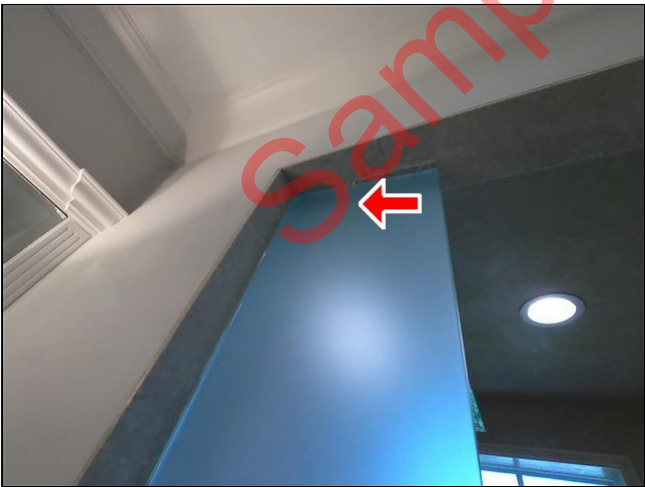
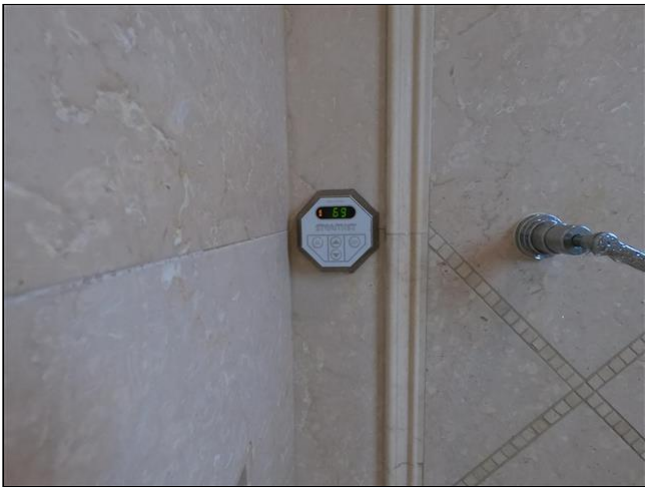
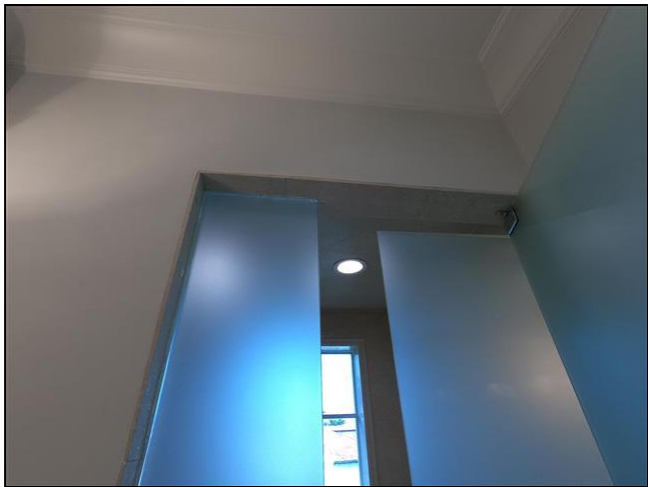
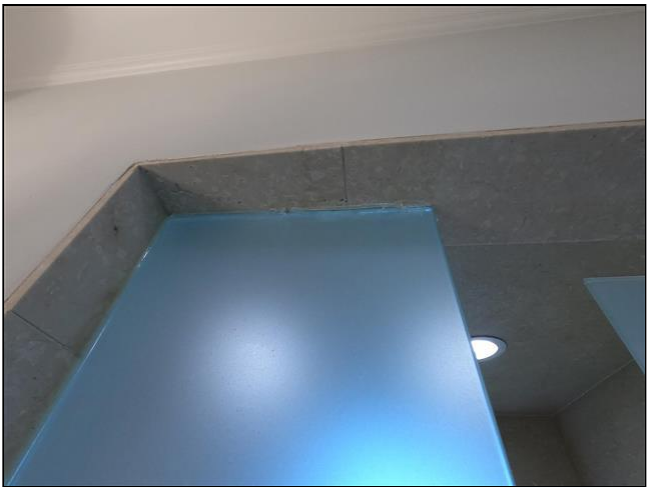
The shower in the bathrooms had functional flow and functional drainage at the time of the inspection. The caulk lines on the bathrooms were very thick. This is normally done to prevent water from getting behind the tiles. Recommend re-grout the joints where the grout has been replaced by silicone.

The glass partition in the master bathroom was poorly installed and it is loose. Recommend you discuss options with a qualified contractor and repair as needed.

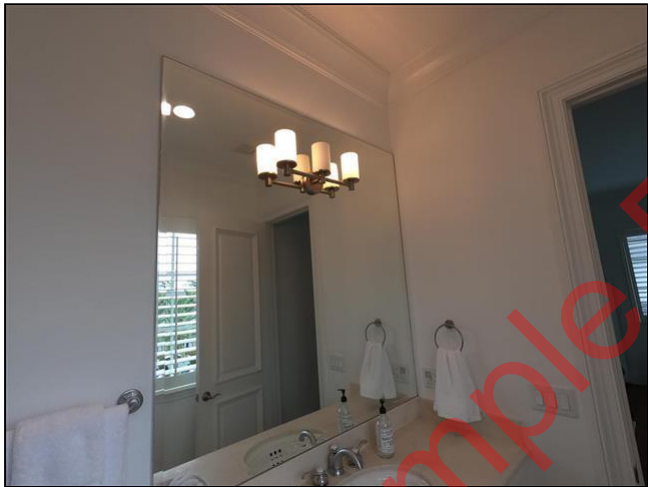
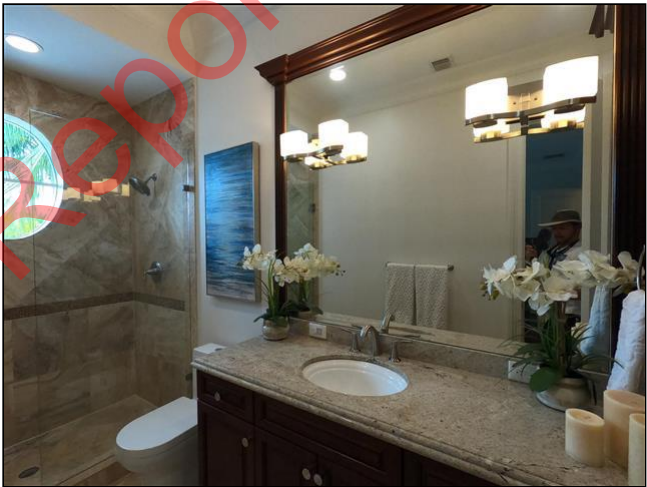
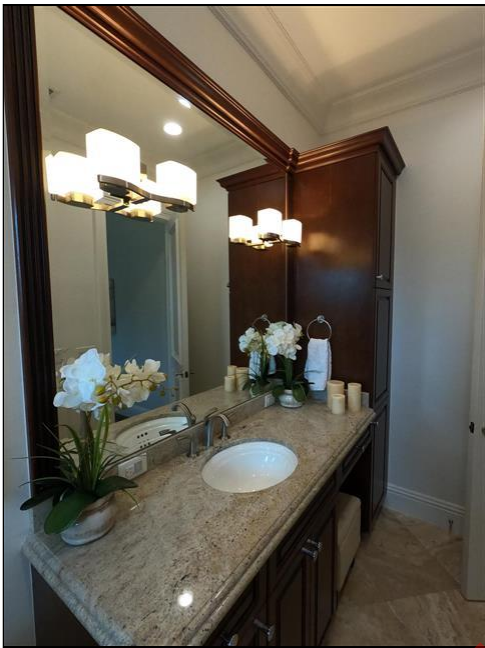
The mirror in the bathrooms was in good condition.

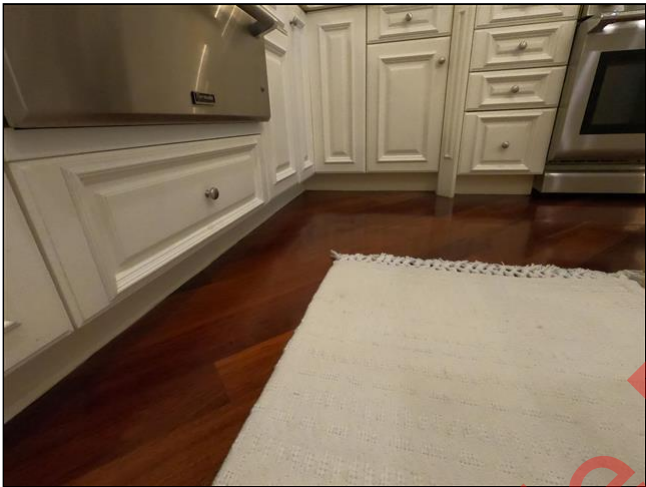
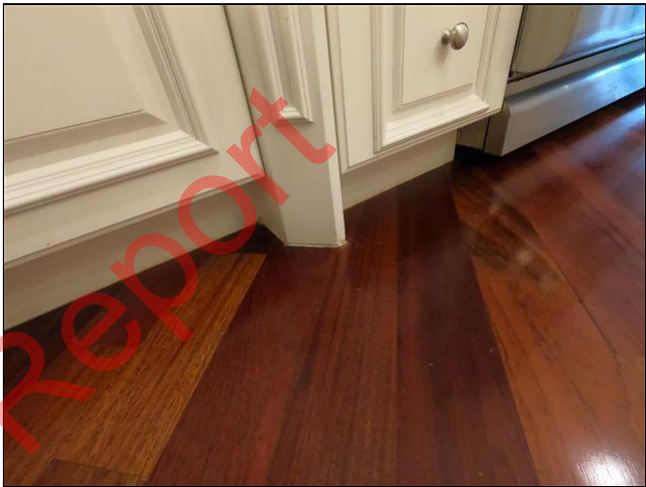
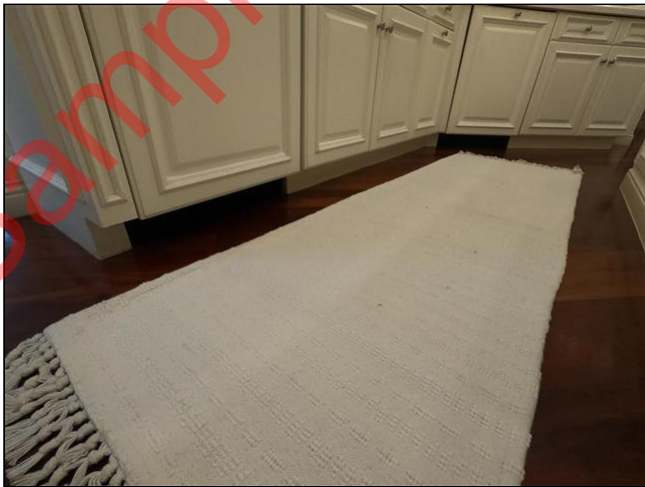
Inspector found no deficiencies with the floors in the kitchen.

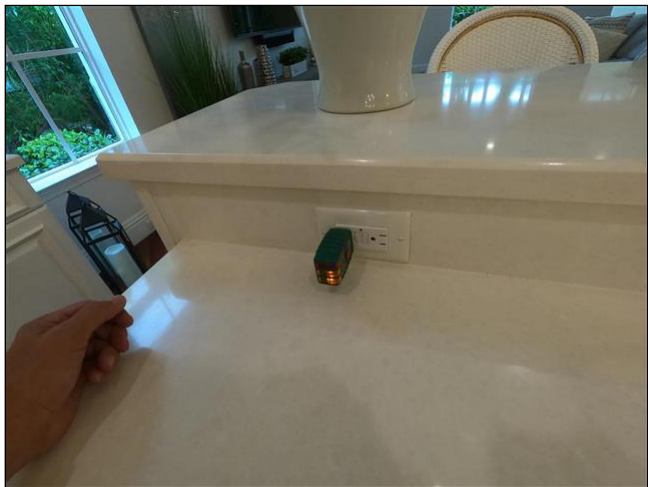
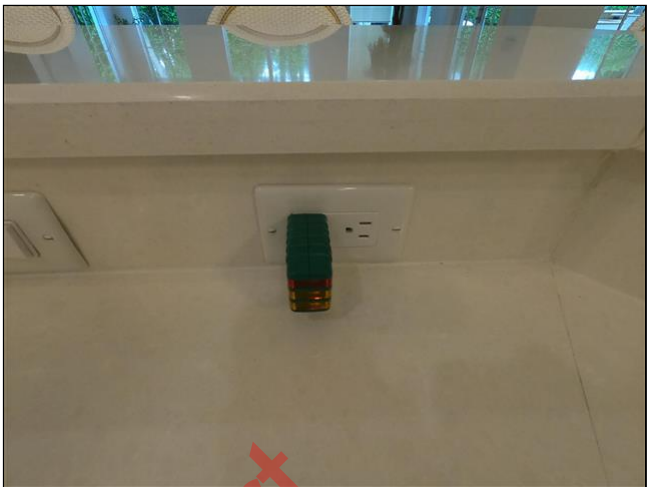
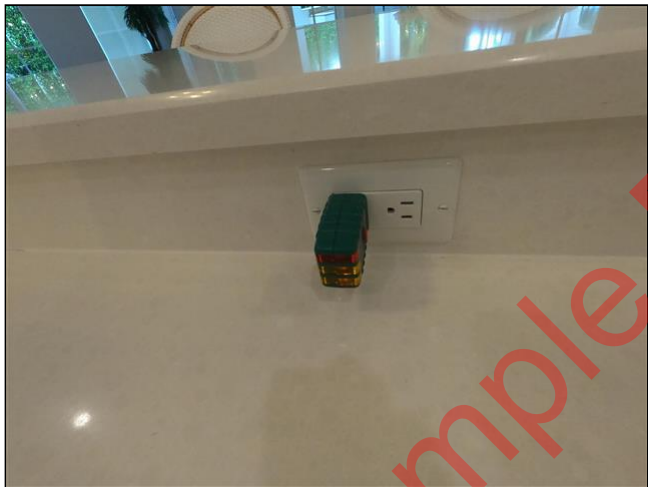
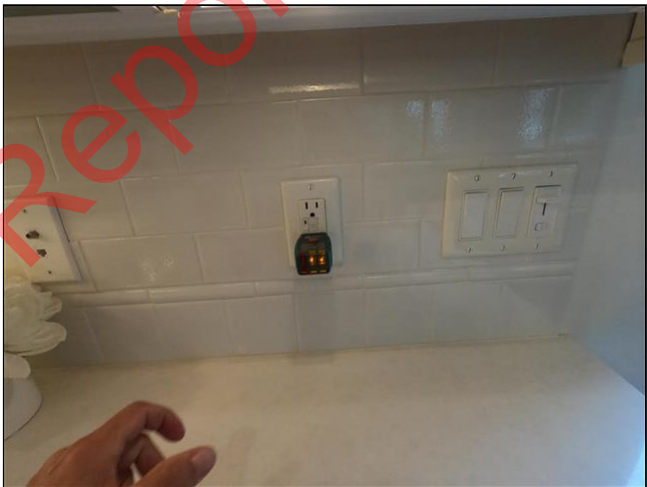
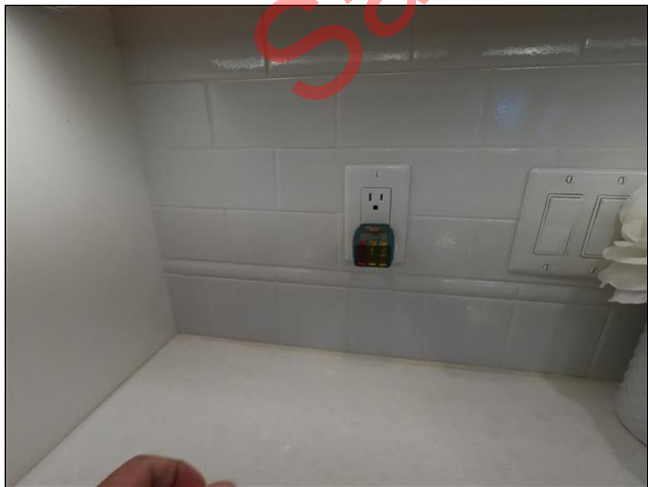
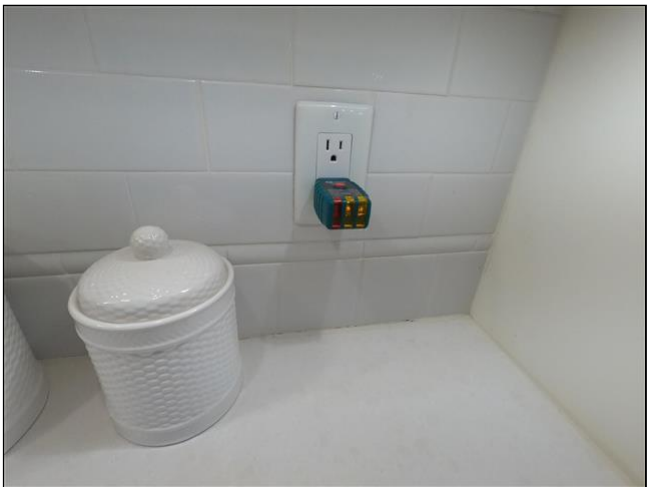
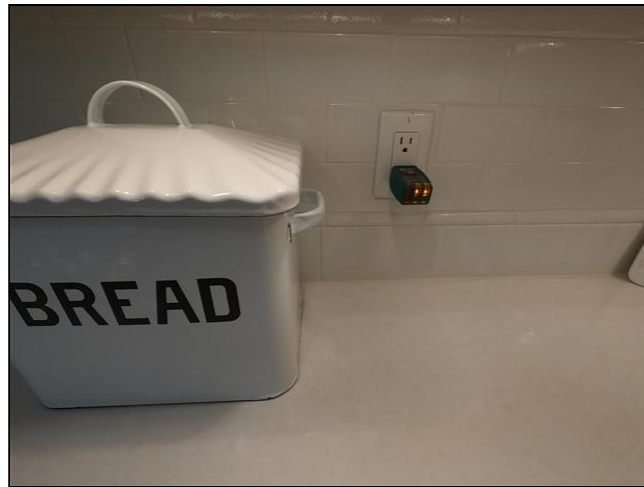
At the time of the inspection, the Inspector observed no deficiencies in the condition of electrical receptacles in the kitchen.

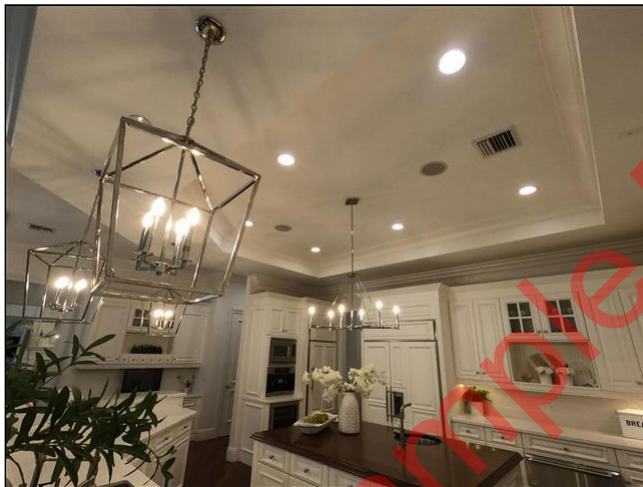
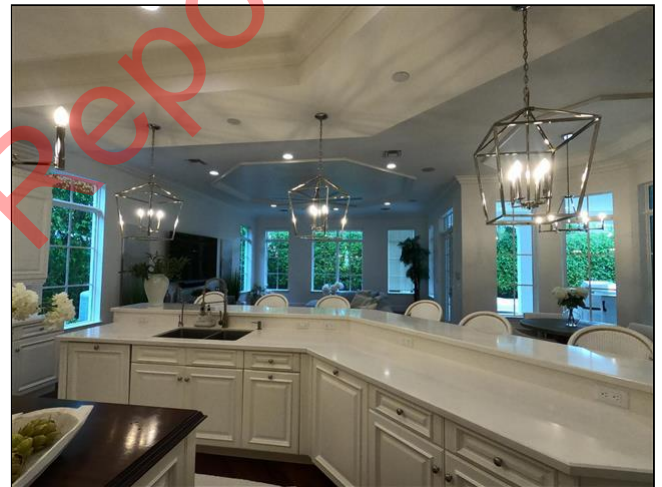
At the time of the inspection, the Inspector observed no deficiencies in the condition and operation of the kitchen lights.

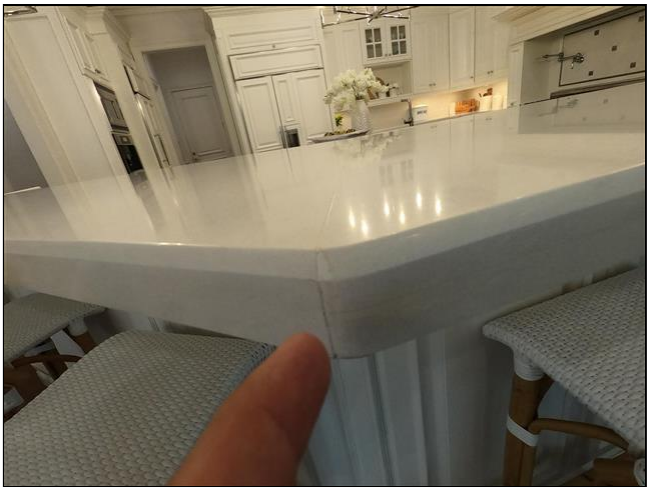
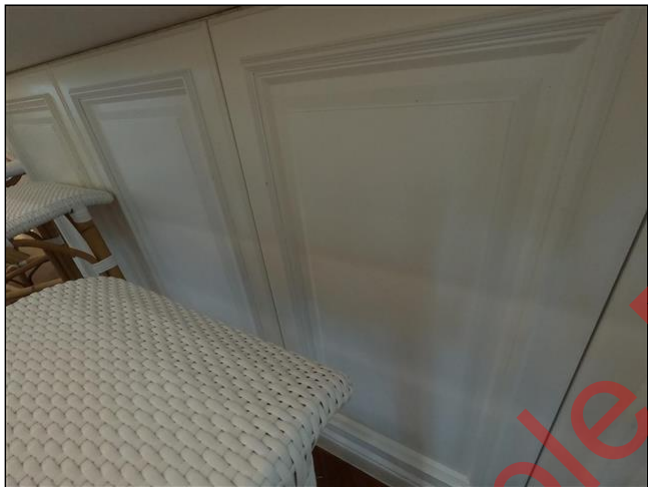
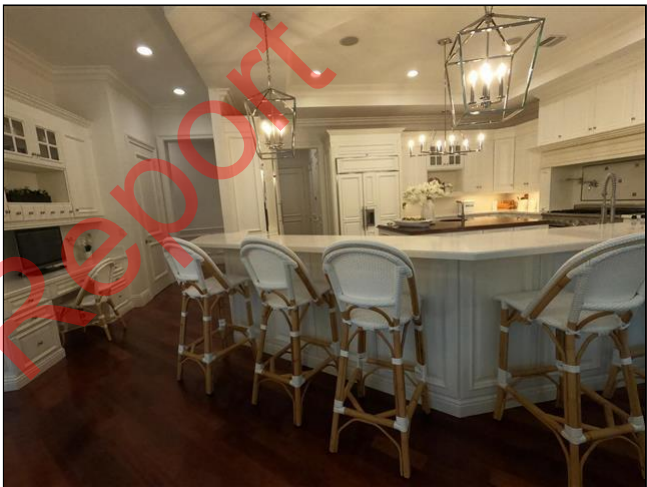
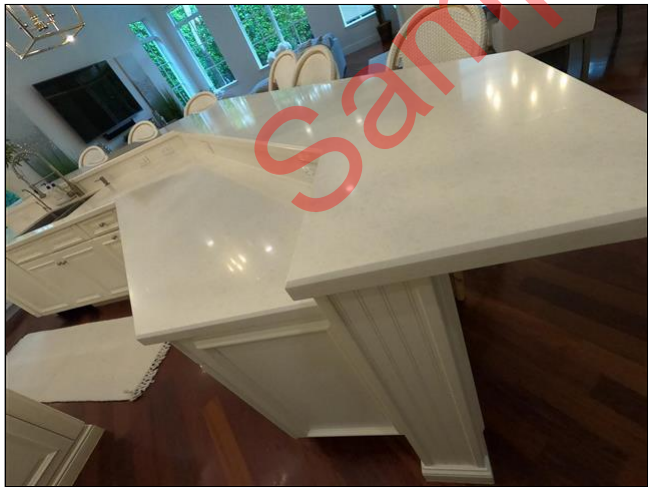
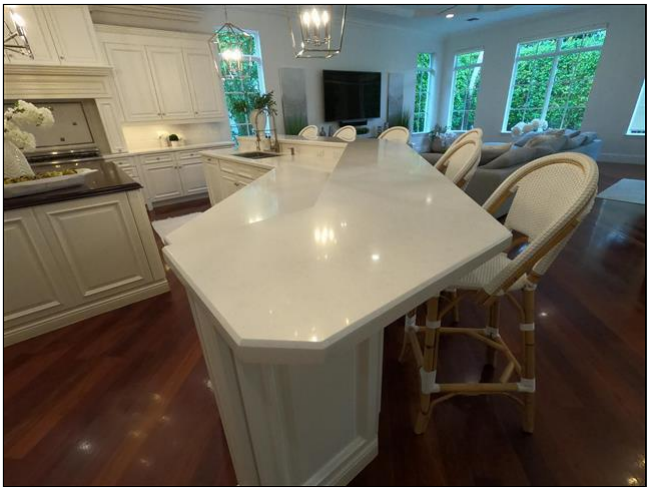
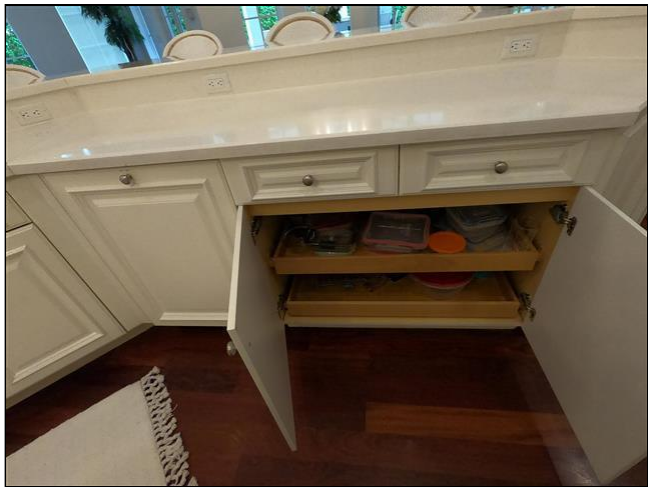
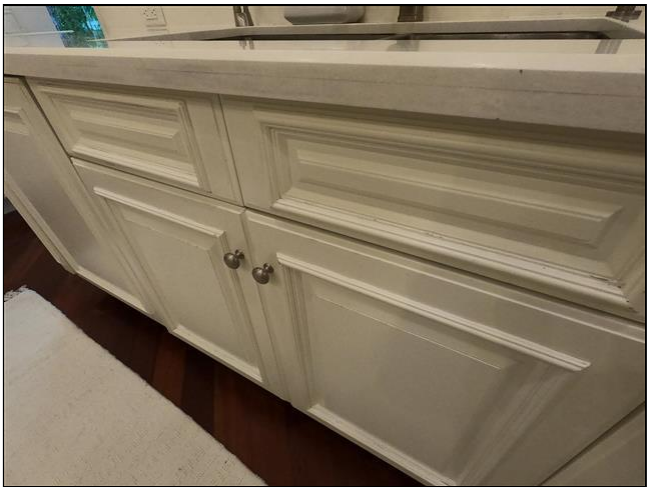
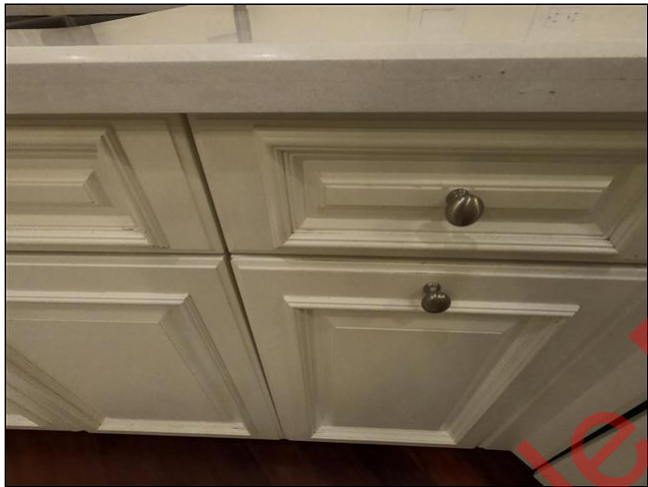
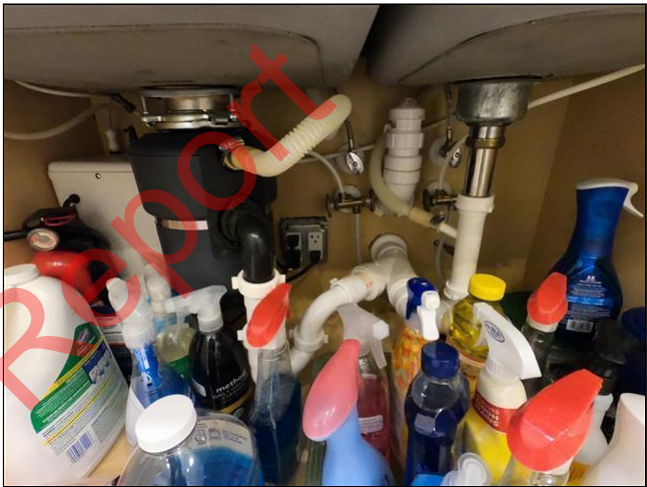
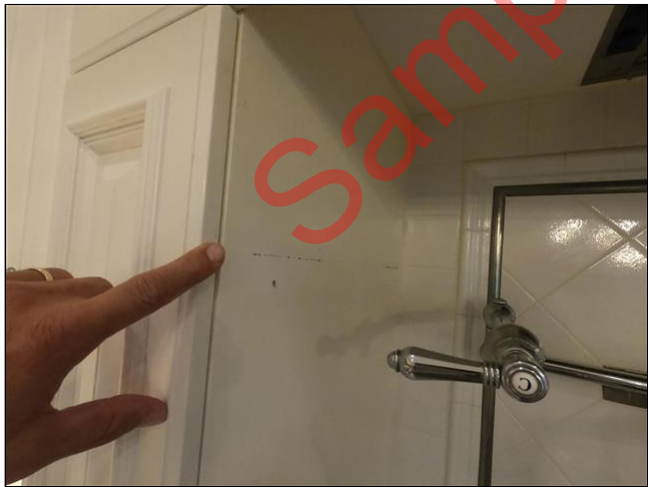
The kitchen cabinets exhibited minor general deterioration commensurate with the age of the home.

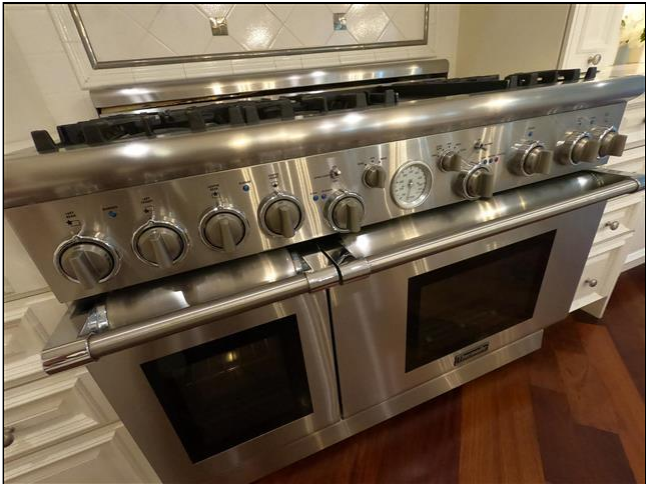
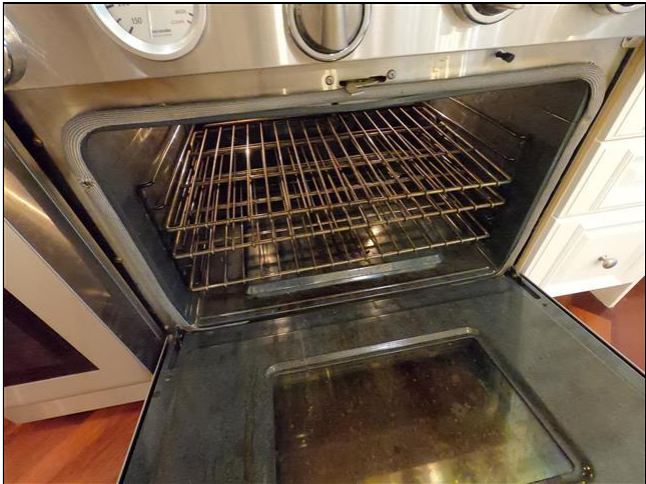
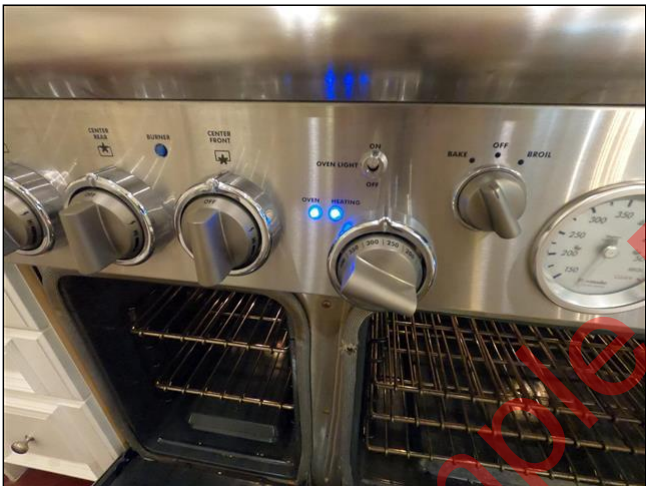
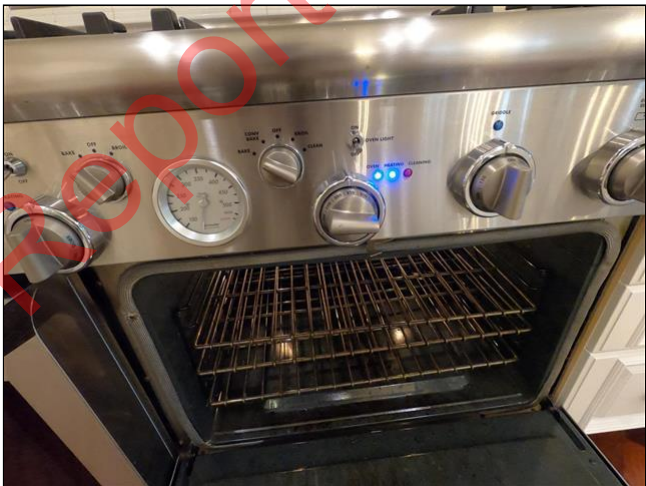
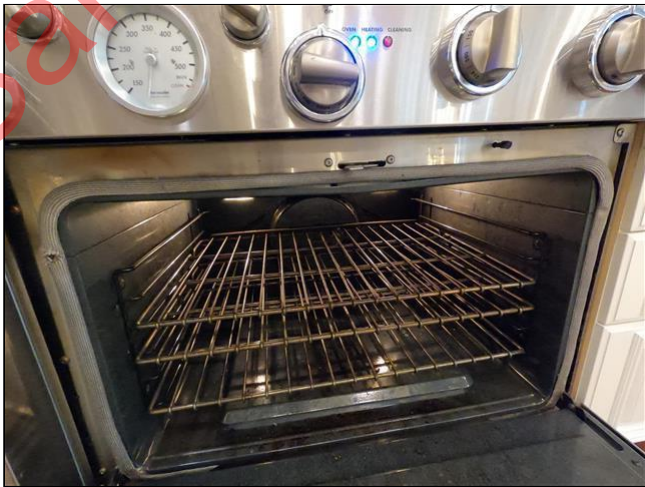
The General Home Inspection testing of ovens does not include testing of all oven features, but is limited to confirmation of bake and broil features. You should ask the seller about the functionality of any other features.
