# General Home Inspection Report

**Property Address:**

2280 W Silver Palm Rd  
Boca Raton FL 33432

**Certified Inspectors, LLC**

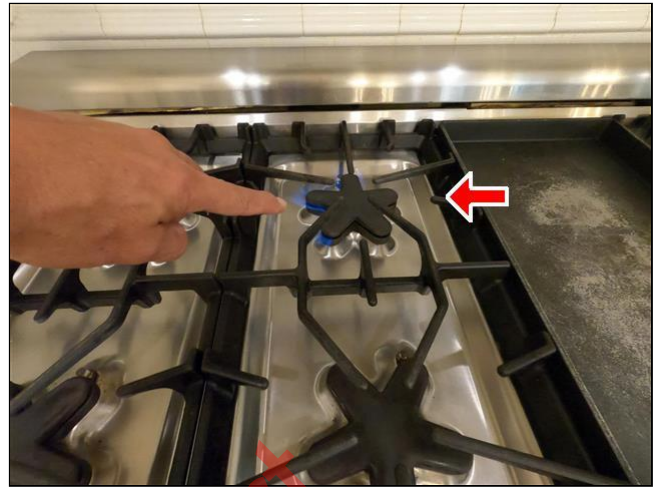
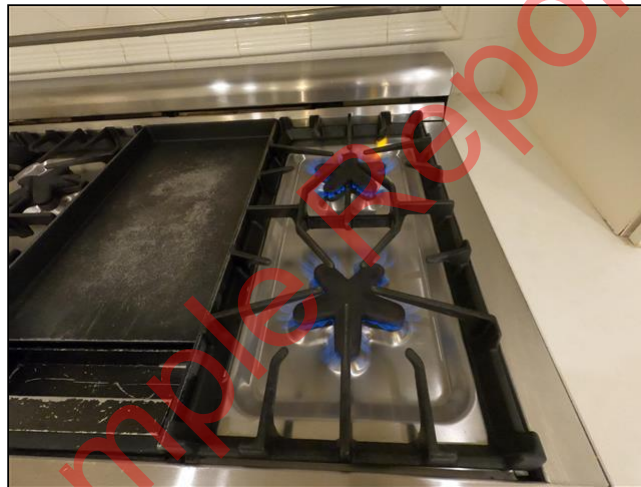
One or more cooktop gas burner failed to ignite when tested. The Inspector recommends service by a qualified technician.

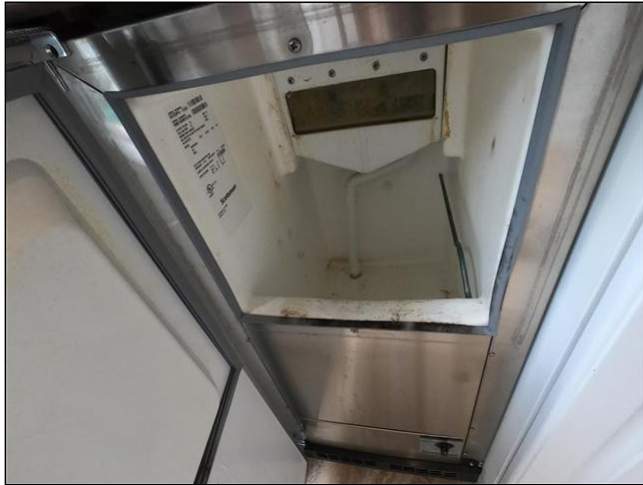
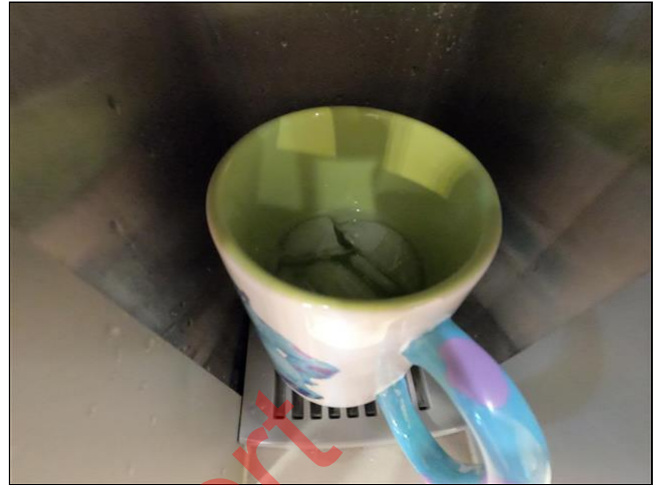
The ice maker at the bar was not functional at the time of the inspection. Recommend repairs.

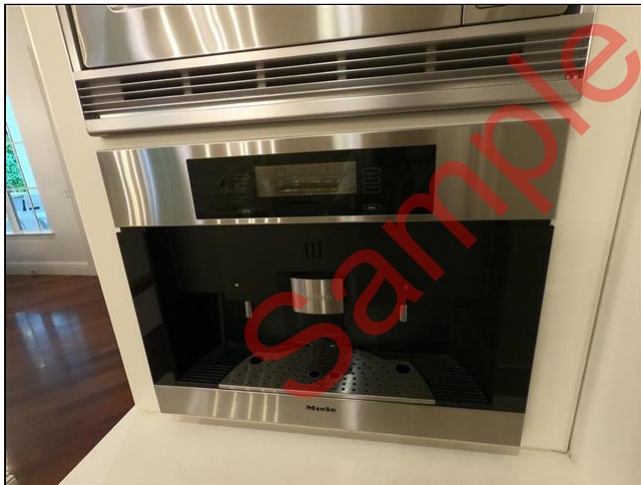
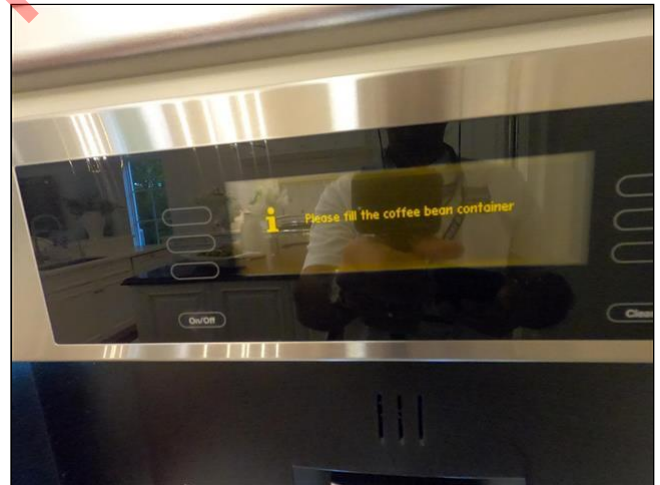
Inspector powered the coffee maker as means of observing the unit for functionality. Inspector did not test the machine through the whole coffee making cycle because this is beyond the scope of a general home inspection.

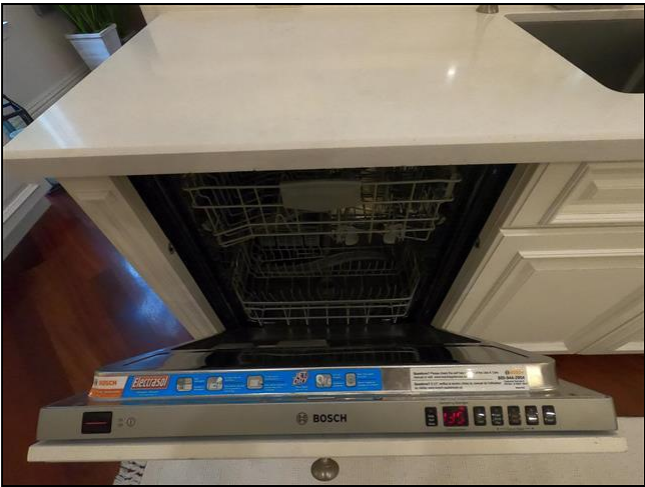
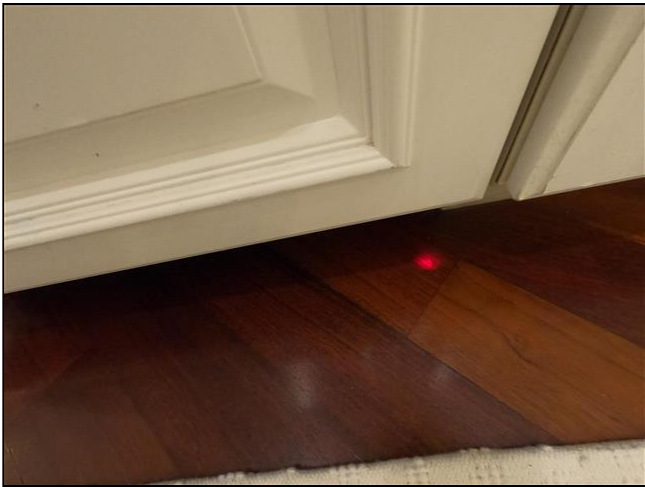
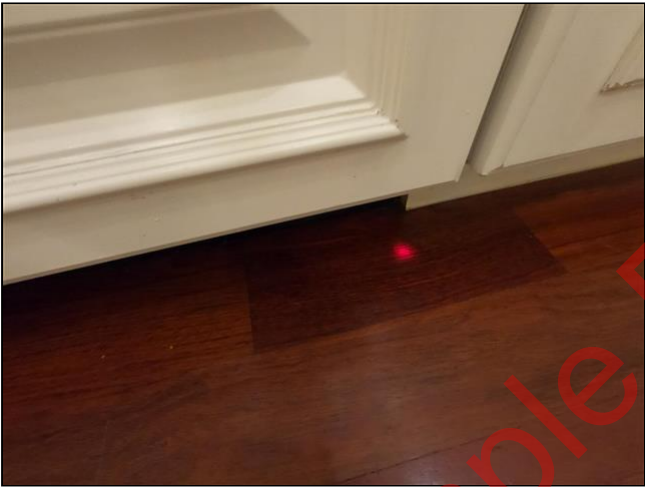
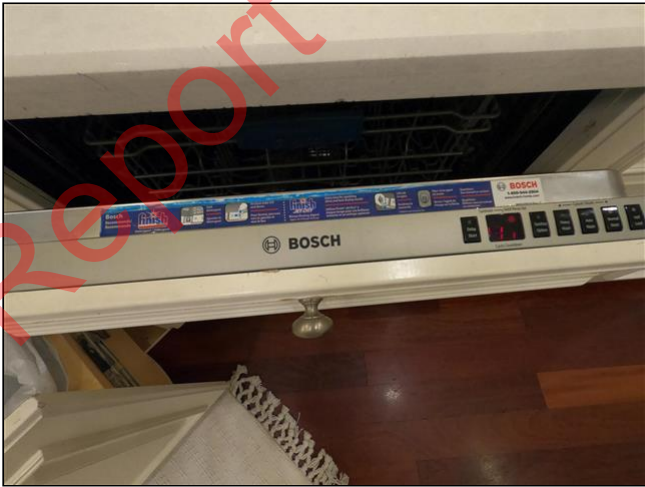
At the time of the inspection, the Inspector observed no deficiencies in the condition and operation of the dishwashers (there are 2). The were operated through a cycle.

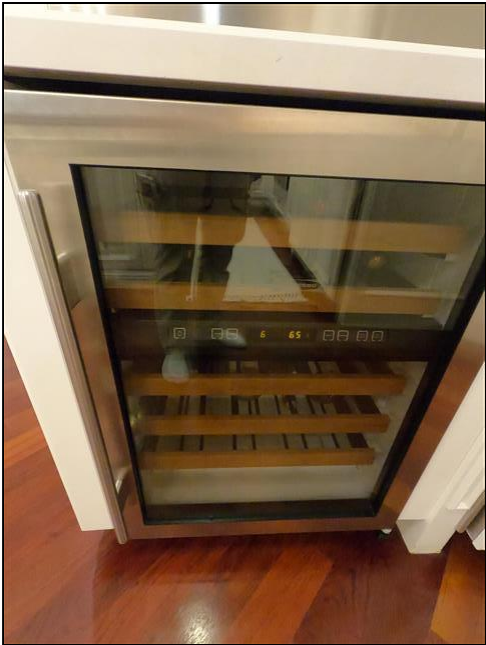
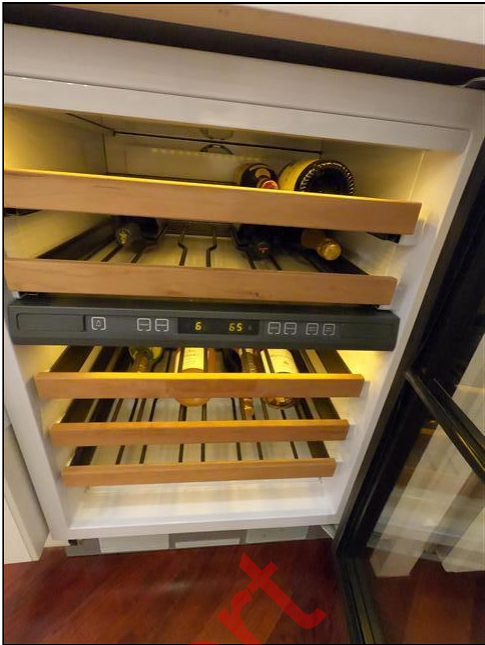
No deficiencies.

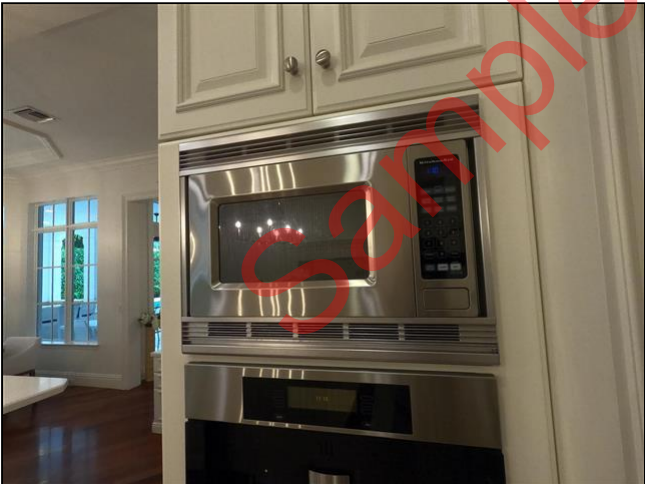
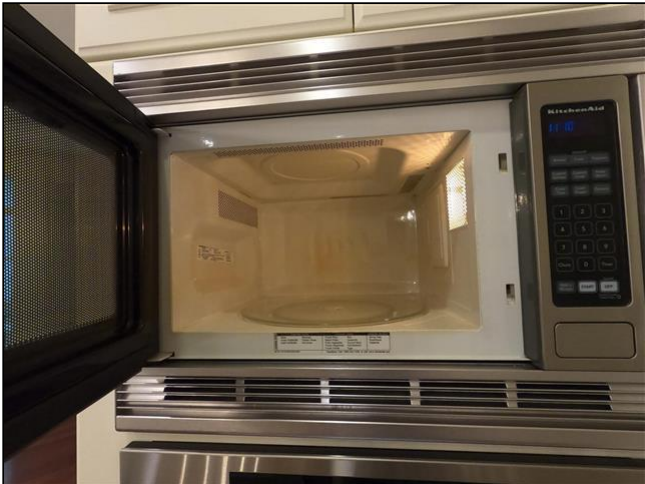
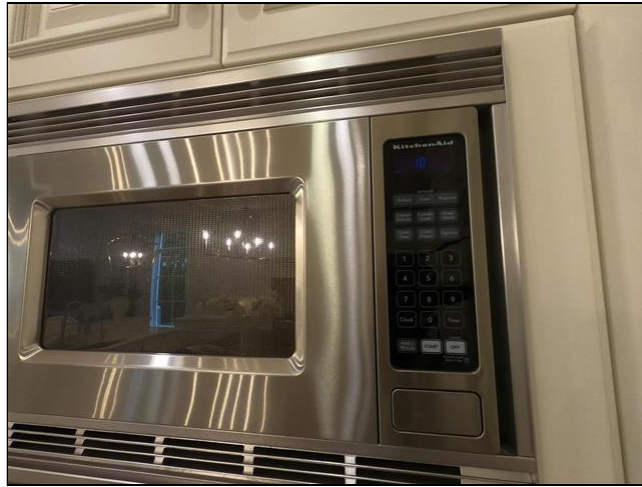
At the time of the inspection, the Inspector observed no deficiencies in the condition and operation of the built-in microwave oven. Built-in microwave ovens are tested using normal operating controls. Unit was tested and appeared to be serviceable at time of inspection. Leak and/or efficiency testing is beyond the scope of this inspection. If concerned, you should seek further evaluation by qualified technician prior to closing.

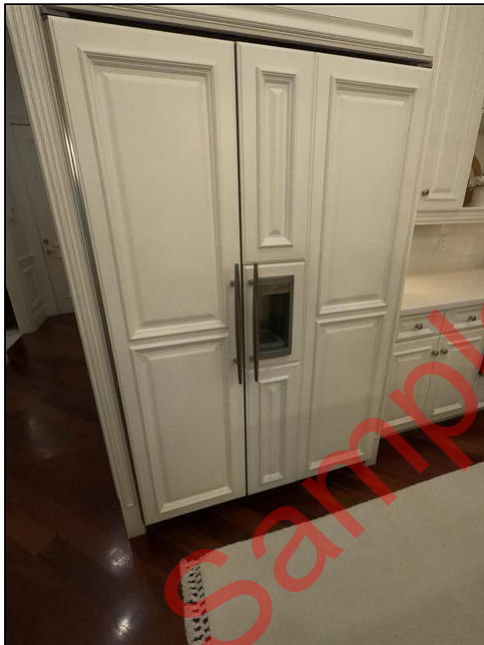
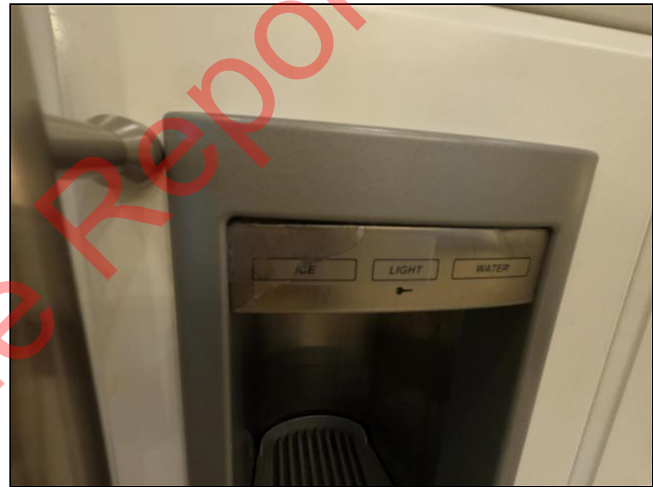
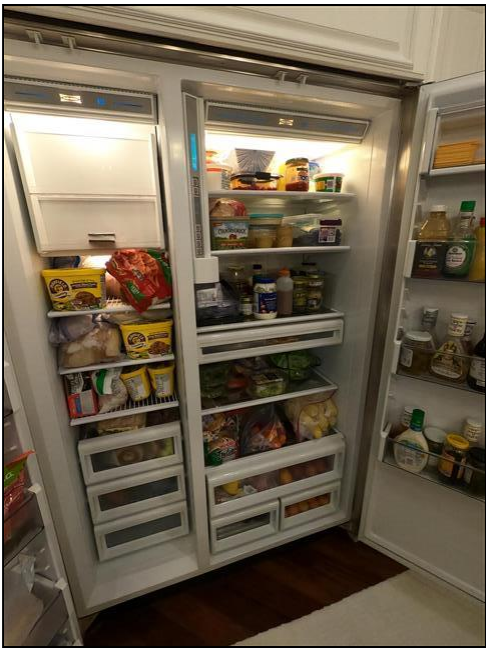
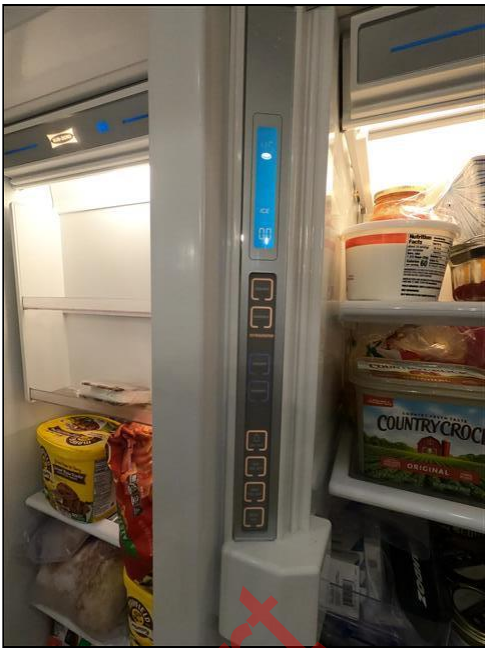
At the time of the inspection, the Inspector observed no deficiencies in the condition of the refrigerator.

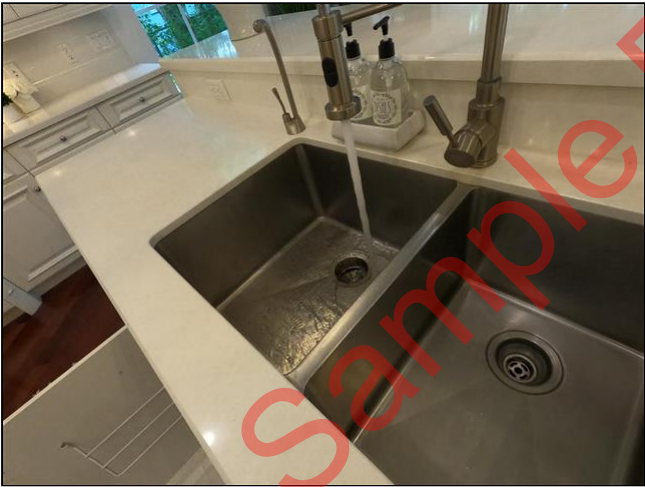
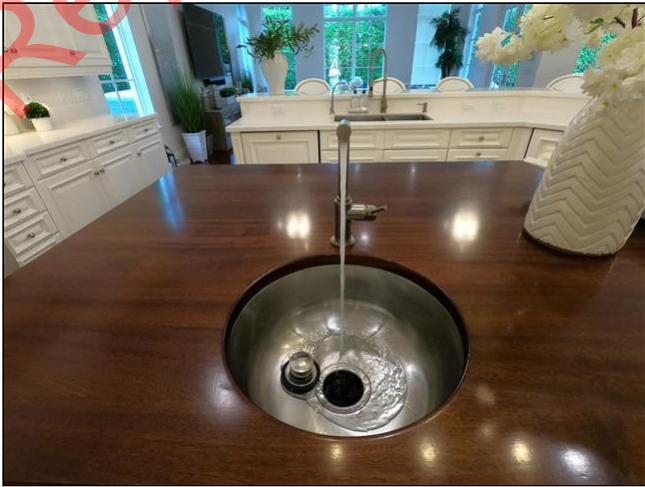
Inspector found no deficiency with the condition of this item at the time of the inspection.

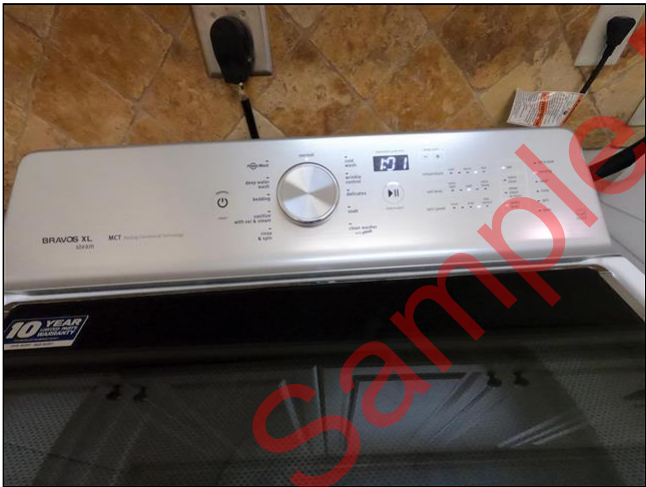
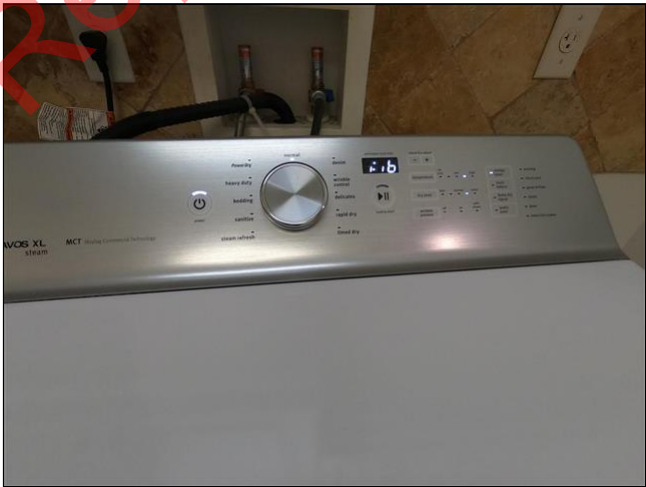
Inspected  
Inspector found no deficiencies with the condition of the washer and dryer at the time of the inspection.

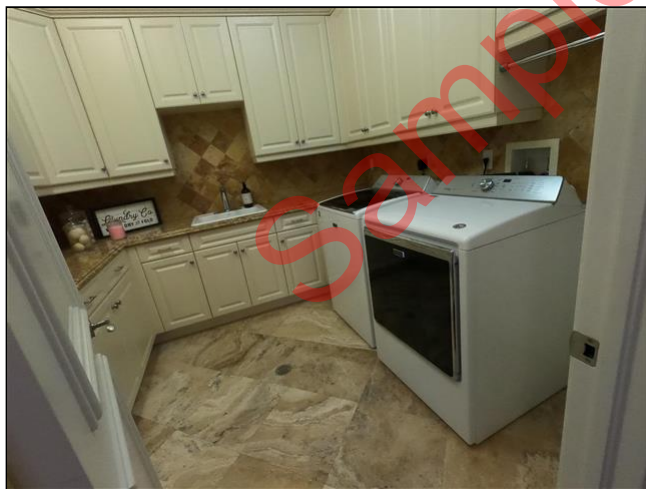
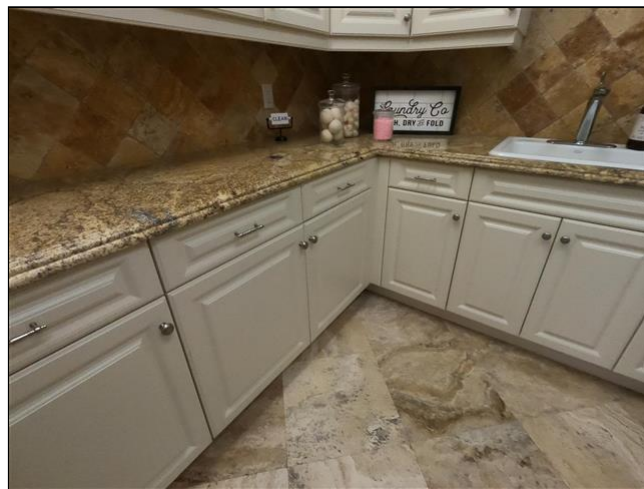
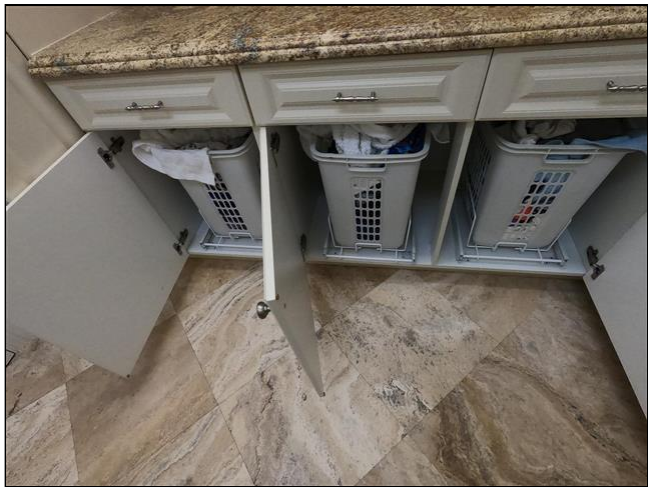
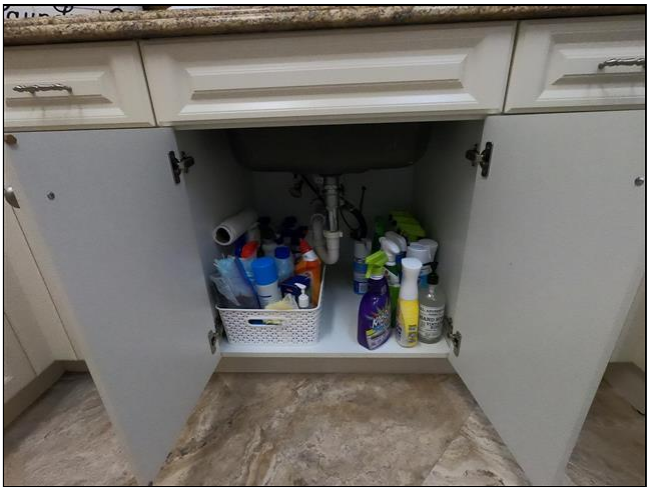
At the time of the inspection, the Inspector observed no deficiencies in the condition of most cabinets in the laundry room.

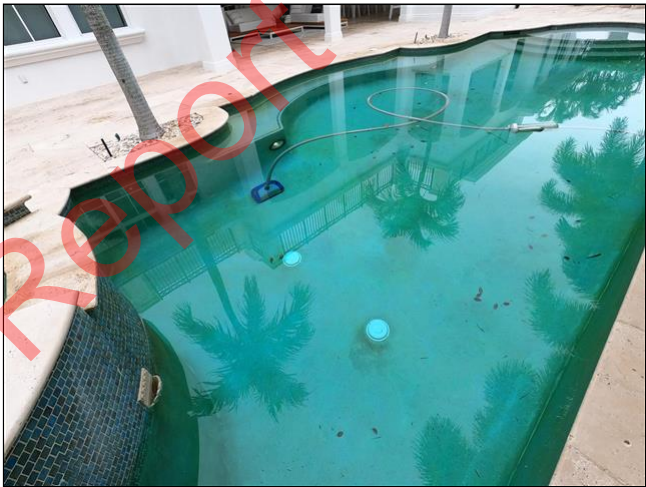
15.1 Item 2 (Picture)

The vessel was constructed of concrete. The pool appeared to have chemical damage resulting in scaling of the portions exposed to water. The Inspector recommends that before the expiration of your Inspection Objection Deadline you consult with a qualified contractor to discuss options and costs for actions that will reduce continuing damage.

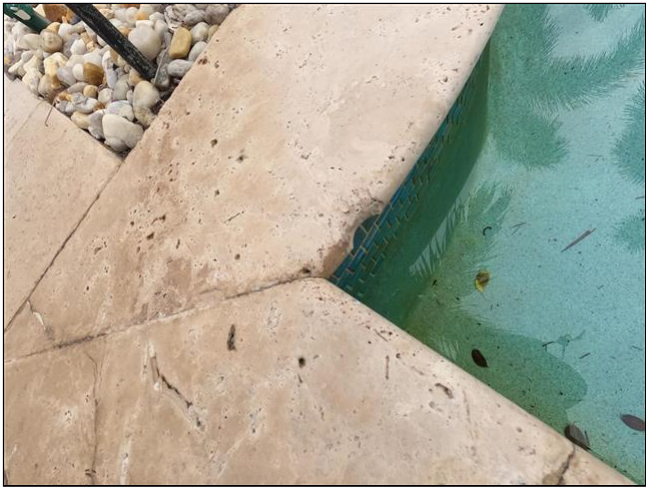
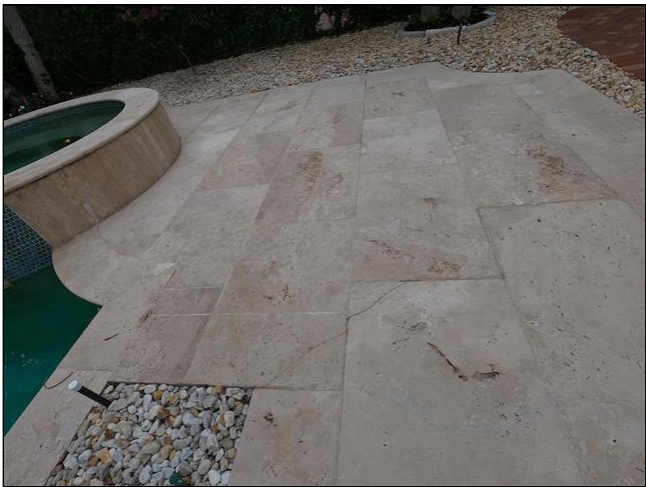
The pool had weathered tile decking. There was one area that had some cracked tiles. Recommend repairs.

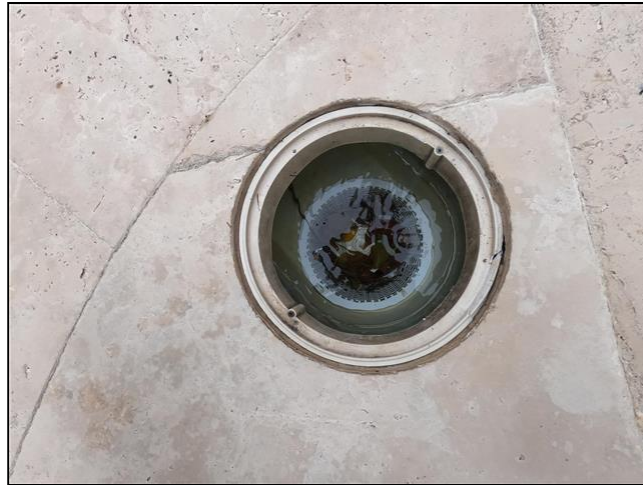
15.5 Item 1 (Picture)

No deficiencies detected.

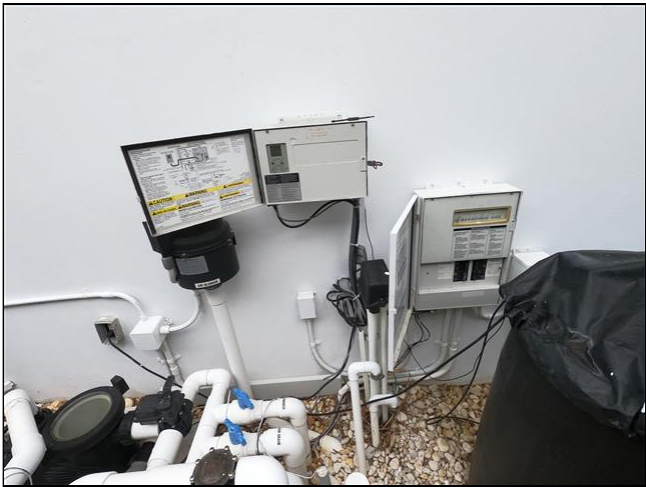
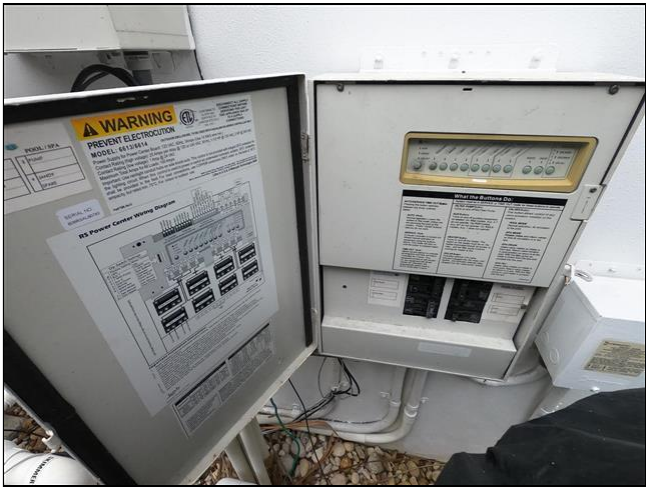
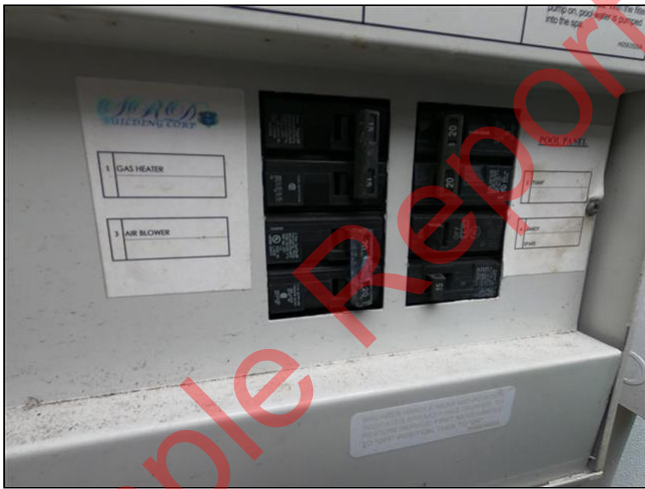
The main disconnect for the pool electrical equipment was located in the service panel located within sight of the ;pool.

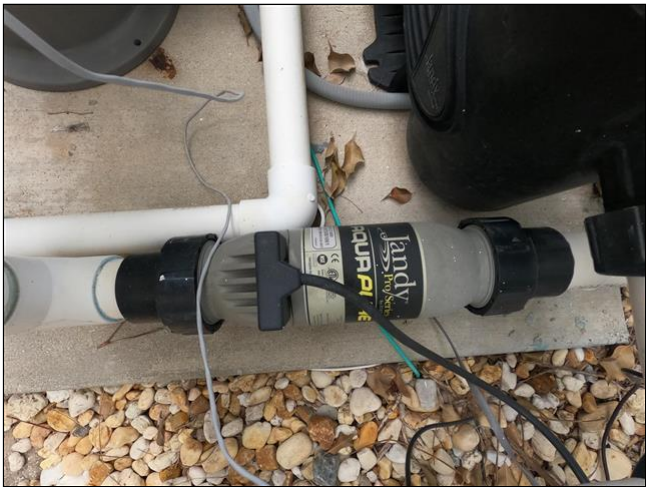
15.8 Item 2 (Picture)

The salt chlorinator was not functional. Recommend repairs.

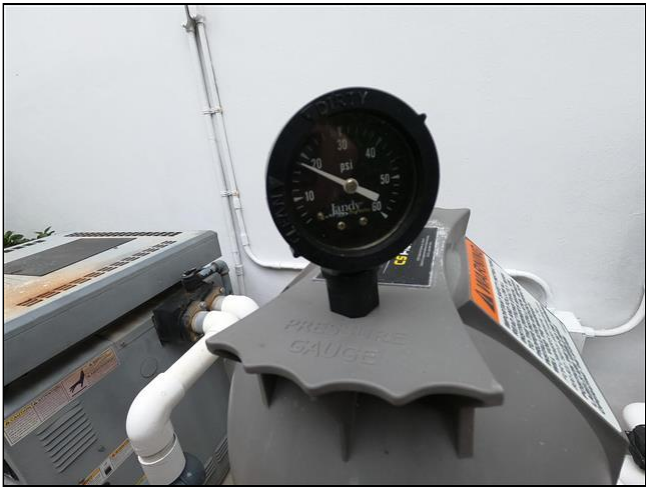
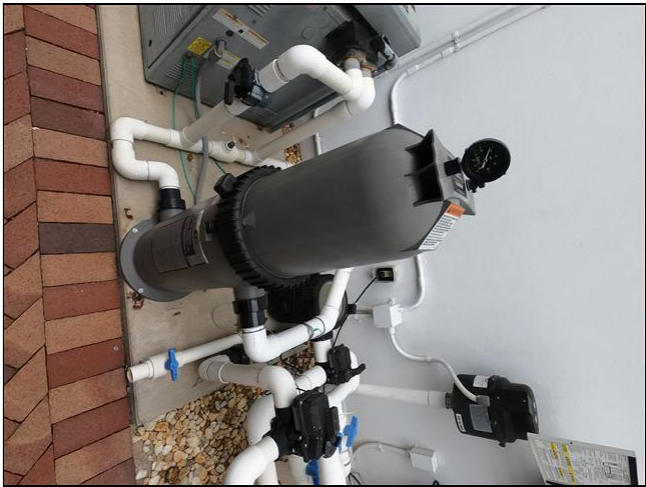
At the time of the inspection, the Inspector observed no deficiencies in the condition and operation of the pool filtration system.

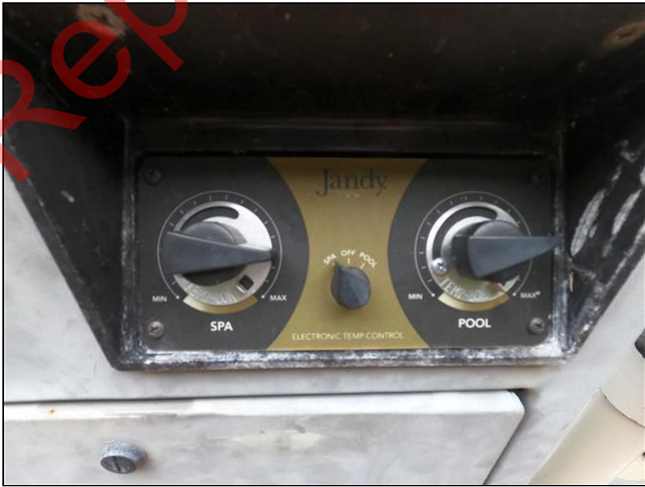
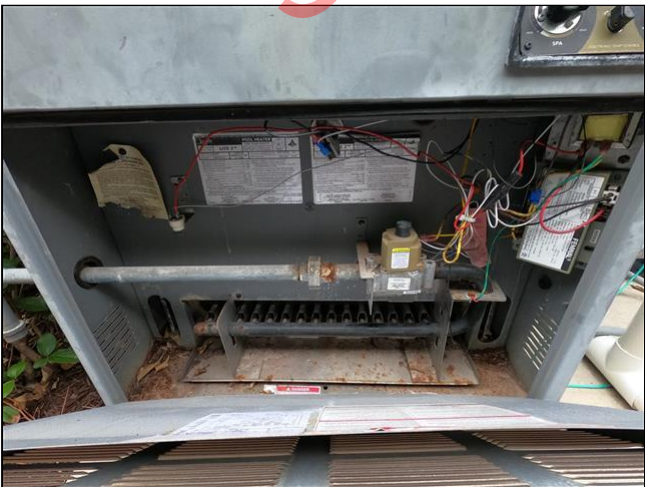
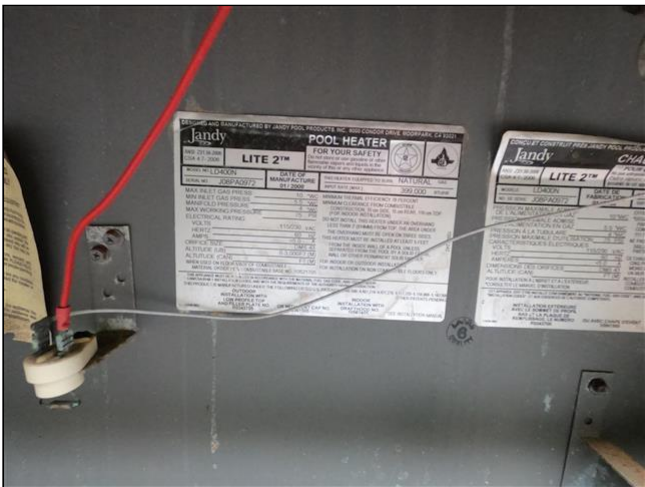
The heater was not functional at the time of the inspection. The burner underneath would not light up. Recommend repairs.

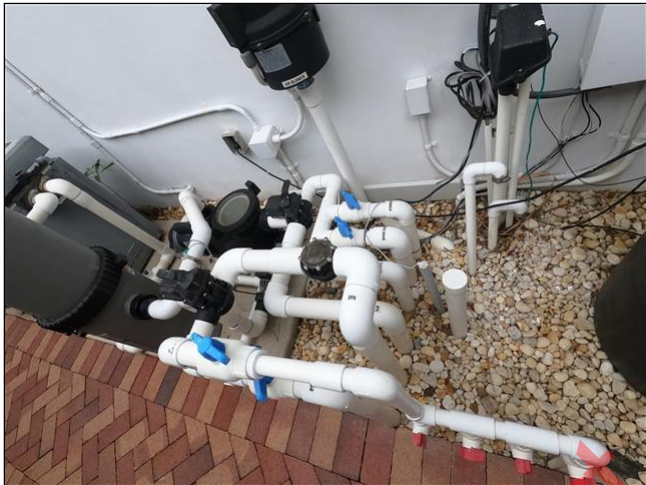
15.11 Item 1 (Picture)

At the time of the inspection, the Inspector observed no deficiencies in the condition of the plumbing pipes.

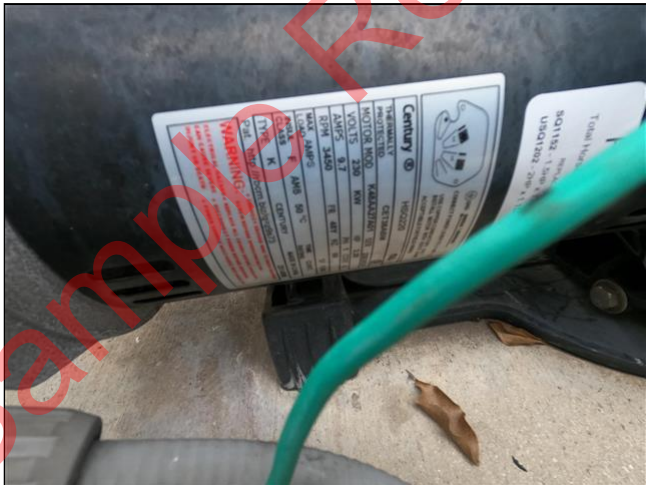
15.12 Item 1 (Picture)

At the time of the inspection, the Inspector observed no deficiencies in the condition and operation of the swimming pool pump.

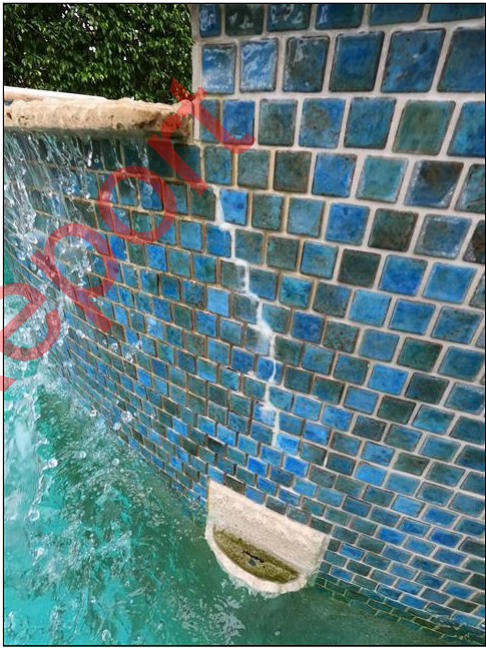
16.0 Item 2 (Picture)

The exterior of the SPA exhibited efflorescence. Recommend repairs. Efflorescence is generally a mineral or salt crystalline compound found in the ground and within concrete that dissolves in moisture that migrates up through the ground and concrete to the tile surface where the moisture evaporates leaving an expansive salt residual.

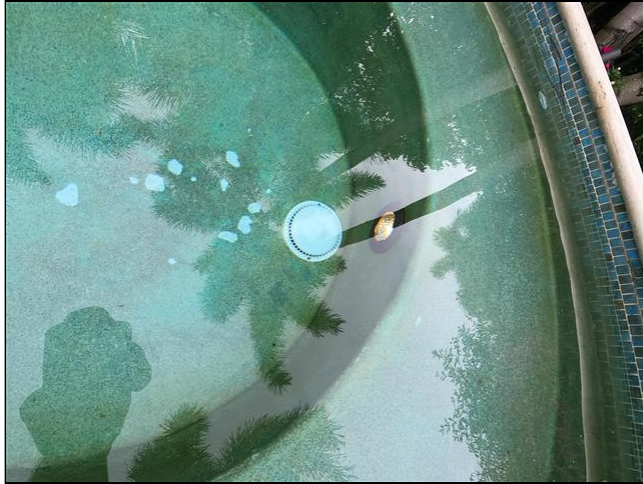
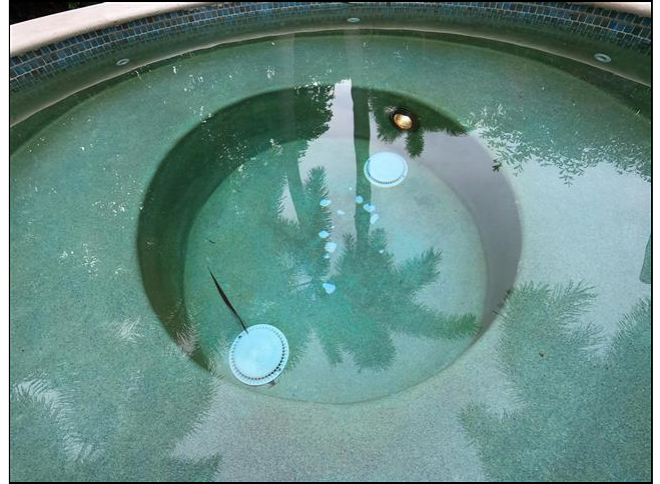
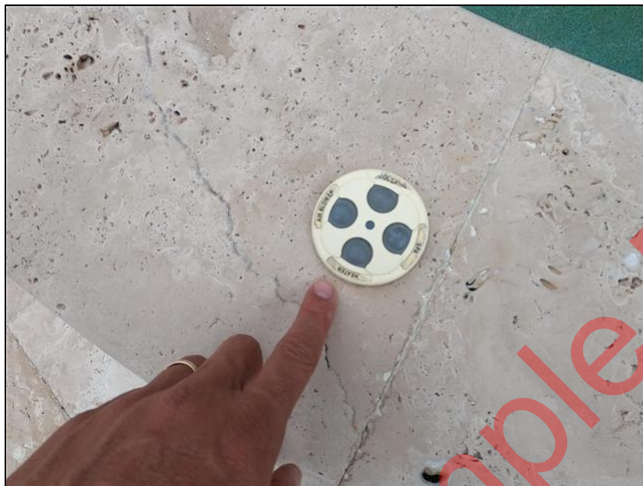
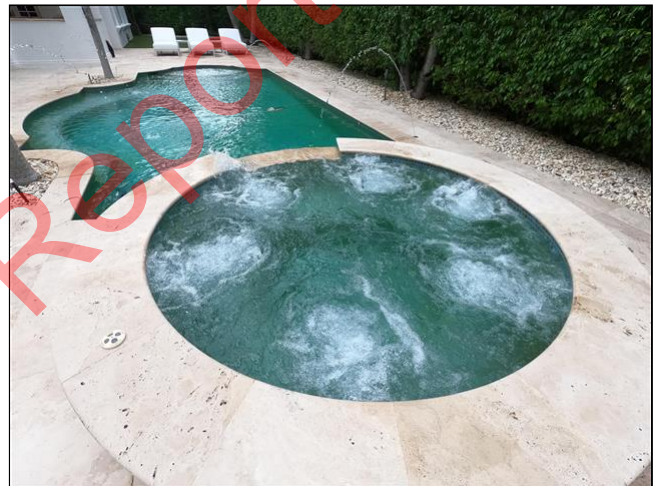
The SPA appeared to have chemical damage resulting in scaling of the portions exposed to water. The Inspector recommends that before the expiration of your Inspection Objection Deadline you consult with a qualified contractor to discuss options and costs for actions that will reduce continuing damage.
