# Home Inspection Report

**Property Address:**

424 NE 5th St  
Boca Raton FL 33432

**Certified Inspectors, LLC**

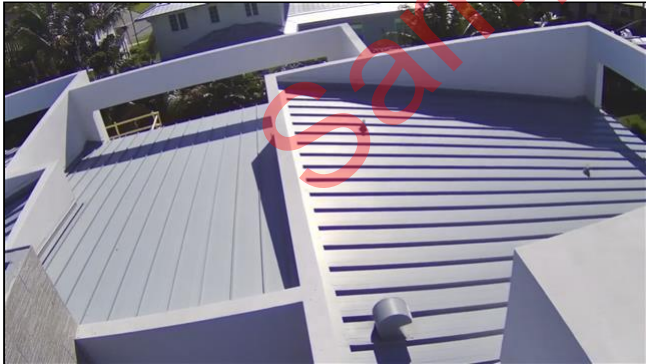
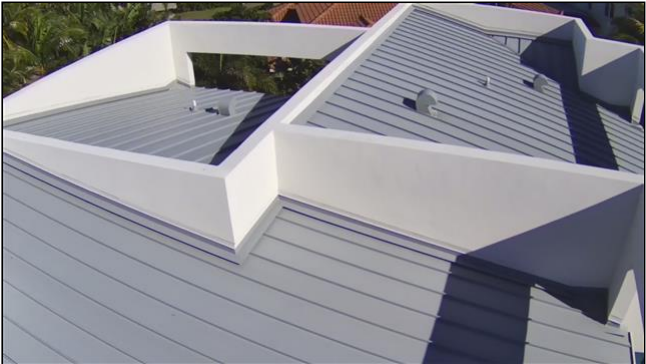
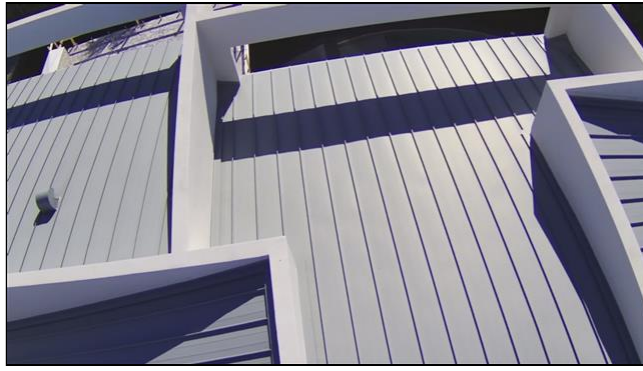
Inspector inspected the roof by Drone. The roof was built in 2017. It is a combination of Metal seam roof and roll roof in some areas. The inspector observed no deficiencies in the condition of the roof structure exterior.

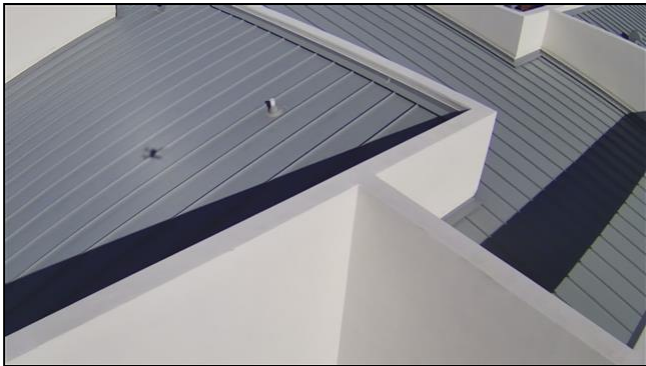
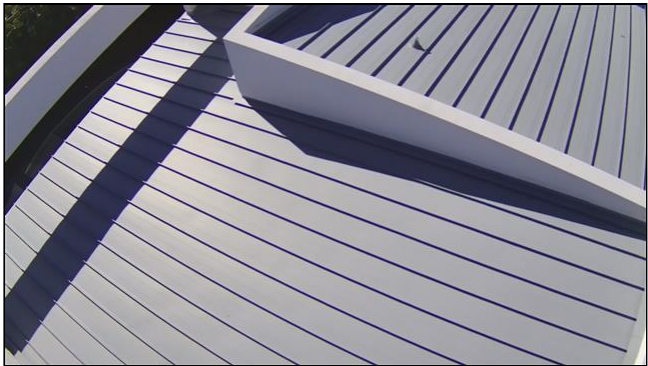
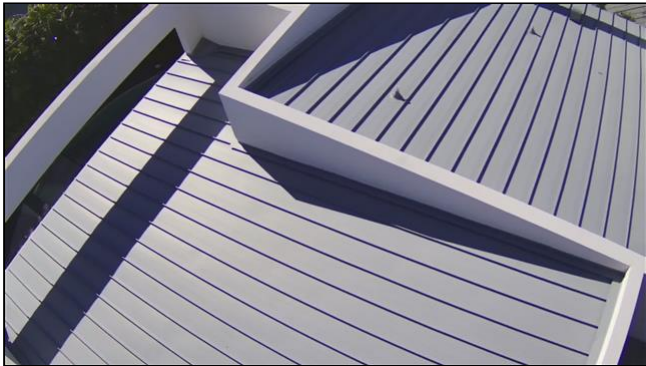
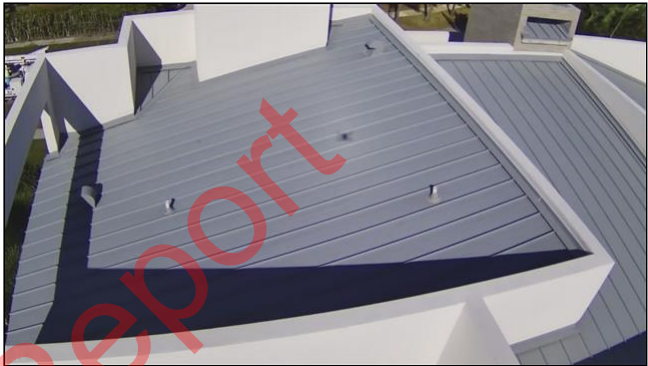
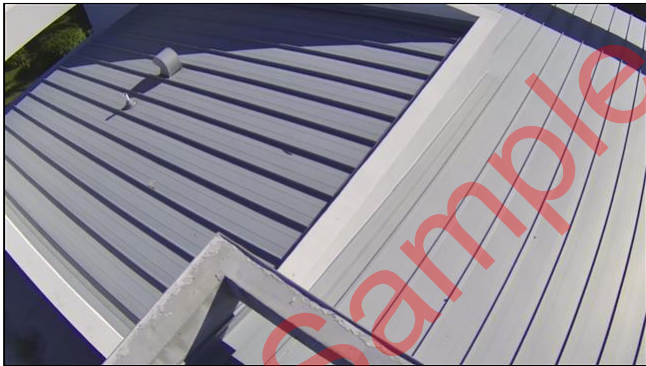
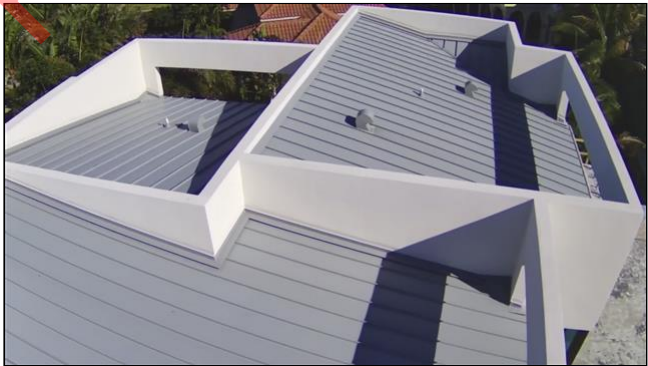
At the time of the inspection, the Inspector observed no deficiencies in the condition of the metal roofing-covering material.

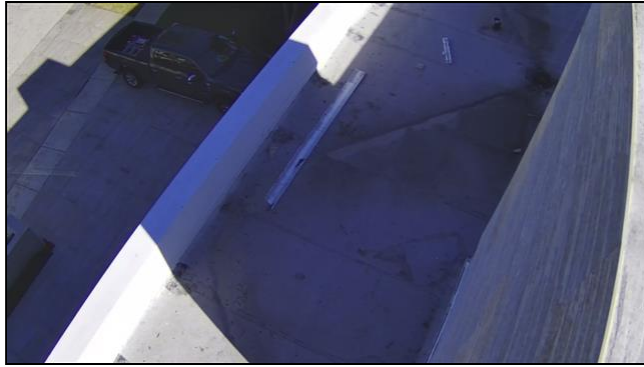
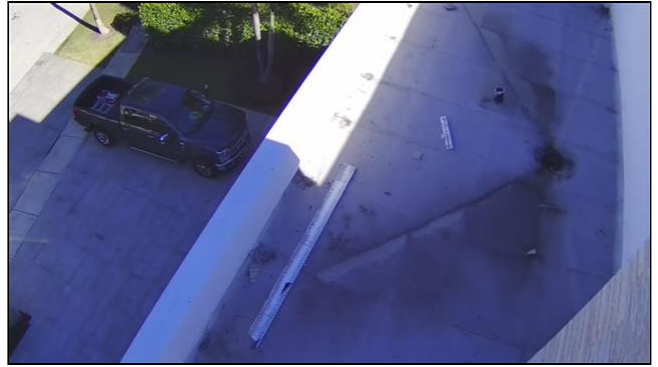
At the time of the inspection, the Inspector observed no deficiencies in the condition of the roll roofing roof-covering material.

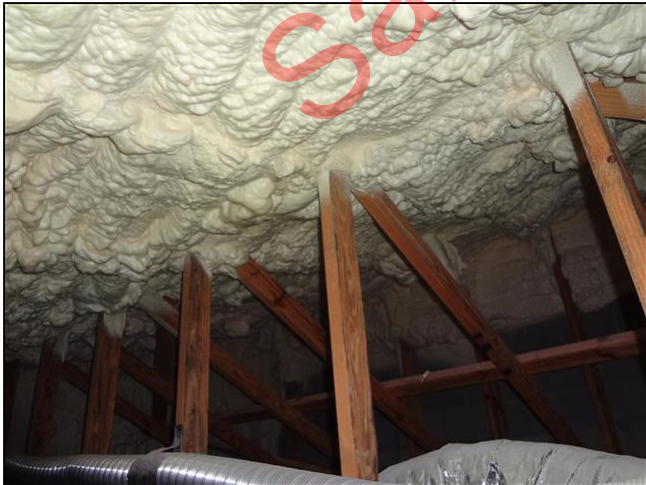
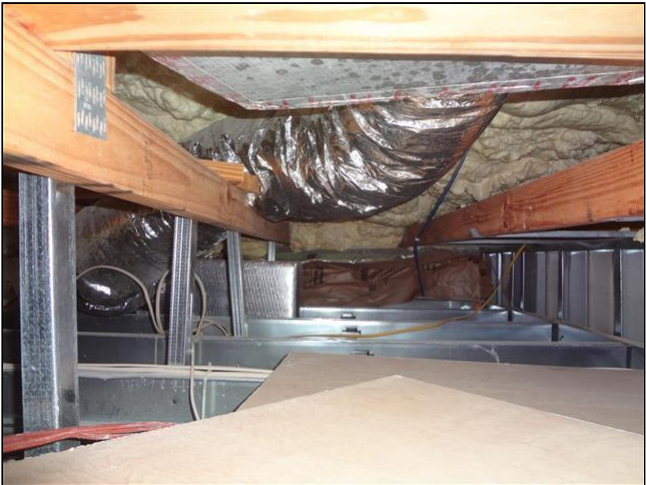
The roof framing was covered in foam insulation (Icynene) and inspector was unable to inspect the roof framing.

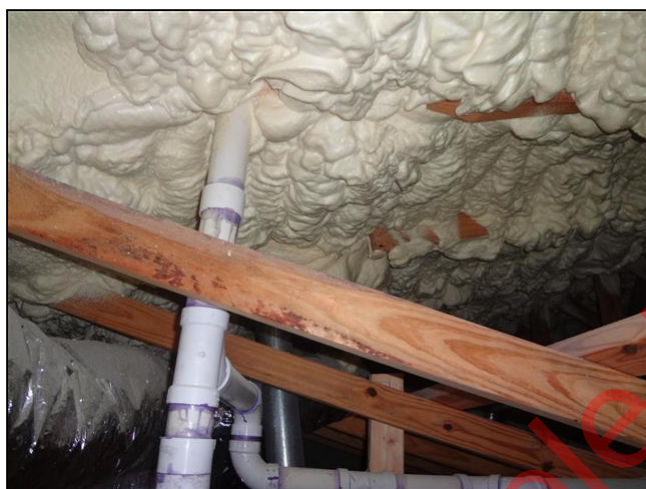
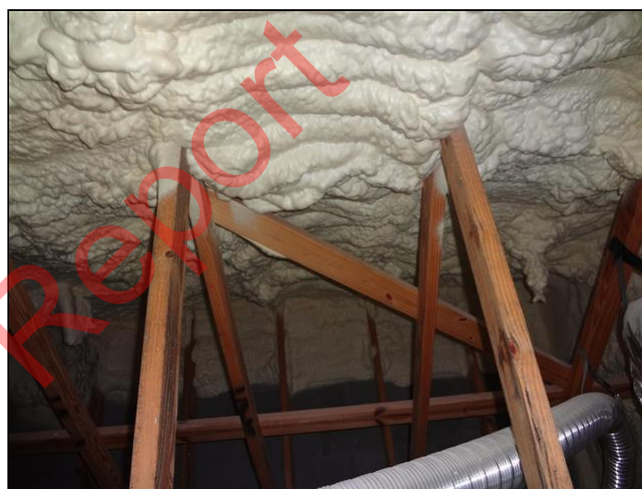
(1) Icynene insulation was the type of insulation. It provides a high performance insulation with a non-vented attic space. Inspection of the thermal envelope is limited to areas that are visible.

(2) The attic floor insulation depth averaged approximately 6 to 8 inches. The Inspector recommends installing additional insulation to comply with local energy codes

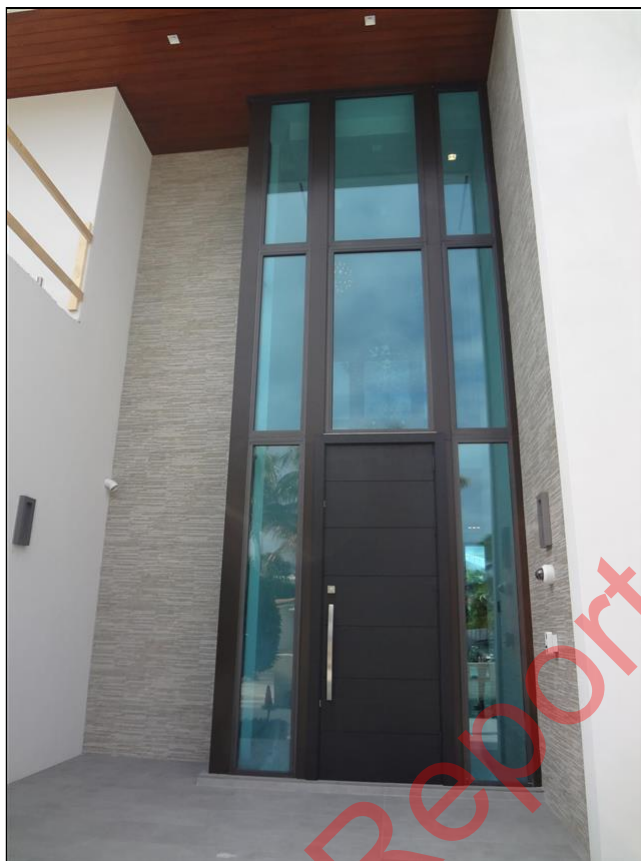
3.4 Item 1(Picture)

At the time of the inspection, the Inspector observed no deficiencies in the condition of the porch.

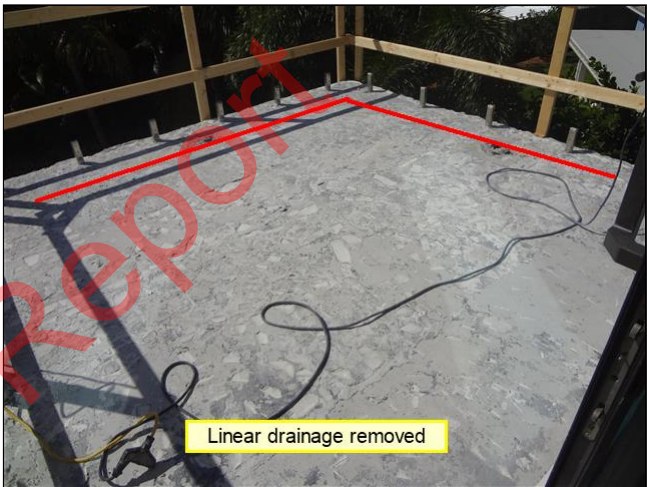
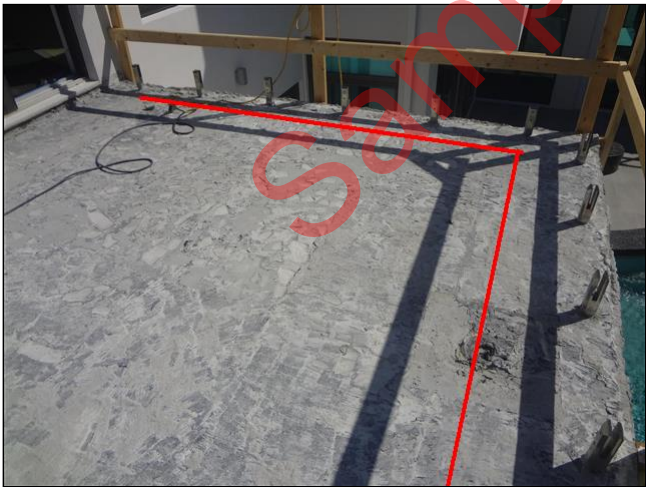
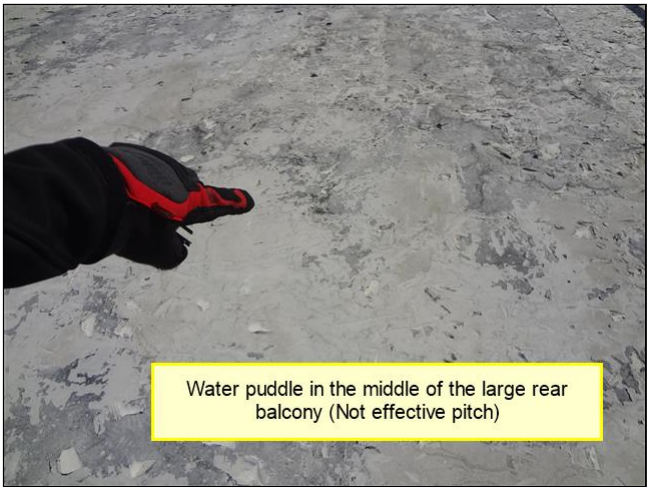
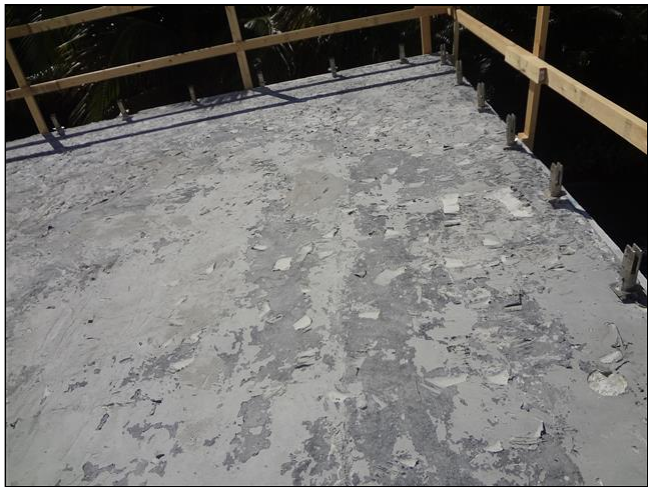
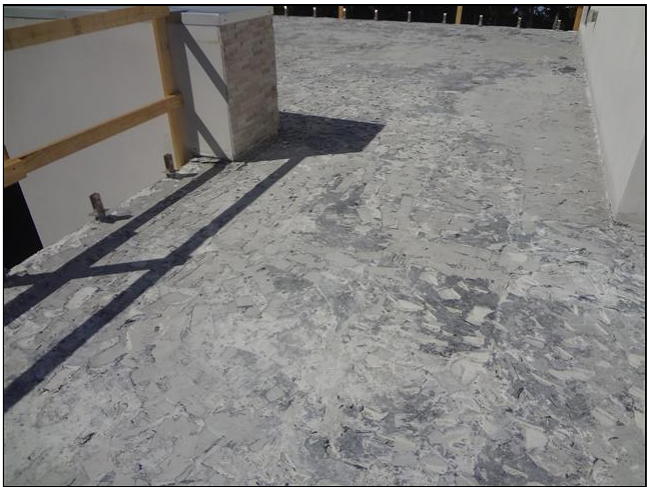
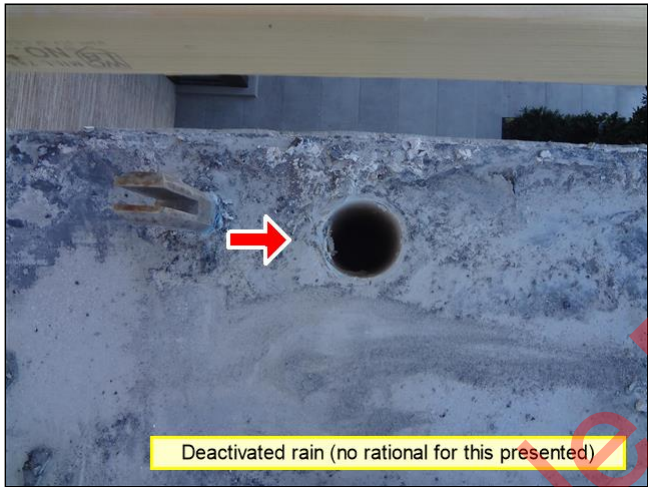
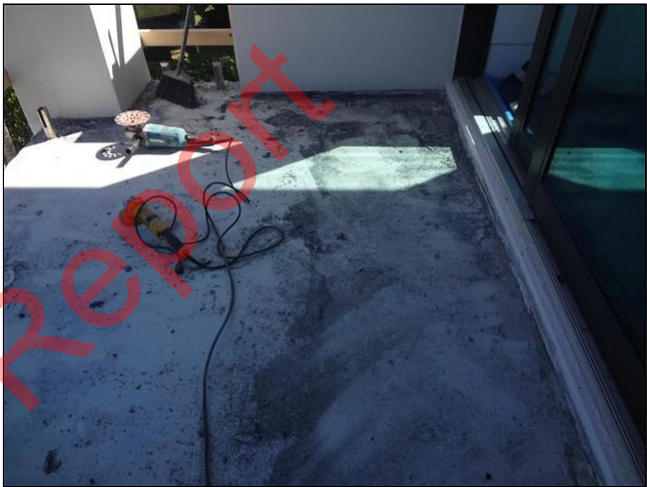
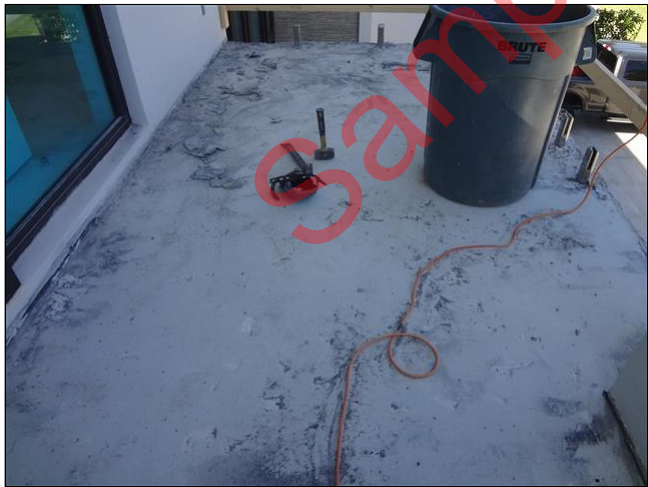
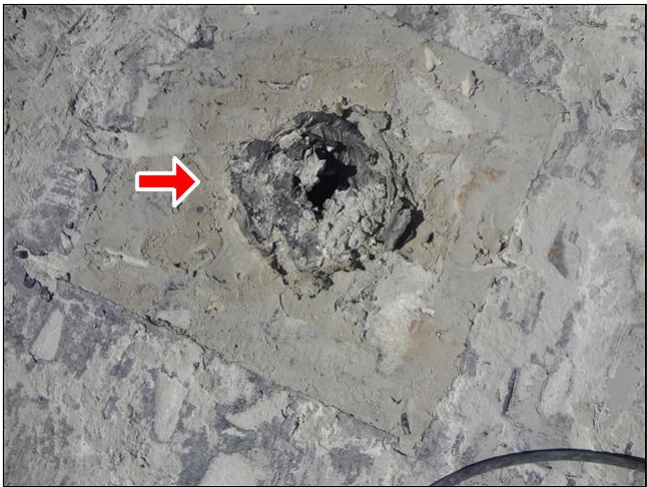
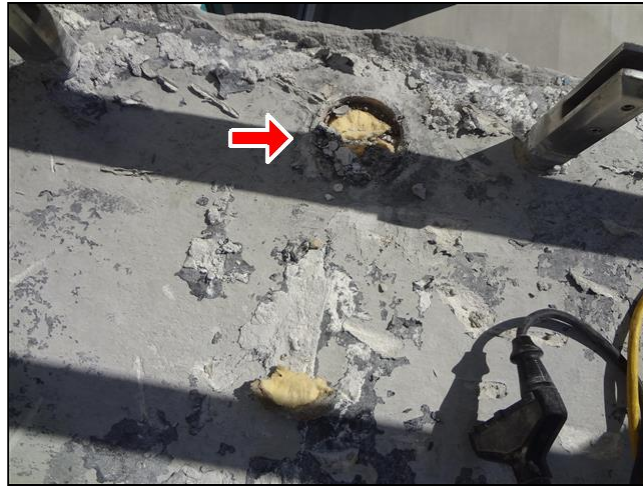
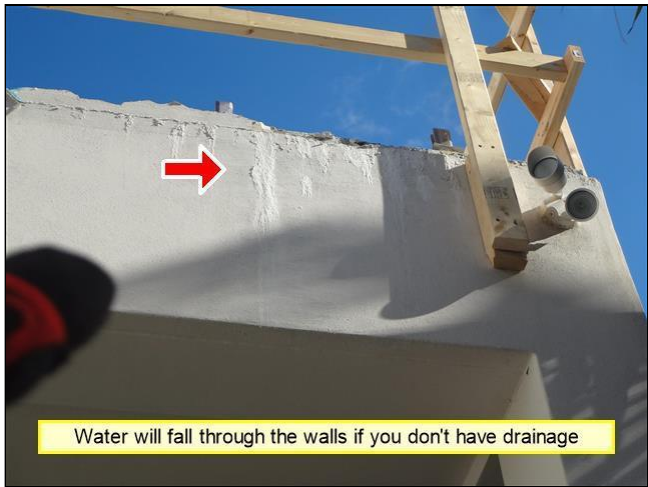
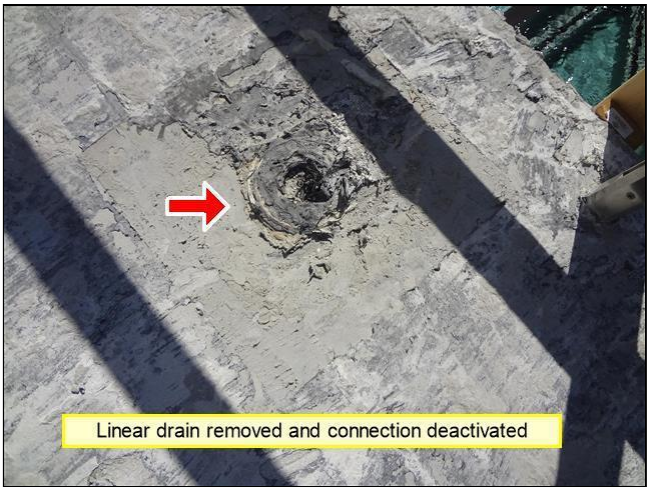
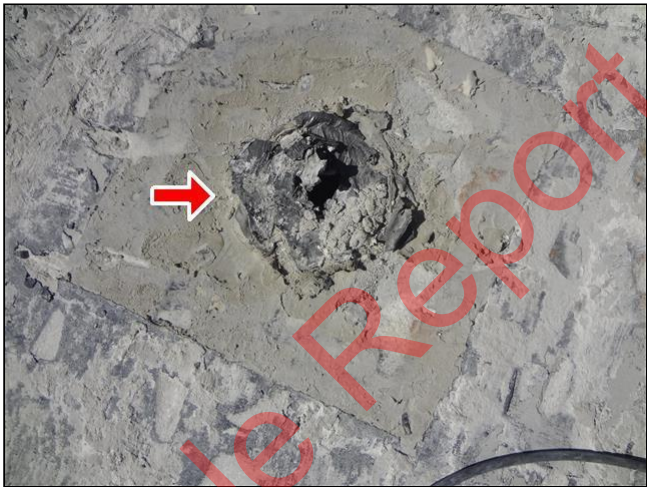
Inspector found all 3 balconies undergoing some form of repair. All balcony floors had been removed due to some kind of water infiltration. Determination of the causes of this infiltration lies beyond the scope of a General Home Inspection.

It is inspector's opinion that lack of effective drainage of rain water combined with poor weatherproofing and poor cover installation are the causes of the infiltration. All drains were blocked and the water is forced to drain over the walls below.

If you look at the plans attached Item 12(Picture) Item 13(Picture) you will see where there should have been a linear drainage system installed at the edge of the balconies. If you don't install effective drainage you may have the same problem in the future or the water will run down the walls and cause other types of problems. You should seek advice from a qualified architect that can design the proper solution to this kind of problem.

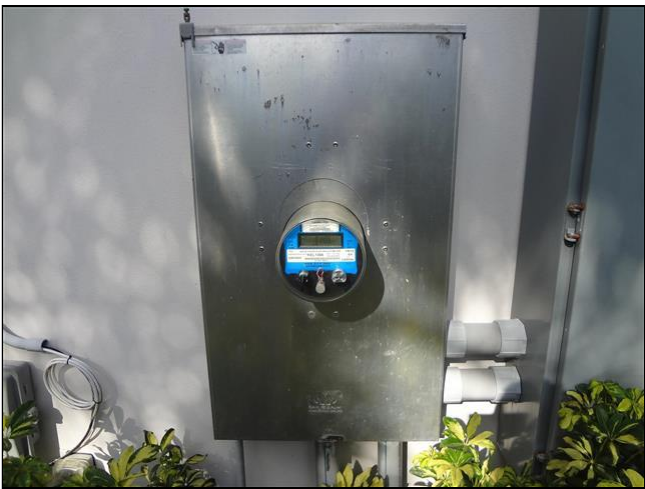
6.2 Item 1(Picture)

At the time of the inspection, the Inspector observed no deficiencies in the condition of the electric meter. Electric meters are installed by utility companies to measure home electrical consumption.

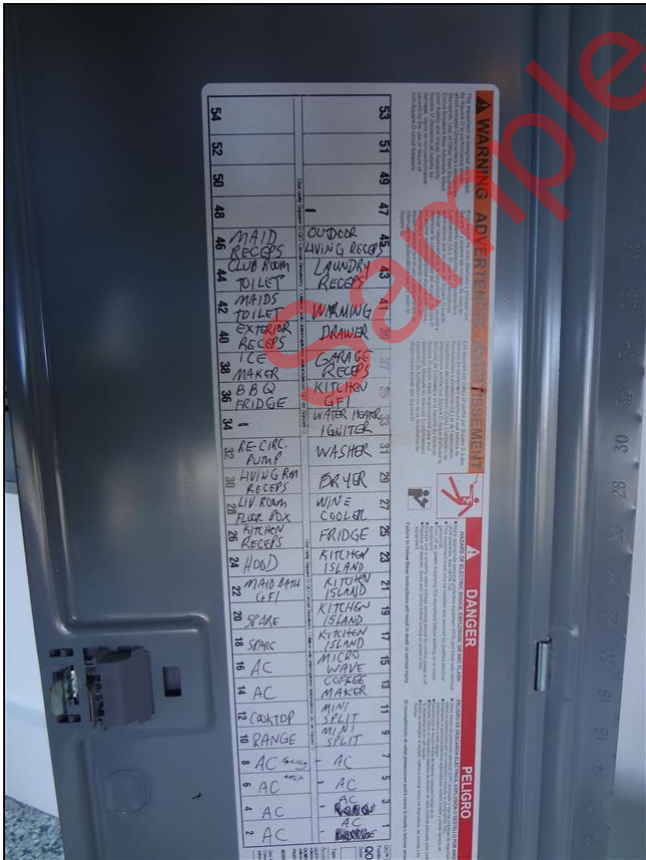
6.4 Item 1(Picture)

The service panel brand was SQUARE D.

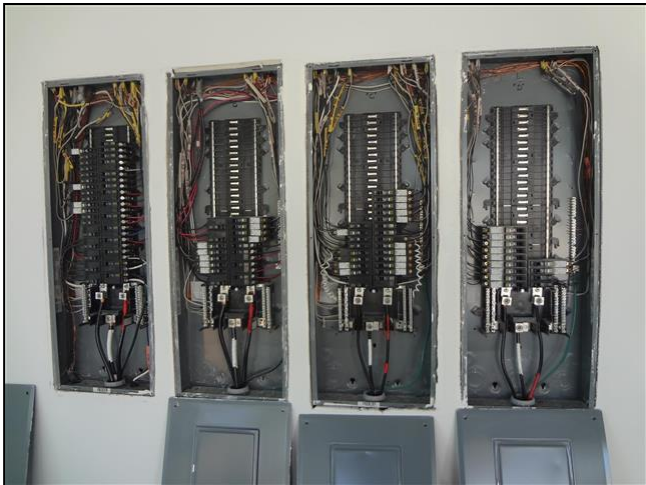
6.7 Item 1(Picture)

Inspector found no deficiency with the condition of the wiring on the electric panel at the time of the inspection.

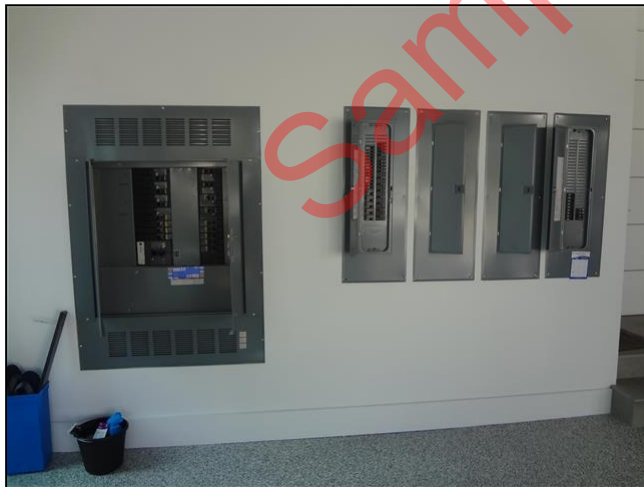
6.8 Item 1(Picture)

The house is equipped with a main disconnect that can cut power to each individual panel. In addition, the same system control power being fed to the Cabana, the elevator, and the Pool. Inspector found no deficiency with the condition of the main disconnects.

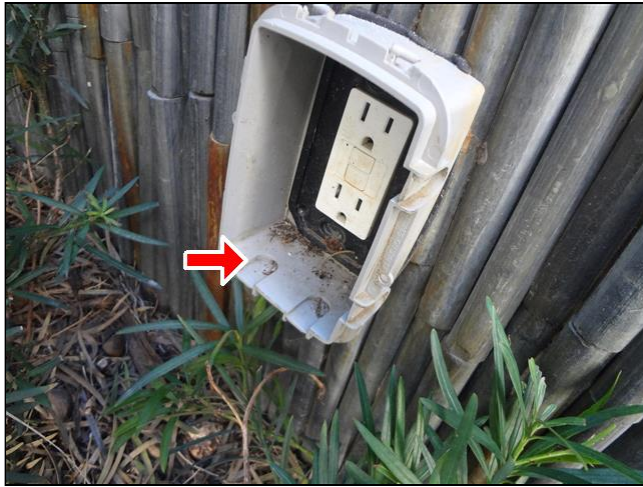
6.12 Item 3(Picture)

One exterior GFCI outlet at the BBQ area had a broken weather protective cover.

The Inspector recommends repairs by a qualified electrical contractor.

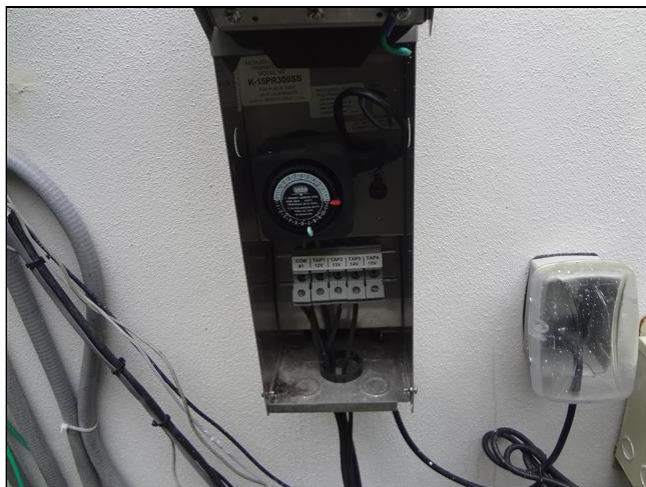
6.16 Item 3(Picture)

Landscaping lighting was set on a timer and inspector was unable to verify functionality. Some landscaping lighting was damaged. The timer cover was damaged.

One of the light fixtures in the garage did not respond. Recommend repairs.

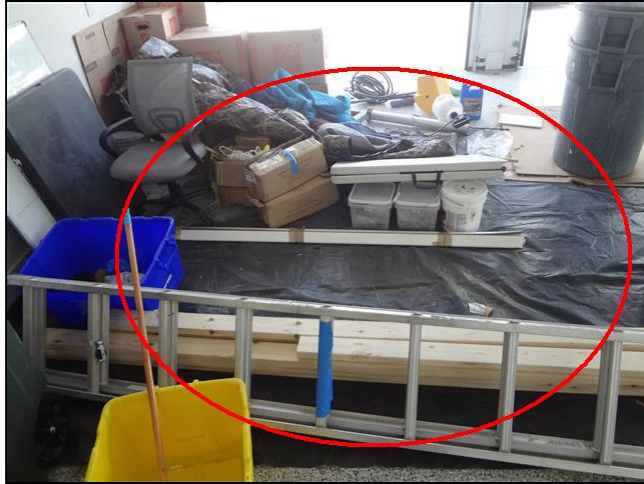
7.2 Item 1(Picture)

At the time of the inspection, the Inspector observed no deficiencies in the condition of the visible portions of the garage floor. At the time of the inspection, the garage was dirty and covered in dust and materials left by contractors. Partial floors were covered with materials and inspector was not able to assess.

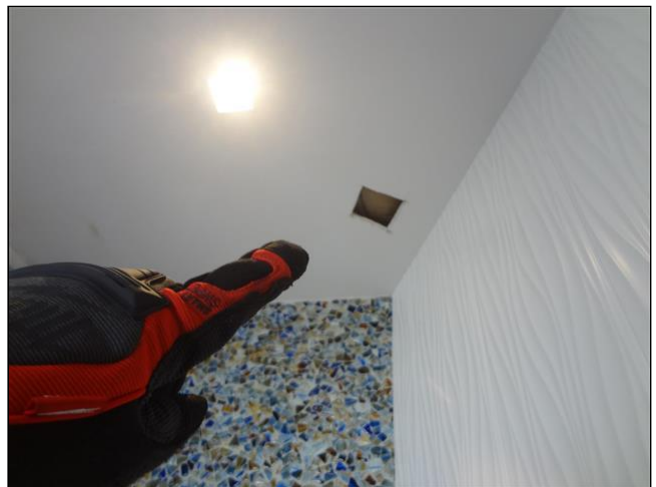
8.2 Item 2(Picture)

The ceiling in the cabana bath exhibited general moderate damage or deterioration at the time of the inspection. It appears that the condensation is being caused by the mixture of cold air around the AC in an environment which is constantly hot and humid air. Recommend repairs and possibly modification on the design as to prevent future problems such as mold.

Inspector also found a hole in the ceiling in the cabana. Recommend repairs.

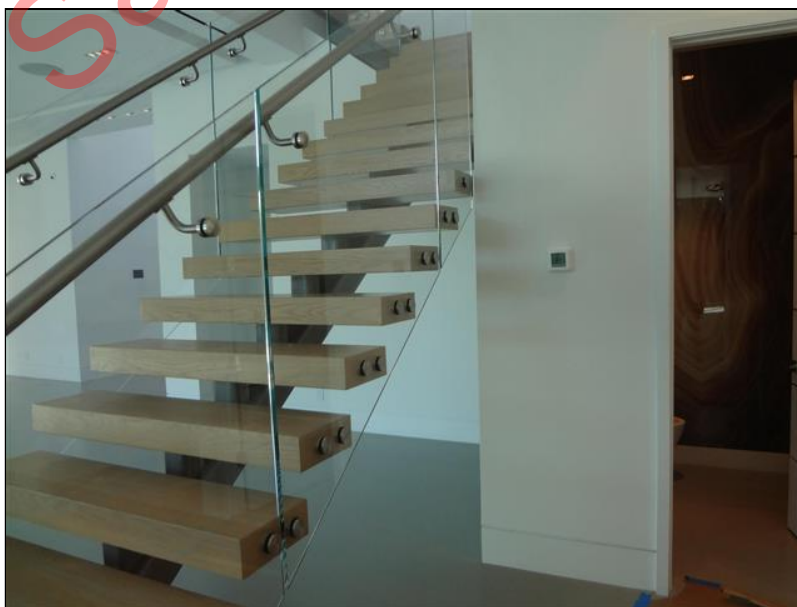
8.9 Item 1(Picture)

At the time of the inspection, the Inspector observed no deficiencies in the condition of this staircase. Inspection of staircases typically includes visual examination of the following:

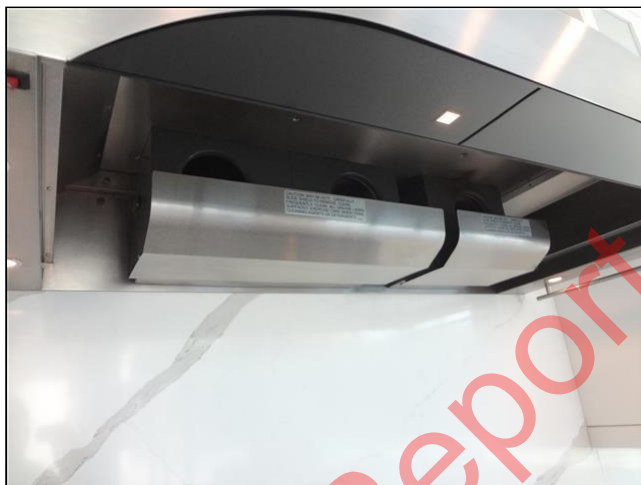
13.5 Item 1(Picture)

The exhaust vent of the range hood discharged exhaust to the home exterior. At the time of the inspection, the Inspector observed no deficiencies in the condition and operation of the range hood exhaust fan and lights.

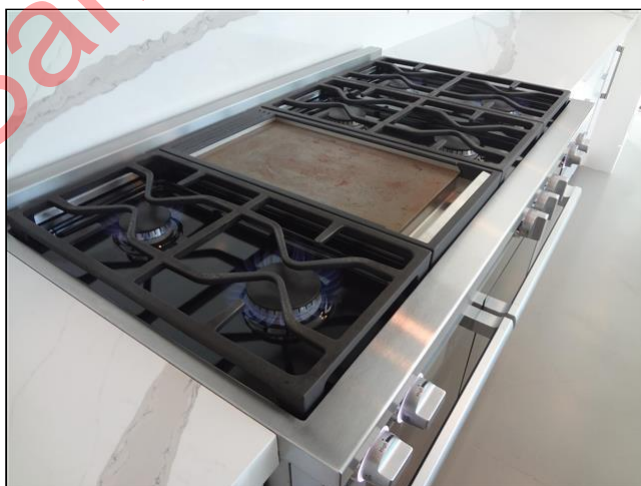
13.7 Item 1(Picture)

The home was equipped with a gas-fired cooktop and separate built-in oven instead of a range. At the time of the inspection, the Inspector observed no deficiencies in the condition and operation of the cooktop.

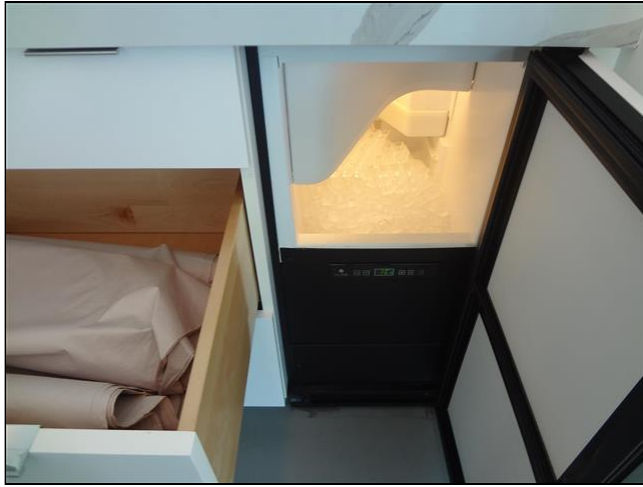
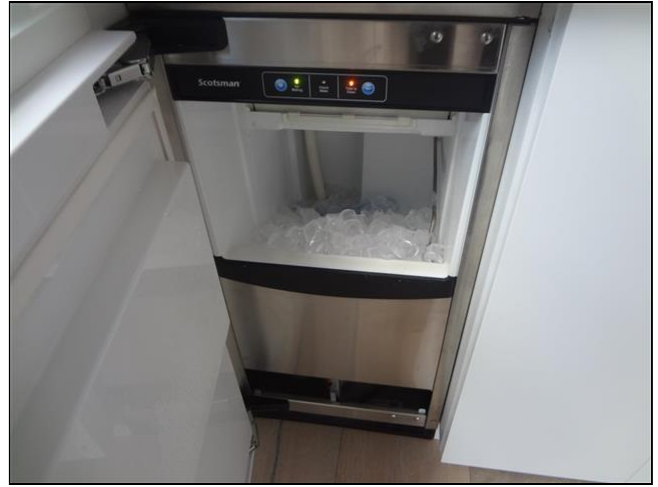
There are two icemakers. One in the kitchen and one in the large living area SW corner of the house. They were both functional.

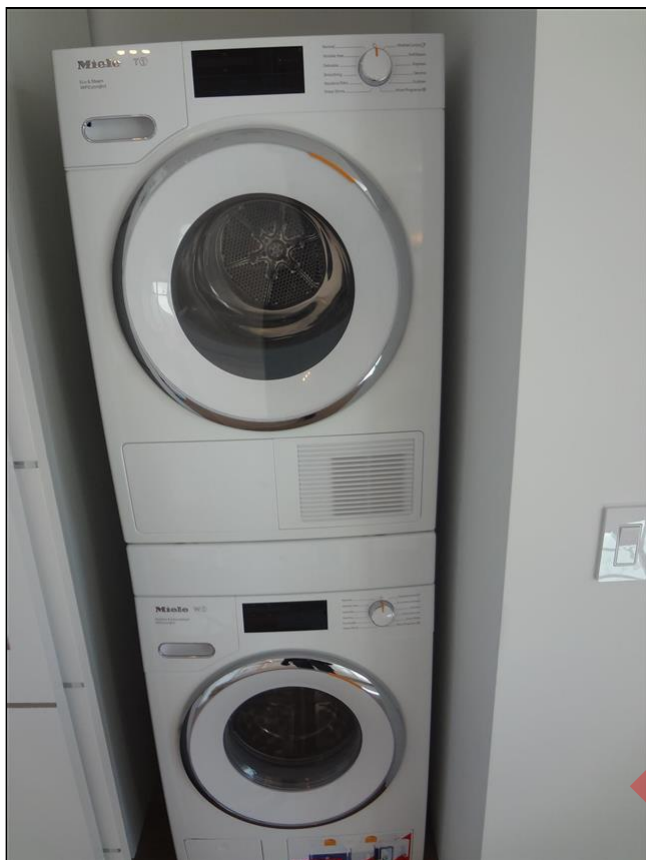
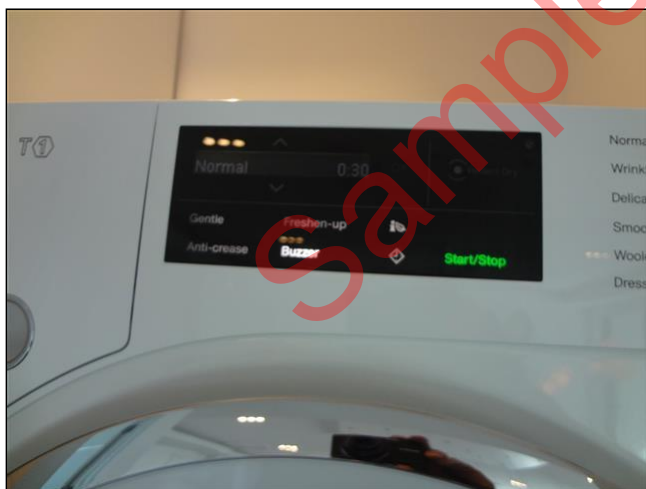
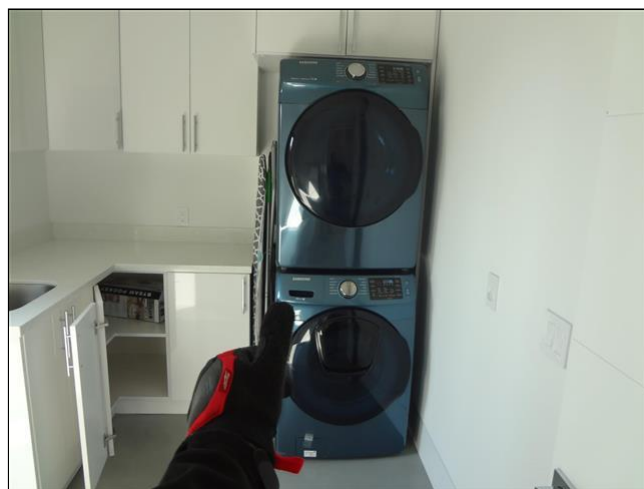
There are two sets found on this house. One upstairs and one downstairs. Inspector found no deficiency with the condition of the Washer and Dryer. They were both operated and appeared to be operating as intended. Inspector did not stay to observe through the entire cycle.

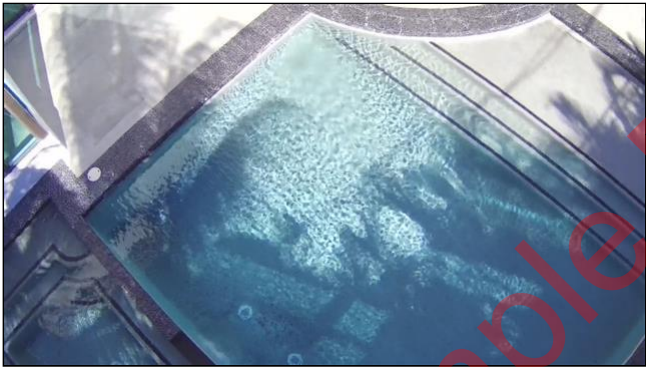
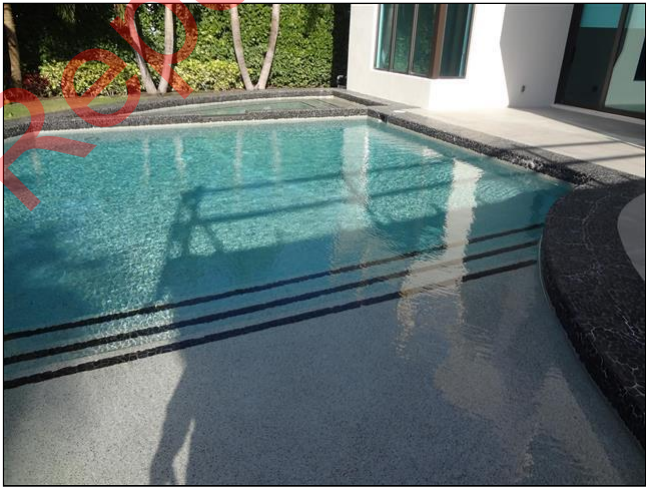
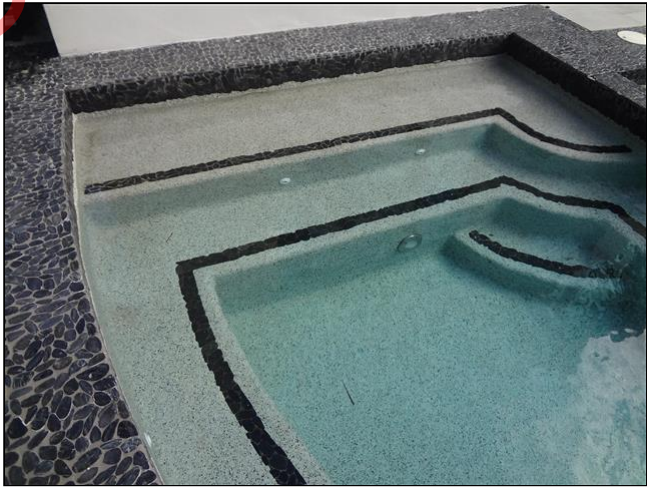
The vessel was constructed of concrete.

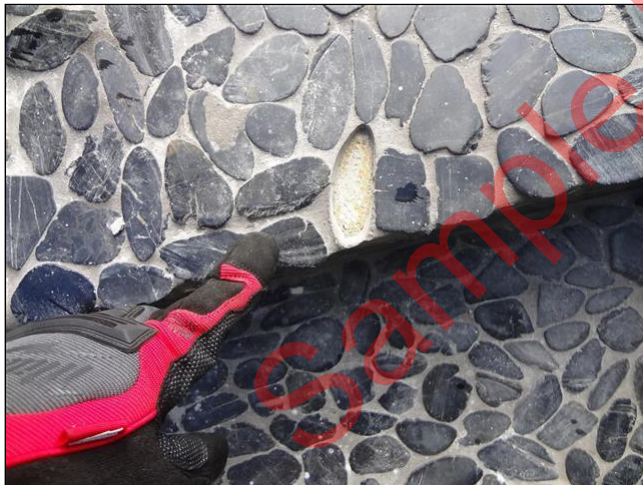
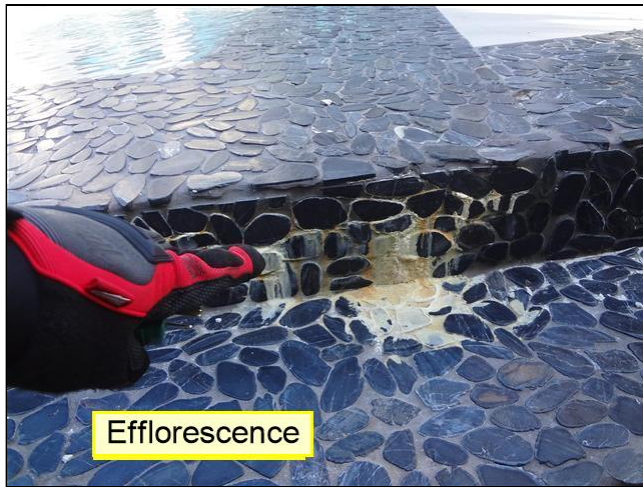
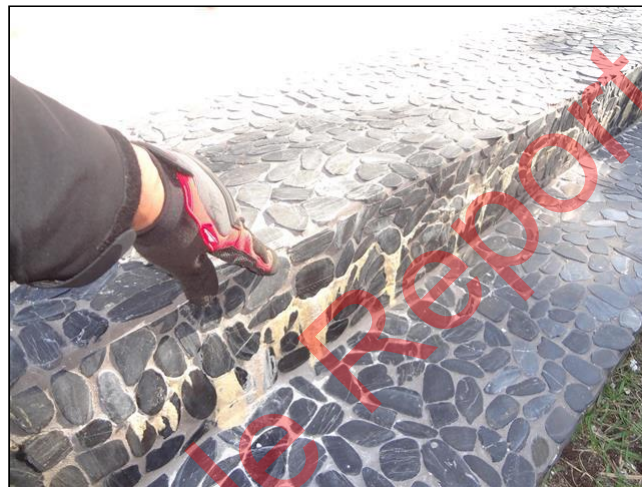
The pool had cracked border materials. All the pebbles installed along the perimeter were coming loose. The choice of material and poor workmanship is not right for the environment.

The Inspector recommends removal and replacement by a qualified contractor.

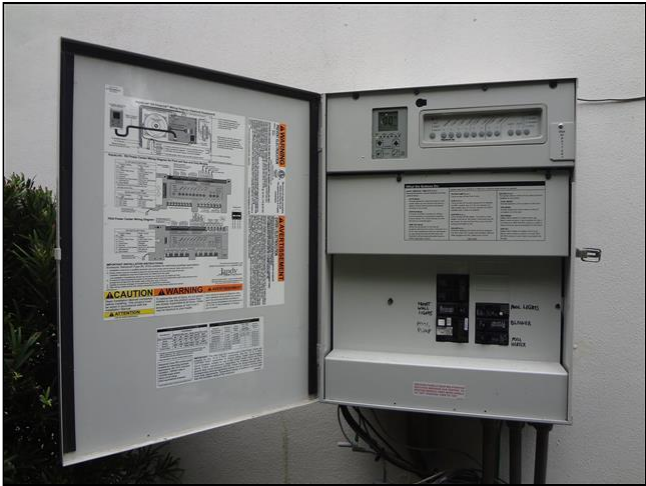
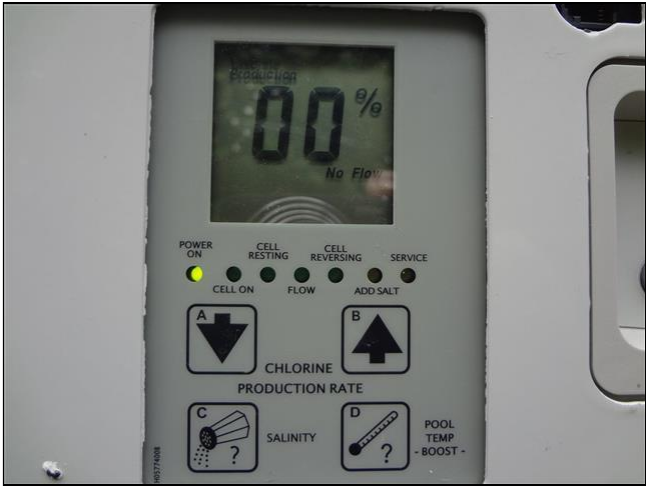
The pool has a central control system. Inspector found no deficiencies with the condition of the system. You should find a pool company that is familiar with this system in order to effectively maintain your pool.

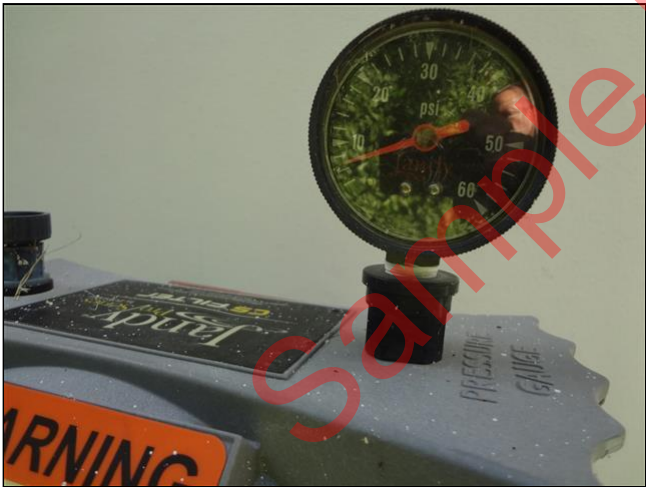
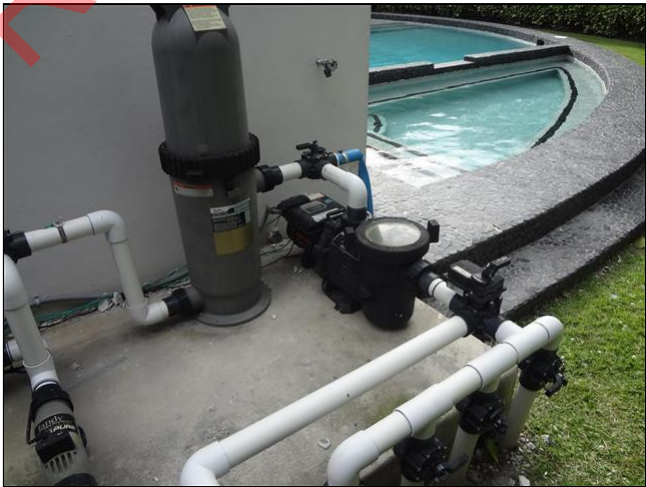
At the time of the inspection, the Inspector observed no deficiencies in the condition and operation of the pool filtration system.

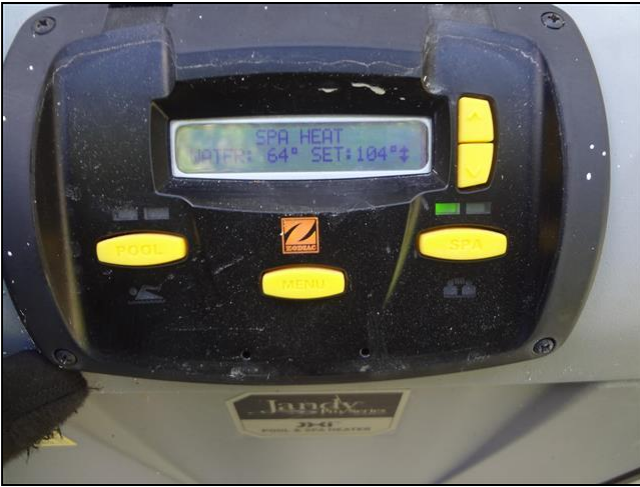
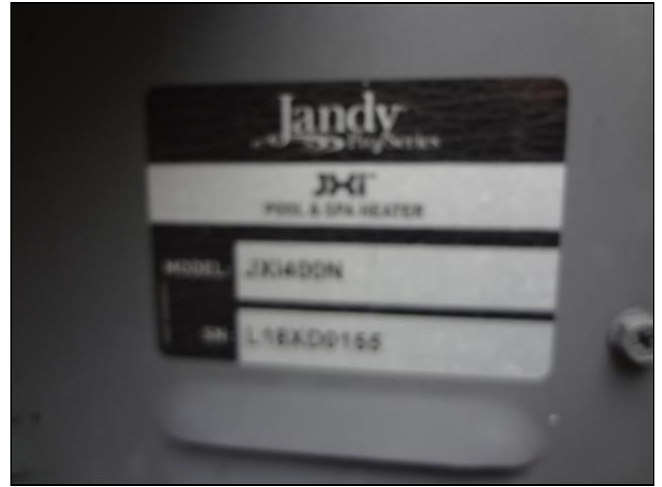
The pool heating system was powered by natural gas.
