# Seawall Inspection Report

## Waterside on the Intracoastal

**Property Address:**  
2881 NE 32nd St  
Fort Lauderdale FL 33306

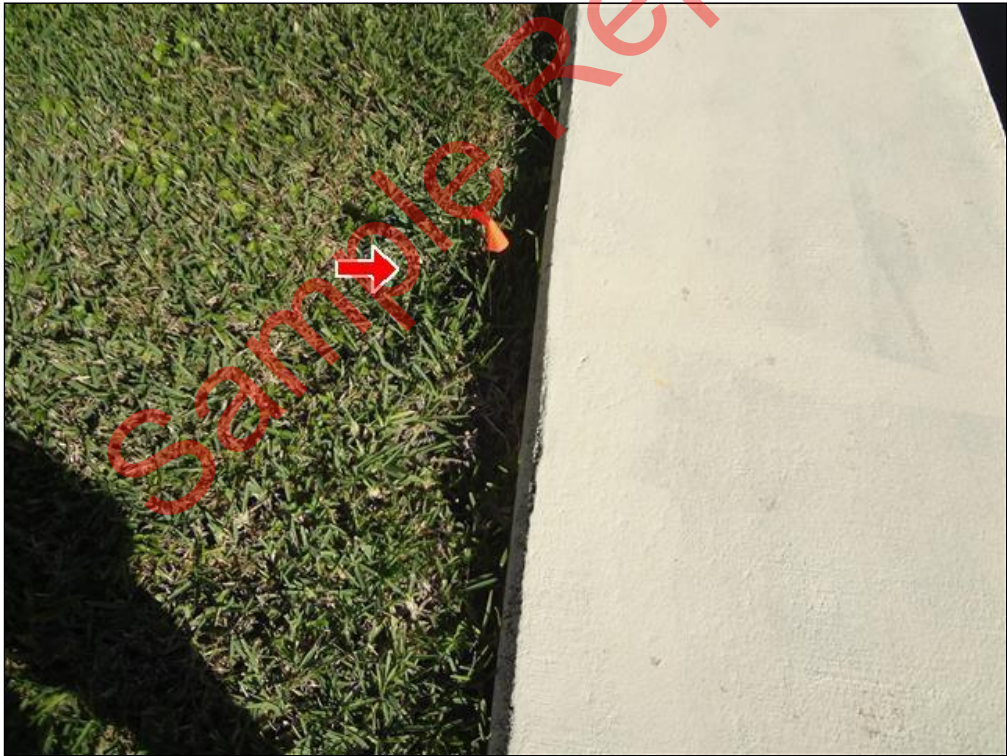
1.0 Item 8(Picture)

Inspector observed the grounds along the North and East faces of the seawall. Inspector found the grounds to be leveled and well kept. However, inspector found widespread signs of erosion and/or soil de-stabilization on both faces of the seawall. Item 2(Picture) Item 3(Picture) Item 4(Picture) Item 5(Picture) Item 6(Picture) Item 7(Picture) Item 8(Picture)
