INSPECTION REPORT  
Royal Palm  
Boca Raton FL 33432

INSPECTED BY  
Angelo Menezes  
Certified Inspectors,  
LLC  
HI9467

INSPECTION DATE  
📅 8/13/2026  
🕒 11:00:00 AM

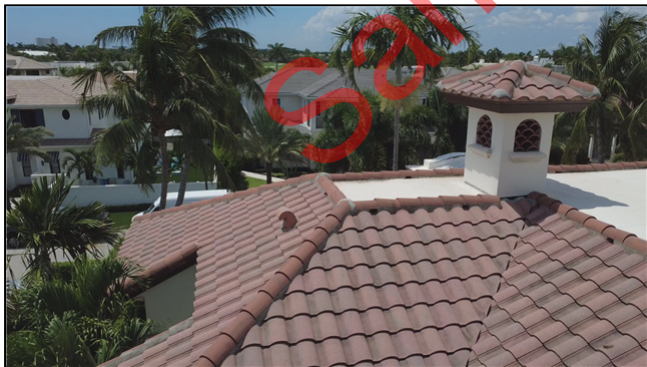
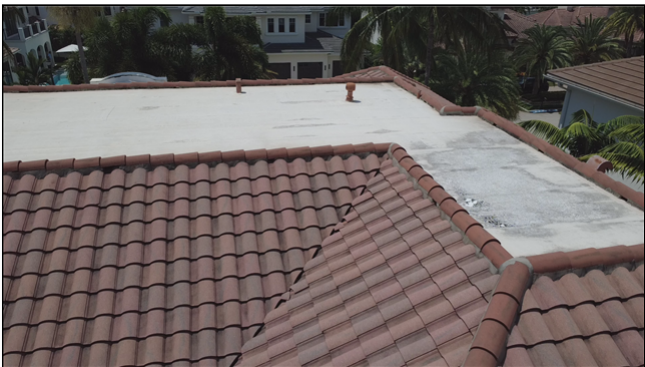
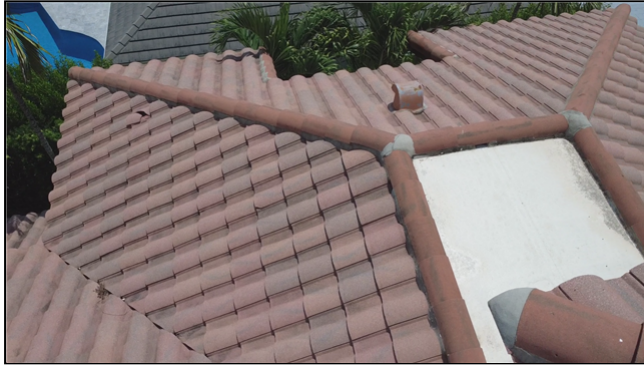
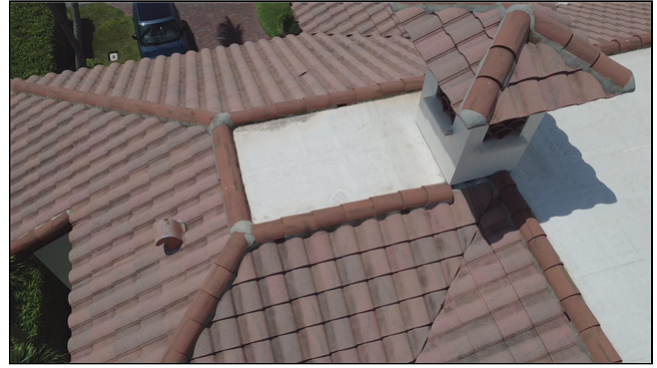
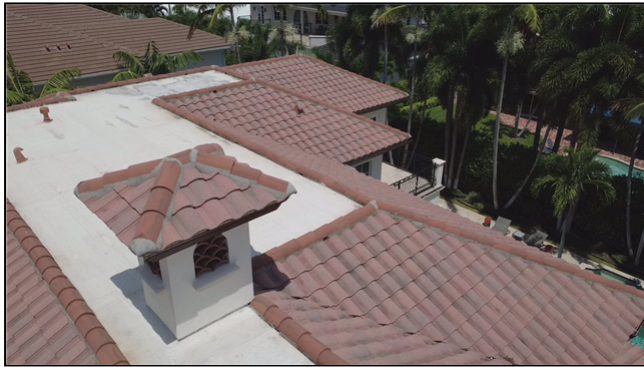
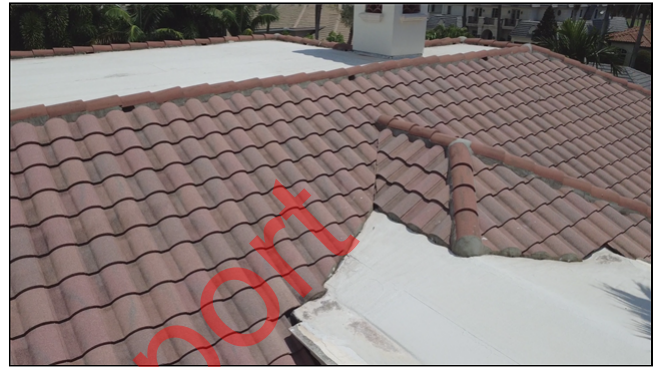
The roof structure consists of a wood-framed roof system supporting the tiled and low-slope roof coverings. Based on the visible roof surfaces, the roof planes appear generally straight and properly aligned, with no significant sagging, deflection, displacement, or other obvious indications of structural distress observed from the accessible areas. The roof structure is largely concealed by the roof coverings and, therefore, individual framing members and their connections could not be fully evaluated from the exterior.

The observed deterioration to the roof tile, ridge/hip cap mortar, and flat-roof coating appears primarily related to the roof covering and weatherproofing components rather than an apparent structural failure of the roof framing. Given the roof's original 2009 construction, continued monitoring is recommended, particularly at areas where water intrusion could potentially affect concealed wood framing. Any evidence of active leakage or moisture intrusion should be evaluated promptly to prevent secondary structural deterioration.

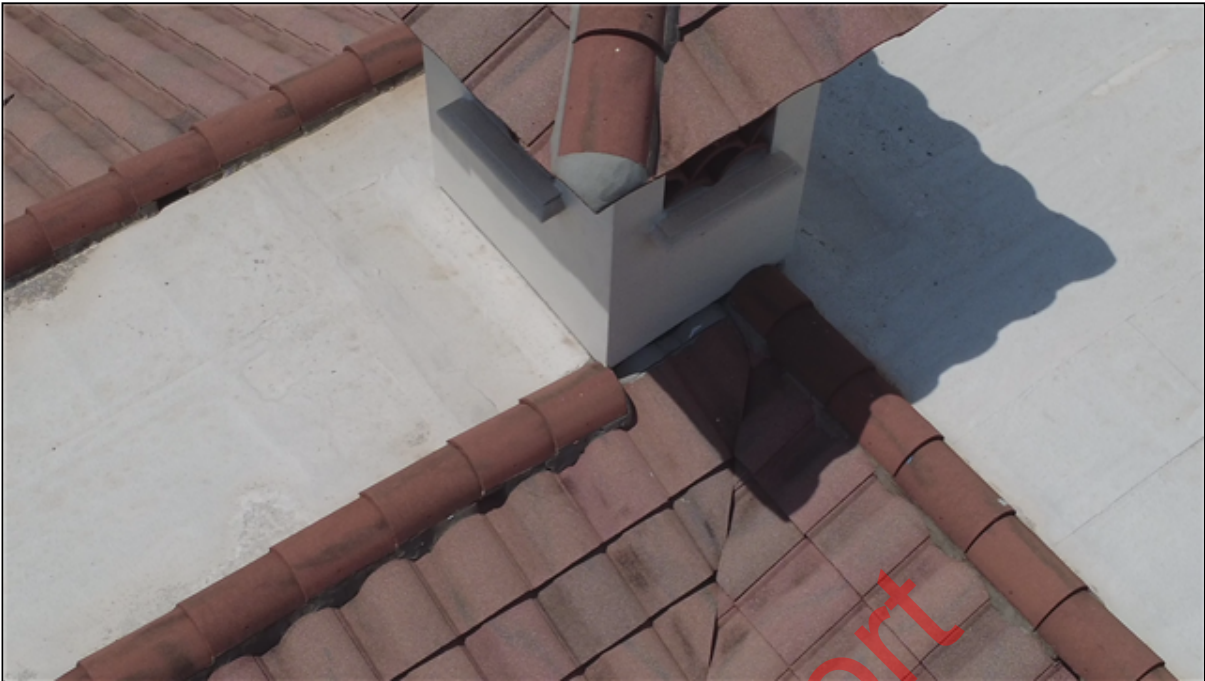
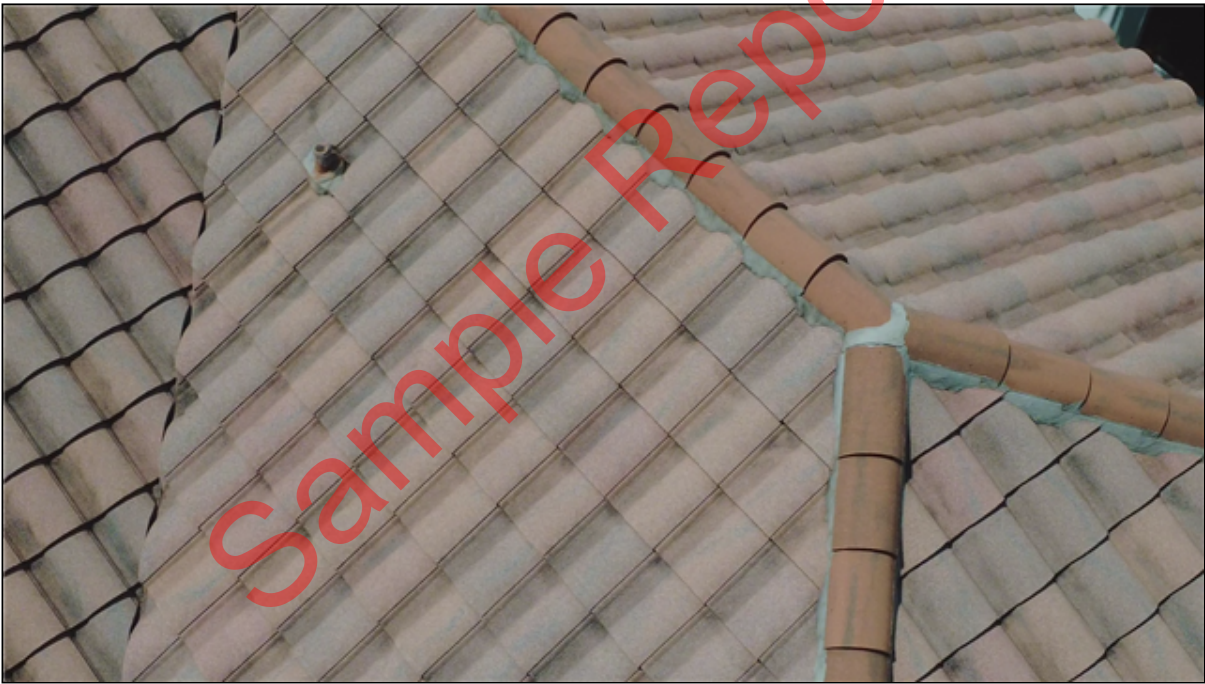
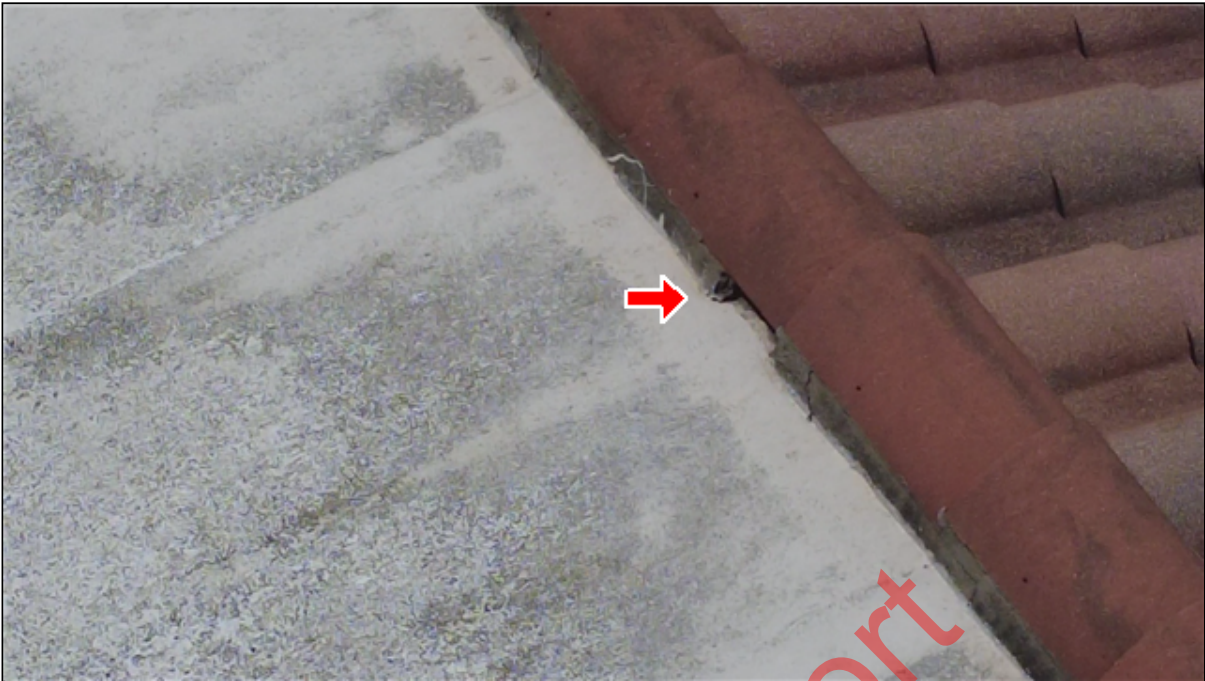
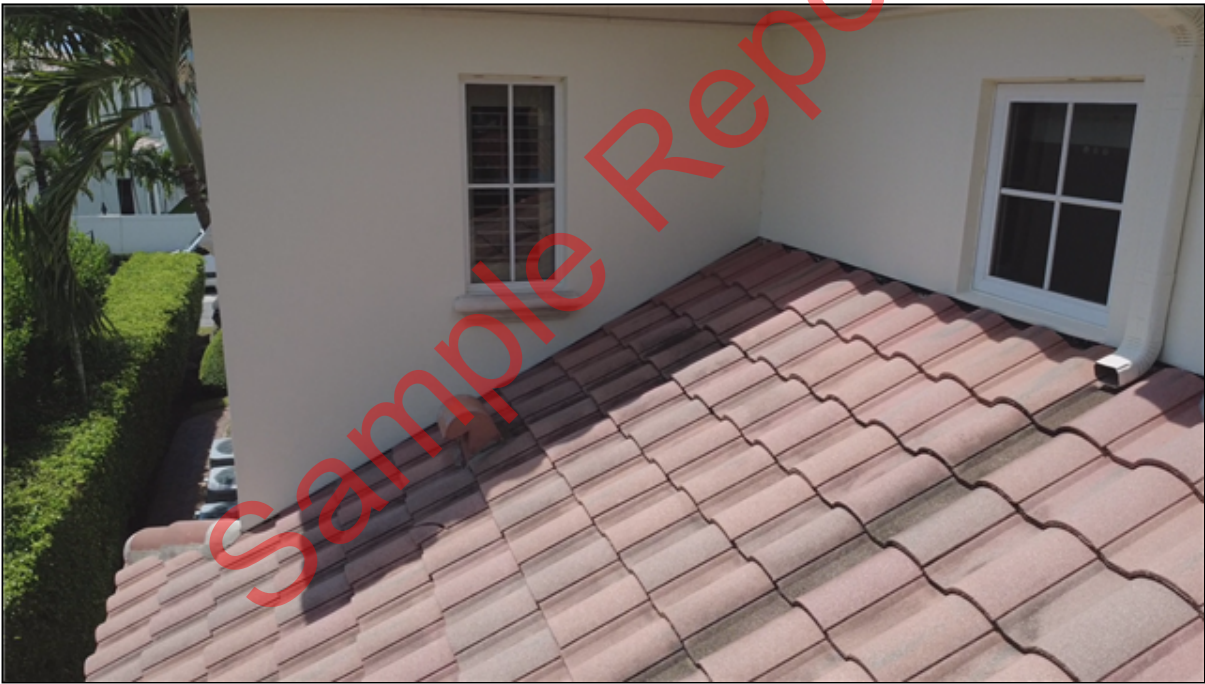
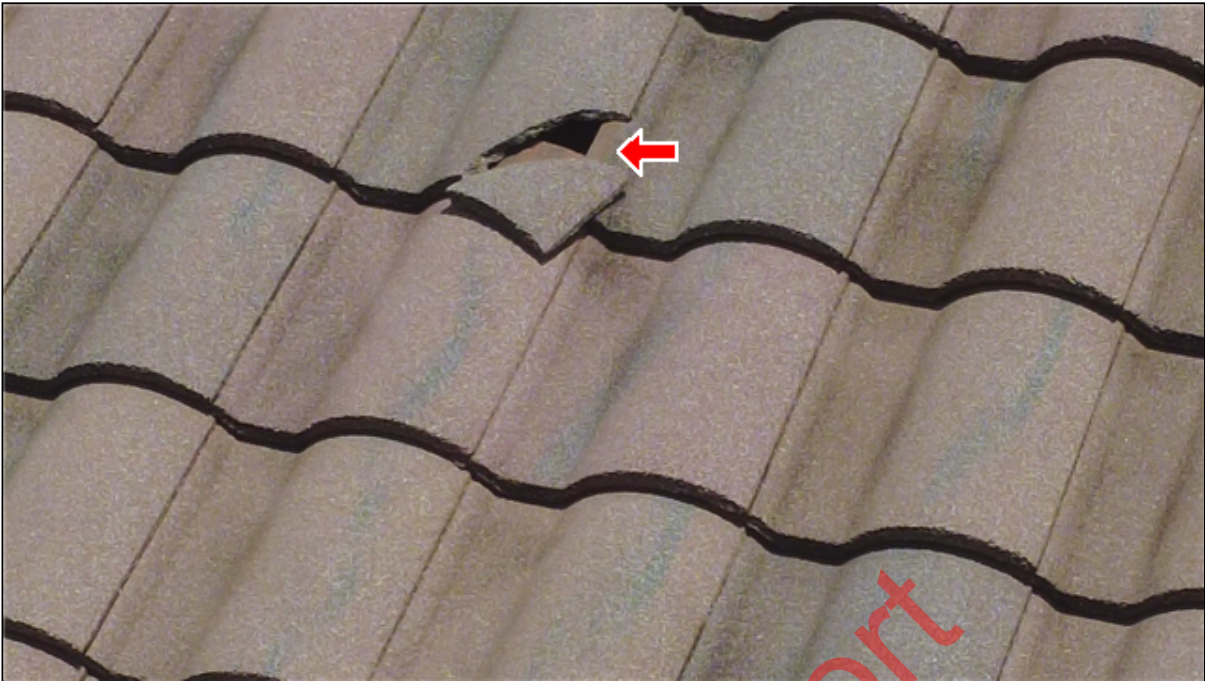
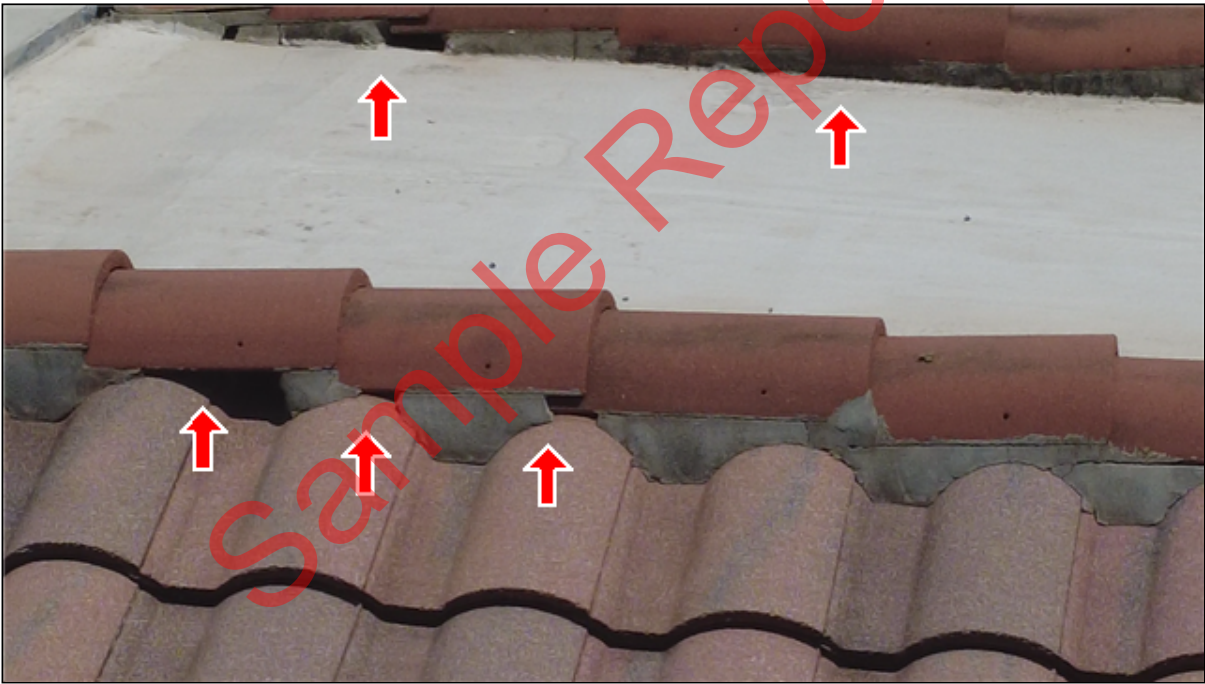
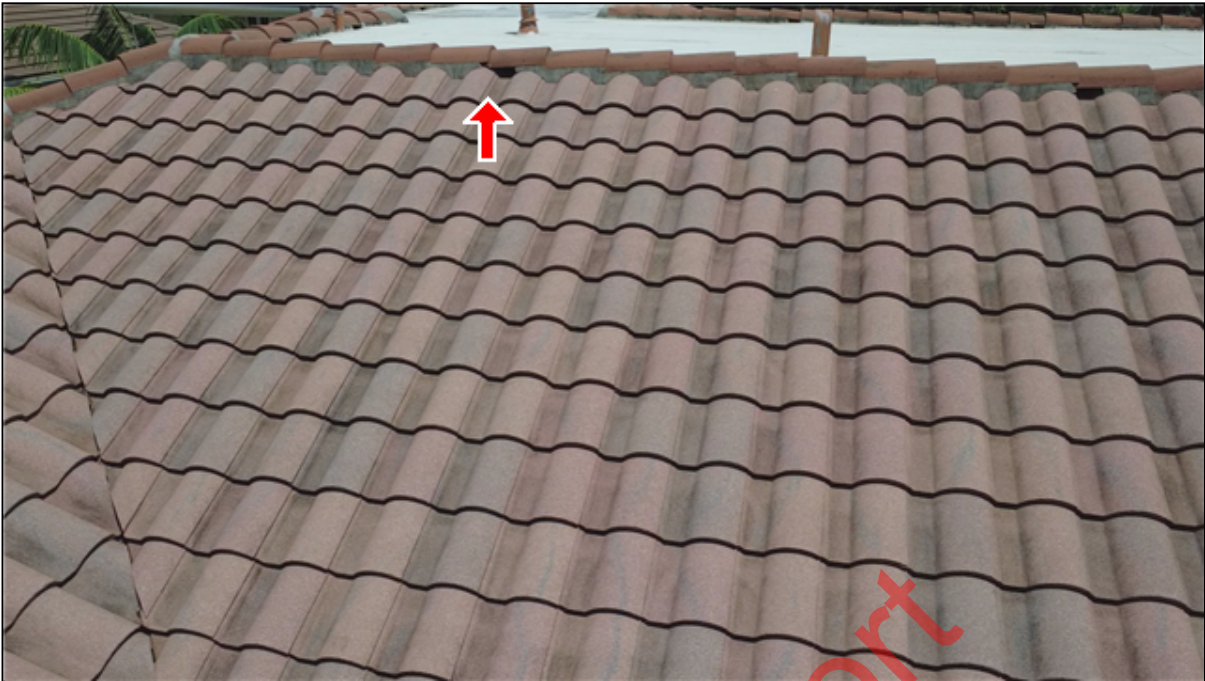
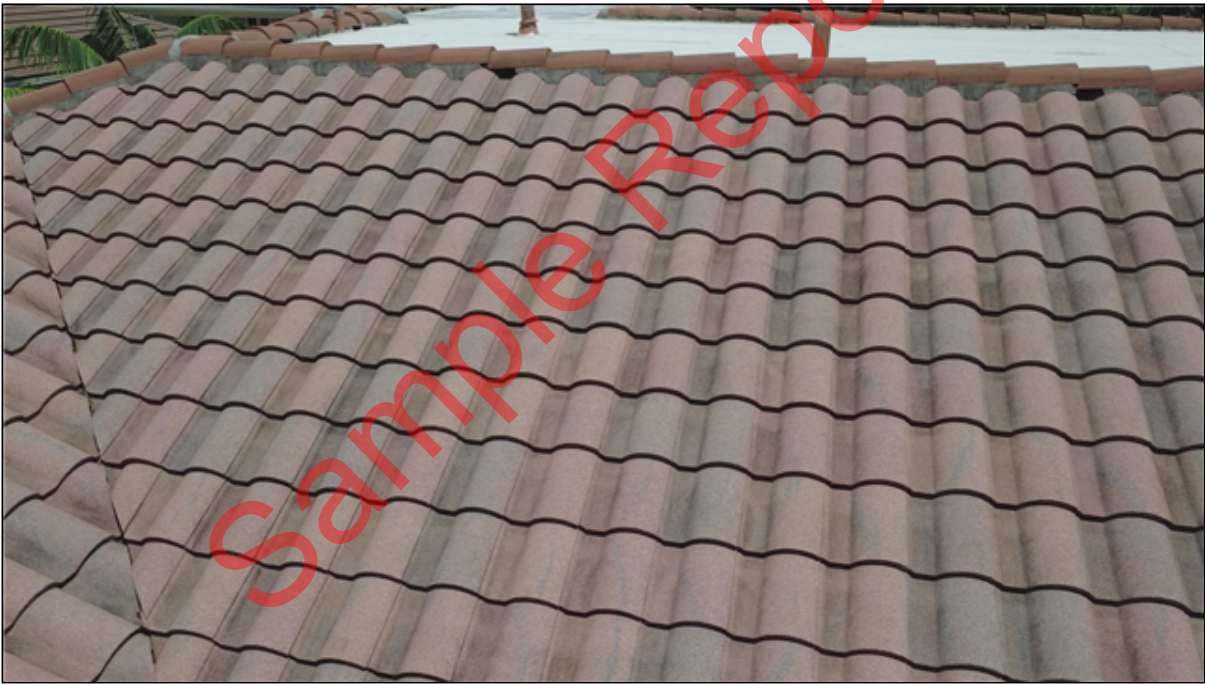
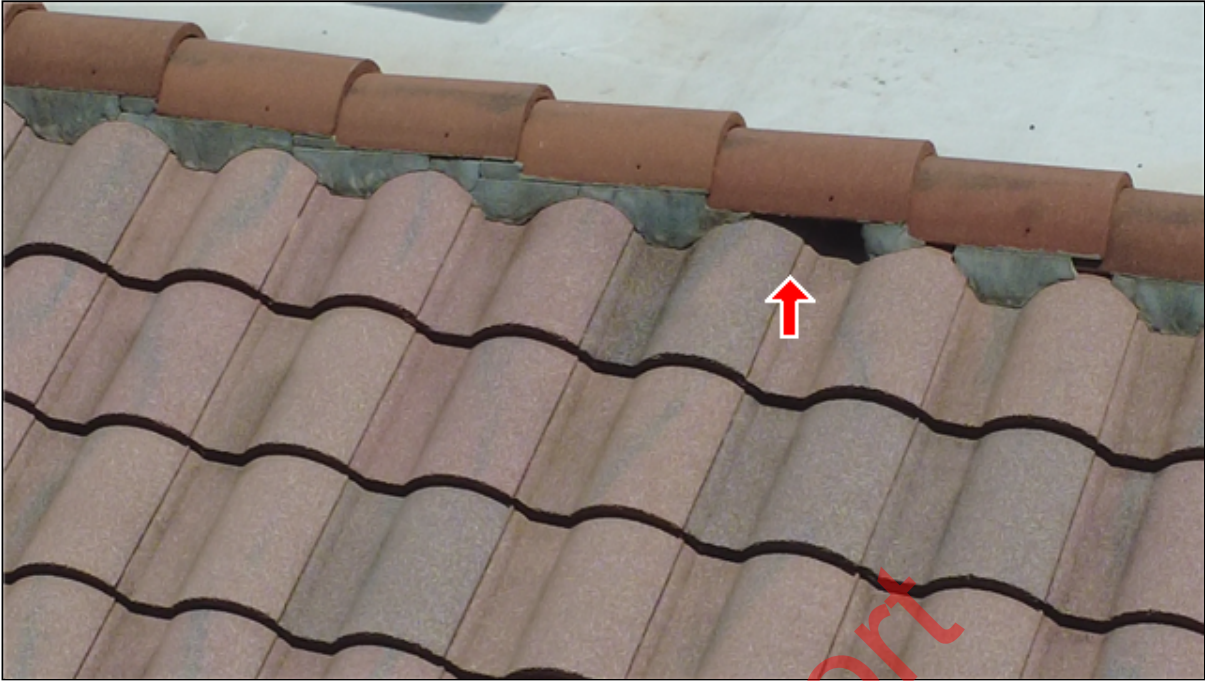
### 1.1 Concrete Tiles

The primary roof covering consists of concrete/clay-style interlocking tile and is reported to be original to the 2009 construction. Overall, the tiled roof was found to be in fair condition for its age. The majority of the tiles remain in place and appear generally serviceable; however, several cracked/broken tiles were observed and should be replaced to maintain the integrity of the roof covering. Several ridge and hip cap tiles also exhibit deterioration or loss of the cementitious/mortar bedding and pointing used to secure and seal these areas. These conditions can increase the potential for water intrusion, particularly during wind-driven rain. Repairs should include replacement of damaged tiles and restoration/resealing of deteriorated ridge and hip cap mortar by a qualified roofing contractor. Given the roof's age of approximately 17 years, continued maintenance and periodic professional evaluation are recommended.

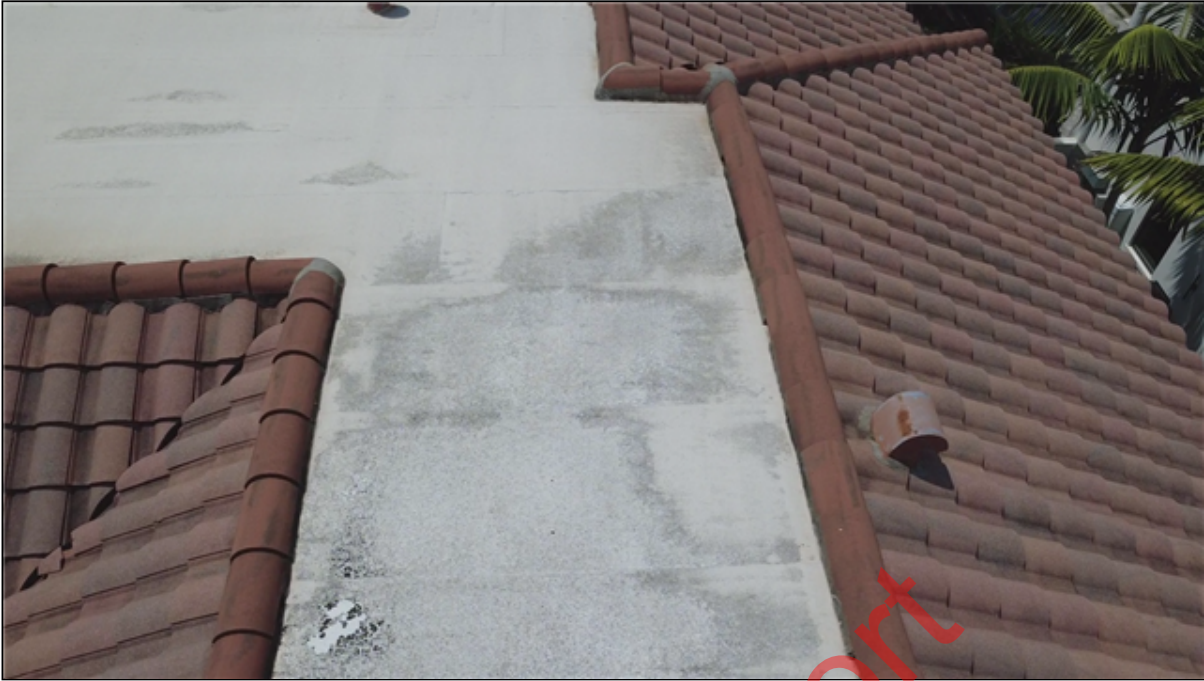
## 1.2 Flat Roof

The flat roof sections consist of a low-slope roof membrane/coating system, which appears to have been coated or resurfaced. The surface exhibits weathering, discoloration, areas of surface deterioration, and localized cracking/aging of the coating, particularly around the perimeter and adjacent to the tile roof transitions. The roof-to-tile interfaces and areas beneath the ridge caps should receive particular attention, as these transitions are susceptible to water intrusion if the underlying flashing or waterproofing has deteriorated. No determination of the remaining service life can be made from a visual inspection alone, and concealed conditions beneath the coating cannot be evaluated. The flat roof should be maintained and monitored, with repairs to deteriorated areas and a more detailed evaluation by a qualified roofing contractor recommended as appropriate.

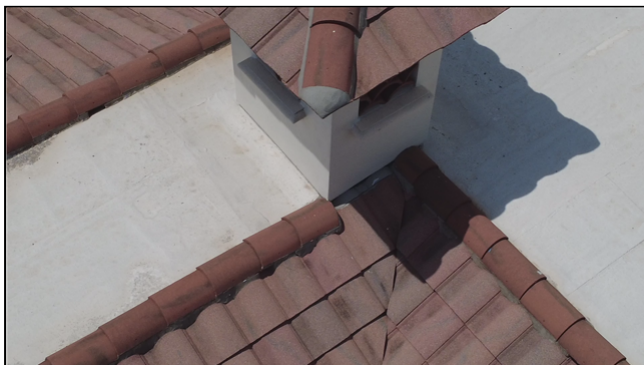
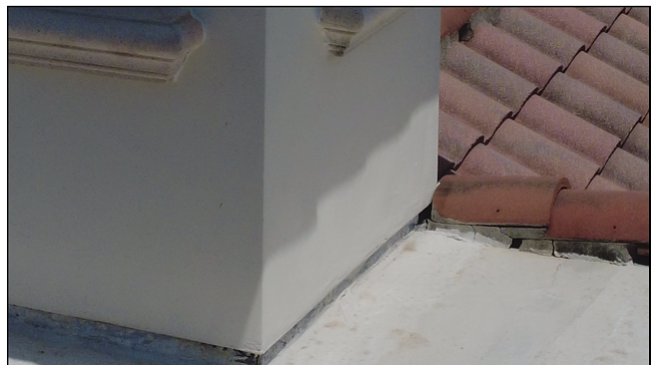
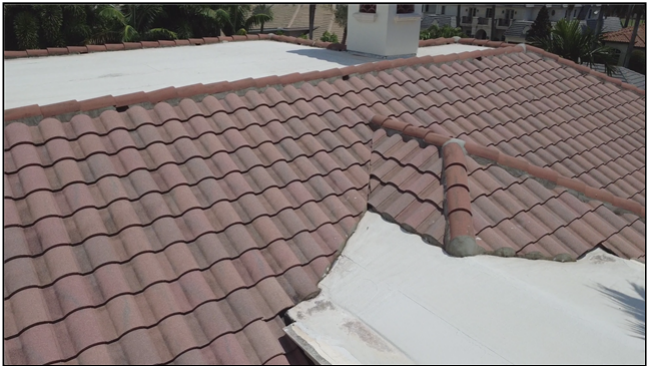
Roof flashing components were visually inspected at accessible roof-to-wall transitions, penetrations, valleys, and other areas where flashing is typically installed. The visible flashings and associated weatherproofing appeared generally serviceable for the age of the roof, with no obvious evidence of active leakage, significant deterioration, or flashing failure observed at the time of inspection. Flashing conditions can vary beneath or behind the roof covering and at concealed transitions that are not visible during a visual inspection. Continued maintenance and periodic inspection of flashing and sealant conditions are recommended, particularly as the roof continues to age.

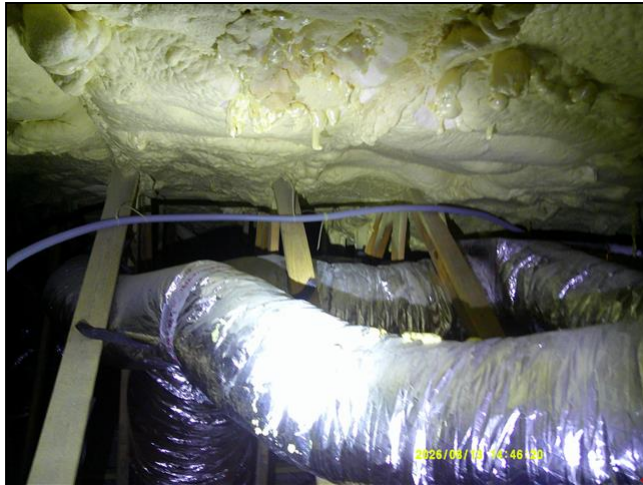
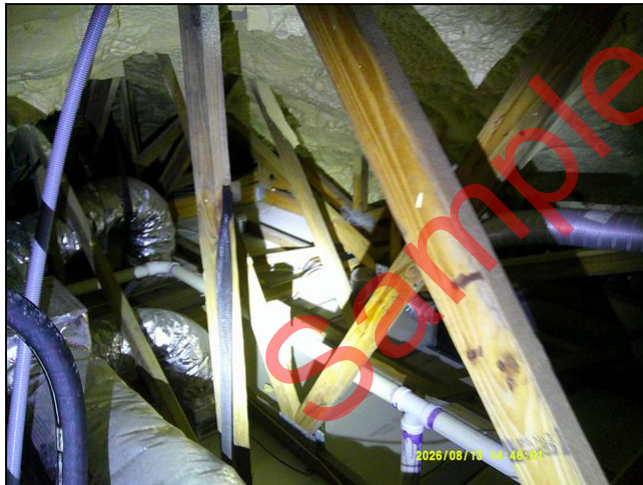
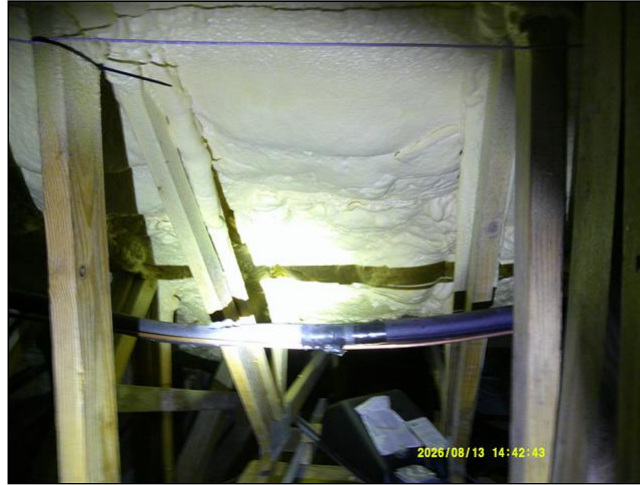
The attic is insulated with spray-applied foam insulation at the underside of the roof deck, with additional insulation present in various areas. The insulation appears generally continuous over the accessible portions of the roof deck and provides a substantial thermal barrier. However, localized areas of separation, gaps, irregular application, and exposed/unfinished foam were observed, including areas where the foam appears to have been applied around roof framing and mechanical components. These conditions may reduce the effectiveness of the insulation and air-sealing system in those locations.

Because the insulation is applied directly to the underside of the roof deck and much of the roof structure is concealed, the full extent and uniformity of the installation could not be verified. The insulation should be maintained in its present condition, with localized areas of deficient or deteriorated foam evaluated and repaired by a qualified insulation contractor as needed.

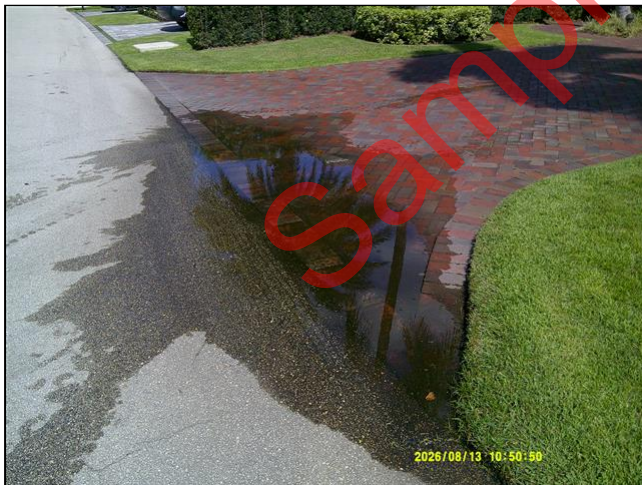
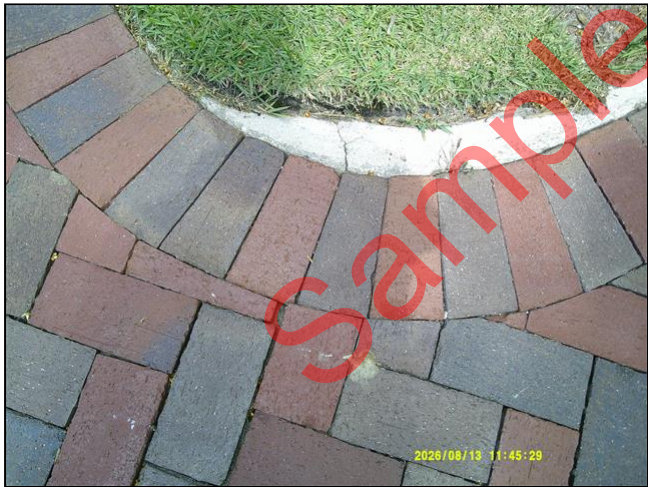
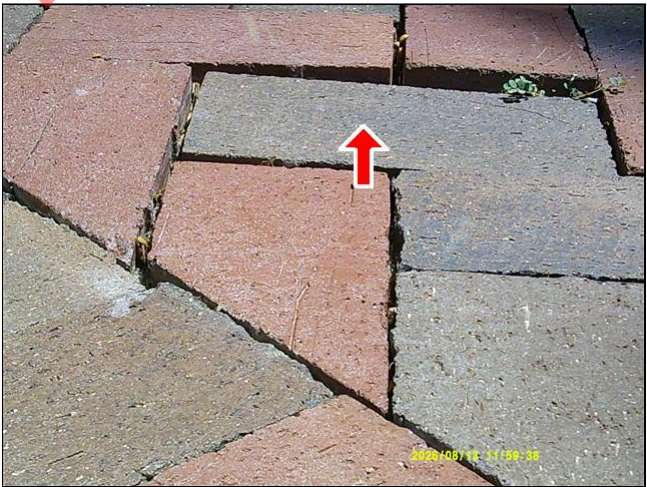
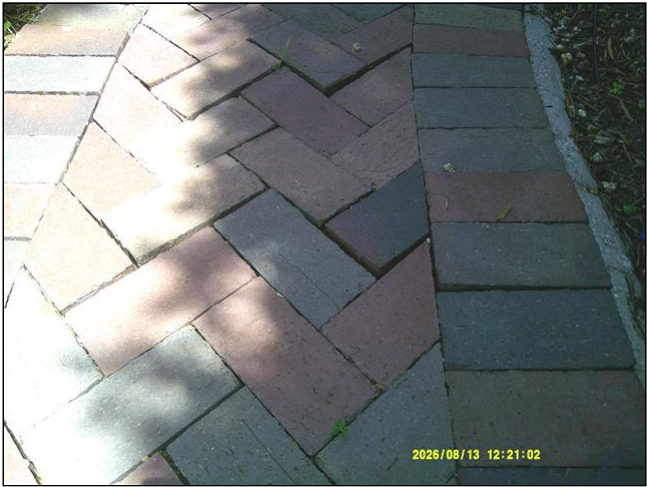
### 3.1 Driveway

The driveway consists of interlocking concrete pavers. The driveway was generally functional; however, several areas exhibited localized settlement and displacement of individual pavers, resulting in uneven surfaces and open joints. Some pavers were loose or raised relative to adjacent pavers, creating potential trip hazards and progressive deterioration.

Standing water was also observed at the driveway/street interface at the time of inspection. This may indicate localized low areas or inadequate surface drainage. The area should be monitored during rainfall and corrected as necessary to promote positive drainage away from the residence and driveway surface.

Recommendation: Have a qualified paver/driveway contractor reset and re-level displaced or settled pavers, restore proper joint spacing, and evaluate drainage at the street transition. Repairs should be performed as needed to reduce trip hazards and prevent further settlement.

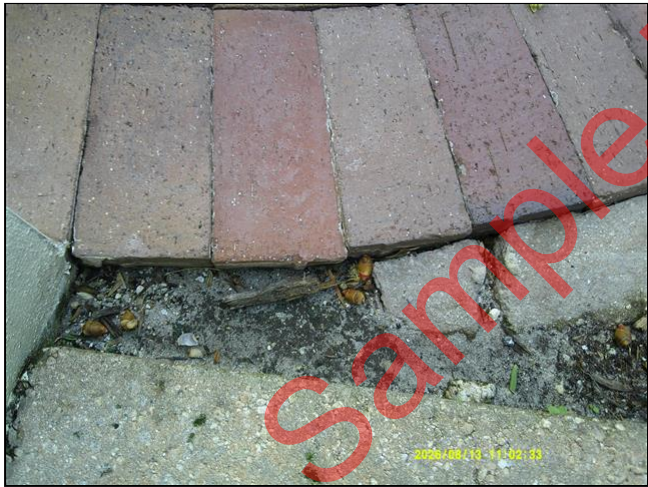
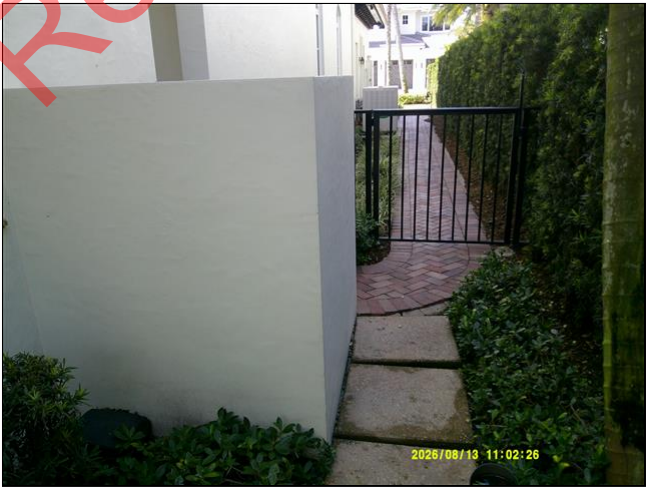
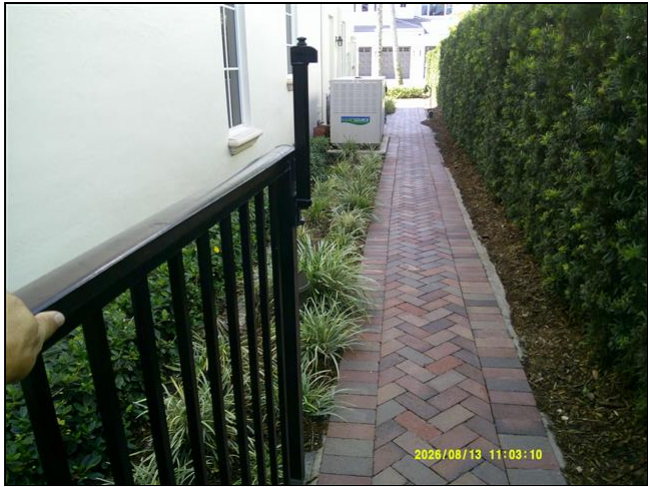
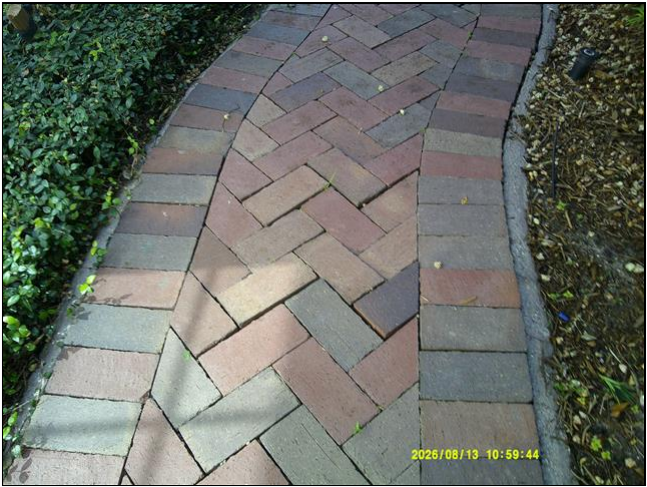
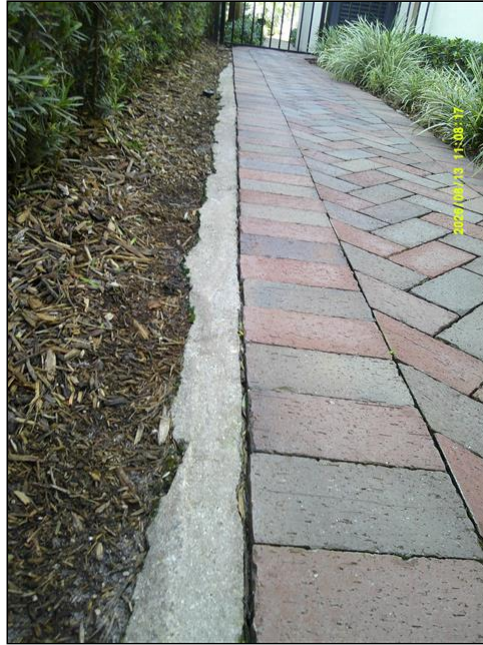
3.2 Walkways

The walkways consist of interlocking concrete pavers. Several areas exhibited settlement, displacement, and uneven pavers, including localized gaps and raised edges. These conditions can create trip hazards and may allow continued movement or deterioration of the walkway.

Recommendation: Have a qualified paver/landscape contractor reset and re-level the affected pavers, restore the joints, and correct the underlying base as necessary to provide a stable and reasonably level walking surface.

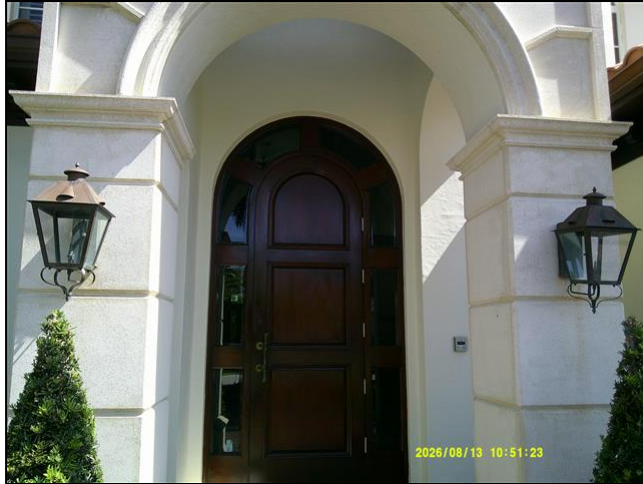
### 3.5 Porch Area

The front porch and entry area were visually inspected. The entry features a decorative stone/stucco surround, wood entry door, sidelights, exterior lighting, and a tiled/stone threshold. The entry door and surrounding architectural features appeared generally serviceable.

A localized area of damaged/drilled stone was noted at the base of the entry door, with several open holes and surface deterioration. These openings should be properly patched/sealed to help prevent water intrusion and insect entry and to restore the finish.

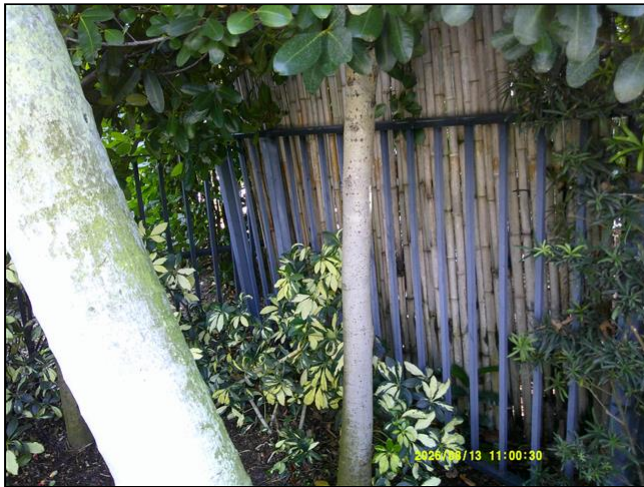
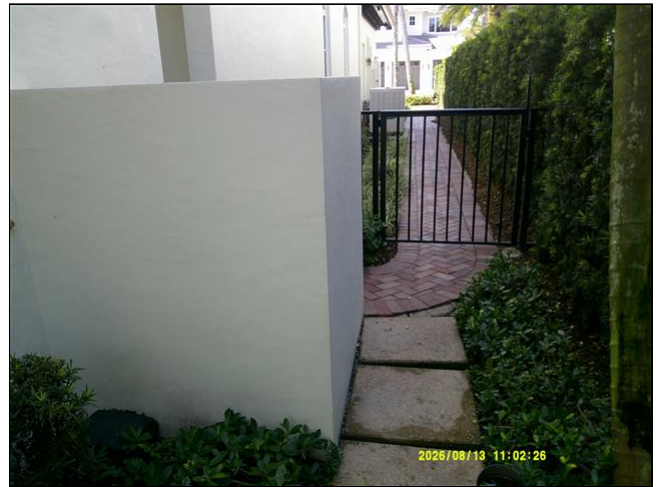
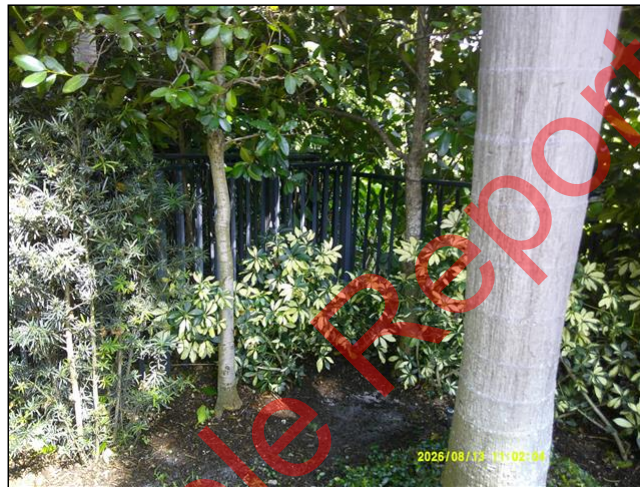
The fences exhibited minor deterioration commensurate with the age of the home.

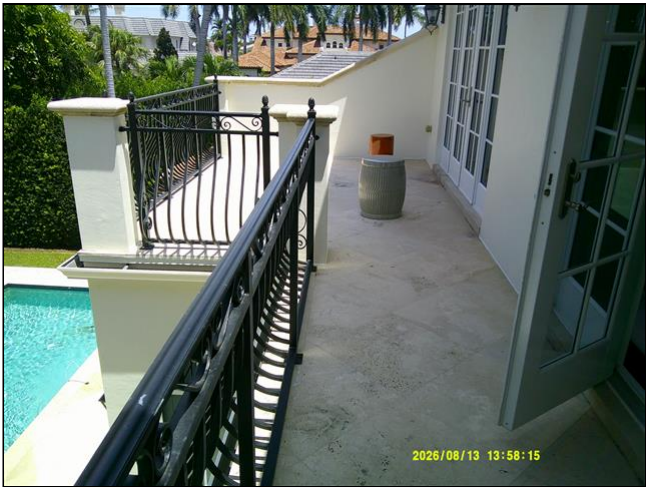
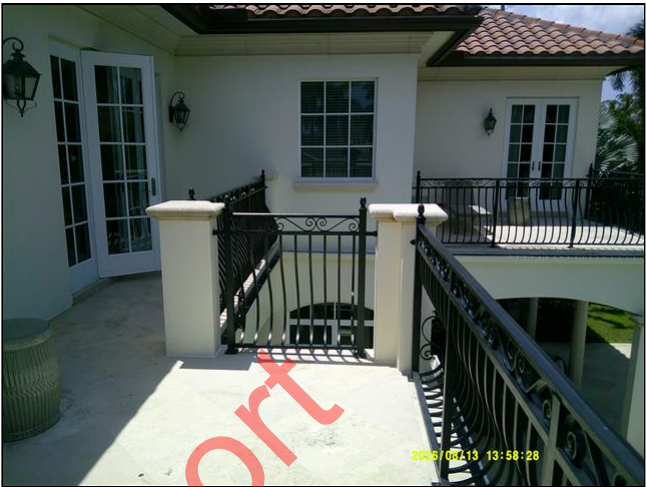
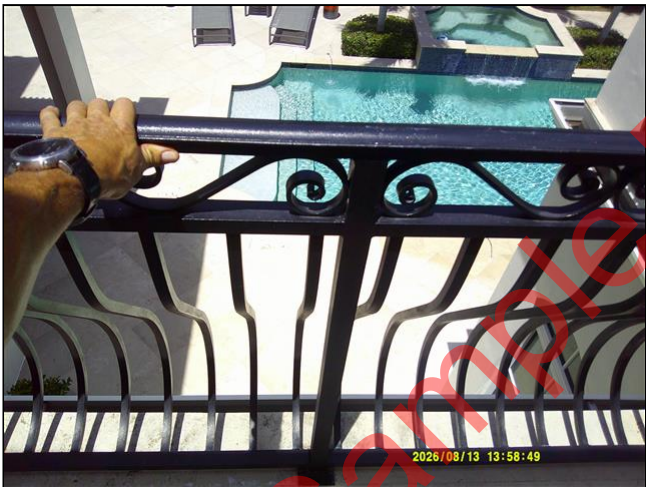
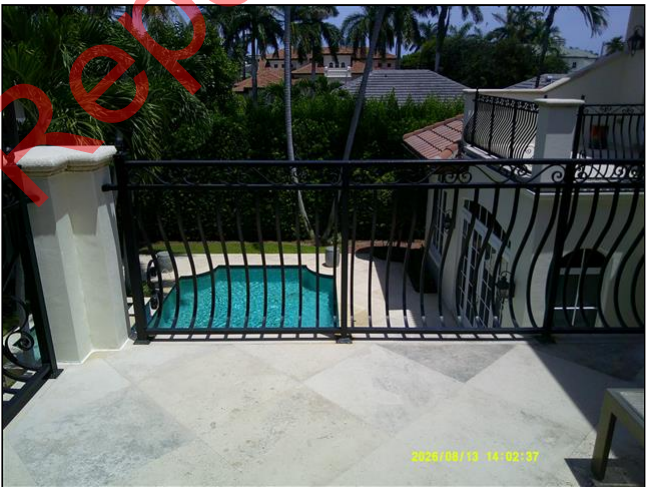
The elevated balconies and associated walking surfaces were visually inspected. The balconies feature concrete walking surfaces with decorative metal guardrails and stucco/stone-clad support columns. The guardrails appeared generally secure and intact, with no significant visible damage or deterioration noted at the time of inspection.

The balcony surfaces exhibited some localized staining/discoloration and normal weathering. No significant deficiencies were observed in the readily accessible balcony components at the time of inspection.

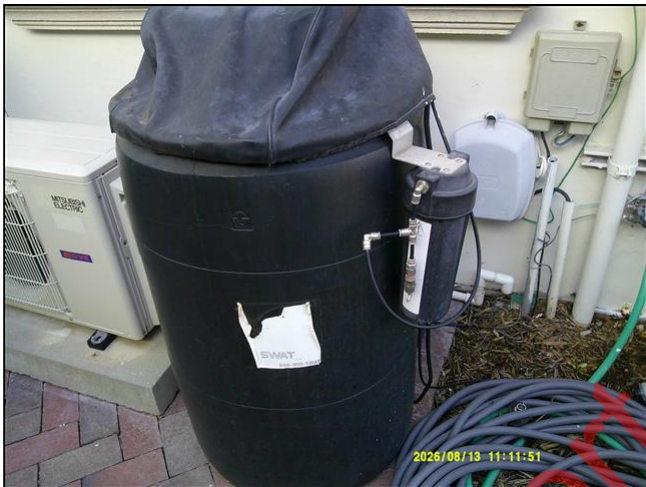
A mosquito control system (SWAT mosquito misting system) was observed at the property. The equipment and associated components were present but were not evaluated as part of the home inspection. The inspection does not include testing of the system's operation, effectiveness, chemical delivery, controls, or maintenance condition.

Evaluation and servicing by the system provider or a qualified mosquito-control technician is recommended if desired.

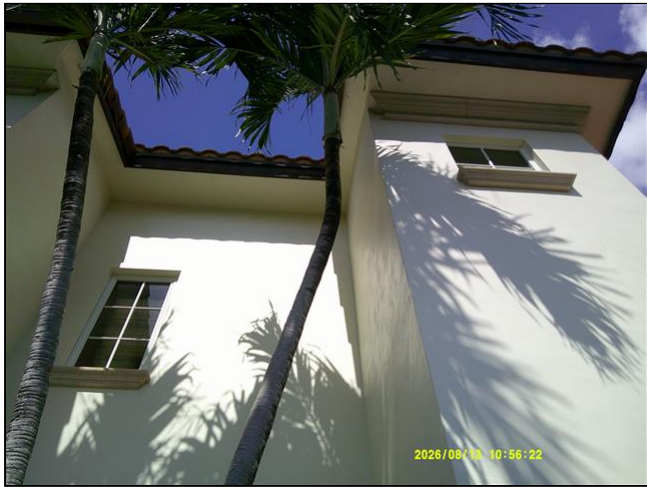
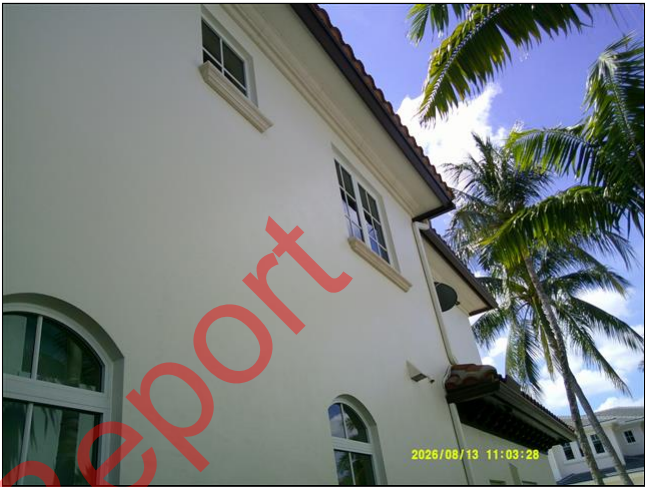
The exterior stucco finish was visually inspected from readily accessible areas. The stucco appeared generally well maintained, with the majority of surfaces exhibiting a uniform finish and no significant areas of delamination, displacement, or major cracking observed.

Localized cracking was observed at portions of the decorative columns in the covered patio/BBQ area, as noted separately in this report. These areas should be repaired and sealed as needed to reduce the potential for moisture intrusion and further deterioration.

Overall, no significant deficiencies were observed in the readily accessible stucco surfaces other than the localized conditions noted above.

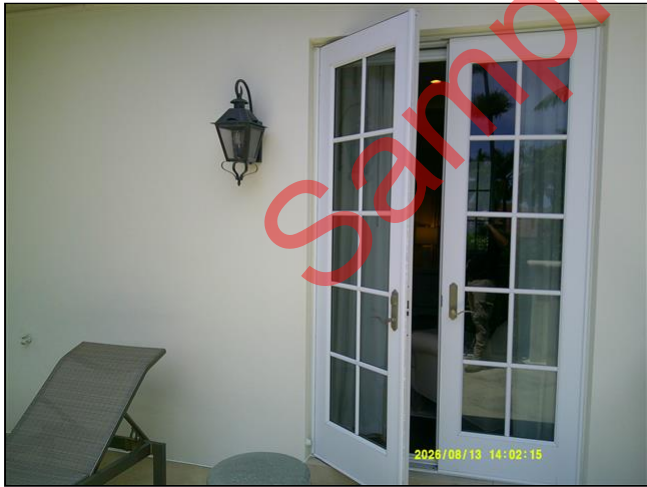
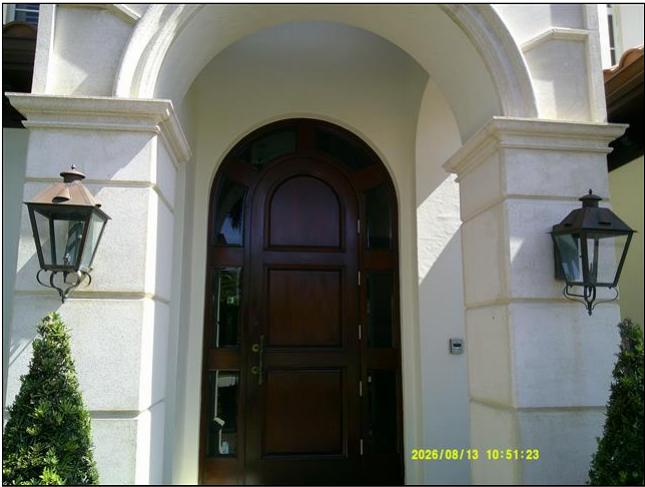
At the time of the inspection, door exteriors showed general weathering, wear, and deterioration commensurate with their age.

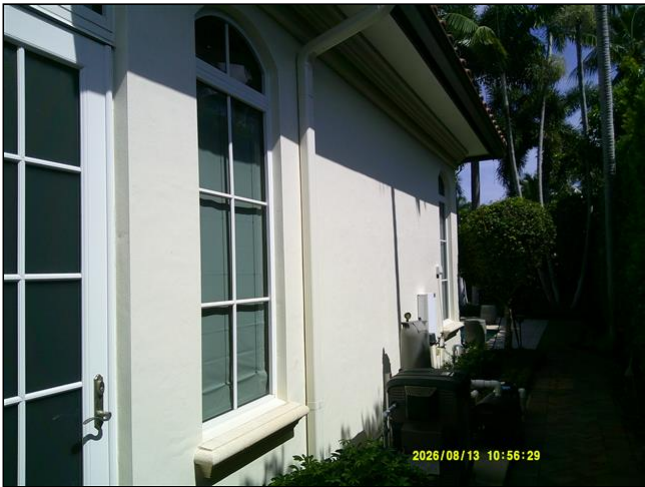
At the time of the inspection, window exteriors showed general weathering, wear, and deterioration commensurate with their age.

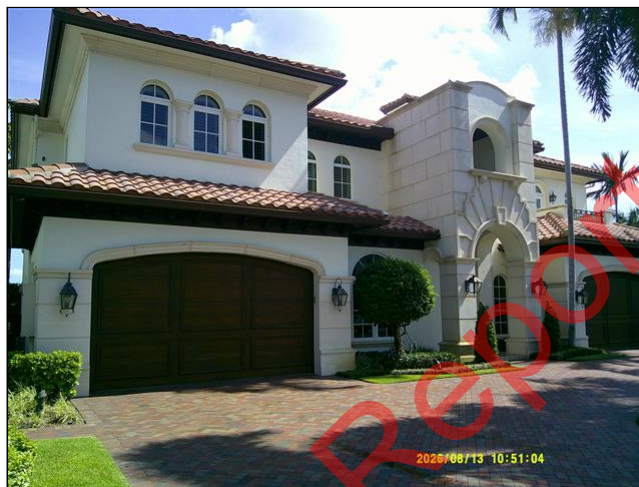
The readily accessible structural components of the dwelling were visually inspected in accordance with the scope and limitations of a home inspection. The structure appears to consist primarily of reinforced masonry/concrete construction with wood-framed roof assemblies and elevated structural components, consistent with the architectural design and construction observed.

No evidence of structural movement, settlement, or structural distress was observed in the readily accessible areas at the time of inspection. Localized cracking at the exterior stucco/decorative column finishes was observed, as noted elsewhere in this report; these observations did not, based on the visual inspection, indicate a readily apparent structural deficiency.

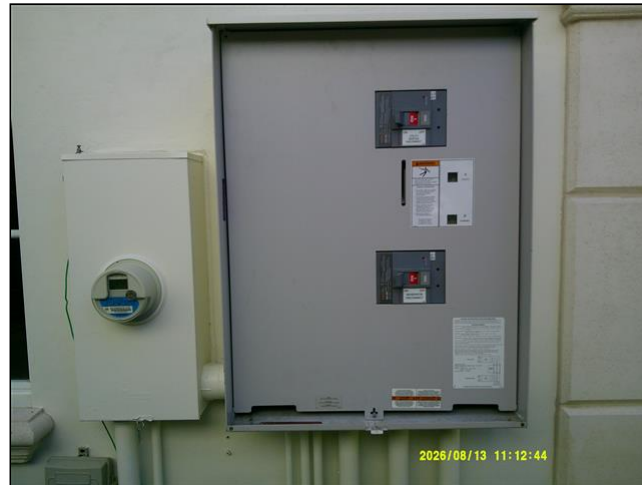
At the time of the inspection, the Inspector observed no deficiencies in the condition of the electric meter. Electric meters are installed by utility companies to measure home electrical consumption.

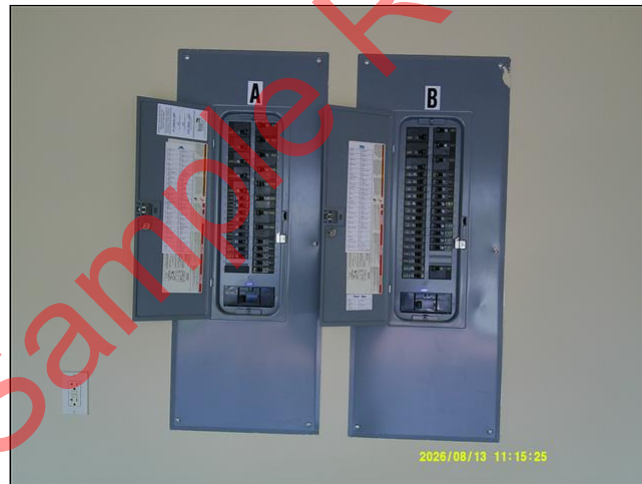
The property is equipped with two 200-amp electrical distribution panels, identified as Panels A and B. Based on the labeling and panel/breaker configuration visible in the photograph, the panels appear to be GE (General Electric) equipment.
