INSPECTION REPORT  
Royal Palm  
Boca Raton FL 33432

INSPECTED BY  
Angelo Menezes  
Certified Inspectors,  
LLC  
HI9467

INSPECTION DATE  
📅 8/13/2026  
🕒 11:00:00 AM

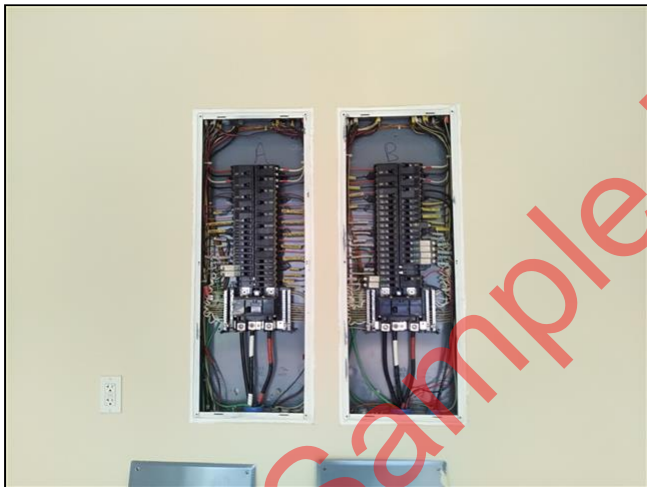
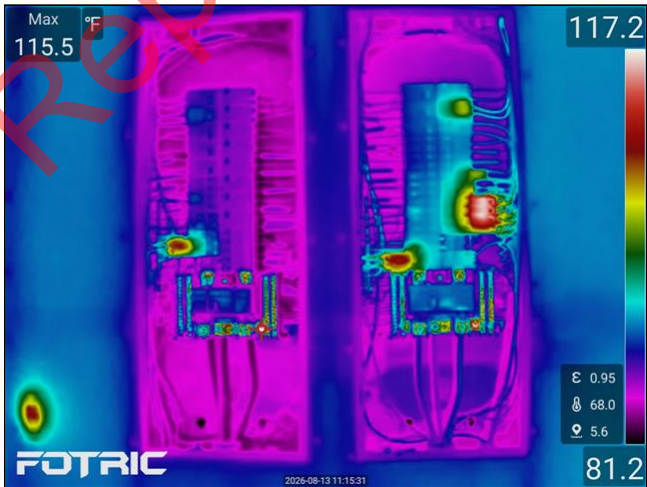
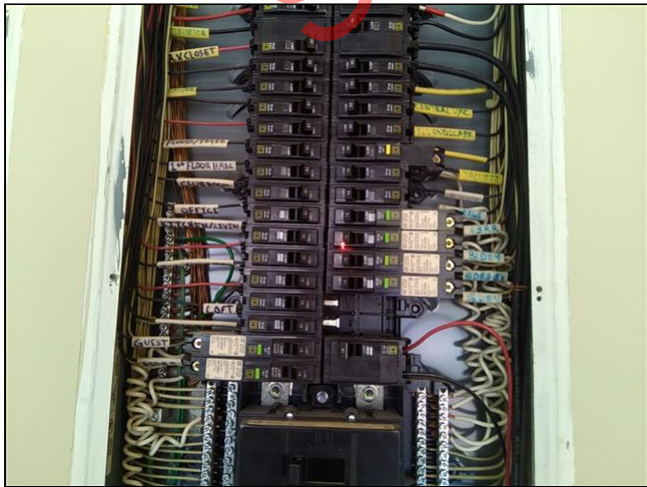
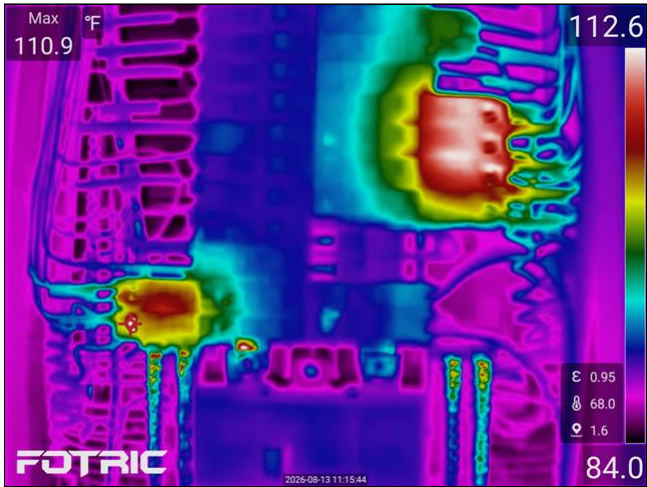
Several circuit breakers exhibited elevated temperatures relative to adjacent breakers during the inspection. The thermal imaging showed localized temperature increases, with the highest observed temperature approximately 117°F compared with an ambient temperature of approximately 81°F. The elevated temperatures appeared to be associated with breakers serving circuits in the panel.

Because portions of the right side of the residence were experiencing electrical faults/power interruptions, these thermal anomalies may be associated with circuits serving the affected areas; however, the infrared scan alone cannot establish the cause or determine whether the elevated temperatures are related to the reported electrical fault. Elevated breaker temperatures can result from normal electrical loading, loose or poor connections, overloaded circuits, defective breakers, or other conditions.

This condition should be considered a priority electrical evaluation due to the combination of reported circuit failures and elevated temperatures observed at the panels.

Recommend prompt evaluation by a licensed electrical contractor. The contractor should identify the circuits serving the affected areas, investigate the reported power interruptions, evaluate the breakers and their connections for abnormal heating or loose connections, and determine whether any repairs or corrective action are necessary.

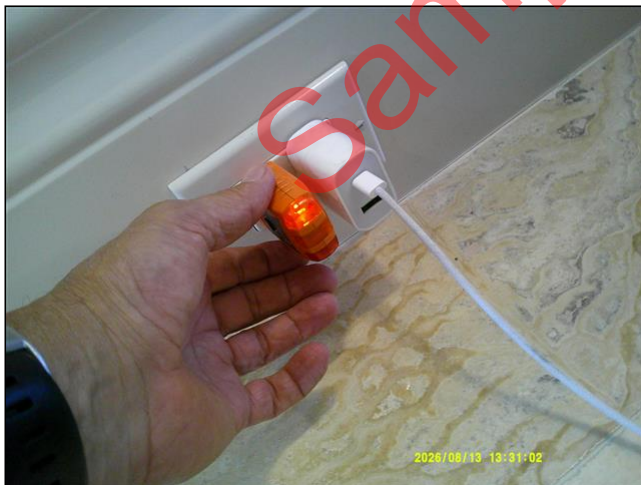
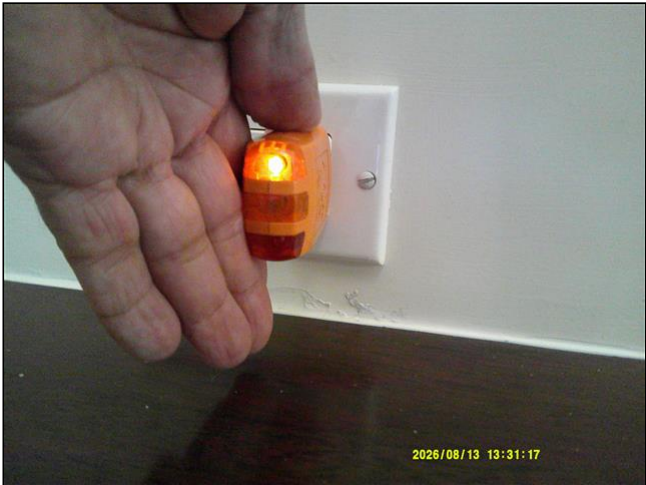
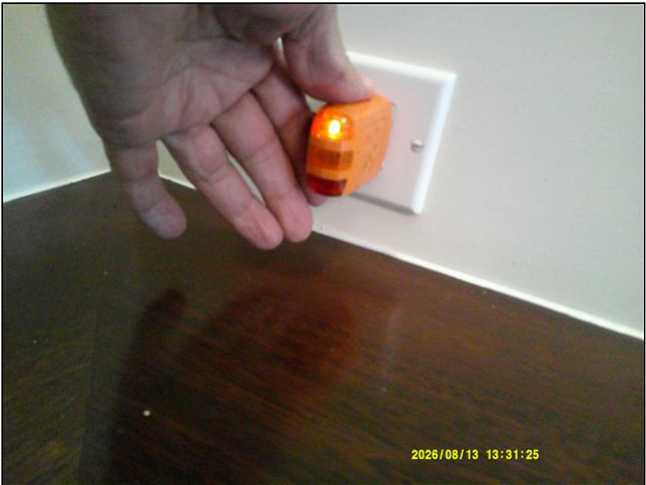
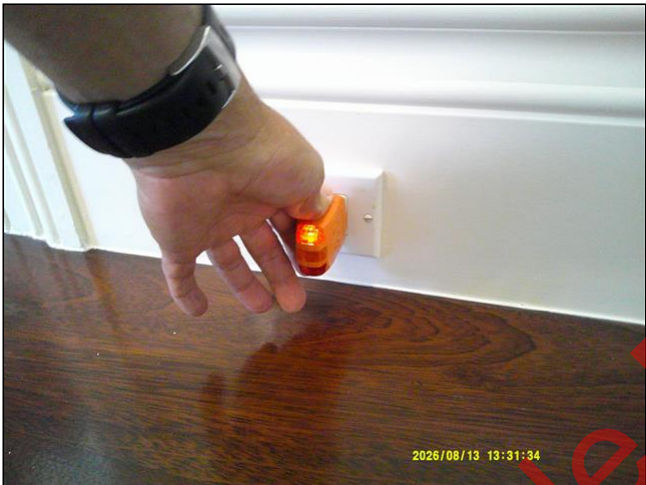
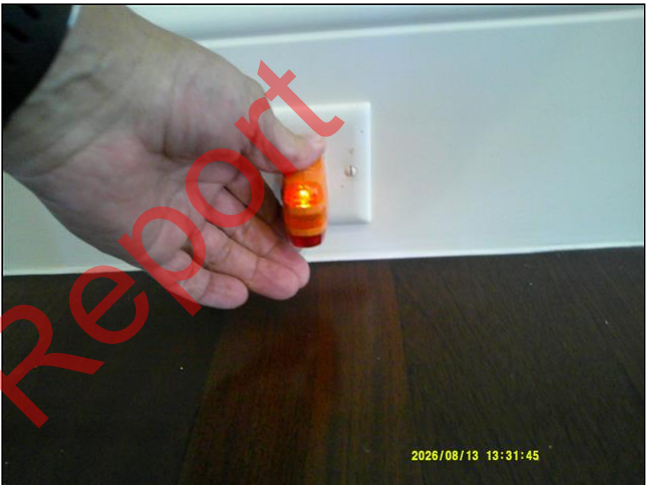
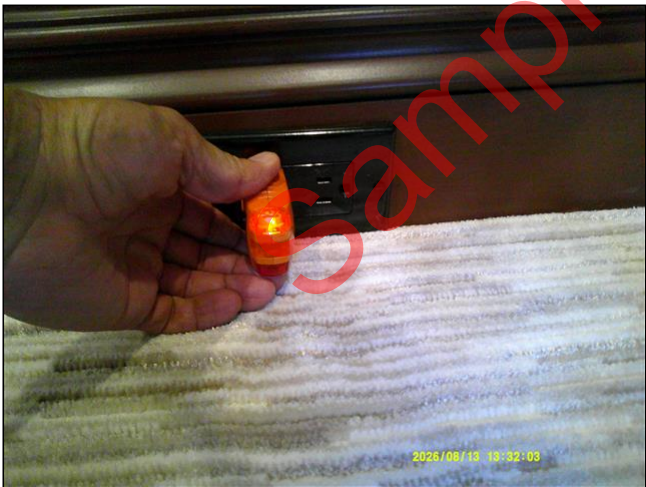
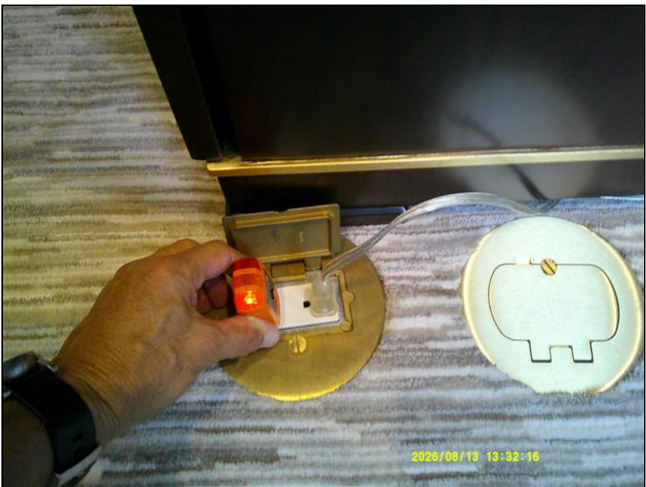
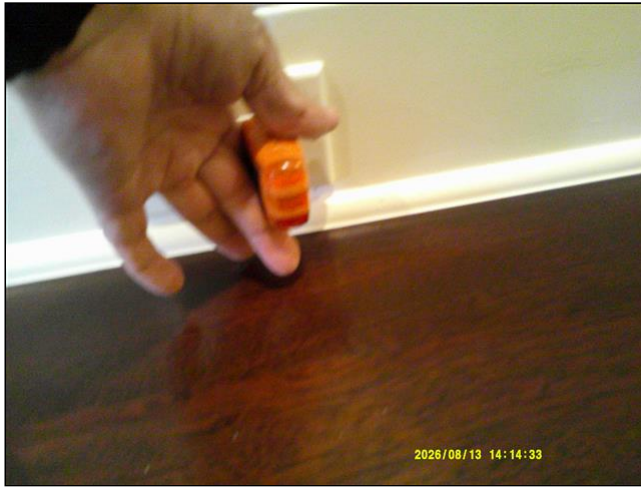
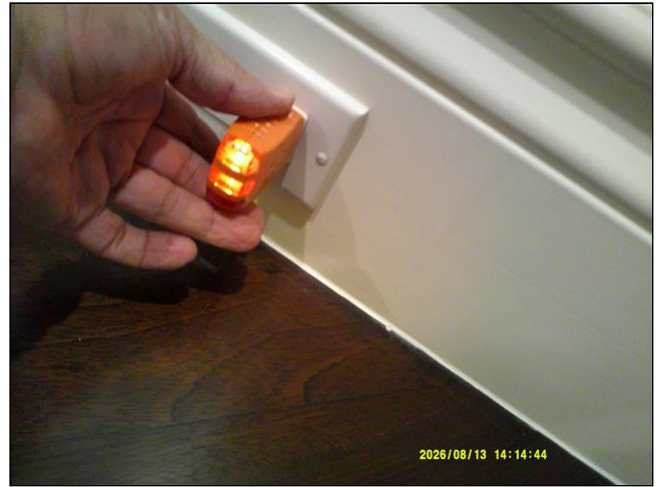
Several receptacles located in the office and theater areas tested with an open ground condition, indicating that the equipment grounding connection may be missing, interrupted, or otherwise improperly connected at these locations. This condition was observed primarily on one side of the home and may be related to the electrical irregularities noted elsewhere in the same area. A damaged/broken receptacle cover plate was also observed and should be replaced. Recommend evaluation by a qualified licensed electrician to determine the cause of the open-ground conditions, verify proper equipment grounding and bonding, and make necessary corrections.

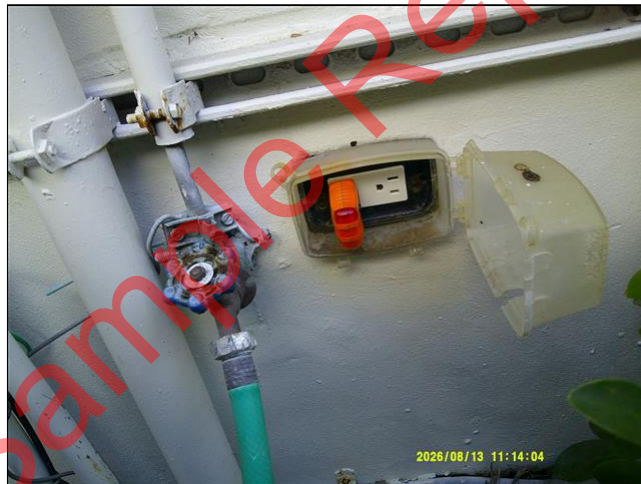
Several exterior GFCI-protected receptacles were tested and did not respond properly to the test function at the time of inspection. GFCI devices are safety devices that can deteriorate with age, weather exposure, and repeated use and require periodic testing and maintenance. Given the age and exterior exposure of the devices, replacement of the affected GFCI receptacles is recommended, followed by testing to verify proper operation and protection of the associated circuits. A qualified electrician should also evaluate the wiring and upstream/downstream GFCI configuration as necessary.

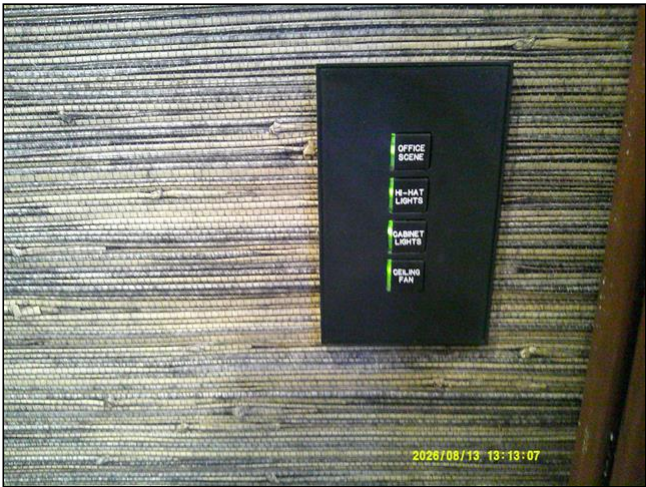
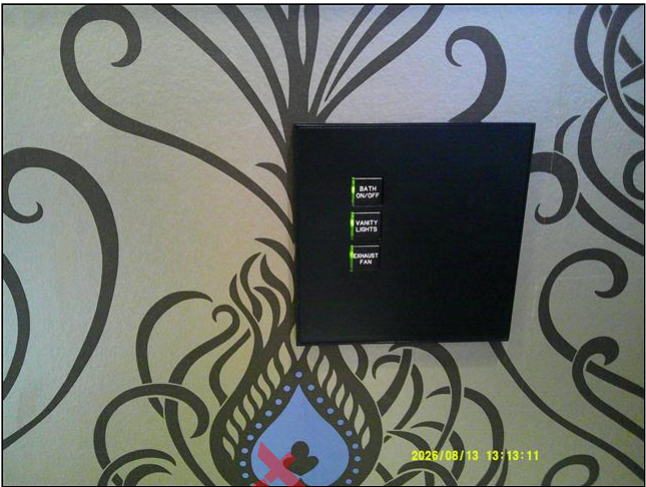
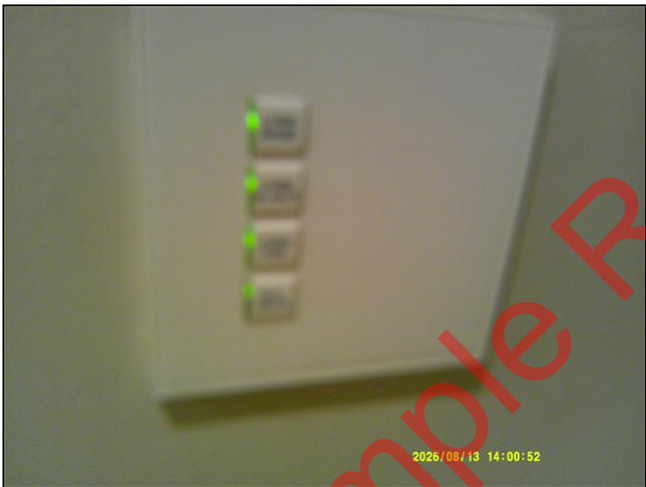
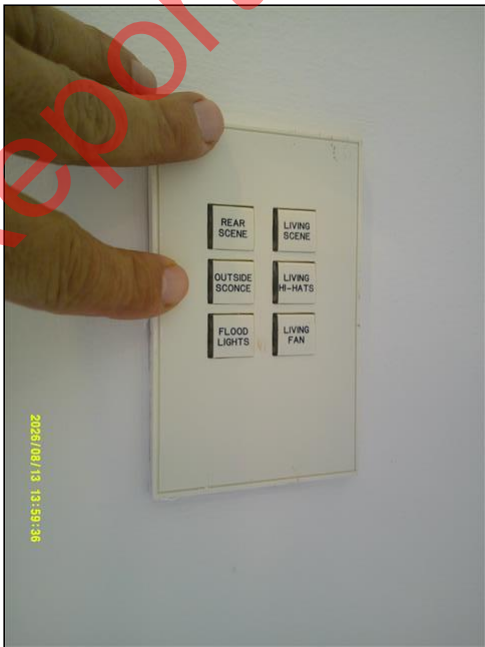
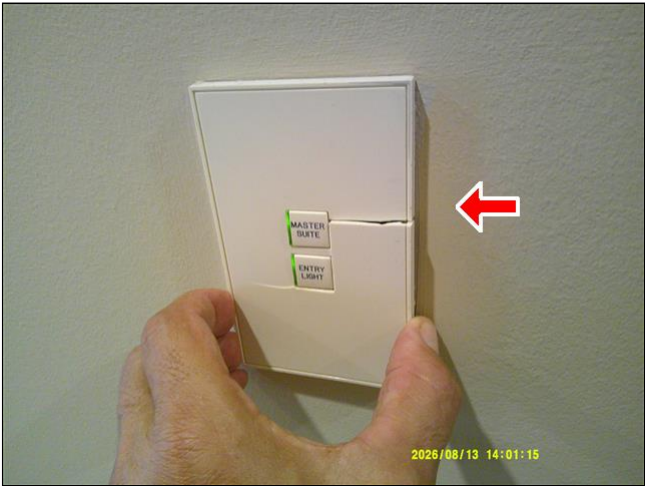
The residence is equipped with a combination of conventional wall switches and decorative/electronic-style switch controls, including multi-function controls for lighting and exhaust fans. The switches tested were generally functional at the time of inspection. One switch plate/control was observed to be physically damaged/broken and should be repaired or replaced. No other operational deficiencies were noted with the switches tested.

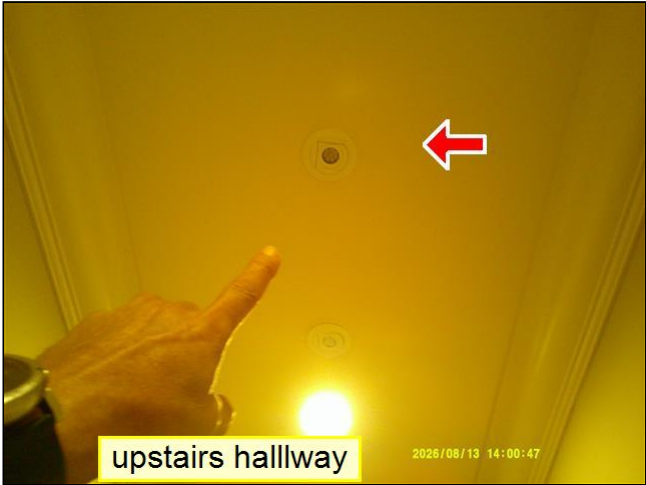
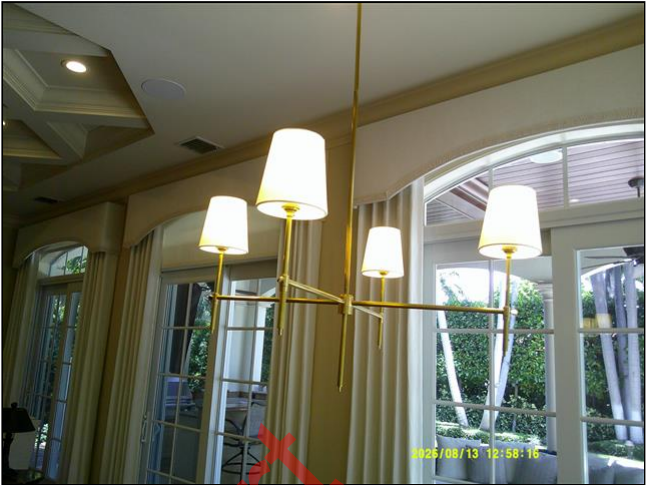
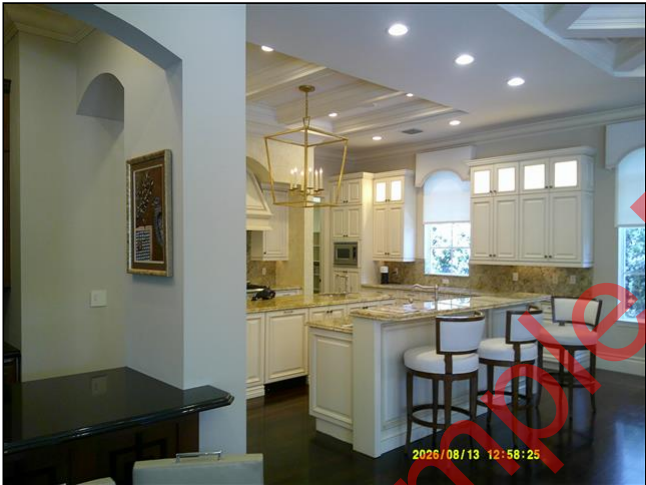
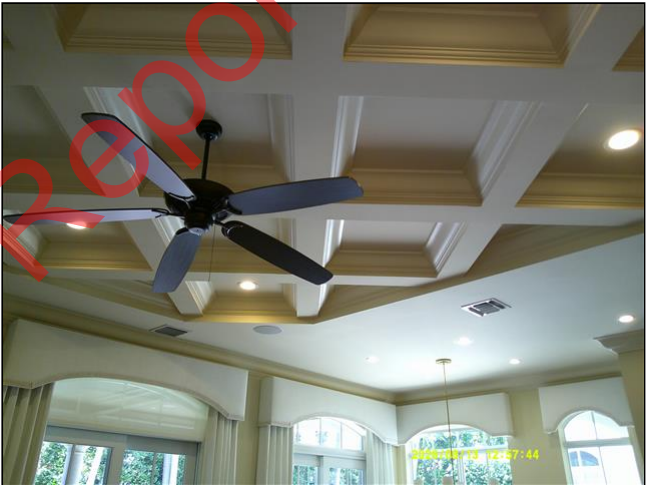
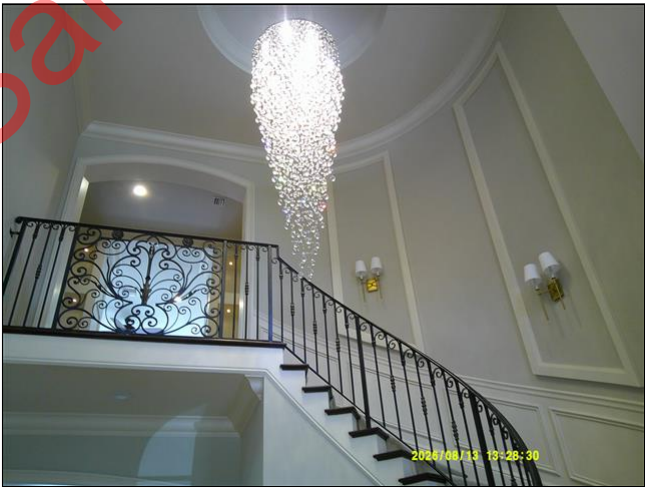
[At the time of the inspection, the Inspector observed few deficiencies in the condition of interior lighting. Notable exceptions will be listed in this report.

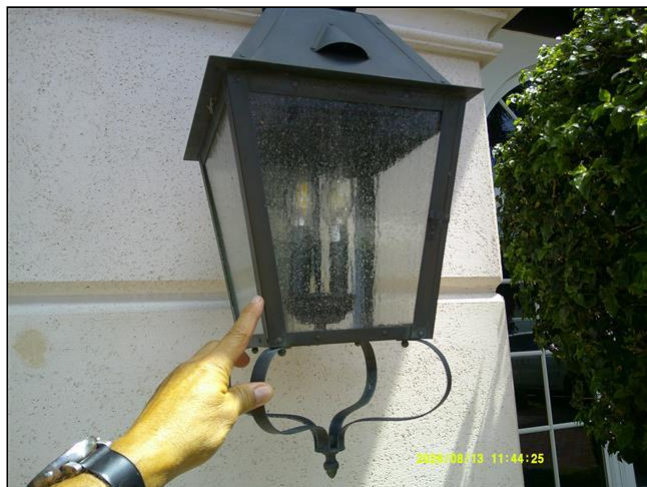
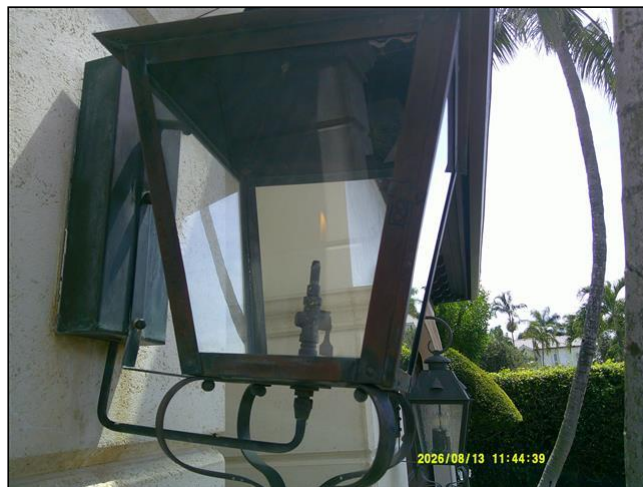
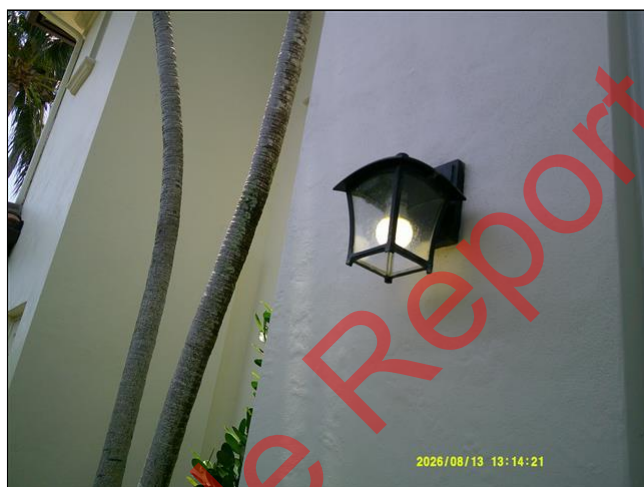
- The two exterior light fixtures located at the left side of the garage were not functional at the time of inspection. The cause could not be determined during a visual inspection and may involve the fixtures, switches, wiring, or power supply.
- Two gas-fired lantern-style light fixtures are installed at the front porch/entry area. These were observed as gas lighting fixtures rather than conventional electrical fixtures.
- Oxidation/corrosion was observed on some exterior floodlight fixtures. This condition can lead to deterioration of the fixtures and should be addressed as needed.

Recommend evaluation and repair/replacement of the non-functional garage-area fixtures and deteriorated exterior lighting fixtures by a qualified electrical contractor.

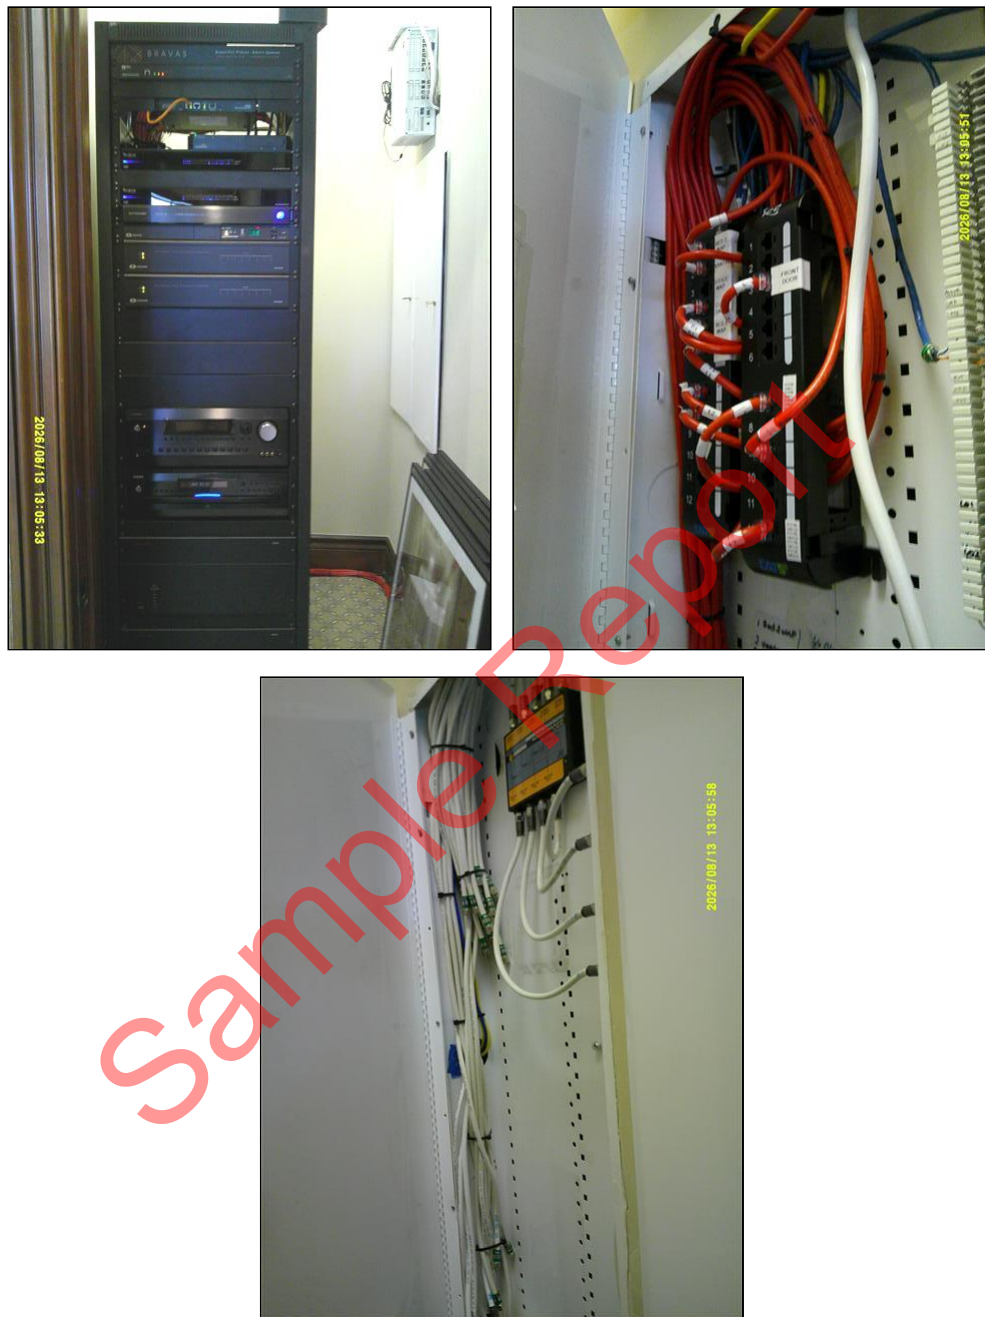
**6.18 Low Voltage**

A dedicated low-voltage/communications equipment installation was observed in a closet serving the theater area. The installation includes structured wiring, distribution equipment, and audio/visual components associated with the home's entertainment and communication systems. Low-voltage wiring, networking, audio/visual equipment, and associated components were not inspected or tested as part of this home inspection, and their operation, configuration, performance, and compliance were not evaluated. Specialized evaluation by a qualified low-voltage/AV technician is recommended if assessment of these systems is desired.

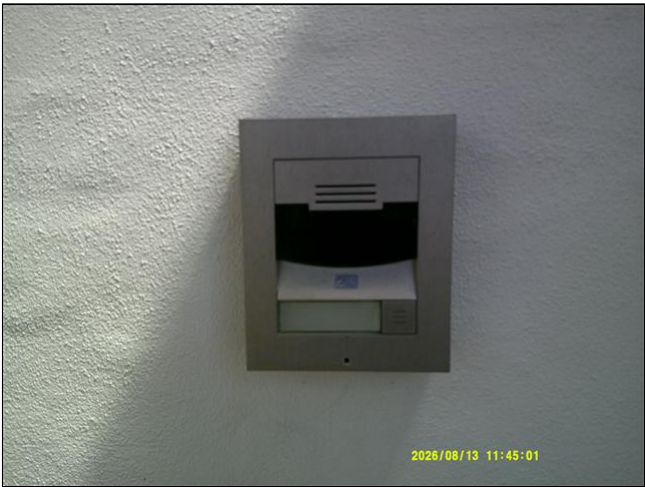
The doorbell responded to the switch at the time of the inspection.

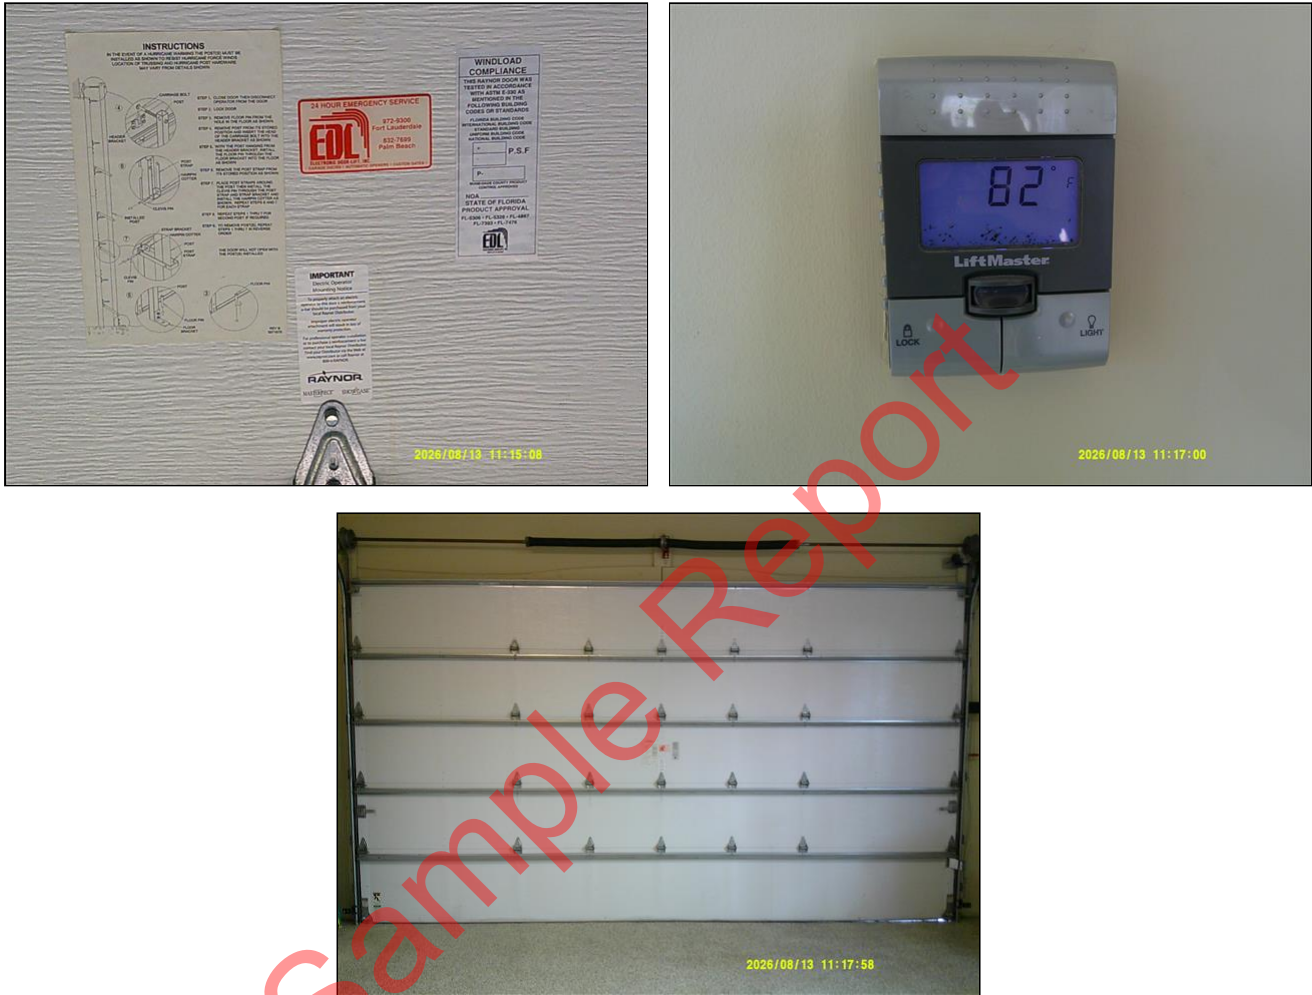
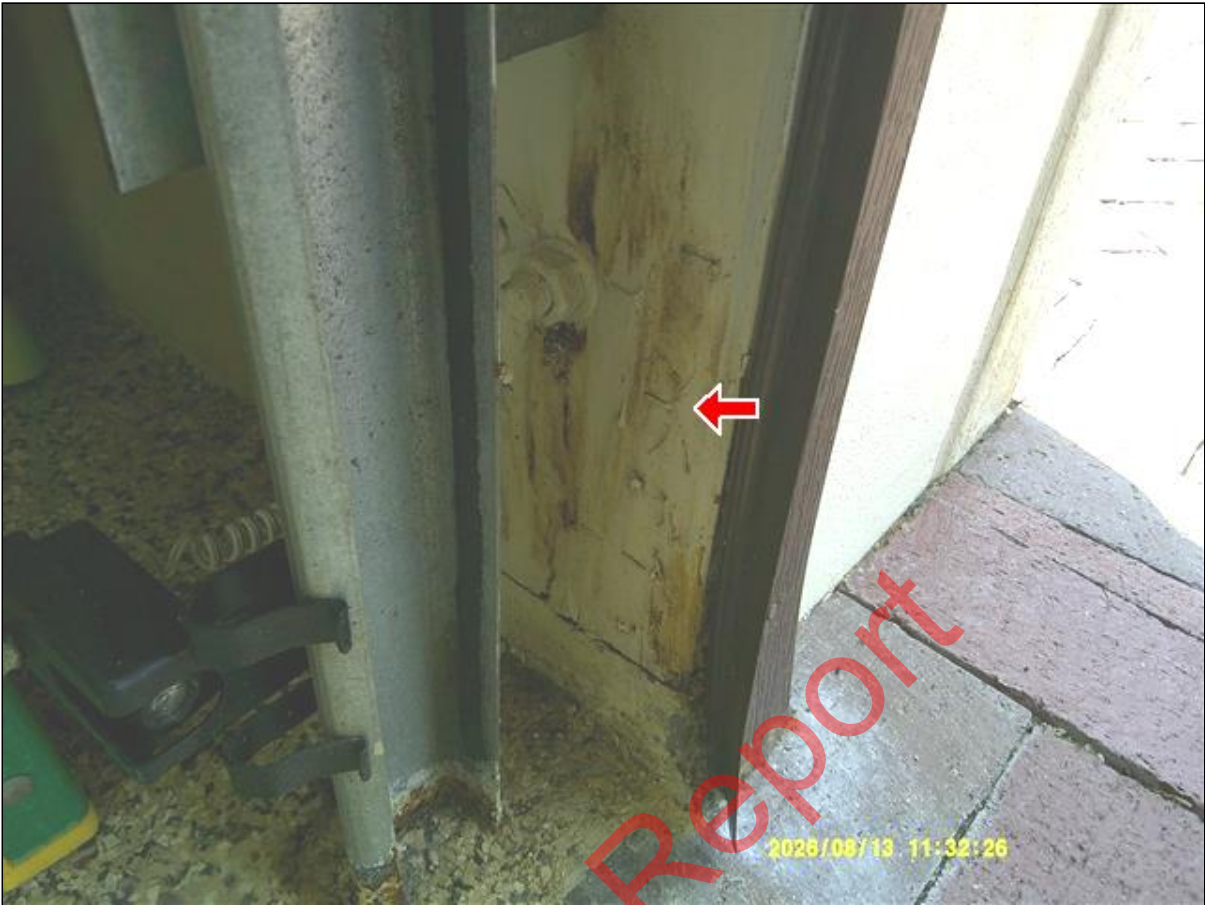
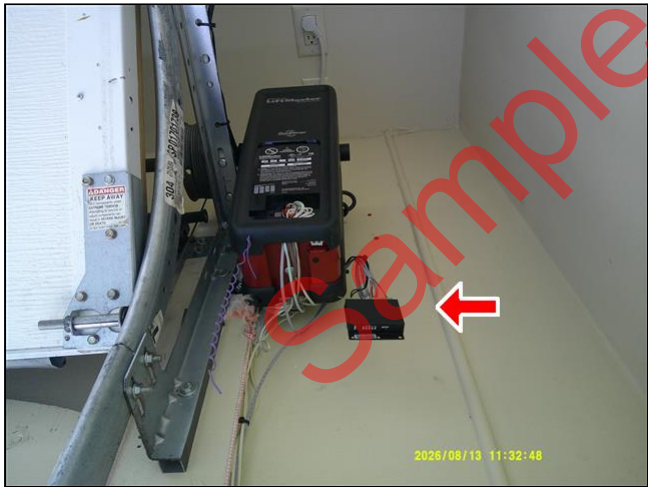
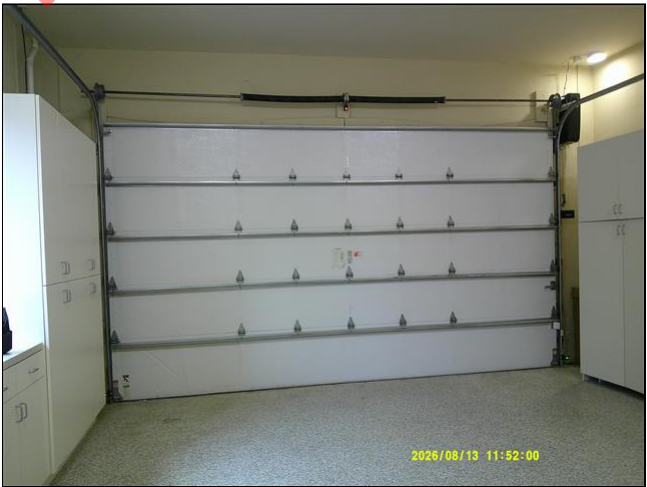
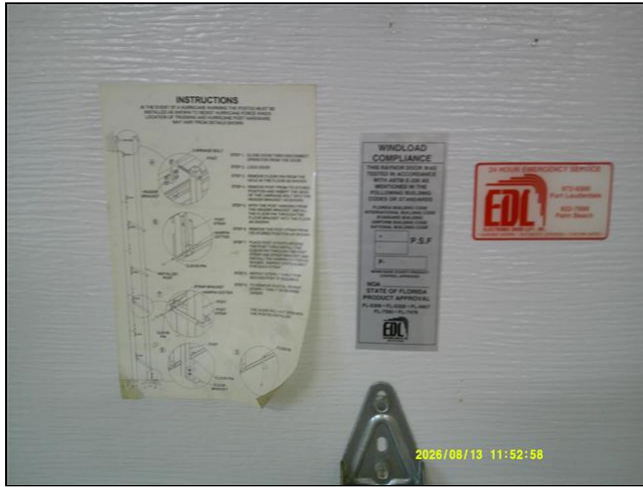
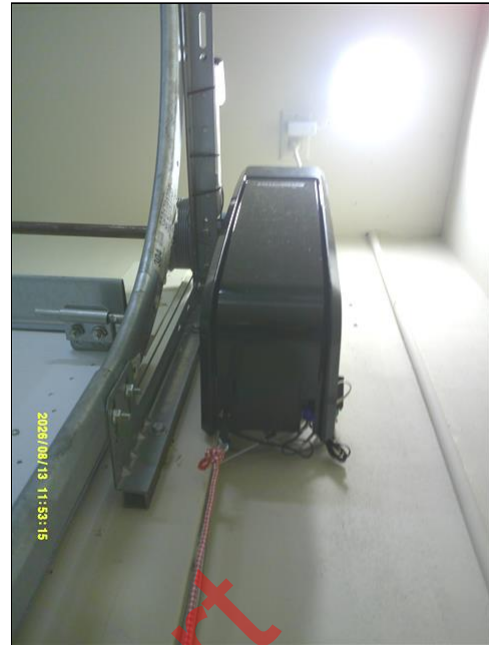
The garage is equipped with two sectional overhead garage doors, apparently designed for wind-load/hurricane resistance, as indicated by the manufacturer's wind-load compliance labeling. The doors are constructed of multiple horizontal panels and operate on overhead tracks with counterbalance systems and automatic garage door openers. Both doors were operated at the time of inspection. The left garage door exhibited localized wood deterioration/rot at the lower frame/jamb area, consistent with moisture exposure. Repair or replacement of the affected deteriorated components is recommended. The opener serving the left door was operational; however, some associated components/accessories were loose and should be properly secured. The specific wind-load rating and product approval were not independently verified as part of this inspection.

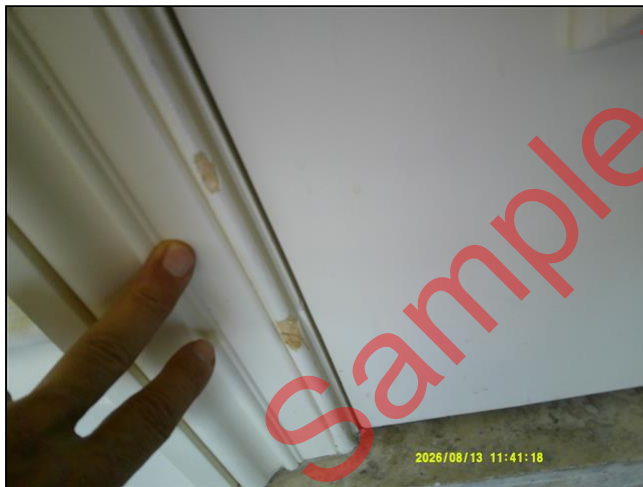
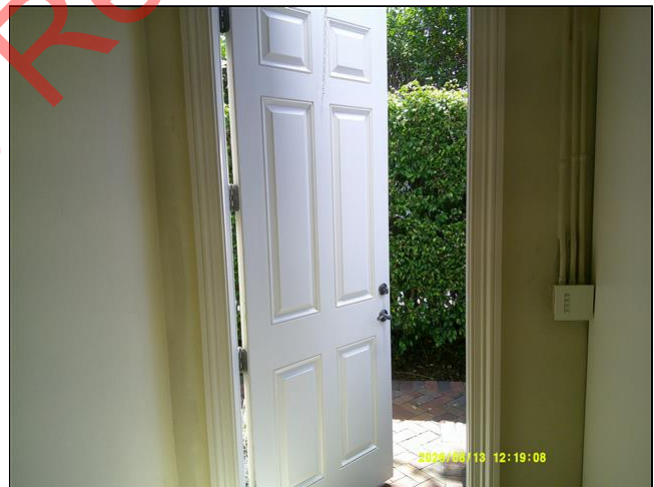
## 7.1 Conventional Doors

The conventional door between the garage and the interior exhibited light wear and/or deterioration commensurate with its age.

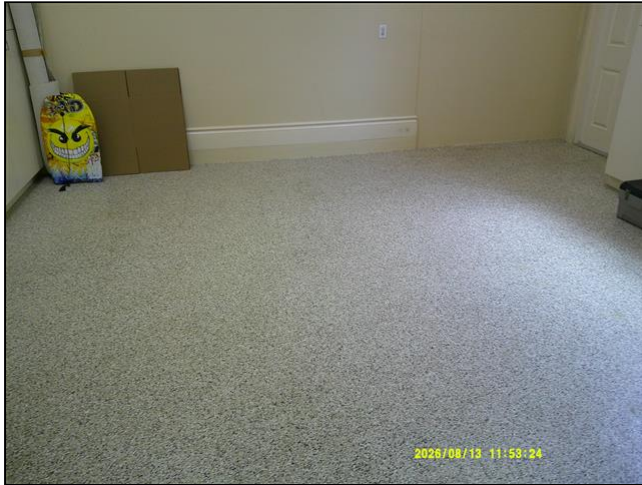
## 7.2 Floors

The garage floors are finished with a decorative epoxy/flaked coating over concrete. The coating was generally serviceable; however, localized cracking, deterioration, and discoloration were observed, particularly along portions of the perimeter and at transitions/edges. Some areas exhibited staining and minor surface deterioration. These conditions should be monitored and repaired as needed to prevent further deterioration of the underlying concrete and coating.

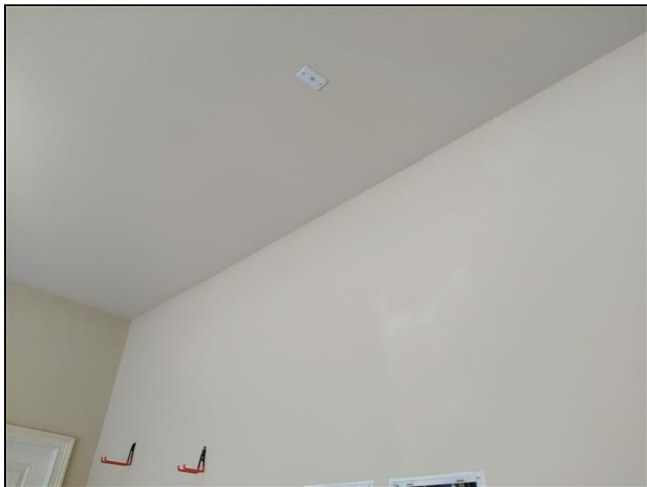
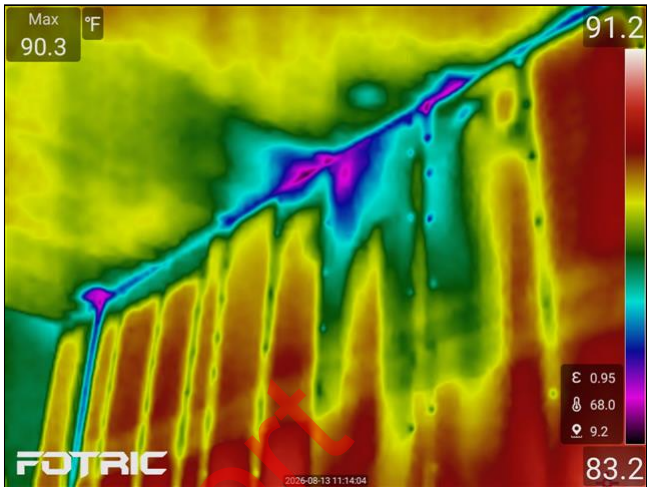
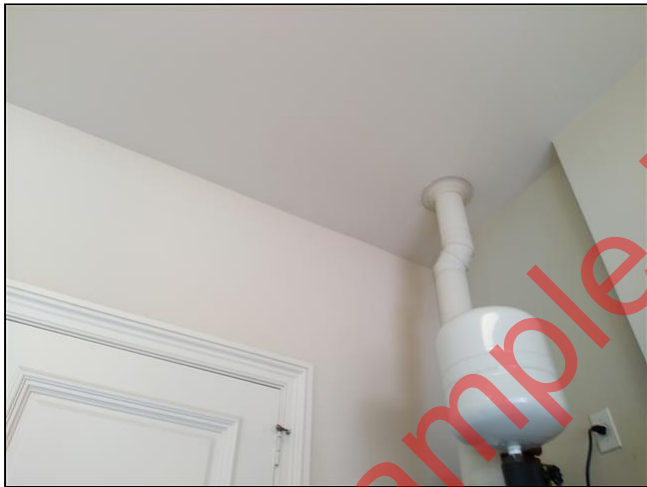
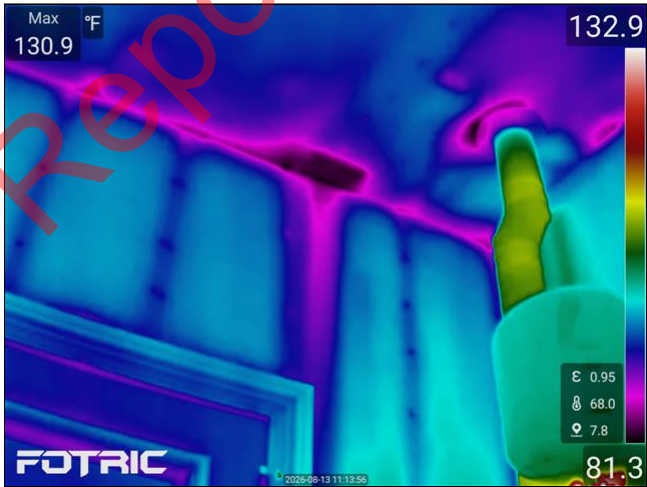
Infrared scanning of the garage ceiling showed localized temperature variations along portions of the ceiling/perimeter area. The thermal image indicates areas of differing thermal patterns that may be associated with variations in insulation, framing, air movement, or other concealed conditions. Infrared imaging is a screening tool and does not by itself establish the presence of a defect or moisture intrusion. No definitive conclusion regarding the cause of the temperature variations can be made from the thermal image alone. Further evaluation would be appropriate if other visual or moisture-related indications are present.

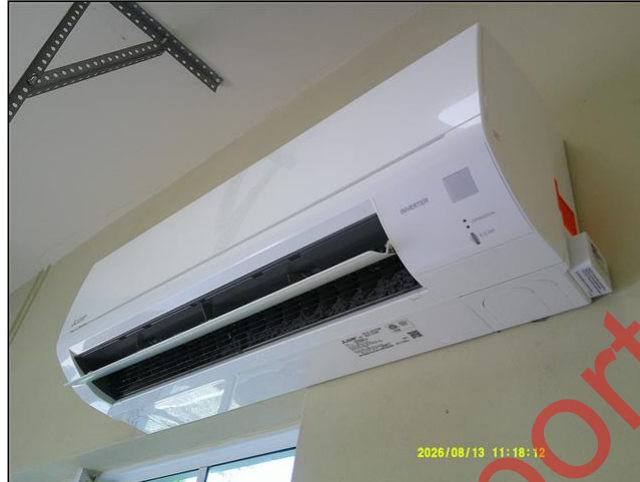
7.6 General Condition and Ventilation

The property has two attached garages, each equipped with a ductless mini-split air-conditioning system. The garages are generally finished and maintained; however, the garage environment is subject to elevated heat and humidity due to its exposure and limited natural ventilation. The left-side mini-split showed visible microbial/mold-like growth within the indoor unit, indicating a need for professional cleaning and servicing. These systems are not typically designed to operate continuously in a garage environment, particularly where garage doors are frequently opened, and maintaining conditioned air in these spaces can result in increased humidity and condensation within the equipment. The garage HVAC systems should be serviced and maintained as recommended by the manufacturer, and adequate ventilation should be maintained when practical.

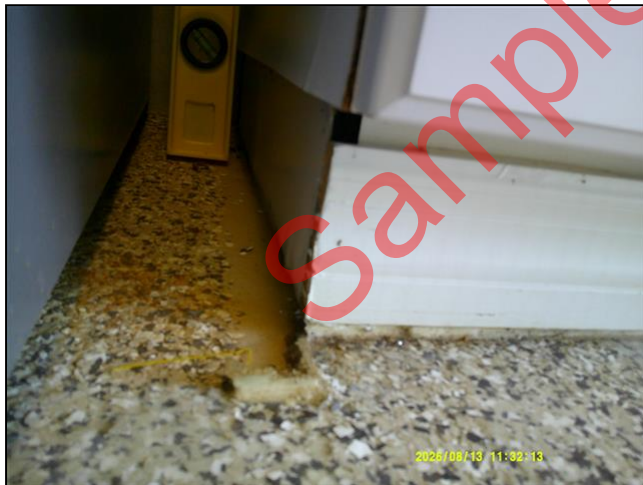
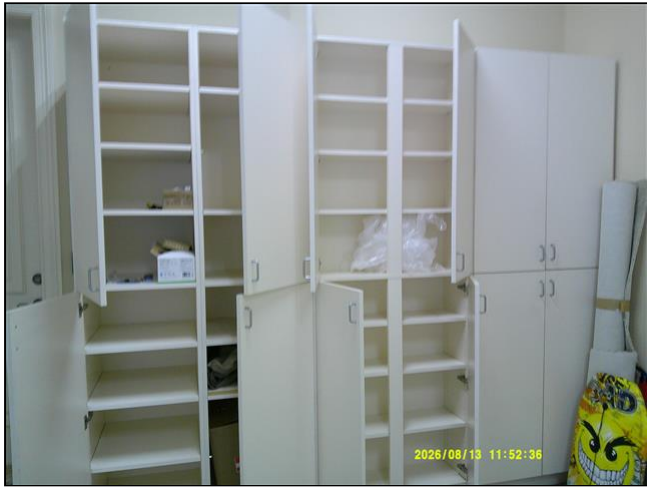
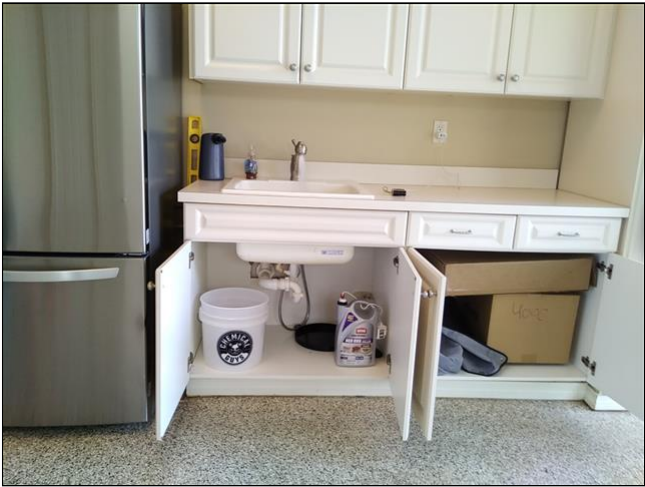
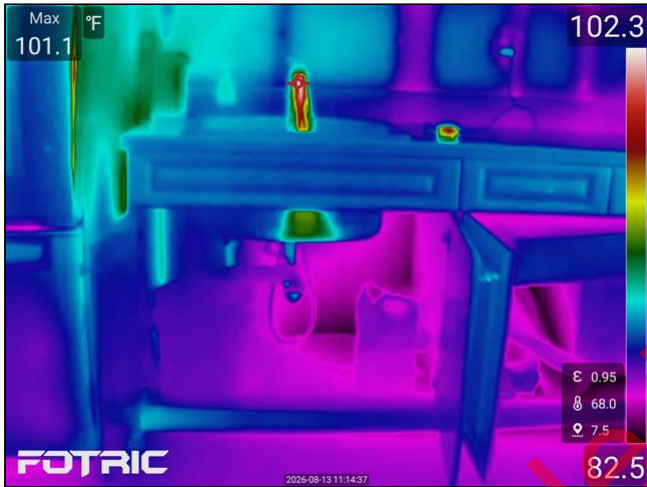
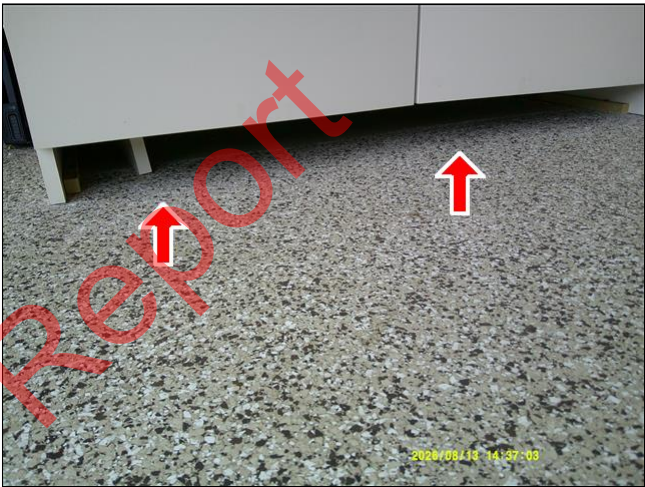
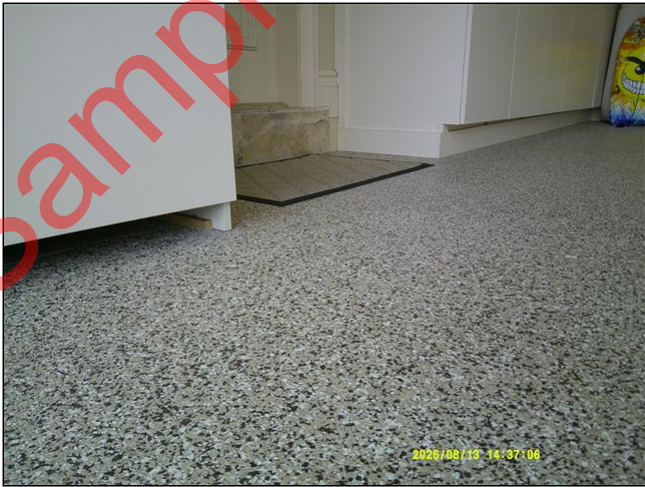
## 7.7 Cabinets

The garage cabinets exhibited evidence of water damage and moderate deterioration, including localized discoloration and deterioration of cabinet materials. The source of the water exposure could not be determined as part of the inspection. The affected cabinets should be further evaluated, and damaged components should be repaired or replaced as appropriate.

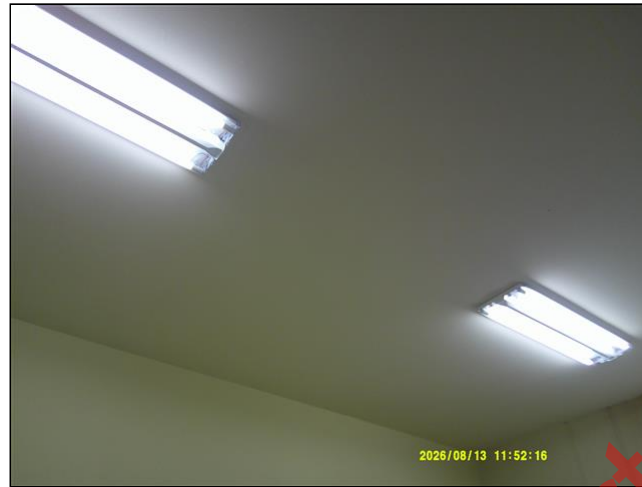
7.8 Lighting

The garage lighting fixtures exhibited damaged and/or missing protective covers. The fixtures serving the right-side garage were missing their covers, while the fixture in the left-side garage had a damaged cover. The affected fixtures should be repaired or replaced to provide proper protection for the electrical components and restore the fixtures to serviceable condition.

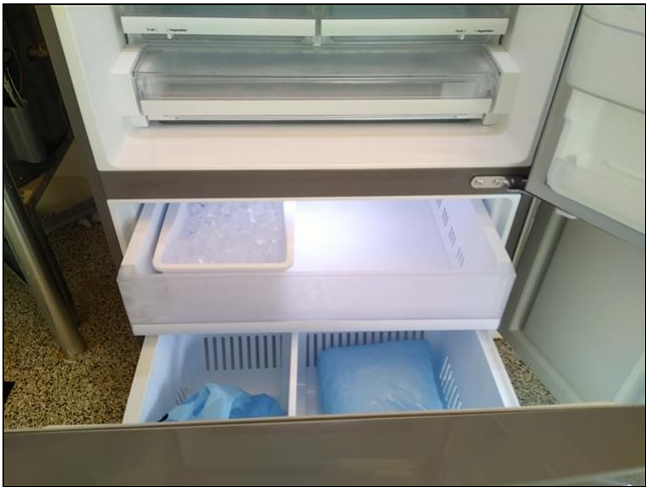
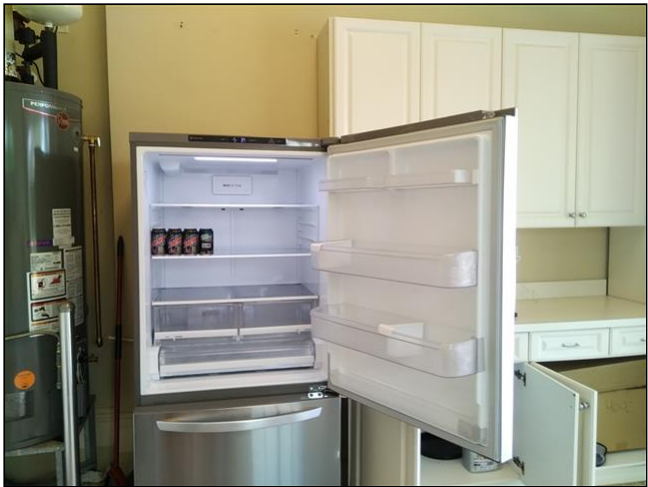
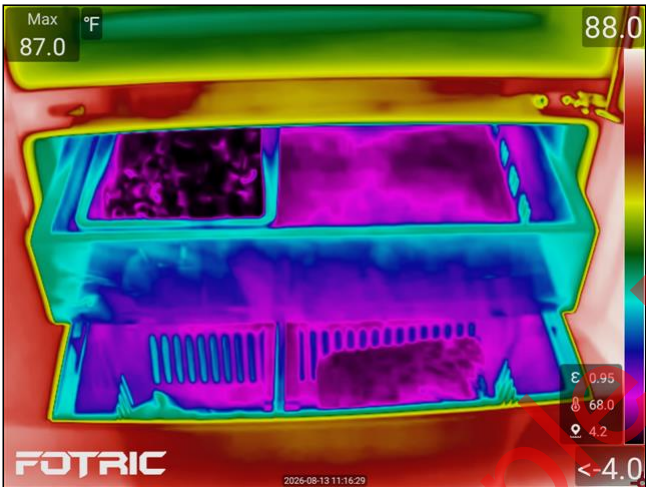
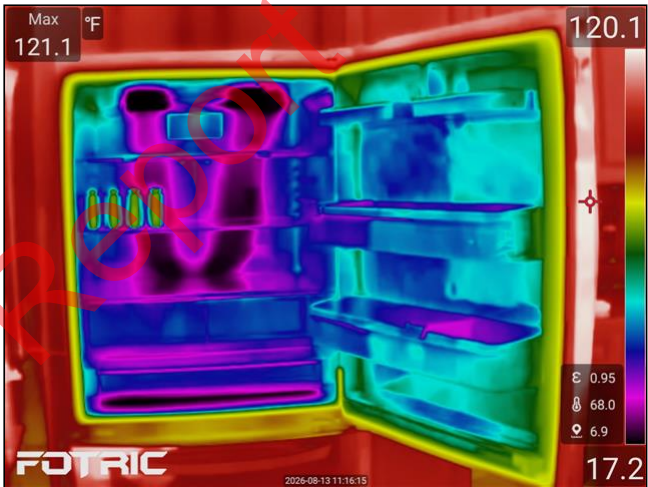
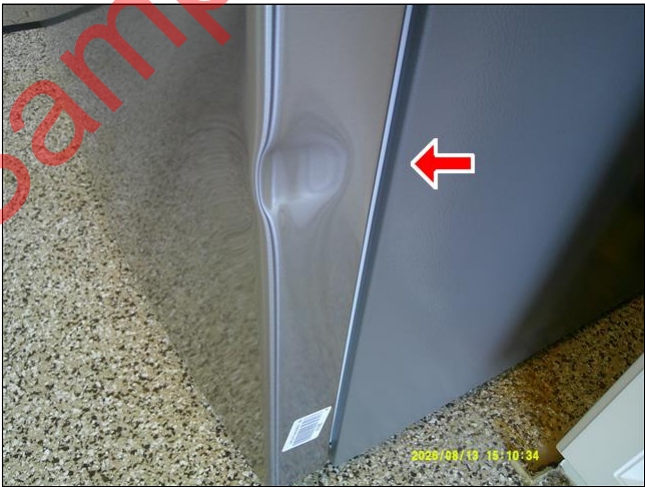
The garage refrigerator exhibited exterior physical damage, including a noticeable dent to the cabinet. The damage appeared primarily cosmetic; however, the appliance should be monitored for proper operation and condition.
