INSPECTION REPORT  
Royal Palm  
Boca Raton FL 33432

INSPECTED BY  
Angelo Menezes  
Certified Inspectors,  
LLC  
HI9467

INSPECTION DATE  
📅 8/13/2026  
🕒 11:00:00 AM

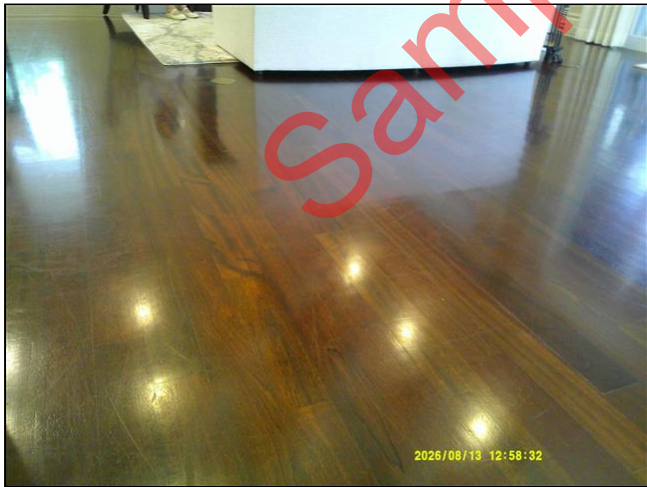
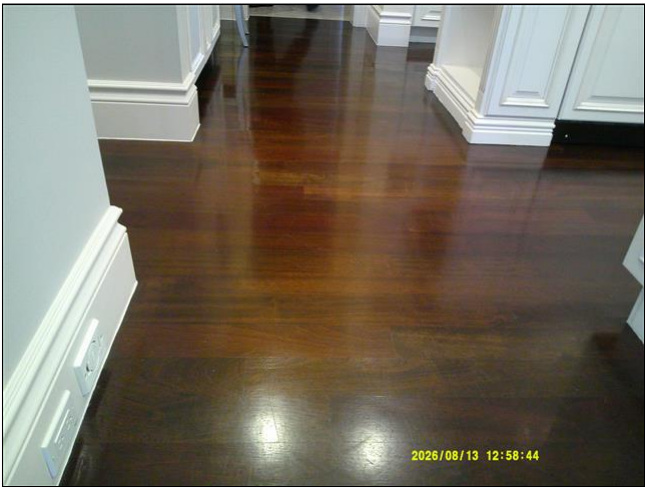
The hardwood flooring throughout the residence was generally in serviceable condition; however, localized scratches, surface wear, and minor finish deterioration were observed in several areas. The flooring would benefit from professional cleaning and appropriate maintenance/polishing or refinishing, as recommended by the flooring manufacturer or a qualified flooring contractor, to improve the appearance and protect the finish. No significant structural deficiencies in the flooring were observed.

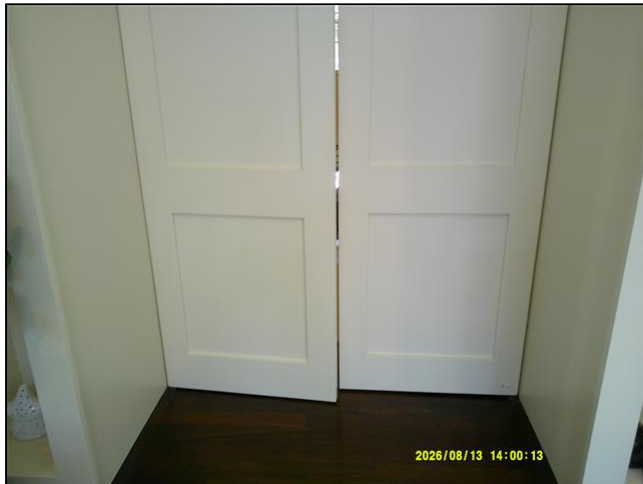
A set of double interior doors leading to the den was observed to have minor cosmetic damage and wear. The doors remained generally functional, with no significant operational deficiency noted. Minor repair or touch-up is recommended as desired to restore the appearance and finish.

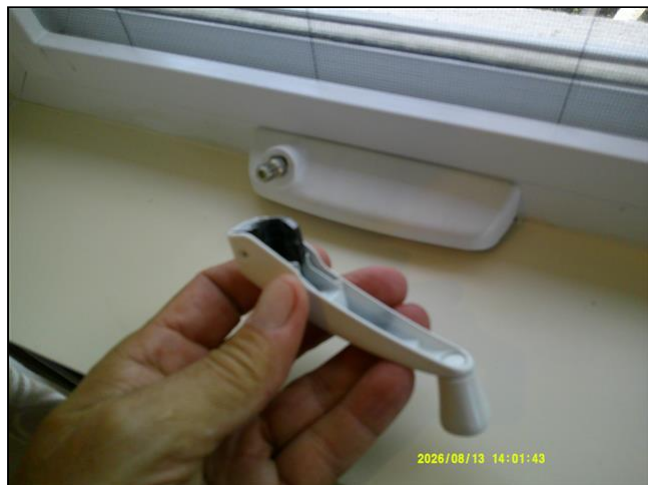
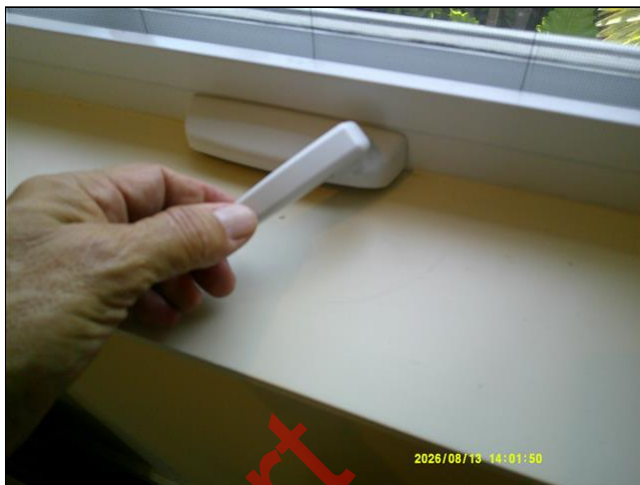
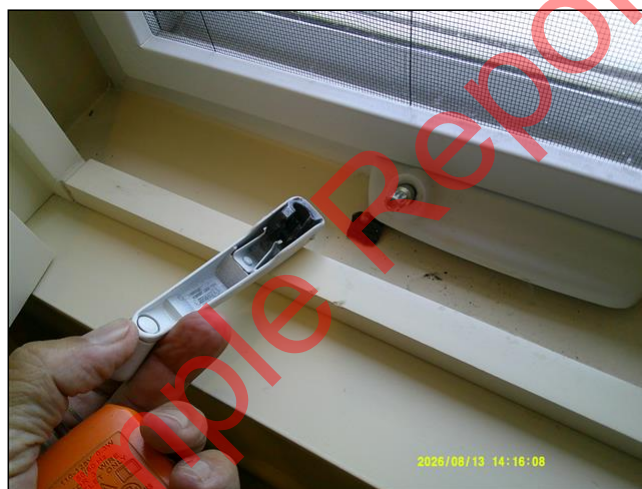
The residence is equipped with impact-rated windows, including casement-style units operated by crank mechanisms. Several window crank handles were found to be damaged or deteriorated, and a number of the hurricane-rated windows were difficult to operate. The affected hardware should be repaired or replaced, and the windows serviced as necessary to ensure smooth operation. The impact-rated glazing and window systems were not independently verified for product certification or design-pressure rating as part of the visual inspection.

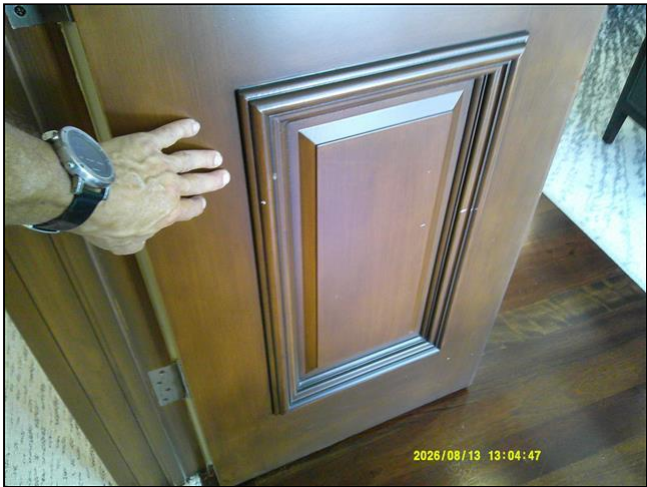
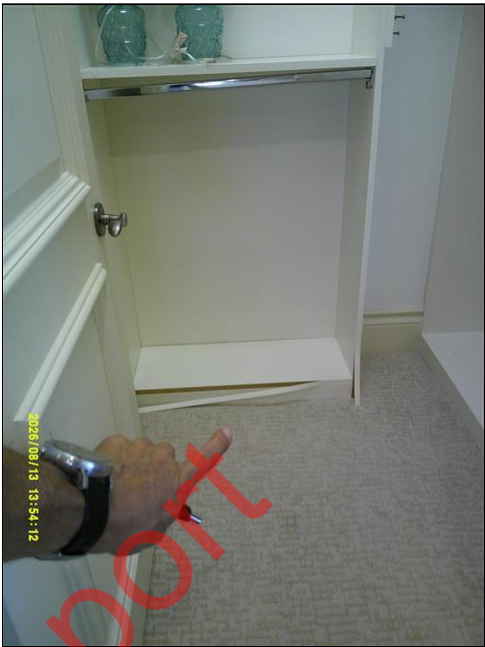
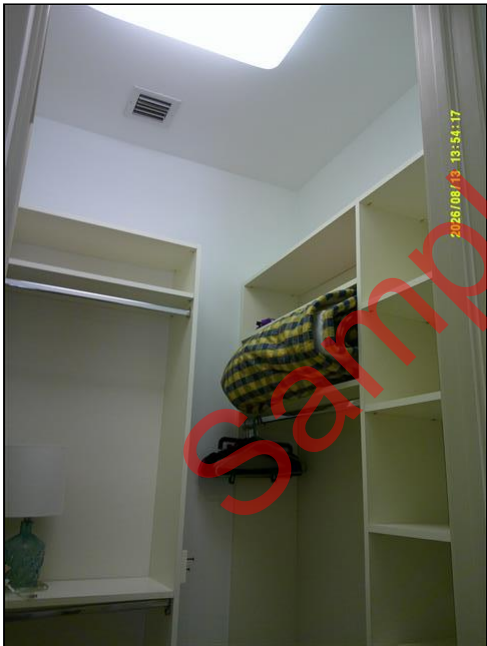
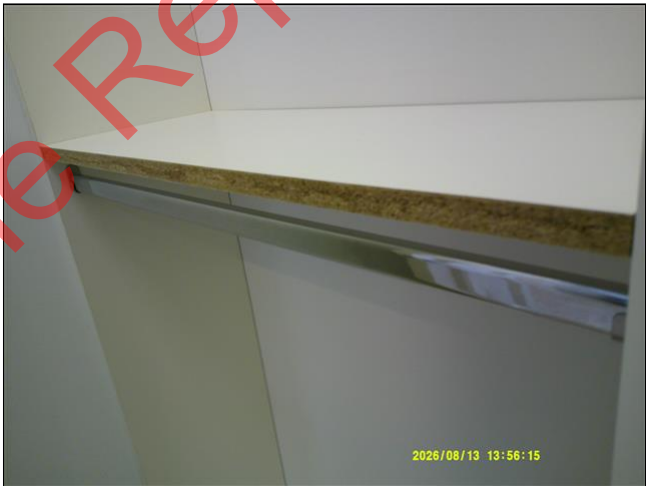
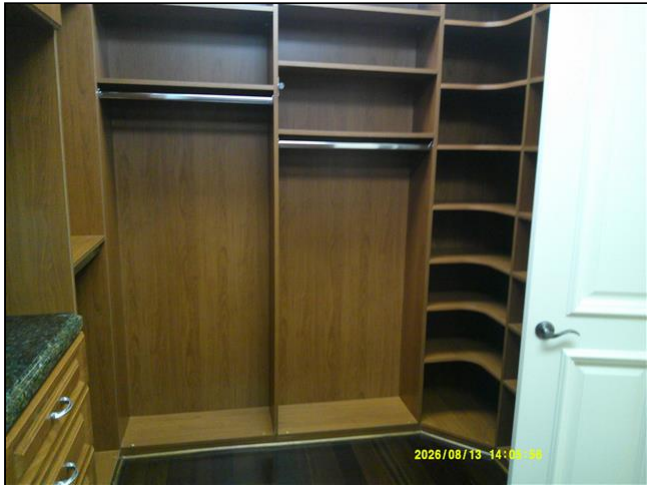
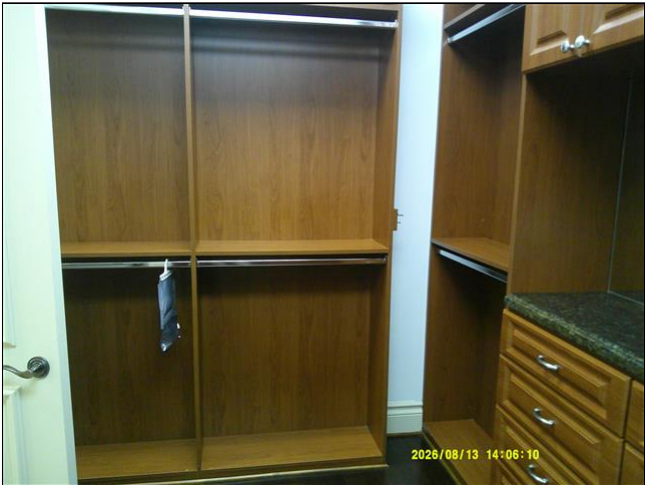
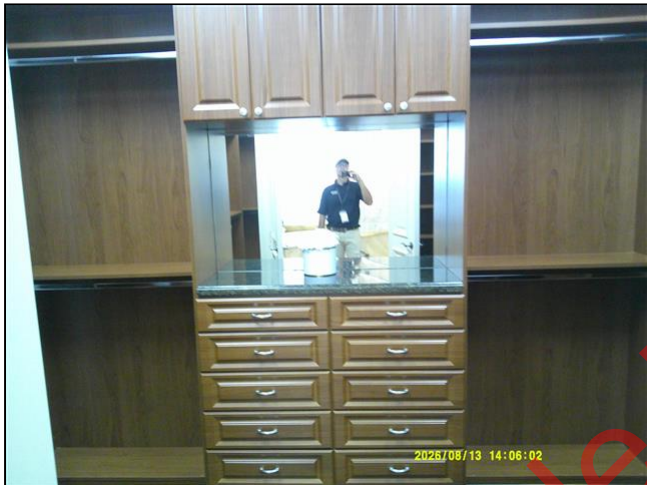
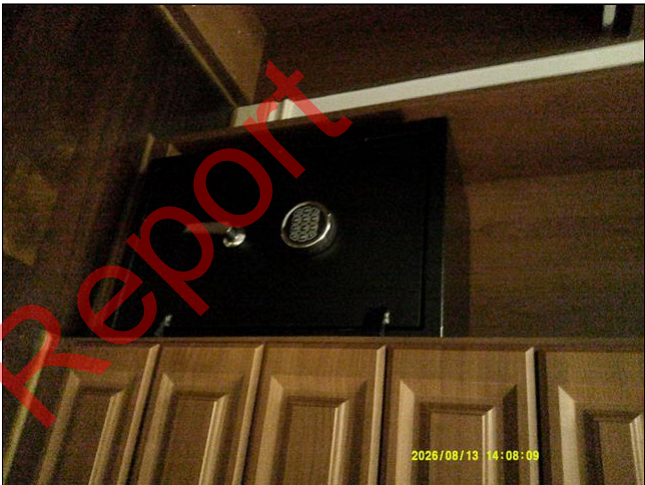
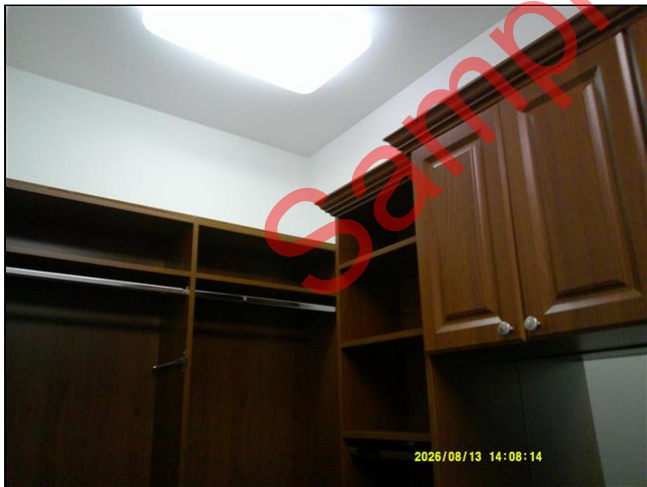
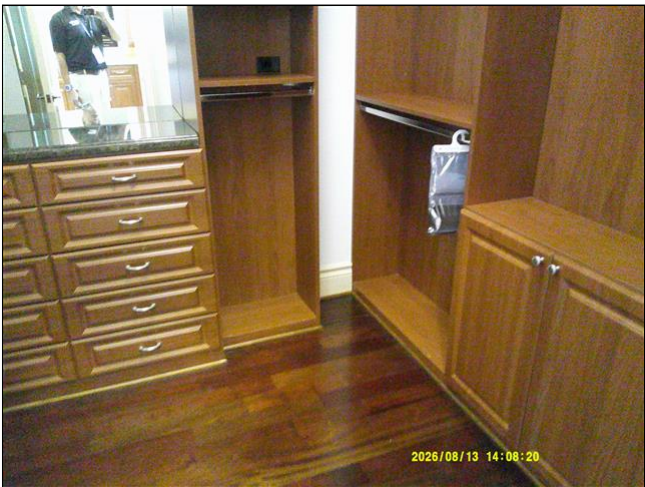
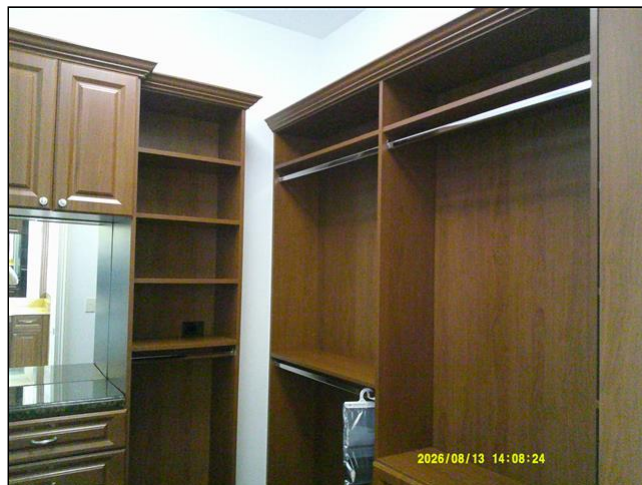
The interior built-in cabinets and storage units were generally observed to be in good, serviceable condition. However, localized areas of loose or delaminated veneer were noted on some cabinet components. These areas should be repaired or re-secured as needed to prevent further peeling or deterioration. Otherwise, the cabinets appeared generally functional and well maintained.

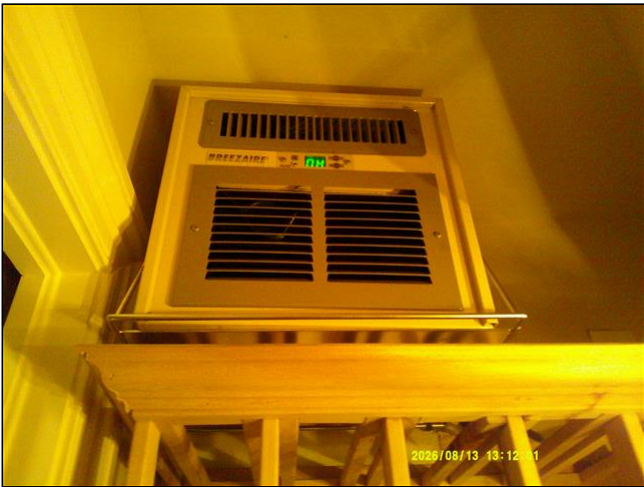
The wine cellar is equipped with a dedicated through-the-wall wine cellar cooling system, identified as a PreZaire unit, designed to provide temperature control for the wine cellar independently of the home's primary HVAC system. The unit was not operational at the time of the inspection and was not producing the expected cooling, preventing a complete evaluation of its operating performance. It was also noted that the electrical system serving the side of the home had an electrical fault at the time of the inspection. Because the wine cellar cooling equipment relies on the home's electrical supply, this electrical fault may have contributed to or interfered with the operation of the cooling unit; however, a causal relationship could not be confirmed during the inspection. The electrical fault should be evaluated and corrected by a

qualified electrician, and the wine cellar cooling system should subsequently be evaluated by a qualified wine-cellar/HVAC technician to verify proper operation.

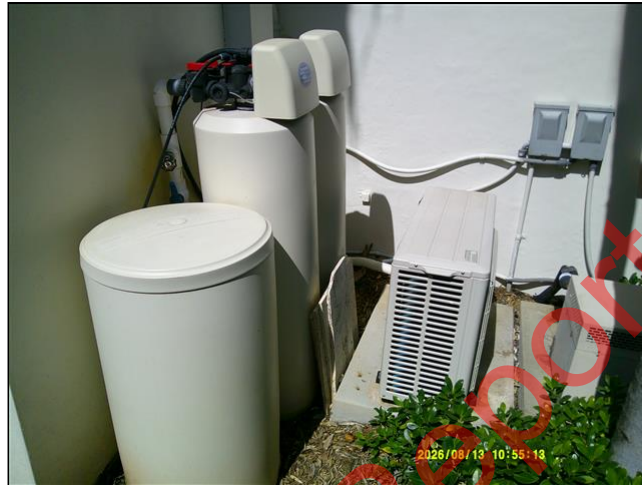
A whole-house water conditioning system, including a salt-based water softener and associated treatment equipment, was observed at the exterior of the residence. The system includes a brine/salt tank, treatment/resin tank, automatic control valve, and associated plumbing. The equipment was visually inspected; however, the system was not subjected to specialized testing or performance verification, and its treatment capacity, water quality, regeneration operation, and internal condition were not determined as part of the general home inspection.

Visible leakage was observed at portions of the plumbing serving the system. The system was not operated, physically manipulated, or functionally tested as part of the inspection; therefore, the operational condition and performance of the filtration/treatment equipment could not be determined. Further evaluation and servicing by a qualified water-treatment/plumbing contractor is recommended.

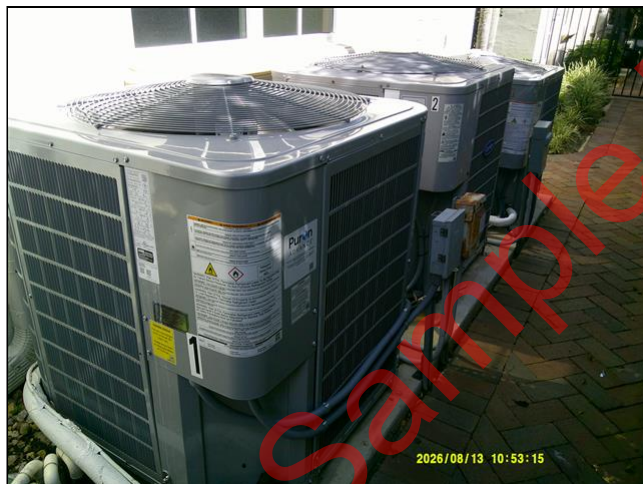
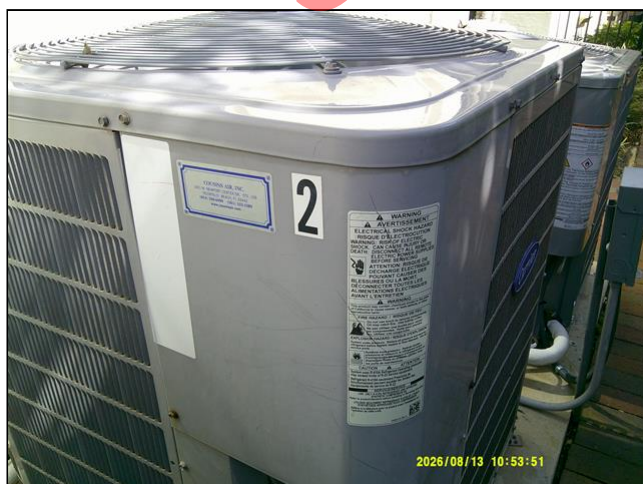
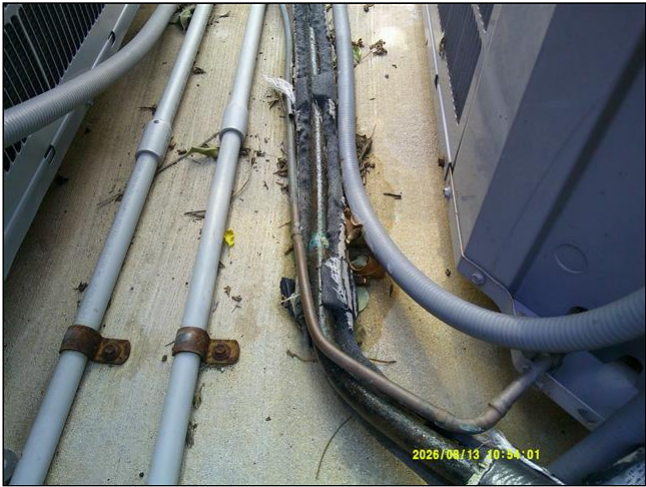
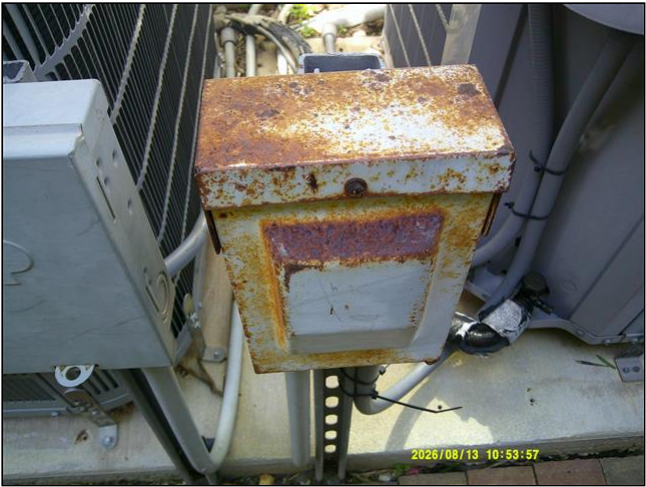
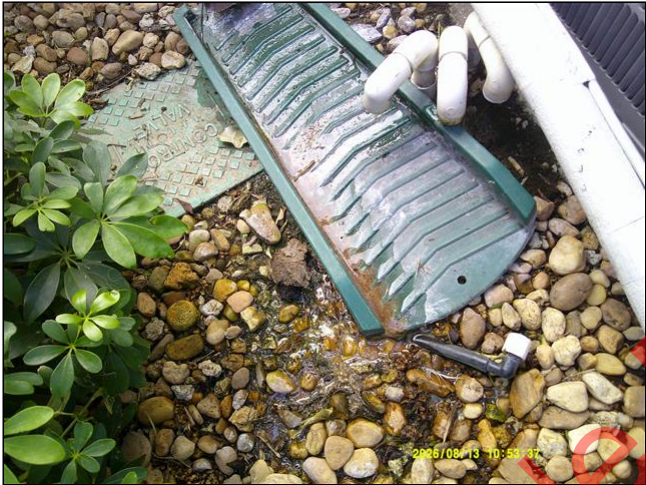
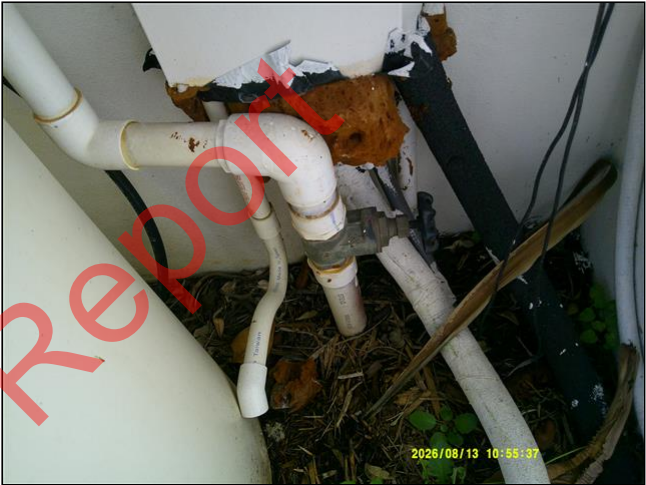
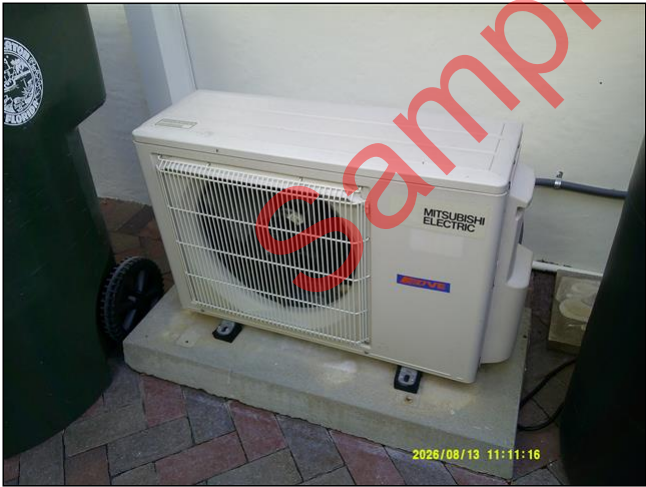
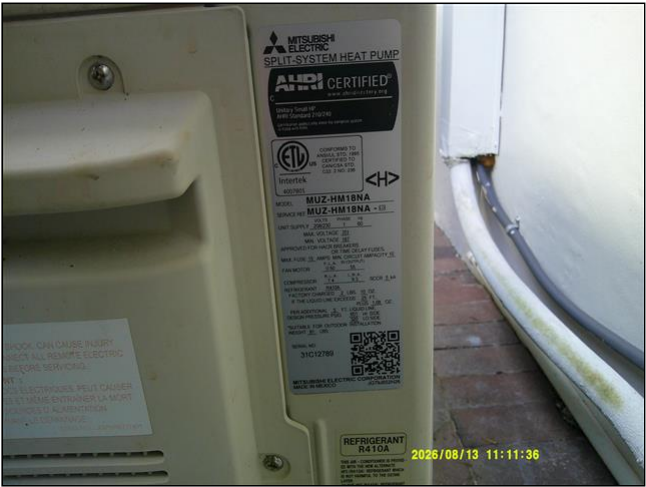
- The outdoor condensing units were generally intact and exhibited no obvious significant cabinet damage. However, several associated exterior components and installation details exhibited deterioration:

- The electrical disconnect enclosure serving the equipment exhibited significant surface corrosion/rusting and should be evaluated and replaced as necessary.

- Refrigerant line insulation was deteriorated and damaged in areas, with portions of the insulation jacket missing or deteriorated. Repair/replacement is recommended to protect the refrigerant piping and maintain proper system efficiency.

- Several metal pipe/support brackets and fasteners exhibited corrosion.
- The exterior equipment area contained debris and vegetation, and localized moisture was observed around the condensate/drainage components.

Recommendation: Have a qualified HVAC contractor service the systems and address the deteriorated exterior accessories, particularly the heavily corroded electrical disconnect, refrigerant-line insulation, and corroded supports/fasteners. These observations are based on visual inspection of accessible components and do not constitute an evaluation of refrigerant charge, compressor performance, or internal electrical components.

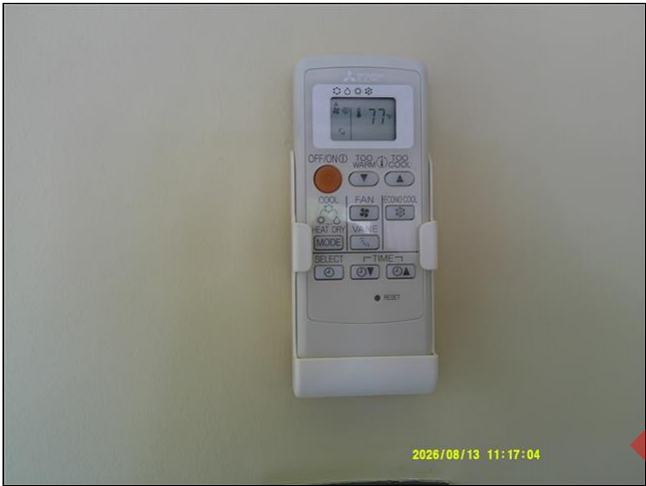
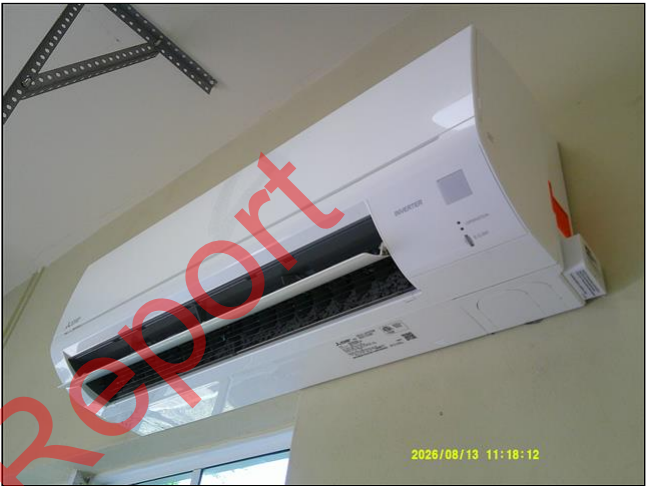
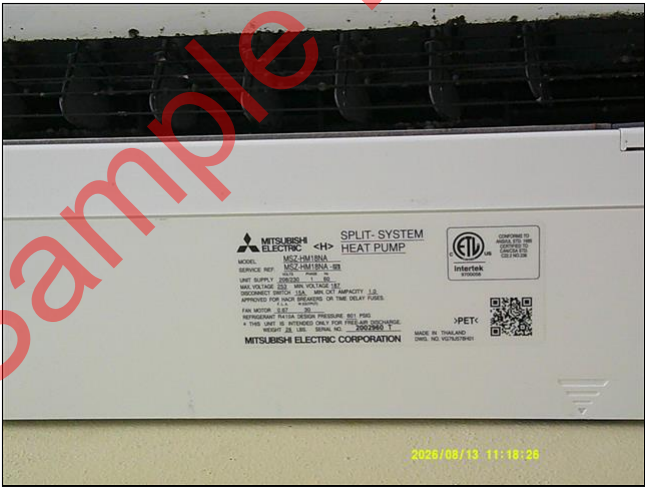
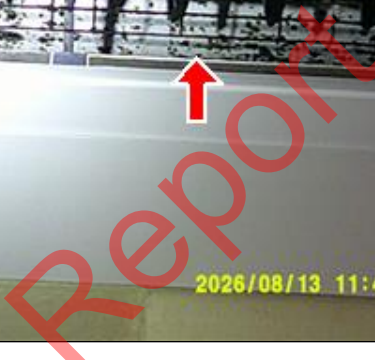
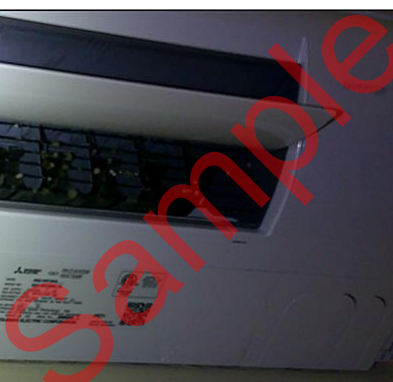
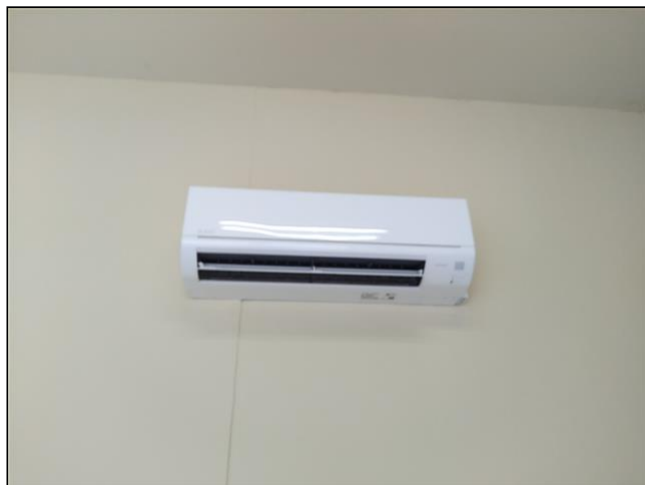
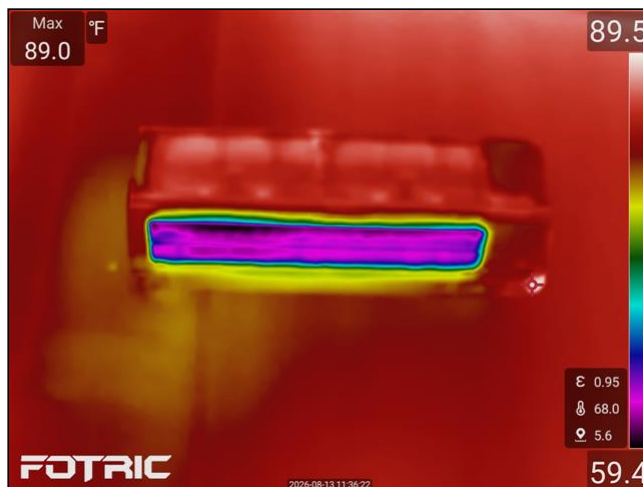
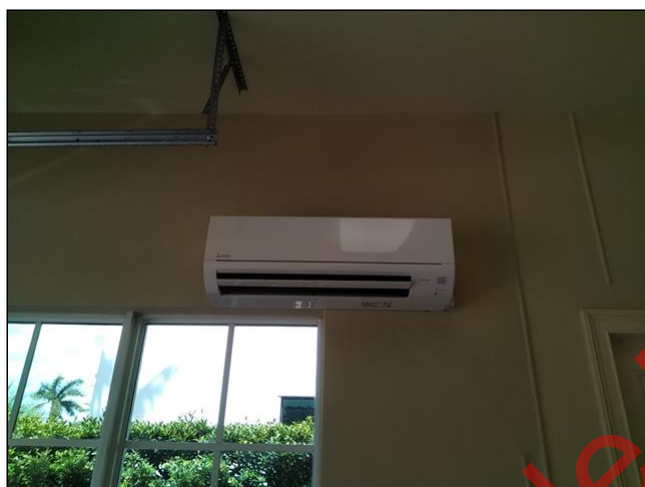
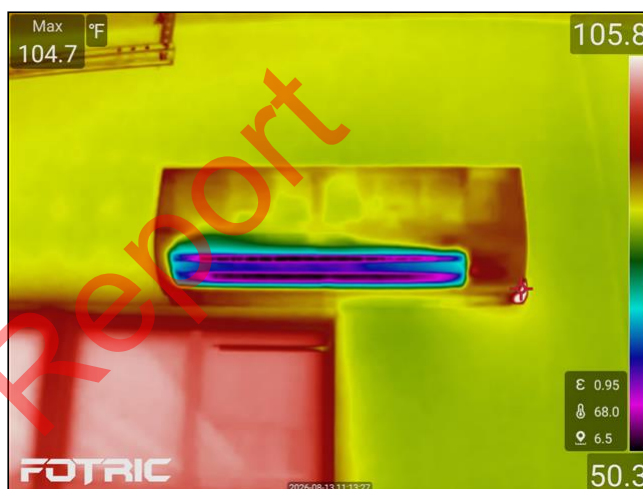
**10.1 Garage Air Conditioning**

Both systems were visually inspected for general condition and operation. The mini-split serving one garage exhibited visible mold/microbial-like growth and accumulated biological debris on the indoor coil and blower area, indicating that the unit requires cleaning and professional servicing. The condition may also affect indoor air quality and system performance. The second mini-split appeared generally serviceable based on the visible components.

Because garage environments can be exposed to elevated heat, humidity, dust, vehicle exhaust, and frequent door opening, these systems require regular cleaning and maintenance. The affected unit should be professionally cleaned and serviced, with the drain pan, condensate system, coil, blower, and filters evaluated for proper operation and cleanliness.

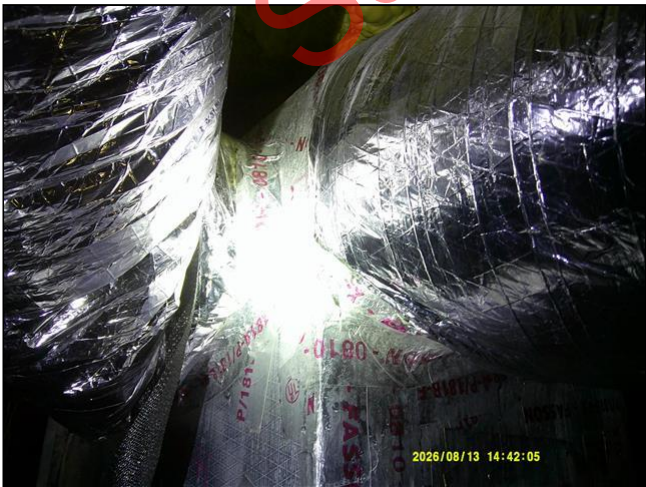
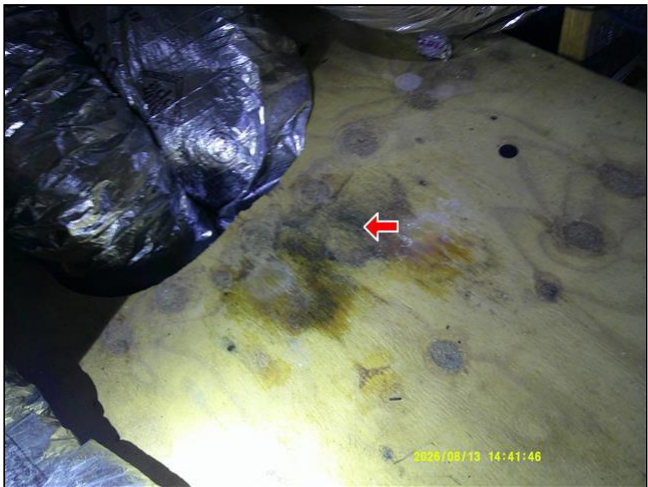
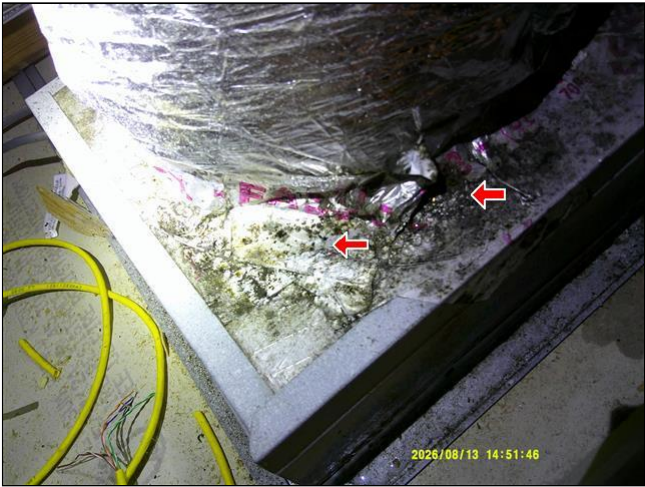
The HVAC ductwork was inspected in the accessible portions of the attic. Localized moisture accumulation, condensation (“sweating”), and apparent leakage were observed at ductwork near the attic entrance above the laundry room. The affected areas showed visible moisture staining/discoloration and deterioration of surrounding insulation. This condition may be related to inadequate insulation/air sealing, excessive humidity, or other duct system conditions and can contribute to moisture damage and microbial growth if left uncorrected.

Recommend evaluation and repair by a qualified HVAC contractor, including inspection of the affected duct insulation, vapor barrier, connections, and condensate/moisture conditions. Damaged or moisture-affected insulation should be repaired or replaced as appropriate.

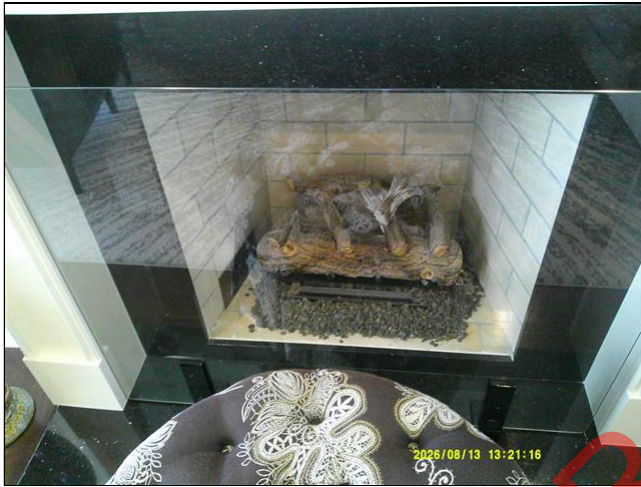
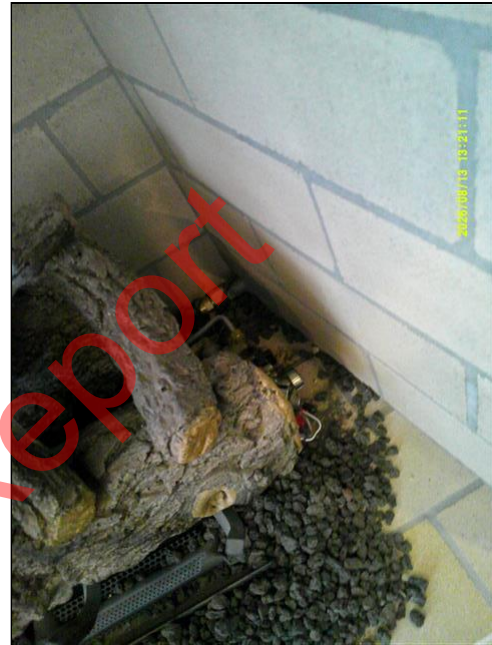
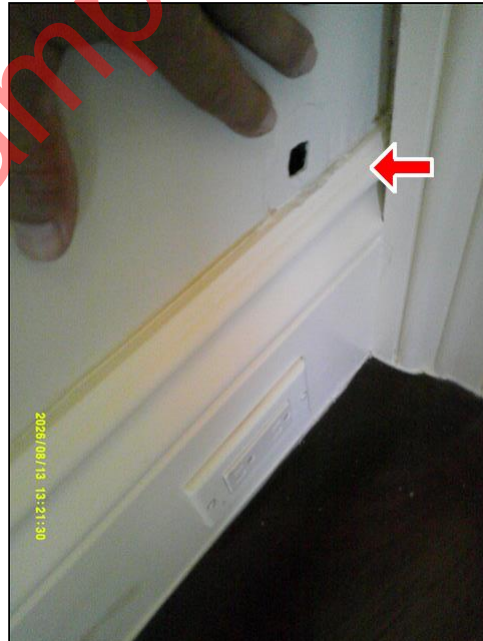
11.2 Fireplace

A direct-vent gas fireplace was observed in the residence. The fireplace was not operated or functionally tested during the inspection because the gas supply to the fireplace was turned off and the property manager did not have the required key/access to the gas control. Home inspectors do not independently turn on or manipulate gas fireplace controls when the system has been intentionally shut off; operation should be demonstrated by the owner, occupant, or property representative when appropriate.

The fireplace and firebox appeared generally clean and showed little evidence of use, suggesting the unit may have seen limited or no recent operation. Because the fireplace could not be tested, the operation of the gas valve, ignition system, burner, flame characteristics, venting, and safety controls could not be verified. Recommend that the fireplace be evaluated and operated by a qualified fireplace/gas contractor after the gas supply is restored, particularly before it is placed into regular service.

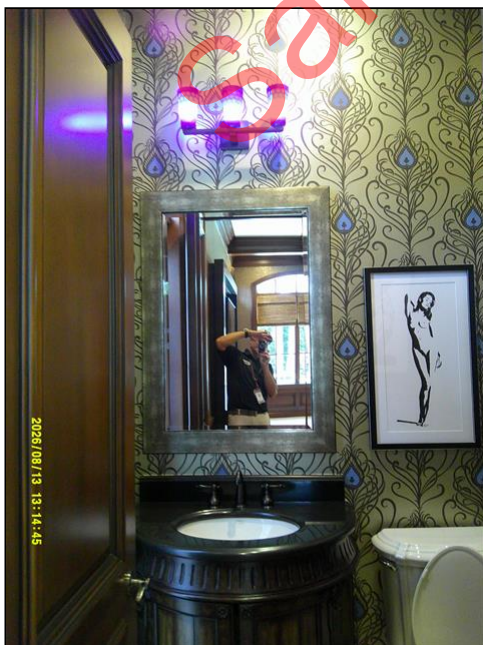
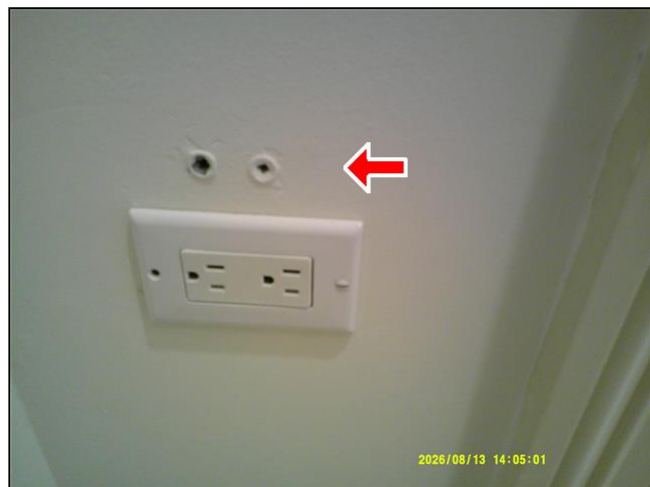
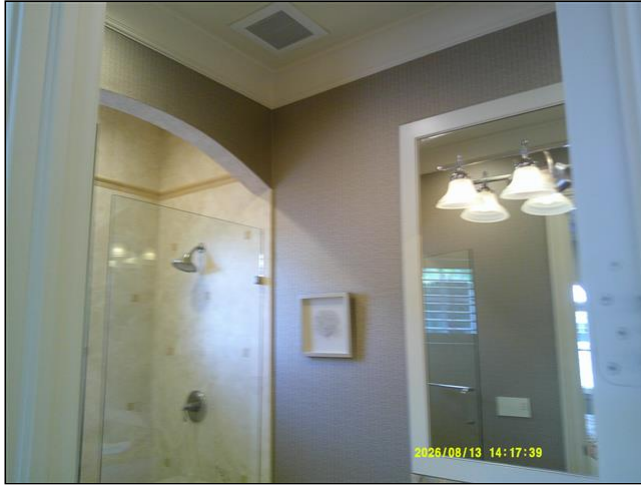
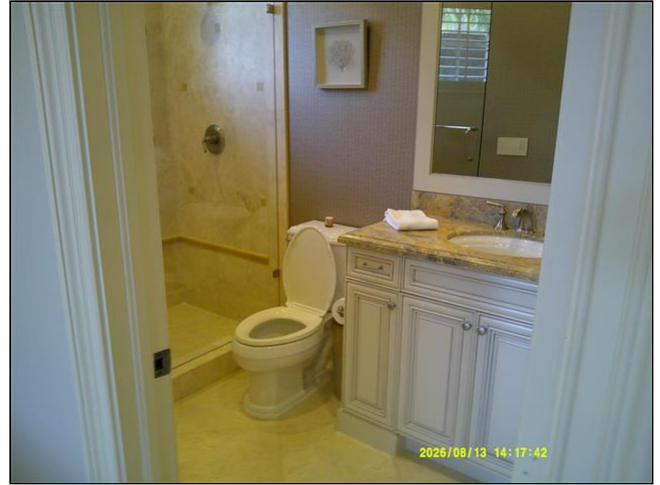
## 12.1 Walls

The bathroom walls were generally observed to be in good, serviceable condition, with only minor cosmetic wear noted in the areas inspected. Localized holes/openings from previously installed fixtures were observed at some wall surfaces and should be properly patched and finished. Several bathrooms also contain decorative wall coverings/ wallpaper, which conceal portions of the underlying wall surfaces; therefore, the condition of the wall substrate behind these coverings could not be determined through visual inspection. Overall, no significant visible deficiencies were noted with the accessible bathroom wall finishes.

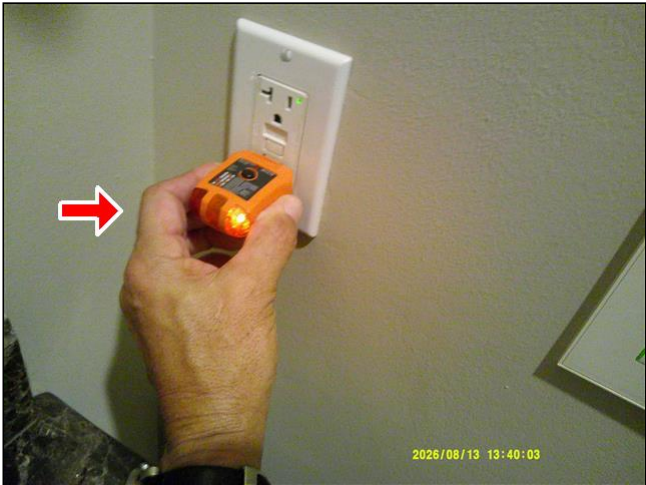
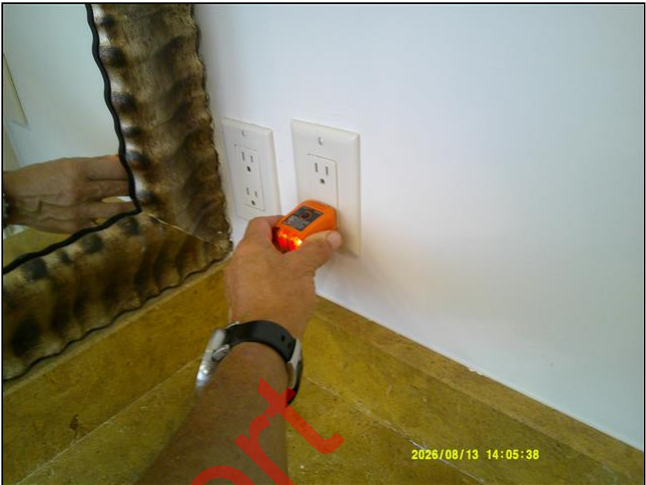
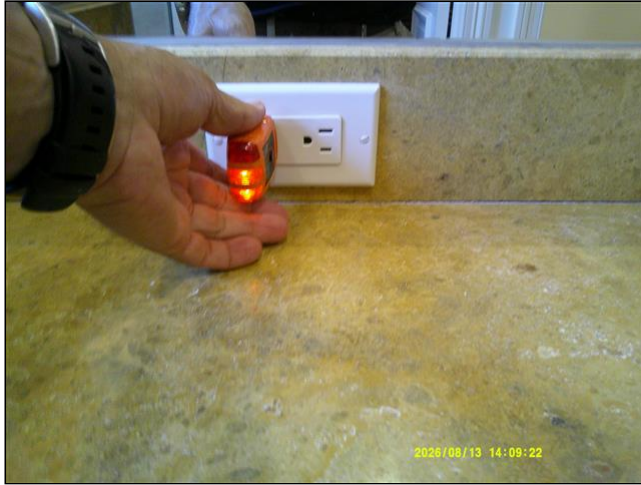
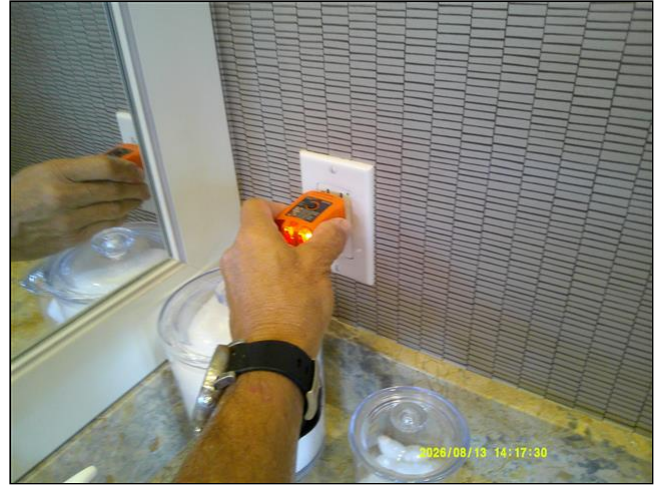
Several GFCI-protected receptacles in the bathrooms exhibited the same open-ground condition previously identified at other receptacles in the residence, particularly on the affected side of the home. Although the GFCI devices responded to testing where tested, an open-ground condition indicates that the equipment grounding connection may be missing, interrupted, or improperly connected. This condition should be evaluated as part of the previously recommended electrical investigation. In addition, one switch in a guest bathroom was observed with a cracked/damaged cover or switch component and should be replaced.

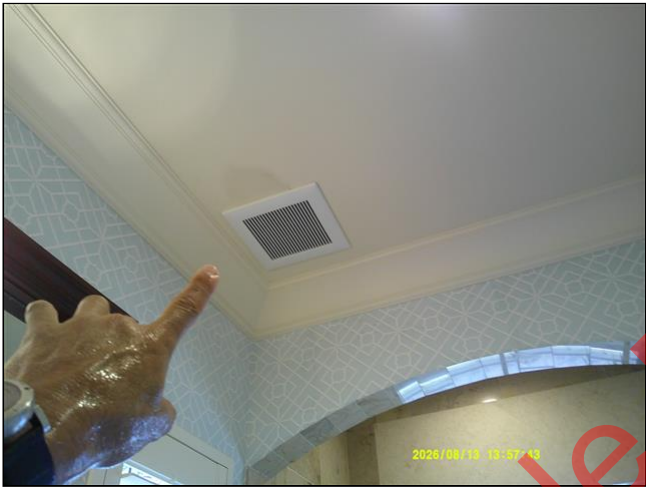
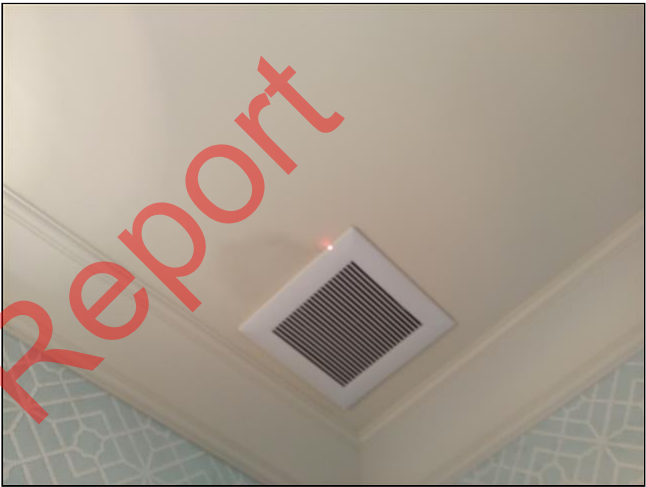
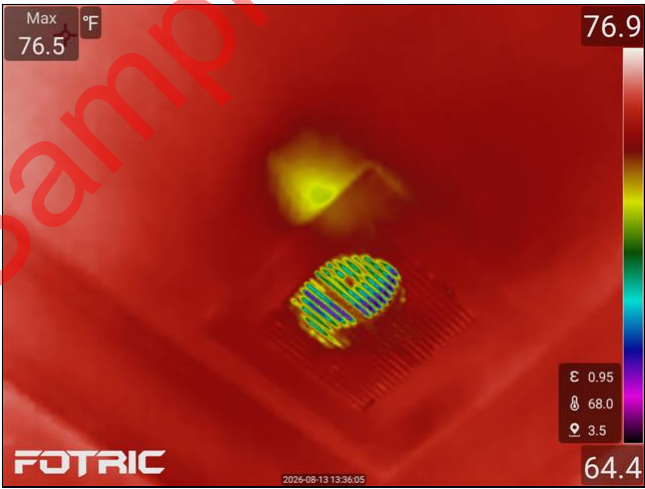
## 12.7 Ventilation

The bathroom exhaust/ventilation fans were generally functional and appeared serviceable at the time of inspection. However, one ceiling exhaust vent was improperly installed or sealed, allowing hot attic air to enter the bathroom. This condition was associated with localized condensation at the ceiling/vent area and may contribute to moisture damage or microbial growth if left uncorrected.

Infrared imaging of the affected bathroom ceiling vent demonstrated a significant temperature differential around the exhaust fan/vent assembly, consistent with warm air movement from the attic into the conditioned bathroom area. The thermal pattern supports the visual observation that the vent assembly was not adequately sealed and may be allowing hot attic air to infiltrate around the fixture, contributing to condensation at the ceiling surface. The thermal image is supplemental and does not independently establish the source of the temperature difference; however, in conjunction with the visible conditions, proper sealing of the vent housing and verification of the duct connection and exterior termination are recommended.

Recommend having the affected exhaust fan and duct connection evaluated and properly sealed by a qualified HVAC contractor, including verification that the fan is properly ducted to the exterior and that the attic air barrier is maintained.
