INSPECTION REPORT  
Royal Palm  
Boca Raton FL 33432

INSPECTED BY  
Angelo Menezes  
Certified Inspectors,  
LLC  
HI9467

INSPECTION DATE  
📅 8/13/2026  
🕒 11:00:00 AM

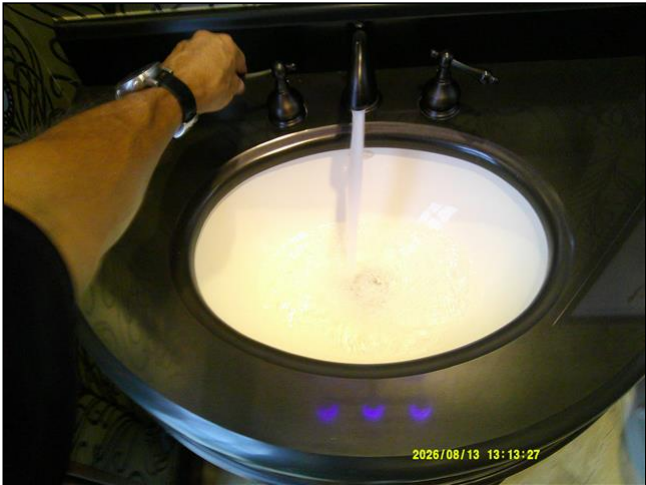
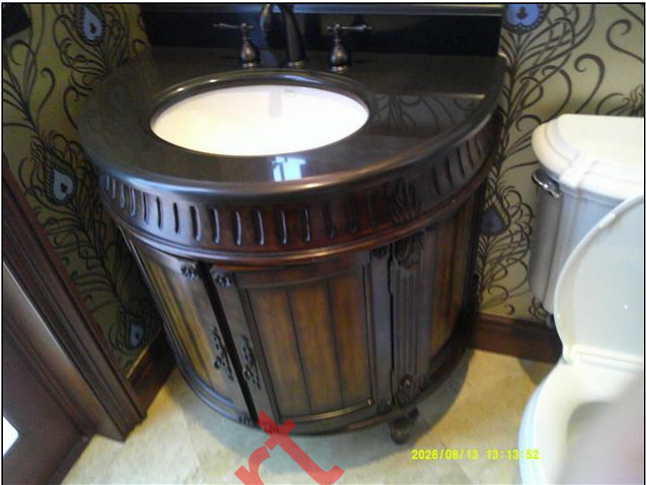
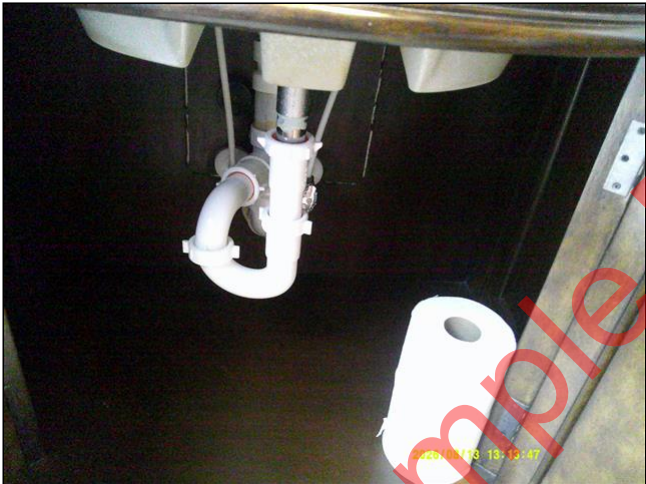
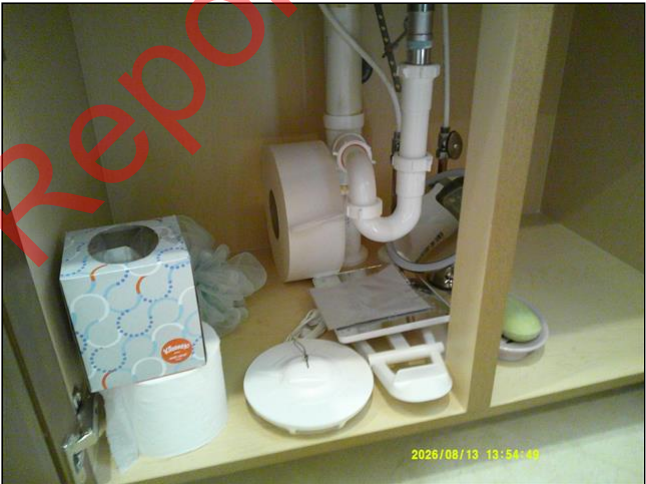
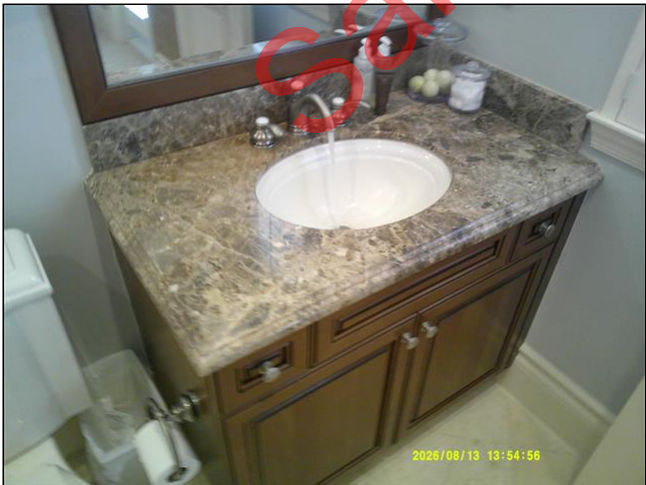
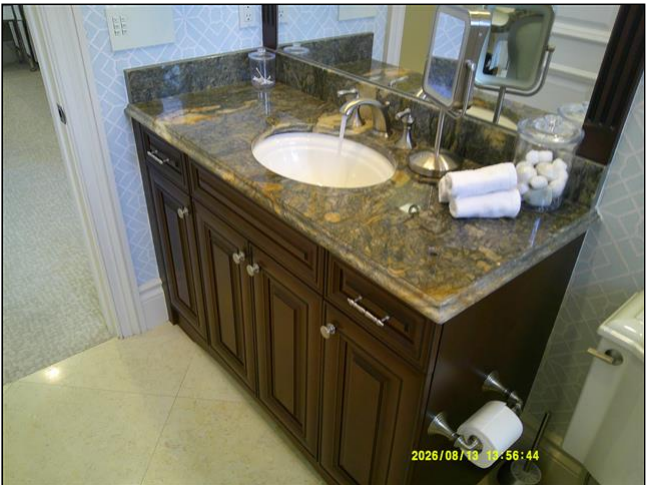
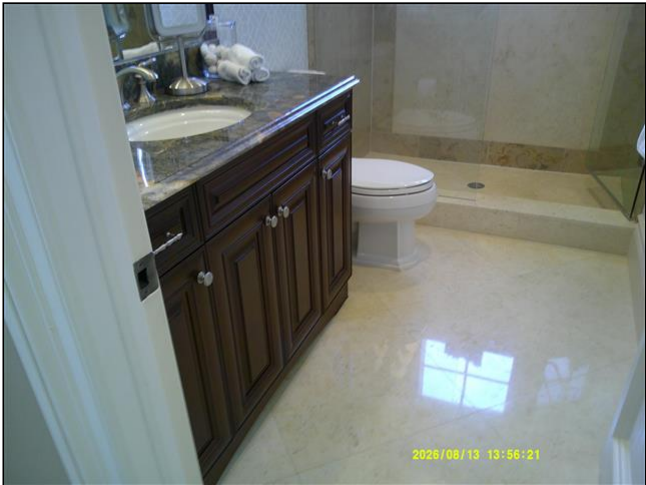
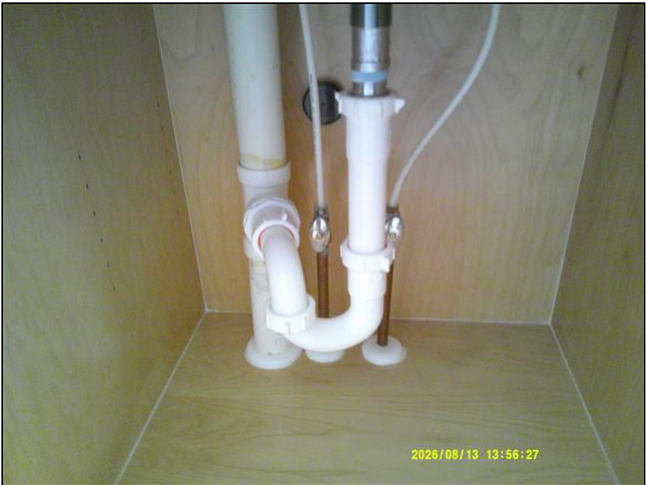
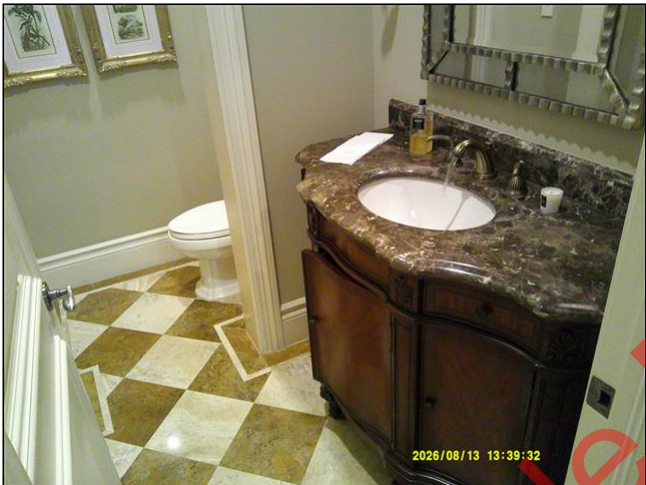
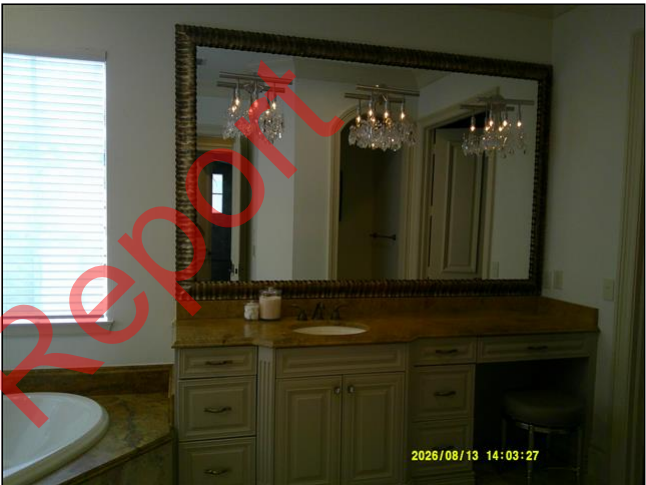
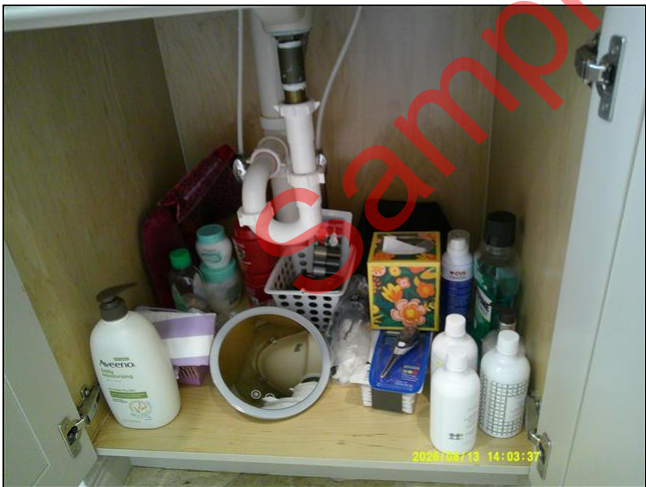
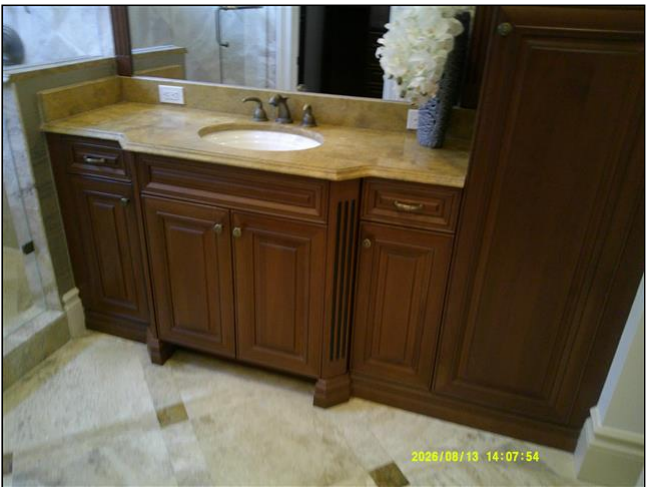
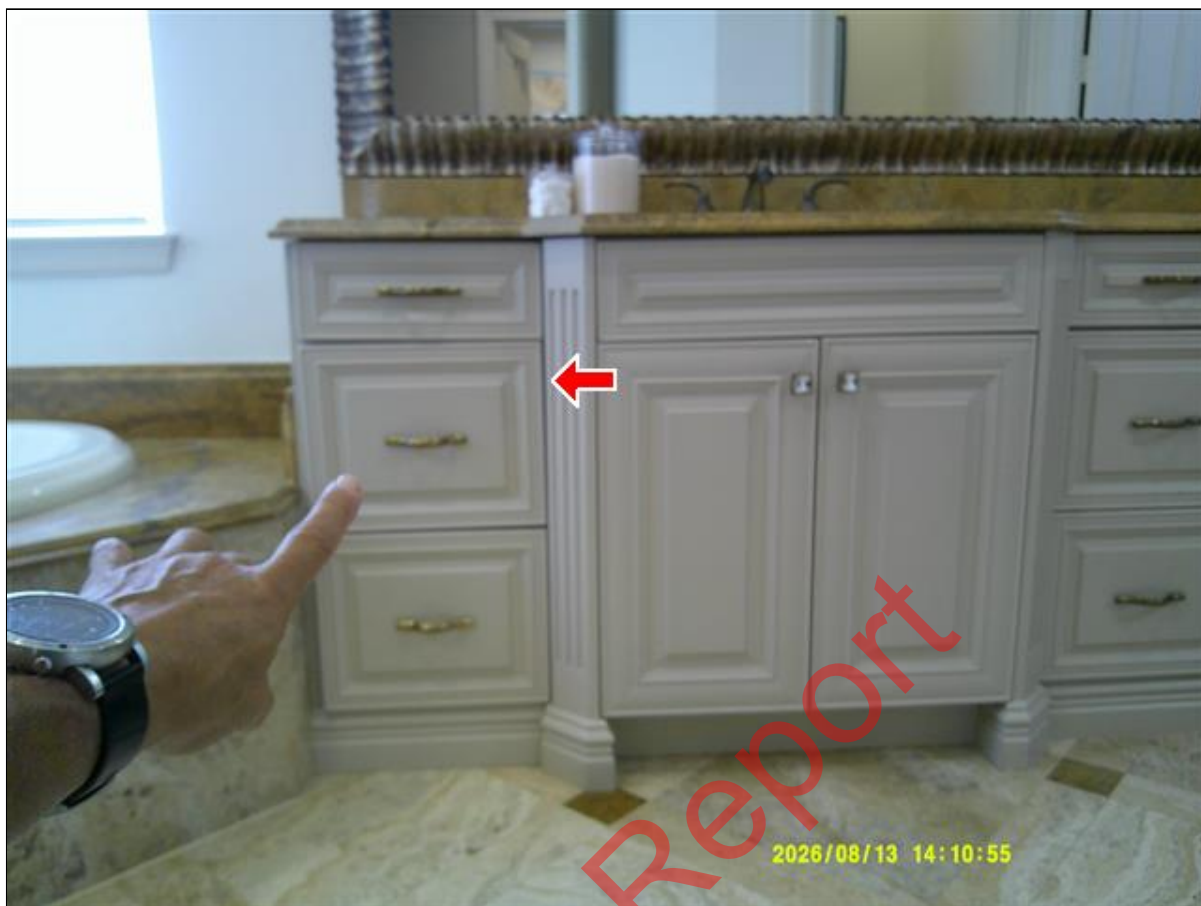
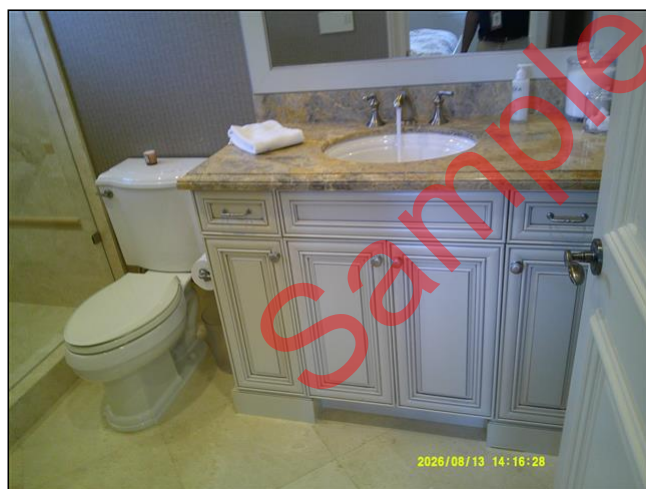
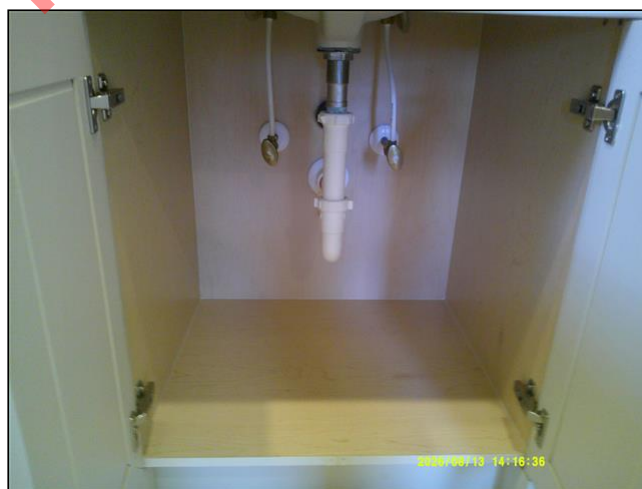
The bathroom vanities are predominantly constructed of wood cabinetry with granite countertop surfaces. Overall, the vanities were observed to be in good, serviceable condition, with the countertops and cabinet components generally intact and functional. One drawer in the master bathroom vanity was misaligned and requires adjustment or minor repair to restore proper operation. No other significant deficiencies were noted with the readily accessible vanity components.

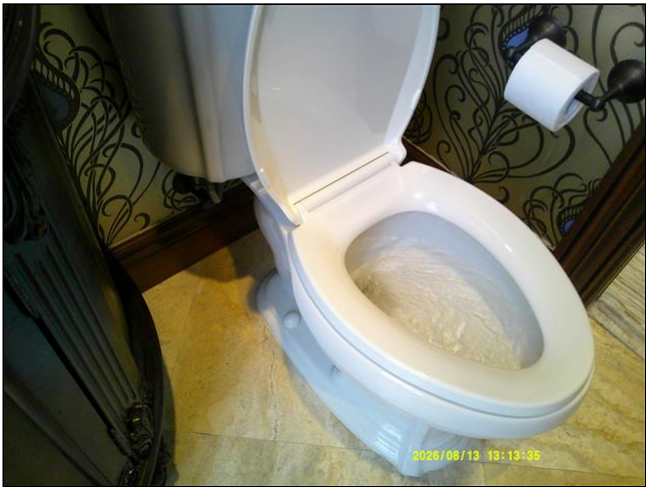
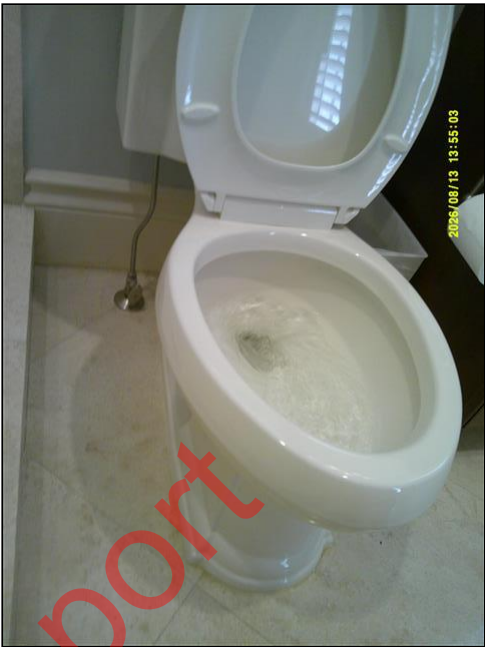
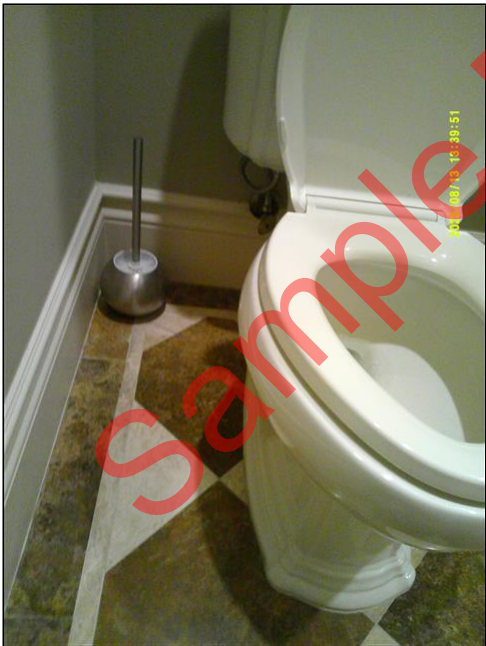
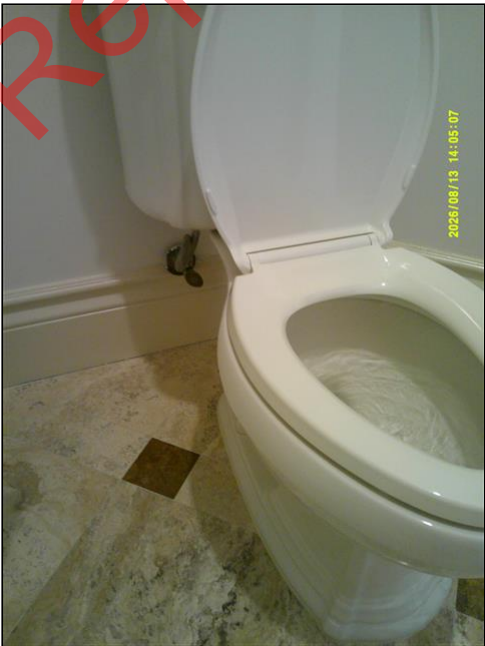
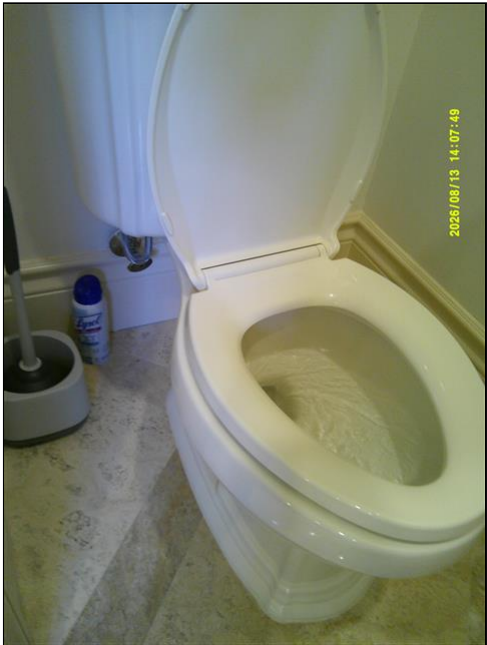
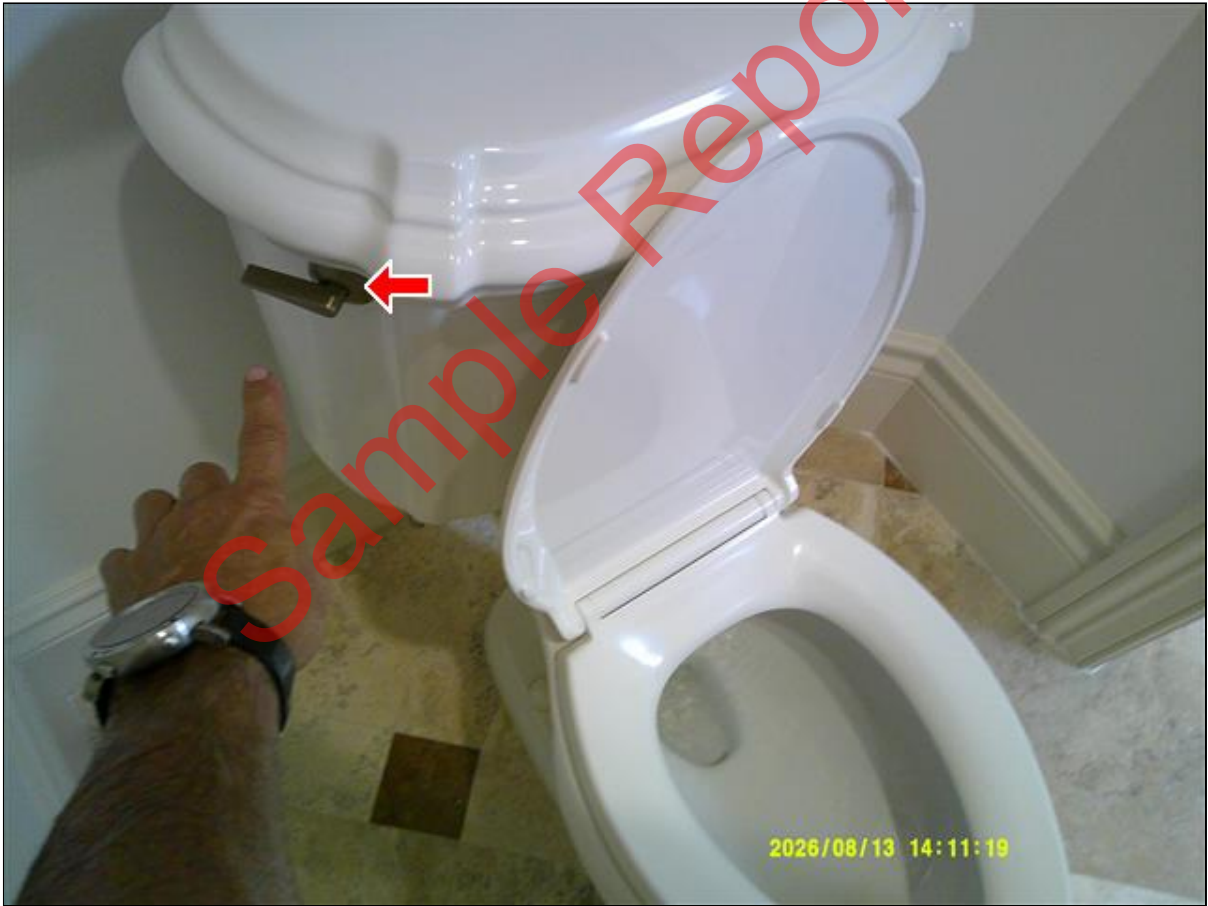
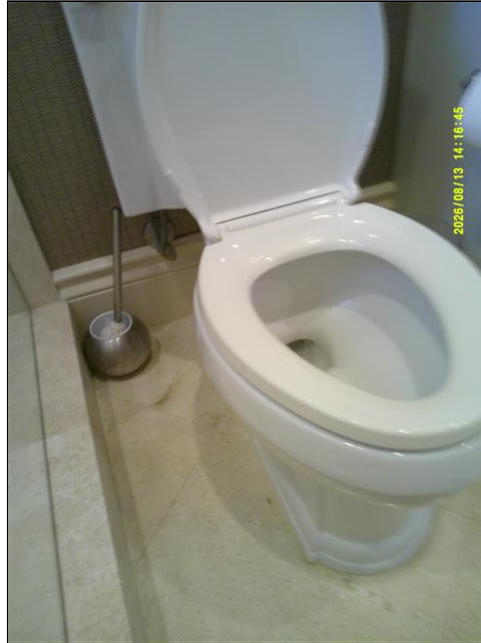
## 12.9 Toilet

The toilets throughout the residence were flushed and functionally tested, and most toilets were found to be operating properly at the time of inspection. One toilet in a guest bathroom had a flush handle that tended to stick after operation, indicating that the handle/mechanism requires adjustment or repair. The affected toilet should be serviced to ensure reliable operation.

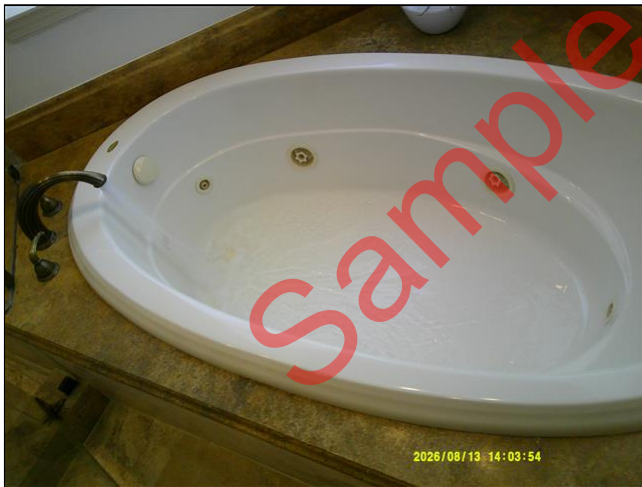
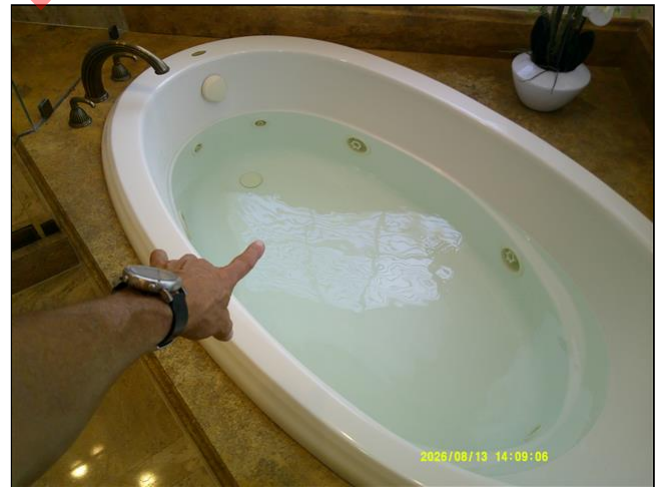
#### 12.10 Bathtub

A jetted/whirlpool bathtub was observed in the master bathroom. The tub basin and visible plumbing fixtures appeared generally intact; however, the whirlpool system was not operational at the time of inspection because the pump/motor was not functioning. As a result, the operation of the jets, pump, controls, and associated plumbing could not be verified. Repair or evaluation by a qualified plumbing or spa-tub service contractor is recommended before relying on the unit for normal use.

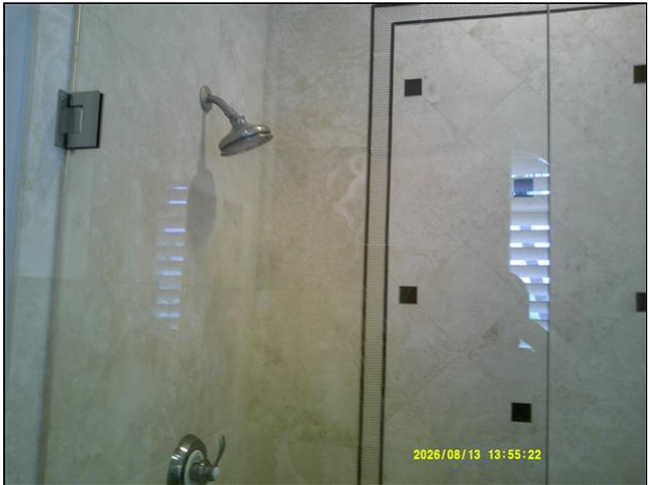
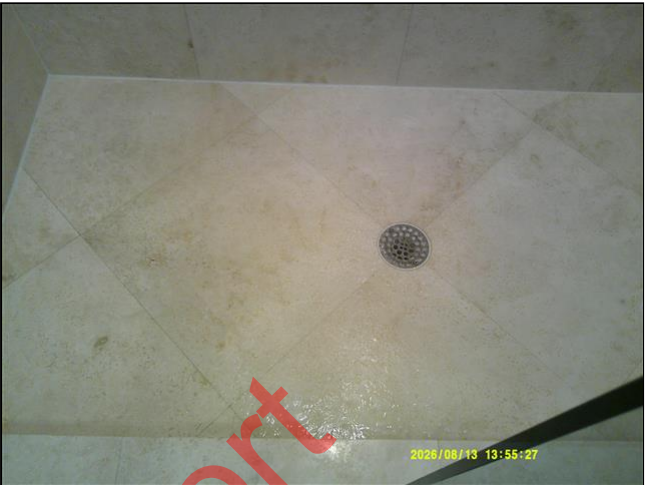
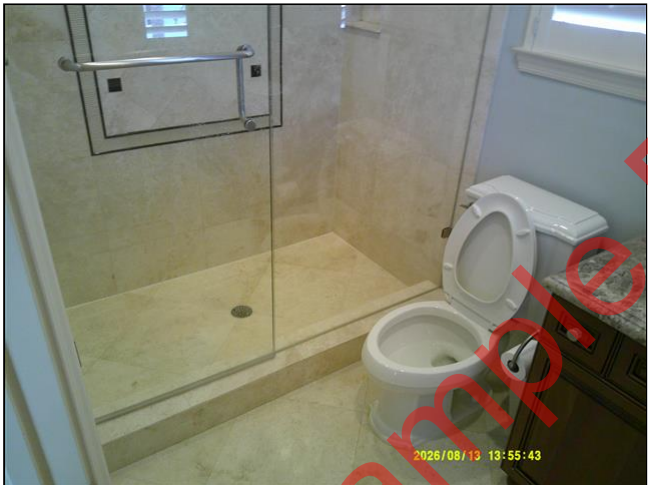
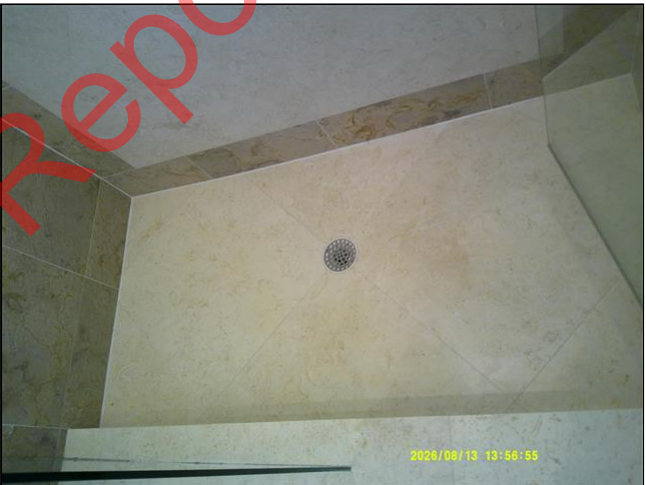
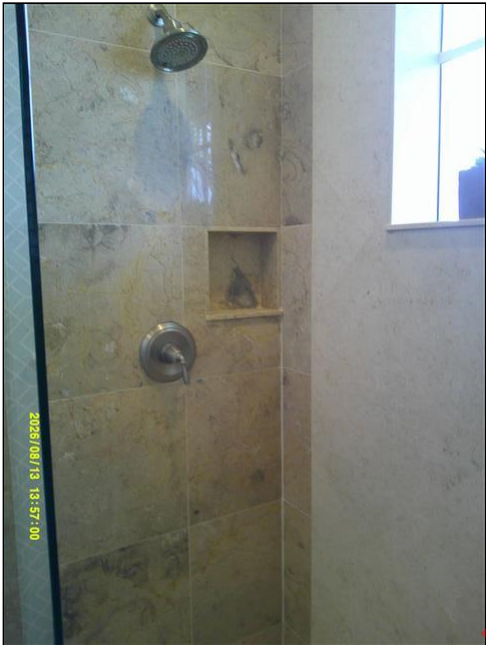
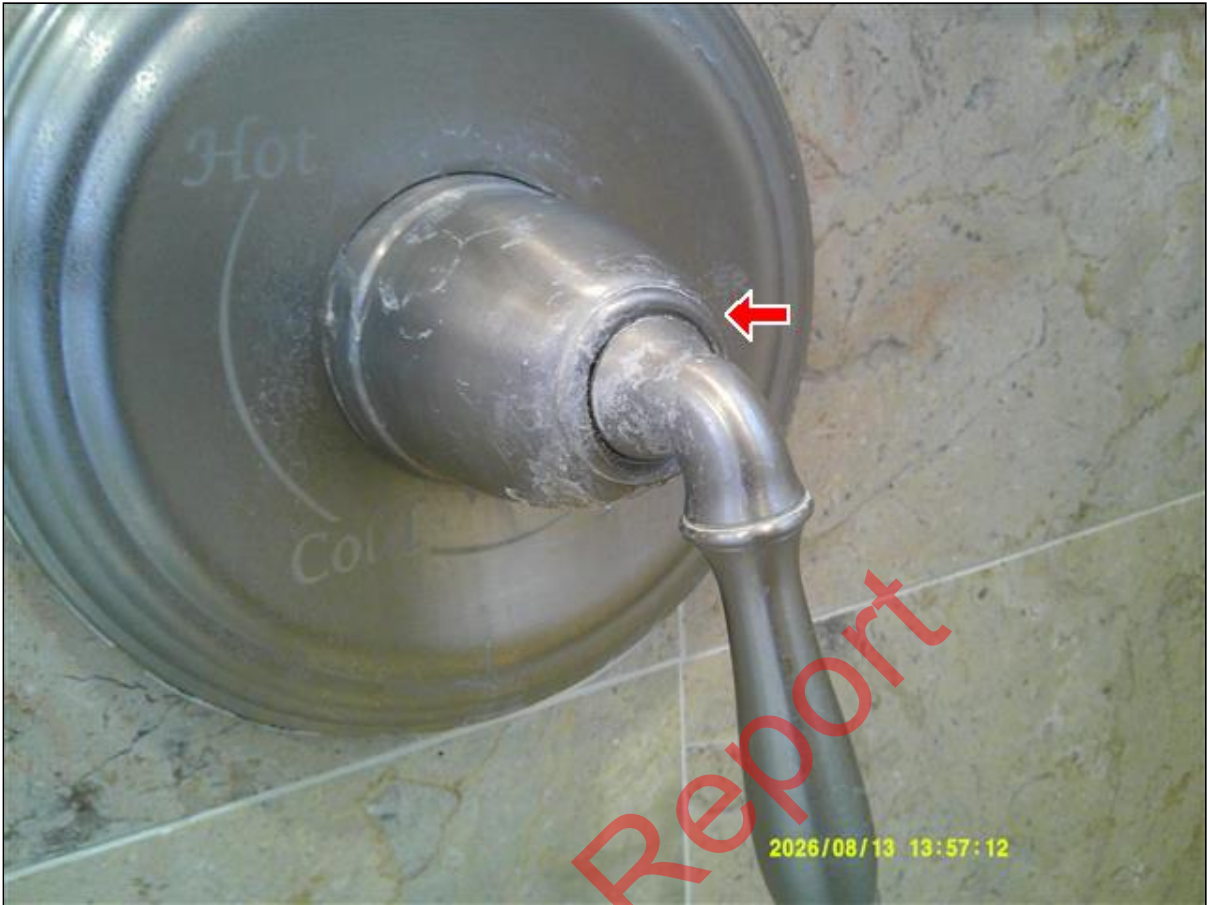
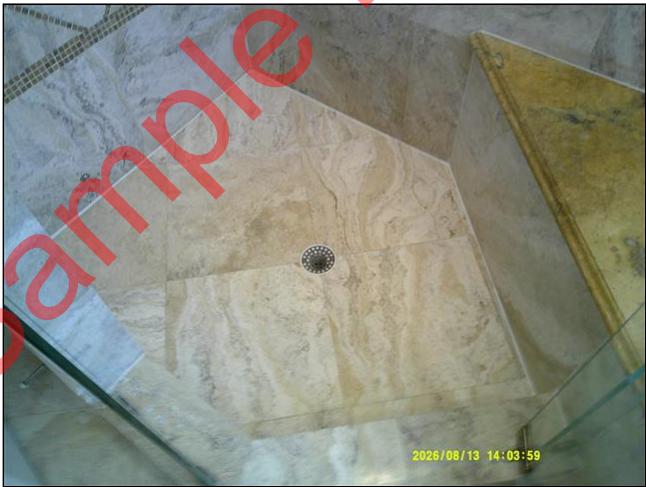
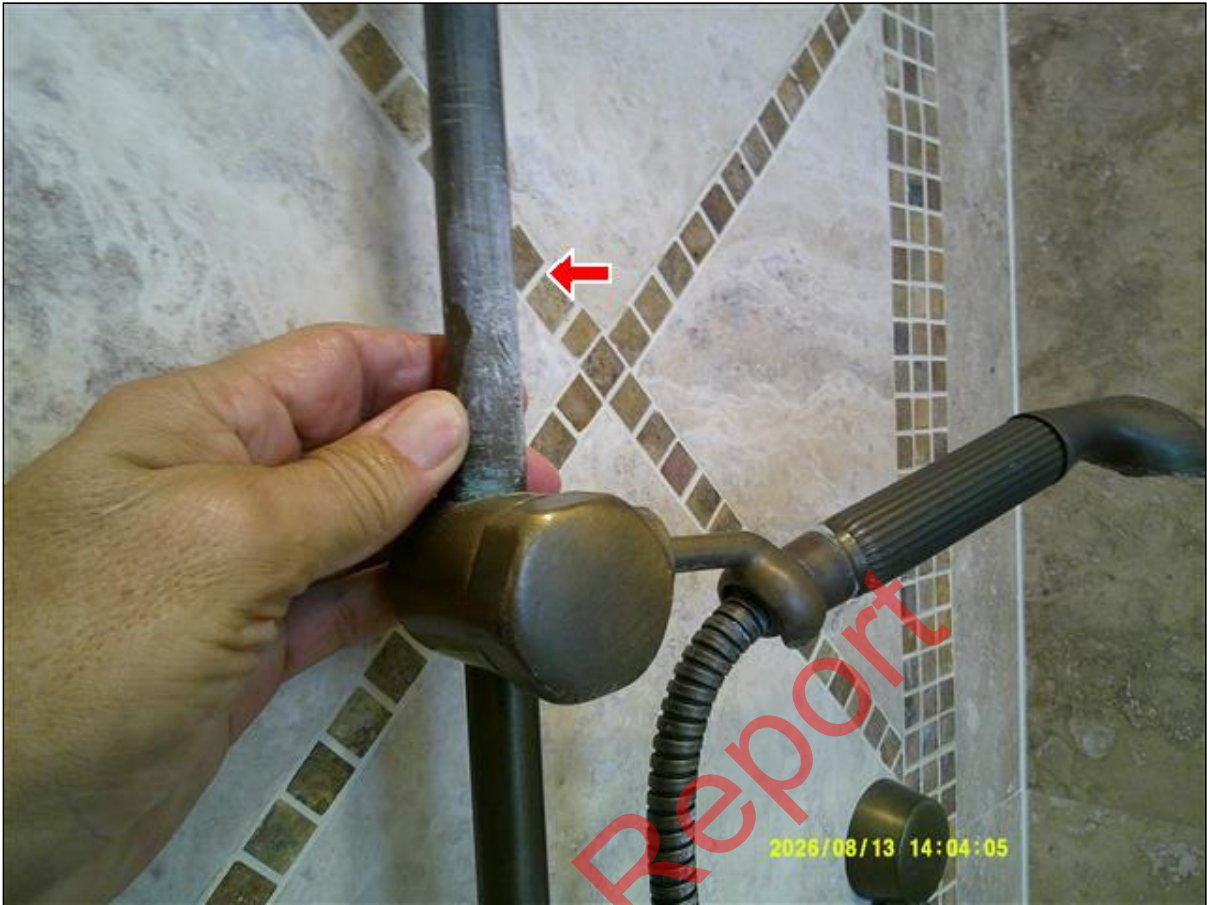
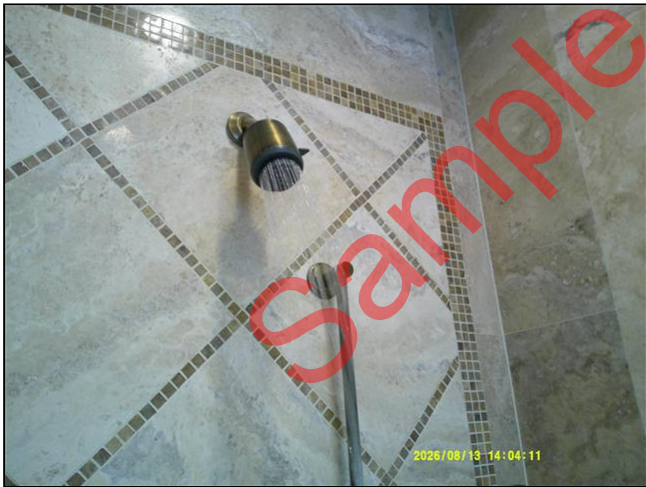
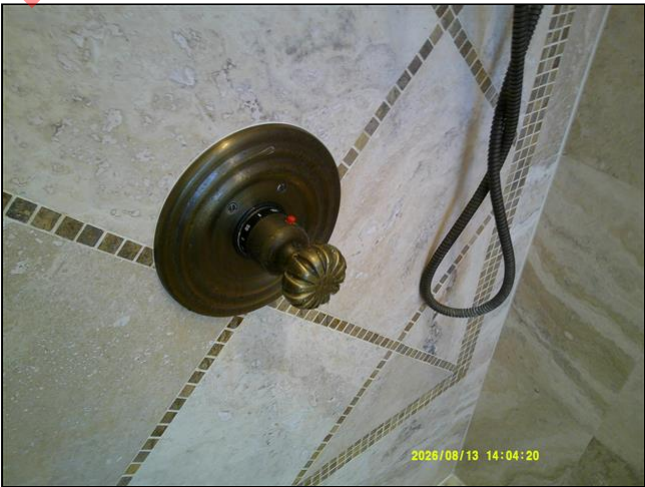
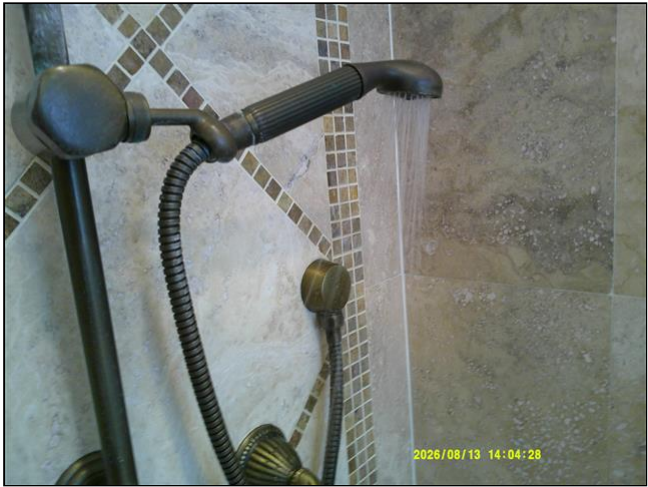
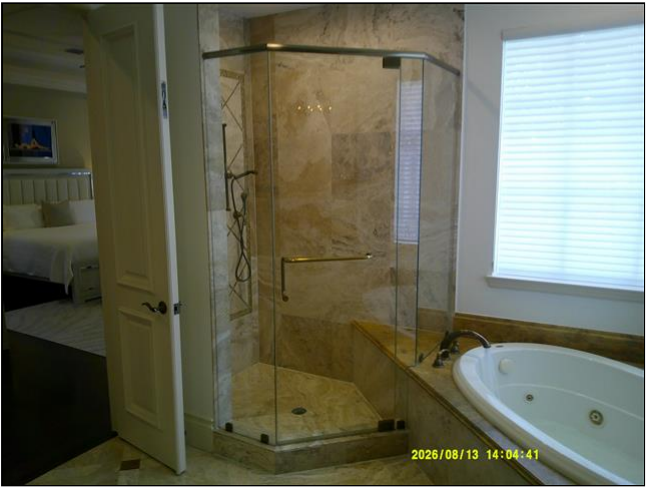
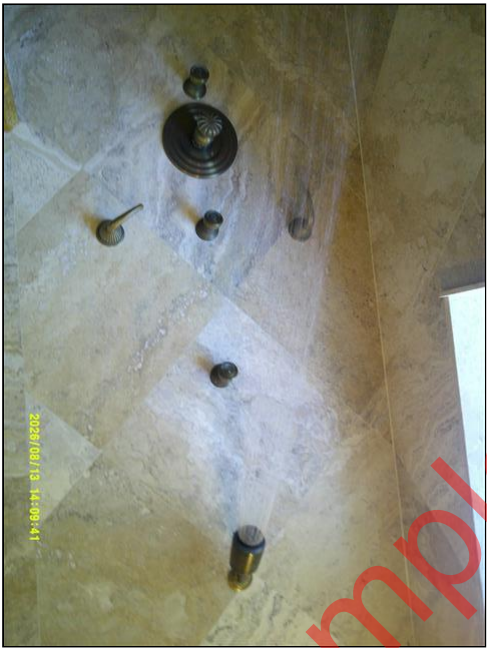
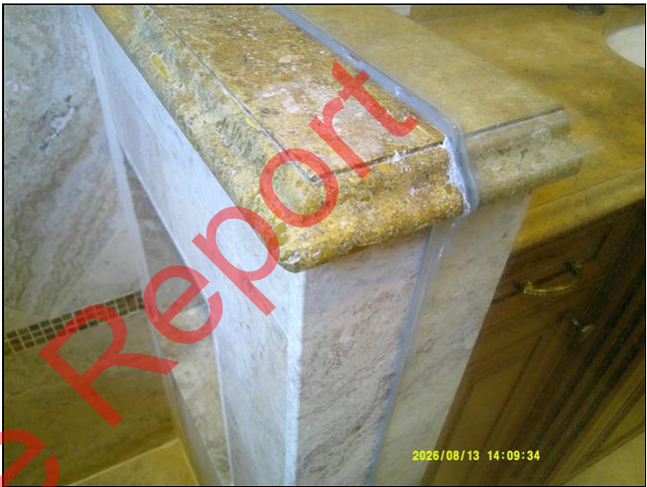
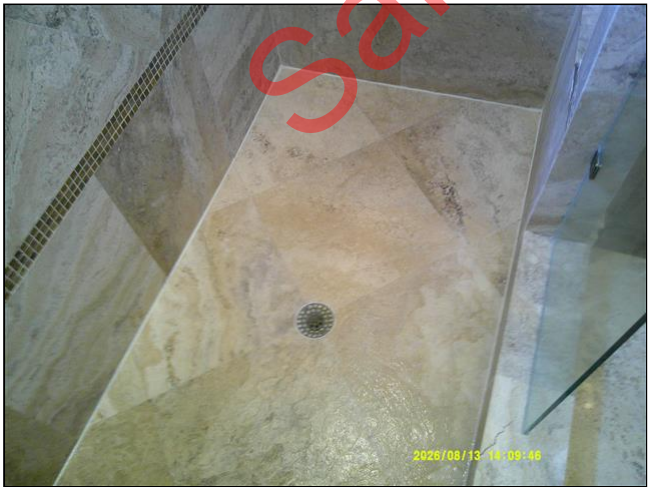
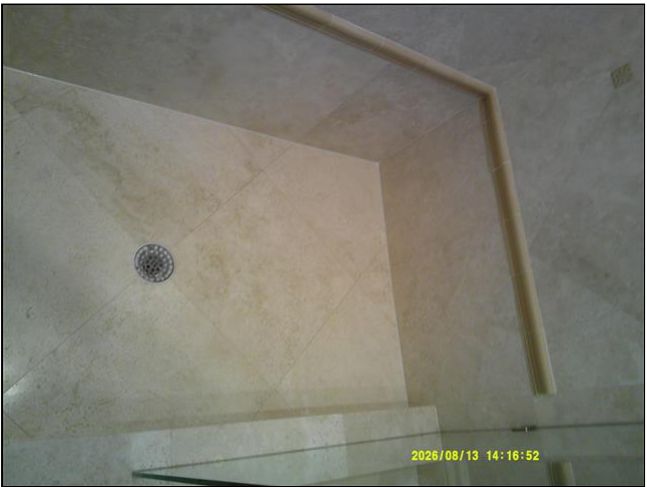
#### 12.11 Shower

The tiled showers throughout the residence were generally observed to be in good, serviceable condition, with the tile surfaces, grout, shower fixtures, and surrounding finishes appearing generally intact. However, the more frequently used bathrooms exhibited significant metal oxidation/corrosion and hard-water mineral deposits on portions of the shower fixtures and associated metal components. These conditions are primarily maintenance-related but may continue to worsen if not addressed. Cleaning and removal of mineral deposits and corrosion, along with servicing or replacement of affected fixtures and hardware as necessary, is recommended.

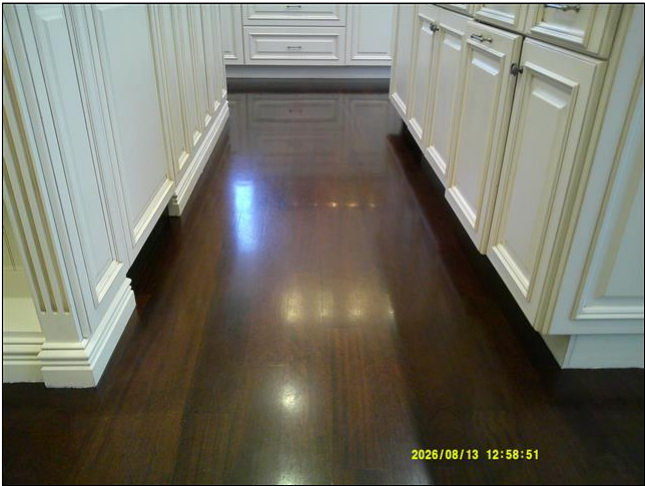
The kitchen flooring consists of hardwood flooring similar to the other interior areas of the residence. The flooring was generally in serviceable condition, with localized scratches, surface wear, and minor finish deterioration consistent with age and normal use. Professional cleaning and appropriate polishing/maintenance, or refinishing as determined by a qualified flooring contractor, would improve the appearance and help protect the finish.

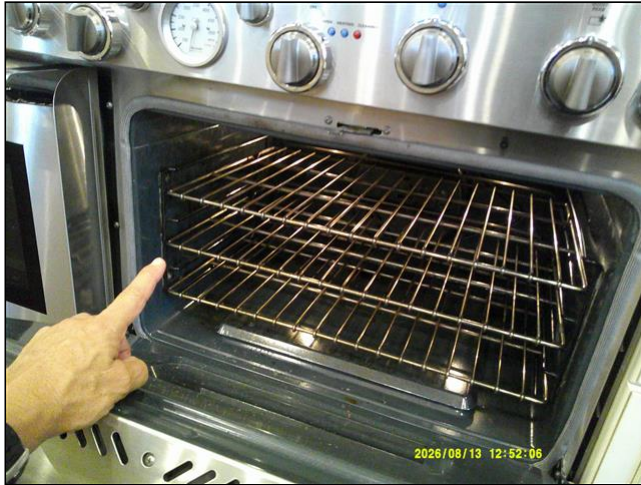
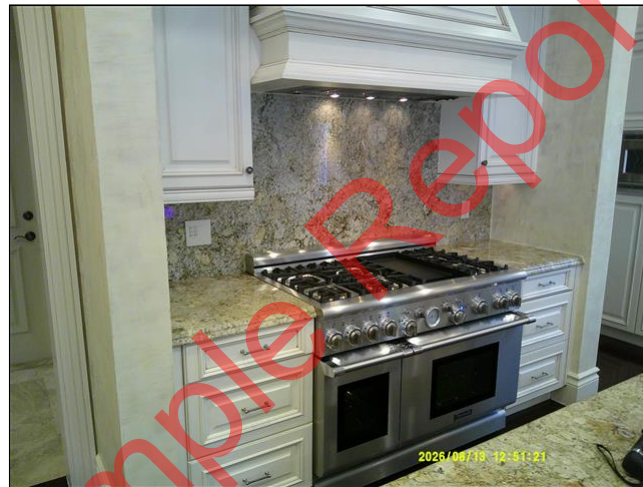
#### 13.4 Range

The kitchen is equipped with a large gas-fired range with an integrated cooktop and two ovens. The gas cooktop burners were functional at the time of inspection; however, neither of the two ovens operated when tested. As previously noted, a noticeable drop/interruption in electrical power occurred when attempting to activate the ovens, and other electrical irregularities were identified elsewhere in the residence. Because the cooktop burners operated while

the ovens did not, and given the previously documented electrical fault affecting this portion of the home, the oven malfunction may be related to an electrical supply or control issue, although the exact cause could not be determined during the inspection. Evaluation by a qualified appliance technician and licensed electrician is recommended to determine the cause and restore proper operation of both ovens.

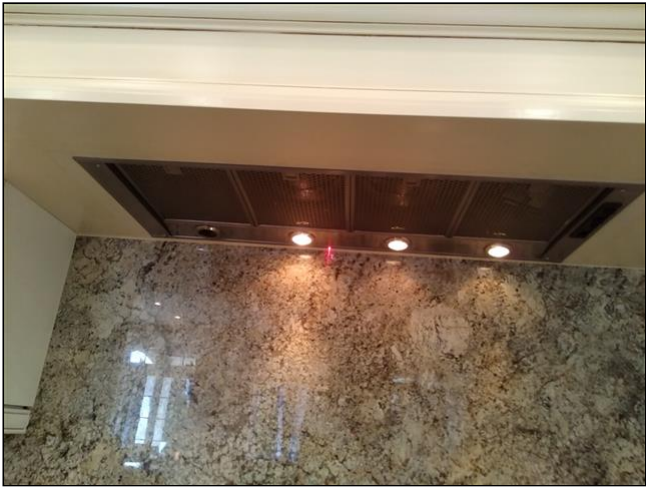
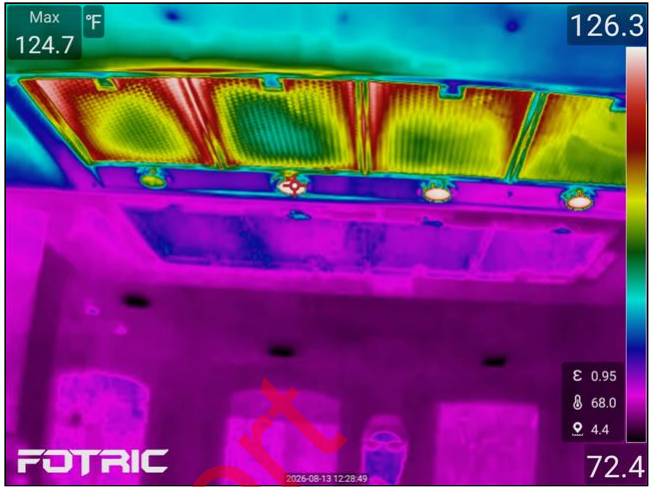
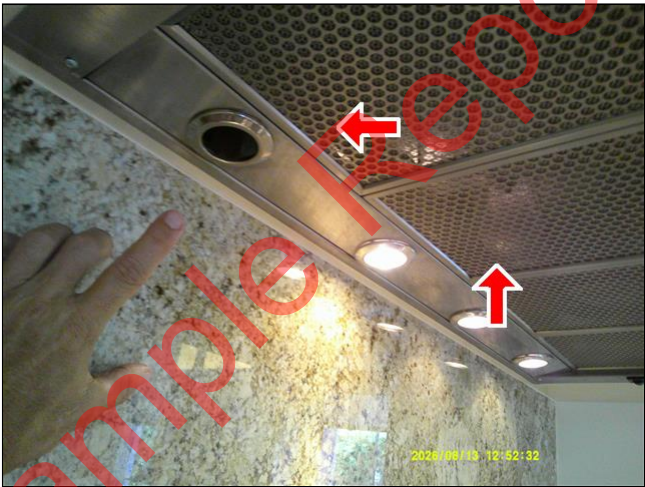
### 13.5 Range Hood

The kitchen range is equipped with an overhead range hood/exhaust hood with integrated lighting. The range hood fan was not operational at the time of inspection, and one of the hood light bulbs was also not functioning. The cause of the fan failure could not be determined during the inspection. Given the previously noted electrical irregularities affecting the kitchen and other portions of the residence, the electrical supply to the hood should also be verified. Recommend evaluation and repair by a qualified appliance/electrical contractor, including verification of proper exhaust fan operation and replacement of the defective light bulb.

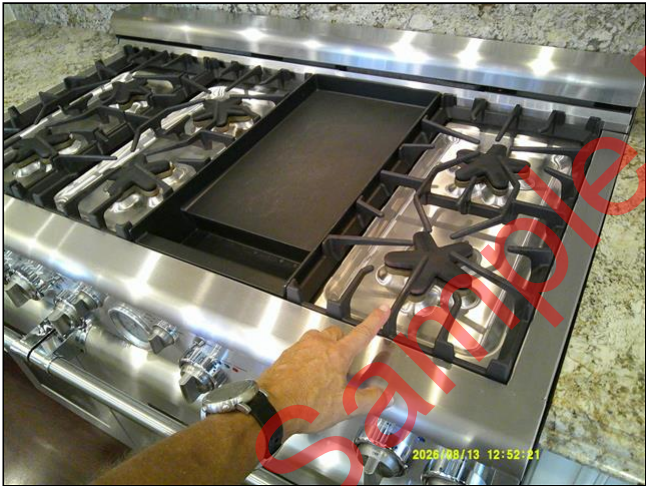
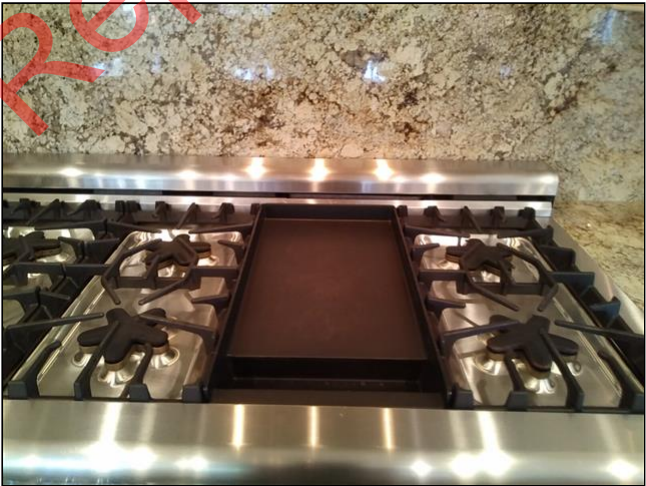
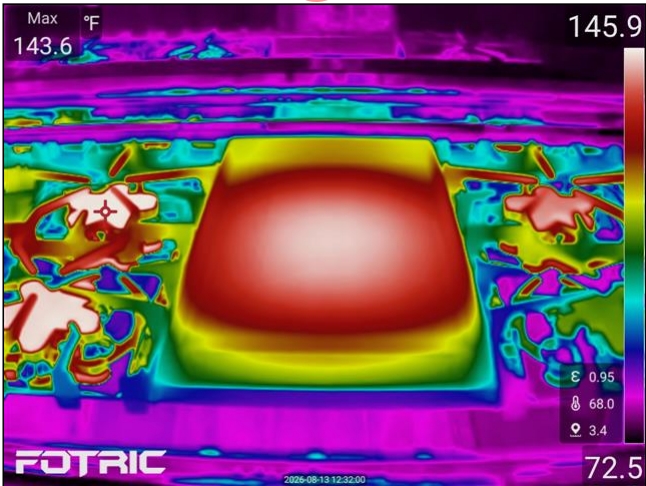
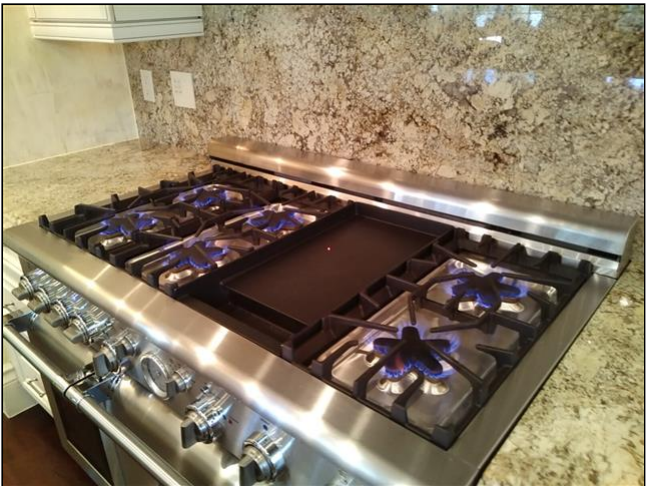
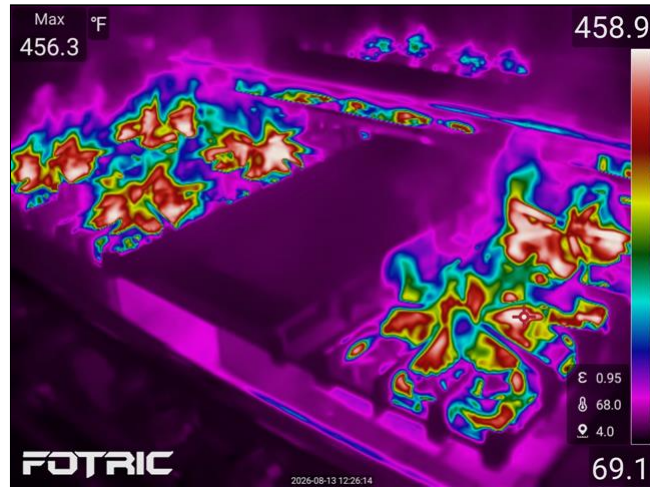
13.7 Cooktop

The kitchen range is equipped with a gas-fired cooktop with multiple surface burners and an integrated griddle. The cooktop burners were tested and operated at the time of inspection. One burner was somewhat more difficult to ignite than the others, requiring additional attention to initiate ignition. The burner and ignition components should be cleaned and/or serviced as necessary to ensure consistent ignition and proper operation.

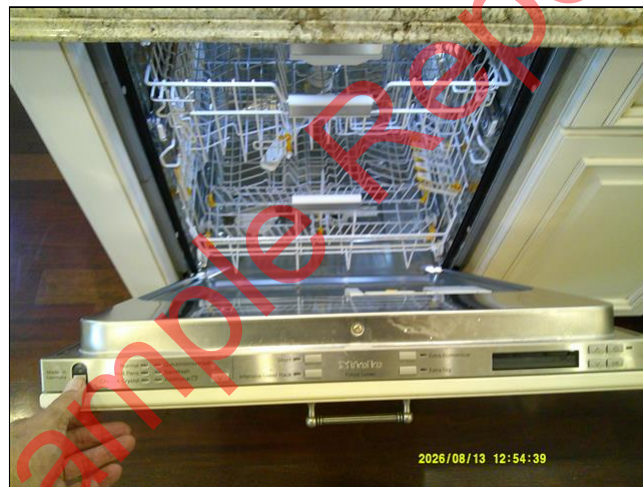
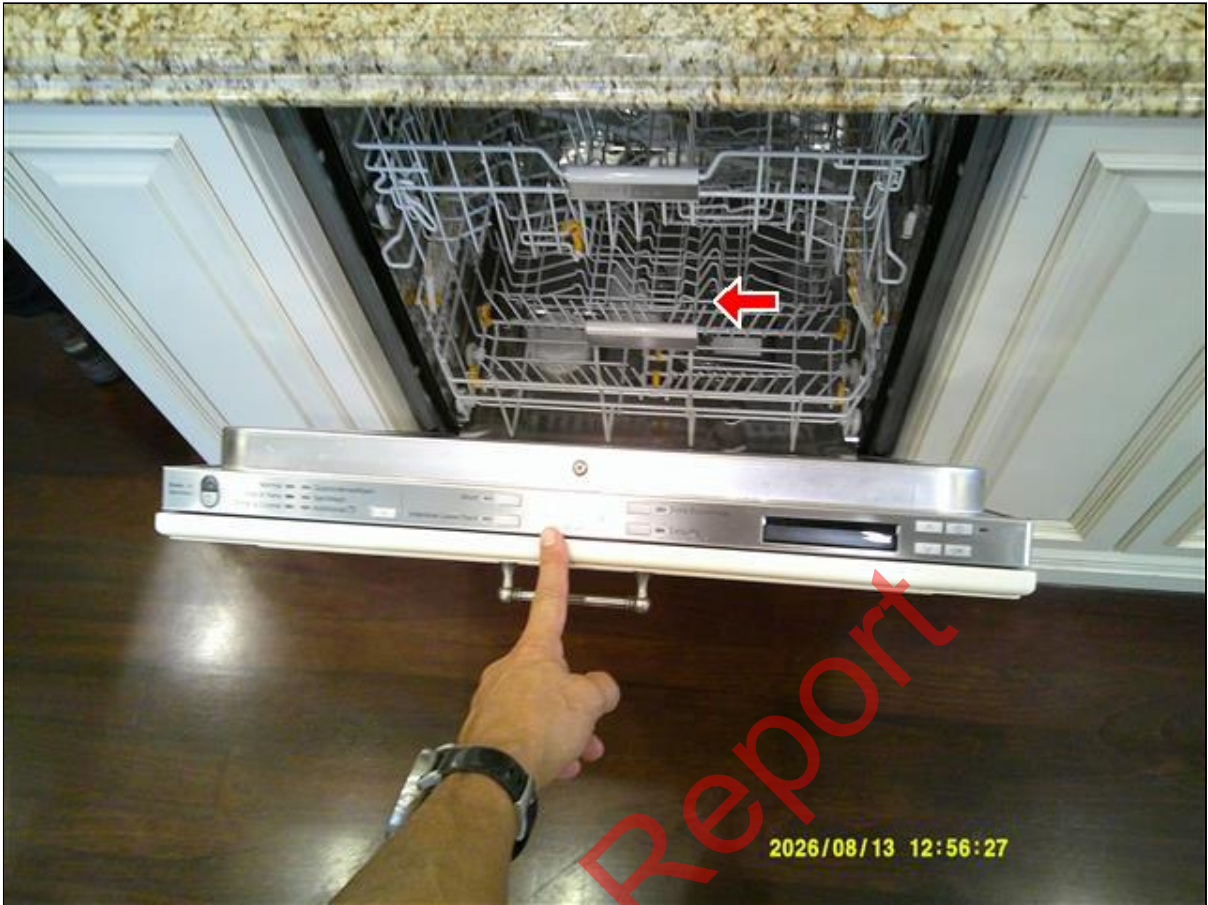
### 13.8 Dishwasher

The kitchen is equipped with two dishwashers. One dishwasher was tested and operated properly at the time of inspection. The second dishwasher was not operational at the time of inspection and did not function as expected when tested. The cause of the malfunction could not be determined during the home inspection. Evaluation and repair by a qualified appliance technician is recommended for the non-functional unit.

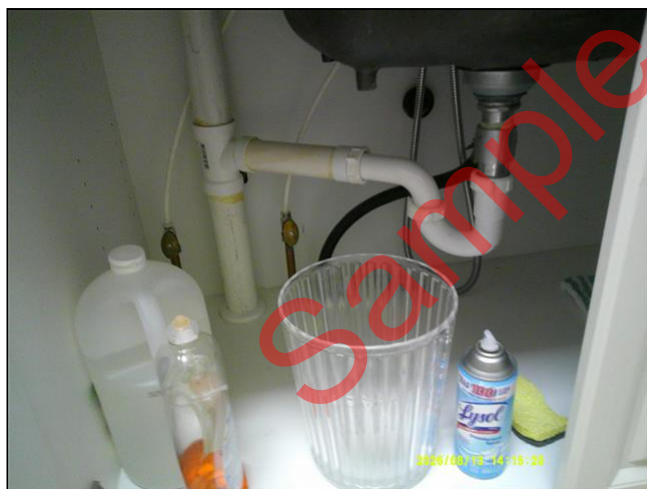
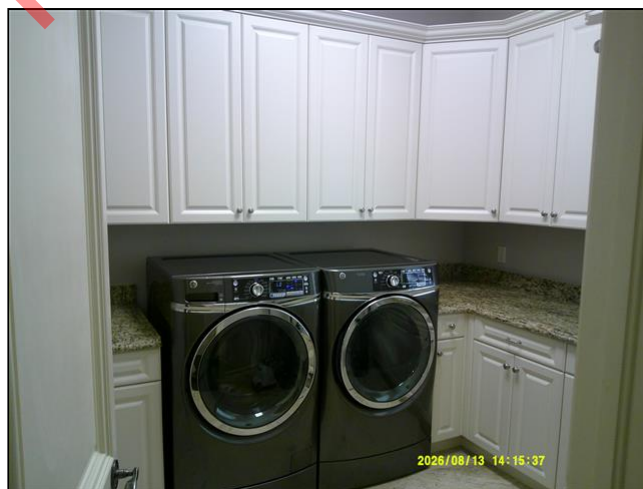
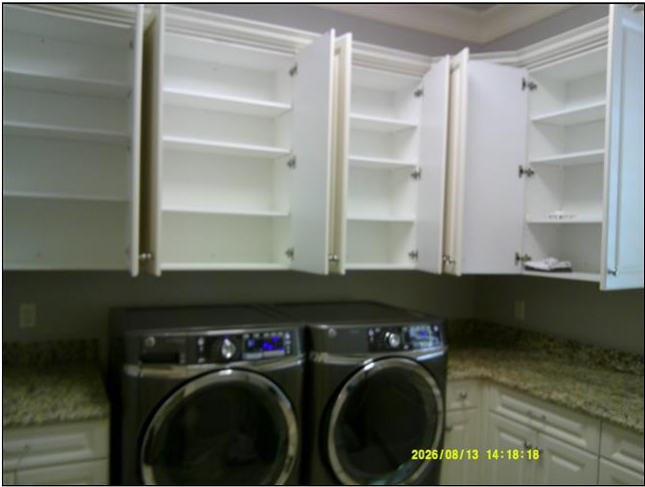
The laundry room cabinetry and counter was visually inspected and appeared generally serviceable and functional. Minor deterioration and normal wear were noted at localized areas of the cabinet finishes, consistent with age and routine use. No significant structural or functional deficiencies were observed in the readily accessible cabinet components.
