INSPECTION REPORT  
Royal Palm  
Boca Raton FL 33432

INSPECTED BY  
Angelo Menezes  
Certified Inspectors,  
LLC  
HI9467

INSPECTION DATE  
📅 8/13/2026  
🕒 11:00:00 AM

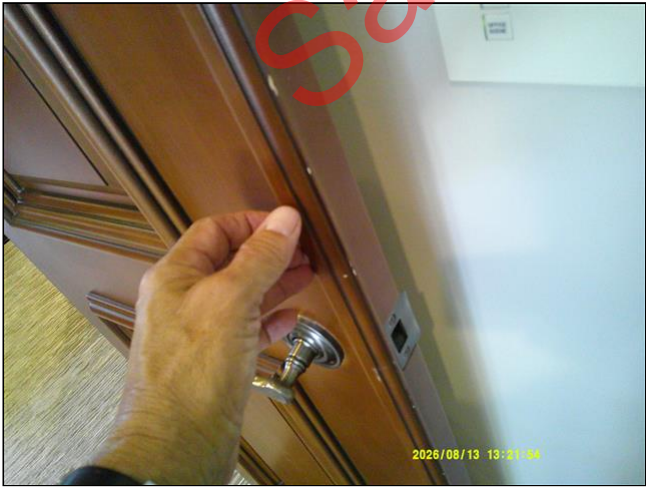
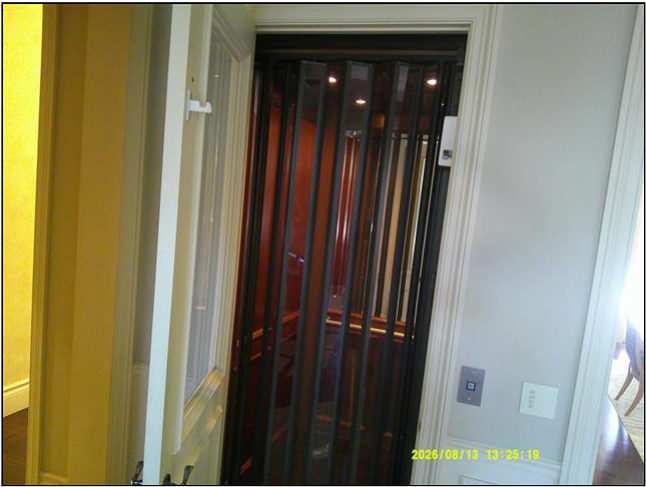
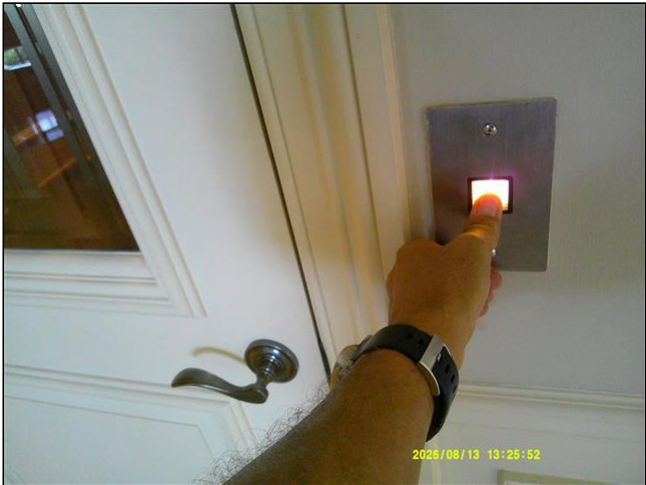
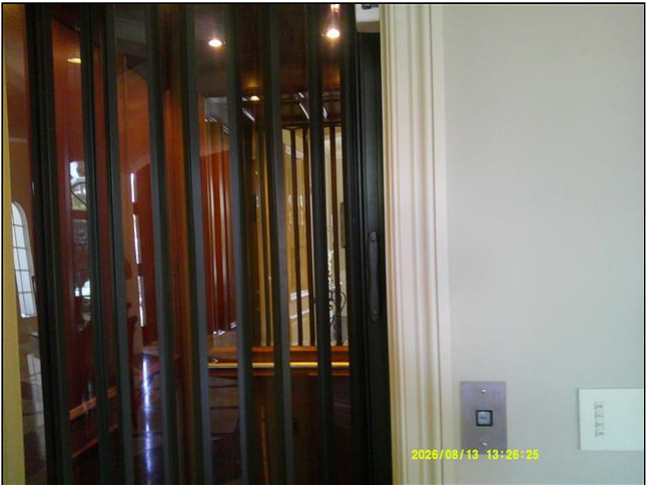
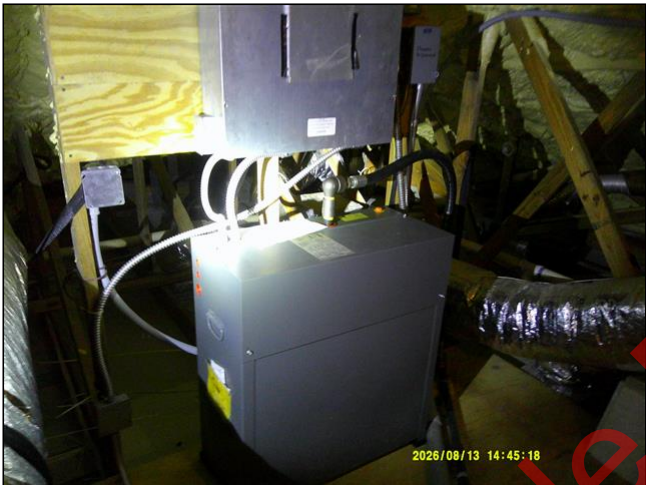
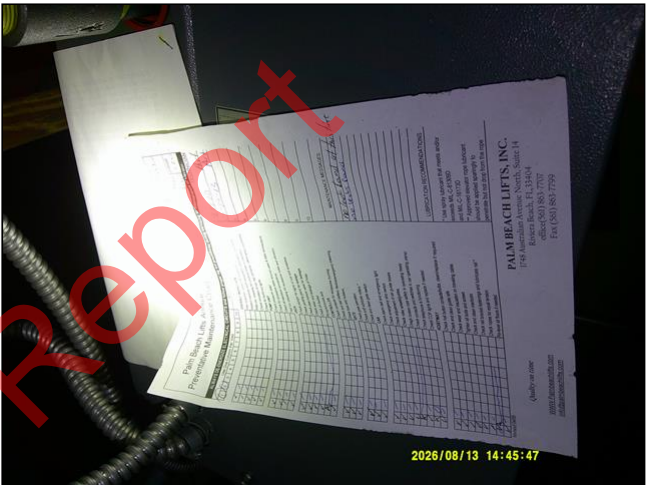
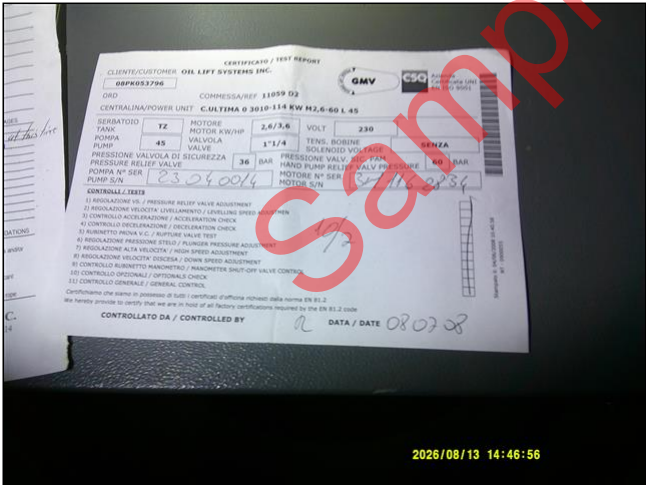
The property is equipped with a 2009 hydraulic home elevator, identified as a CULTIMA 3010, 11.4 kW unit manufactured by GMV, serving the residence via an enclosed elevator cab. At the time of the inspection, the elevator was not operational and could not be functionally tested. The property manager contacted the elevator service company during the inspection and was able to schedule a technician to evaluate and repair the system, with service reportedly scheduled for approximately two weeks after the inspection. Elevator maintenance and service records were requested but were not provided for review; therefore, the inspection could not verify the unit's maintenance history, prior repairs, or compliance/service history. Evaluation and repair by a qualified elevator contractor is recommended before relying on the elevator for normal use.

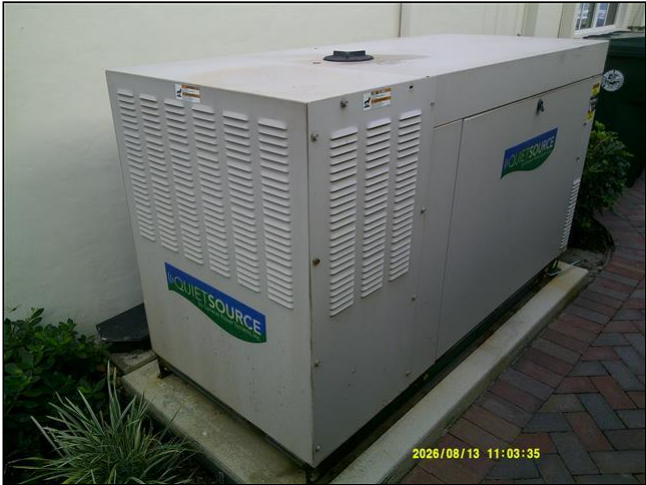
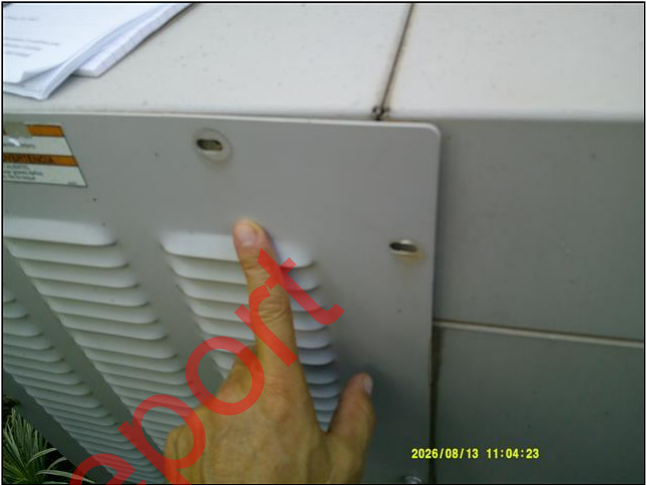
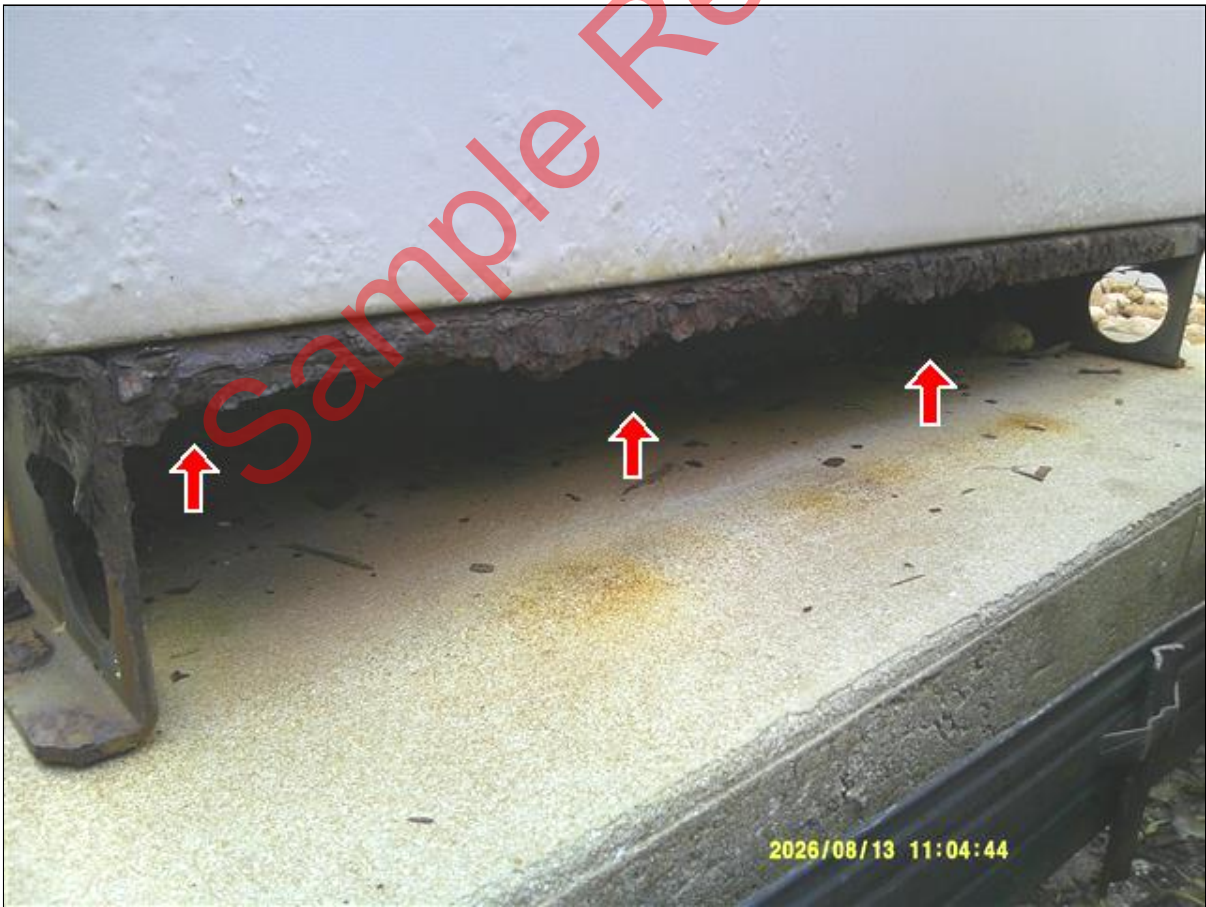
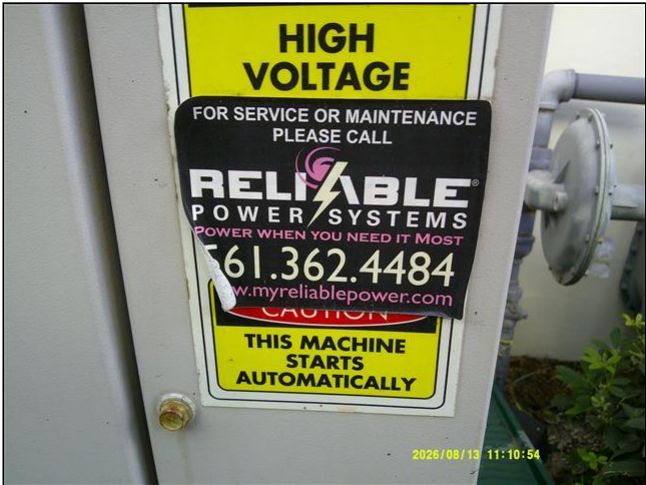
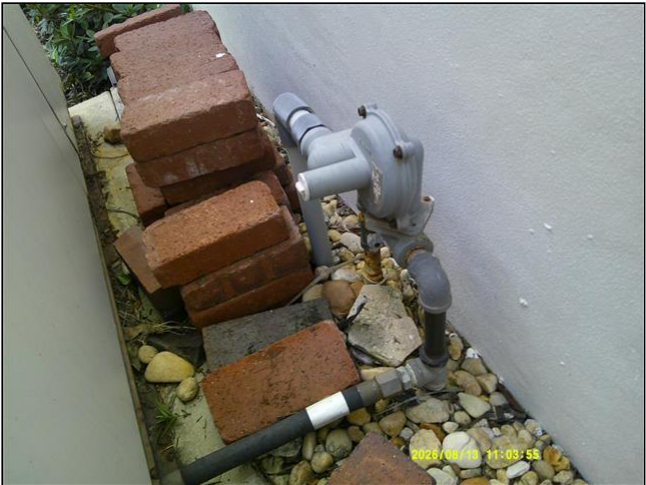
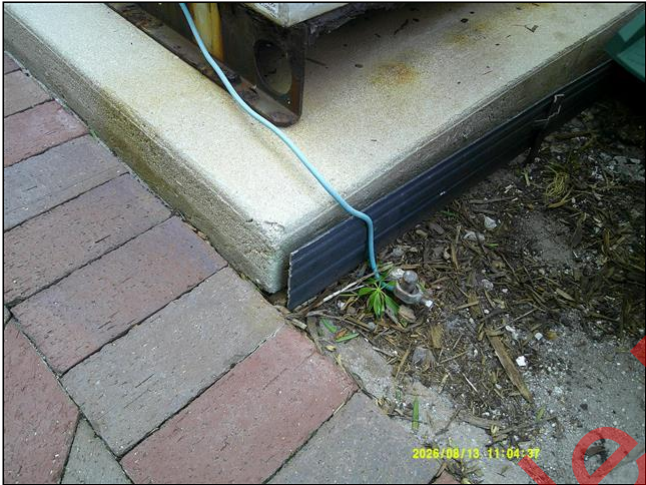
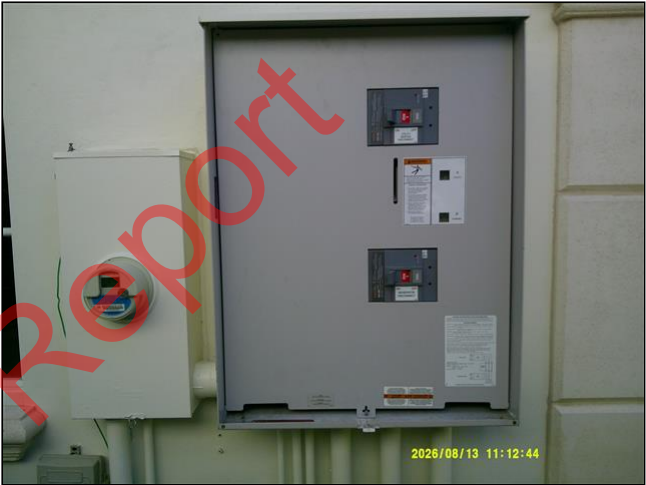
A 2009 Generac QuietSource permanent standby generator was observed at the property. Based on the unit's size and configuration, its capacity is estimated at approximately 40–48 kW; the exact capacity could not be verified from the accessible information. The generator configured to provide whole-house standby power via natural gas. An

associated automatic transfer switch/transfer equipment with separate utility and generator disconnects was also observed adjacent to the electrical service equipment. The generator was not operated or functionally tested during the inspection. Electrical irregularities were identified elsewhere in the home, including observed drops in power while testing kitchen appliances and multiple receptacles with open-ground conditions on one side of the residence. Due to these previously identified electrical conditions, the inspector did not disconnect power to the entire residence to initiate an automatic transfer and generator startup, as doing so could have resulted in additional electrical interruption or potentially unsafe conditions. Consequently, the generator's automatic startup, transfer operation, voltage output, load performance, and related functions were not verified. Further evaluation and operational testing of the generator and transfer equipment by a qualified generator/electrical contractor is recommended, particularly before relying on the system for whole-house emergency power.

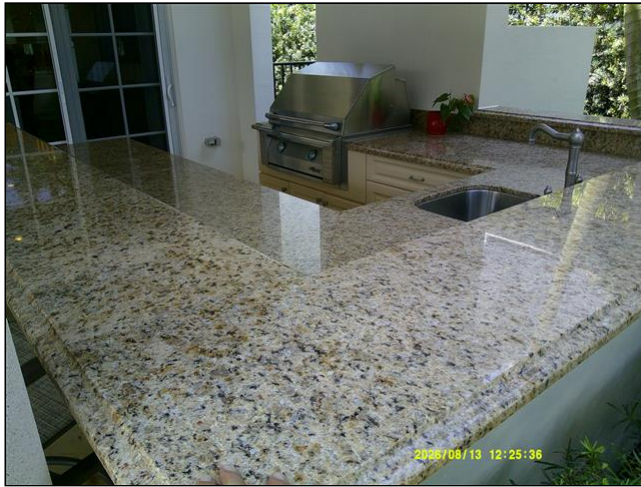
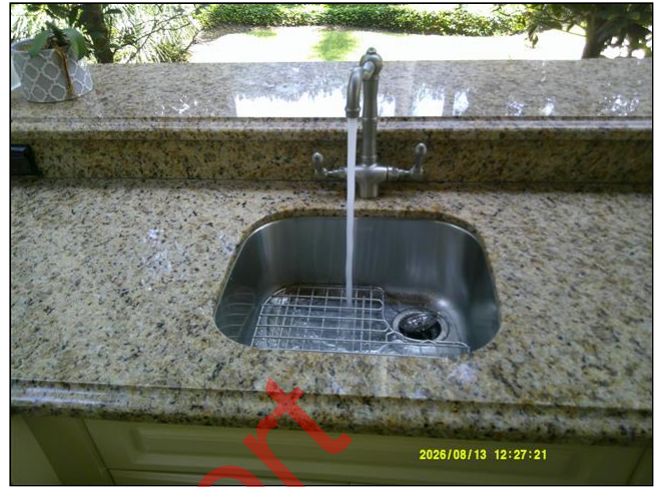
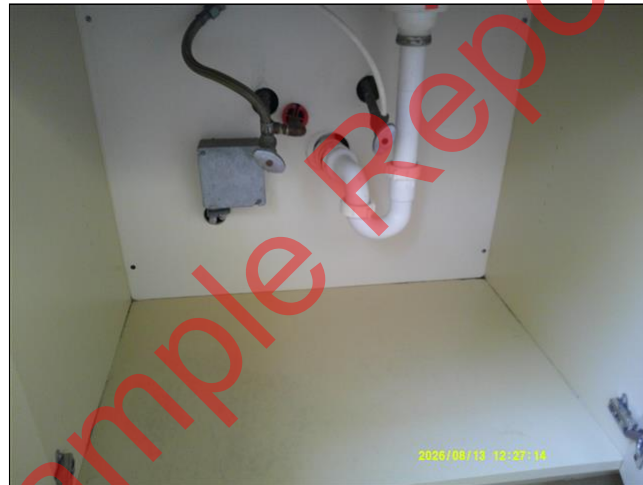
**17.0 Counter & Cabinets**  
**Comments:** Inspected

The outdoor kitchen includes granite countertop surfaces, built-in cabinetry, and an integrated sink/plumbing system. The countertops and cabinets were generally observed to be in good, serviceable condition, with minor deterioration and normal weather-related wear noted at localized areas. The accessible plumbing beneath the sink appeared generally intact, with no significant leakage or damage observed at the time of inspection. Continued routine maintenance and sealing of the exterior cabinetry and countertop surfaces is recommended as needed to protect the materials from ongoing exposure to weather and moisture.

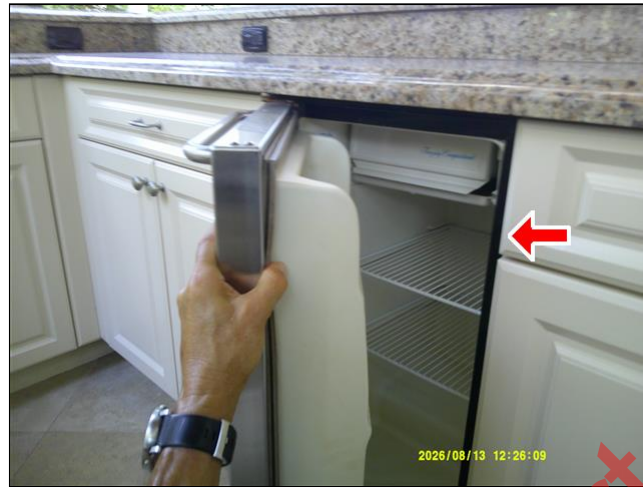
#### 17.1 Appliances

A small built-in refrigerator was installed as part of the outdoor kitchen. The refrigerator was not operational at the time of inspection and did not provide cooling when tested. The cause of the malfunction could not be determined during the inspection. Evaluation and repair or replacement by a qualified appliance technician is recommended before relying on the unit for use.

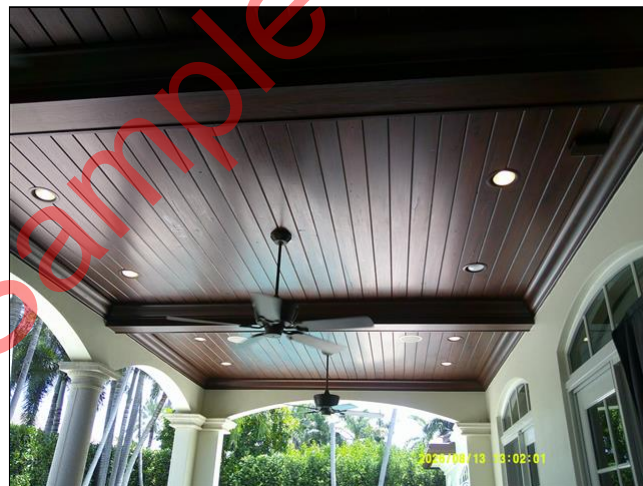
## 17.2 Ceilings

The covered outdoor kitchen and patio areas feature a wood-paneled tongue-and-groove ceiling with exposed decorative beams, recessed lighting, and ceiling fans. The ceiling forms part of the covered exterior living area and provides a finished architectural surface while protecting the patio from direct weather exposure. The visible wood components, trim, lighting fixtures, and ceiling fans appeared generally well maintained and in good, serviceable condition at the time of inspection. No significant sagging, deterioration, staining, or other readily visible deficiencies were noted. Continued routine maintenance and periodic sealing/painting of the exterior wood finish are recommended to protect the ceiling from the effects of moisture, humidity, and prolonged outdoor exposure.

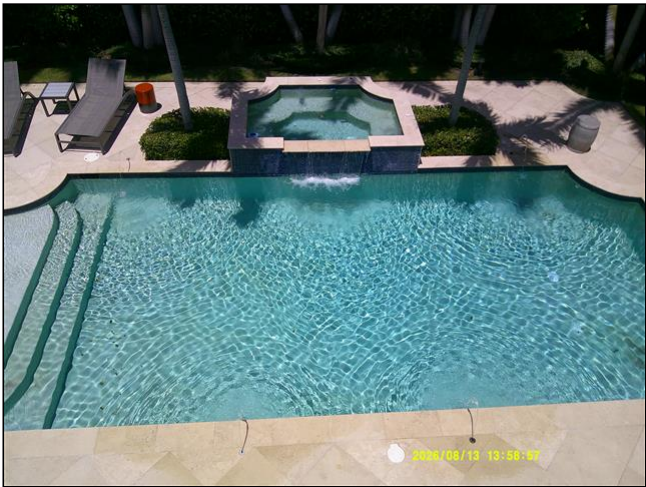
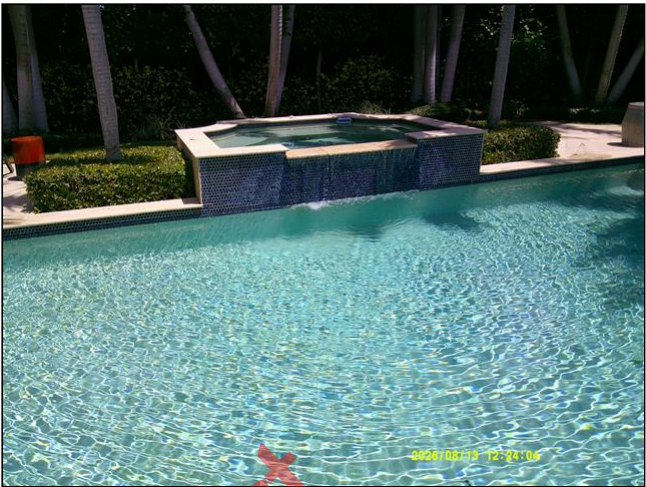
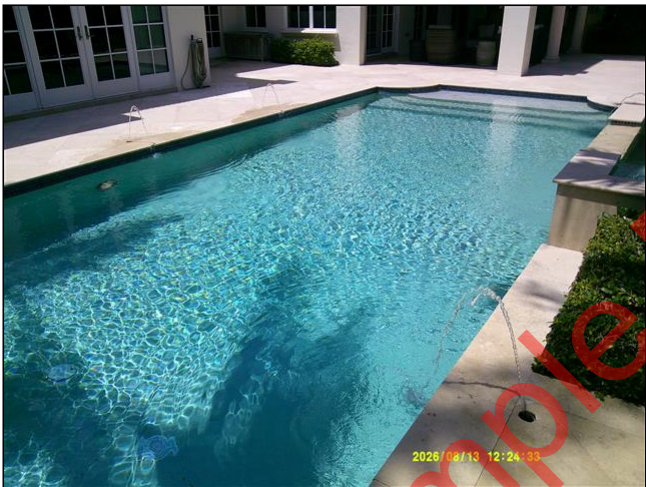
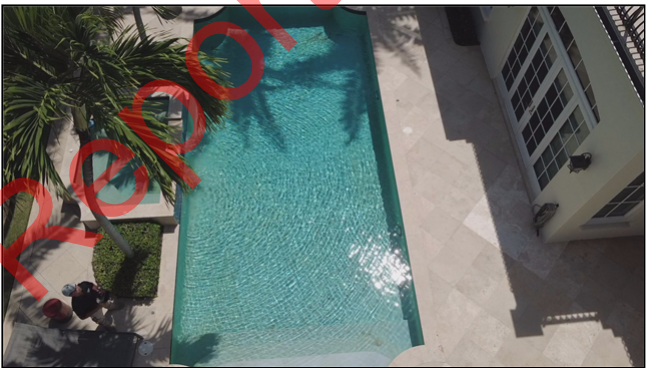
The swimming pool and spa vessel are constructed of gunitite/concrete with a plaster interior finish. The pool was filled and circulating at the time of inspection. Staining and localized surface scaling/deposits were observed on the plaster finish, consistent with mineral buildup and/or water-chemistry-related surface deterioration. The observed conditions

are primarily surface-related at this time; however, continued scaling can contribute to progressive deterioration of the plaster if not addressed. Professional pool service is recommended to evaluate the water chemistry and plaster condition and to clean or acid-wash the affected surfaces as appropriate. Any acid-washing should be performed by a qualified pool contractor using methods appropriate for the existing plaster finish.

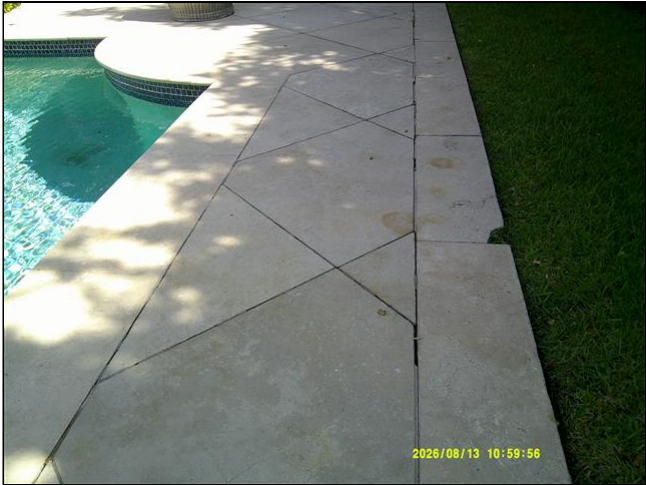
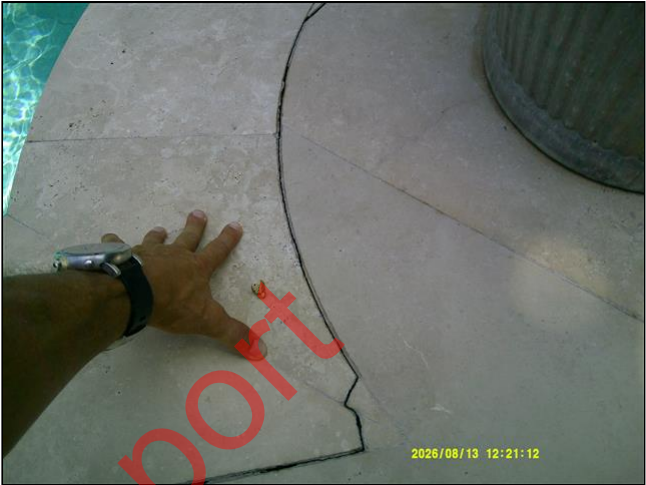
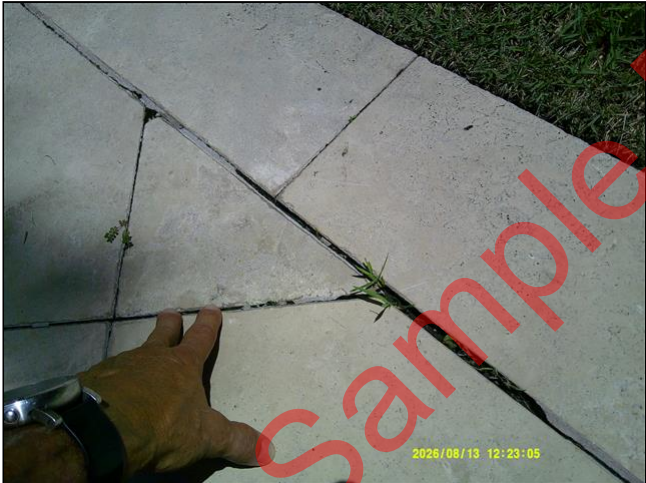
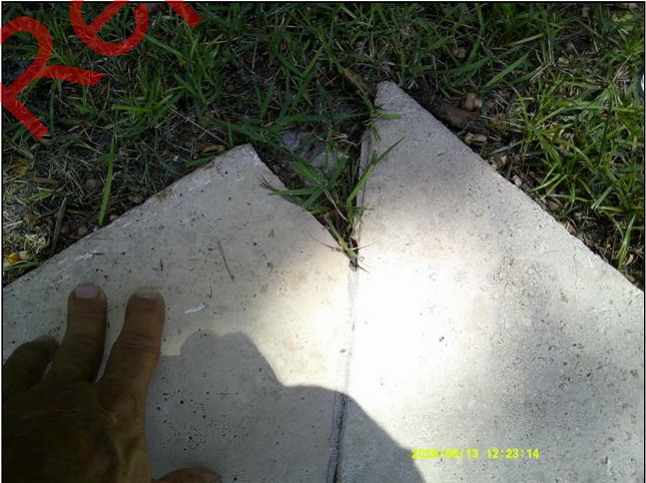
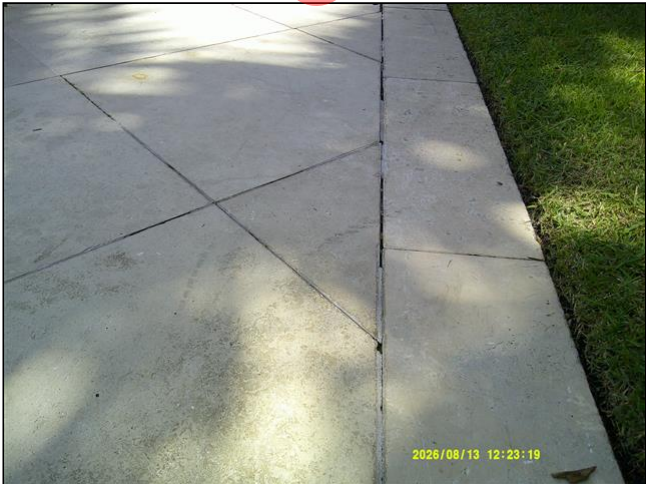
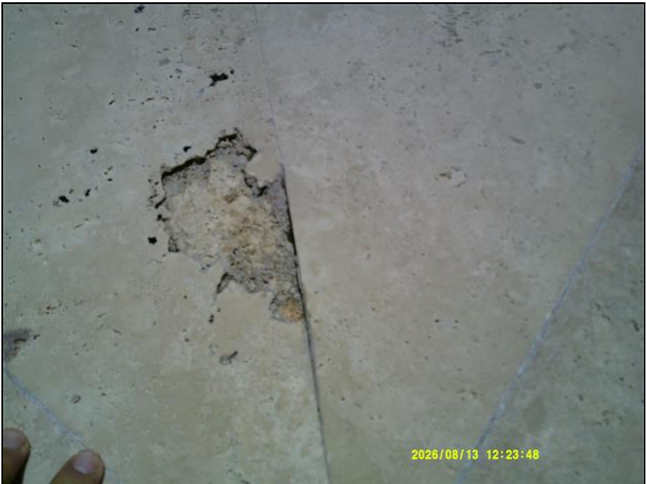
18.2 Deck

The pool deck consists primarily of natural stone/tile pavers installed over a concrete substrate and extends around the swimming pool and spa. The deck was generally serviceable; however, multiple cracks, open joints, and localized separation between deck sections were observed. Some joints were sufficiently open to allow vegetation growth, and several areas appeared uneven or displaced. These conditions can develop further with movement, moisture intrusion, or settlement and may create localized trip hazards.

Recommend evaluation by a qualified pool-deck/masonry contractor, with repair of cracked or separated sections, restoration/sealing of open joints, and correction of any displaced or uneven areas as necessary.

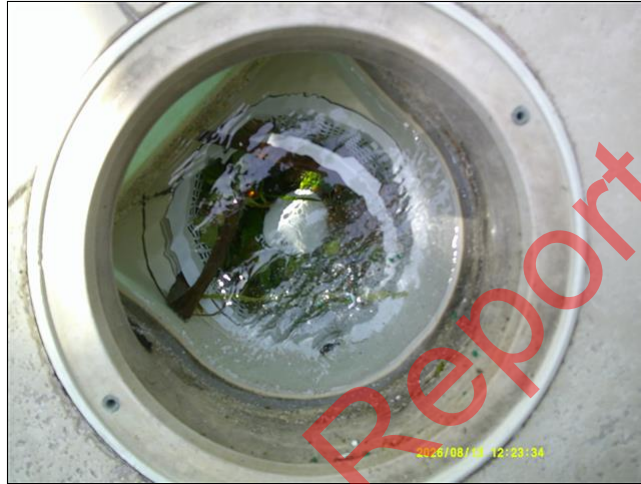
The pool system includes surface skimmers, floor/drain fittings, and return/venturi jets associated with the circulation and filtration system. These components were visually inspected where accessible and appeared generally intact and functional, with water circulation observed during the inspection. Minor debris and mineral buildup were present at some fittings and drain/skimmer components, consistent with normal outdoor pool operation. Routine cleaning and maintenance of the skimmers, drains, and return fittings should be continued to maintain proper water circulation and filtration.

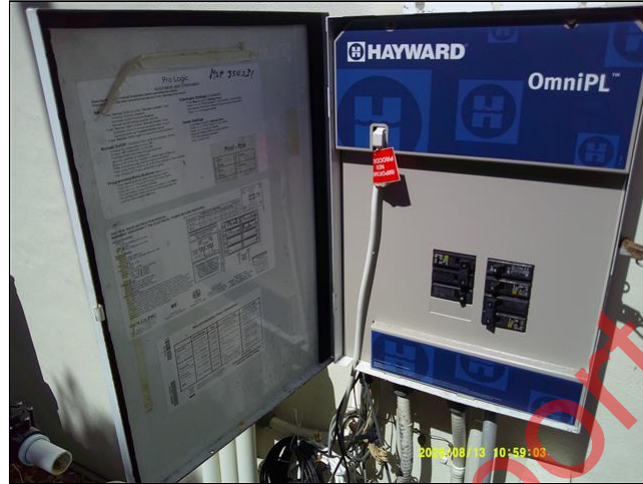
The pool and associated equipment are served by a dedicated Hayward OmniPL pool automation/control system with associated circuit breakers, controls, and electrical components. The equipment enclosure and controls were visually inspected. The system appeared generally intact and functional at the time of inspection, with no significant visible damage to the accessible enclosure or breakers noted. Because pool electrical systems are exposed to moisture and present specific electrical safety considerations, the inspection was limited to readily accessible components and basic operational observations. Specialized testing of bonding, grounding, GFCI protection, equipment grounding continuity, and other concealed or specialized pool electrical components is outside the scope of a general home inspection and should be performed by a qualified pool electrician when warranted.

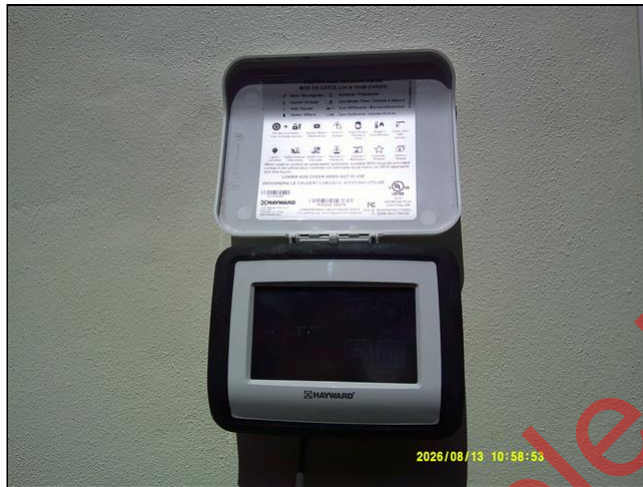
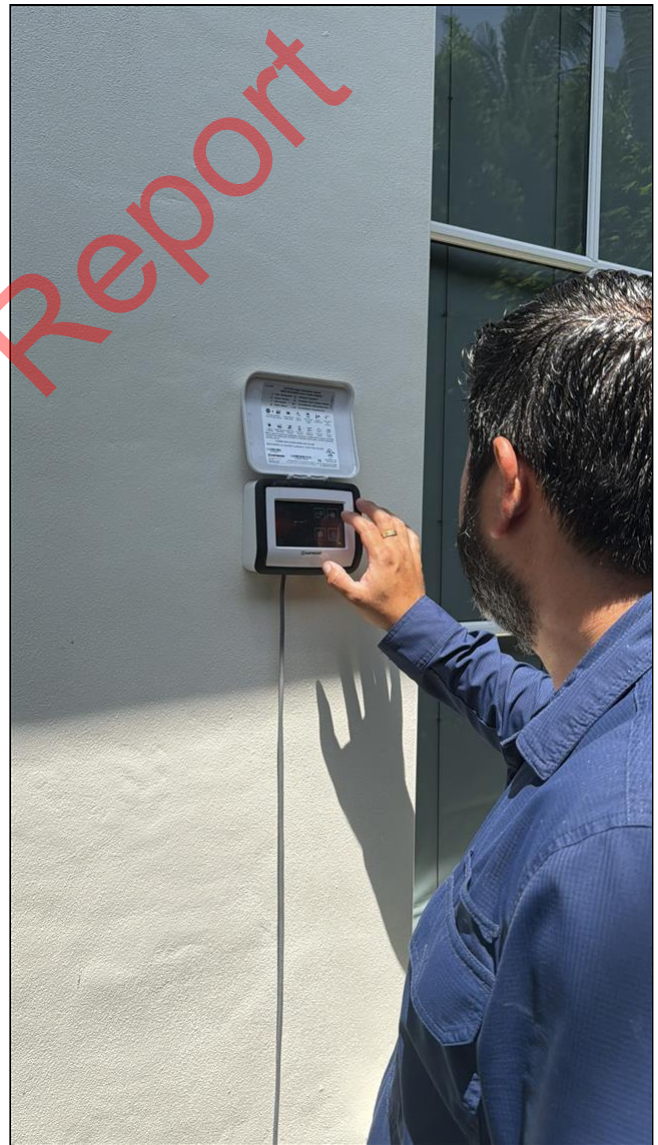
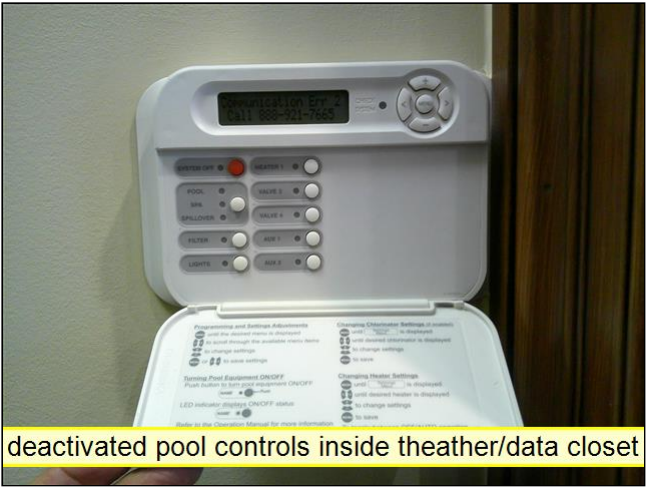
#### 18.7 Control Systems

The pool and spa are equipped with a Hayward OmniPL automation and control system, which provides centralized control of the pool circulation equipment, heating system, spa functions, water features, lighting, and other connected pool equipment. The system includes a wall-mounted digital/touchscreen controller located near the pool equipment. Although the controller appeared physically intact, operation of the controls was difficult during the inspection, even with assistance from the property manager. The property manager was unable to successfully operate the pool heater or activate the spa jets using the controller at the time of inspection. Consequently, proper operation of these functions could not be verified.

deactivated pool controls inside theater/data closet

Hayward Omni automation systems can be configured with remote/mobile control capability, depending on the specific installation and whether the system has the required internet/network connection and associated equipment. A mobile application/remote-access function may therefore be available for this installation, but no remote control device, mobile application, or network-access credentials were provided or made available for testing during the inspection. The inspector therefore could not determine whether remote operation was installed or functional. Recommend that the owner/property manager demonstrate operation of all pool automation functions, including pool and spa heating, spa jets, pumps, valves, lighting, and any available remote/mobile controls, or have the system evaluated and serviced by a qualified Hayward pool automation technician.

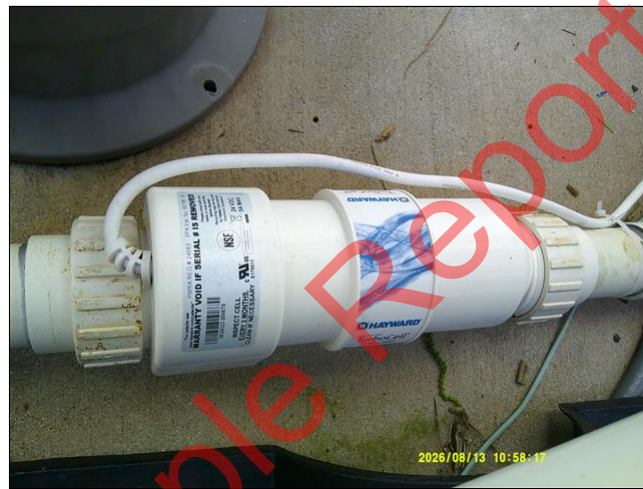
At the time of inspection, the salt-chlorination system information/status could not be successfully read or verified through the Hayward OmniPL controller. The property manager was unable to access the system's operating information sufficiently to confirm the cell's chlorine-production status, salt level, or other operating parameters. Therefore, proper operation of the salt-generation system could not be confirmed.

The TurboCell is a self-cleaning cell, but it still requires periodic inspection for calcium/mineral scaling. In normal service, the cell should generally be visually inspected approximately every 2–3 months and cleaned when significant scale or mineral buildup is present. Cleaning frequency depends heavily on pool water chemistry, particularly pH, calcium hardness, and water temperature; frequent acid cleaning is not recommended because excessive cleaning can shorten cell life. The cell and automation system should be evaluated by a qualified pool technician, including verification of communication with the OmniPL controller, chlorine production, salt concentration, and the condition of the TurboCell.

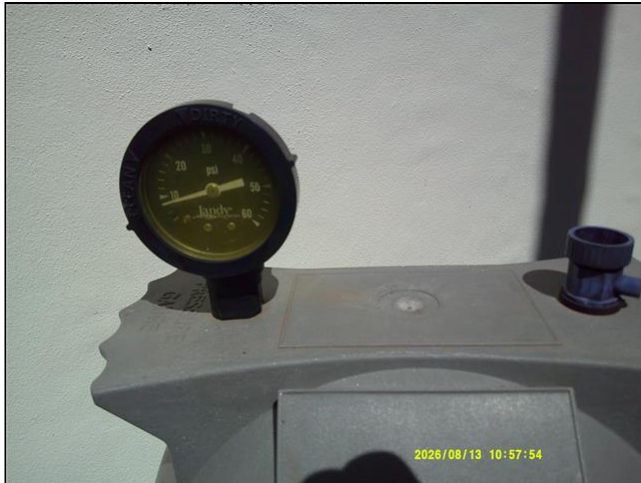
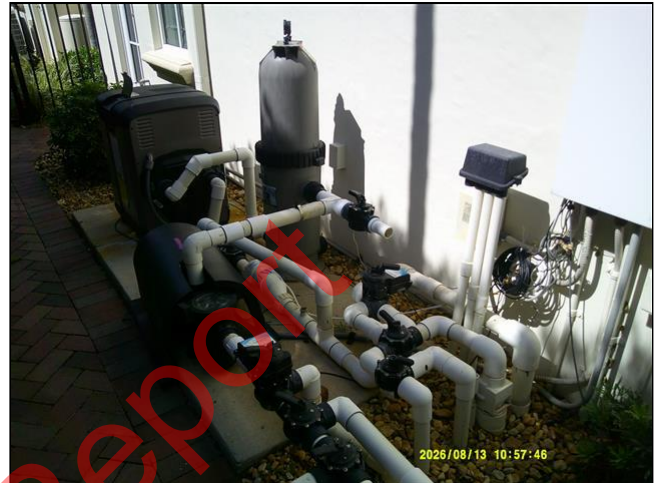
### 18.9 Filters

The pool is equipped with a Hayward swimming pool filtration and circulation system, consisting of a cartridge-style filter assembly, circulation pump, pressure gauge, valves, and associated PVC piping. The filter is designed to remove suspended debris and contaminants from the circulating pool water, with the pressure gauge used to monitor system pressure and indicate when filter cleaning or servicing may be needed.

The filtration equipment appeared generally intact and serviceable at the time of inspection. Water circulation was observed, and no significant visible leakage or damage to the accessible filter housing, pump, valves, or associated piping was noted. Routine maintenance should include monitoring the filter pressure and cleaning the filter media in accordance with the manufacturer's recommendations and whenever the operating pressure rises above the system's normal clean-filter pressure.

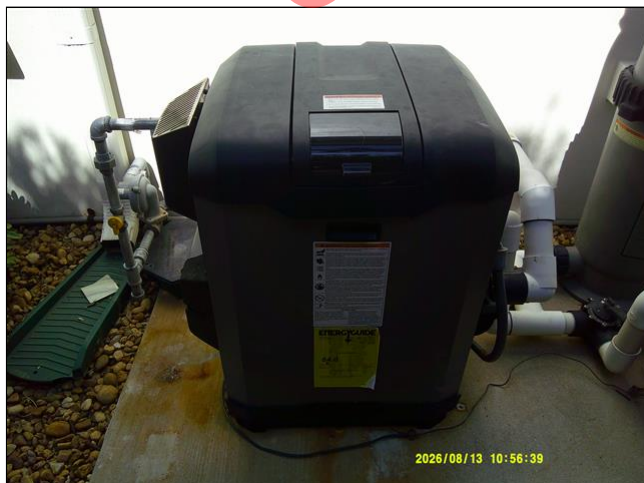
#### 18.10 Heating System

The pool is equipped with a Hayward gas-fired pool heater, integrated with the Hayward pool automation/control system. The heater was visually inspected, but its operation could not be verified at the time of inspection. The property manager was unable to successfully operate the pool heater through the pool controller, which was also difficult to navigate and operate during the inspection. As a result, the heater could not be demonstrated in operation, and proper ignition, heating performance, temperature control, and safety functions could not be confirmed.

The heater appeared generally intact from the accessible exterior; however, its functional condition remains undetermined. Recommend evaluation by a qualified pool-heating/Hayward service technician, including verification of the heater, controls, gas supply, ignition, heating operation, and communication with the OmniPL automation system.

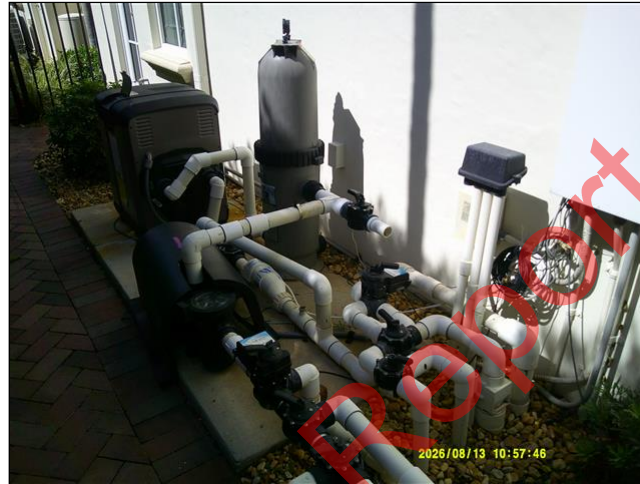
### 18.11 Plumbing System

The pool and spa plumbing system consists primarily of PVC circulation piping, valves, fittings, and associated connections serving the pool, spa, filtration system, heater, salt-chlorination system, and water features. The accessible portions of the plumbing appeared generally intact and serviceable, with water circulation observed during the inspection and no significant active leakage noted at the readily accessible piping and connections.

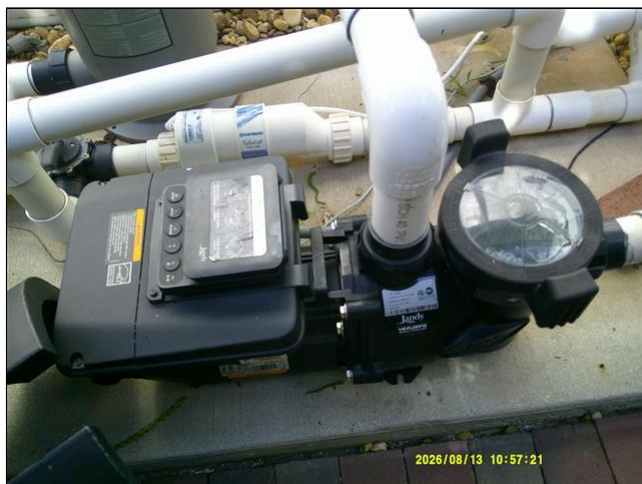
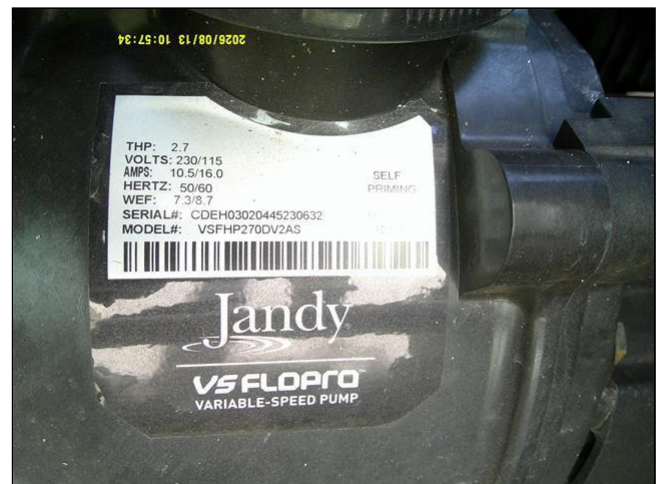
### 18.12 Pump

The pool circulation system is equipped with a Jandy variable-speed VS FloPro pump, designed to provide adjustable circulation rates for the pool and associated equipment. The pump includes an integrated electronic speed/control interface and a clear strainer basket housing for monitoring debris and water flow. The pump was operating at the time of inspection and water circulation was observed. The accessible pump housing, motor, and plumbing connections appeared generally intact, with no significant active leakage or visible damage noted.

Routine maintenance should include cleaning the strainer basket, monitoring pump operation and operating pressure, and servicing the pump in accordance with the manufacturer's recommendations.

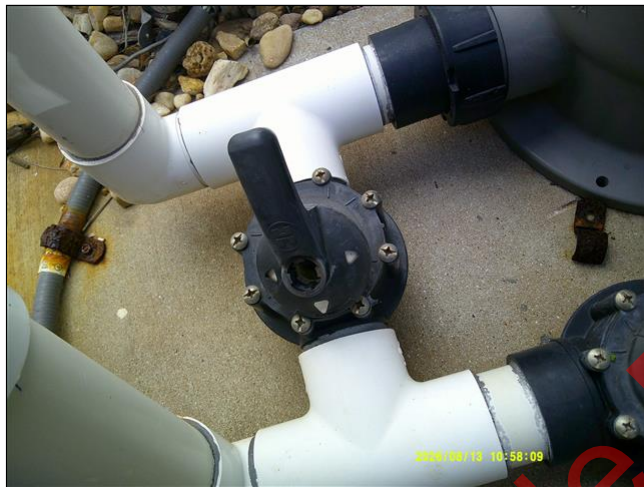
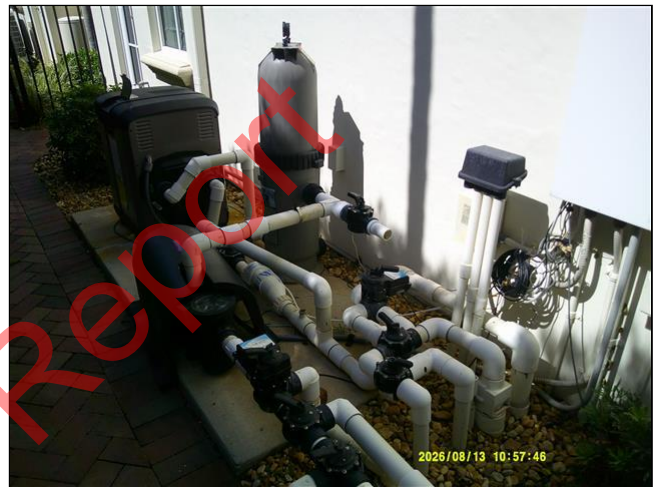
### 18.13 Pool Valve Actuator Control

The pool circulation system is equipped with motorized valve actuators associated with the pool/spa automation system. These electrically operated actuators are used to automatically change water-flow paths between the pool, spa, heater, filtration system, and other water features when commanded by the pool control system. The actuators and associated valves were visually inspected and appeared generally intact; however, their full operation could not be verified because the pool automation controls could not be successfully demonstrated during the inspection. The property manager was unable to operate the controller sufficiently to demonstrate functions such as the spa jets and pool heater. Accordingly, the proper operation and positioning of the motorized valves and actuators remains undetermined.

Recommend evaluation by a qualified pool service technician to verify operation of all valve actuators, valves, and associated automation controls and to confirm that the system properly switches between pool, spa, heating, filtration, and water-feature modes.

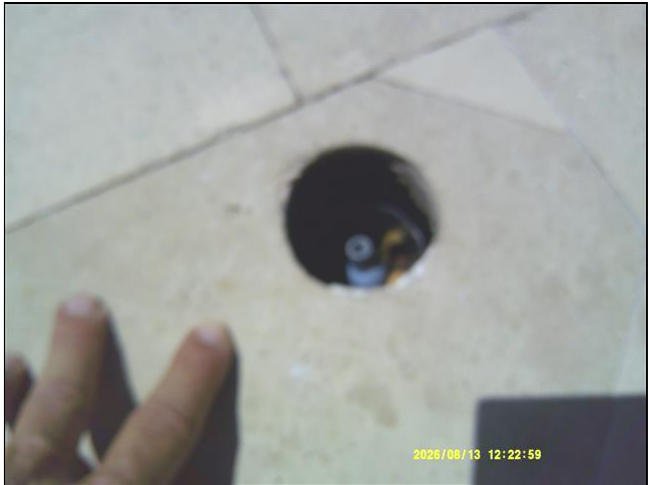
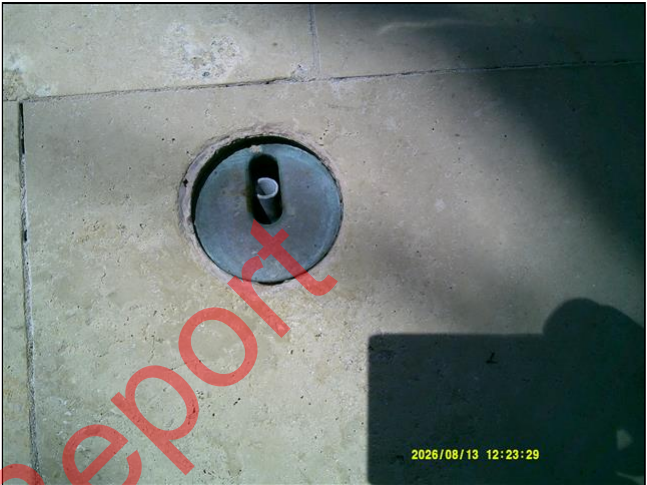
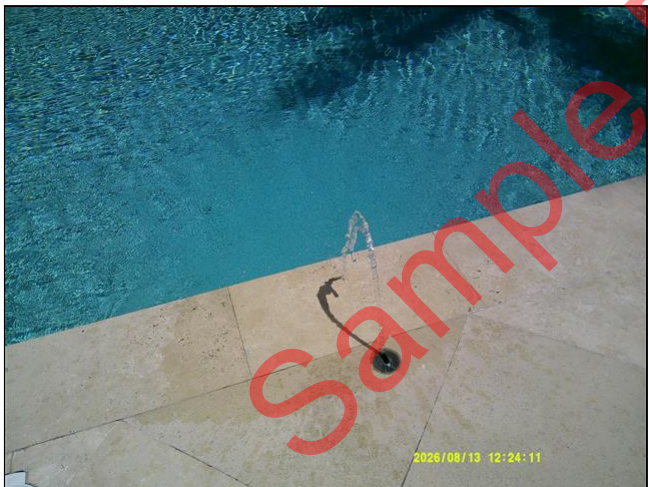
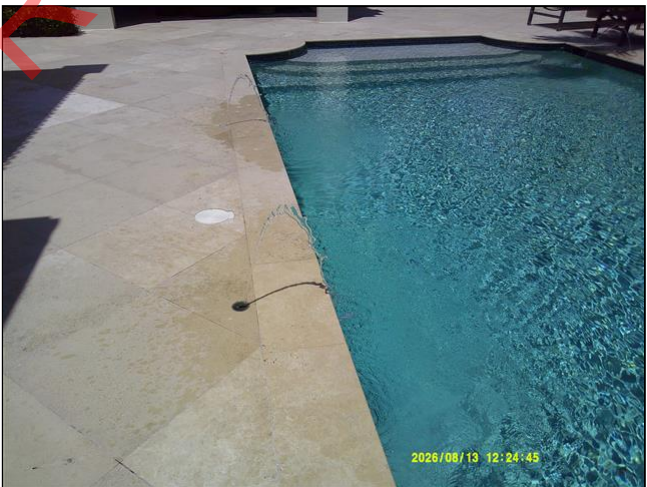
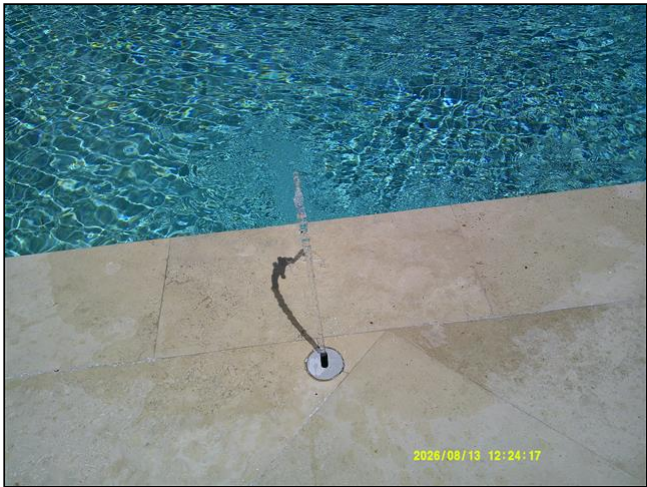
### 18.14 Water Feature

The pool includes decorative water-feature returns/fountains designed to discharge water into the pool. At the time of inspection, the water feature exhibited weak/limited water flow, and one of the water-feature fittings was missing its protective/cosmetic cap. Because of the reduced flow, water was observed overshooting/spilling onto the adjacent pool deck, creating unnecessary wetting of the deck surface. The cause of the reduced flow could not be determined during the general inspection and may involve valve positioning, pump flow, obstruction, or the water-feature fitting itself.

Recommend evaluation and adjustment by a qualified pool contractor, including inspection of the associated valve/actuator, plumbing, and water-feature fitting. The missing cap should also be replaced, and the feature should be adjusted so that discharged water remains within the pool rather than wetting the surrounding deck.

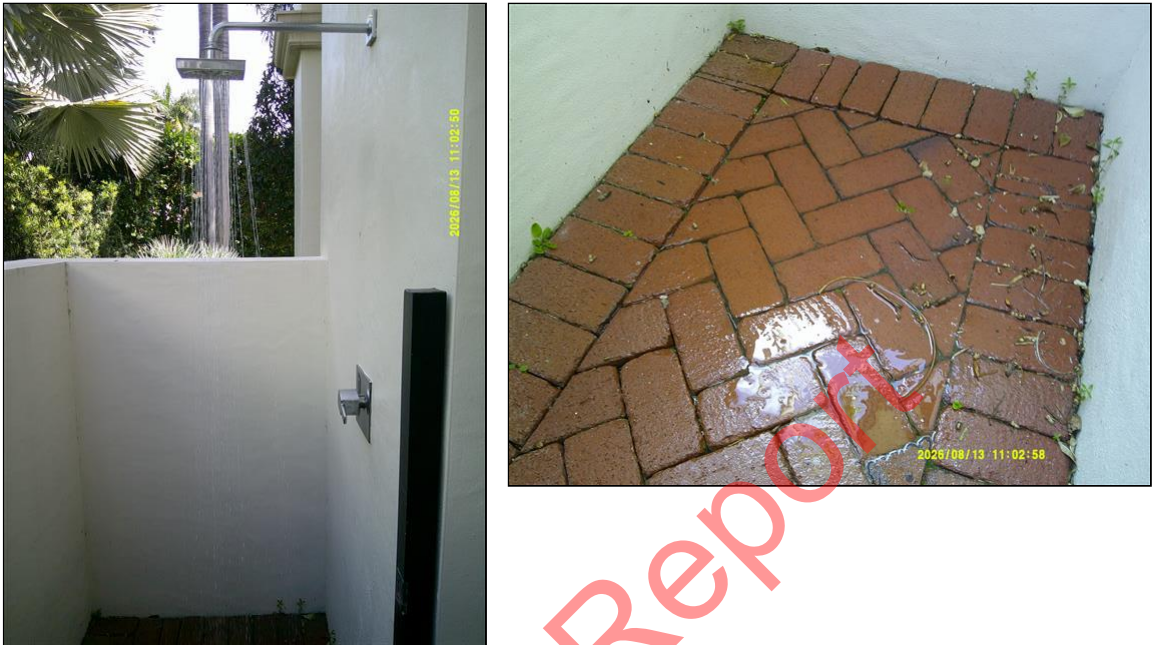
18.15 Outdoor Shower

An exterior shower is provided at the pool area and includes a wall-mounted shower fixture and control valve. The shower enclosure and fixtures appeared generally intact and serviceable at the time of inspection. However, the shower area does not appear to have a dedicated drain or effective drainage system, and water can remain on the brick-paver surface after use. This condition may contribute to standing water, staining, vegetation growth, and deterioration of the surrounding finishes. Improving drainage and maintaining positive water runoff away from the structure is recommended.

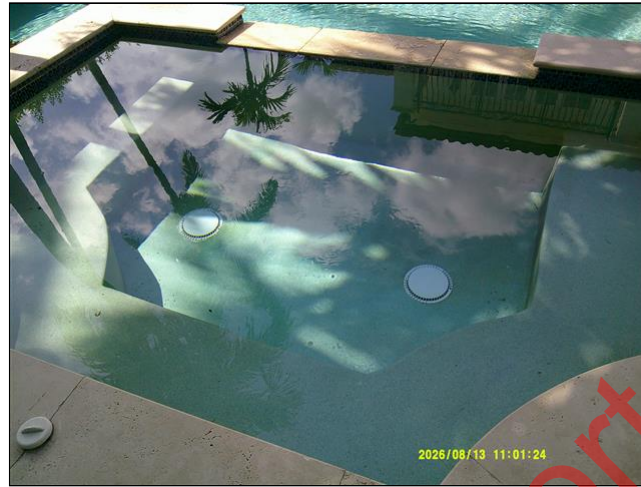
The spa vessel is constructed of gunite/concrete with a plaster interior finish and is integrated with the swimming pool system. The spa was filled with water and appeared generally intact at the time of inspection. Surface staining and localized mineral scaling/deposits were observed on portions of the plaster finish, similar to conditions noted in the main pool. These conditions are consistent with surface buildup and/or water-chemistry-related deterioration. Professional pool service is recommended to evaluate the spa water chemistry and plaster condition and to clean or acid-wash the affected surfaces as appropriate, using methods suitable for the existing plaster finish.

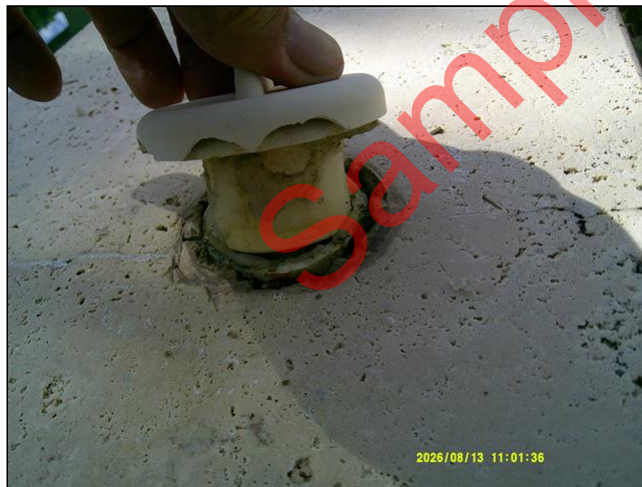
### 19.1 Misc. Components (Drains, Ladder, Skimmer, Venturi)

The spa is equipped with hydrotherapy jet and circulation fittings integrated into the spa vessel. The accessible fittings were generally intact; however, localized mineral buildup, staining, and deterioration were observed around some of the fittings and their surrounding seals/finish. One or more fitting covers also showed signs of age-related deterioration. The condition of concealed portions of the jet assemblies and associated plumbing could not be determined through visual inspection. Recommend cleaning and servicing the affected fittings and replacing deteriorated covers, seals, or fittings as necessary. A qualified pool contractor should also verify proper operation of the spa jet system and inspect the fittings for secure attachment and watertight connections.
