INSPECTION REPORT  
Royal Palm  
Boca Raton FL 33432

INSPECTED BY  
Angelo Menezes  
Certified Inspectors,  
LLC  
HI9467

INSPECTION DATE  
📅 8/13/2026  
🕒 11:00:00 AM

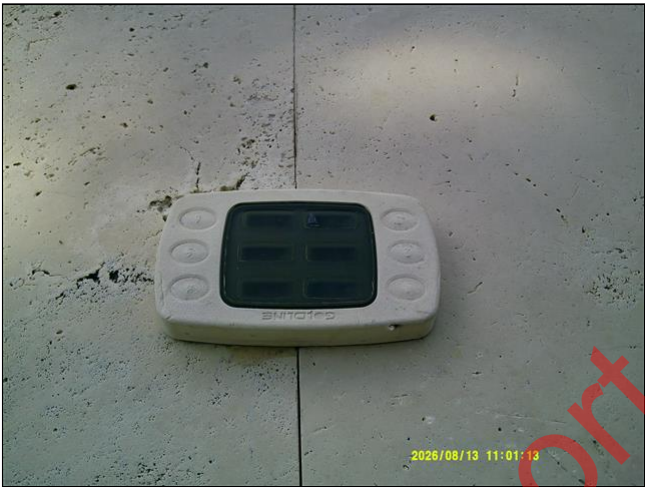
### 19.2 Control Systems

An older SunTouch spa control/interface was observed at the spa. The control appears to be an older auxiliary controller and did not appear to be operational at the time of inspection. The pool and spa equipment has since been integrated into the newer Hayward OmniPL automation system, which appears to be the primary control system for the pool and spa. Because the older SunTouch controller could not be demonstrated and its relationship to the current automation system could not be fully verified, its present functional status is undetermined. The controller should be evaluated by a qualified pool automation technician, and it should be removed, repaired, or properly decommissioned as appropriate so that it does not create confusion regarding operation of the spa system.
